**Technology Transfer Demonstrations and Post-Mortem Testing of Cast Iron
and Steel Pipe Lined with Cured-in-Place Liners (CIPL)**

**Final Report
(Public Version)**

**HE Stewart, TD O'Rourke, BP Wham, AN Netravali, C Argyrou, X Zeng,
and TK Bond**

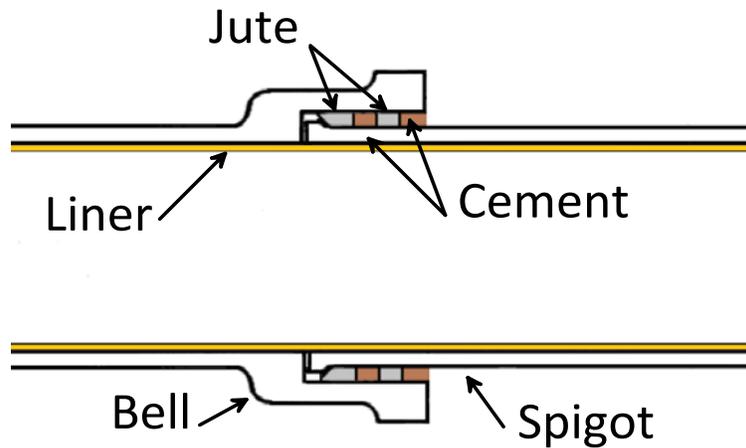
Figure 4.2. Schematic of Cement Caulked Joint for 6 in. (150 mm) Pipe Specimens

Figure 4.2 shows a schematic of the joint in the 6-in. (150-mm) CI pipe. The joints were caulked with cement mortar and jute packing. They were very stiff joints.

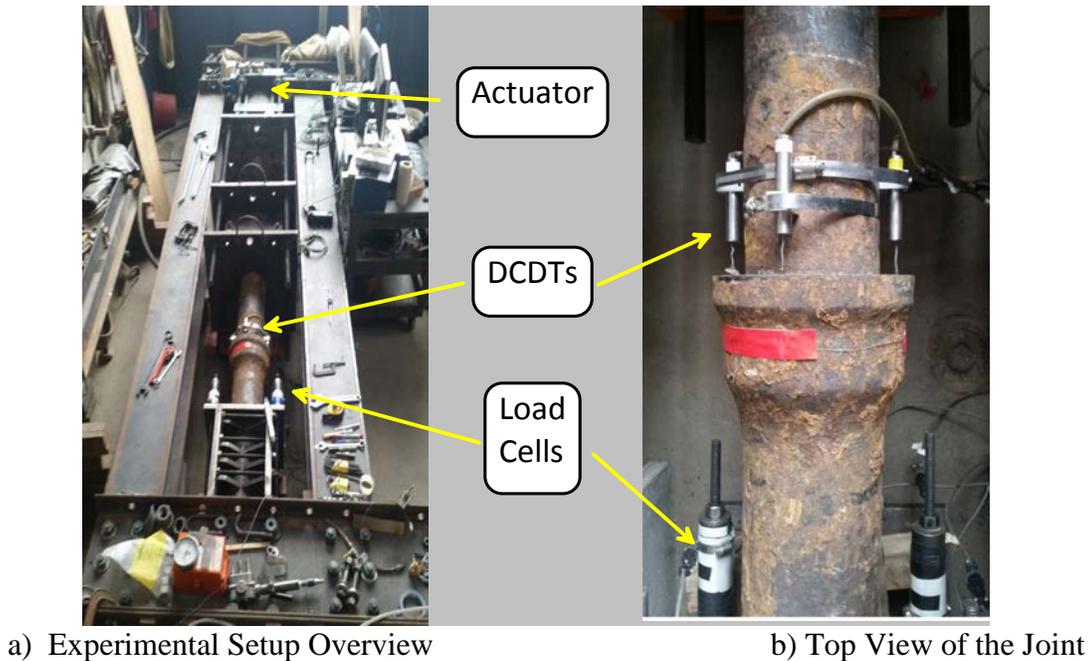
Figure 4.9. Specimen 6-1 in Test Frame for Thermal Loadings

Figure 4.9 shows photographs of Specimen 6-1 in the test frame used to apply thermal cycles.

Specimen 6-1 did not leak throughout all of the mechanical aging tests. Further, the interior of the pipe section showed the highly desirable effect of local debonding of the liner in the vicinity of the joint.

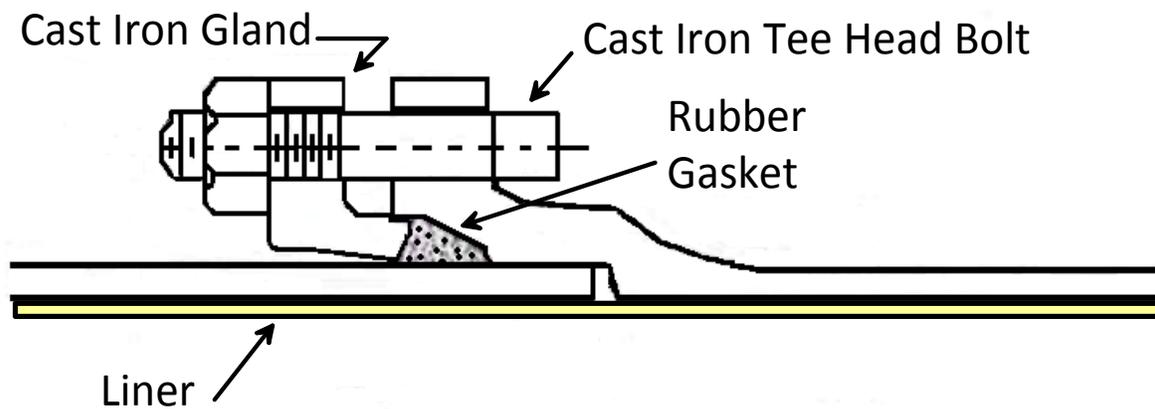
Figure 5.4. Schematic of Mechanical Clamp on 12 in. (300 mm) Pipe Specimens

Figure 5.4 shows a schematic of the 12 in. (300 mm) CI pipe joint. The joints had an Inner-Tite (or equivalent) mechanical clamp. The rubber gasket is compressed by the cast iron gland, providing a pressure-tight seal.
