### Final Financial Report

Prepared by: CC Technologies, Inc.

**Evaluation and Validation of Aboveground  
Techniques for Coating Condition Assessment**

FEBRUARY 28, 2006

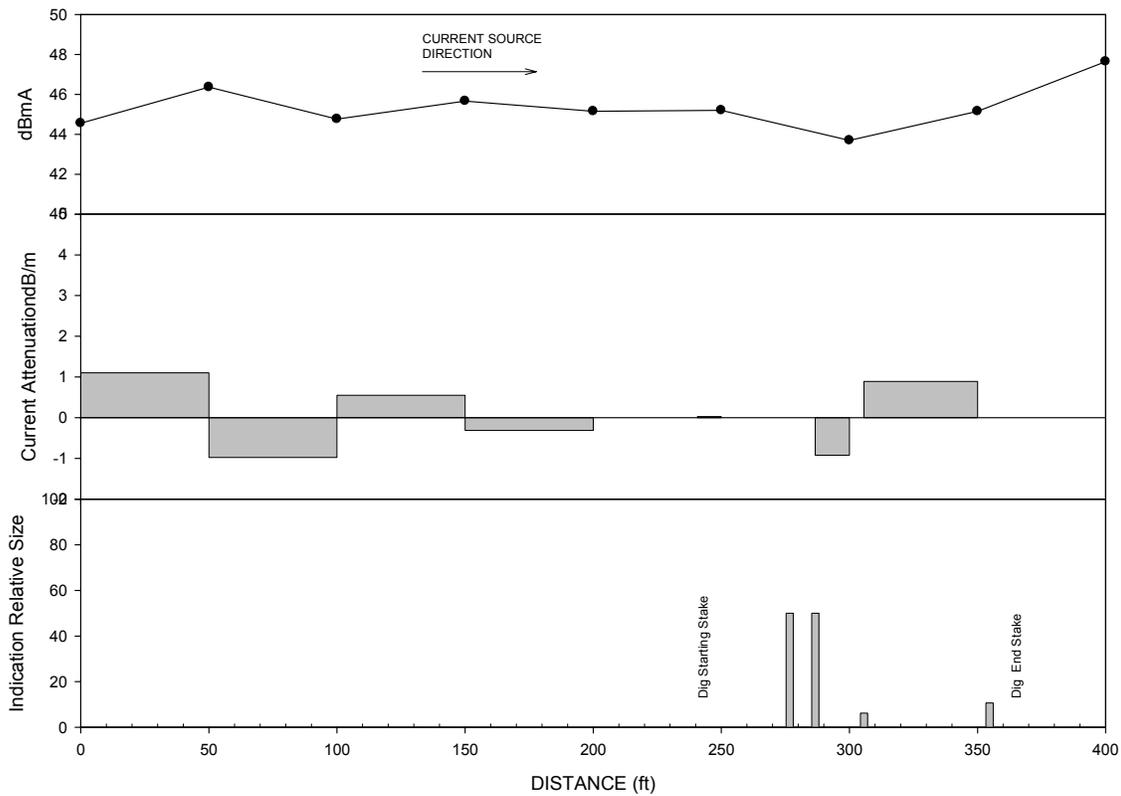
survey procedure manual). When readings are taken at a closer spacing, the current attenuation data may show inconsistency as current magnitude variations with distance are within the same range of the equipment precision. The current attenuation results in Figure 3 vary randomly from negative to positive values with no valid interpretation other than the presence of a perturbed magnetic field. Additionally the magnetic field could be affected by the current flow through the damaged coating or distorted by other elements such as an abrupt change in pipe depth or a bend.

Figure 3: Current Attenuation results obtained with PCM tool calculating attenuation from current readings at 50 ft intervals

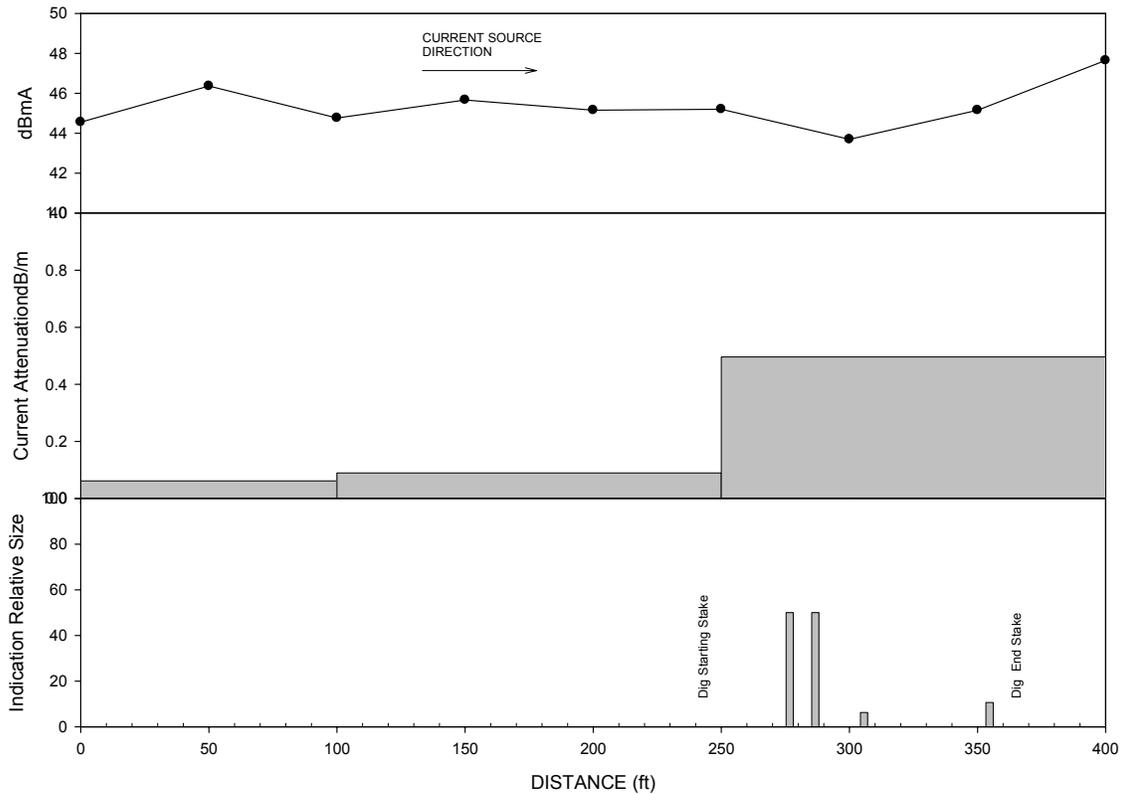
After analyzing the data shown above and using current readings at 150 ft spacing to calculate current attenuation values a more consistent curve was obtained and is presented in Figure 4.

Figure 4: Current Attenuation results obtained with PCM tool calculating attenuation from current readings at 150 ft intervals

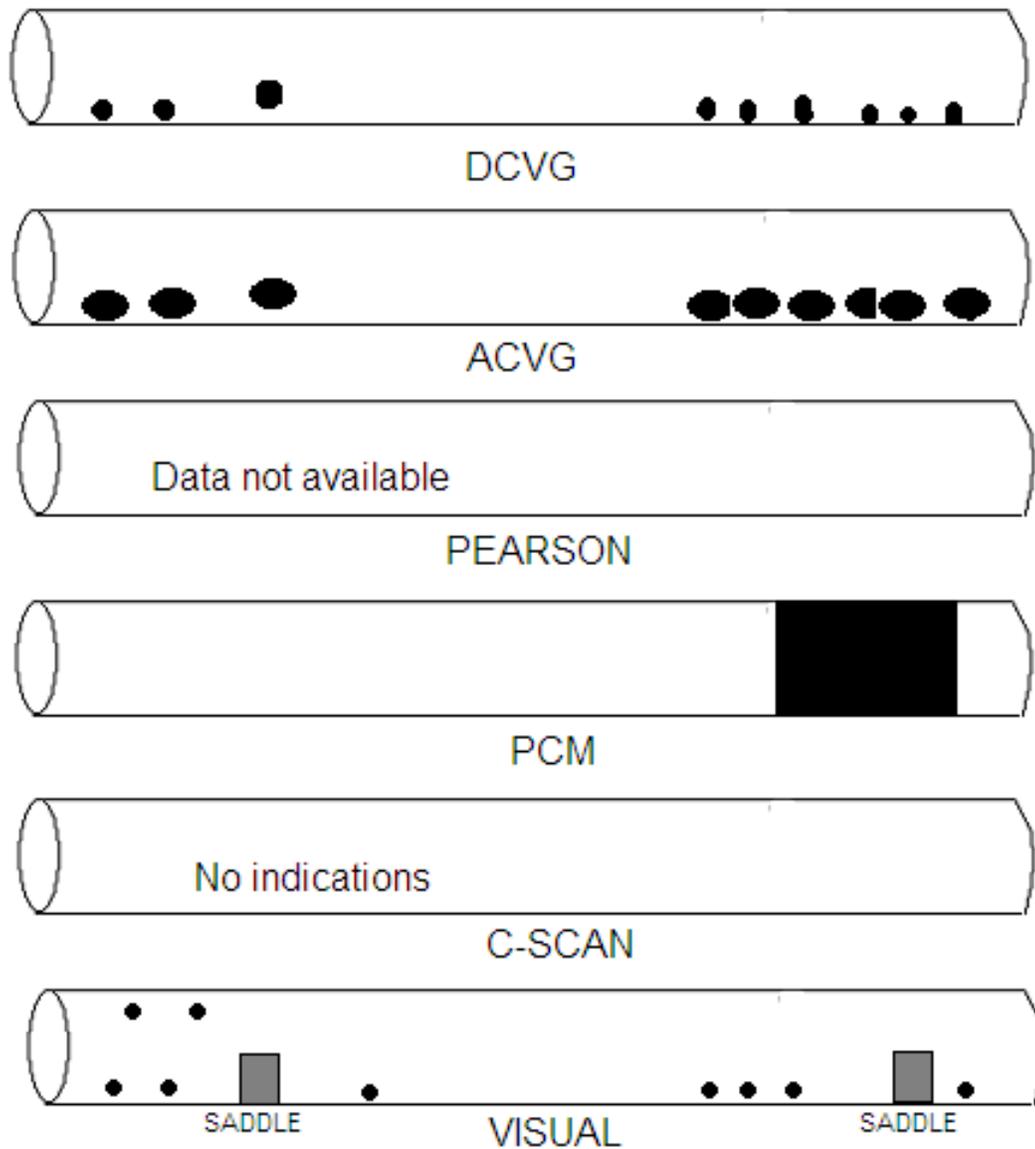
Figure 52: Comparison of techniques from Site 2a. The black areas represent either the size of the coating fault (from surveys) or the area of exposed steel (from visual exam).

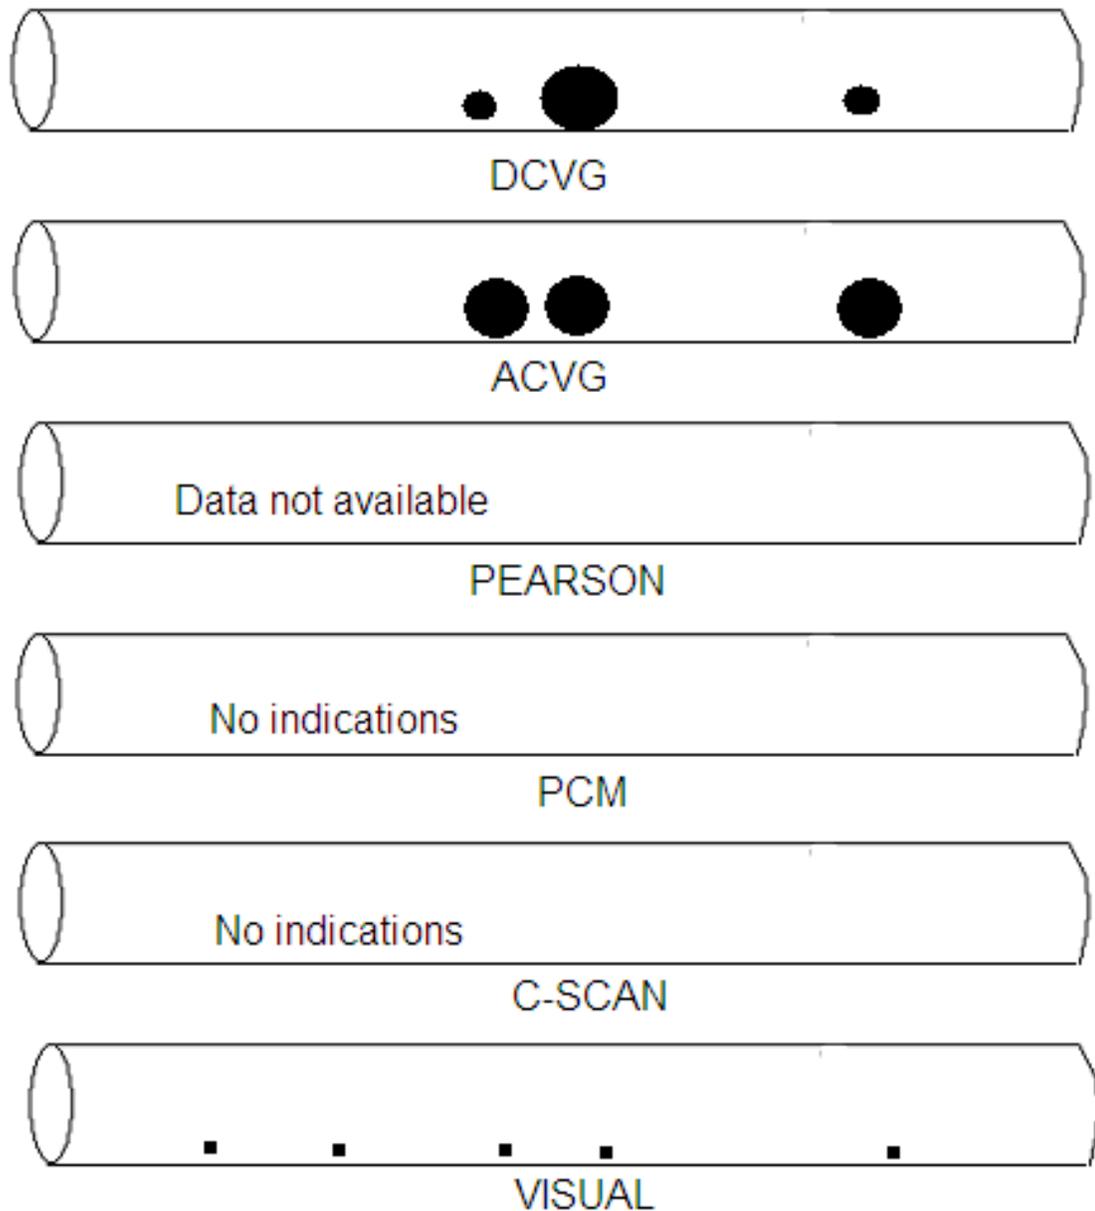
Figure 53: Comparison of techniques from Site 2b. The black areas represent either the size of the coating fault (from surveys) or the area of exposed steel (from visual exam).

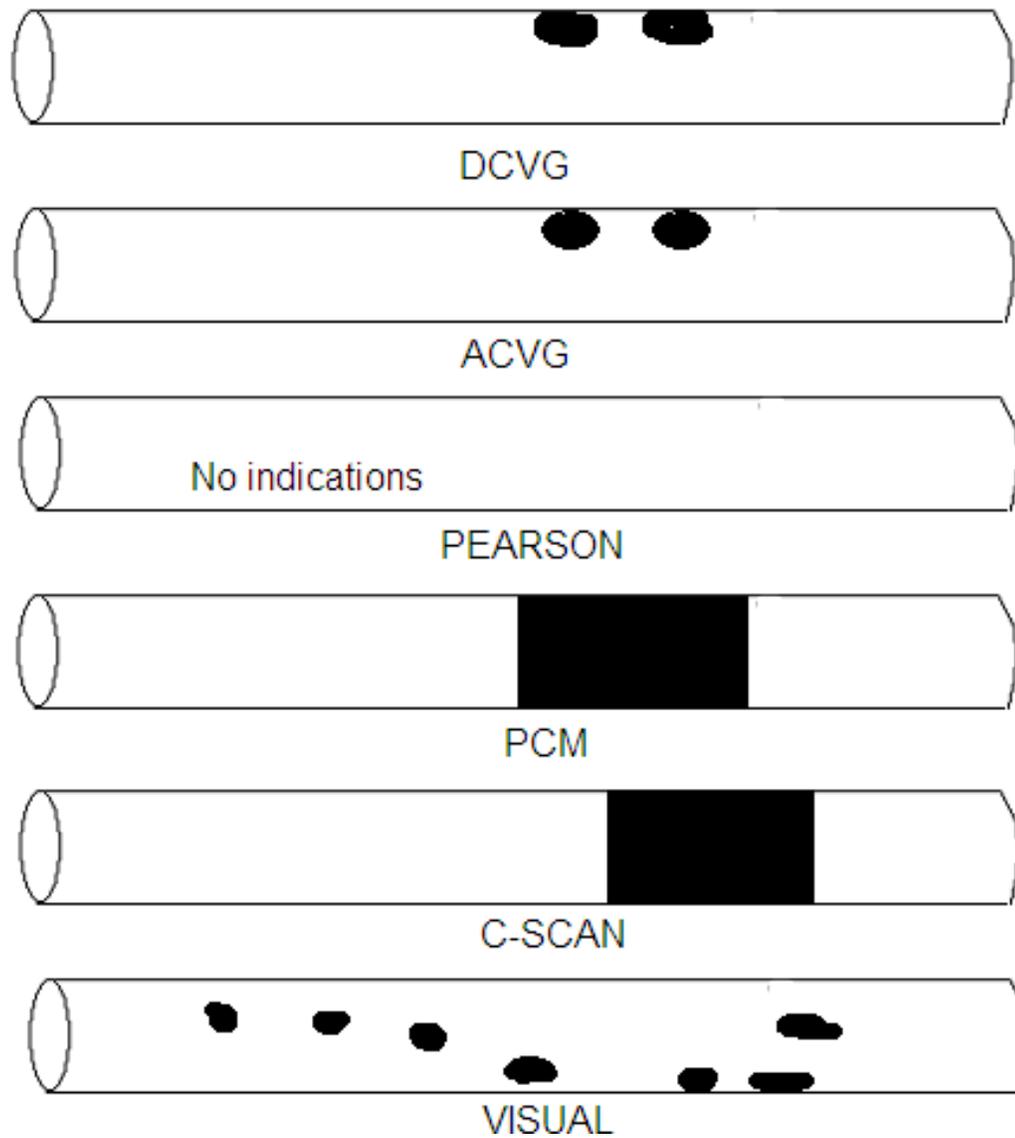
Figure 55: Comparison of techniques from Site 3b. The black areas represent either the size of the coating fault (from surveys) or the area of exposed steel (from visual exam).

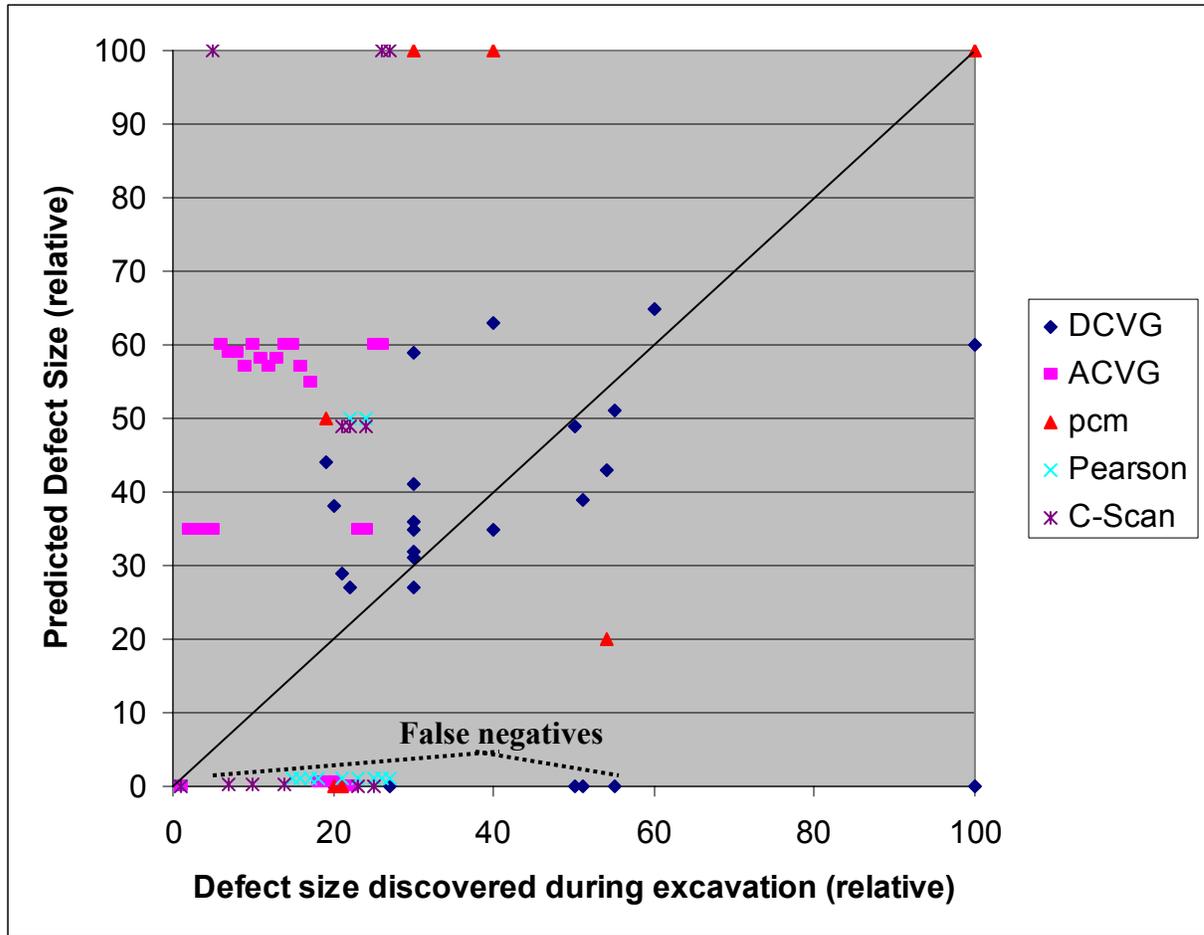
Figure 56 shows the relative performance of each technique from a sizing/locating perspective. From this graph the accuracy of DCVG appeared to be the highest. ACVG tended to overestimate the size of most of the defects, and also did not differentiate size as well. The current attenuation techniques, PCM and C-scan, were “all-or-nothing” indicators which essentially indicated either intact coating or poor coating, with little in between.

Figure 56: Graphic comparison of the performance of each technique with respect to defect sizing (points close to 45° line indicate high degree of accuracy).
