Kaneb Pipe Line Operating Partnership, L.P., a Valero L.P. company
7340 West 21st St. N., Suite 200 • Wichita, Kansas 67205
Telephone (316) 773-9000

RE: CPF NO. 3-2007-5002 – Response to NOPV

EXHIBIT A

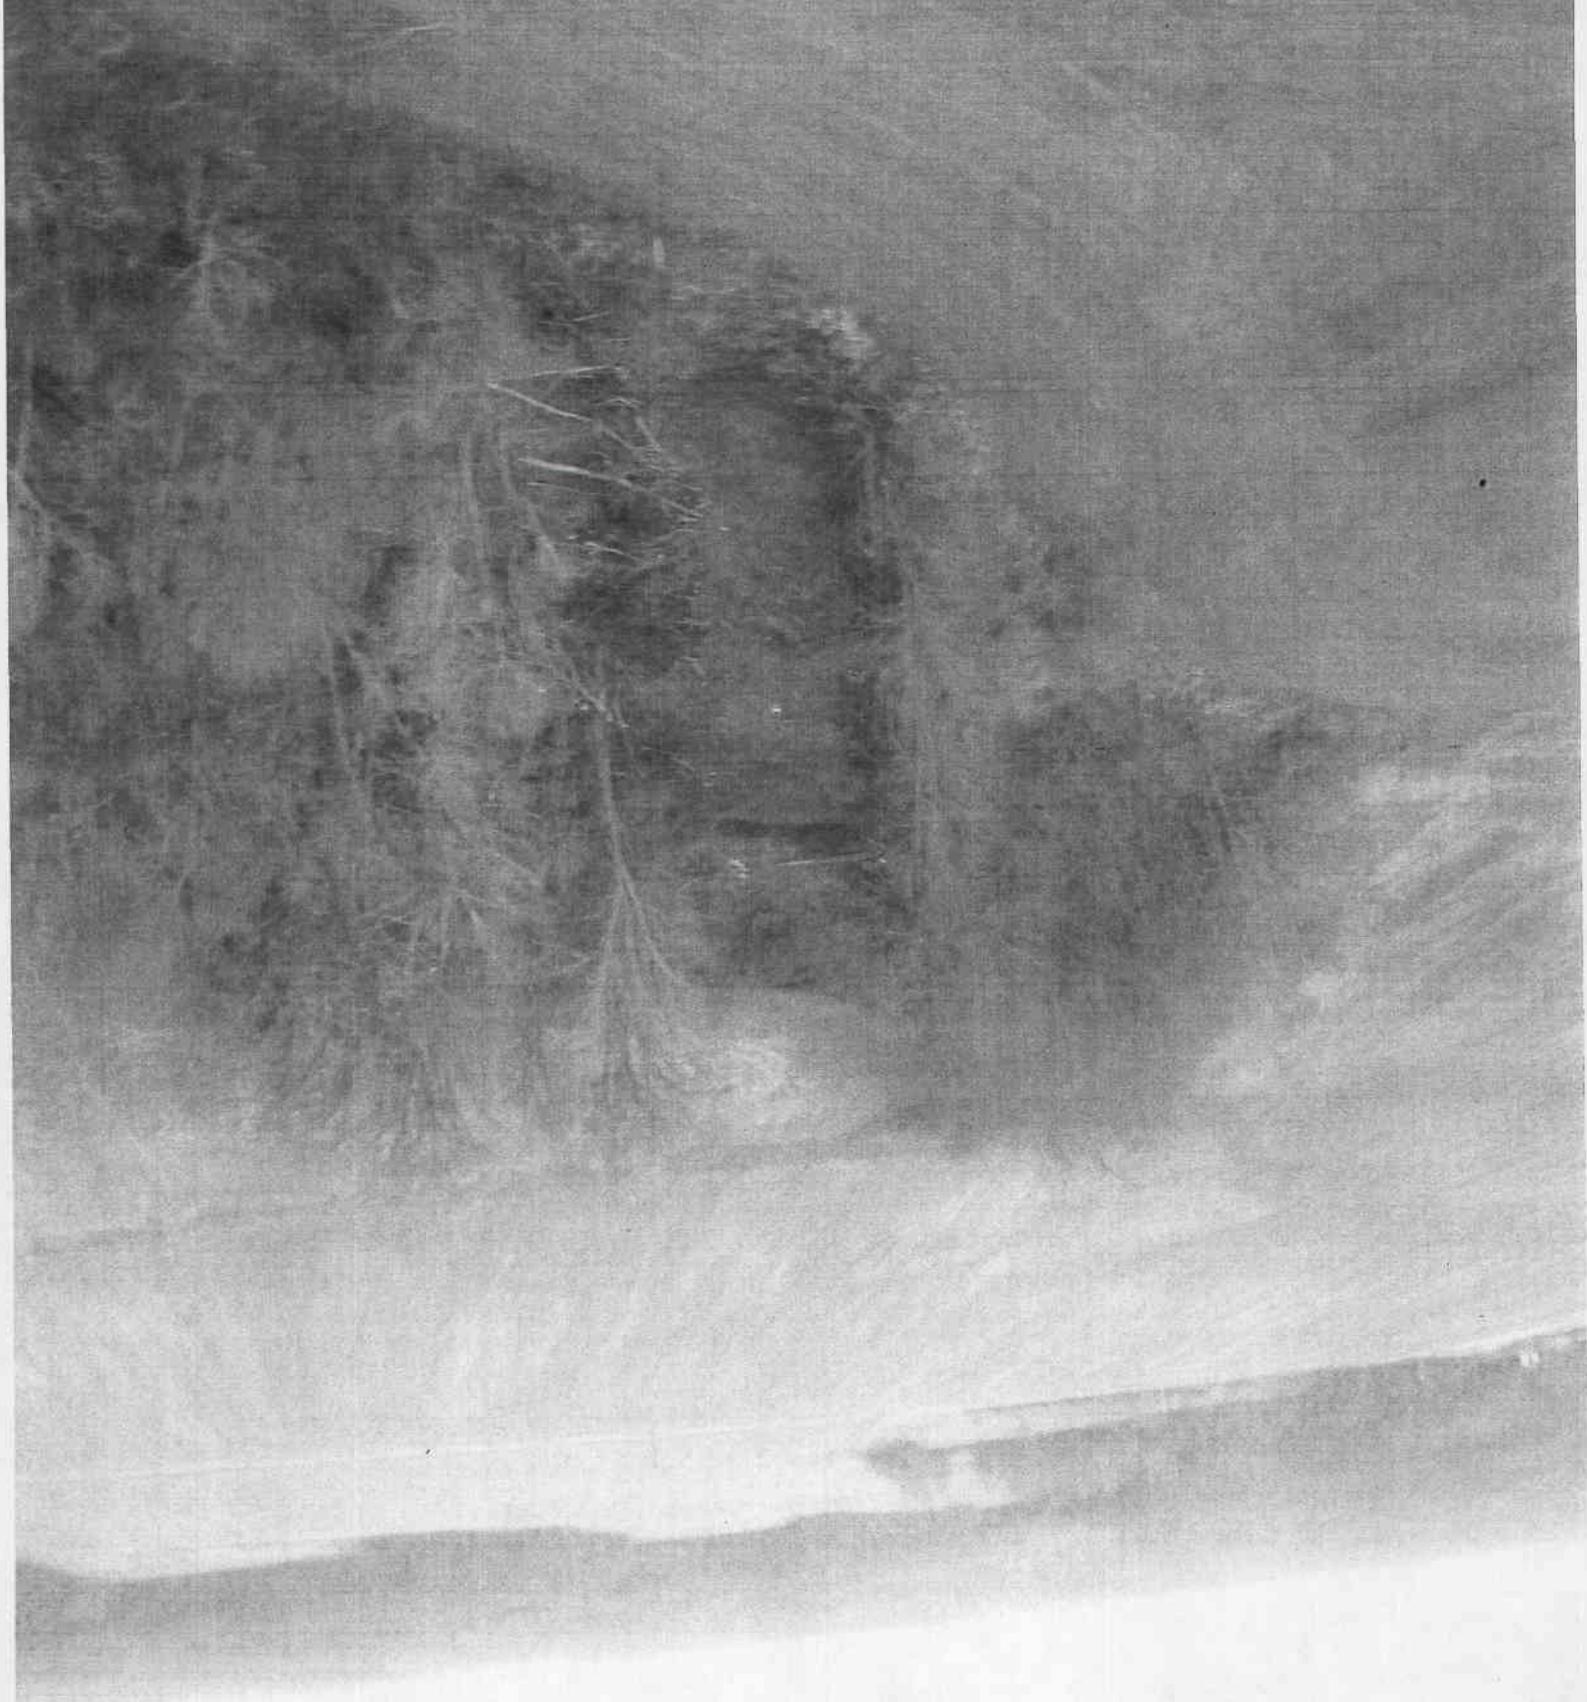
- 3) In an approximate 300 foot section of small woods on either side of a creek crossing at MP115.1 near Trilla, Illinois
 - Picture 21: Before
 - Picture 22: After
 - Picture 23: Aerial After

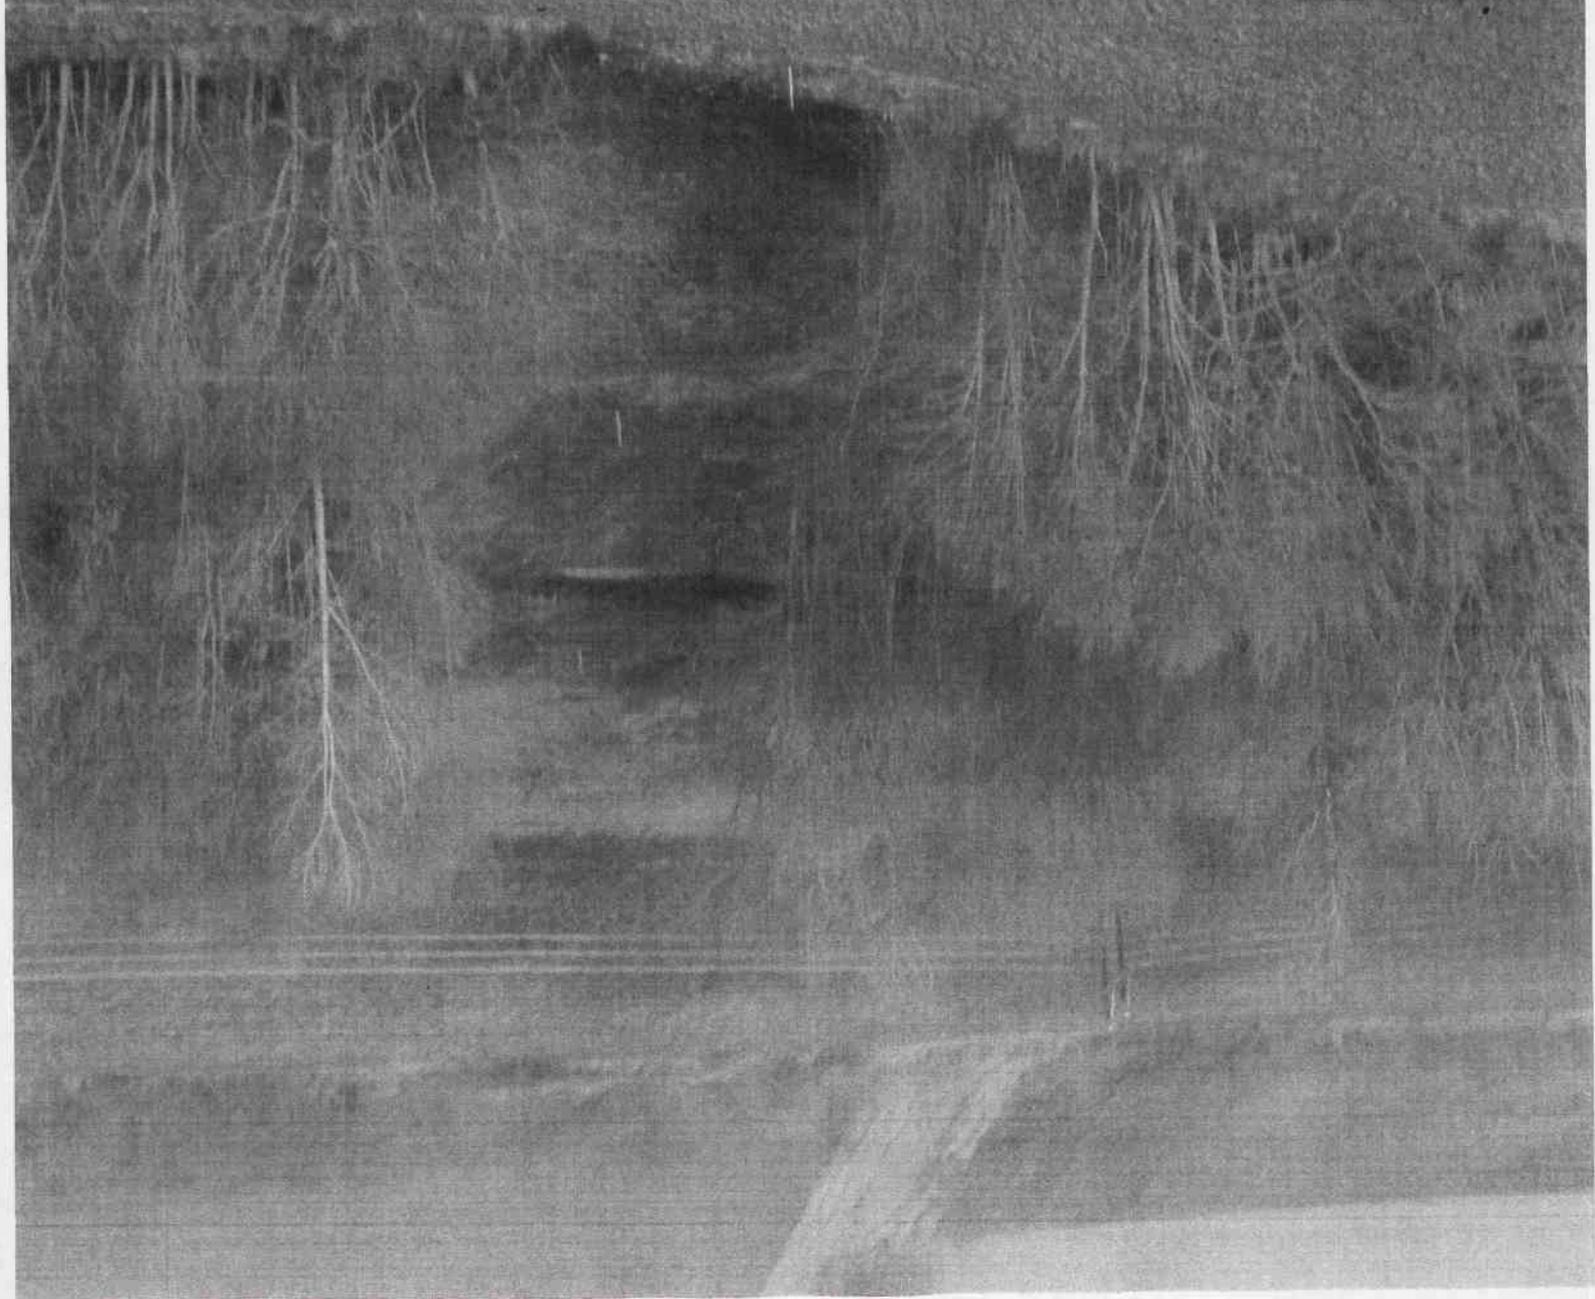
- 4) In an approximate 200 foot section of small woods on the west side of the Elkhorn River crossing at MP33.0 near Arlington, Nebraska
 - Picture 24: Before
 - Picture 25: After
 - Picture 26 & 27: Aerial After
