FINAL REPORTGTI PROJECT NUMBER 20385

Plastic Pipe Failure, Risk, and Threat Analysis

DOT Project# 194

Contract Number: DTPH56-06-T-0004

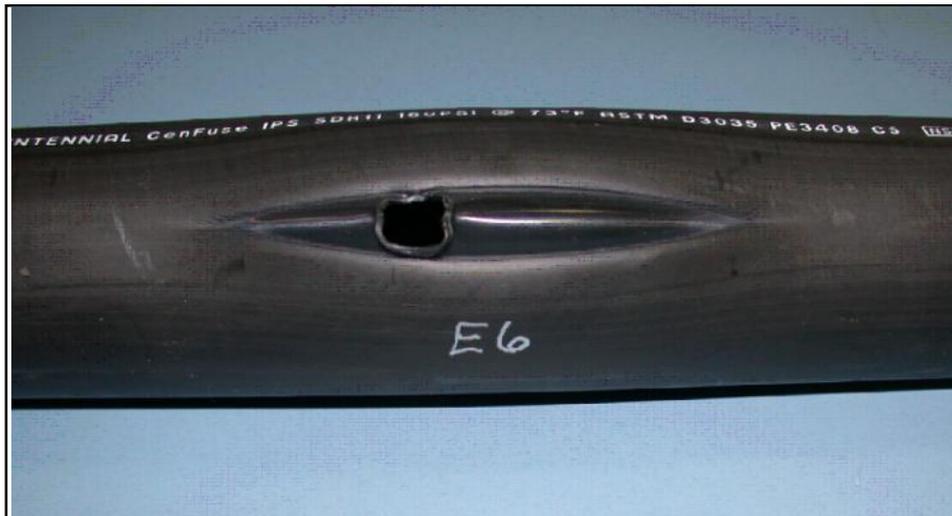
Figure 6. Ductile Failure Resulting From a Quick Burst Test

Plastic pipes experience ductile rupture failures due to the presence of high internal pressures. The failure mode is manifested in large localized plastic permanent deformations of the pipe wall. For PE pipes, they occur as a result of increasing pressure to levels greater than 400psig. Increasing pressures cause the pipe to undergo large diametric expansions typically resulting in wall thinning and stretching until a point where the remaining wall ligament is not sufficiently large to withstand the induced high circumferential hoop stresses. Figure 6 and Figure 7 show typical ductile failures in PE gas pipe materials subjected to high pressures.

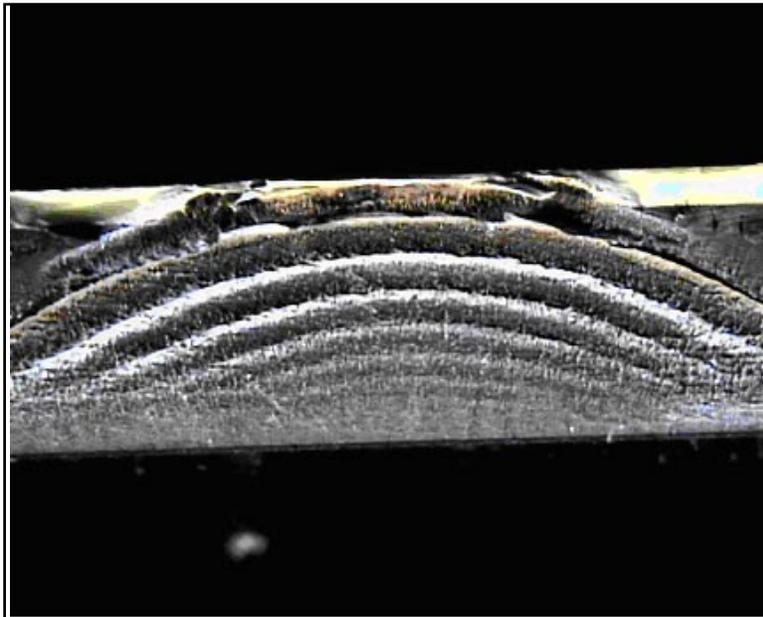
Figure 8. SCG Failure Morphology

Figure 8 shows an optical micrograph of the SCG failure process in the PE pipe specimen. The SCG failure initiated on the inner diameter (ID) and grew in a SCG manner along the axial direction and through the pipe wall to the outer diameter (OD) surface. The observed step-wise growth of the SCG process, exhibited in the form of striation marks (or tidal waves) from ID to OD, is typical of the SCG failure morphology observed for most of the PE gas pipe materials that fail in service.

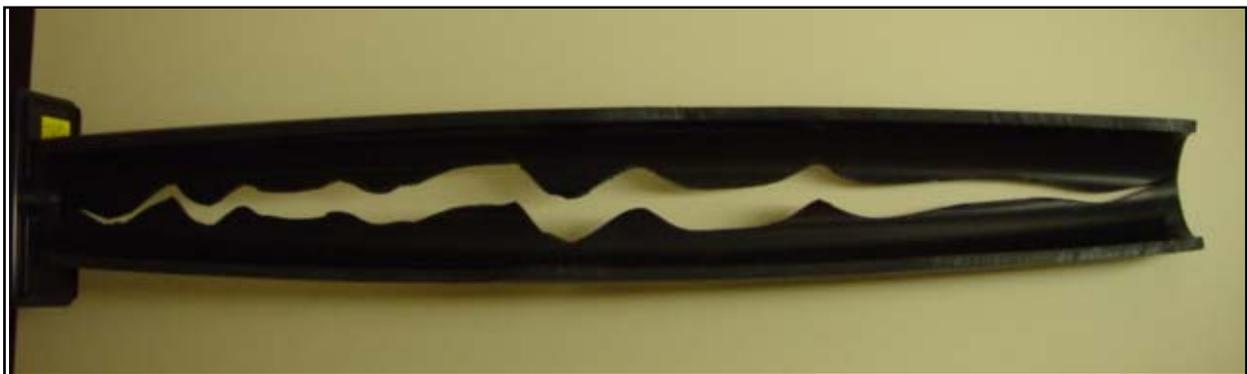
Figure 9. RCP Rupture in a PE Pipe Subjected To a Small-Scale Steady State (S-4) Test

RCP failures are manifested in the form of a large-scale brittle crack that propagates at high speeds exceeding 300 ft/sec over a long span of polyethylene pipe. RCP failures could be catastrophic due to the rapid release of high volumes of gas over long spans. In order for RCP to occur, a “critical” initial axial notch must exist in the pipe wall and the driving force has to exceed the dynamic fracture resistance of the material. The dynamic fracture resistance decreases with decreasing temperatures making PE materials more susceptible to RCP ruptures at lower field temperatures. The susceptibility to RCP also increases with increasing field service pressure, increasing pipe diameter, increasing dimension ratio, SDR, and decreasing modulus of elasticity of the PE. Figure 9 shows an RCP rupture induced in a Small-Scale Steady State S-4 test.

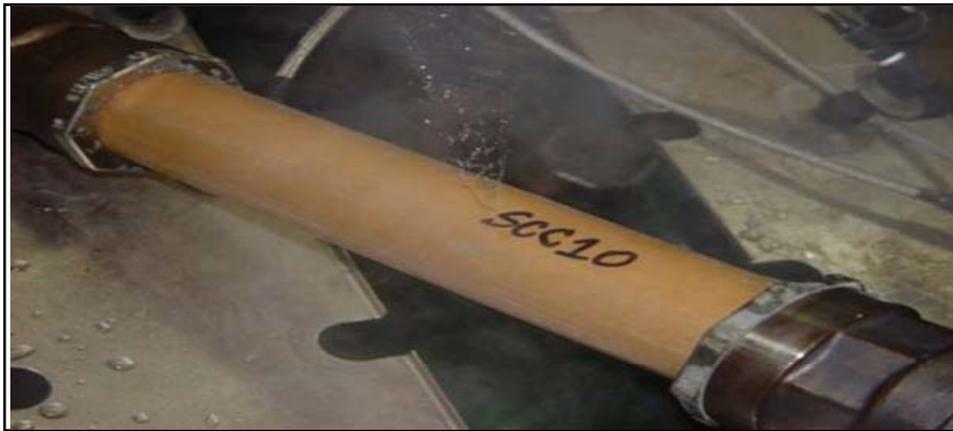
Figure 27. Pipe Exhibited Through Wall Axial Slit While Under Internal Pressure

Figure 27 shows an Aldyl-A MDPE pipe sample that experienced a SCG axial slit failure/leak while in a standard long-term laboratory test under a constant internal pressure. Microscopic examinations showed that the failure initiated at a very small (less than 5-mills in depth) surface pin-size hole on the inner pipe surface. The examination also showed that the pin-

size hole grew in an SCG mode along the axial direction and through the pipe wall. The final failure was in the form of an axial slit visible on the pipe outer surface.

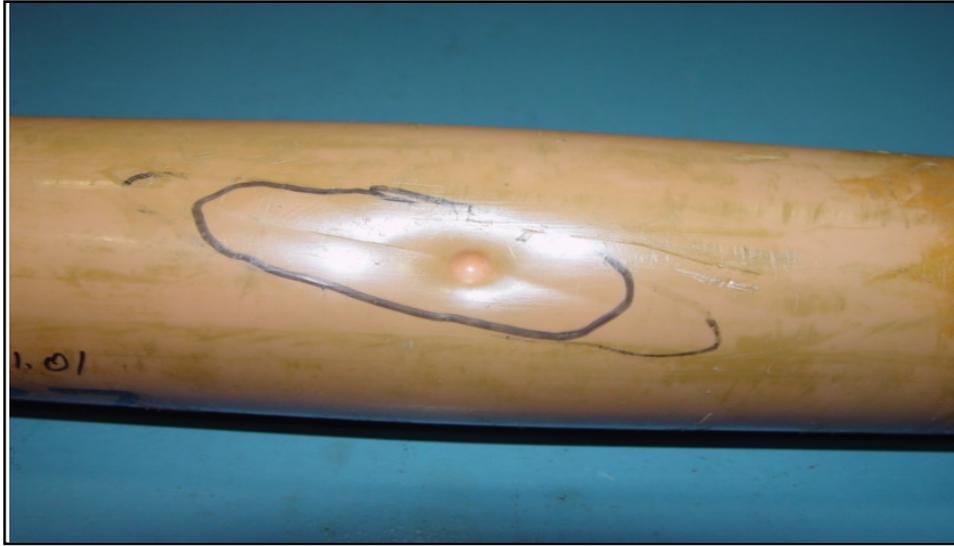
Figure 28. Rock Impingement Failure

Figure 28 shows a slit on the outer surface of an Aldyl-A pipe sample that experienced failure as a result of internal pressure combined with a rock impingement indentation load. The failure initiated on the inner pipe surface underneath the impinging rock/indenter. The failure grew through the pipe wall and in a direction that was oriented at an angle of about 20-degree relative to the pipe longitudinal axis.

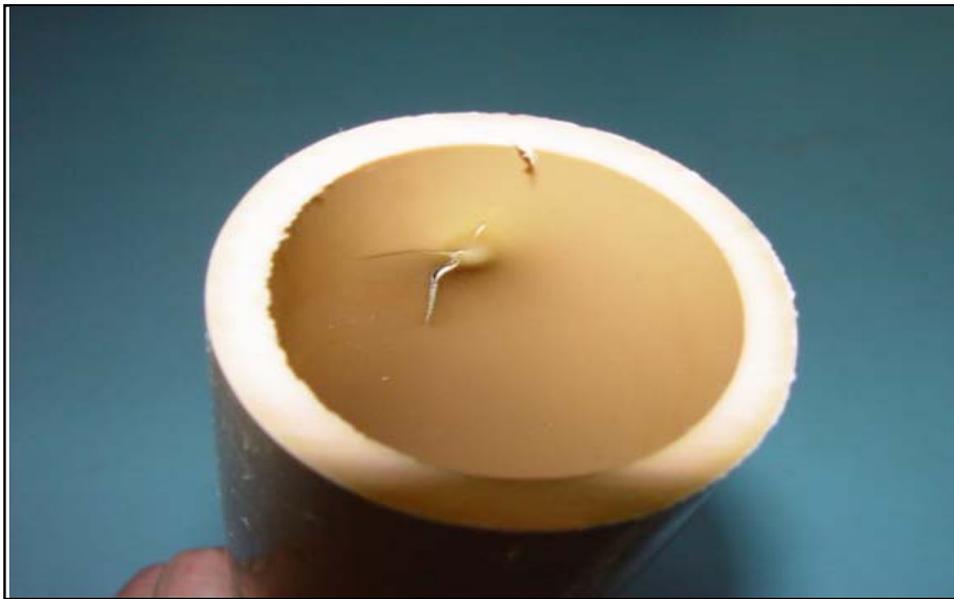
Figure 29. Off-Axis Slit Failure that Initiated on the ID Due to an Impinging Rock

Figure 29 shows that a slit failure induced by an impinging rock load, initiated on the inner pipe surface. Examinations of pipes that failed due to rock impingement loads clearly show that the failure morphology is SCG brittle slit processes similar to that observed in pipes subjected to internal pressure as shown in Figure 8.

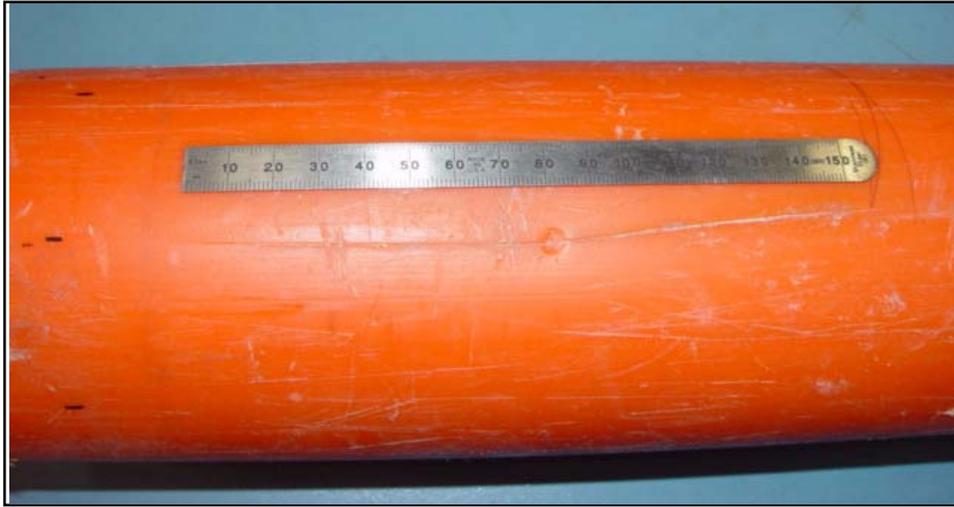
Figure 30. Rock Impingement Failure Induced in Field Service

Figure 30 shows a PLEXCO PE 2306 MDPE gas pipe specimen that failed in field service due to an impinging rock. Visual and microscopic examinations showed that this rock-impingement field failure resulted in a slit that initiated on the inner pipe surface and grew

through the pipe wall to the outer surface. The orientation of the slit was slightly off the pipe longitudinal axis.

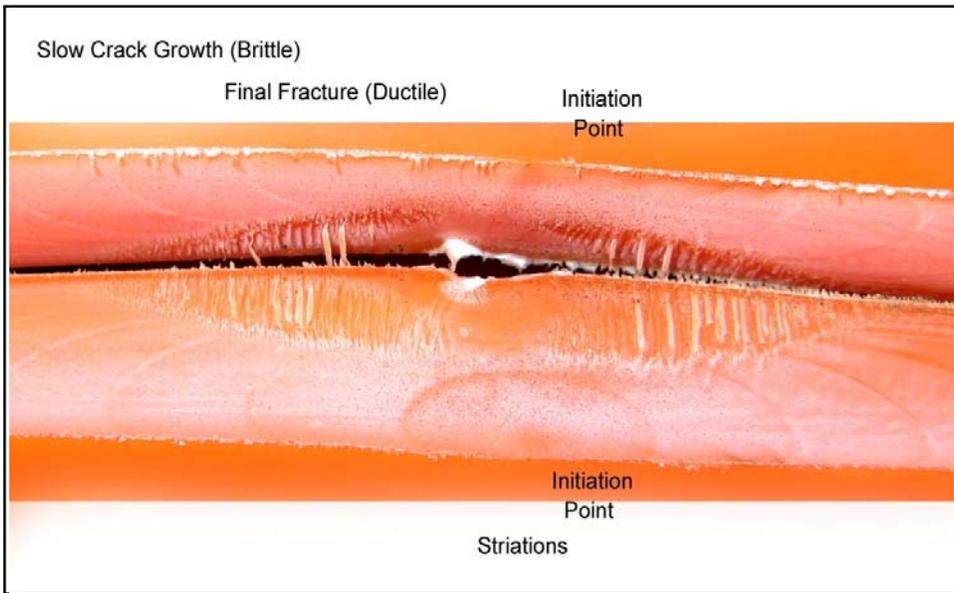
Figure 31. Micrograph of the SCG Fracture Surface of a Rock Impingement Failure

The fracture surface was examined using optical microscopy. Figure 31 shows the fracture surface morphology under magnification. This figure shows the crack initiation point on the ID and the progressive SCG growth of the damage zone and the crack. This SCG failure process is manifested in the form of the striation marks corresponding to the progressive incubation, initiation and growth of the crazed material over several periods.

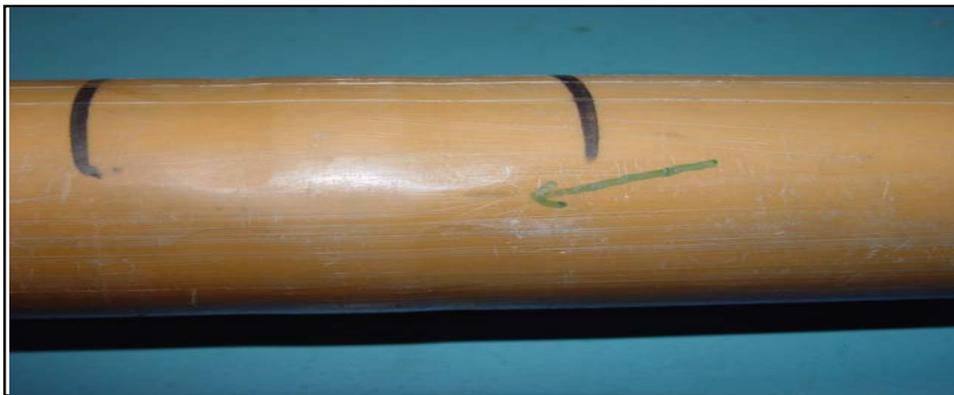
Figure 32. Failure of an Aldyl-A Pipe at Squeeze Ears

Figure 32 is a photograph of an Aldyl-A pipe sample that exhibited SCG failure/leak at the ears of the squeeze-off. Figure 33 shows the inner surface of the Aldyl-A pipe sample shown in Figure 32.

Figure 32 and Figure 33 demonstrate that the squeeze-off caused material crazing manifested in the form of material whitening, discoloration, and some surface roughening. The craze initiated first on the inner surface at the squeeze "ears". Then the damage grew through the wall and unto the outer surface. As the amount of squeeze, or pipe wall compression increased, more of the material experienced crazing/damage.

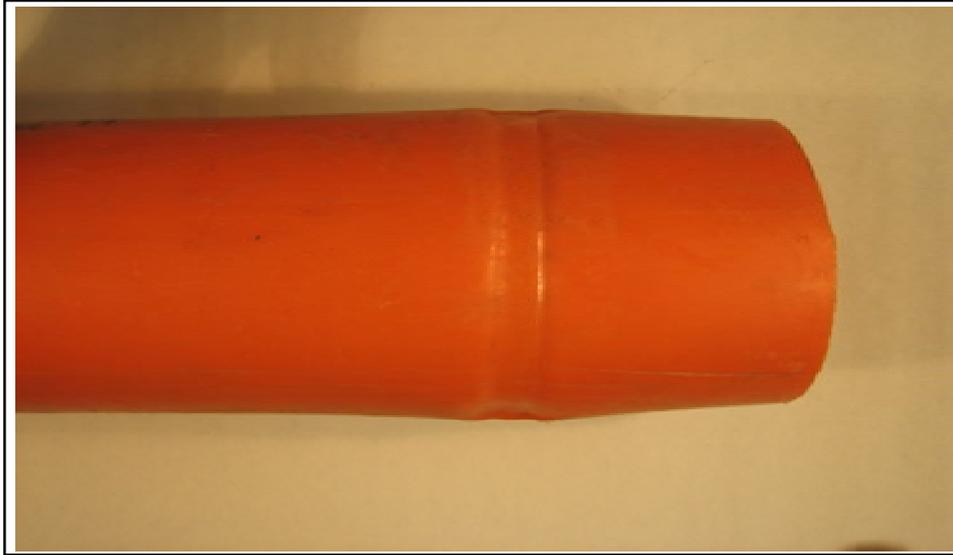
Figure 34. MDPE Pipe that Failed in Field Service Due to a Squeeze-Off

With excessive squeeze-off, large voids, whitening, and cracks develop at the squeeze ears on the inner pipe surface. At the ears, the pipe undergoes permanent localized large plastic deformations and wall thinning. Also, an axial slit can initiate on the inner pipe surface at the “ears” and grow axially through the pipe wall. Photographs of a MDPE 2306 pipe that failed in field service due to excessive squeeze-off are shown in Figure 34 to Figure 36.

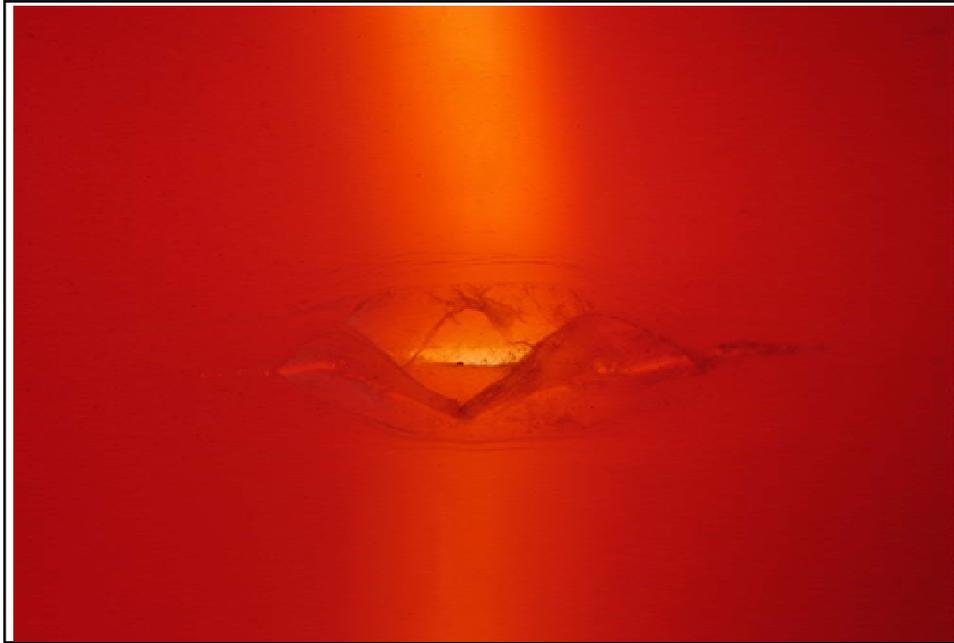
Figure 36. Pipe ID with Axial Slit at the Ears of Pipe Shown in Figure 34

The observed SCG slit failure mode in the squeezed pipe specimen is similar to failures exhibited by specimens subjected to internal pressure or internal pressure combined with a rock impingement load. The SCG failure mode observed in squeeze-off involves the progressive striations indicative of incubation and growth of the crack-tip-opening displacement (CTOD) through the pipe wall.

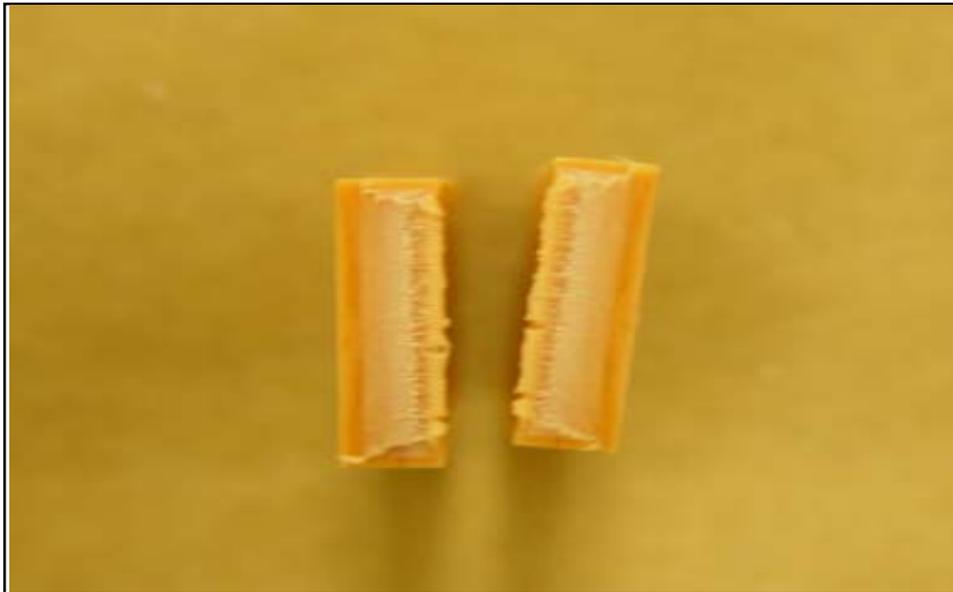
Figure 39 and Figure 40 show the mating fractured surfaces, at low magnification, of two PENT test specimens, that experienced SCG brittle fracture in the PENT test. The two specimens were prepared from two different PE gas pipe materials. The brittle SCG failure mode in the PENT test specimen is evident from the observed discoloration, whitening and the crack-growth striations (rings) that are observed in the fractured surface.

Figure 39. Brittle SCG Failure of a PLEXCO MDPE 2406 PENT Test Specimen

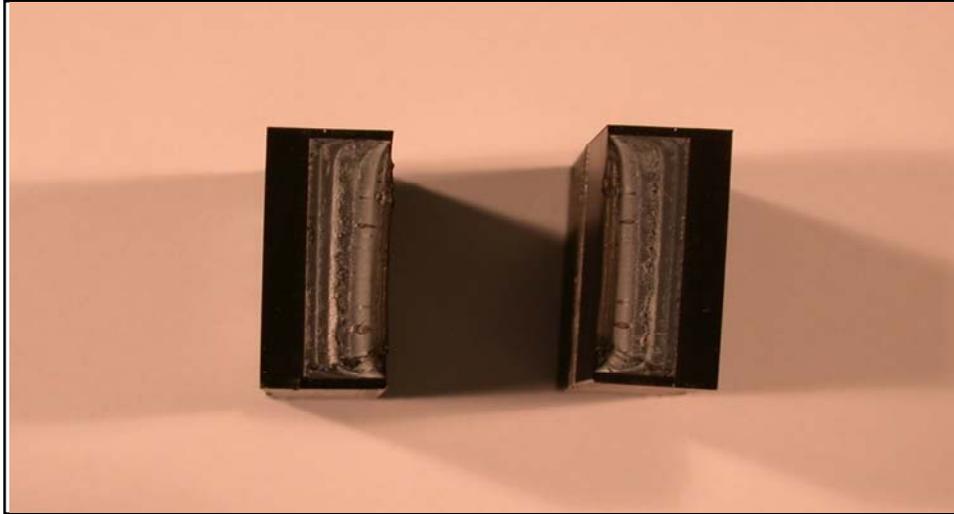
Figure 40. Brittle SCG Failure of HDPE Performance Pipe PENT Test Specimen

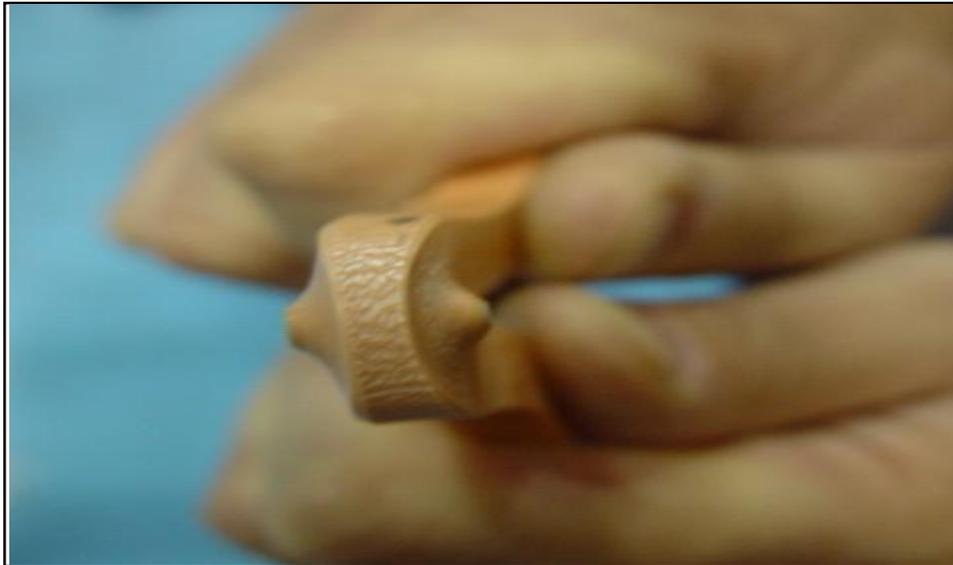
For comparative purposes, the results of the bend-back test are presented to visually illustrate the presence of LDIW material. Sector specimens prepared from an Aldyl-A PE 2306 material manufactured in February 1971 were subjected to bend-back tests. Figure 42 shows the surface crazing consisting of discoloration, whitening, and surface roughening. The observed material crazing is typical of a LDIW pipe material and is indicative of an inferior spherulitic microstructure that is susceptible to pre-mature brittle SCG failure.

Figure 42. Bend-Back Test Exhibiting LDIW Surface Features

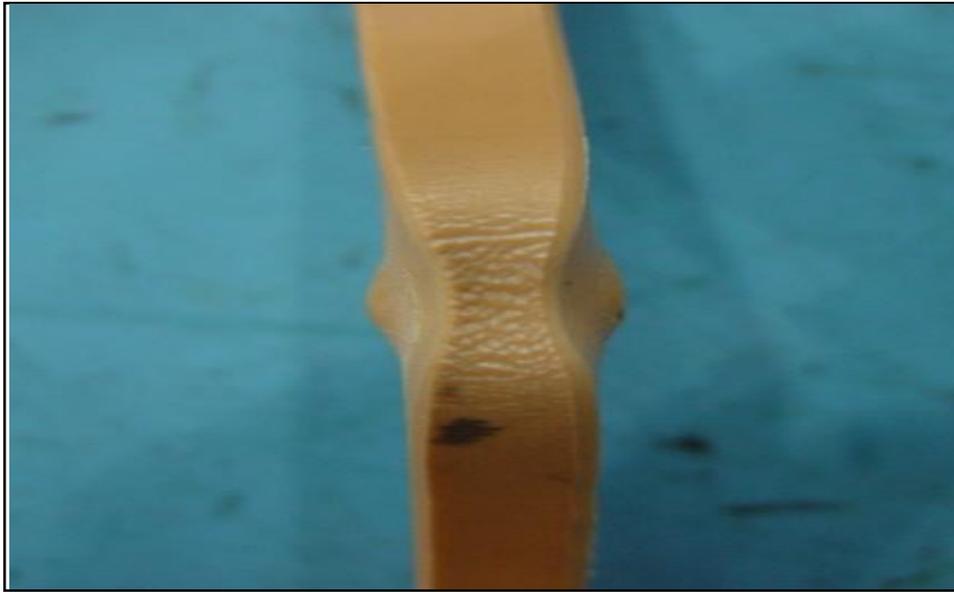
The results of the Bend-Back test on this LDIW material are also presented for comparative evaluations. Figure 43 shows a sector specimen made from the Aldyl-A PE 2306 pipe material manufactured in March 1971. Figure 43 shows the surface crazing consisting of discoloration, whitening, and surface roughening. The observed crazing is indicative of an inferior LDIW Aldyl-A pipe material due to a spherulitic microstructure that is susceptible to pre-mature brittle SCG failure.

Figure 43. Bend-Back Test Exhibiting LDIW Surface Features

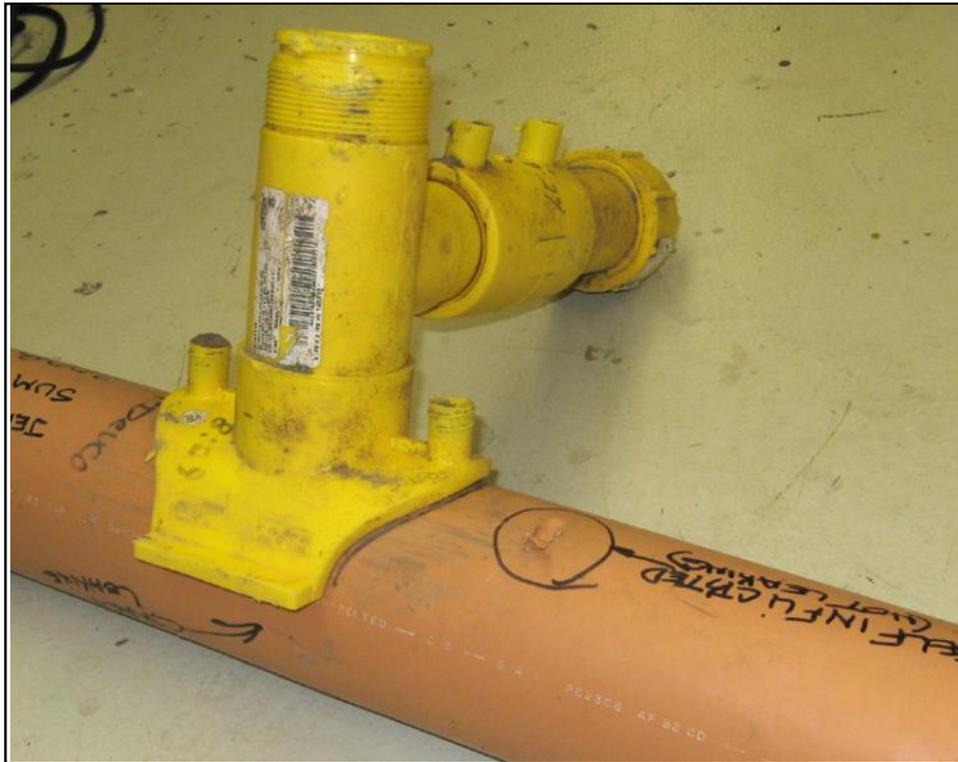
The laboratory analysis procedure used for this project is described for sample number #602533. This specimen is identified as a 4" IPS SDR 11.5 DuPont Aldyl-A PE 2306 manufactured in 1984. It was removed from service in 2008 and submitted to GTI for analysis. Upon receipt, the specimen was photographed and examined. The as received sample is shown in Figure 61. Background and service information are summarized in Table 14.

Figure 61. As Received Sample with Attached 4" X 2" Electrofusion Tapping Tee

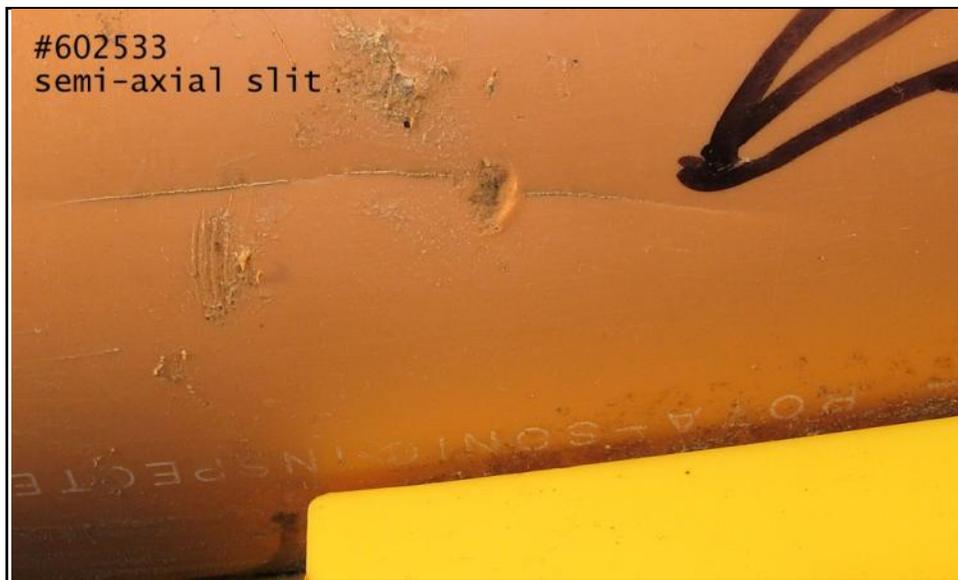
The sample revealed an off-axis slit failure which grew in two directions from an indentation in the outer wall. The specimen was cut in half to reveal an approximately 3" slit on the inner wall. The outer and inner wall of the pipe can be seen in Figure 62 and Figure 63 respectively. The specimen was cut from each end to within about ¼" of the crack. It was then force fractured using liquid nitrogen to reveal the fracture face as seen in Figure 64 and Figure 65.

Figure 62. Slit Failure Growing Away From Impingement Point

Because the battery of tests suggests nothing was out of the ordinary with the pipe material, it is quite unlikely that the pipe extrusion process contributed to the slow crack growth failure. It was concluded that the highly localized stresses induced on the pipe wall by a foreign body, most likely a rock, led to the initiation of a slit failure on the inner pipe wall. The crack grew stepwise in two directions away from the initiation point with the final through wall fracture occurring in a ductile manner. This sample is classified as a material SCG failure due to rock impingement.

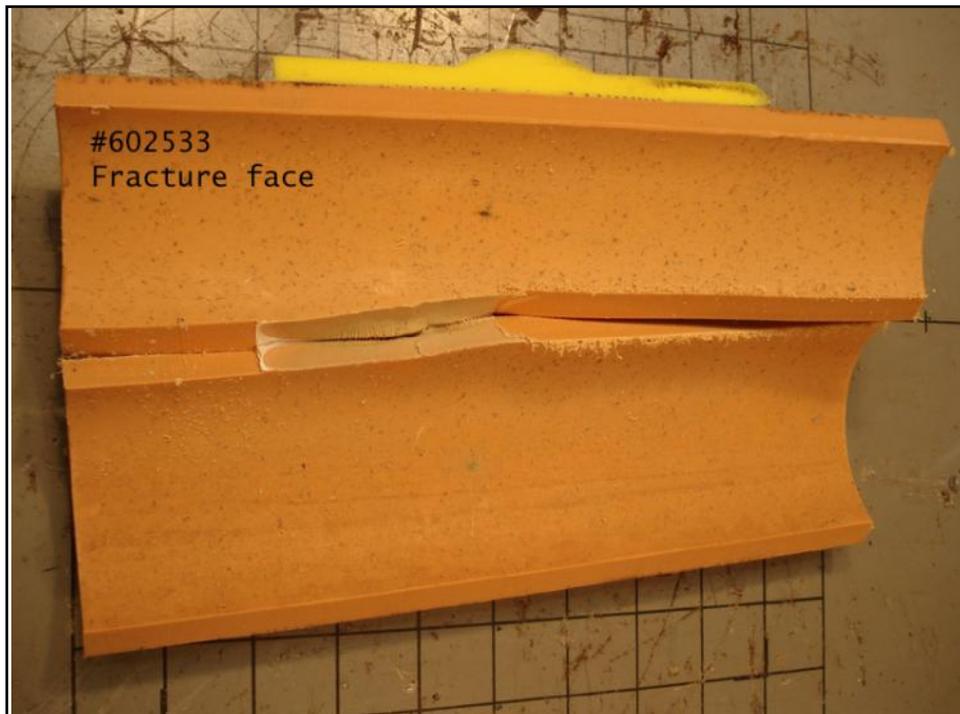
Figure 64. Pipe Was Force Fractured to Reveal the Fracture Faces

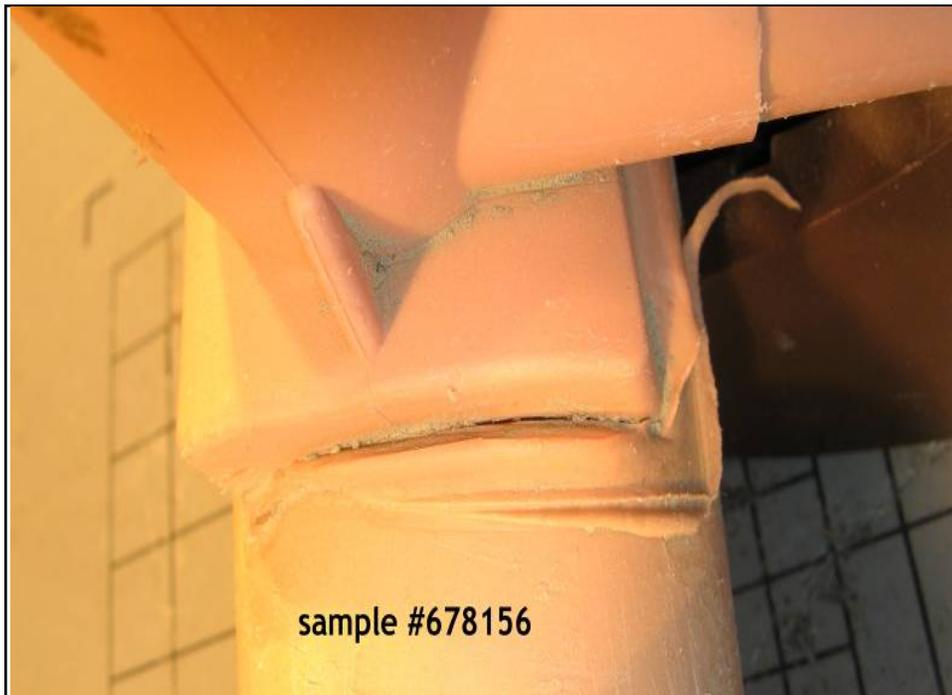
Figure 73. Untapped Tee with Circumferential Slit

The submitted pipe section was subjected to initial examination. The examination indicated the presence of a slit immediately adjacent to one side of the tee with minimal bead and rollback as shown in Figure 73. The section was leak tested to verify the leak location at the observed slit as shown in Figure 74. The section was cut longitudinally to expose the inner surface (Figure 75) then further cut to expose both fracture surfaces (Figure 76). The fracture surfaces contained debris on the surface consistent with soil. A spherical particle was observed and initially thought to be imbedded in the pipe wall on the tee side of the fracture but closer inspection revealed the absence of a companion dimple on the pipe side of the fracture. It was concluded that this particle had deposited itself post fracture. The particle can be seen in Figure 79.

Based on the tests performed, it was concluded that the submitted section failed due to the stress concentration at the edge of the fusion tee. Typical loads associated with pipe burial/settling and the relatively low resistance to crack propagation of older generation PE material combined with the stress concentrator to lead to the observed SCG failure.

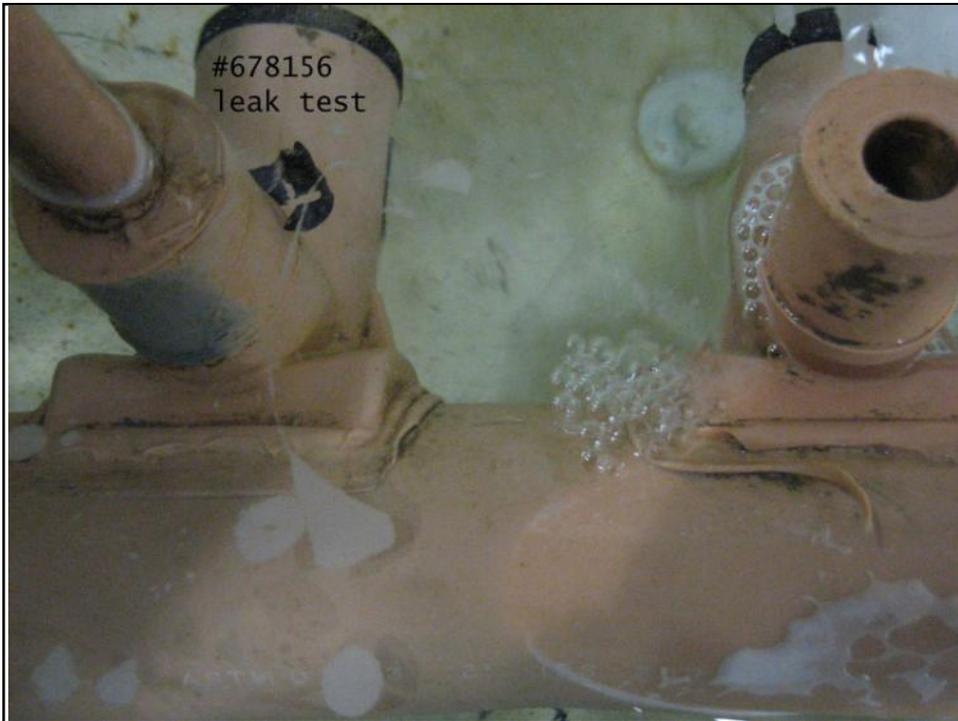
Figure 74. Underwater Leak Test Revealing Leak Location

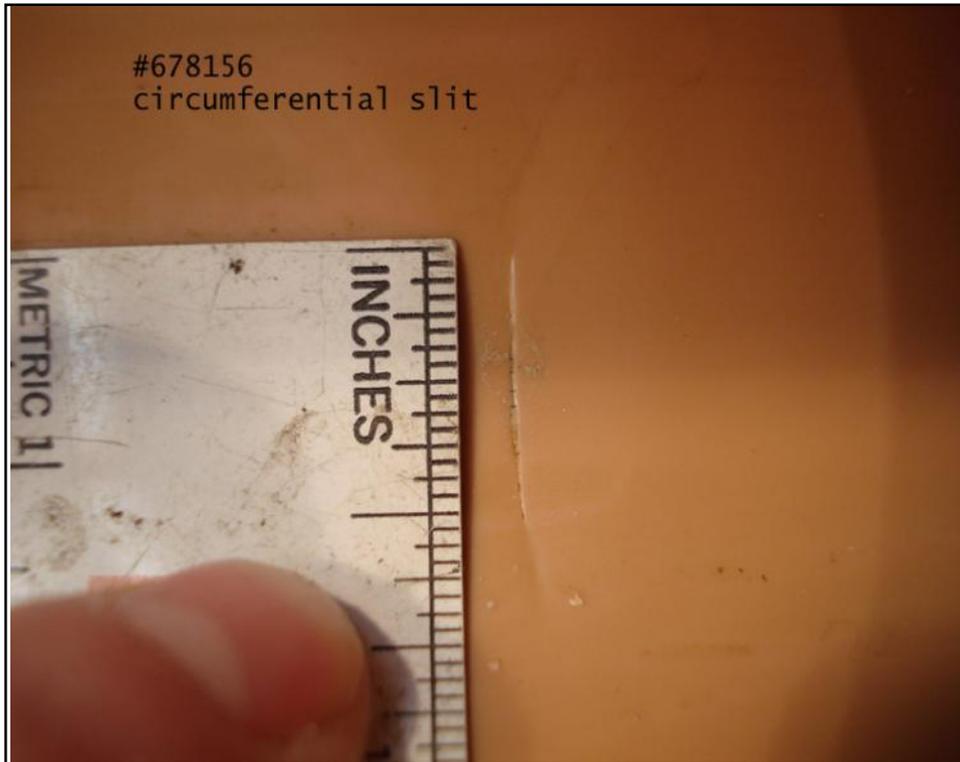
Figure 76. Close Up of the Circumferential Slit on the Inner Wall

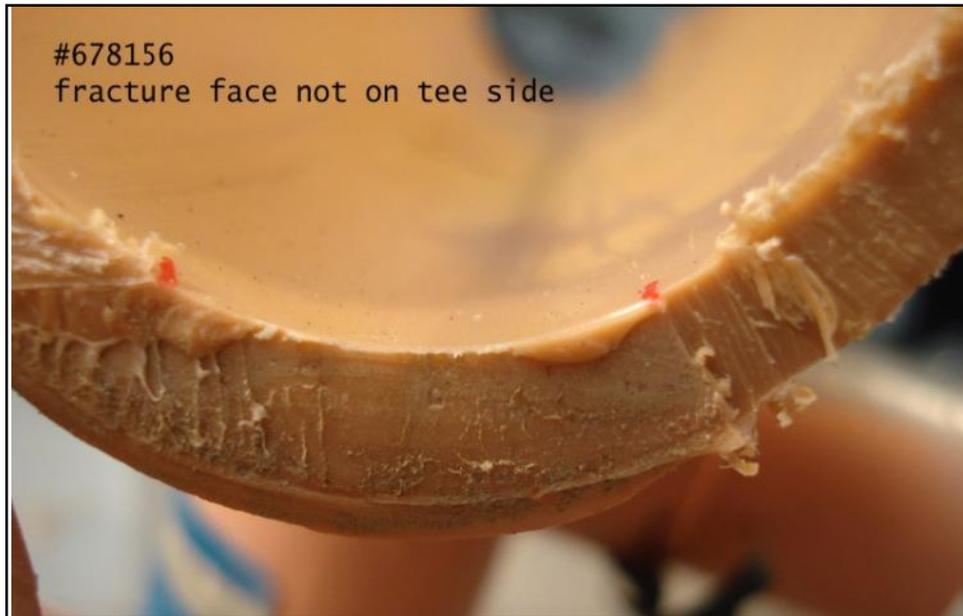
Figure 78. Close up of the Fracture Face Away from the Tee

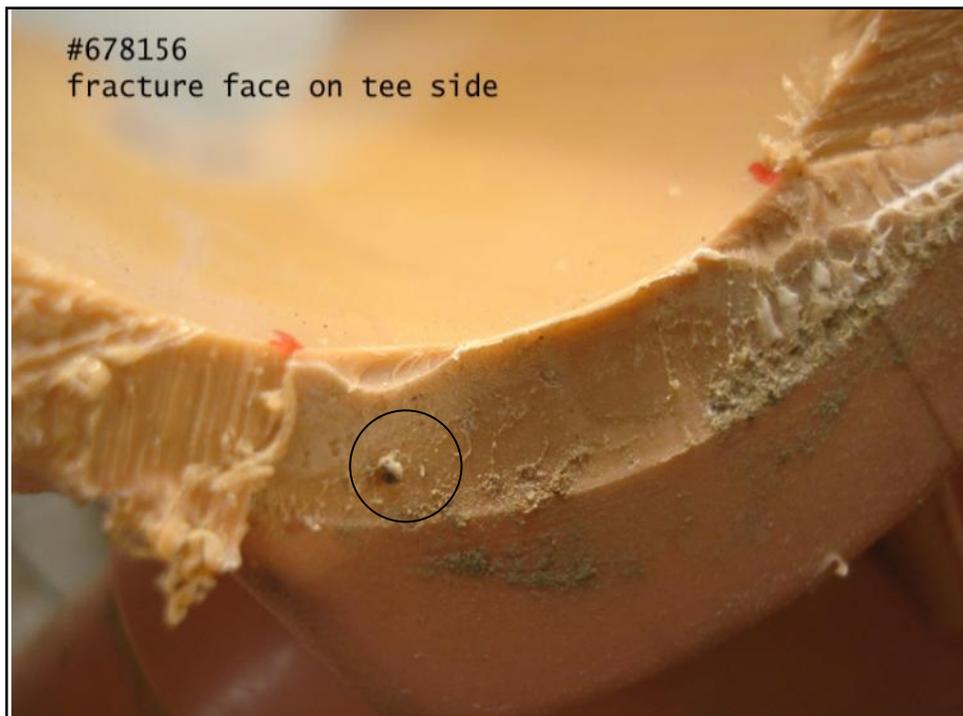
Figure 79. Close up of the Fracture Face towards the Tee with Area of Interest Identified

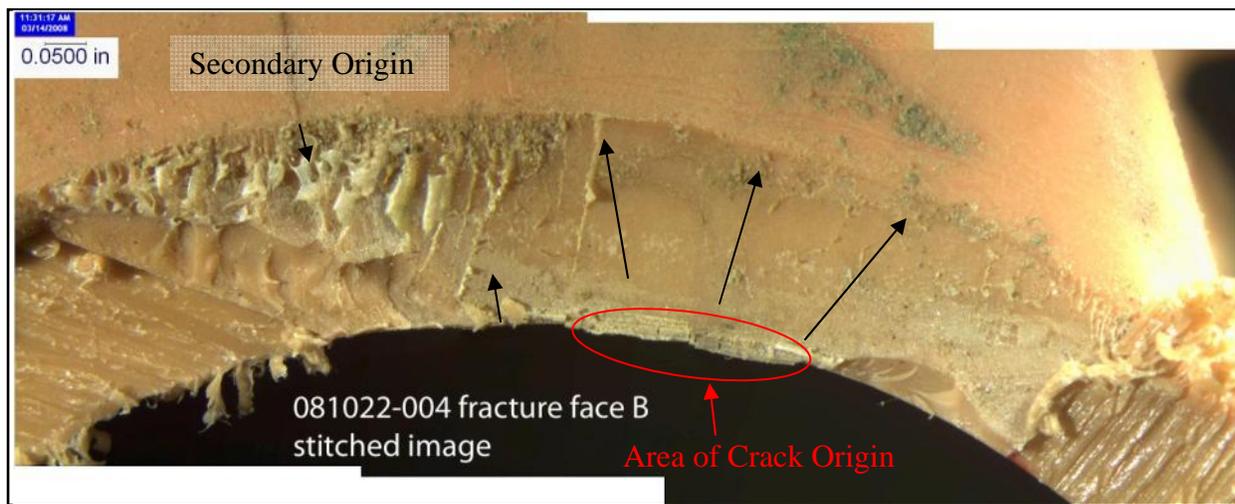
The surfaces were examined with a stereo optical microscope and revealed that the SCG fracture originated from the inner wall of the pipe and proceeded outward as shown in Figure 80. Another area exhibited a secondary SCG fracture origin originating near the outer surface of the pipe then proceeding inward, suggesting a change or compound loading of the area. The secondary origin is identified in Figure 81.

Figure 81. Microscopy of the Fracture Face towards the Tee

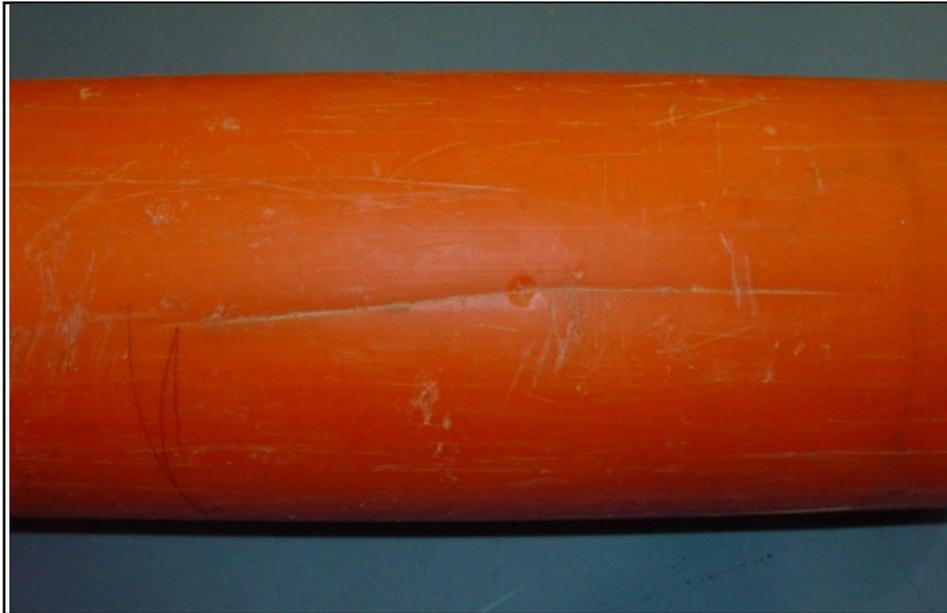
Figure 87. As Received Condition

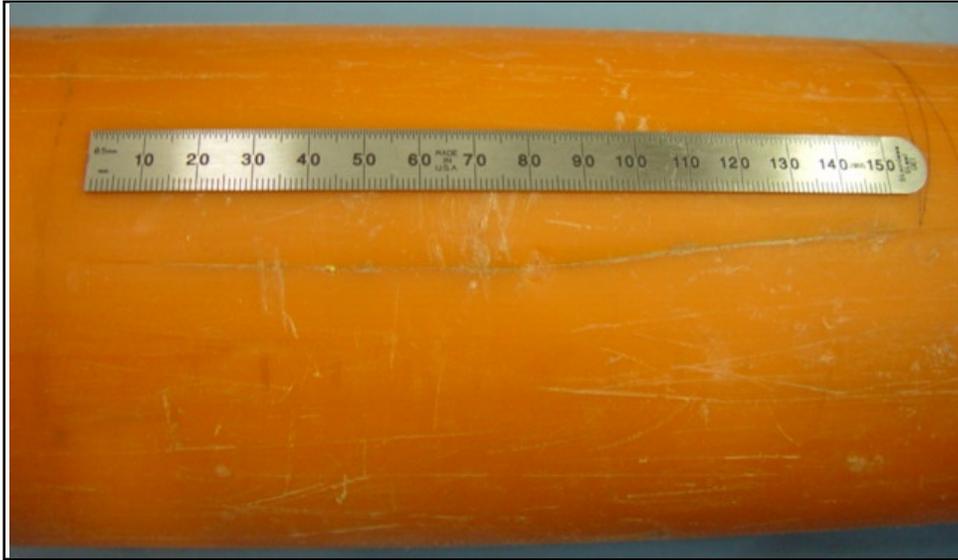
The sample contained a crack approximately 6.25" in length in the outer wall of the pipe (Figure 88) and a dimple in the exterior surface of the pipe located approximately midway in the crack length (Figure 89). Examination of the inner pipe wall confirmed that the crack had traversed through the pipe wall as shown in Figure 90.

Figure 88. Crack on Outer Wall

- 1) The fracture in the submitted pipe section resulted from rock impingement with the crack propagating by SCG process,
- 2) There were no observed pre-existing defects in the pipe; and
- 3) The pipe was consistent with properly extruded PE 2306 material.

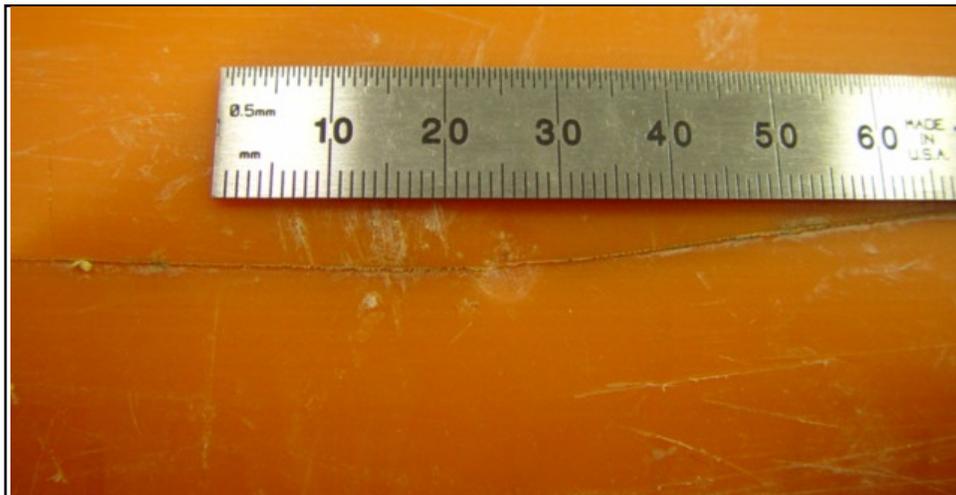
Figure 89. Close Up, Dimple and Crack

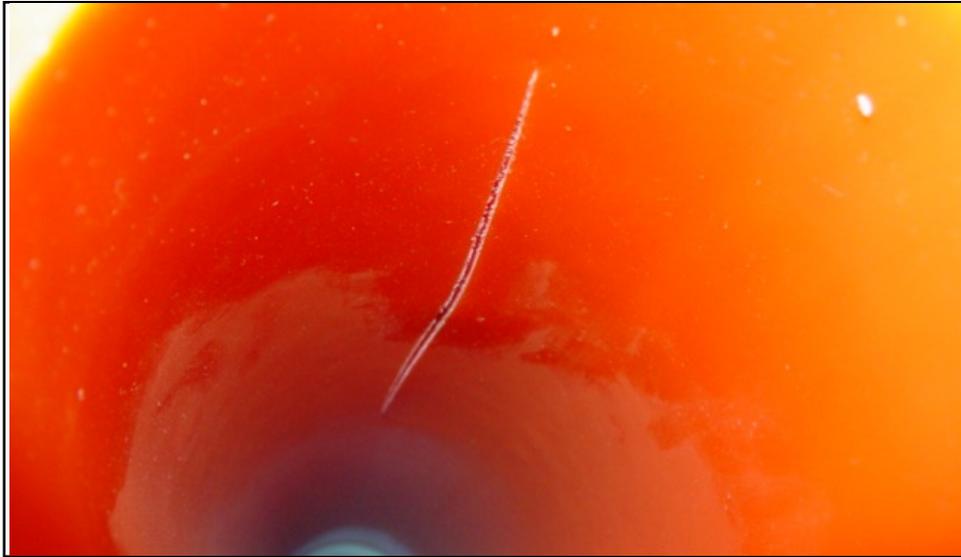
Figure 90. Crack As Seen On Inner Wall

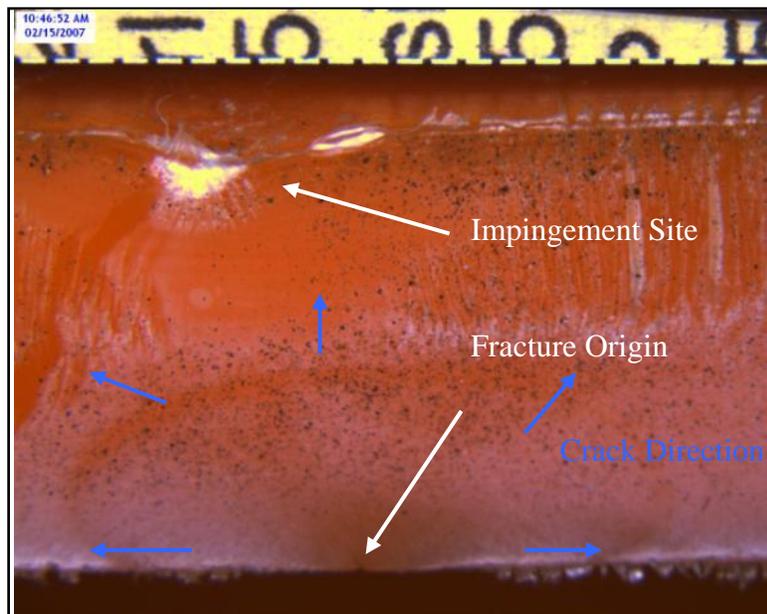
The pipe was the carefully cut so as to expose the fracture surface while minimizing opposing fracture surface contact and associated smearing of the surface morphology during the cutting operation. Once the fracture surfaces were exposed they were visually examined at magnifications up to 160X. The origin of the fracture, visible in Figure 91 and Figure 92, was found in the inner wall; located almost directly beneath the dimple in the outer wall. There was no evidence of defects or foreign material in the pipe wall.

Figure 91. Fracture Origin

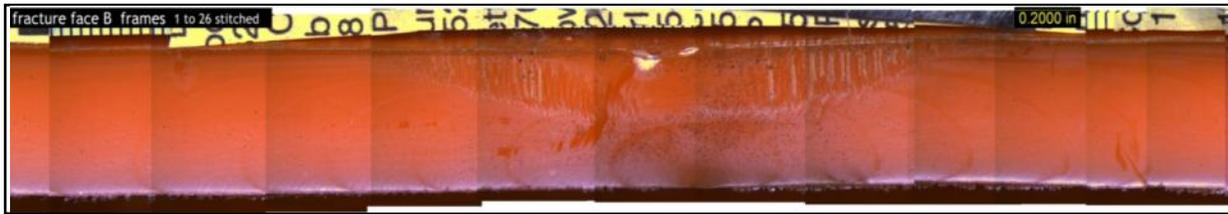
Figure 92. Composite Photo, Fracture Surface - Outer Wall at Top

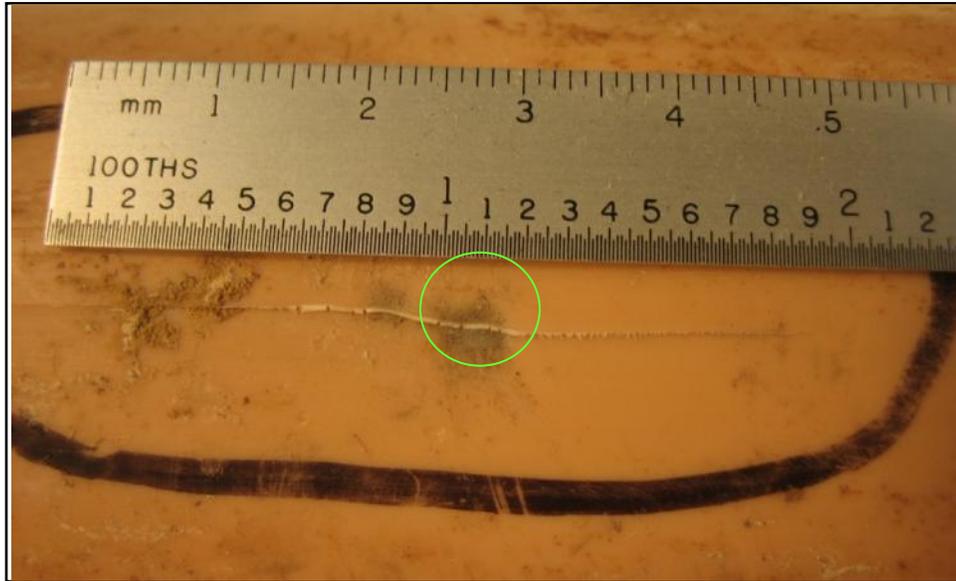
The failure report and background documentation provided with this sample indicated the presence of a rock in the ditch at the failure location. The impingement point is expressed by a green circle in Figure 94 below. Figure 95 shows the slit as seen on the inner wall. The location of the slit on the inner wall corresponds to the outer wall location. The impingement of the rock resulted in localized pipe loading/deformation leading to an axial slit wise crack. Most likely, it initiated on the ID (under tensile load) and grew through the wall to the OD.

Figure 94. Axial Slit on Outer Wall

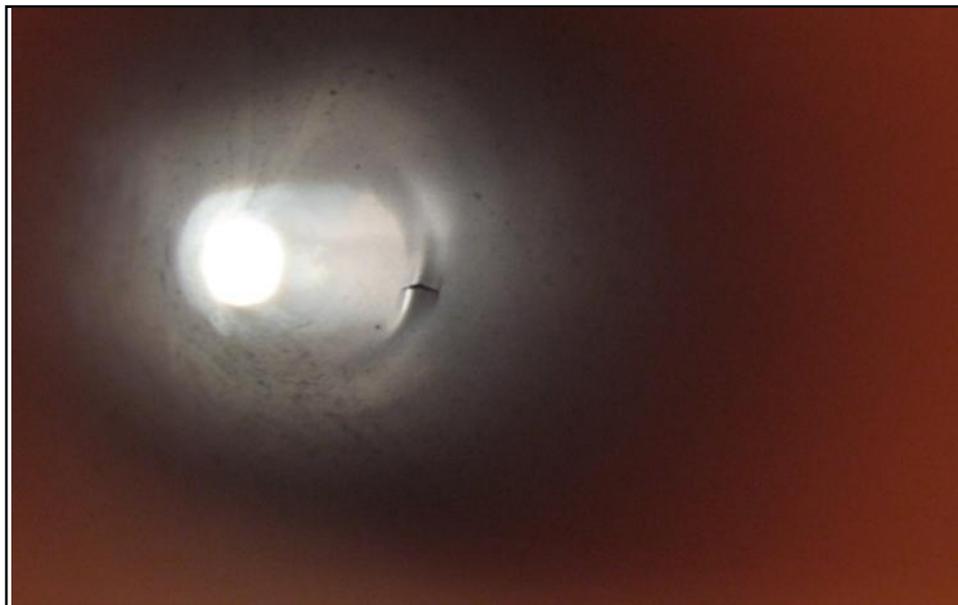
Figure 95. Axial Slit on Inner Pipe Wall

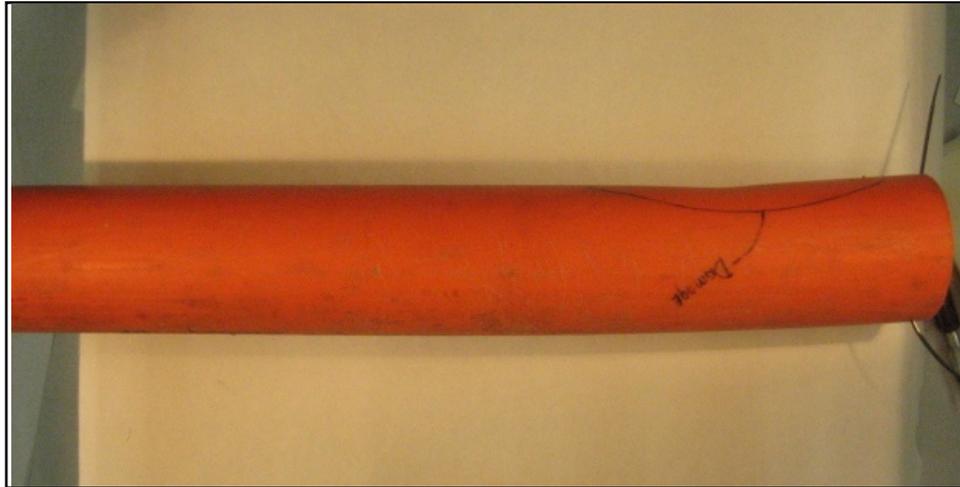
Figure 96. As Received Sample

According to background information provided by the submitting company, the pipe was found resting on a 4-inch steel main. This resulted in a localized shell bending load and deformation of the plastic pipe. An axial slit-wise crack was observed centered on the inner wall at the load point. The slit on the inner wall was measured at approximately 4" long. The crack exhibited full wall penetration resulting in a 1" slit on the outer wall.

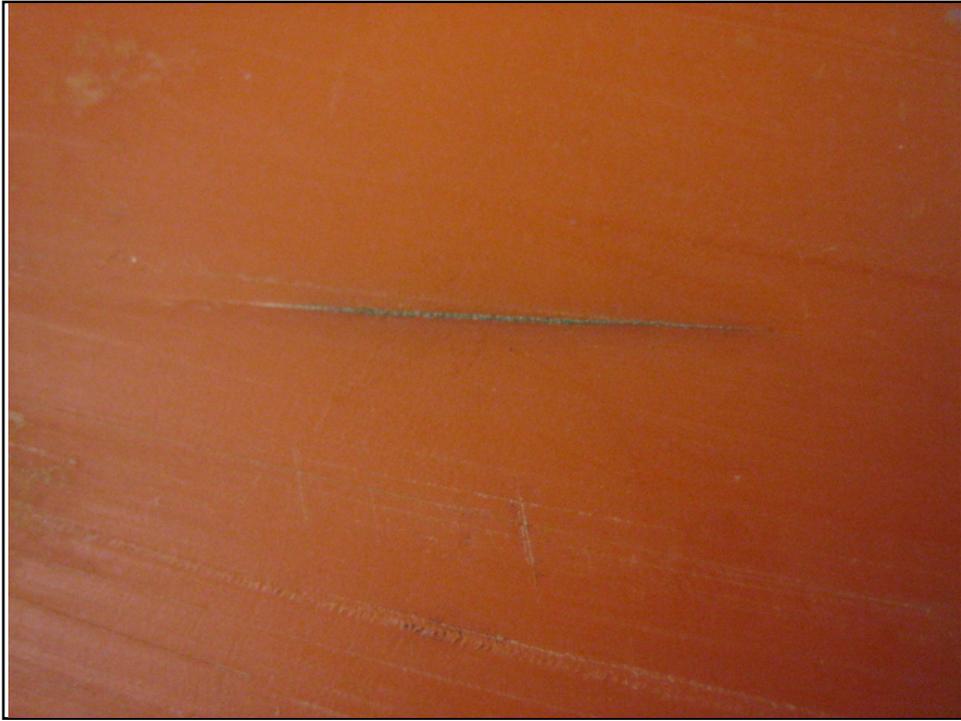
Figure 98. Slit on Outer Wall
