FINAL REPORTGTI PROJECT NUMBER 20385

Plastic Pipe Failure, Risk, and Threat Analysis

DOT Project# 194

Contract Number: DTPH56-06-T-0004

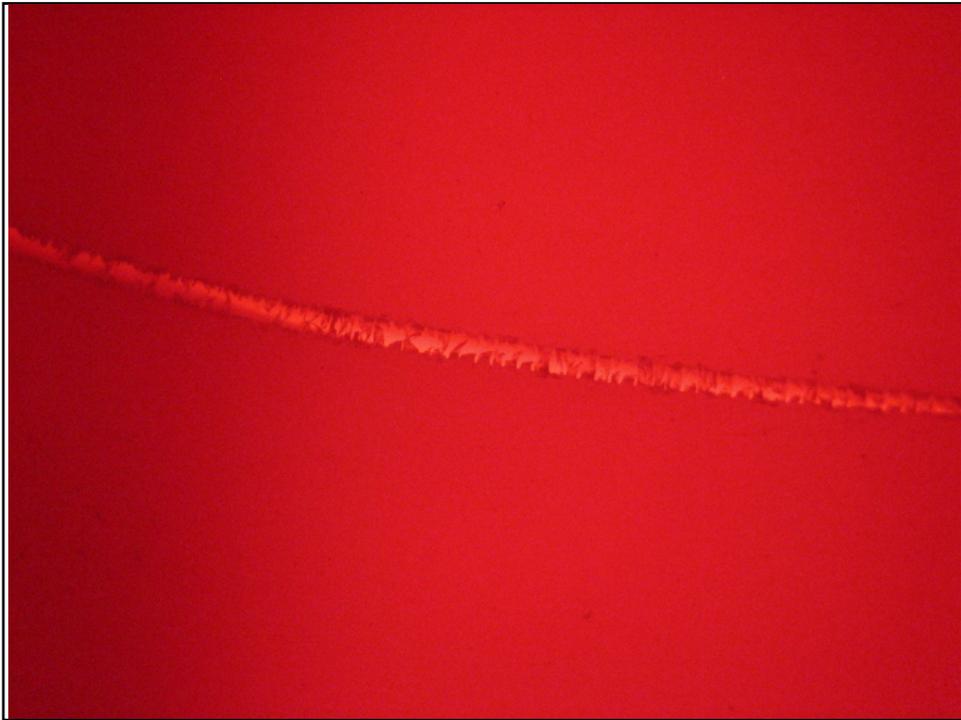
Figure 99. Slit on Inner Wall

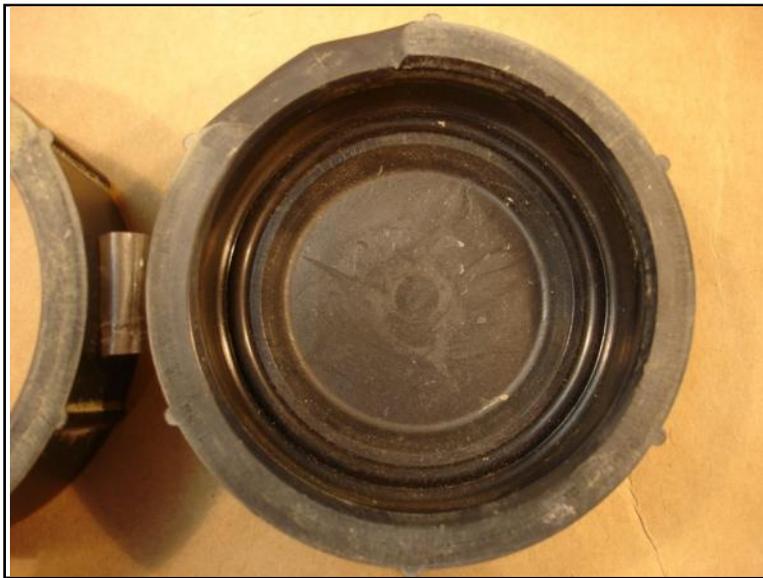
The top-side fracture surface was further examined using the stereo optical microscope with magnification capabilities to 320X. The results of this examination failed to indicate a single fracture origin. Instead it was determined that the fracture originated at the root of the last thread (nearest the top of the cap) and radiated outward tangent to this thread root. The fracture surface exhibited no indication of a torsional force component. White streaks were observed in the fracture surface as seen in Figure 104.

Figure 101. Topside Fracture Surface

- 1) Nylon materials are known to be to generally tough materials. The subject cap was manufactured from nylon, a 40% Kaolin filled (polyamide) 6,6. Nylon 6,6 the most commonly used of this material family.
- 2) The cap failure initiated in the root of the thread nearest the top off the cap. This area served to concentrate the tensile stress resulting from the mating of the cap to the companion tee.
- 3) There were no indications of over tightening or improper processing of the cap.
- 4) The banding observed in the fracture surfaces was the result of a differential cooling rate across the thickness of the part. This is common and was not a major contributor to the cap failure.
- 5) The white material found on the fracture surfaces was later determined to be unpigmented nylon 6,6 and was not a major contributor, if at all, to the cap failure.

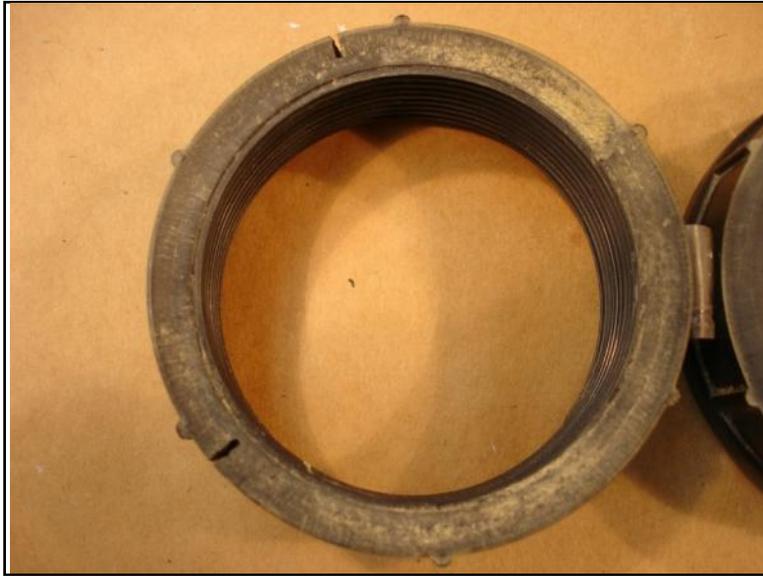
The cap was transversely split in two. The topside of the cap contained an o-ring for sealing the cap to the tee. This o-ring was free of nicks, had no embedded material and was also free of cracking. The actual cap material adjacent to the o-ring was free of scratches and gouges suggesting that the cap was tightened down without the top of the tee coming in contact with the cap which would have suggested potential over-tightening of the cap during installation. Both the top side (Figure 101) and bottom side (Figure 102) fracture surfaces were lightly covered with dirt from the installation site with more dust on the open-side fracture surface. The cap threads were free from distortion and damage as shown in Figure 103.

Figure 102. Bottom Side Fracture Surface

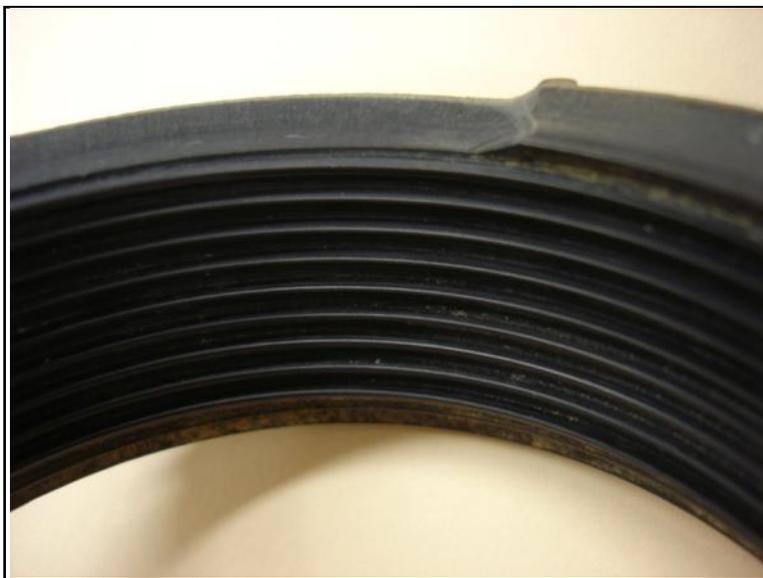
Figure 103. Cap Threads

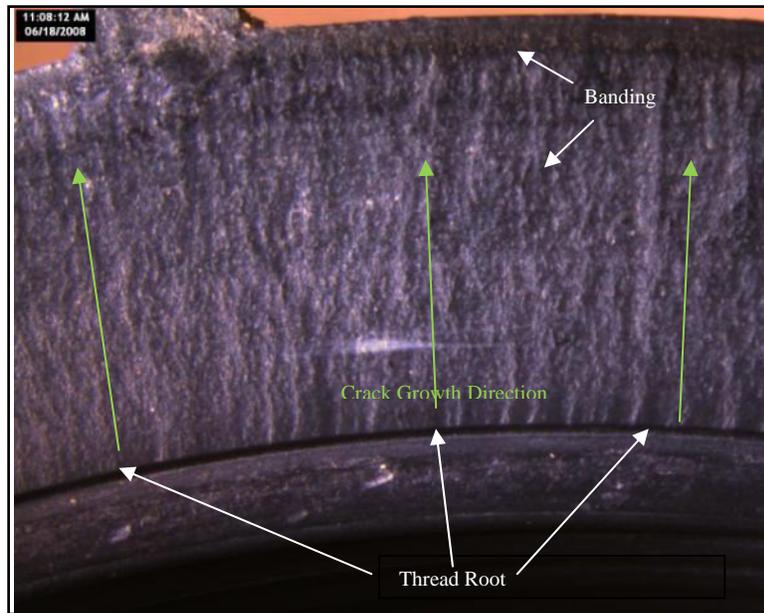
Figure 104. Topside Fracture Surface

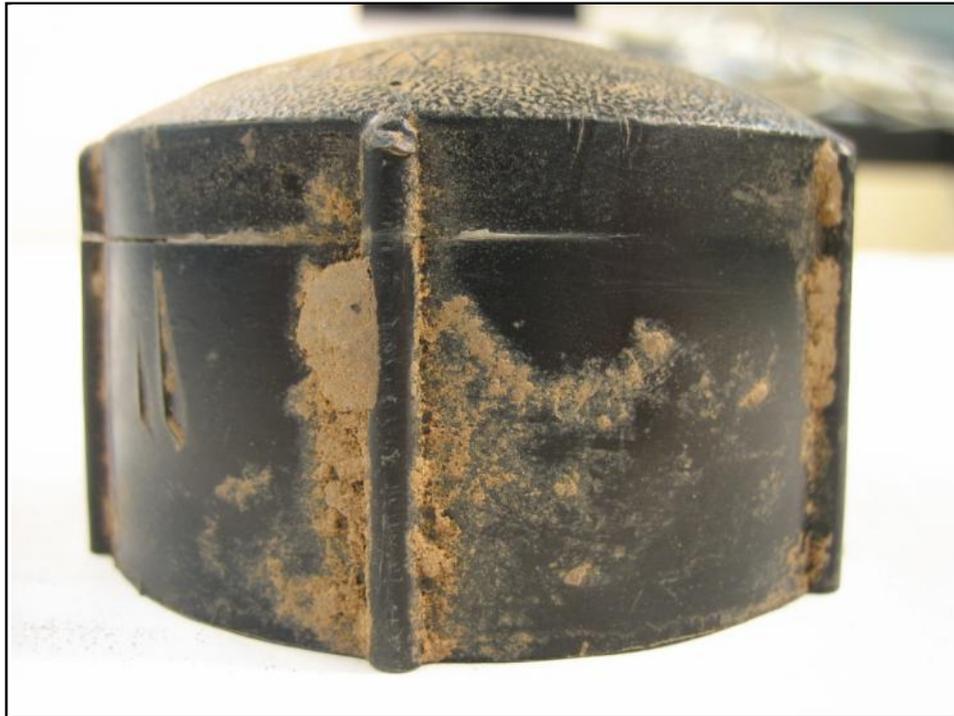
Figure 109. As Received Cap

This cap, manufactured by Wayne, exhibited a crack which extended approximately 230° around the circumference. The crack appeared to have originated in the first thread. Gouges indicative of the use of a wrench were apparent as seen to the left in Figure 109 though it is not possible to determine whether these marks were created during installation, service, or removal.

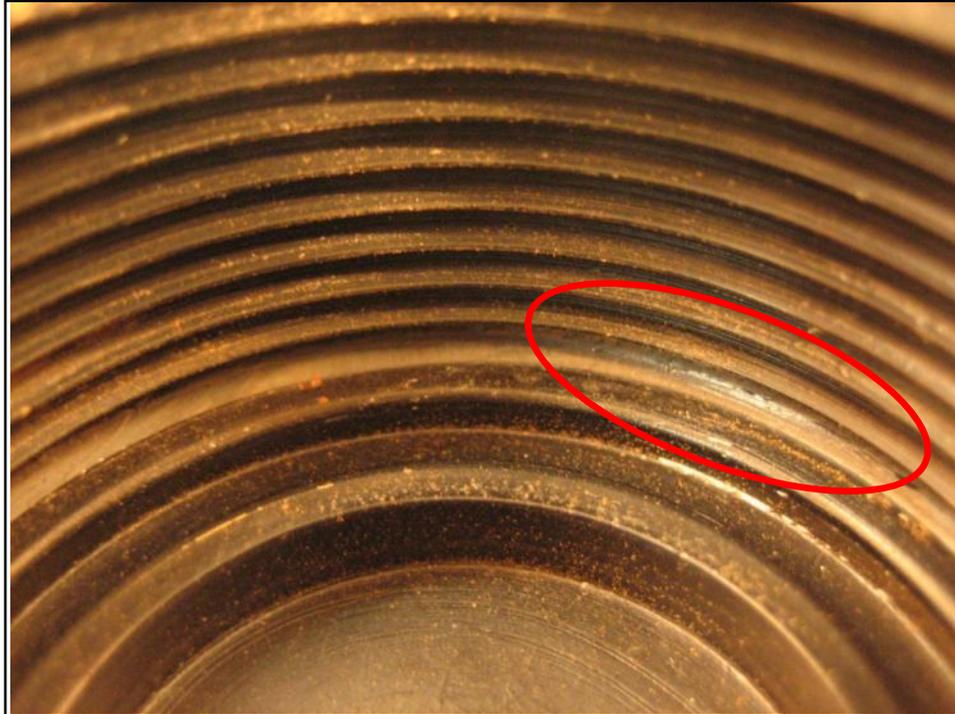
Figure 110. Crack Seen Inside the Cap.

This cap exhibited a crack which ran about 200° around the circumference. The crack on this cap appears to have started at the first thread and also exhibited signs of wrench use.

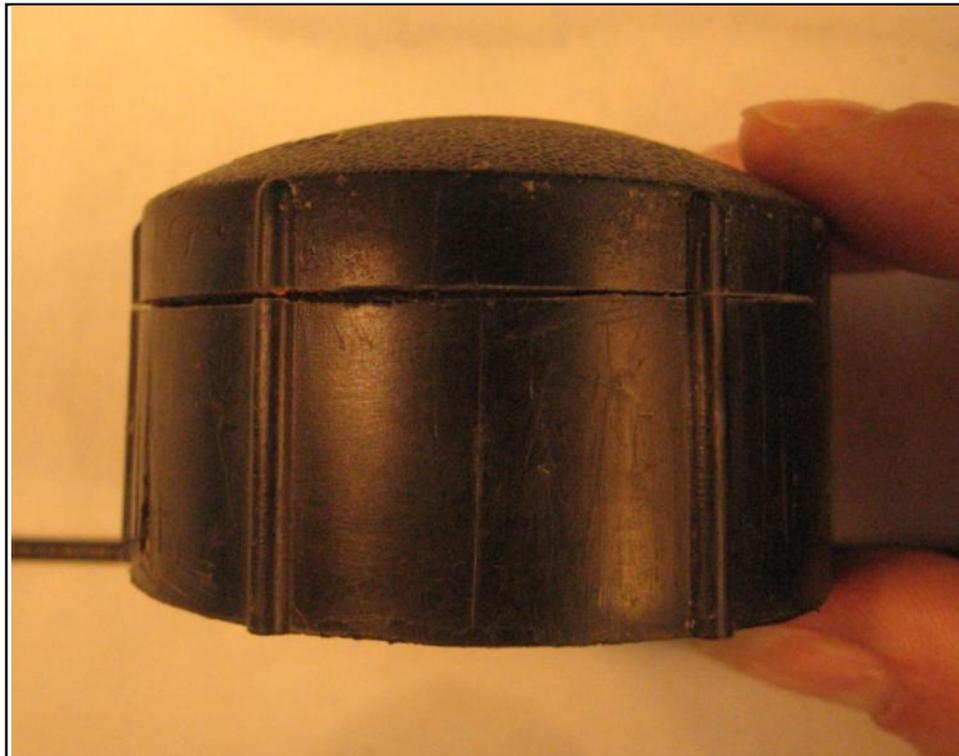
Figure 111. As Received Cap

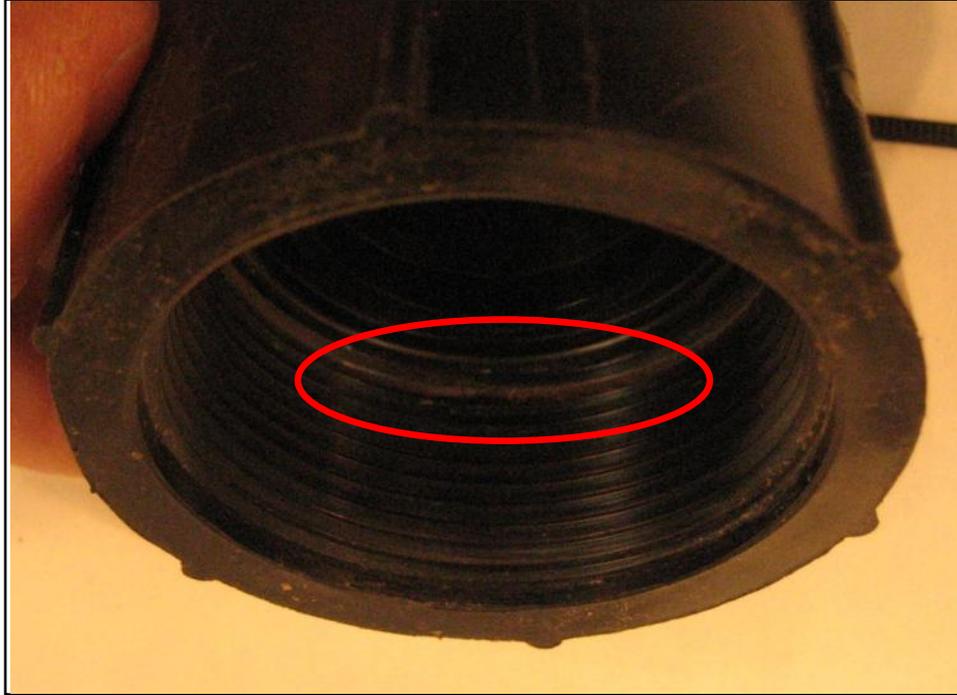
Figure 112. Soil on Interior Surface

This cap exhibited a crack which extended approximately 215° around the circumference. The crack appears to have originated in the first thread as indicated by the soil visible on the interior of the cap shown in Figure 114.

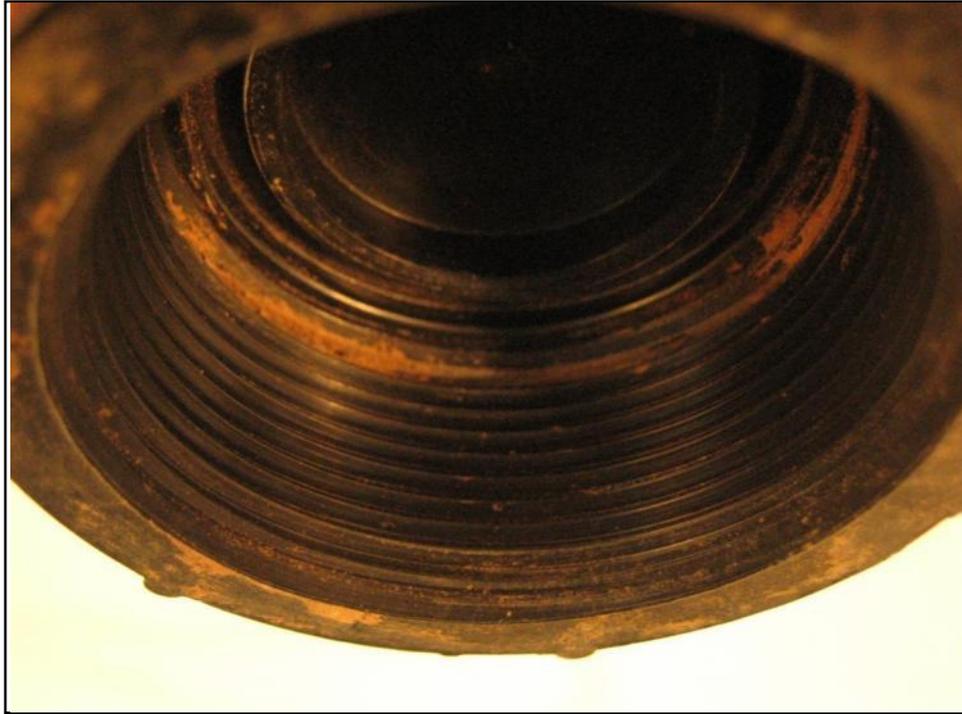
Figure 114. Dirty Interior Surface

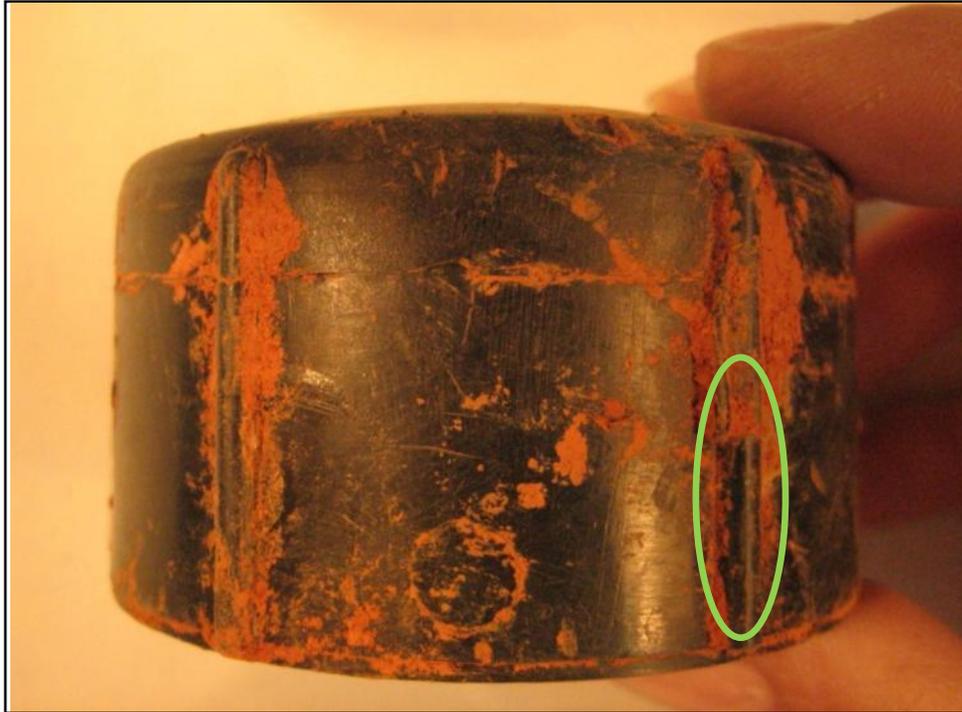
This cap from an unknown manufacturer exhibited a crack which was visible around the entire circumference. The crack appeared to have originated in the first thread. Gouges indicative of the use of a wrench were apparent as seen in Figure 116.

Figure 116. Cracked Cap with Wrench Marks

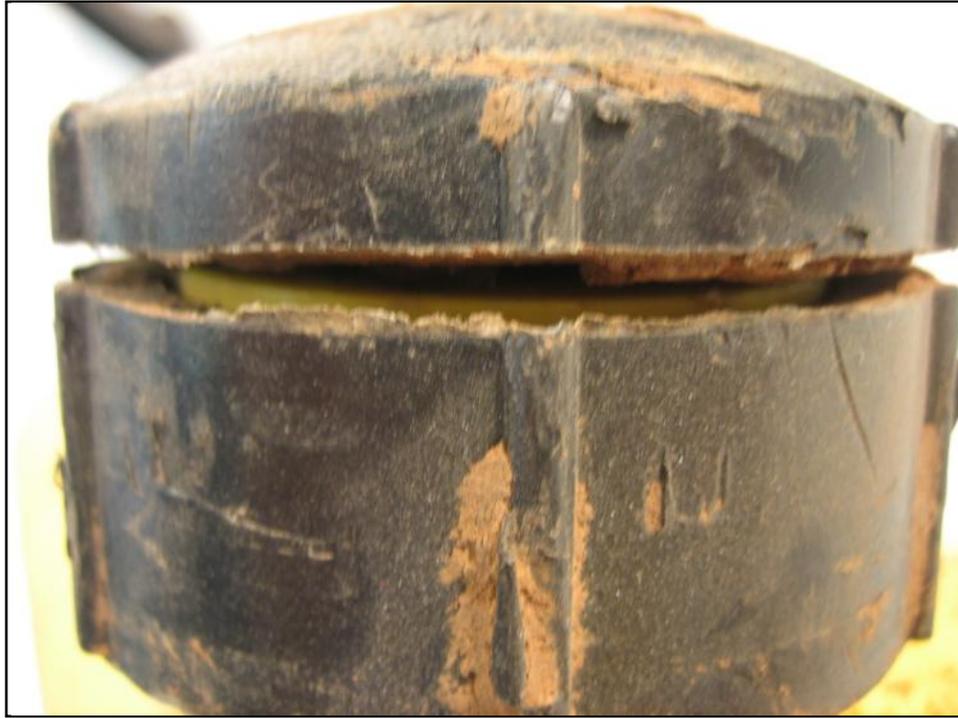
This cap exhibited a crack which extended approximately 240° around the circumference. The crack appeared to have originated in the same place as the previous caps. Gouges indicative of the use of a wrench can be seen in Figure 118.

Figure 118. Yellow Tee Visible Through the Crack

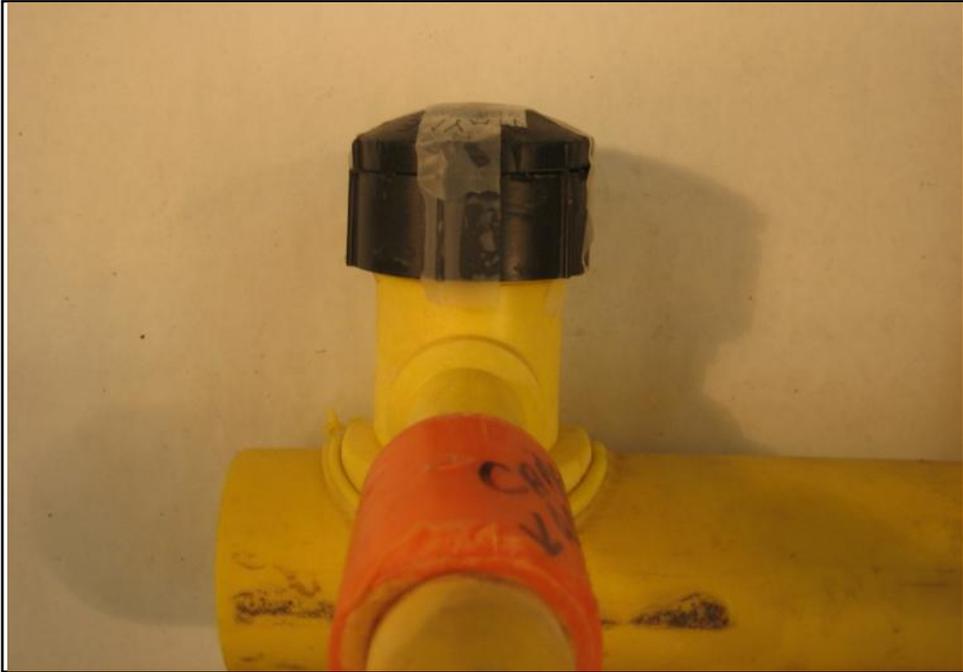
Figure 119. As Received Service Tee with Broken Cap

The received sample contained two service tees. The caps on each tee were completely severed. As seen in Figure 121, the cracks originated at the first thread on one of the caps.

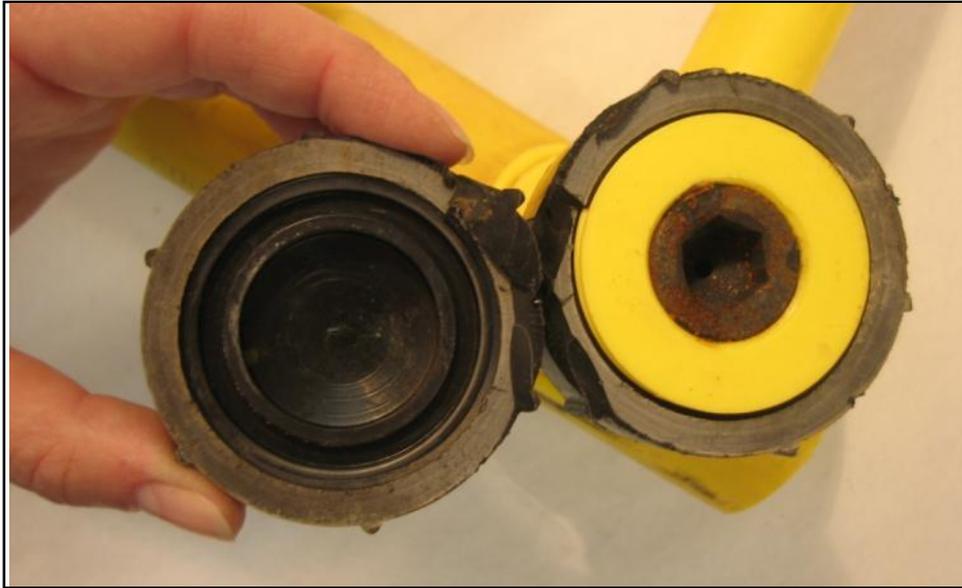
Figure 120. Fracture Surfaces of Cap

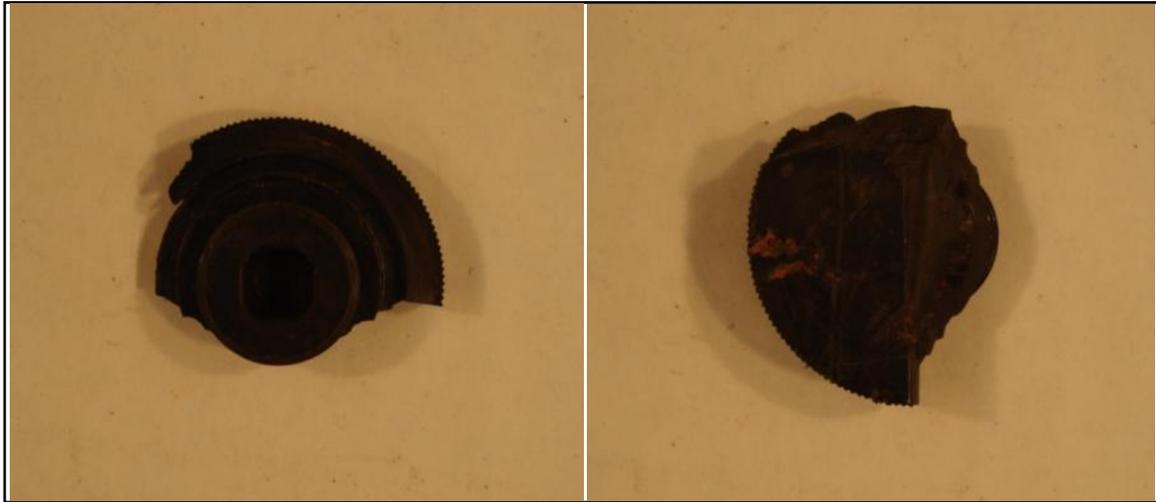
The cap was extensively damaged yet all of the external threads appeared to have remained intact. The corresponding internal threads in the saddle tee were intact as well. The cap exhibited multiple fracture planes with associated multiple fracture origins. Fifty 50% of the upper portion of the cap was missing along with the o-ring. The general orientation of the major fracture planes suggested that the cap may have been subjected to significant loading from above.

Figure 123. Cap, Underside Left and Topside Right

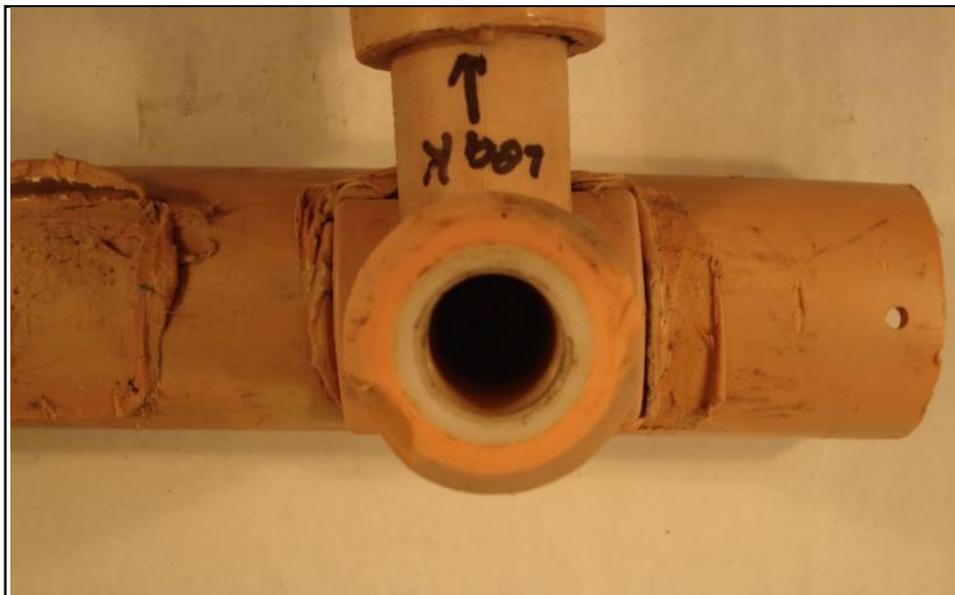
Figure 124. Internal Threads of the Saddle Tee

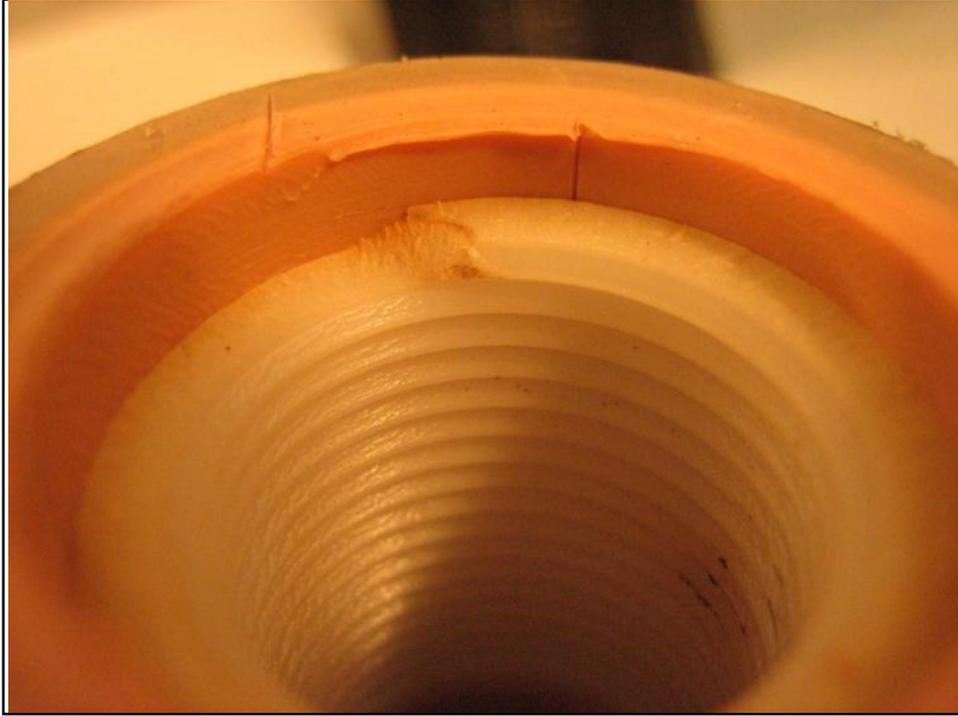
The sample was missing background data and companion cap upon submission. GTI was unable to obtain either. The failure initiated at root of the second thread. The thread root acted as a stress concentrator to the tensile forces produced by tightening the cap.

Figure 126. Close-up View of Thread Insert

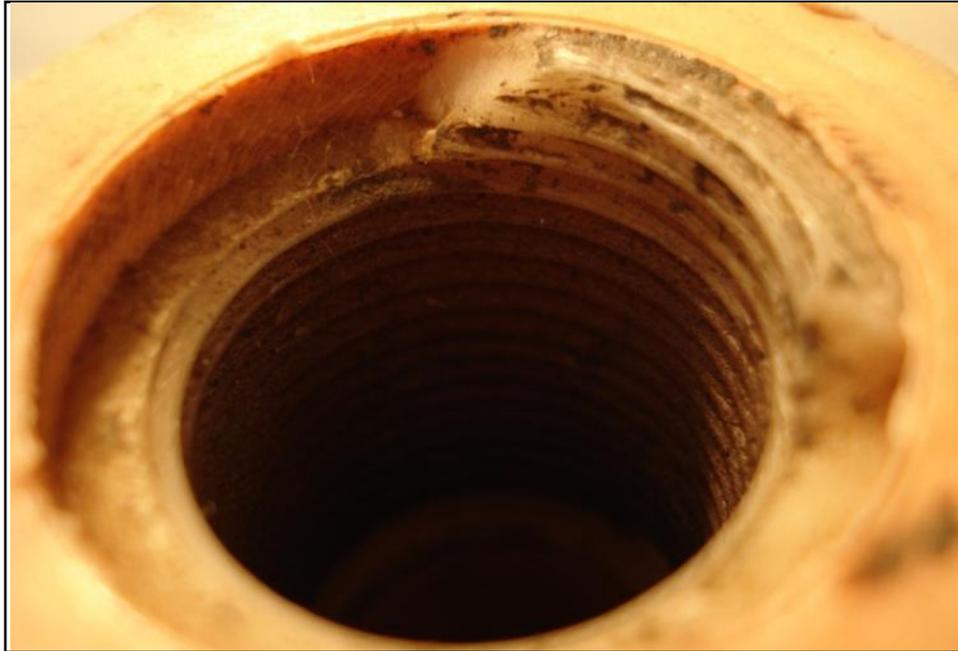
The threaded insert fractured about 300° at the second thread which remained attached to the cap. The thread root acted as a stress concentrator to the tensile forces produced by tightening the cap. The cap contained deposits consistent with an aged lubricant that was most likely applied to the o-ring on a previous occasion. Lubricants can embrittle certain types of plastic but without identifying this particular insert material it cannot be stated with certainty.

Figure 128. Close up of Severed Insert

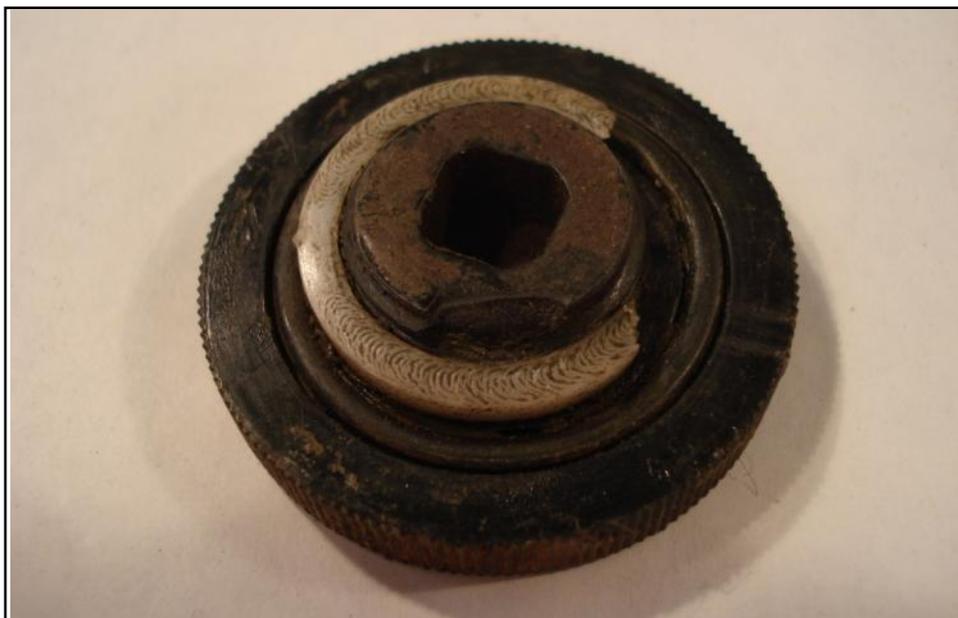
Figure 129. Cap with Insert Attached

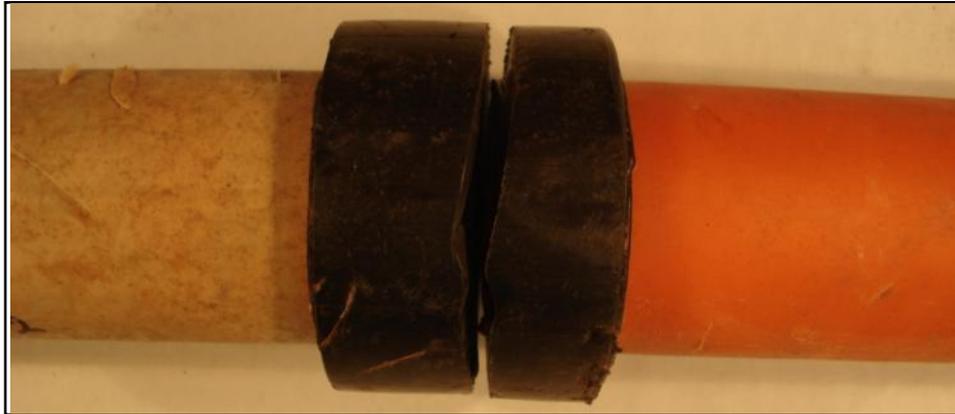
The coupling exhibited complete separation in plane with the end of the orange pipe. Preliminary examination of the fracture surface indicated the presence of torsional loading of the coupling and adjacent pipe. Approximately 50% of the face of the failure exhibited features similar to SCG. The crack appears to have initiated on the ID then grew towards the OD with final ductile rupture at the OD surface. In Figure 132, the whitened area below the yellow line shows the SCG features. The ductile rupture area is above the yellow line.

Figure 131. Severed Coupling

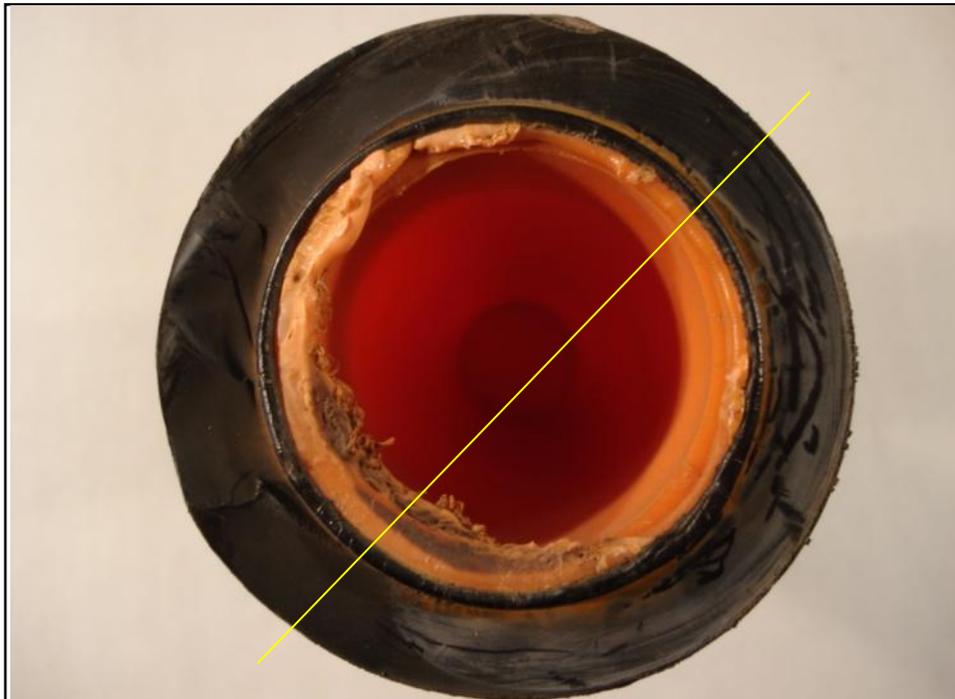
Figure 132. Fracture Face

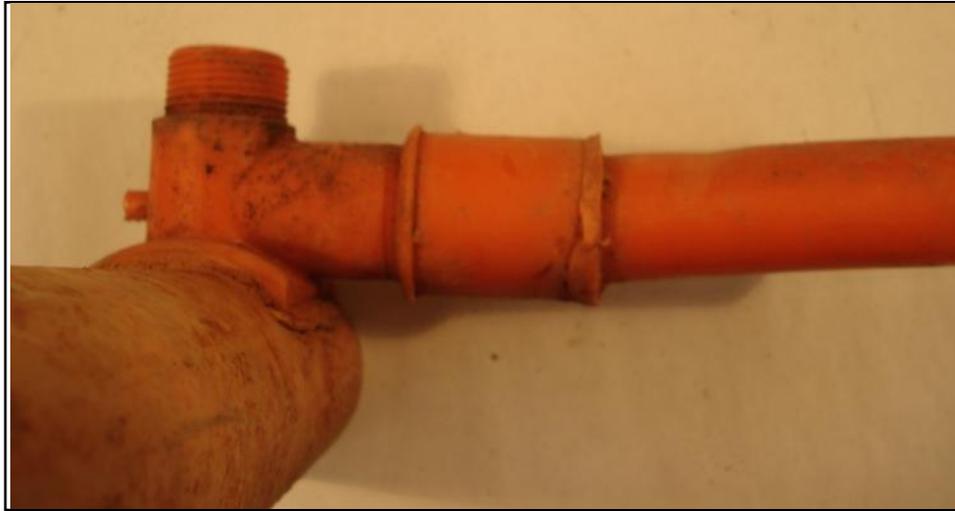
The socket coupling showed signs of overheating to the point of deformation. A 1 – ¾” circumferential slit was observed on the underside of the socket. The slit appears to line up with end of the service line pipe. The side view of the specimen in Figure 134 shows the service line in parallel misalignment. The direction of the misalignment relative to the location of the crack indicates that an excessive bending stress was applied.

Figure 134. Side View

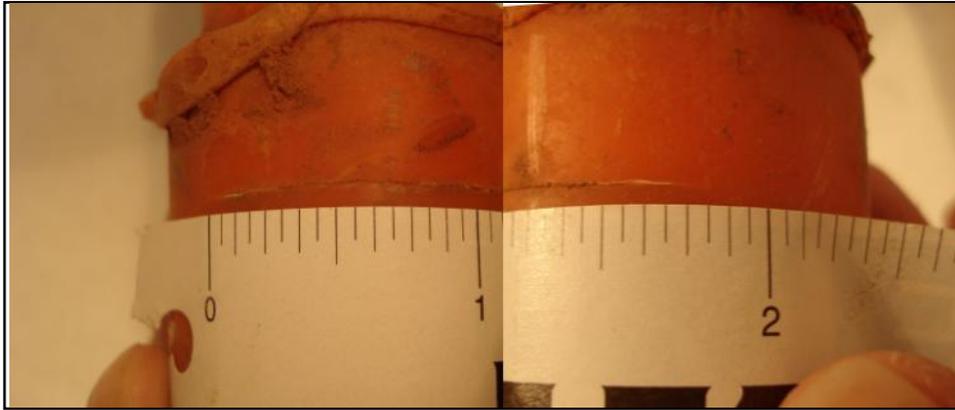
Figure 136. 1 - $\frac{3}{4}$ " Circumferential Slit on Underside of Coupling

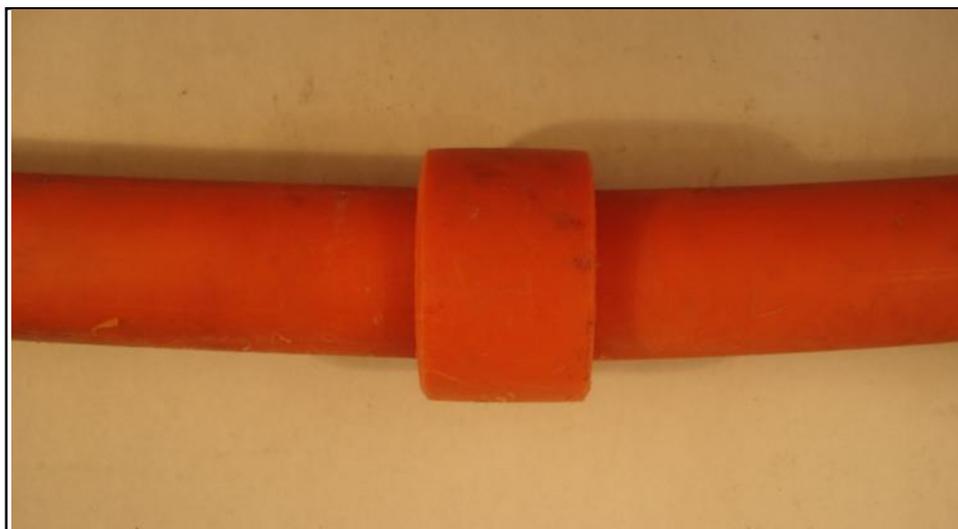
Figure 137. As Received Coupling

As seen in Figure 137, the pipe was under a bending moment from installation conditions. Because the bending made it impossible to observe the entire inside of the pipe, one end was cut off. A slit failure in the circumferential direction was observed on the pipe wall as seen in Figure 138. The crack lined up with the edge of the coupling which is also where external leak location was identified during pressure testing as identified by an arrow in Figure 139. The direction of the misalignment relative to the location of the crack indicates that an excessive bending stress was applied.

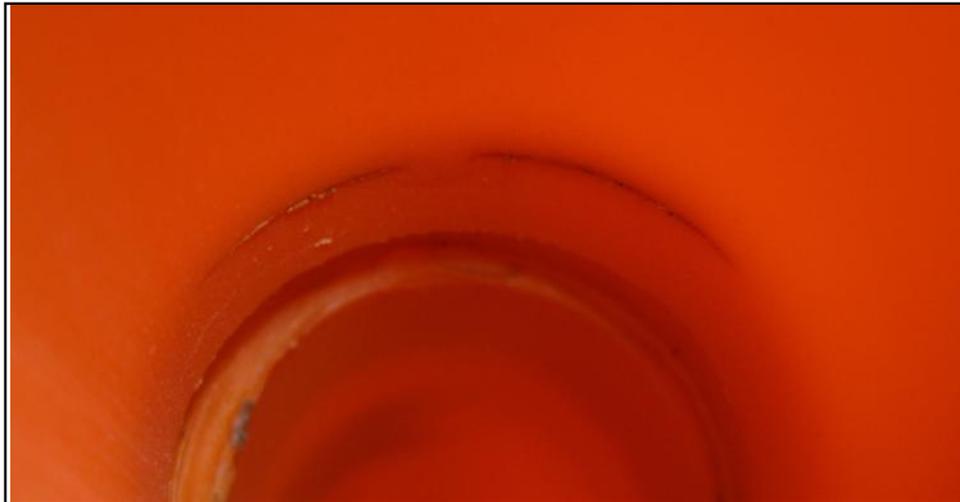
Figure 138. Crack in Pipe Wall on ID

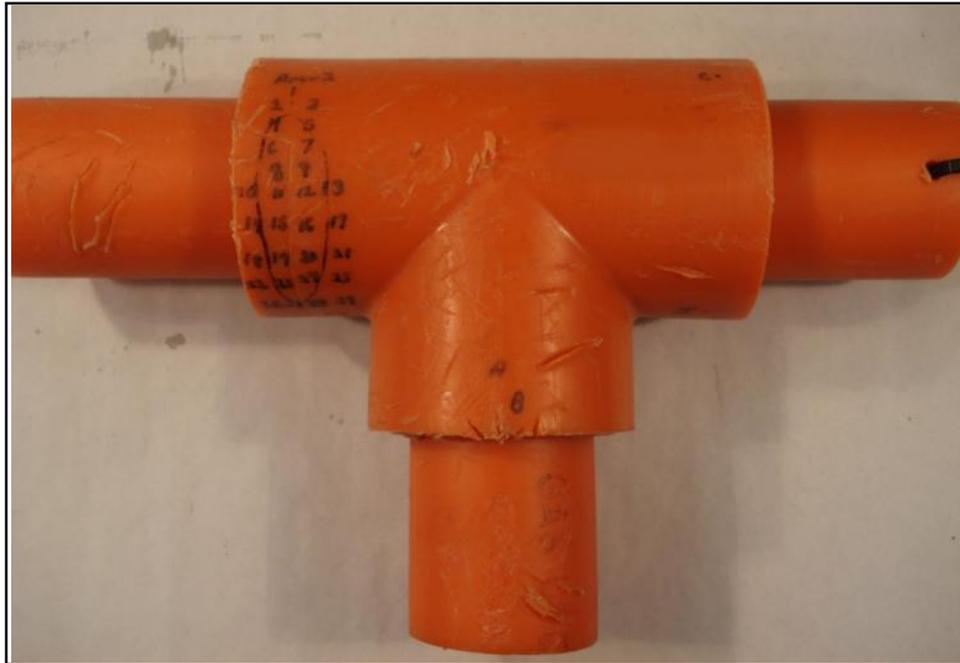
Figure 142. As Received Socket Tee

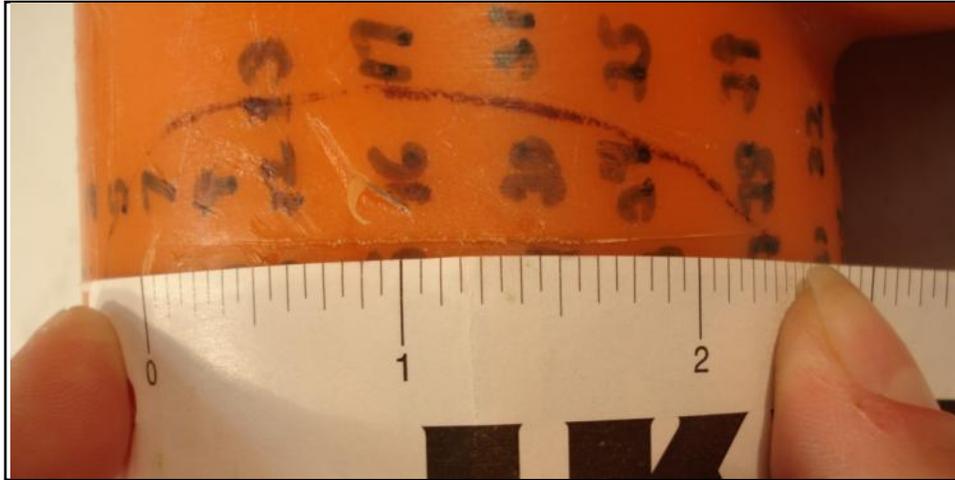
A 2” circumferential slit crack in the socket that grew completely through the socket wall was observed. The slit was approximately lined up with the end of the pipe where stress was most likely concentrated due to radial distortion also noted on this sample.

Figure 143. Circumferential Slit in Socket

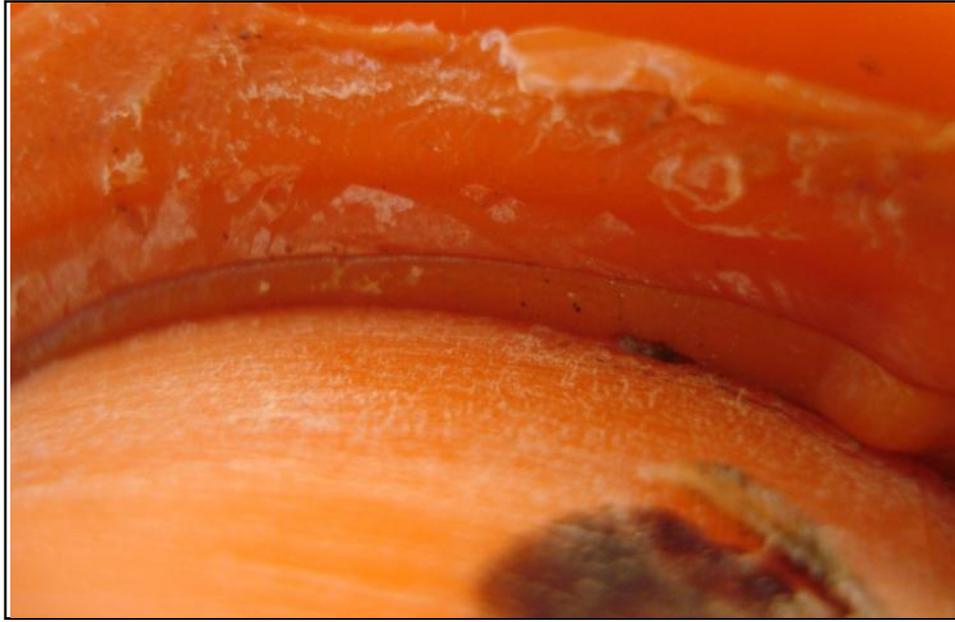
A crack was observed on the face of socket tee as seen in Figure 145. Looking into the fitting, a ledge was observed, suggesting this is a molded part rather than an extruded pipe. A circumferential crack extending 60° around the circumference and discoloring were also observed. These three features are identified by arrows in Figure 146.

Figure 145. Crack on Socket Surface

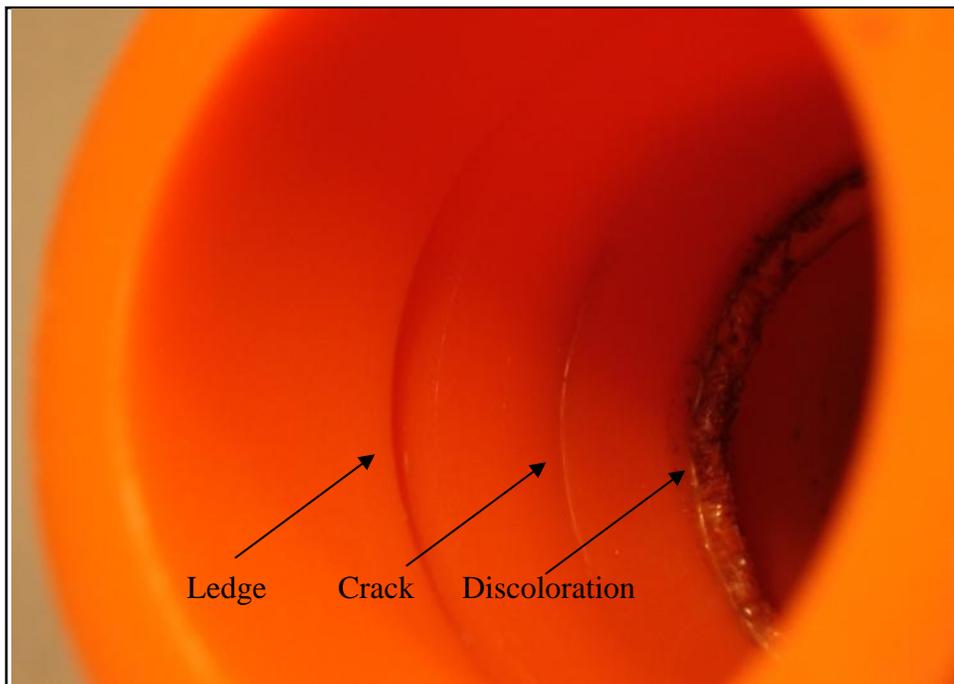
Figure 146. Features on ID

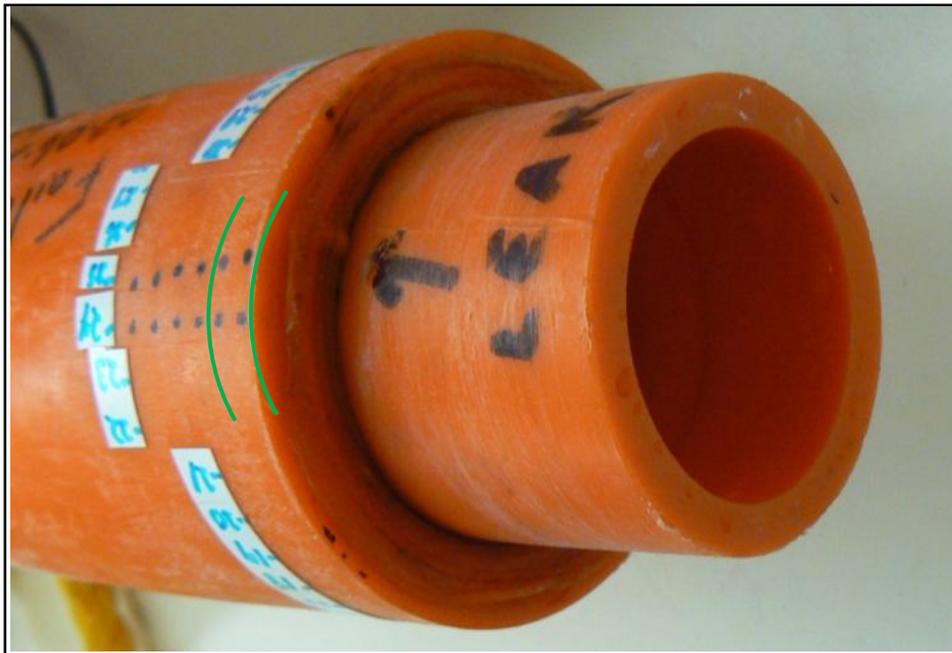
This sample was also shared with PHMSA sponsored project “Nonmetallic Joint Quality Assessment” (Project #217 Contract Number: DTPH56-07-T-000001). Black dots seen in Figure 147 show ultrasonic measurement locations. The measurements showed poor fusion quality at the pipe/coupling interface for a distance of 0.3” in from the edge of the socket tee. This area is marked by green arcs in Figure 147. Beyond this area, fusion quality improved dramatically going towards the body of the tee. The location of the crack on the molded part/pipe was 0.3” from the edge of the socket tee. The information suggests gas escaped out of the crack and through the un-bonded area between the pipe and coupling.

Figure 147: Photograph of Tee Showing Location of Leak

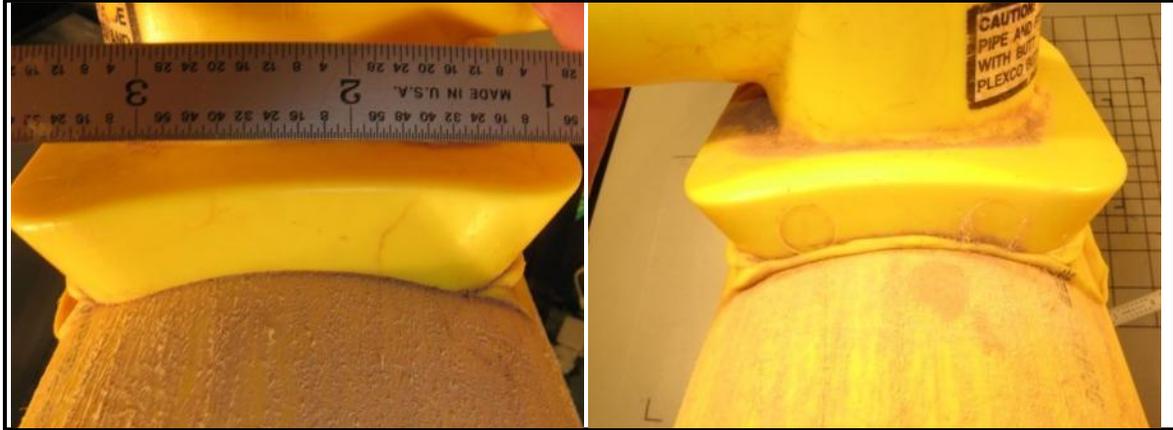
Areas of uneven rollback or no rollback were discovered at the tee-pipe interface as shown in the photos in Figure 149. A gap was noted on the inside of the tee between the tee and the pipe outer wall as seen in Figure 150. This gap suggested an area of discontinuous fusion.

Figure 149. Left Side with No Bead Rollback and Right Side with Uneven Bead Rollback

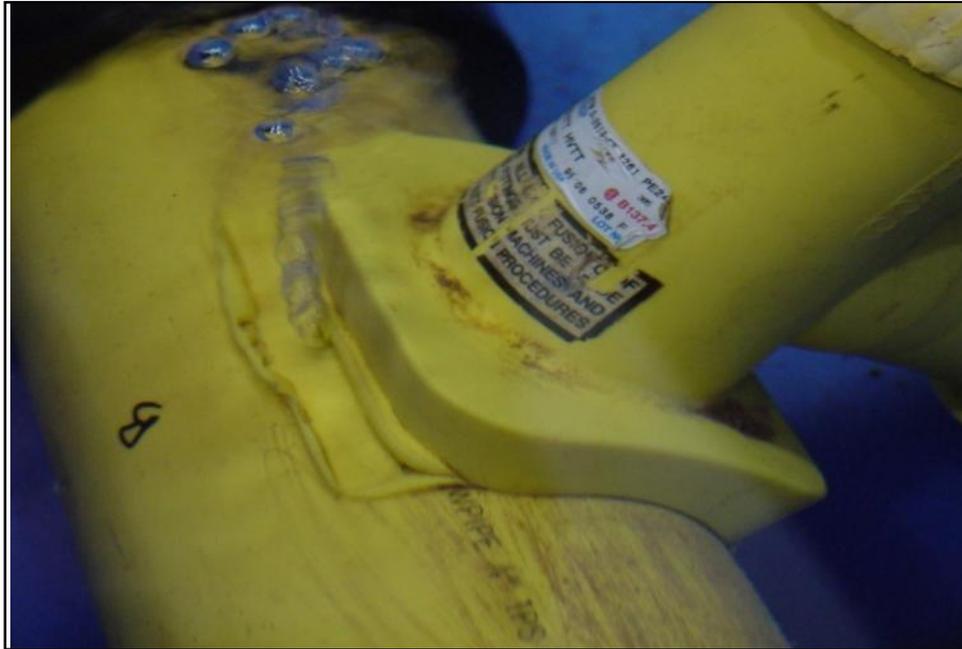
The specimen was capped, immersed in water, and pressurized to 15 psi to verify the location of the leak. As seen in Figure 151, the leak was found on the backside of the tee at the fusion interface.

Figure 151. Pressure Test to Identify Leak Location

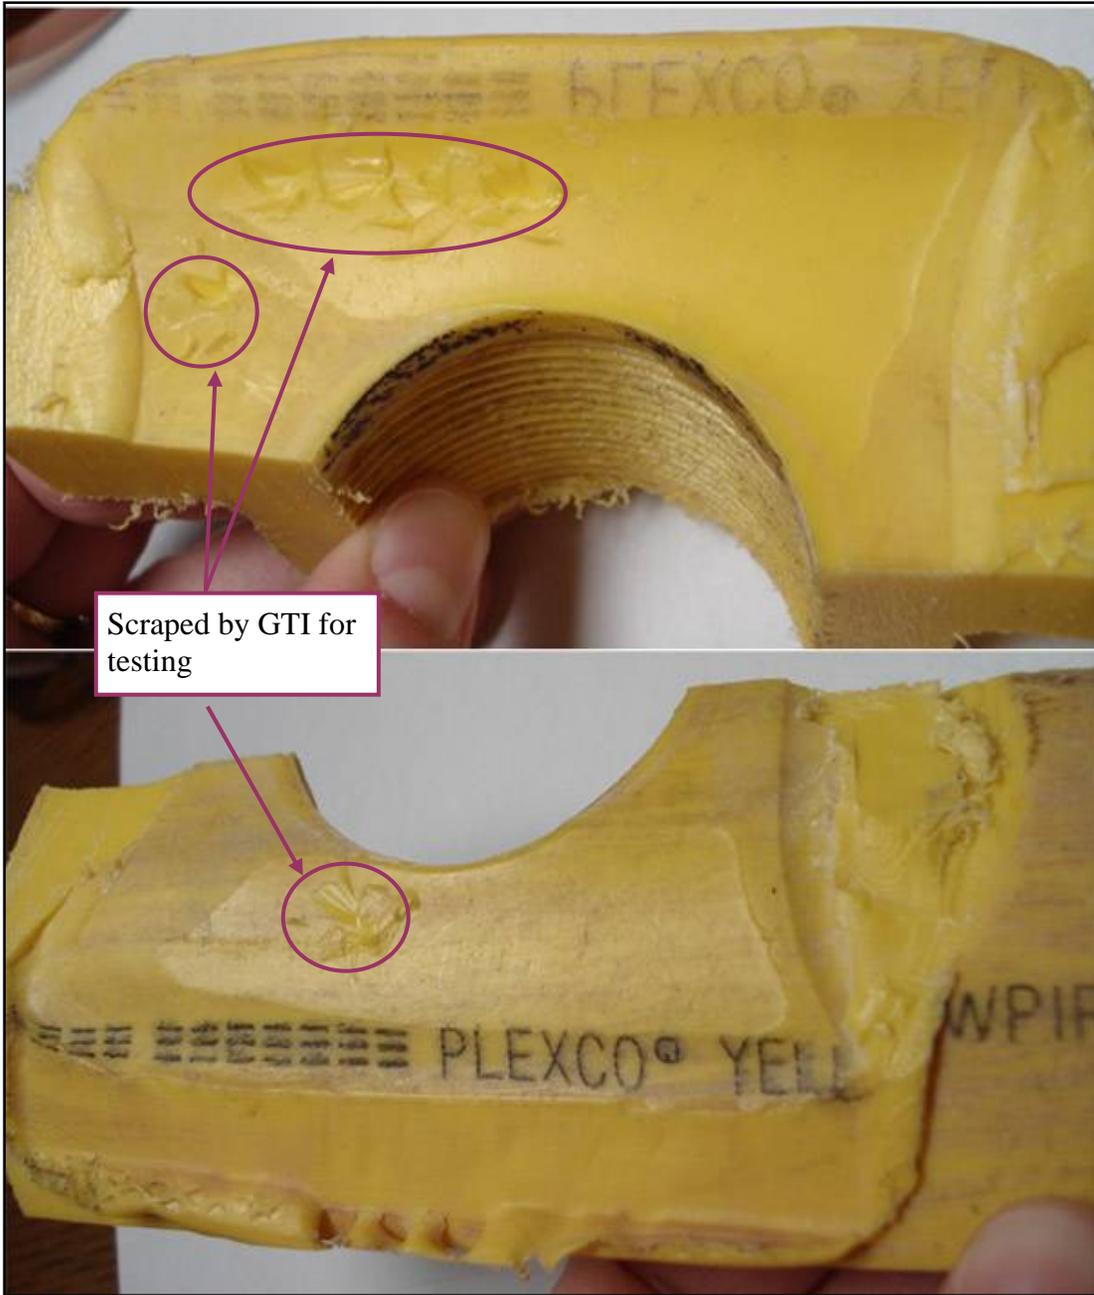
Figure 153. Mating Surfaces of the Tee and Pipe
