FINAL REPORTGTI PROJECT NUMBER 20385

Plastic Pipe Failure, Risk, and Threat Analysis

DOT Project# 194

Contract Number: DTPH56-06-T-0004

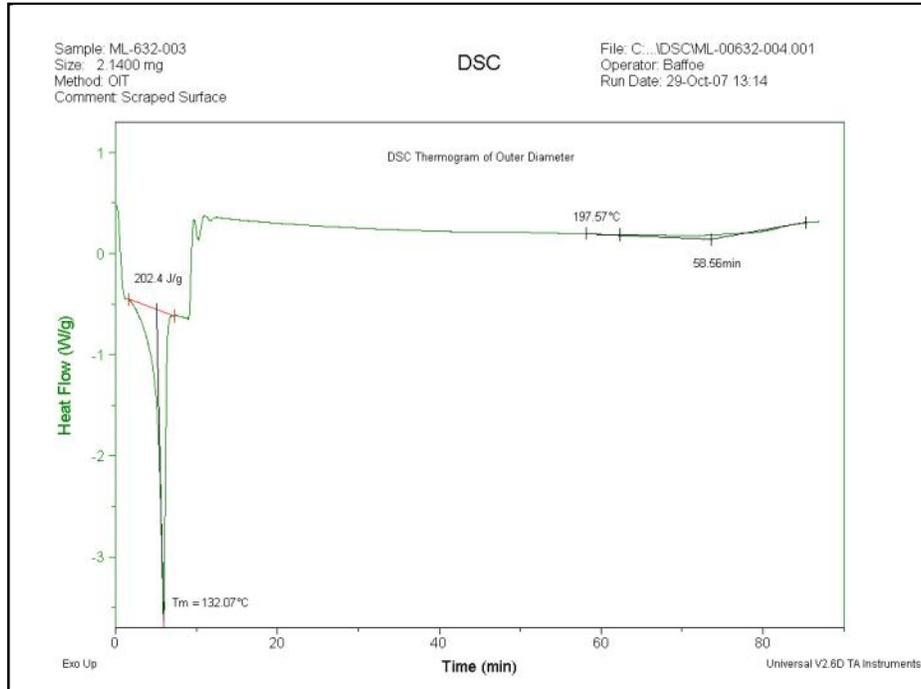
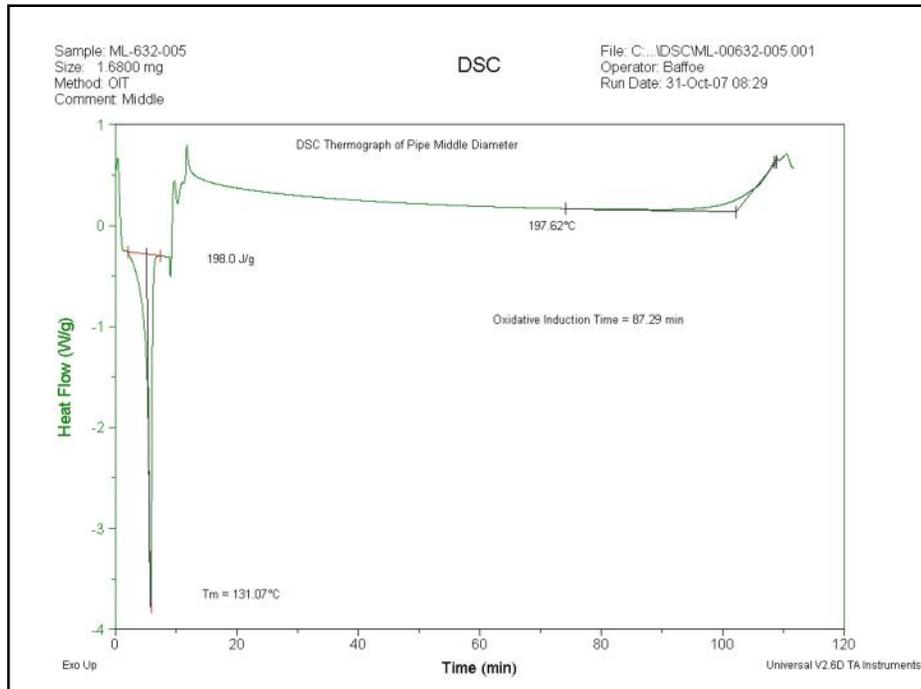
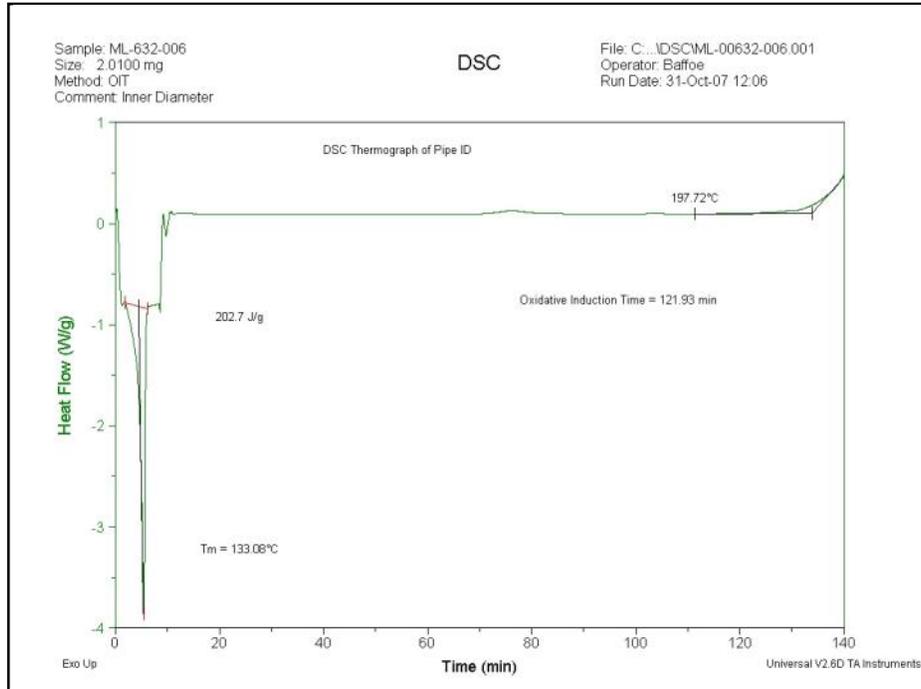
Specimens were prepared from the pipe section by removing material from the pipe fusion surface, middle of the pipe wall, and the inner pipe wall surface. These specimens were subjected to ASTM D3418 differential scanning calorimetry. The resulting thermograms indicated consistent levels of crystallinity for each of the specimens. No additional melting or exotherms were detected which would have suggested the presence of contamination. In addition, ASTM D3895 oxidative-induction time was performed on another set of prepared specimens. The scraped surface prepared for the fusion exhibited a slightly lower induction time than the middle and inner layers of the pipe. This was consistent with pipe that has been in the field. The OIT and DSC thermograms are shown in Figure 154, Figure 155, and Figure 156.

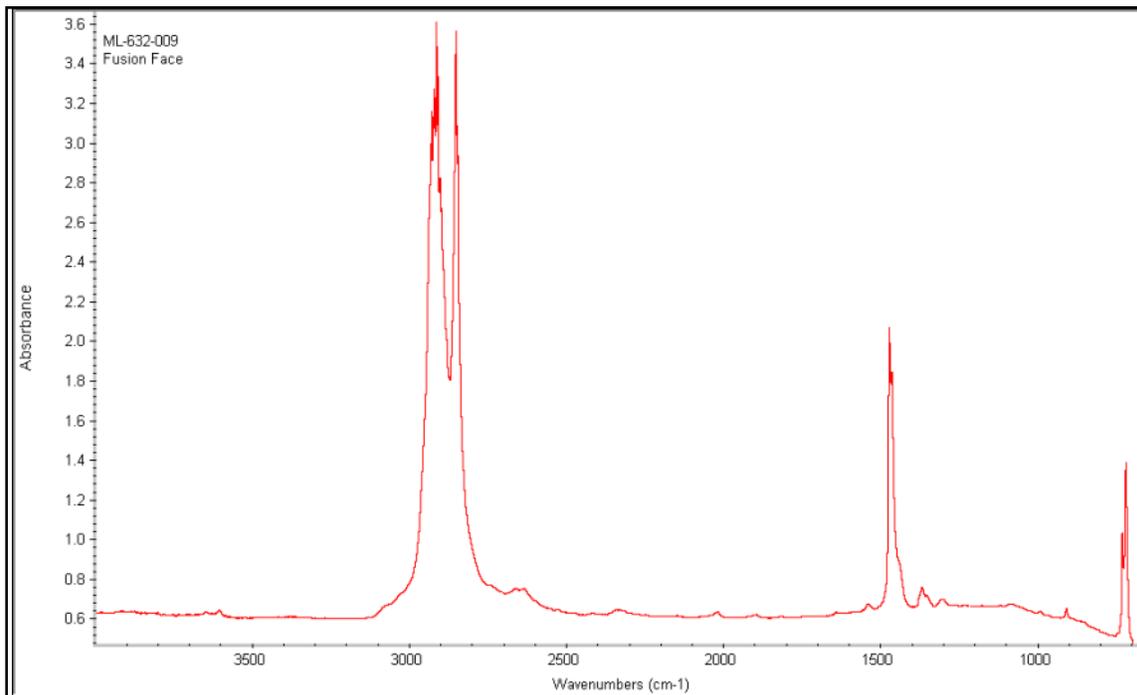
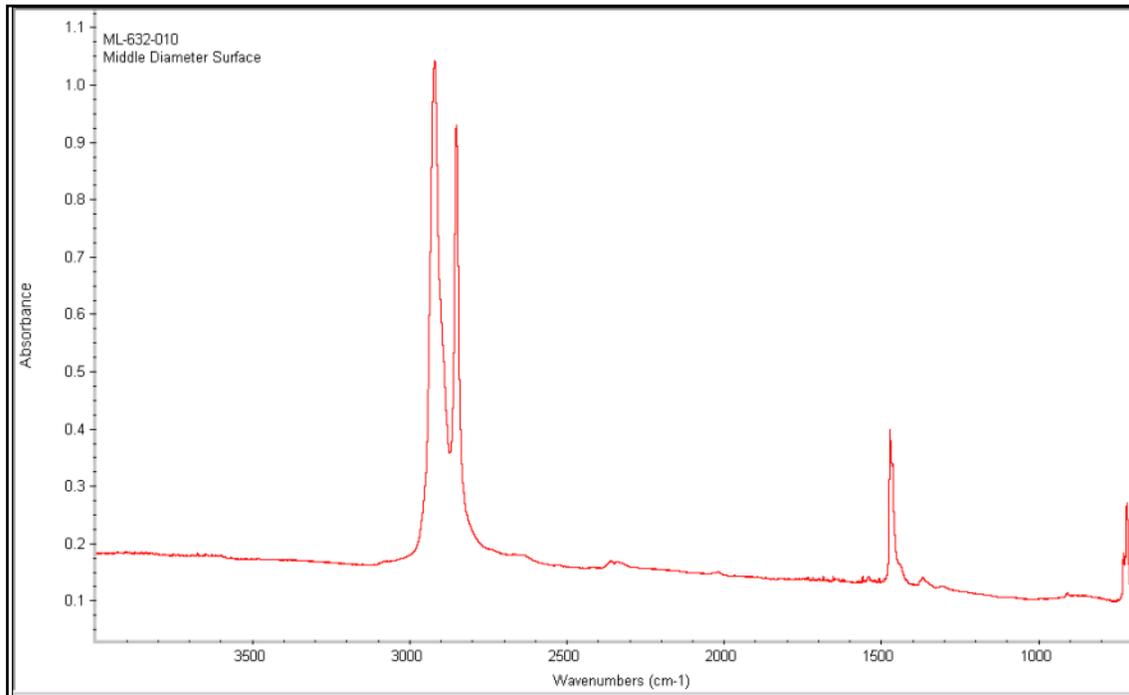
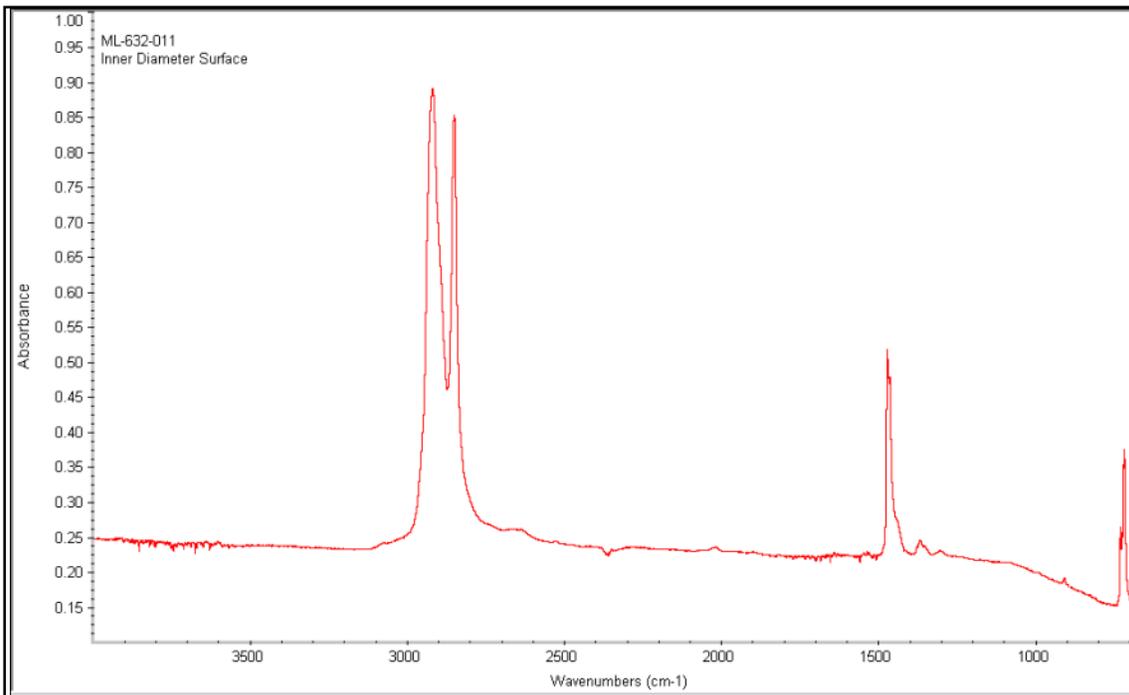
A comprehensive analysis was performed to determine the condition of the pipe and tee sections as well as detect the presence of any organic materials not associated with the pipe material. The resulting spectra were analyzed and indicated no any foreign organic materials in the outer diameter fusion area, middle, and inner diameter surfaces. The 1650cm-1 to 1750cm-1 region of the resulting spectra were closely examined. Absorbencies in this region are associated with PE oxidative products. No absorbencies were detected in this region. This suggested that the pipe was manufactured and stored acceptably prior to installation. The FT-IR charts for the outer, middle, and inner walls can be seen in Figure 157, Figure 158, and Figure 159, respectively.

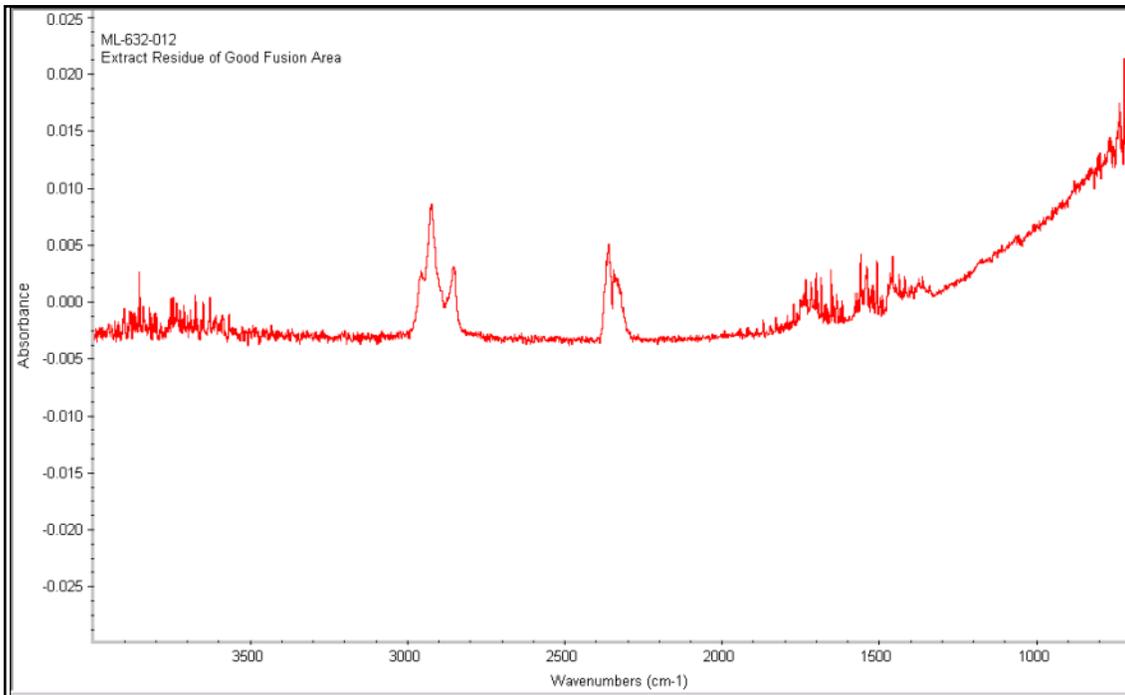
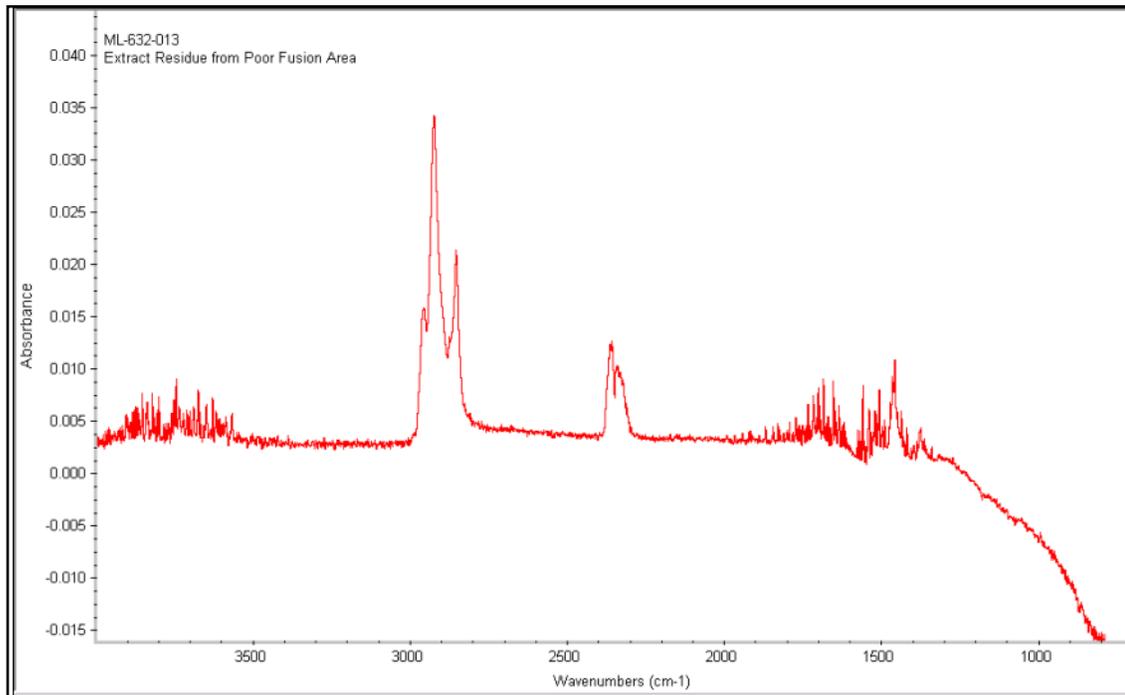
Acetone extractions of the good (adjacent to proper rollback on fusion bead) and poor (adjacent to area with no fusion bead) fusion areas of the tee were performed to see if any organic materials not associated with the tee material could be detected. No abnormal absorbencies were detected in the resulting spectra shown in Figure 160 and Figure 161.

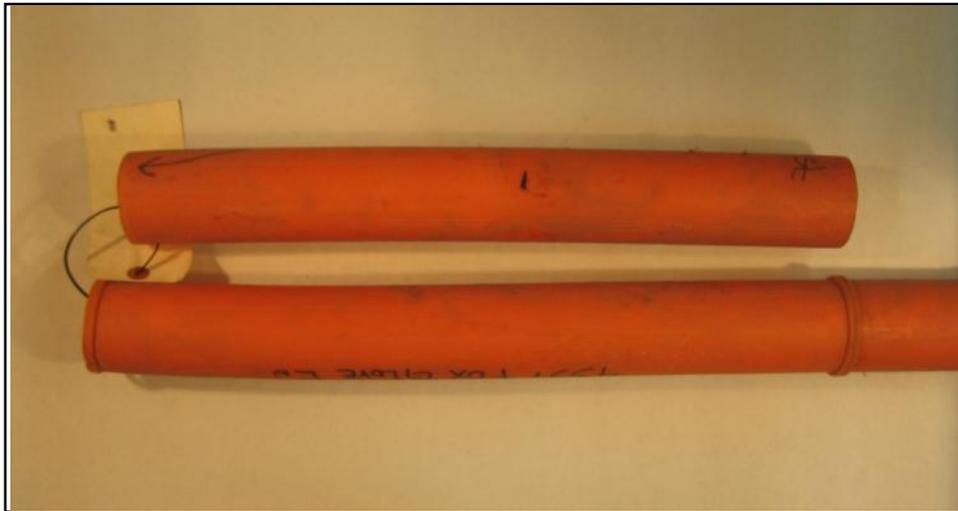
Figure 162. As Received Butt Fusion

The internal and external beads were symmetric and displayed a proper amount of rollover. Examination of the fracture surfaces showed no indication of cold fusion or slow crack growth. Instead, the surfaces were indicative of a dynamic brittle fracture over the majority of the face with the final fracture location exhibiting ductile fibrils/tearing. These features are typical of an overload failure.

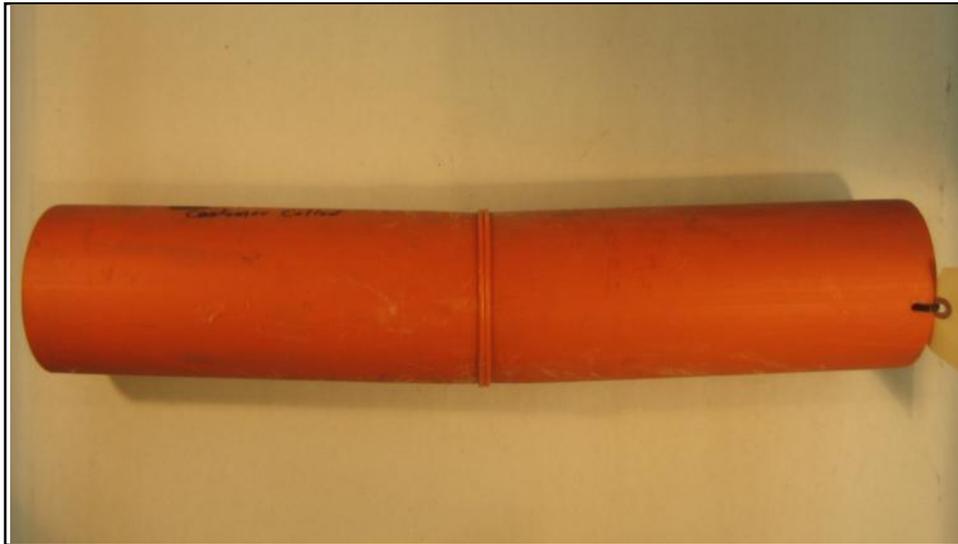
Figure 166. As Received Butt Fusion

As can be seen in Figure 166, the sample exhibited an axial misalignment resulting in the appearance of mitered faces. The internal and external fusion beads did not exhibit complete rollover, as seen in Figure 167.

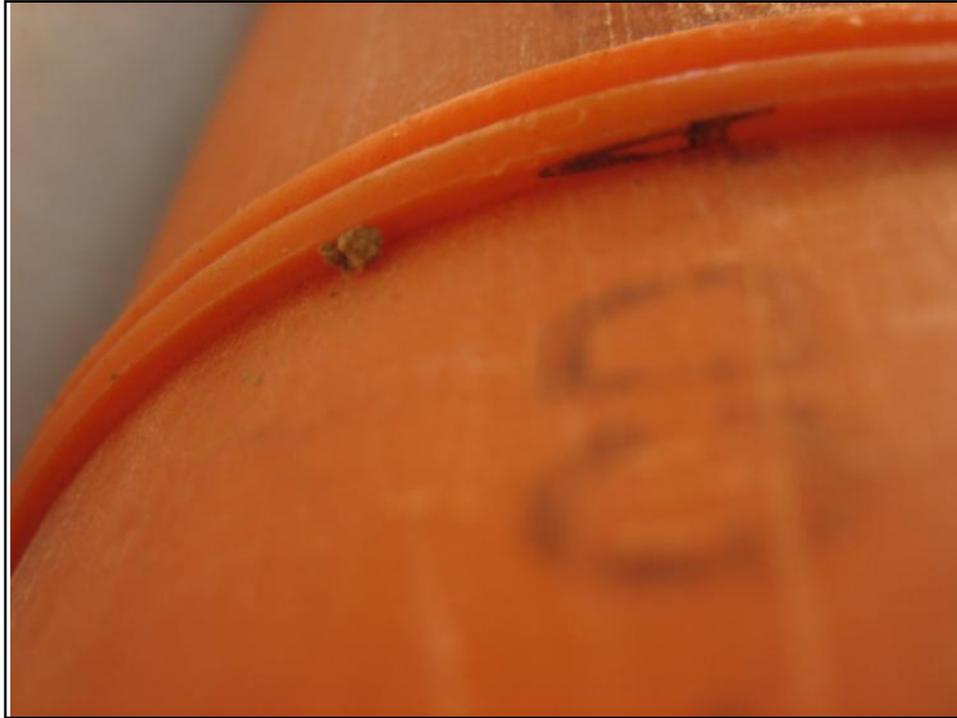
Figure 167. Incomplete Bead Rollover

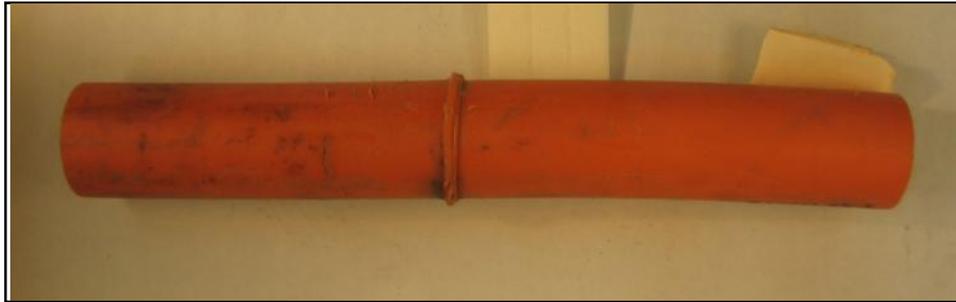
Figure 170. As Received Butt Fusion

The overall workmanship of this fusion was poor. Relative to each other, the pipes displayed parallel misalignment (Figure 170) as well as asymmetric beads (Figure 171). Individual beads were not easily discernable. One was barely visible and neither showed proper rollover suggesting inadequate heat/time/pressure during the fusion procedure.

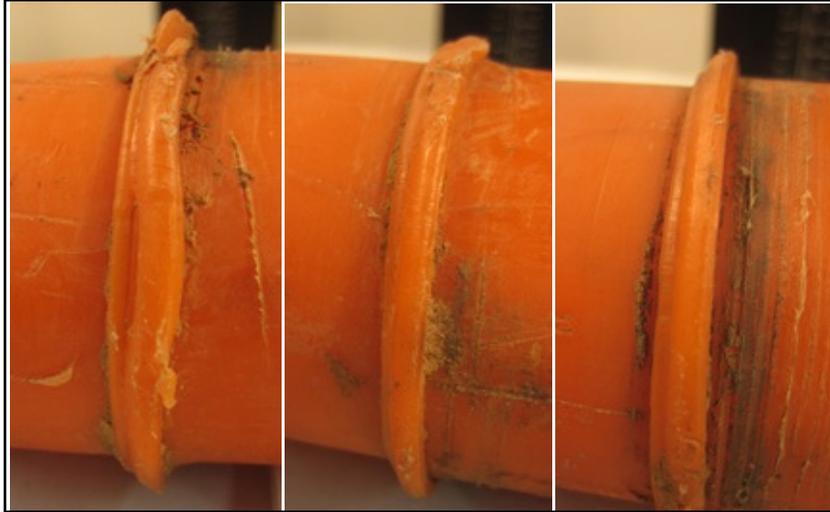
Figure 171. Uneven Rollback

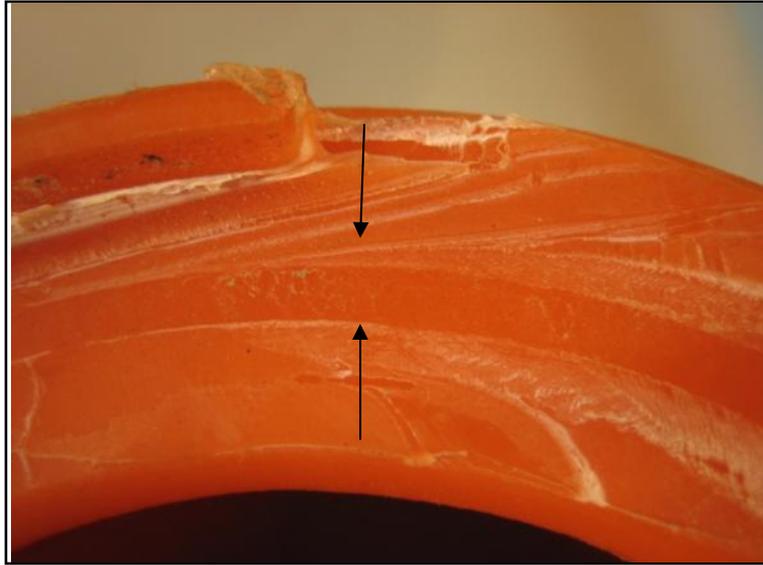
The external bead rolover appeared adequate based on the visual exam. The internal bead did not appear to rolover completely. As seen in Figure 174, the mid-wall displayed a lack of bond penetration of approximately 20-30% cold fusion around the entire circumference.

Figure 174. Area of Cold Fusion

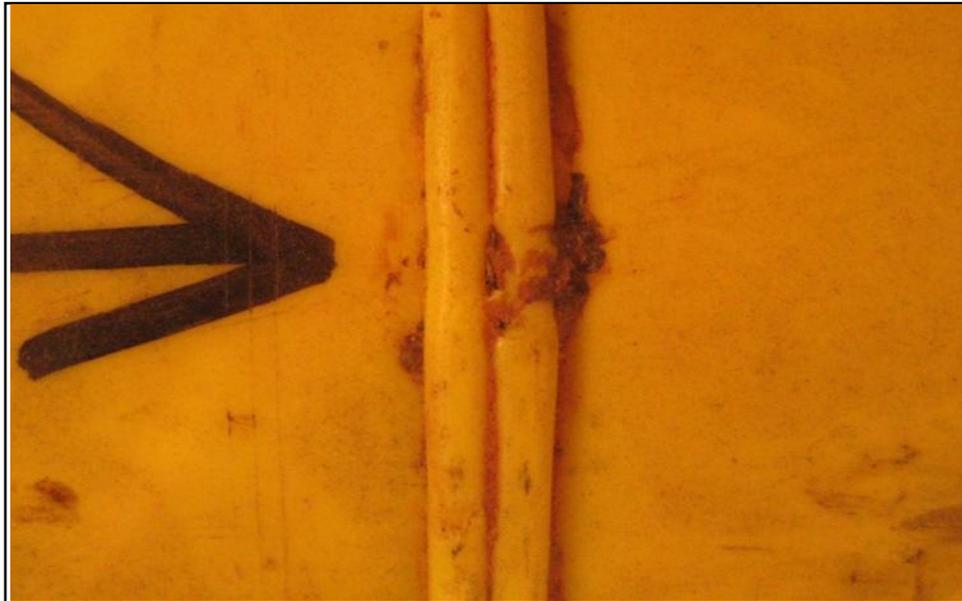
Visually, this joint exemplified adequate bead size and rollover. A void was noticeable at the leak location, as identified by the arrow in Figure 177. Looking down the interior of the pipe revealed the presence of foreign matter (Figure 178). The foreign object, which resembled a plant (Figure 179), was embedded in the fusion at the location of the leak location identified on the external wall.

Figure 177. Leak Location at the Bead Weld

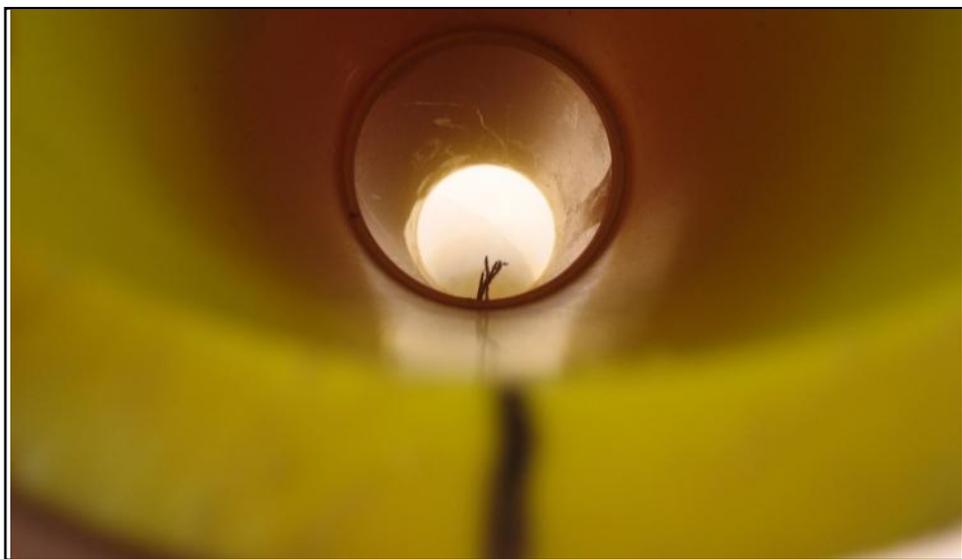
Figure 178. View down the Inside of the Pipe Section

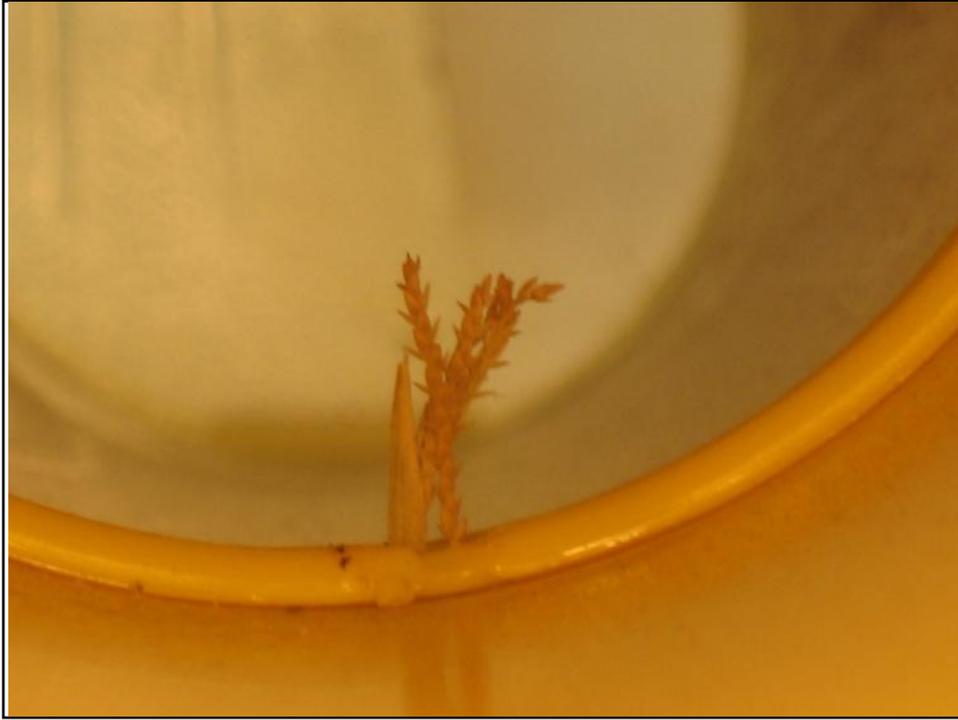
Figure 179. Close-up of the Inner Weld Bead

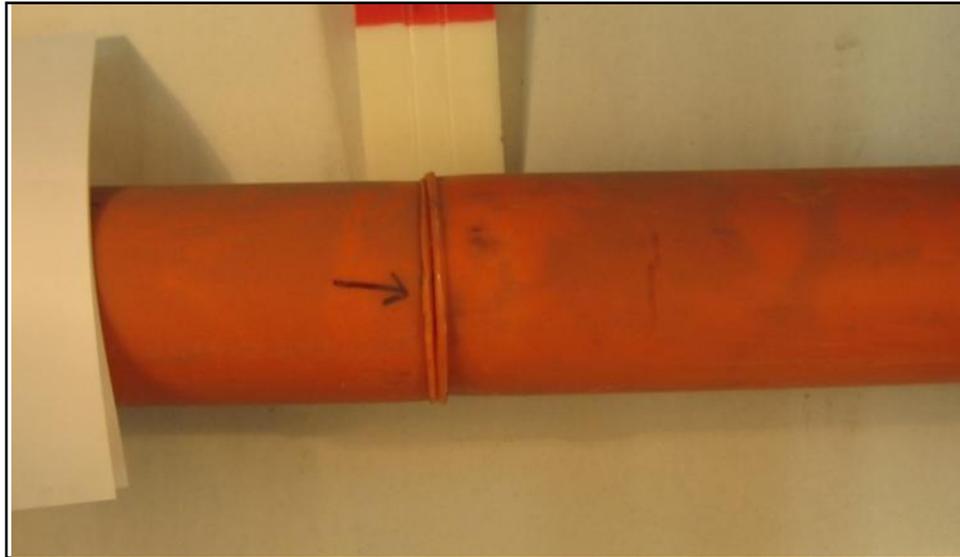
Figure 180. As Received

This fusion joint displayed axial misalignment of the pipe ends (Figure 180) and a visible separation within the joint (Figure 181). Bead rolover was also inadequate and nonsymmetrical as seen in Figure 182.

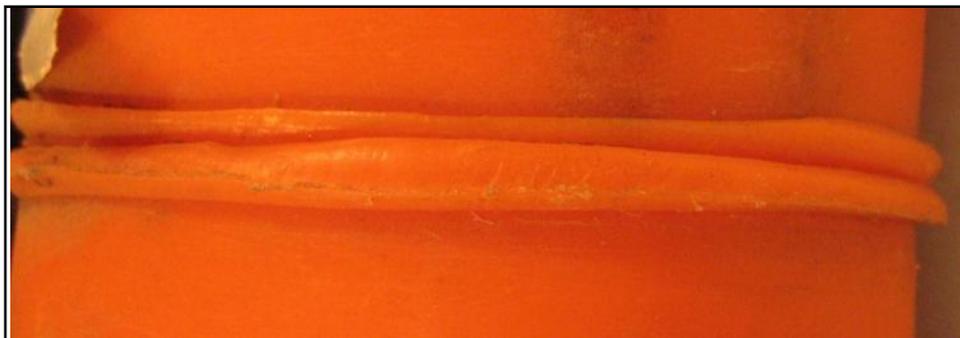
Figure 182. Uneven Beads

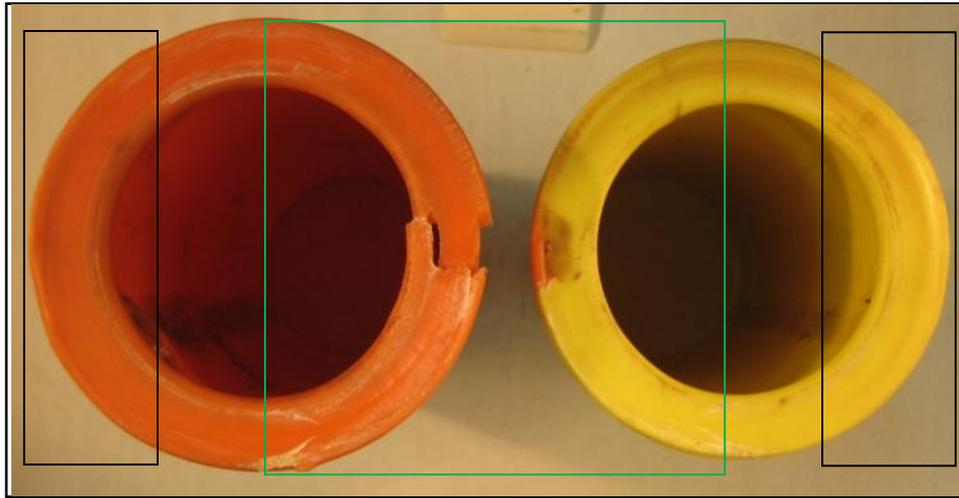
Figure 184. Fusion Faces

Cold fusion occurred over at least 50% of the fusion surface resulting in an inadequate bond. The bead shows inconsistent rollover. Using Figure 184 as a reference, the beads within the green box exhibited proper bead rollover. The beads within the black boxes did not roll over completely. The discrepancy of the beads indicates a problem with heat/time/pressure during the fusion process.

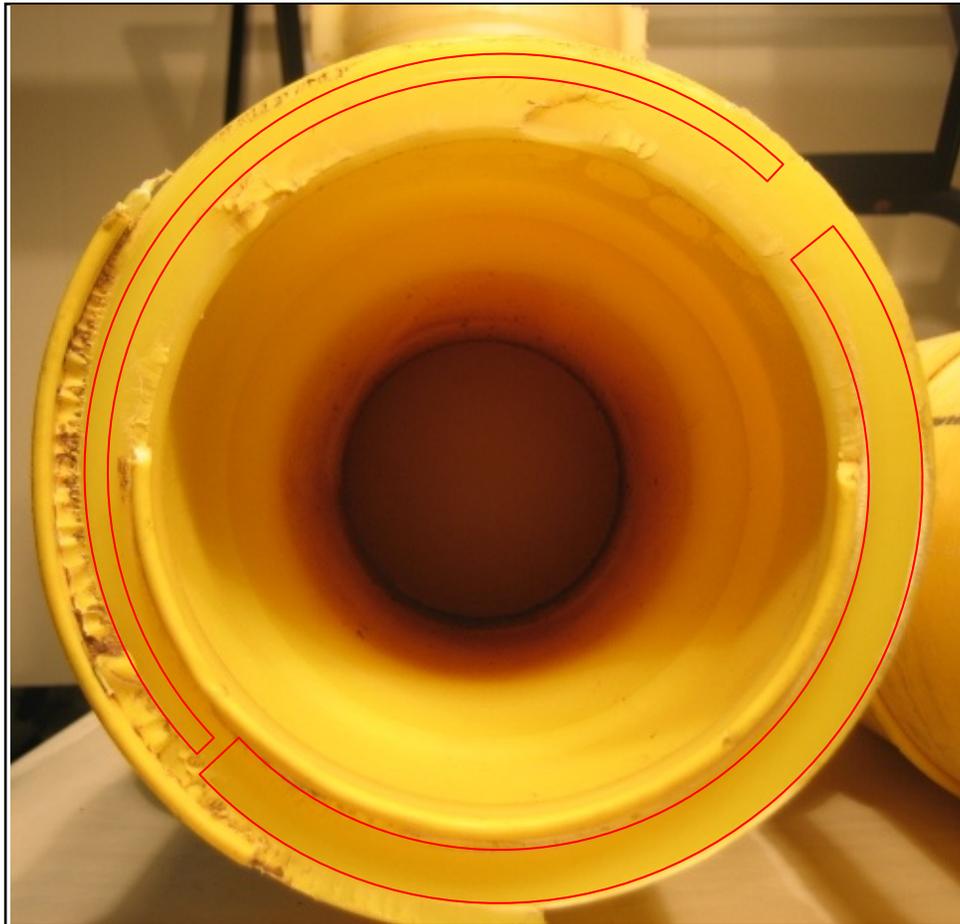
Figure 186. Fusion Face, Valve

There does not appear to be any misalignment of the faces. Rollback looks even internally and externally. The fusion faces appeared to have about 80% cold fusion, shown in red in Figure 186. The fused portion occurred about 180° around the ID and on about 120° (6-10 o'clock) of the OD as seen on the valve side. The pipe surface has been grit blasted by gas flow.

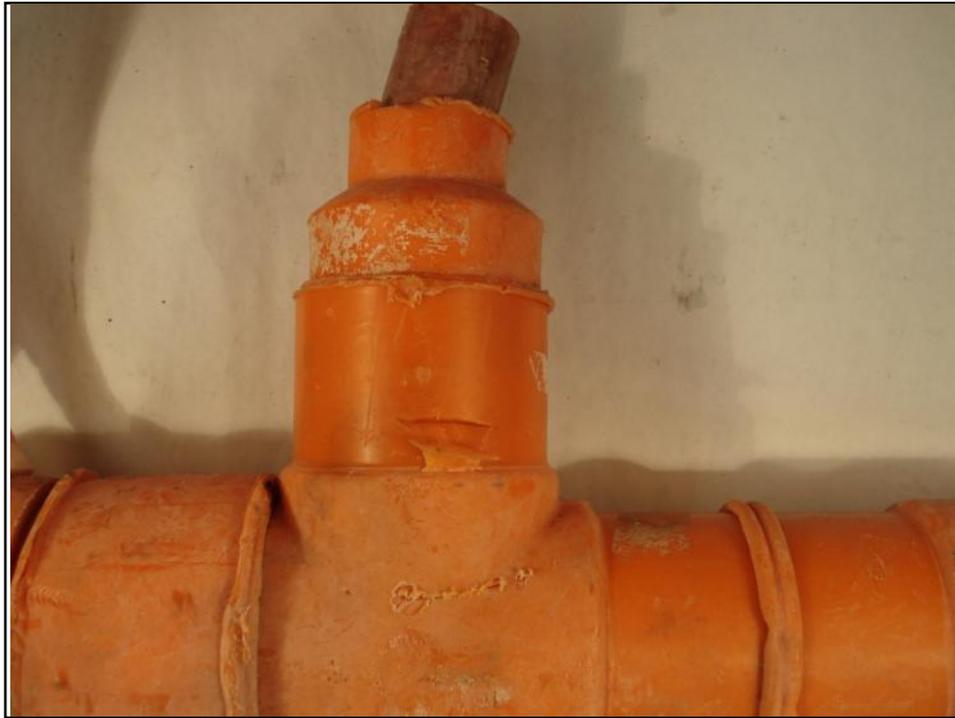
Figure 190. Misalignment and Poor Bead Rollover at the Reducing Coupling

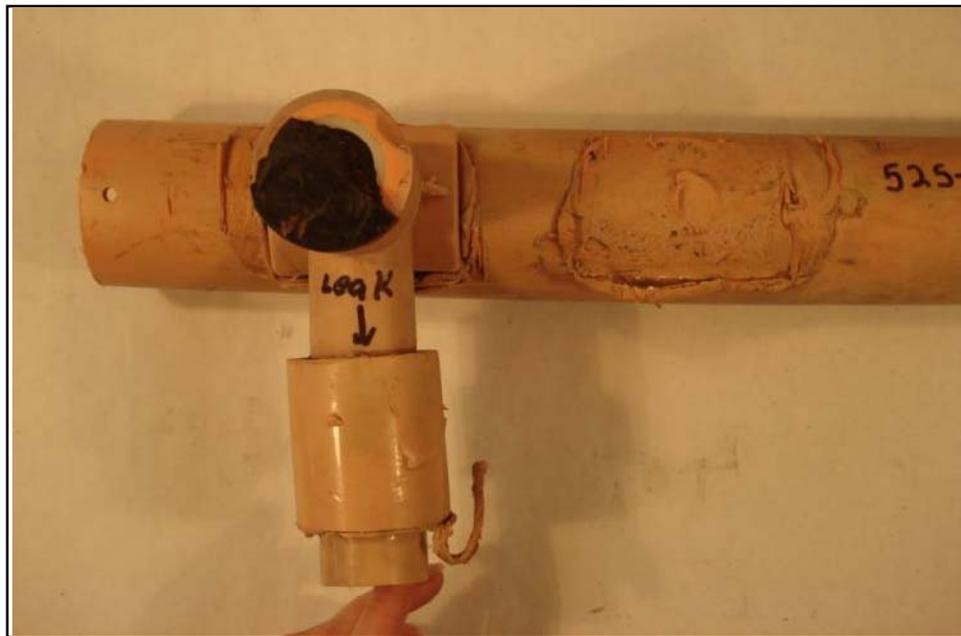
Figure 193. Leak Location

The leak location was marked by the field crew during removal of the section. The marking was approximately 1" around the circumference of the pipe as seen in Figure 193. The coupling and pipe were in parallel misalignment to each other. Due to the nature of this sample, the root cause cannot be determined without sectioning.

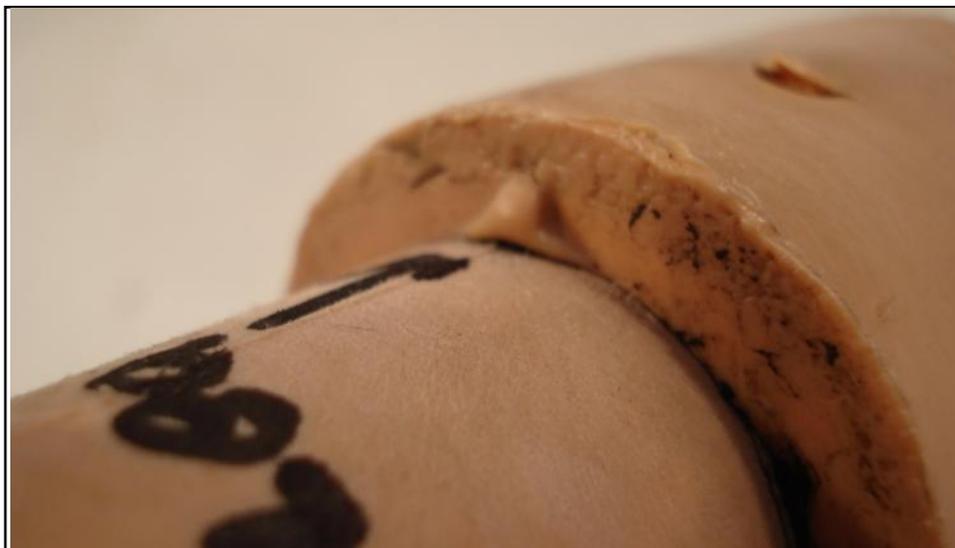
Figure 196. Leak Location as Identified by Utility

The sample exhibited poor workmanship though no obvious sign exists for the coupling leak. Ruler approximation of the “nose” of the tee relative to the edge of the coupling suggested inappropriate stab depth of the coupling onto the tee. This interior surface showed minimal to no rollback. The external surface where the leak location was noted showed little and inconsistent rollback of the companion materials. Further examination by destructive methods could provide better information.

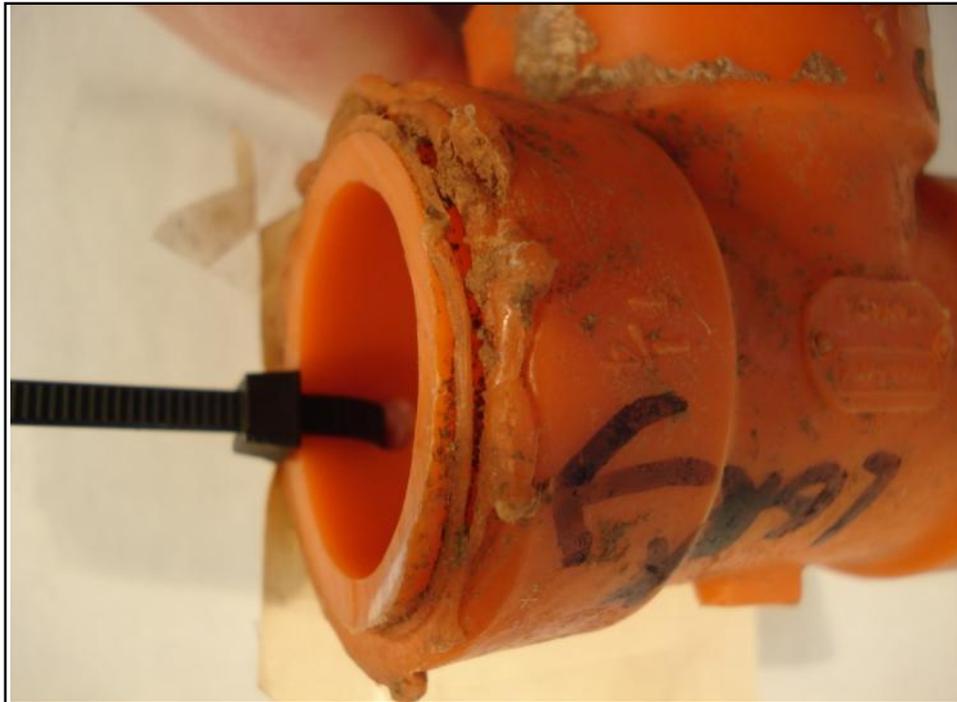
Figure 198. Leak Location as Identified by Utility

Visually, the melting was improper but in order to determine the leak path and the root cause, the sample would need to be sectioned.

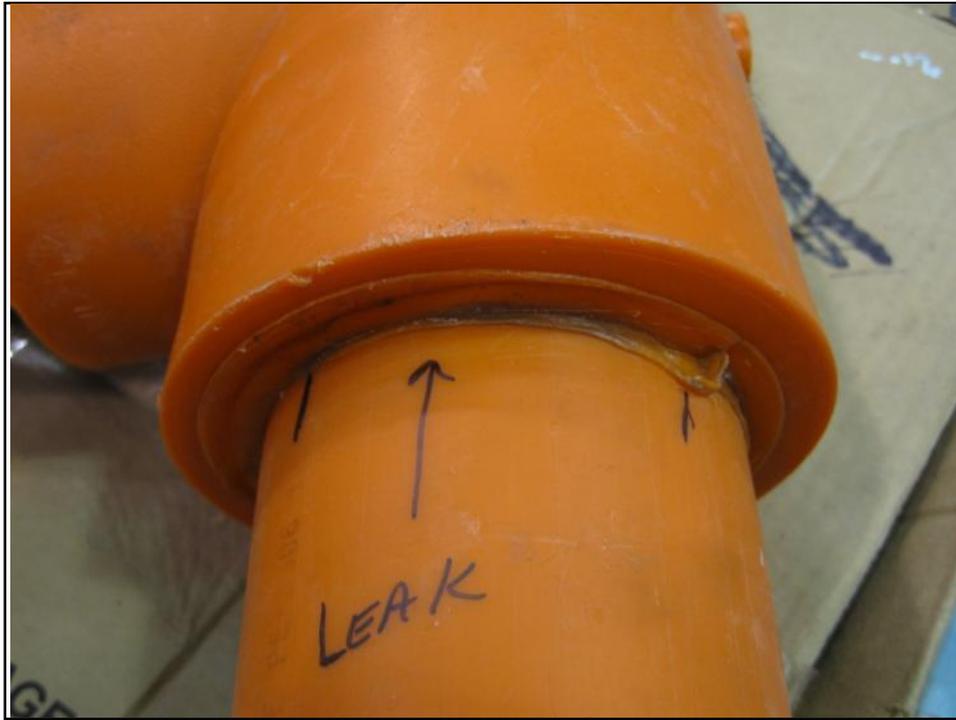
Figure 202. Leak at Pipe/Socket Interface

Radial distortion as seen in Figure 201 was observed in the sockets. Misalignment of the pipes into the sockets was also apparent. This sample was submitted without any indication of the leak location. A pressure test was performed and determined that gas leaked out of the joint at the pipe/socket interface. As shown in Figure 202, the leak occurred over 3” of the circumference in the fusion joint. A close up of this area is shown in Figure 203.

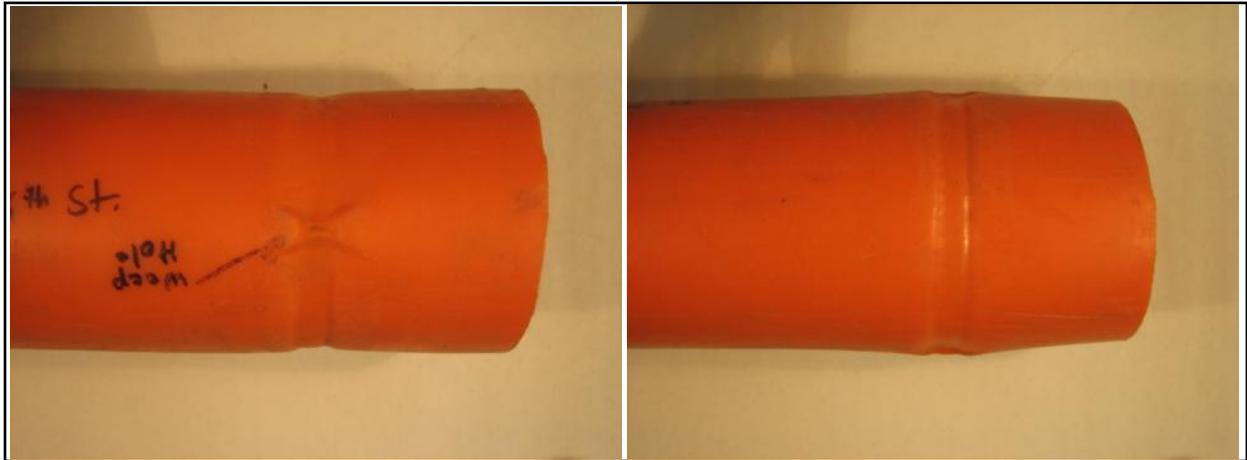
Figure 204. Top and Side View of as Received Squeeze-off

The pipe was squeezed with a single bar squeeze off tool. Visual observations indicated the pipe was significantly over squeezed above recommended values. The excessive squeeze resulted in significant amounts of permanent deformation at the squeeze ears and apparent wall thinning. Large voids, whitening, and cracks were present at the squeeze ears on the inner surface of the pipe. These can be seen in Figure 205 and Figure 206. An axial slit at one ear was apparent at the outer surface, as seen in Figure 204, indicating the crack initiated on the inner surface and grew through the wall to the outer surface.

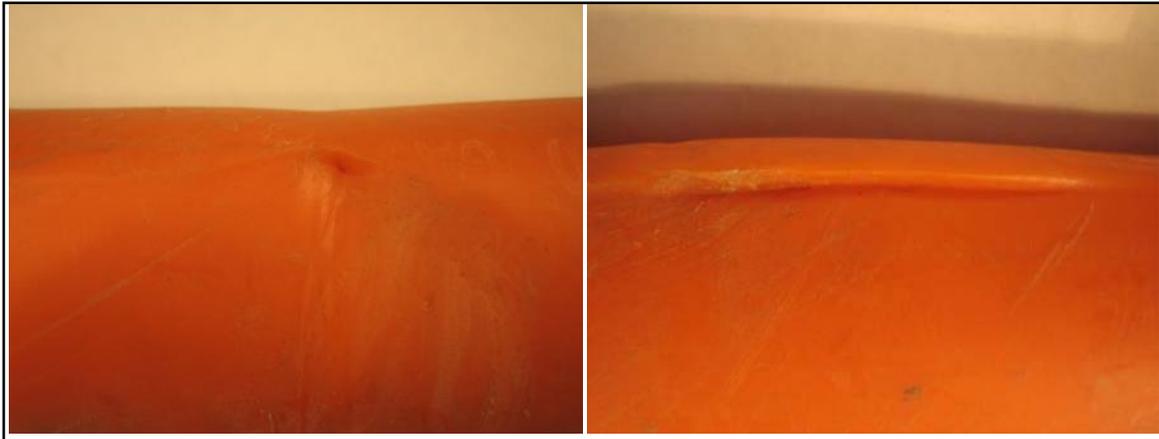
Figure 208. Dimpling and Buckling

The sample appears to have been squeezed three times within an 8" length of pipe using a single bar squeeze tool. The deformations were about 3" and 4.5" center to center separation. It is possible that the squeeze tool was not equipped with stops resulting in excessive plastic deformation and yielding. Wall thinning, buckling, and dimpling were apparent on the outer wall as seen in Figure 208. On the inner wall, a yielded region was observed in the axial direction extending from one squeeze location to another.

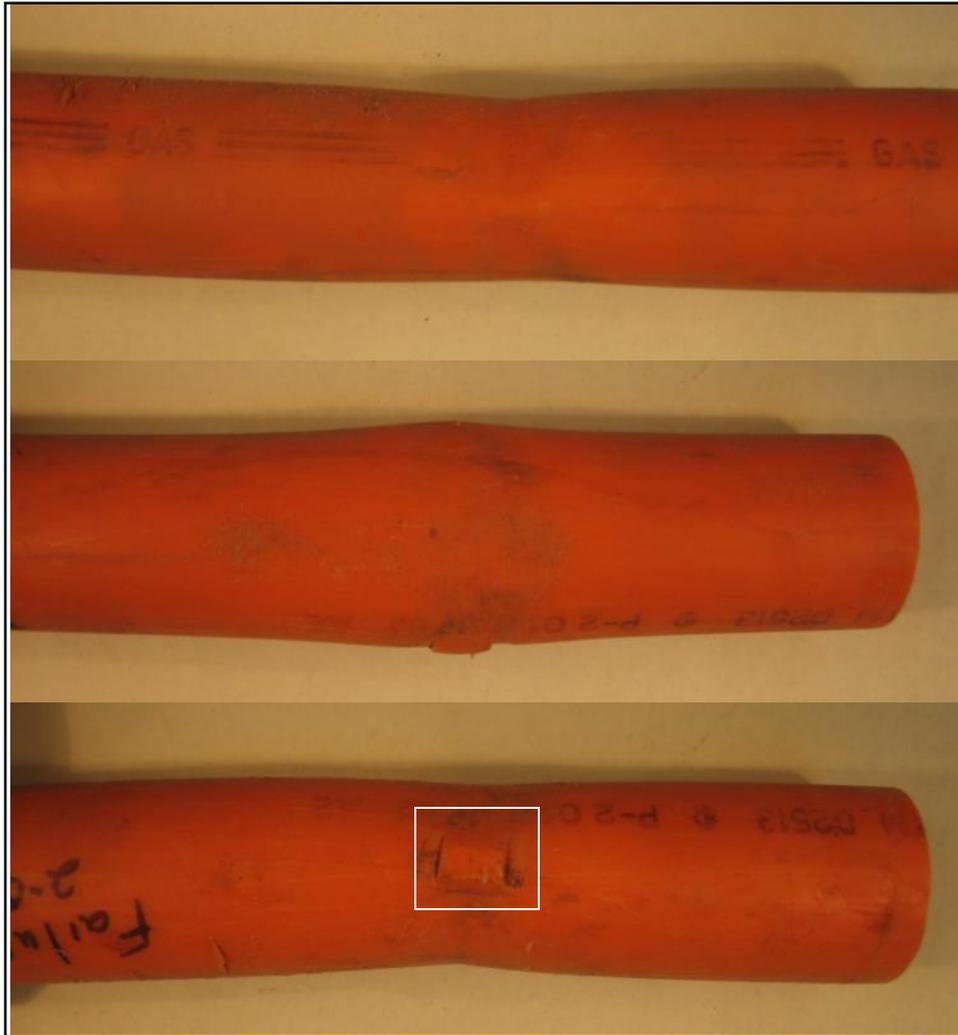
Figure 211. Top and Sides of Squeeze Location

As with other samples, this pipe exhibited markings of a single bar squeeze off machine. In the ear region, a square shaped deformation (Figure 211) implied the pipe was not centered in the squeeze off machine. Observations of the inner wall show a large cavity (Figure 212) and an axial slit under the square shaped deformation.

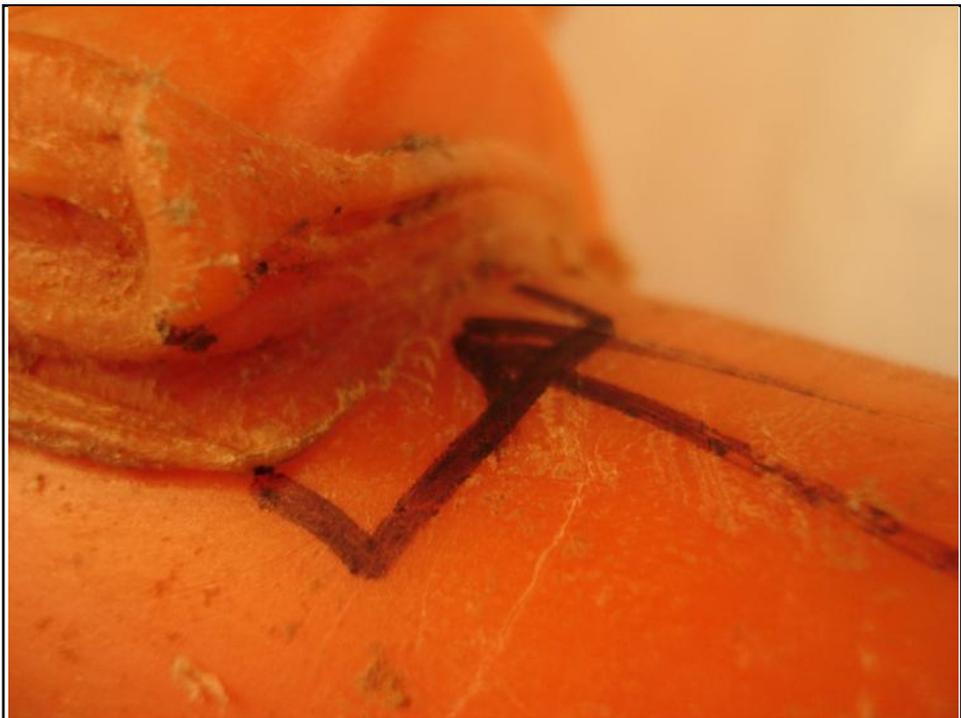
Figure 216. Leak Location

This fusion exhibited a very asymmetric and poorly formed bead. The marked location of the leak was at a location with a high stress concentration between the pad and the pipe. During the visual examination no crack or void was seen so a leak test would need to be performed to verify the leak path. The likely cause for failure is poor workmanship.

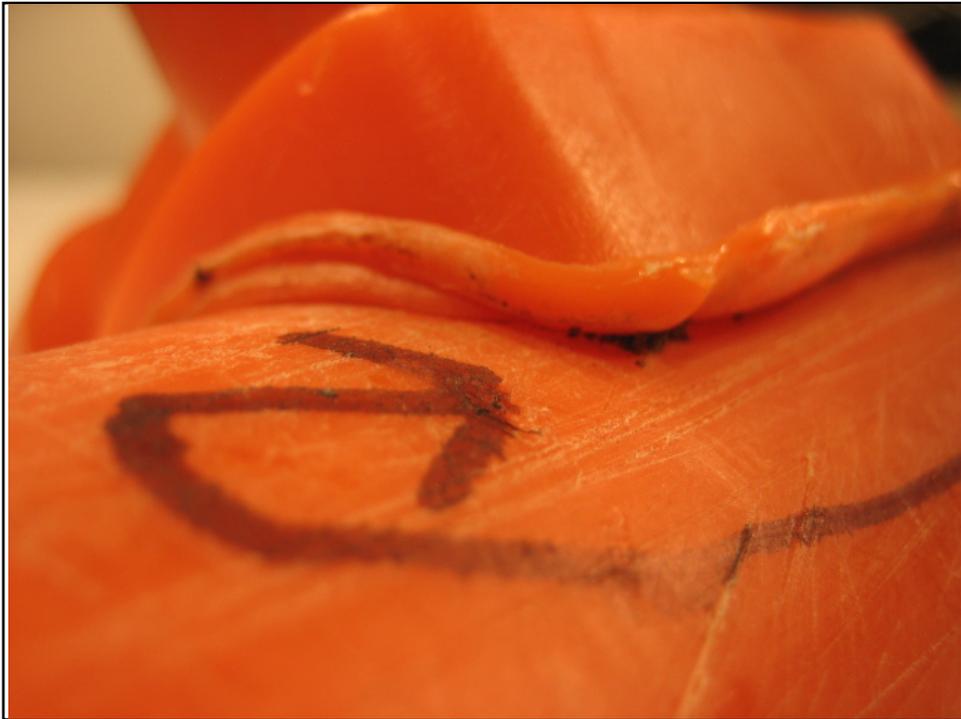
Figure 219. Close-up of Backside of Tee

The sample had inadequate melt and roll over on the backside of the saddle tee where the leak locations are marked. This sample would require sectioning for further comment.

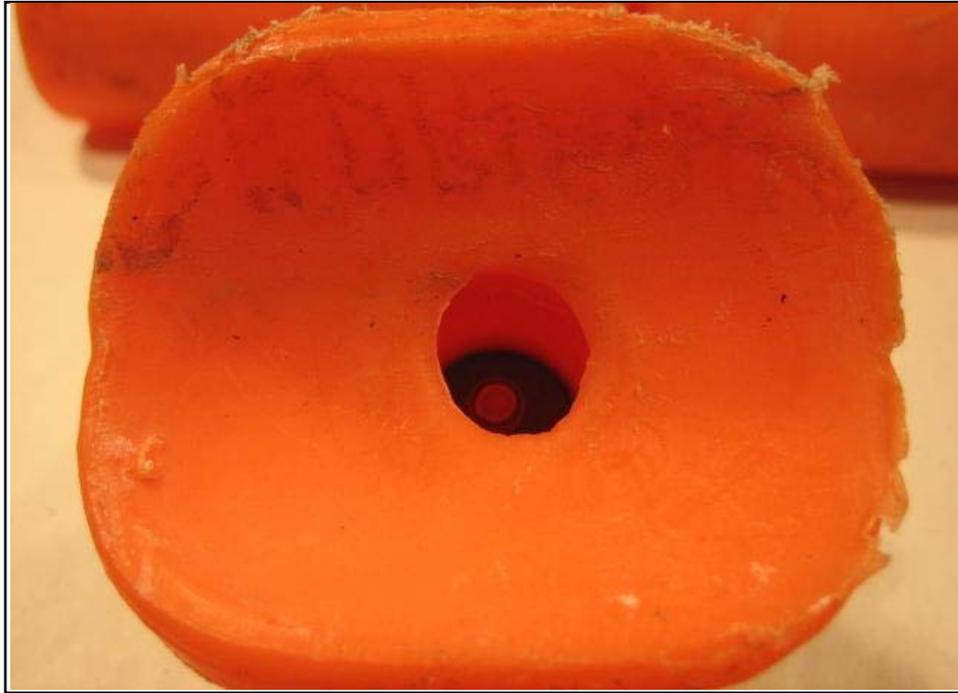
Figure 222. Saddle Face

Examination showed cold fusion over about 90% of the fusion area. The fusion face on the pipe still had visible superficial scratches. These scratches would have been created during fusion preparation, which points to a lack of heat and fusion during the joining process.
