FINAL REPORTGTI PROJECT NUMBER 20385

Plastic Pipe Failure, Risk, and Threat Analysis

DOT Project# 194

Contract Number: DTPH56-06-T-0004

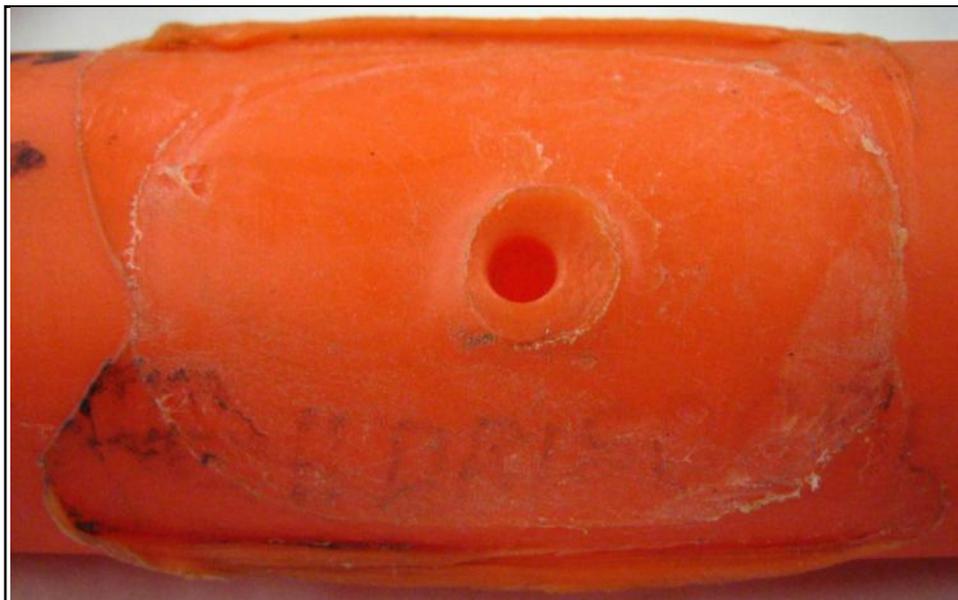
Figure 223. Pipe Surface

Examination showed cold fusion over about 90% of the fusion area. The fusion face on the pipe still had visible superficial scratches. These scratches would have been created during fusion preparation, which points to a lack of heat and fusion during the joining process.

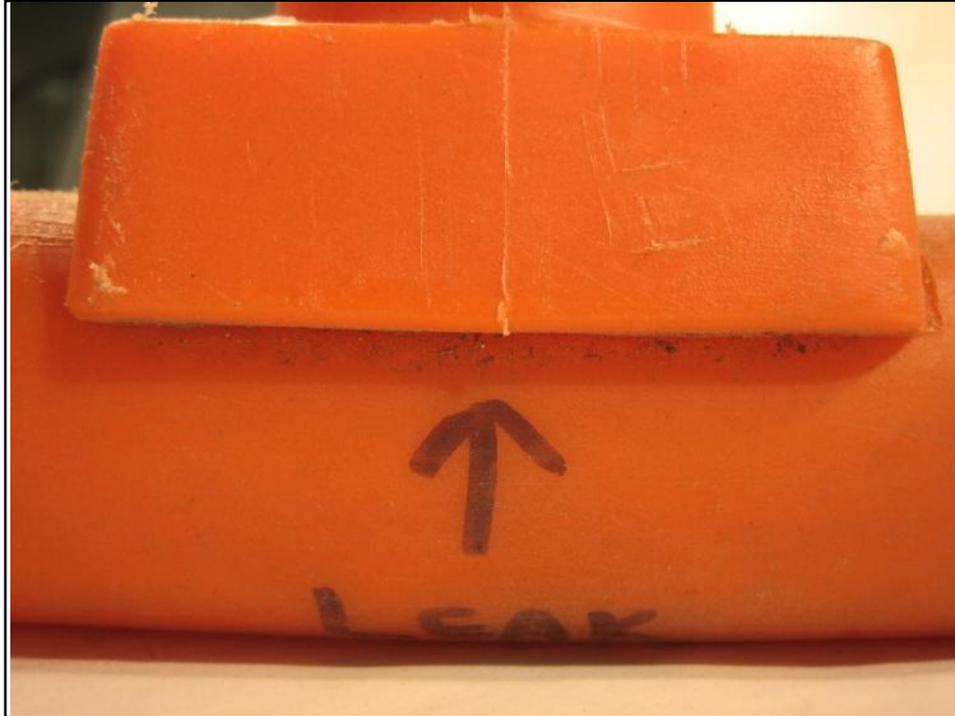
Figure 225. Backside of Tee

Because no bead was present, inadequate melting due to poor workmanship is suspected as the primary reason for leaking.

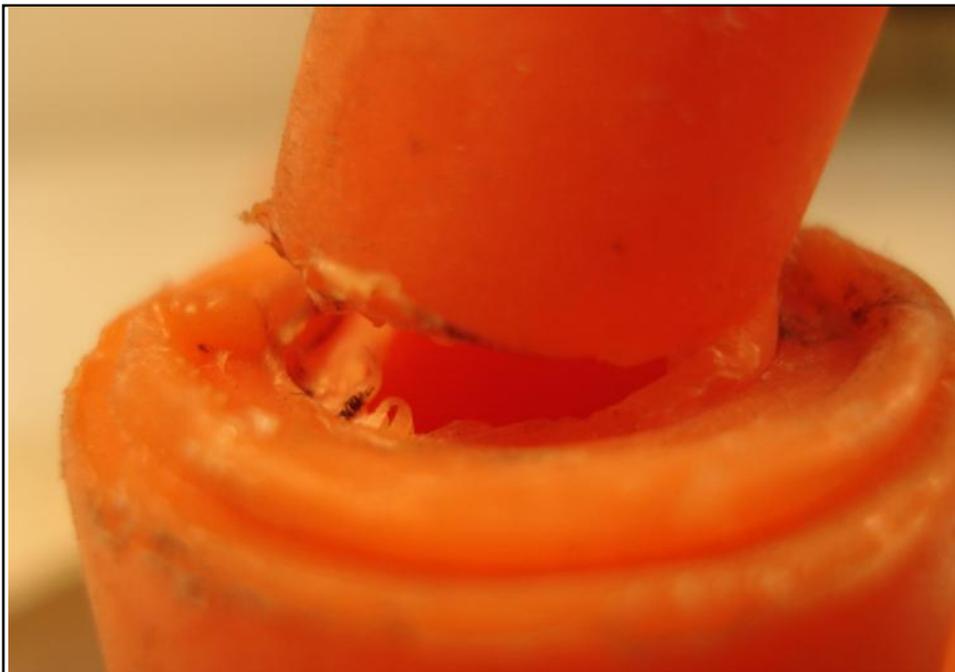
Figure 228. Ductile Tearing

Background information provided with the sample included field notes indicating the tee was on an angle. This likely caused undue stresses on the service pipe which lead to an unrecoverable bending moment. Signs of ductile overload (Figure 228) and necking of the pipe wall thickness were present.

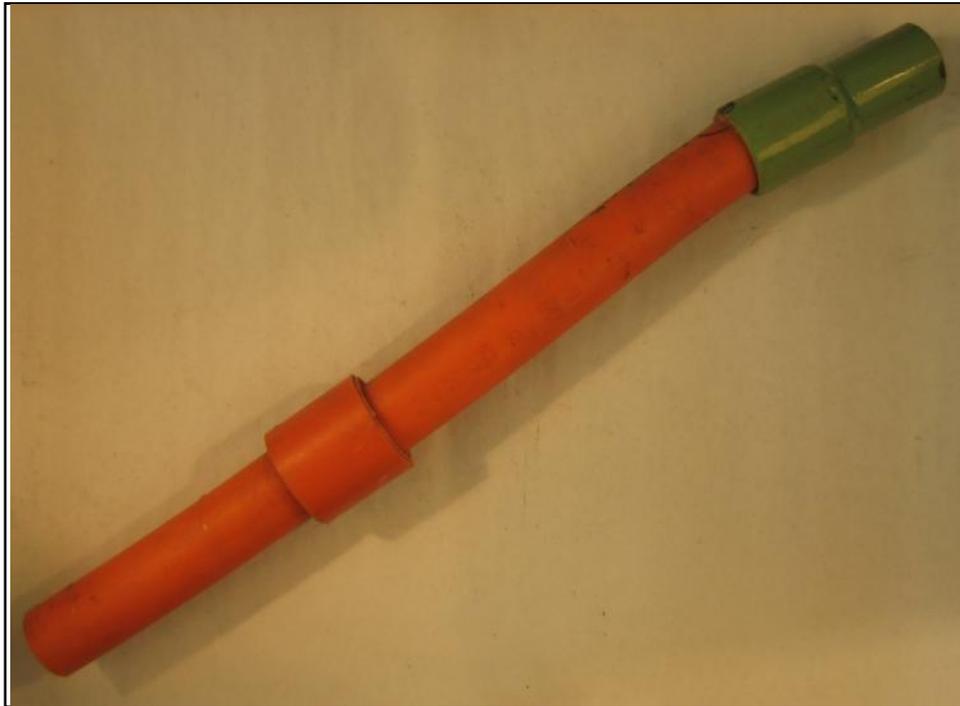
Figure 229. As Received

The sample suffered excessive bending between the pipe and the stab fitting likely due to improper support on the underside of the pipe based on the field report.

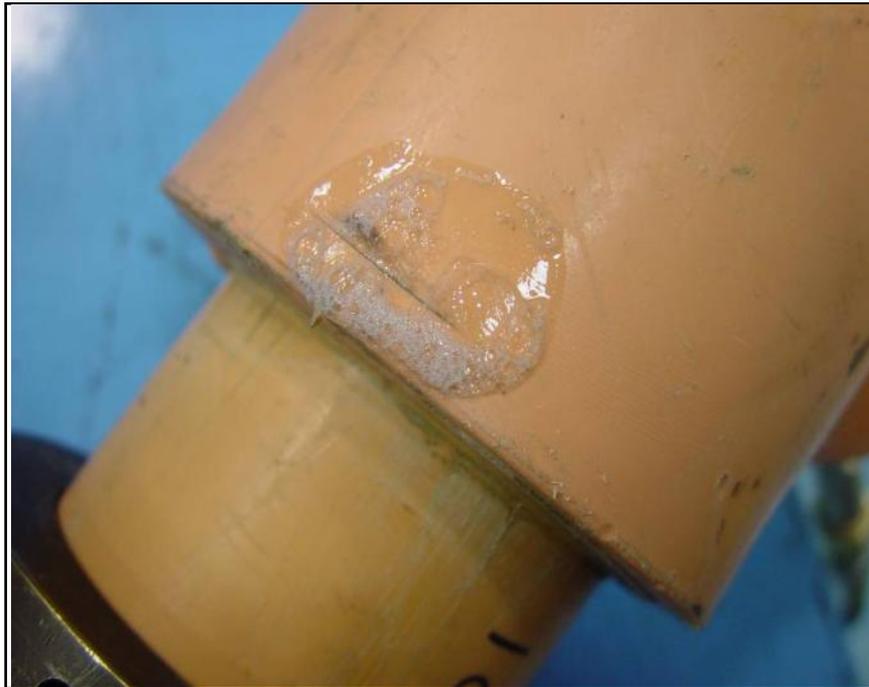
Figure 232. Leak Location As Identified By a Soap Solution

The submitted section was subjected to visual examination. The results of this examination indicated the presence of a circumferential slit in the injection molded elbow. The section was capped, pressurized, and subjected to leak testing using soap solution. Leaking occurred at the slit as seen in Figure 232. Next, the section was cut longitudinally (Figure 233) to examine the exposed inner surface. Radial distortion of the elbow and pipe were noted. A gap was detected in the socket fusion area at the pipe/elbow interface as identified in Figure 234 and Figure 235. The area was moderately flexed by hand and movement of the joint was observed and photographed.

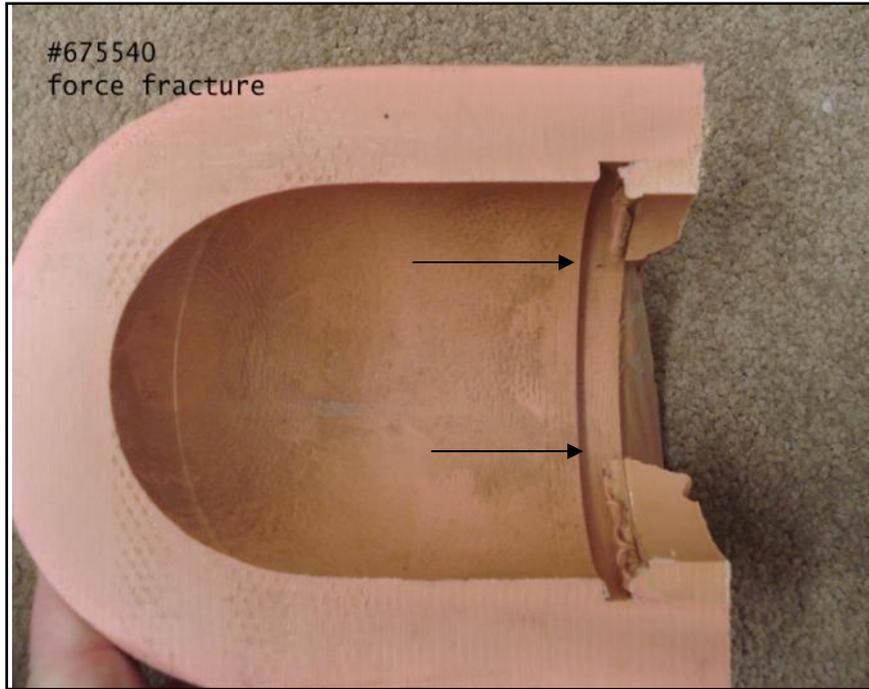
Figure 237. Force Fracture of the Sample, Showing Area of Observed Lack of Fusion

The section containing the leak path was cooled with liquid nitrogen and force fractured to expose the associated surfaces as seen in Figure 237 through Figure 242. Examination of the surface confirmed the earlier observed area of significantly poor fusion. At higher magnification areas of banding (Figure 239) and ductile failure regions were observed as well as debris deposited by the gas leak. Closer scrutiny indicated the presence of dark spots imbedded in the fracture surfaces as seen in Figure 243 and Figure 244.

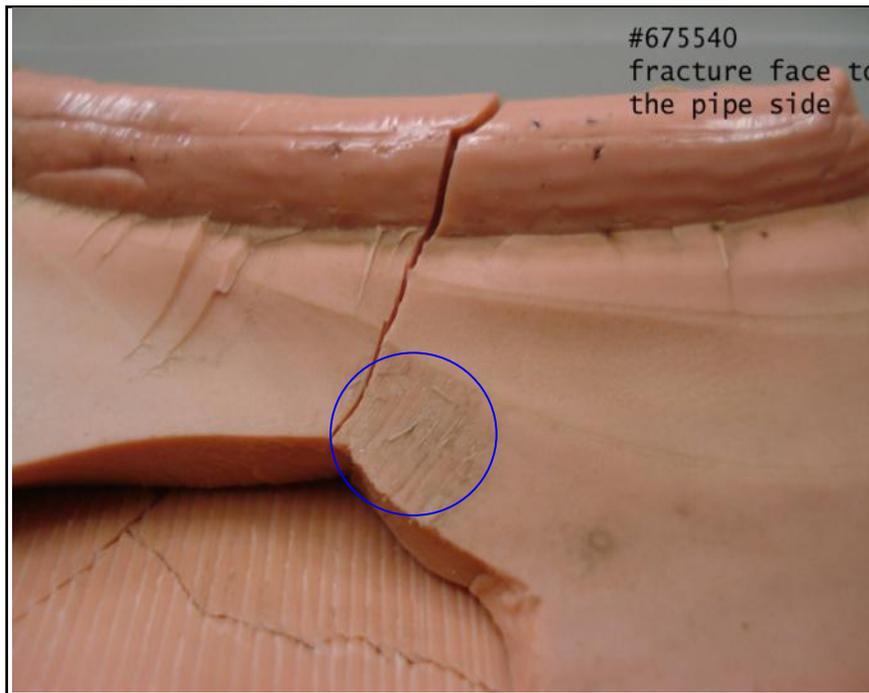
Figure 241. Close up of the Fracture Face on the Pipe Side

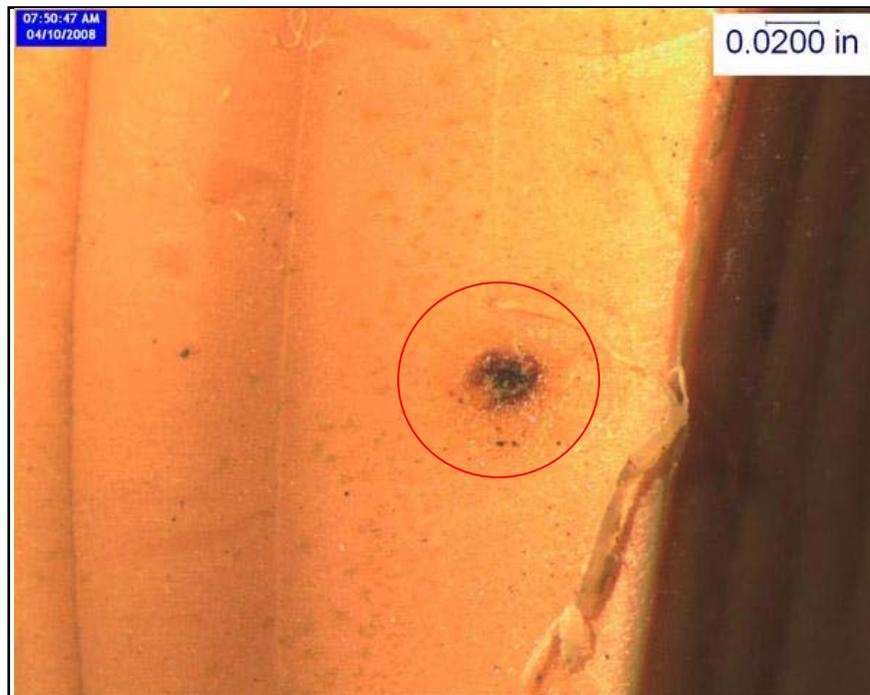
Figure 242. Fracture Face on the Pipe Side with an Area of Interest Identified

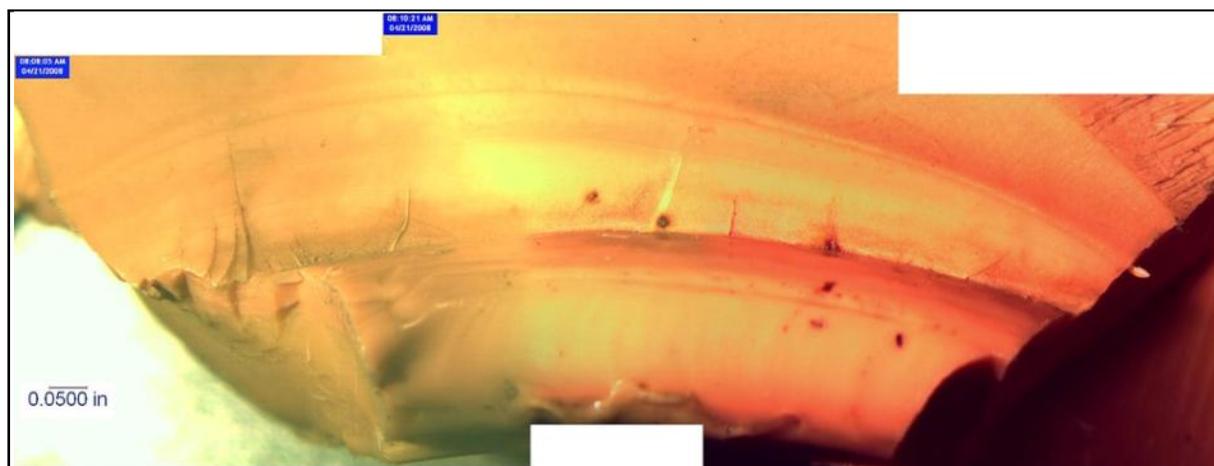
Figure 243. Microscopy - Fracture Face of Elbow – Toward the Elbow Side

- 1) There was a significant area of poor fusion that contributed to the failure.
- 2) There were particles imbedded in the fracture surface of the elbow indicating that this material entered during the molding of the part that contributed to the failure.
- 3) The elbow and companion pipe exhibited radial distortion which indicated significant radial stress was present. This stress resulted from the interference fit between the elbow and pipe causing expansion of the elbow and resulted in peak stress concentration at the pipe edge/elbow interface. This elevated stress state aided the formation and propagation of the fracture.

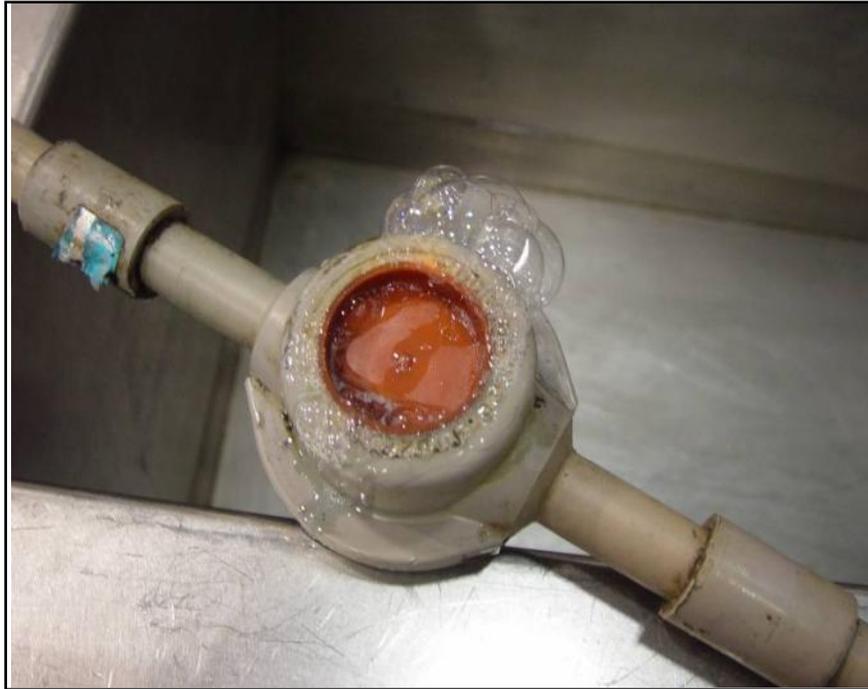
Figure 255. As Received Sample Shown Leaking from Under the Cap

Soap solution testing showed the leak originating from the underside of the valve as seen in Figure 255 and Figure 256. The entire valve was transversely sectioned and examined. The results of this examination did not detect any damage to the core, seal, or housing. As shown in Figure 257 and Figure 258. The examination focus was on the lower half of the valve. The position of the valve core was indexed relative to the housing using a series of markings shown in Figure 259. The valve was placed into a fixture and using appropriately sized tools, the core was carefully displaced from the valve body as shown in Figure 260. There were two o-rings on the core section. There was a noticeable loss of material observed on the bottom o-ring and a piece of rubber was observed wedged between the upper o-ring and its companion groove. These damaged areas can be seen in Figure 261, Figure 262, and, Figure 263. Upon removal the piece of rubber was found to match well with the damaged area of the bottom o-ring as demonstrated in Figure 264 and Figure 265. Lubricant was observed on all surfaces which is consistent with the fact that the o-rings are typically lubricated prior to assembly.

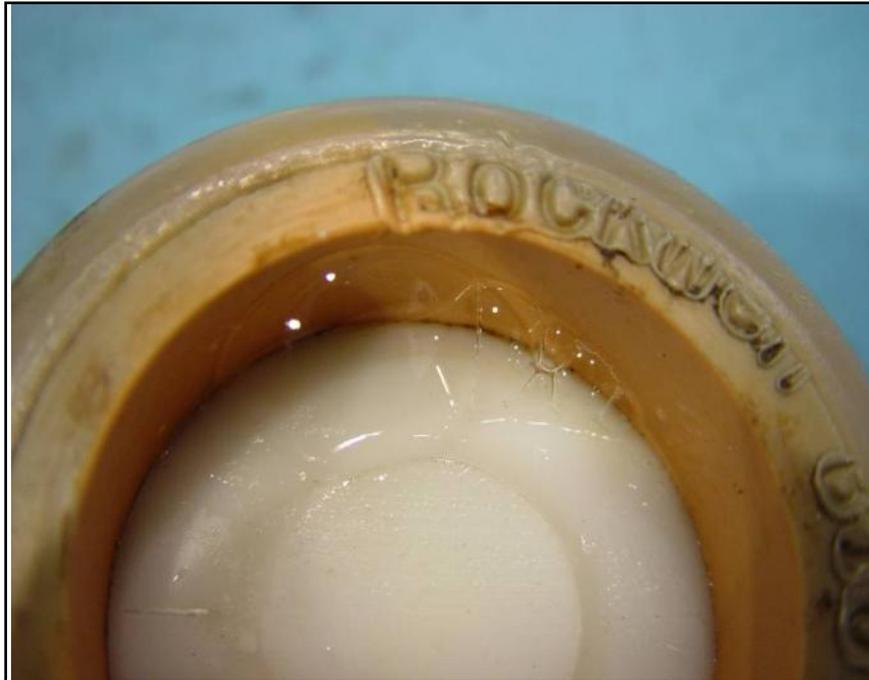
Figure 256. Valve with Leak Pinpointed

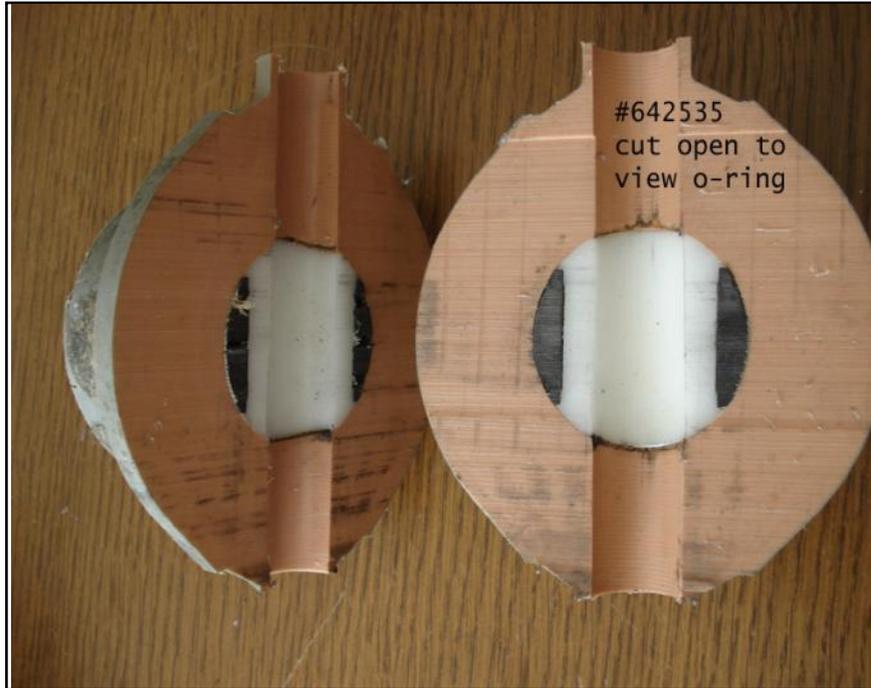
Figure 257. Valve Was Halved to Help Expose O-Ring

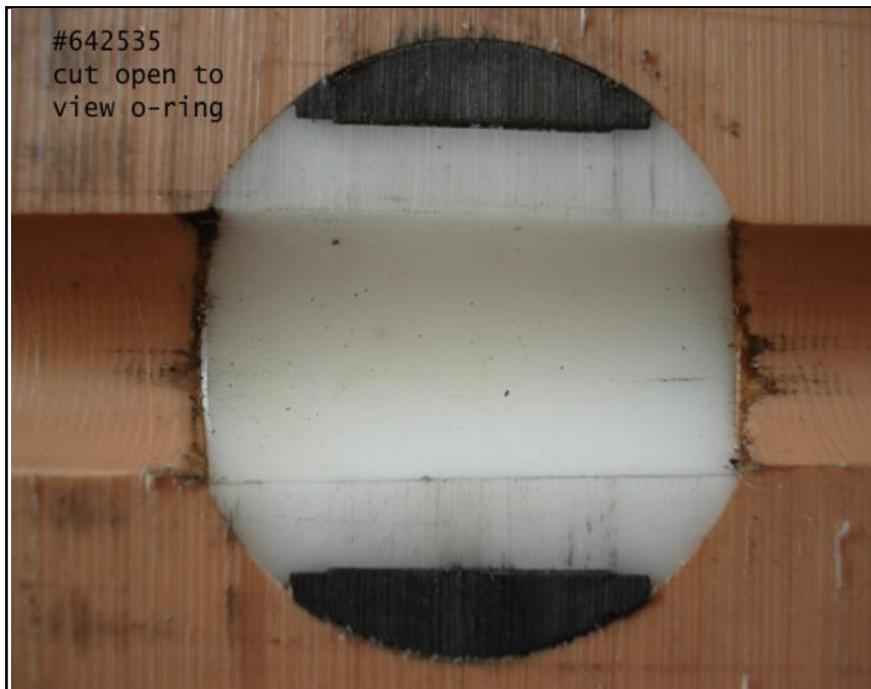
Figure 258. Close up of the Core and Seal

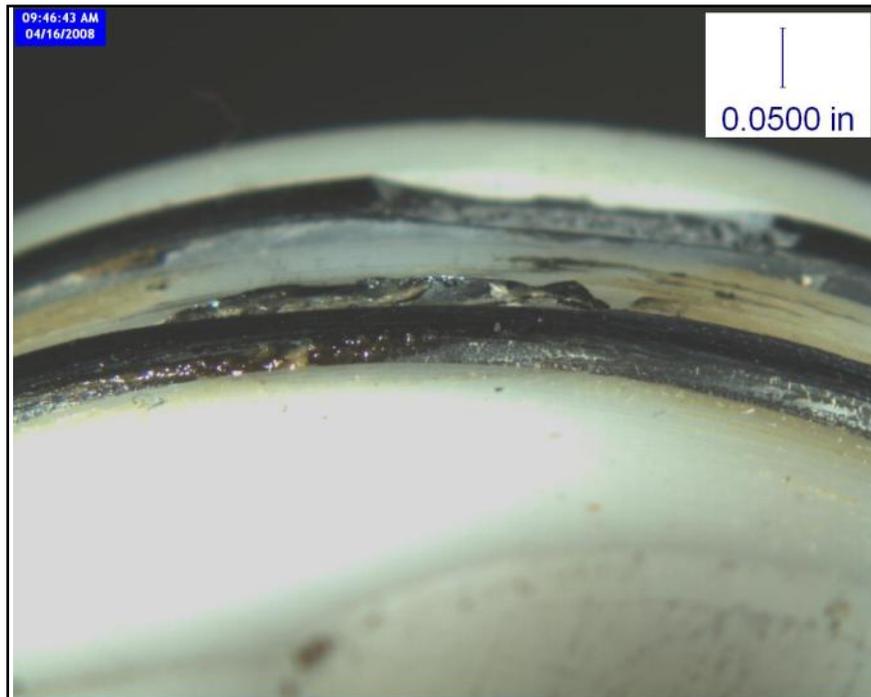
Figure 262. O-Ring Damage. Upper O-Ring, Foreground. Lower O-Ring, Background.

- 1) The cause of the leak was damage to the lower o-ring during assembly, which resulted in a section of rubber breaking off from the o-ring. In time, this rubber section migrated to and wedged itself between the upper o-ring and its groove. Both conditions reduced the sealing effectiveness of the o-rings.
- 2) Both o-rings were manufactured from nitrile rubber. Nitrile rubber is commonly used in natural gas systems. Hardness testing indicated Shore hardness of up to 74A. Typically as these materials age they become harder and their sealing effectiveness decreases. When the o-rings were new, they were still able to seal despite the observed damage. As the o-rings aged, they were no longer effective in maintaining a good seal.

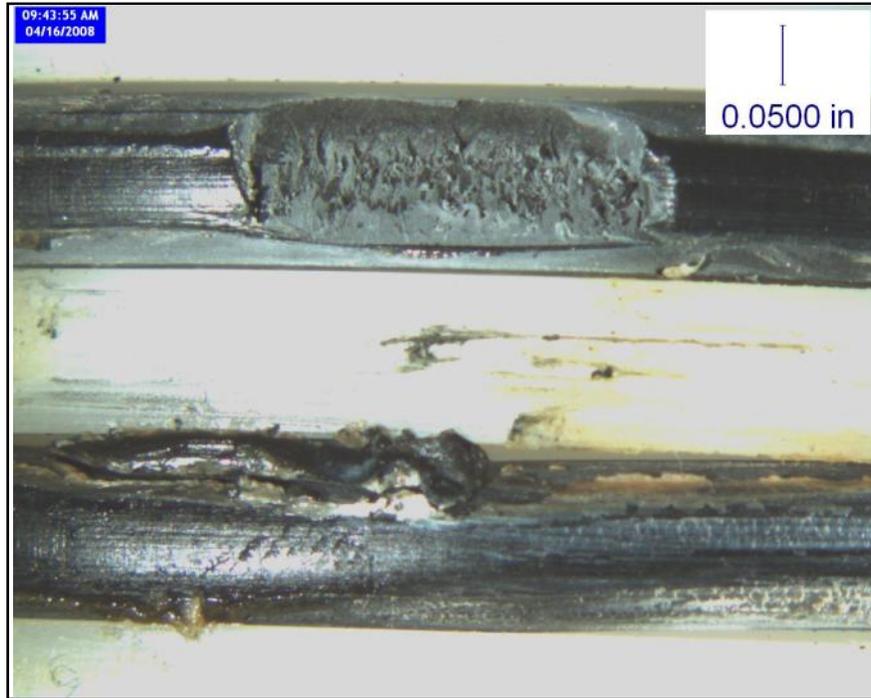
Figure 263. Imbedded Fragment Between Upper O-Ring and Core Land.

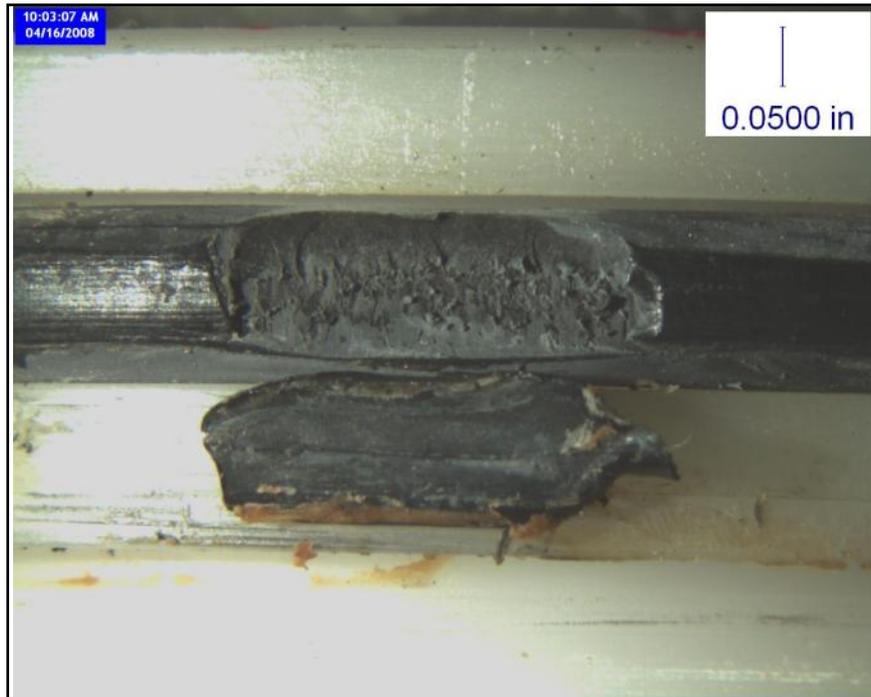
Figure 264. O-Ring Fragment Removed from the Upper O-ring Land Area.

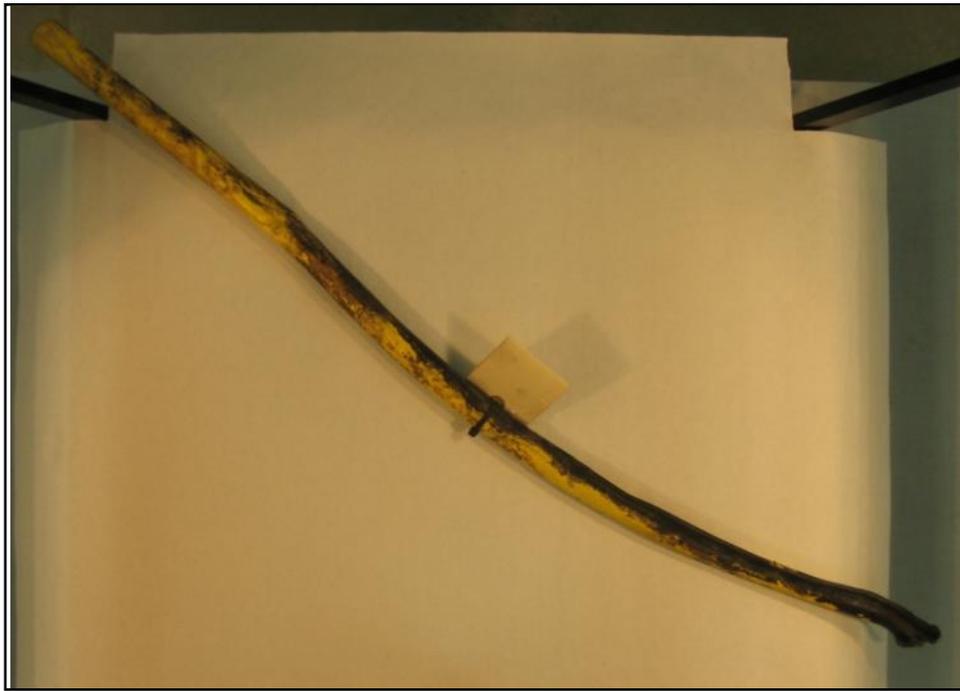
Figure 268. As Received

This pipe section was exposed to excessive heating from a shorted electric cable. The pipe was installed by boring and may have caused the damage to the electric cable insulation.

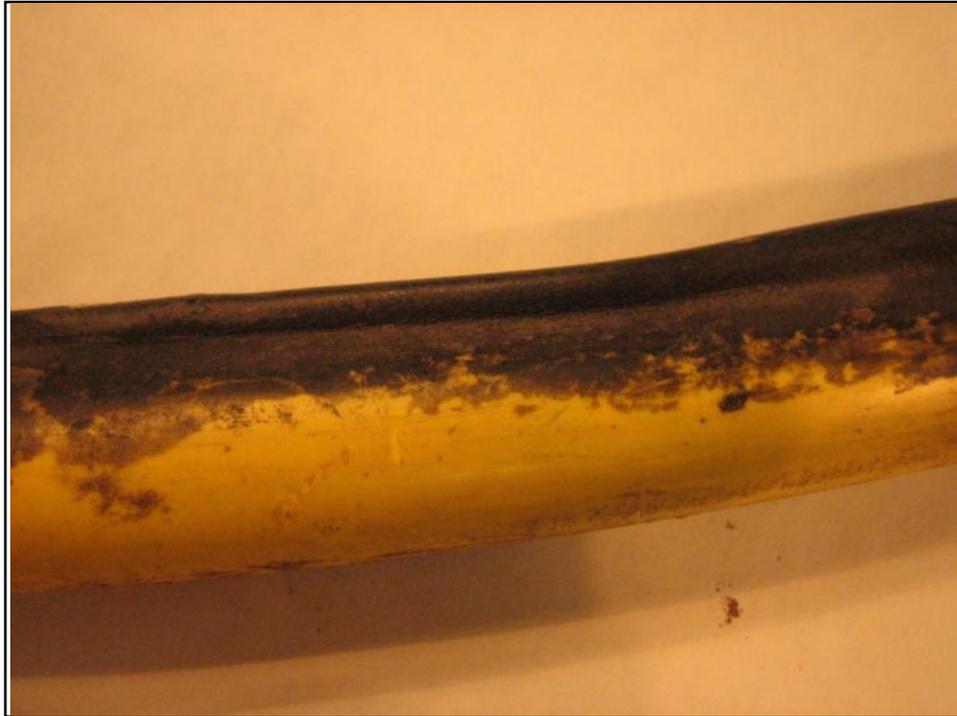
Figure 269. Up Close View of Damaged Pipe Section

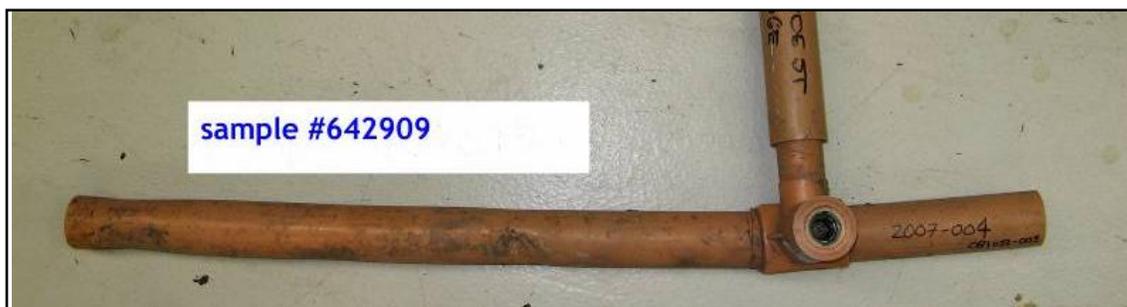
Figure 270. As Received Sample of a Leaking Tee

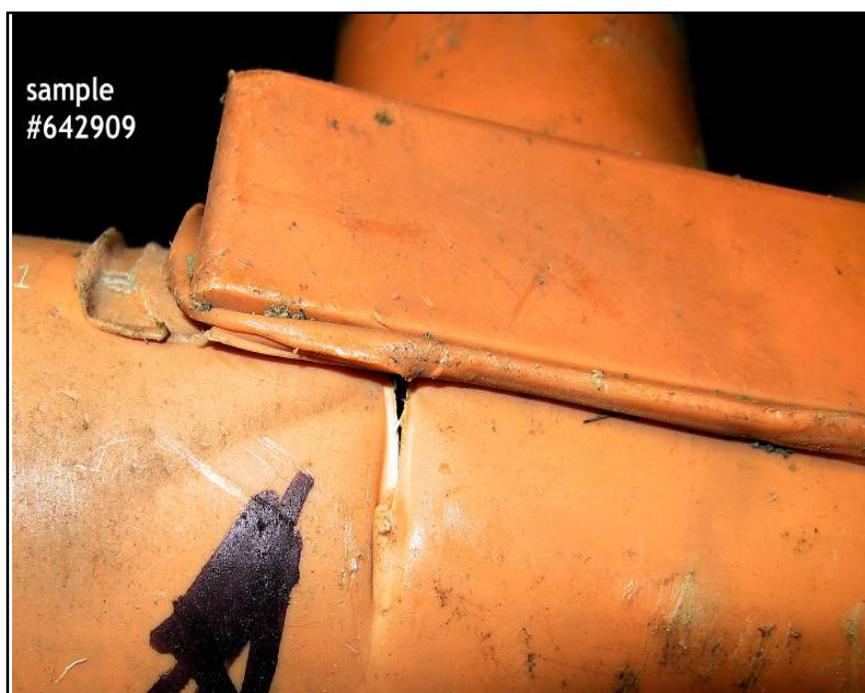
Figure 271. Circumferential Slit on the Backside of the Tee

The results of this examination indicated that the pipe segment section was permanently deformed 90 degrees from the saddle fused service tee. On the back side of the tee, away from the service outlet, a fracture in the pipe was observed as seen in Figure 271. Also in this area immediately adjacent to the fracture, the saddle fusion appeared to have minimal roll back on this side of the tee. The opposite side of the tee exhibited a double bead and significantly more material roll back than the side immediately adjacent to the observed fracture.

- 1) The saddle fusion surface tee exhibited a large area that was not properly fused. A good fusion would be stronger than the pipe wall itself and would result in tearing of the pipe wall before separation of the fusion.
- 2) The pipe segment was significantly deformed. The deformation was consistent with significantly high loads, possibly from digging equipment.
- 3) Examination of the fractured surfaces indicated ductile overload of the pipe wall material. No smaller fracture characteristics were observed which would have indicated a pre-existing crack prior to the ductile overload.
- 4) Excavation damage is the most likely the cause of failure.

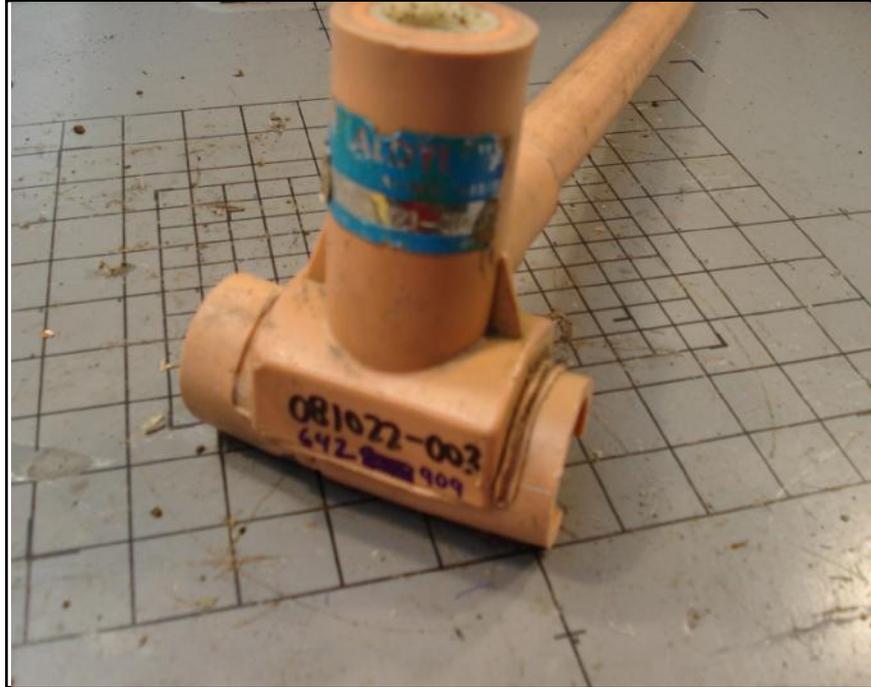
The pipe segment was cut longitudinally approximately 180 degrees from the service tee. The area of interest was then carefully cut further aiding exposure of the fracture surfaces of the observed crack as shown in Figure 272 through Figure 274. After opening the fracture, the saddle fused service tee exhibited a large area of poor adhesion to the pipe as seen in Figure 275. Visual examination (Figure 276 and Figure 277) and higher magnification examination (Figure 278 and Figure 279) using a stereo optical microscope indicated that the fracture surfaces were white and exhibited characteristics consistent with ductile failure of the pipe wall.

Figure 272. Pipe Was Cut Away to Reveal the Inner Pipe Wall

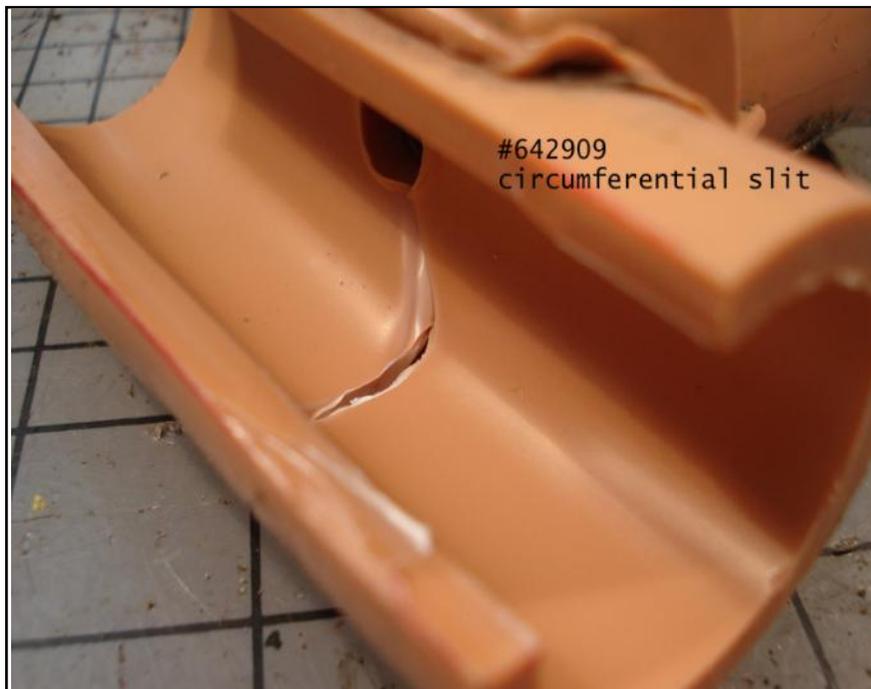
Figure 273. Damage on the Inner Wall

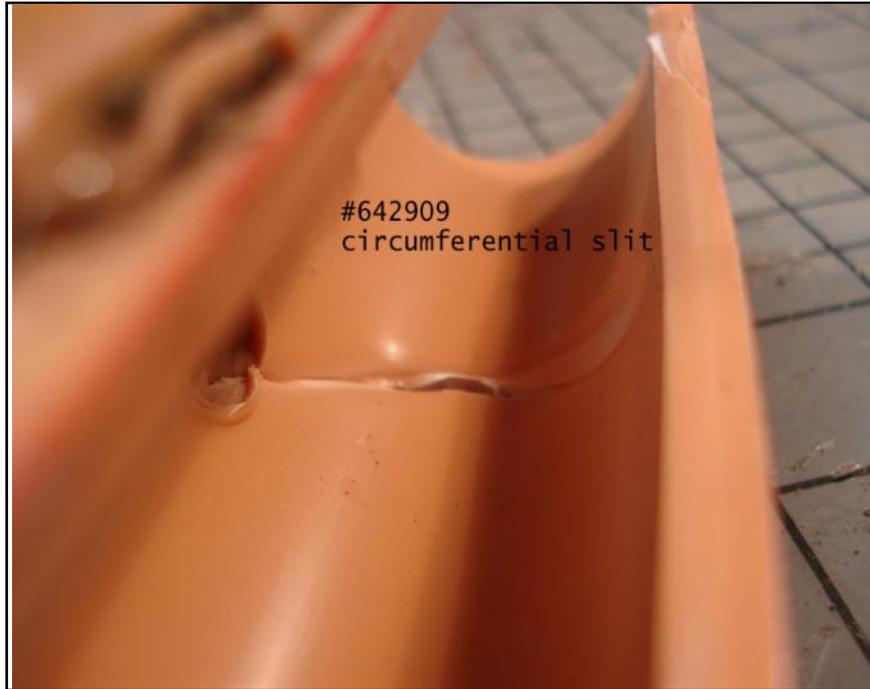
Figure 274. Damage on the Inner Wall

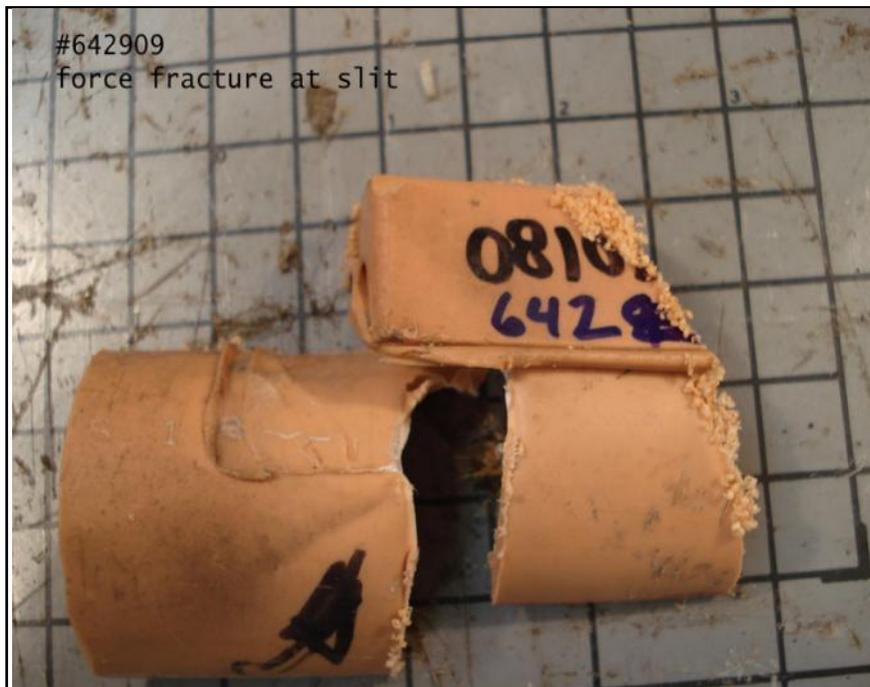
Figure 275. Tee Separated from Pipe during Force Fracture

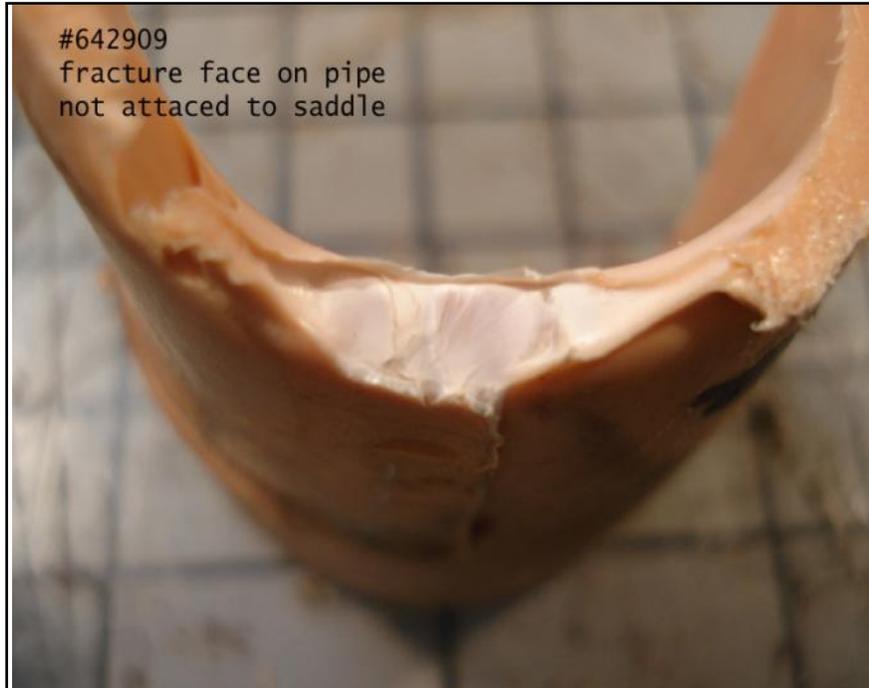
Figure 276. Fracture Face on the Pipe No Longer Attached to the Tee

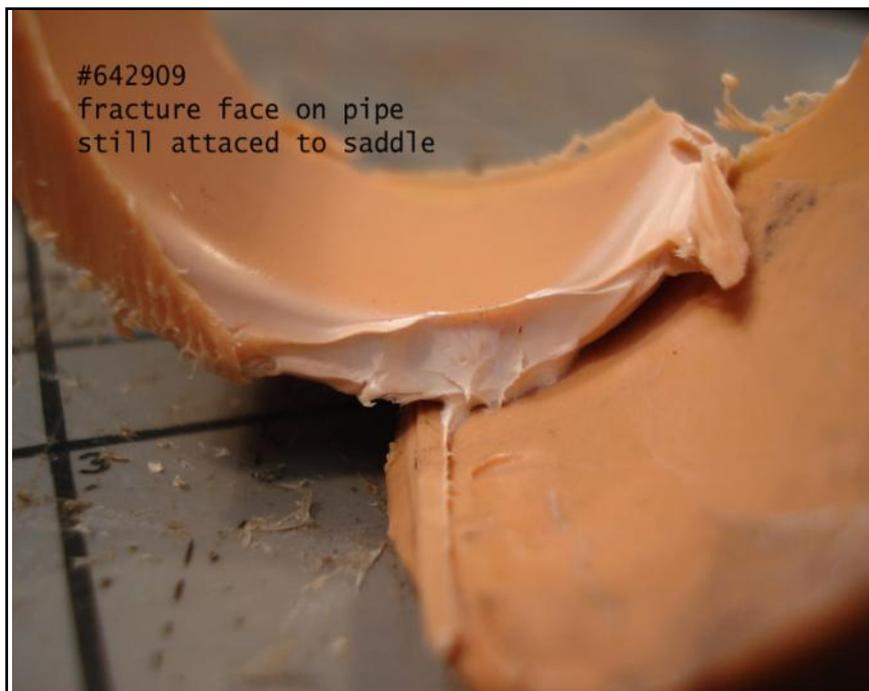
Figure 277. Opposing Fracture Face

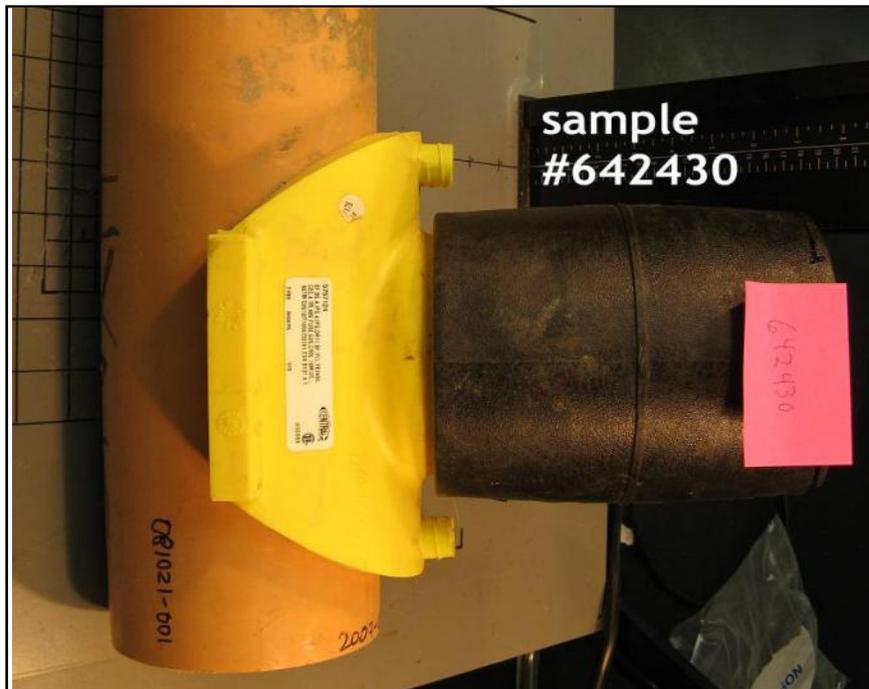
Figure 285. As Received Sample

The pipe segment containing the electrofused saddle tee (Figure 285) was subjected to visual examination using the naked eye as well as high powered stereo optical microscopy. Results of this examination indicated a solidified area of material between the saddle fusion tee and the pipe that had seeped from the tee-pipe interface as seen in Figure 286.

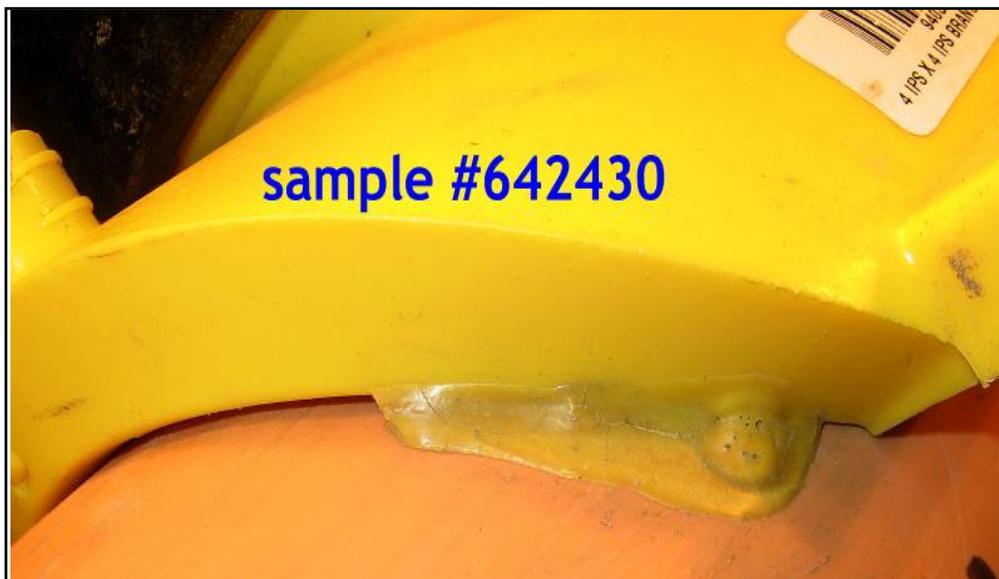
Figure 286. Brittle Plastic Seepage from the Tee

- 1) The electrofusion saddle generated enough heat to degrade the pipe and tee material at the fusion interface. This degradation was detected by both DSC-OIT and FT-IR. The degradation was severe enough to cause a significant localized melt viscosity reduction or thinning of the material, facilitating the observed seepage. The effects of this degradation on the fusion longevity could not be determined and would require a more in depth study.
- 2) Some potential causes include equipment malfunction and/or electrofusion programming error(s).

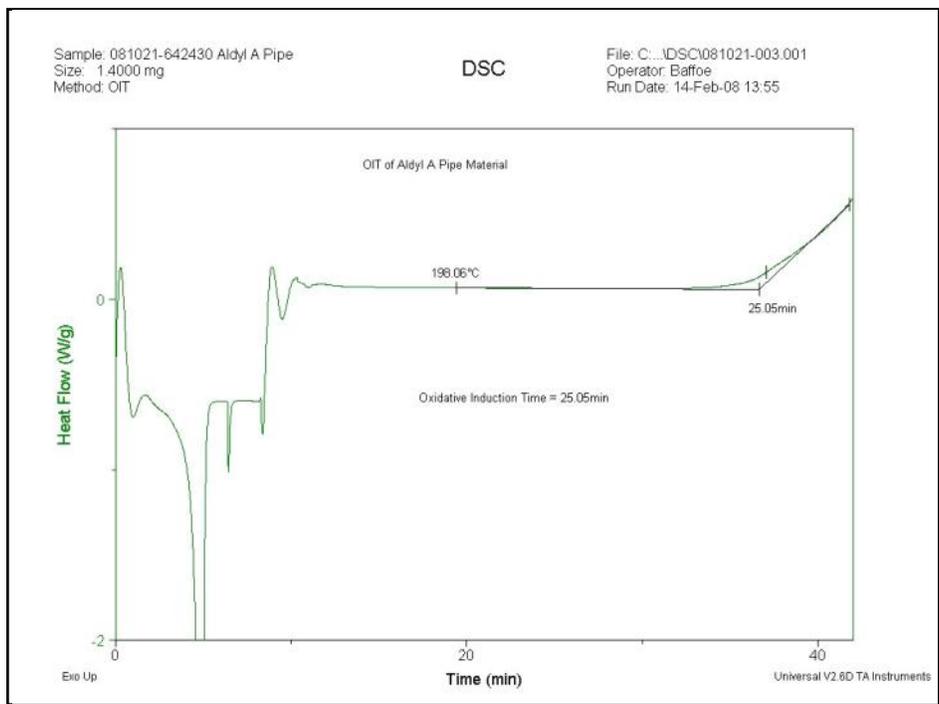
Figure 287. Oxidative Induction Time - Pipe

Specimens were prepared from the pipe section and companion electrofused tee as well as the seepage material and subjected to ASTM D3895. The resulting thermograms indicated oxidative induction times (OITs) of 27, 70, and 14 minutes for the pipe, tee, and seepage material respectively. See Figure 287, Figure 288, and Figure 289. The OIT of 27 minutes for the pipe material was considered on the low side of normal for an in service pipe. The OIT of 70 minutes for the tee material was considered normal. The OIT of 14 minutes for the seepage material was significantly low and suggested significant material degradation.

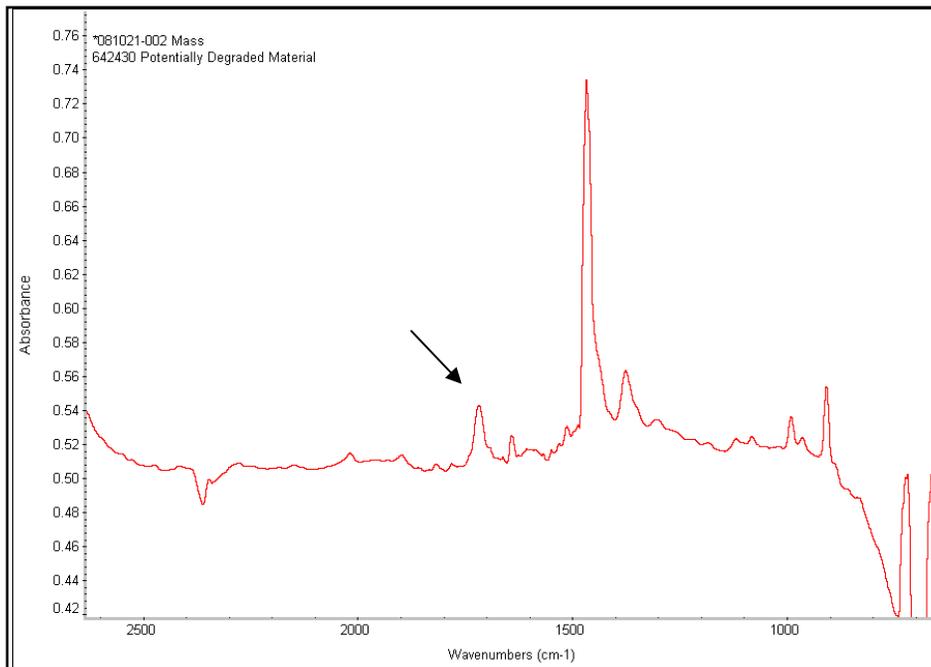
A comprehensive infrared analysis was performed to determine the condition of the pipe, tee, and seepage material and to detect the presence of any organic compounds not associated with the respective materials. The results did not indicate the presence of any foreign organic compounds in the material specimens. There were no detectable oxidation absorbencies in the pipe or tee material as shown in Figure 293 and Figure 294, respectively. An absorbance was detected at 1718cm^{-1} of the seepage material spectrum characteristic of a ketone compound consistent with oxidation products of polyethylene. The absorbance peak is noted in Figure 295. The peak height was measured and compared against the 1460cm^{-1} peak of the spectrum. The resulting quotient was 0.17 (carbonyl index, CI). Typical CI for non-aged samples is 0.01-0.05.

Figure 295. FT-IR Spectrum – Seepage Material: Note ketone absorbance

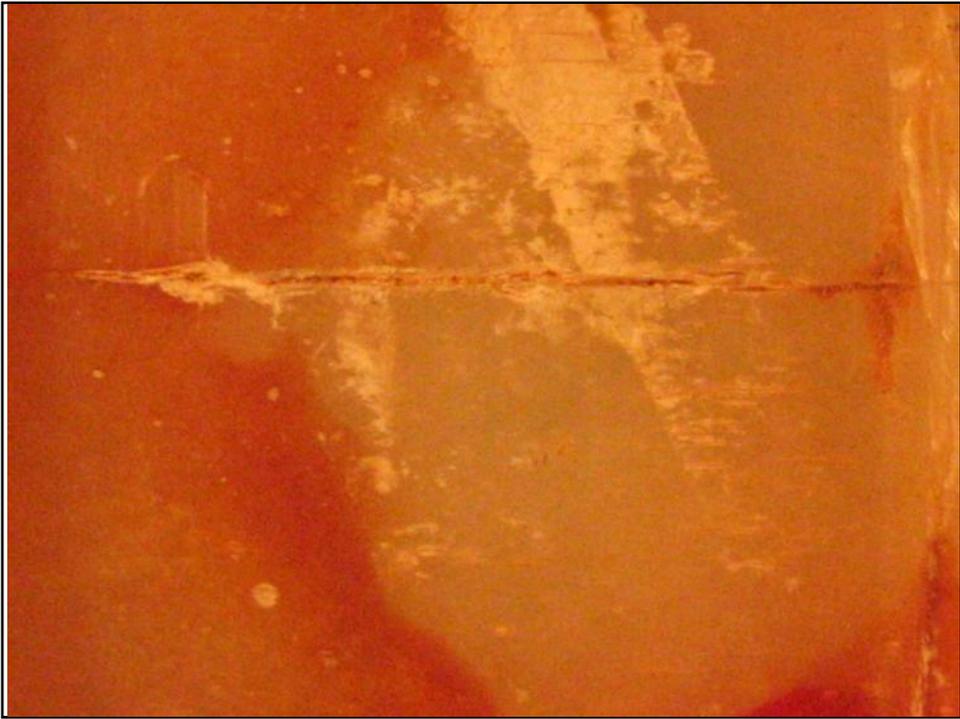
The fitting exhibited a slit failure at the mold seam/knit line as shown up close in Figure 297. All surfaces of the fitting show crazing.

Figure 297. Slit at Knit Line

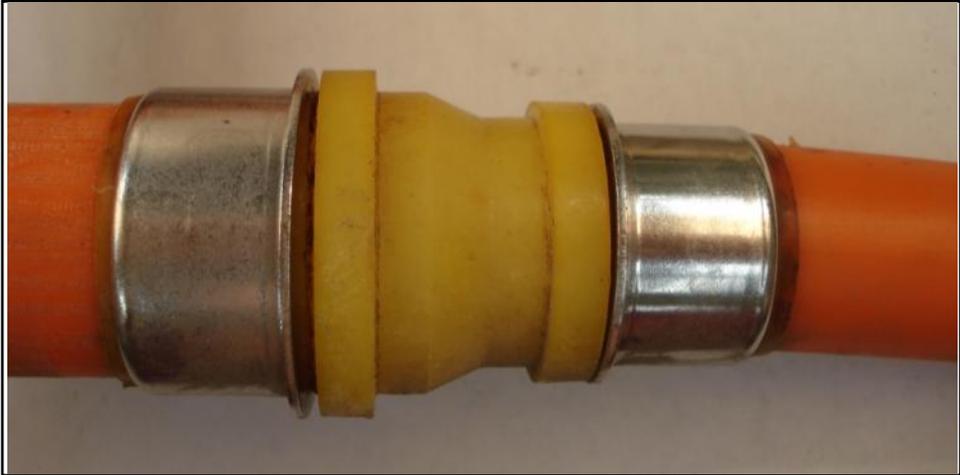
Figure 299. Close up View of AMP Fitting

The AMP fitting exhibited a partial pullout. The actual cause cannot be determined without dissecting the fitting.

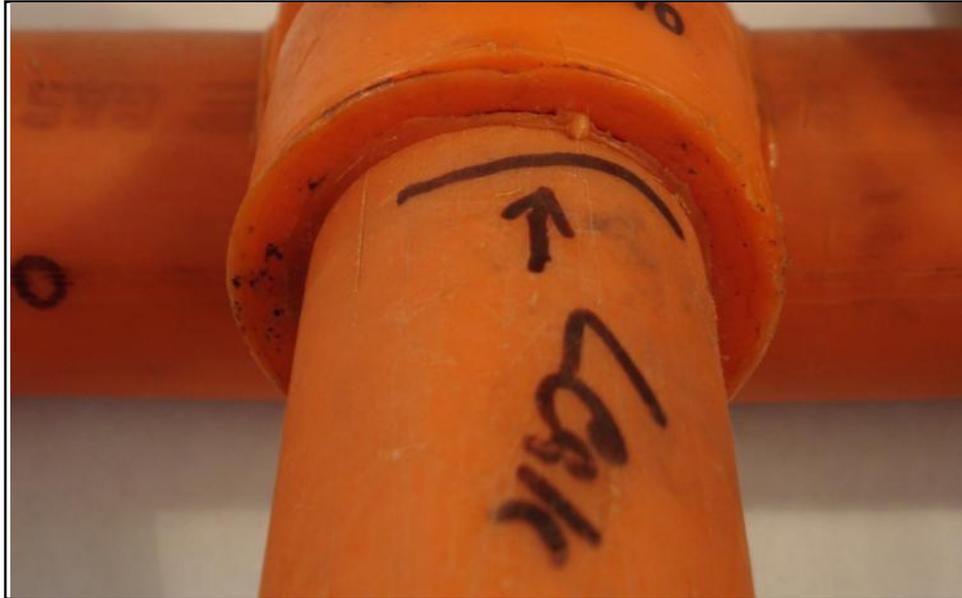
A circumferential gap/crack was located between the ID of the socket and the OD of the pipe. The area containing the crack had less rollback than the remaining socket surface. Root cause determination would require sectioning of the fusion joint though poor workmanship is probable.

Figure 301. Socket Joint
