FINAL REPORTGTI PROJECT NUMBER 20385

Plastic Pipe Failure, Risk, and Threat Analysis

DOT Project# 194

Contract Number: DTPH56-06-T-0004

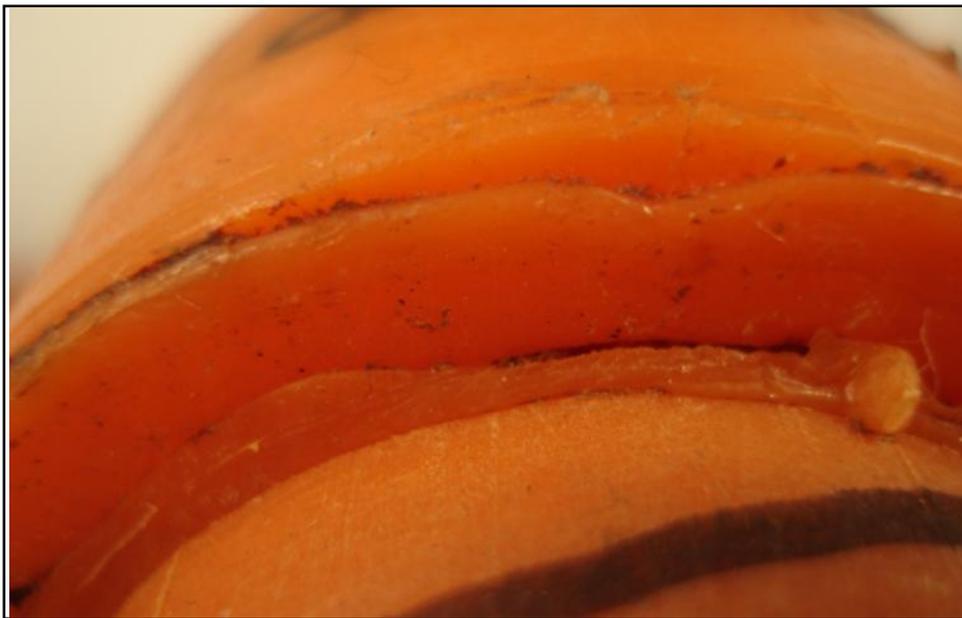
A circumferential gap/crack was located between the ID of the socket and the OD of the pipe. The area containing the crack had less rollback than the remaining socket surface. Root cause determination would require sectioning of the fusion joint though poor workmanship is probable.

Figure 302. Area Identified as Leaking

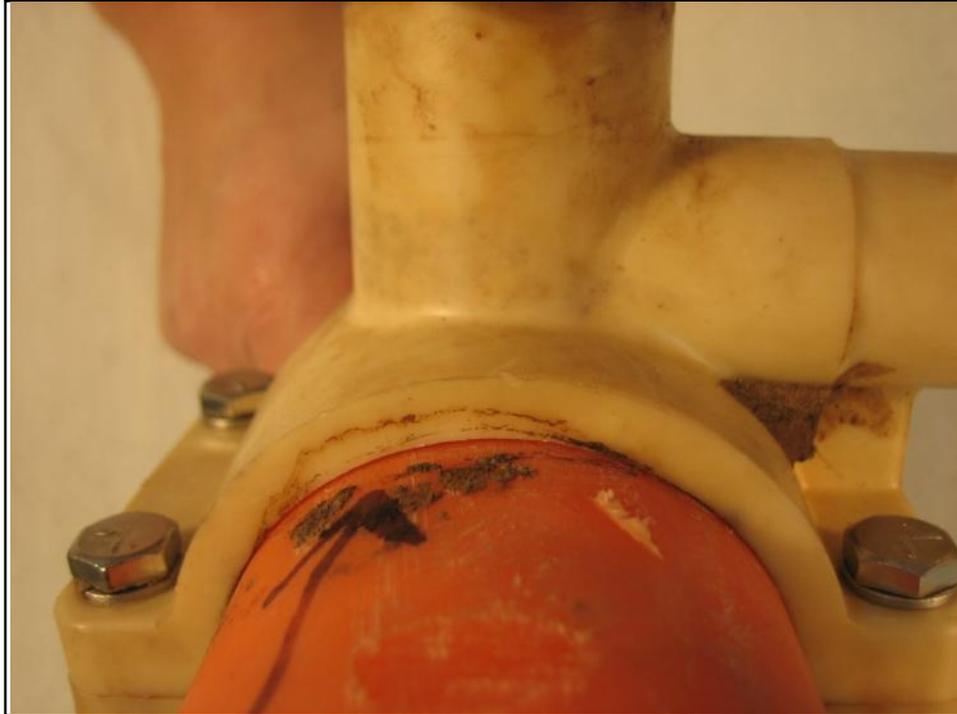
Figure 304. Side View of Mechanical Tee

Leak markings were indicated on both sides of the fitting. The inner surface of the pipe did not show signs of cracking which would suggest that the leak was caused by the service tee seal. A definitive cause would require fitting disassembly.

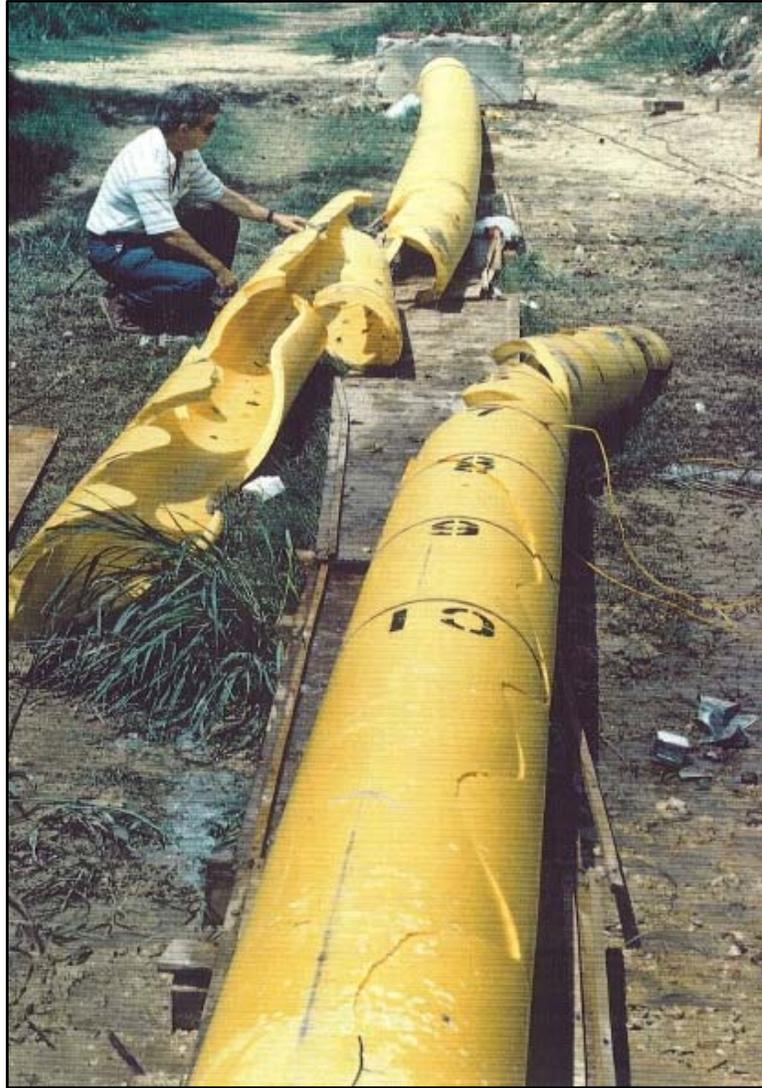
Figure 306: Full Scale RCP Testing Result (Kanninen Et Al., 1997)

Figure 306 is a photographic view of one of GTI full-scale tests that were conducted on a 100-ft long pipe sample. This view shows the possible catastrophic failure that can occur during a RCP event and also illustrates the RCP sinusoidal crack that propagated axially along the pipe length.

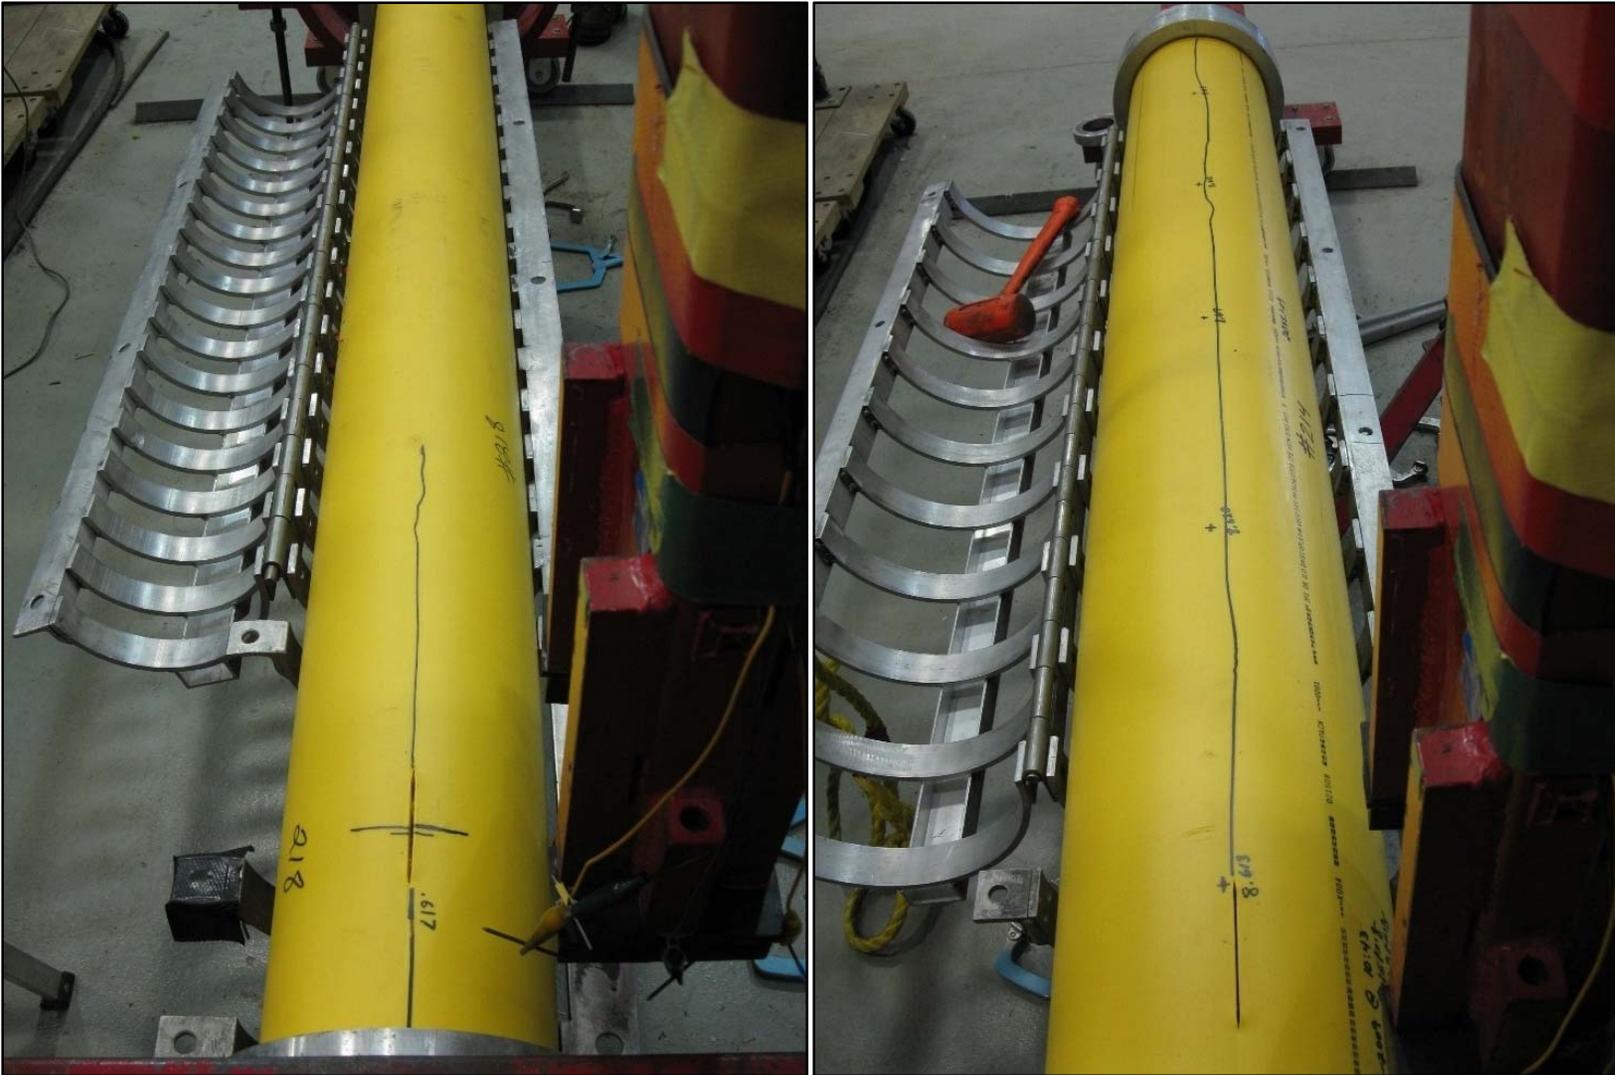
Figure 318: 6" MDPE S-4 Tests: Left, Crack Arrest; Right, Crack Propagation

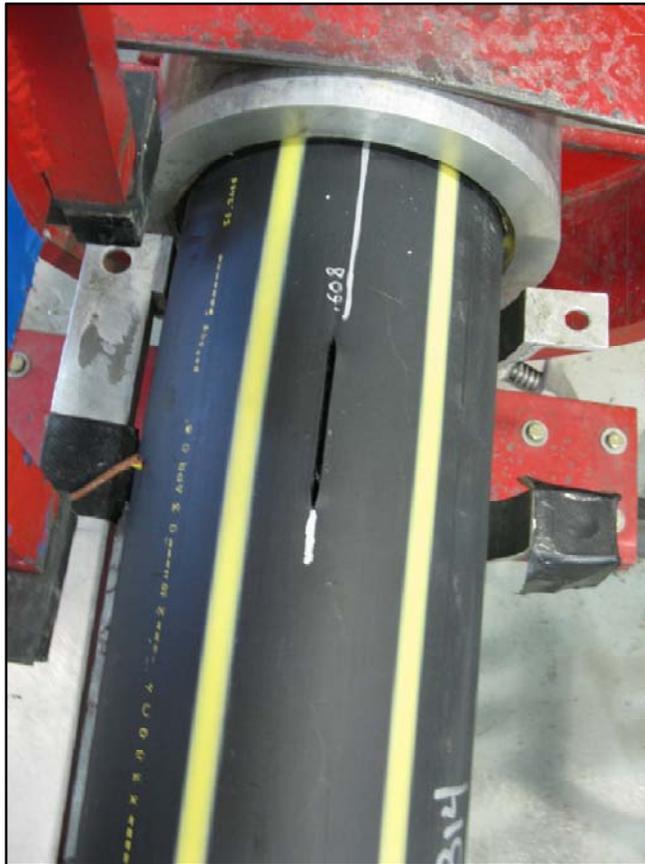
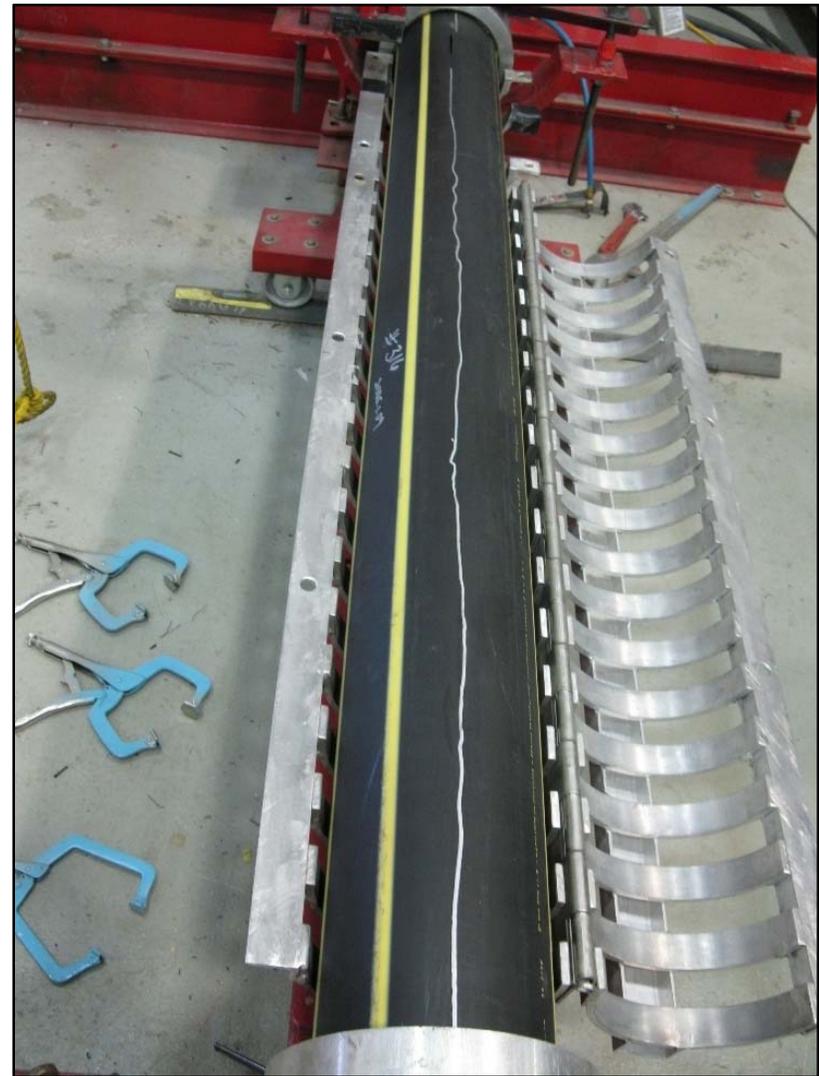
Figure 321: 6"HDPE S-4 Tests: Left, an Insufficient Crack Length; Right, Crack Propagation

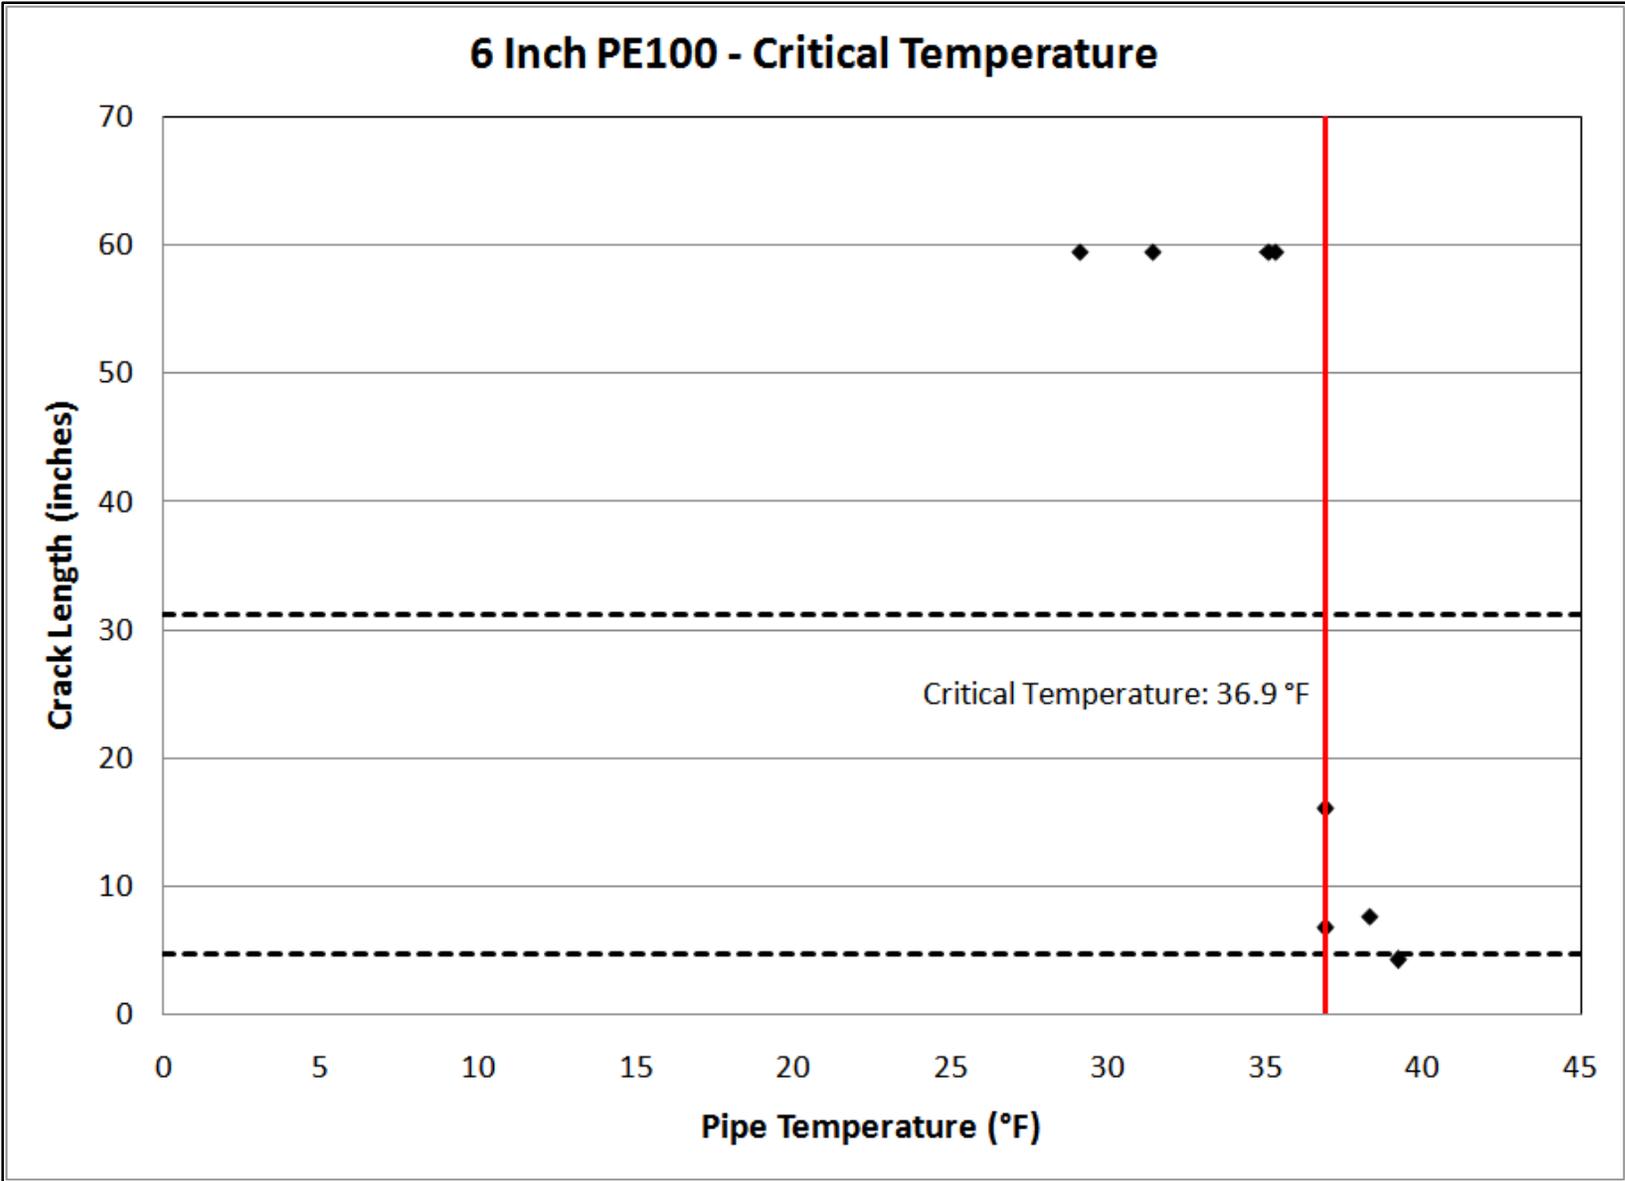
Figure 323: 6" PE 100 Critical Temperature Test Results: Critical Temperature: 36.9 °F

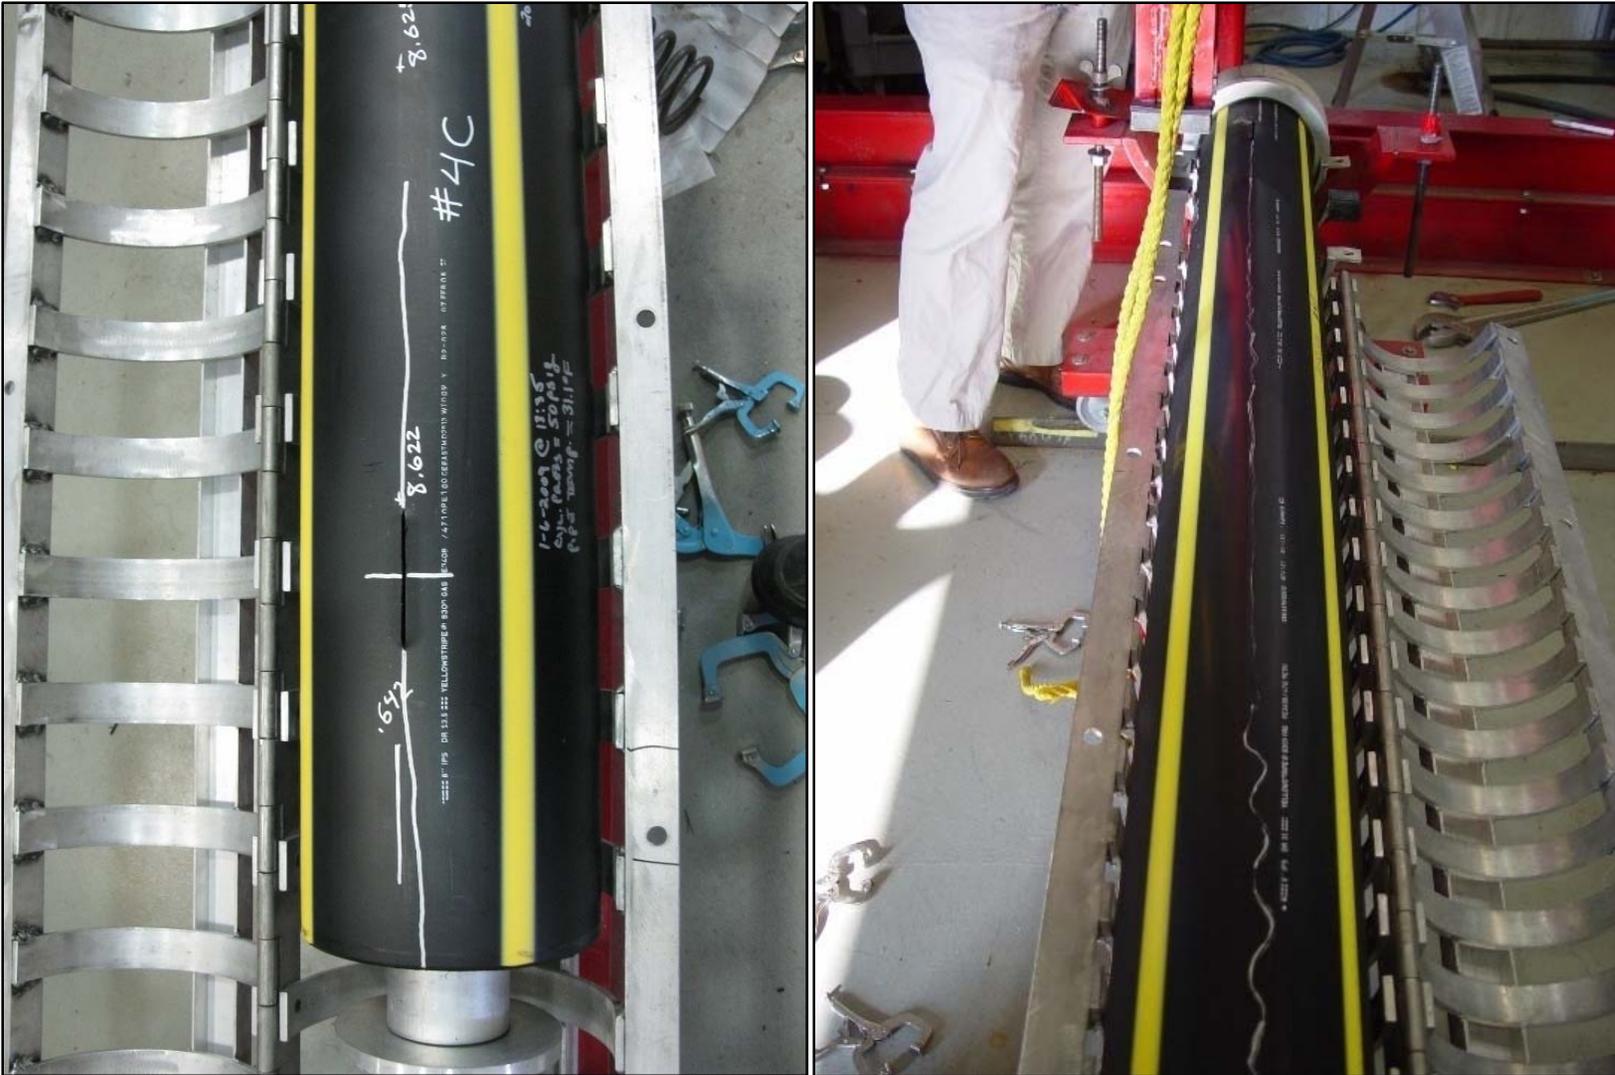
Figure 324: 6"PE100 S-4 Tests: Left, Initiation Test; Right, Crack Propagation

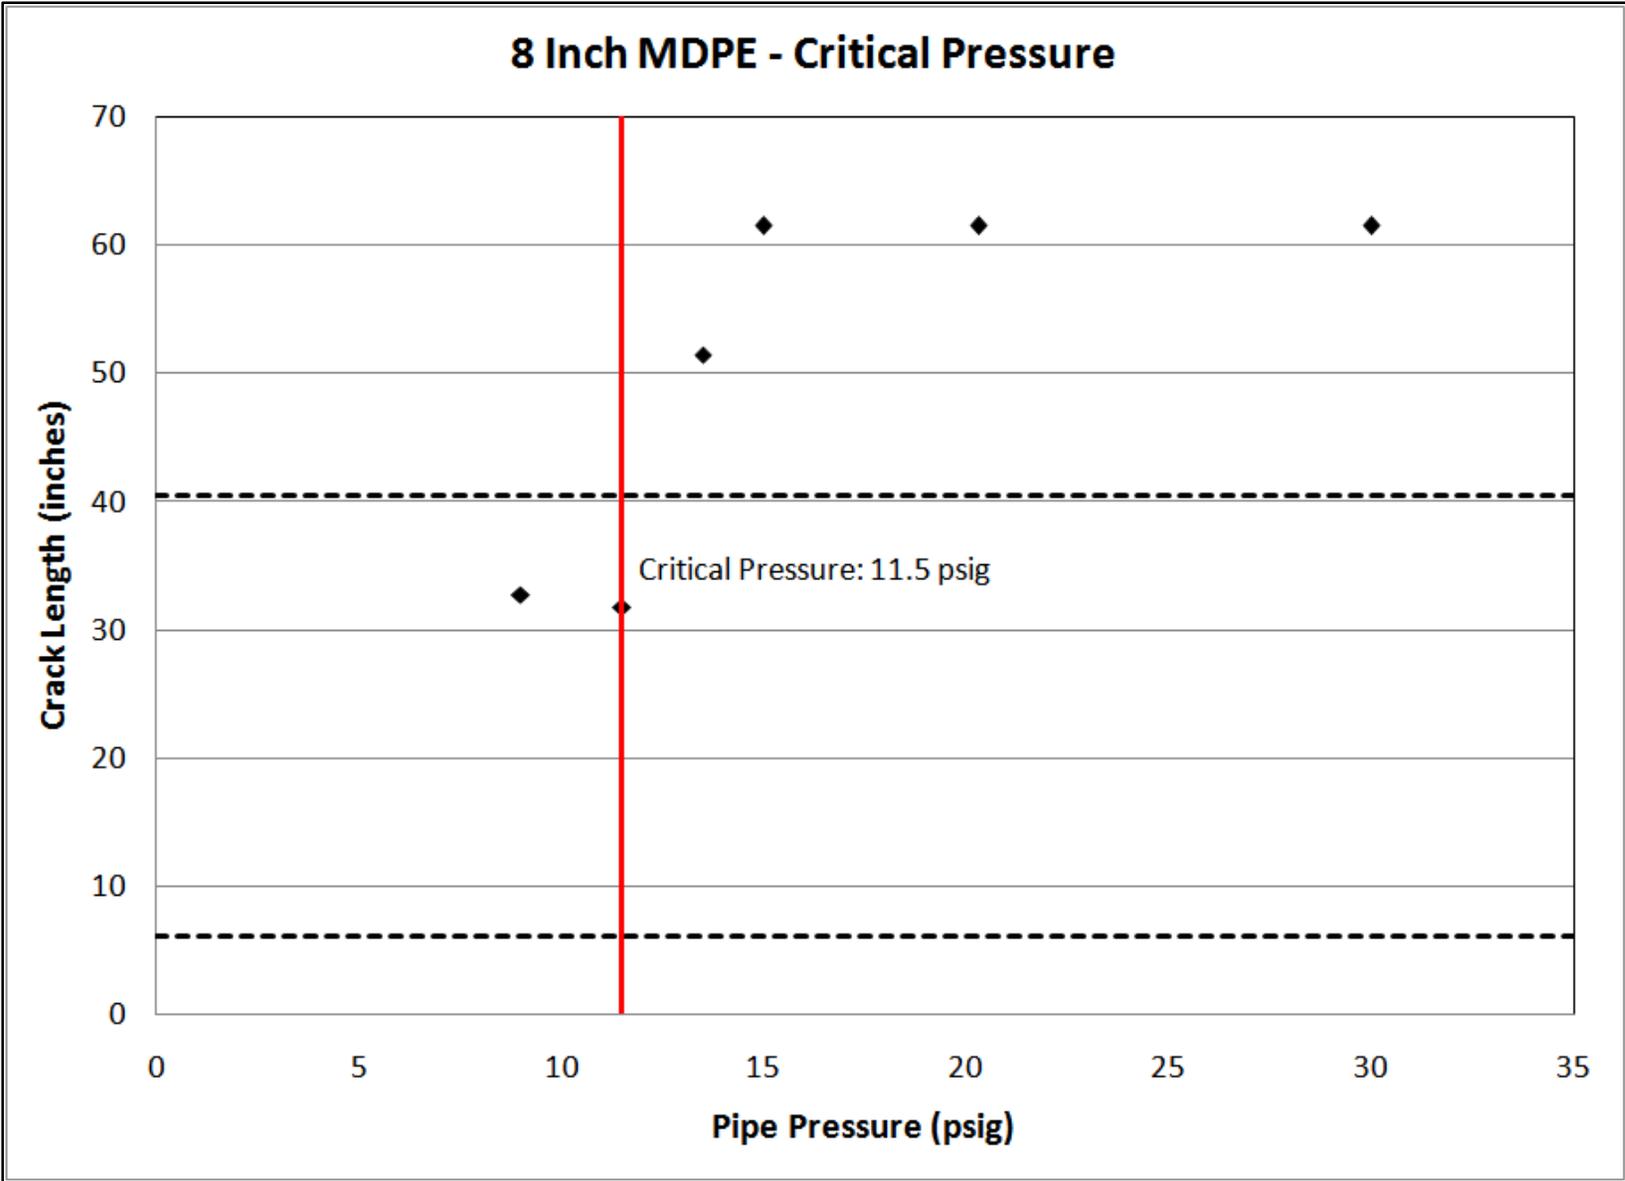
Figure 325: 8" MDPE Critical Pressure Test Results: Critical Pressure: 11.5 Psig

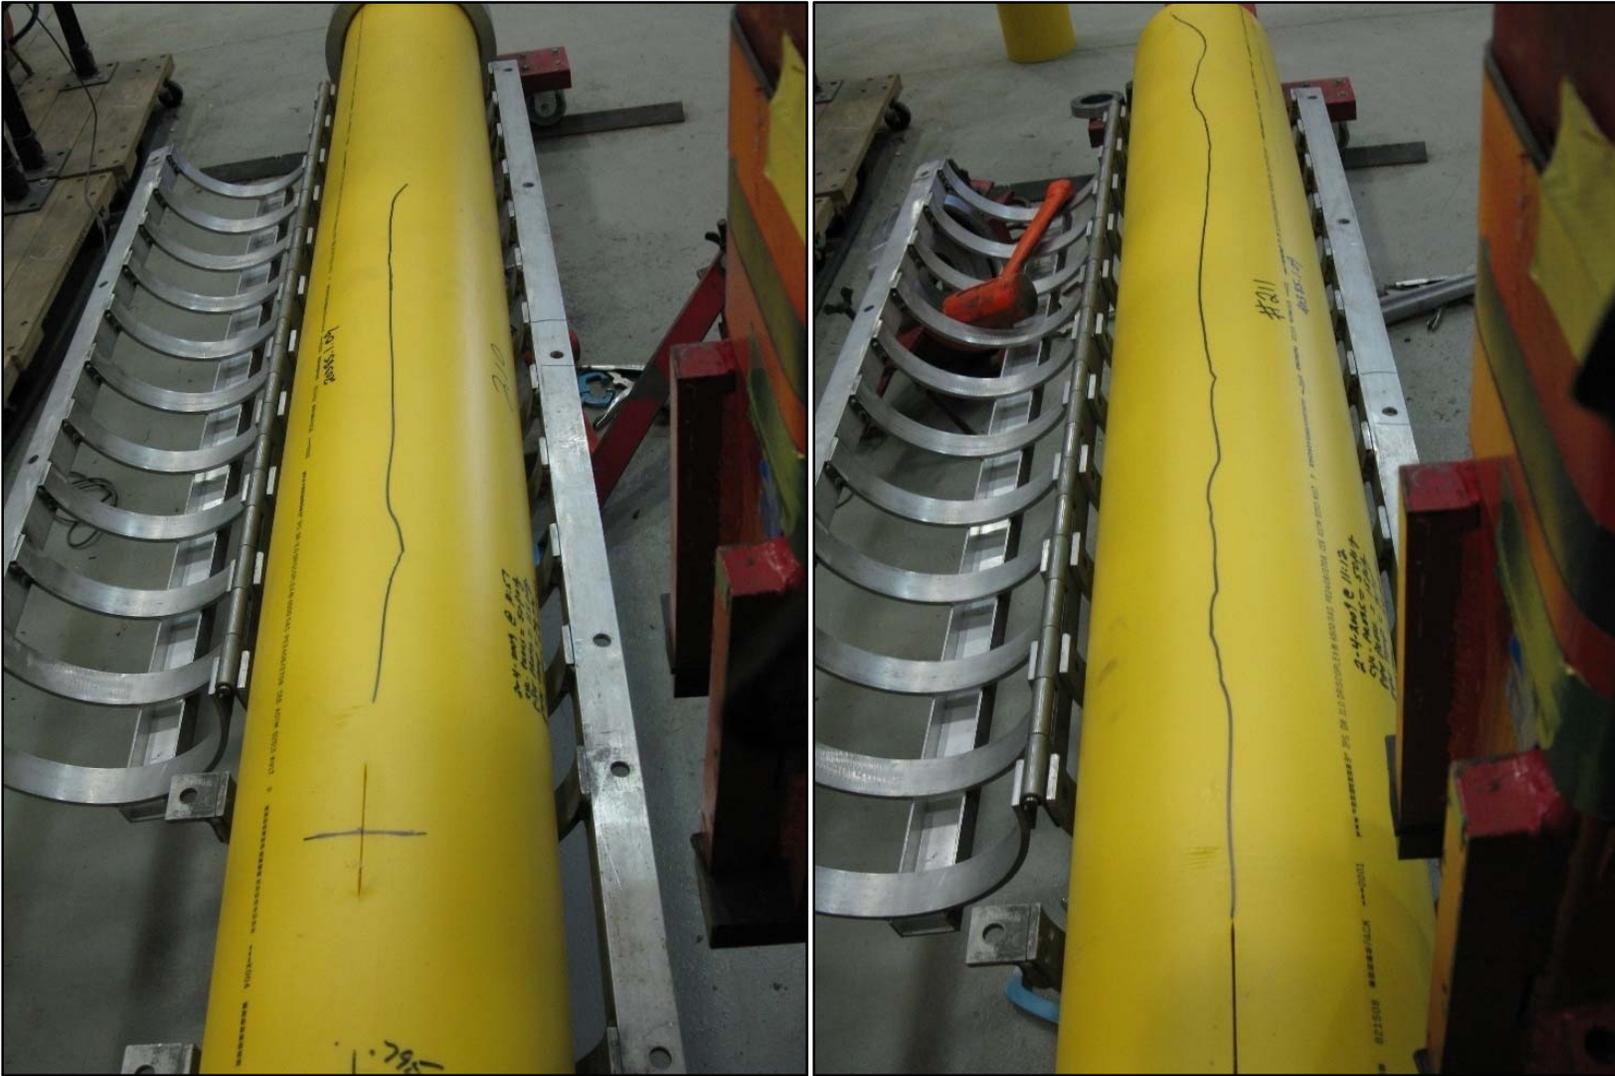
Figure 326: 8" MDPE S-4 Tests: Left, Crack Arrest; Right, Crack Propagation

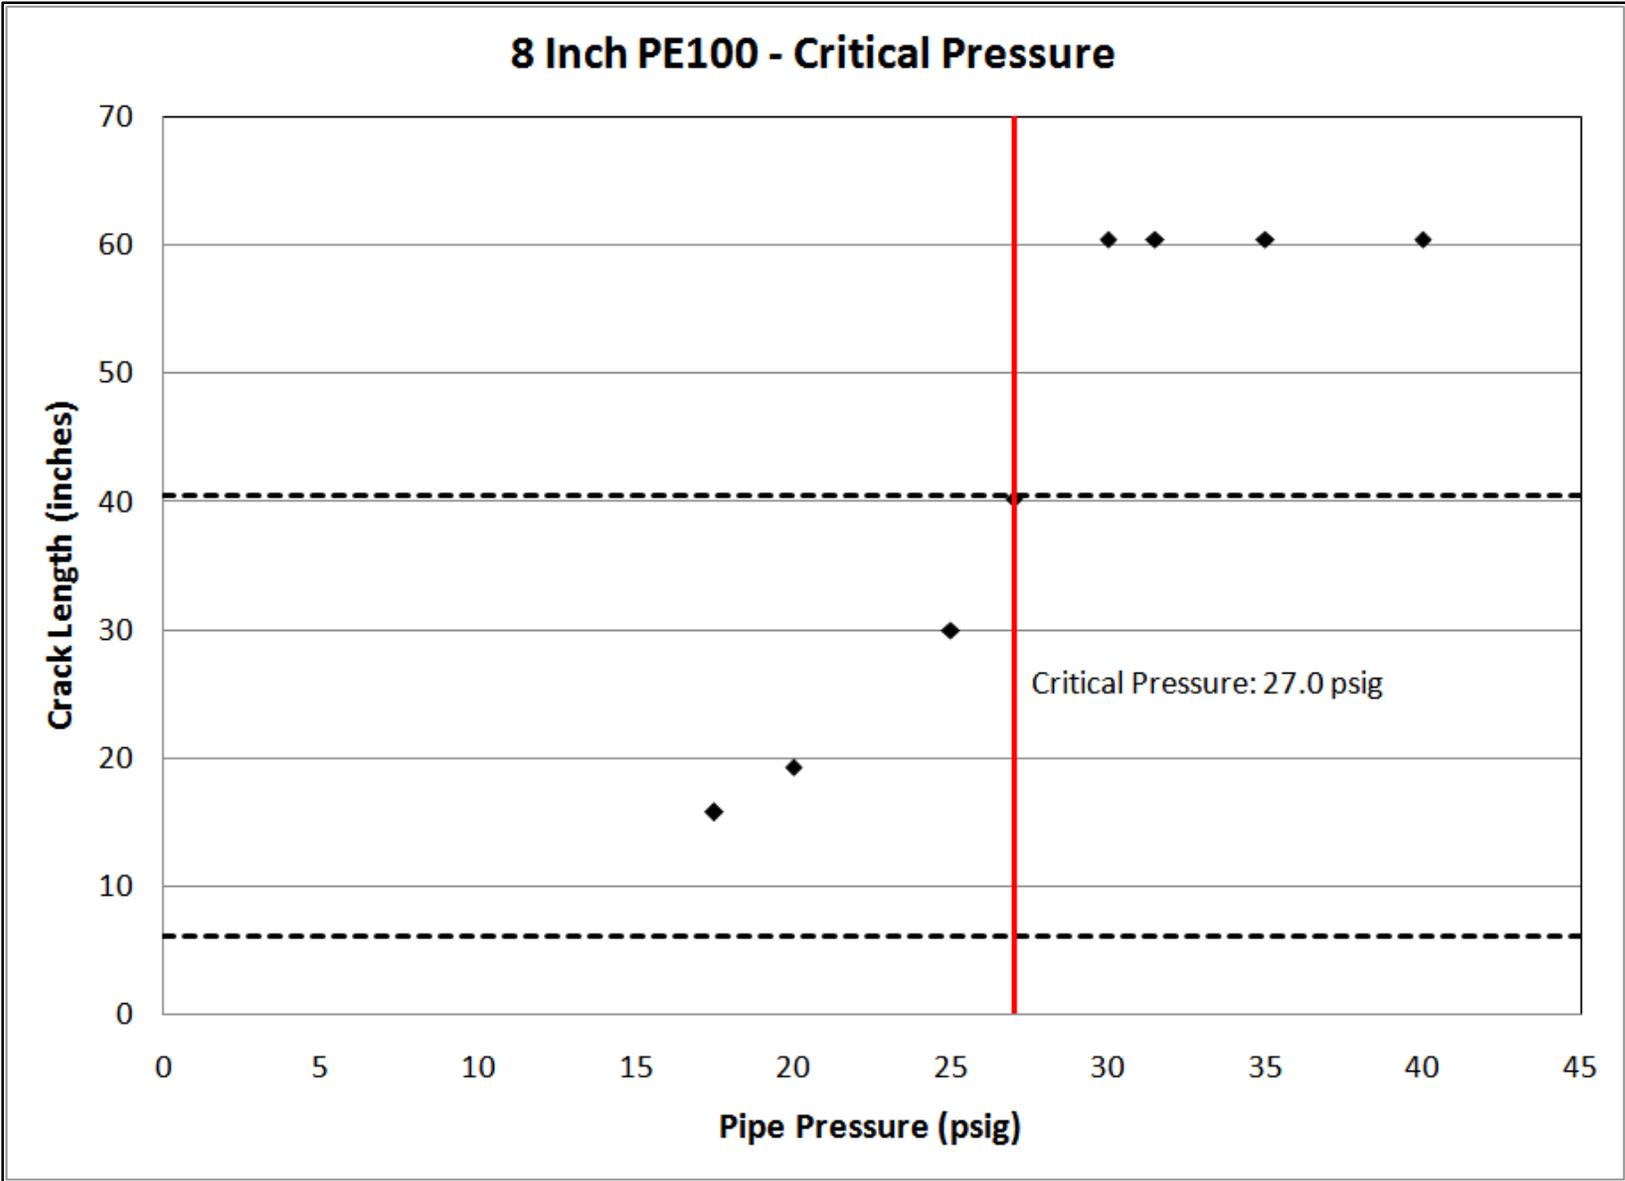
Figure 327: 8" PE 100 Critical Pressure Test Results: Critical Pressure: 27.0 Psig

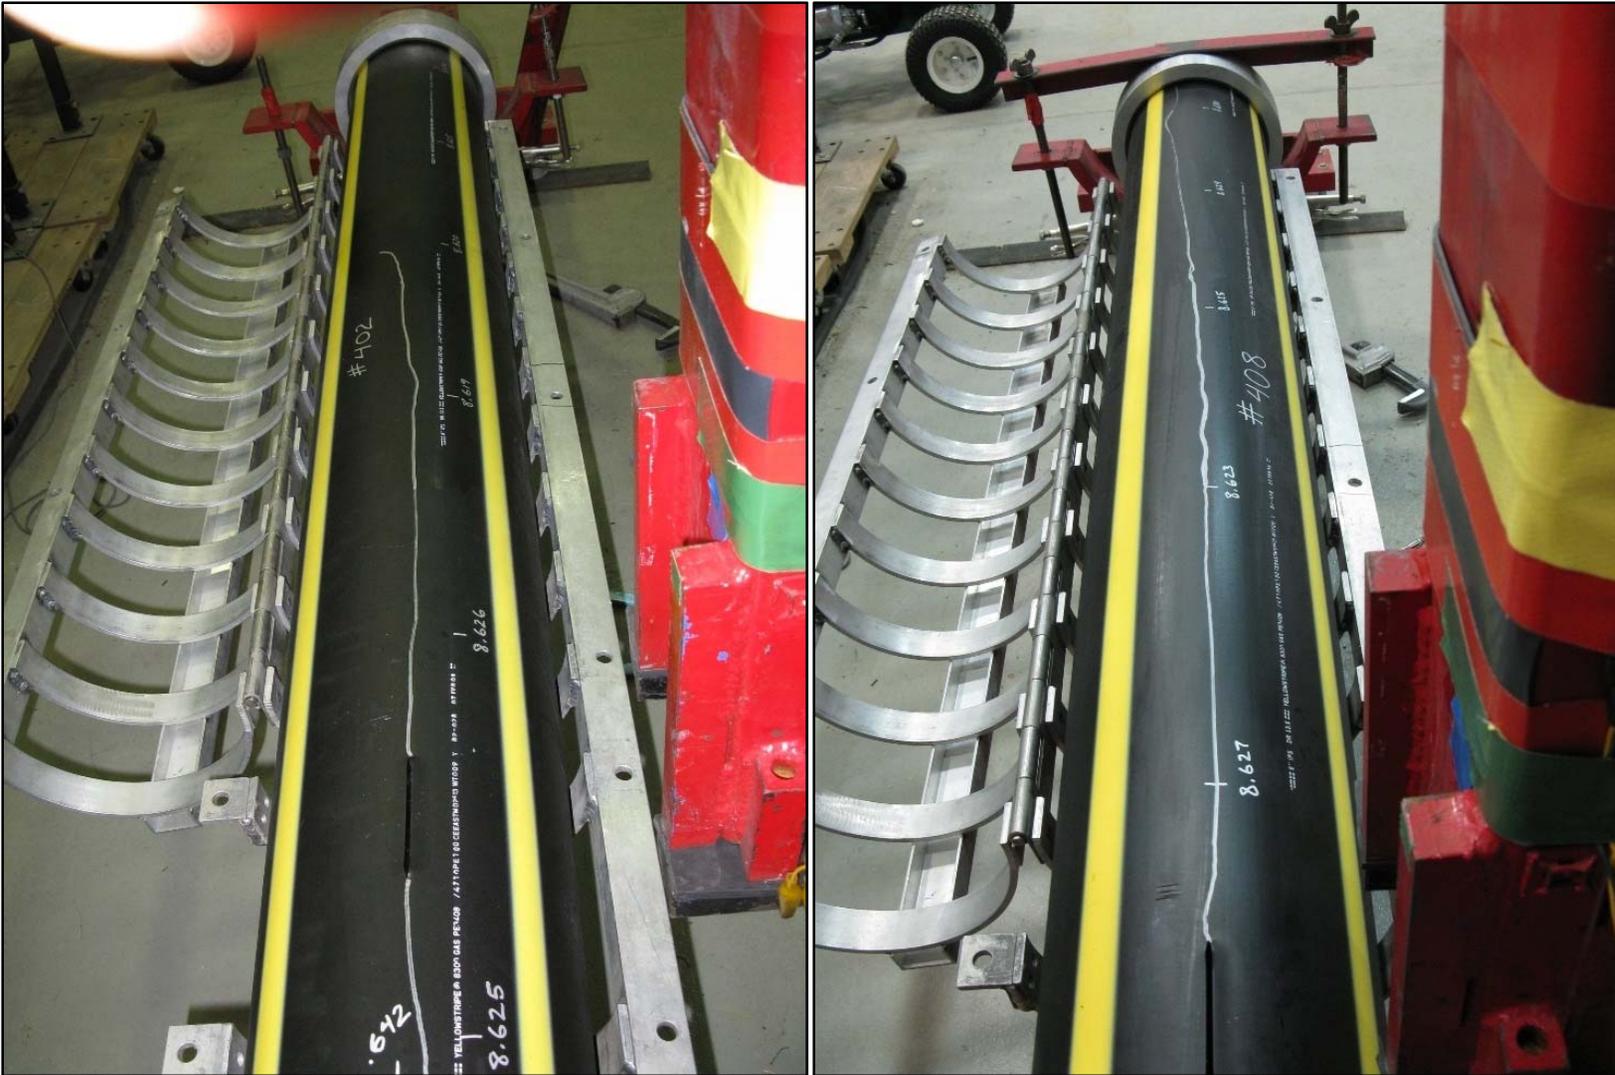
Figure 328: 8" PE 100 S-4 Tests: Left, Crack Arrest; Right, Crack Propagation

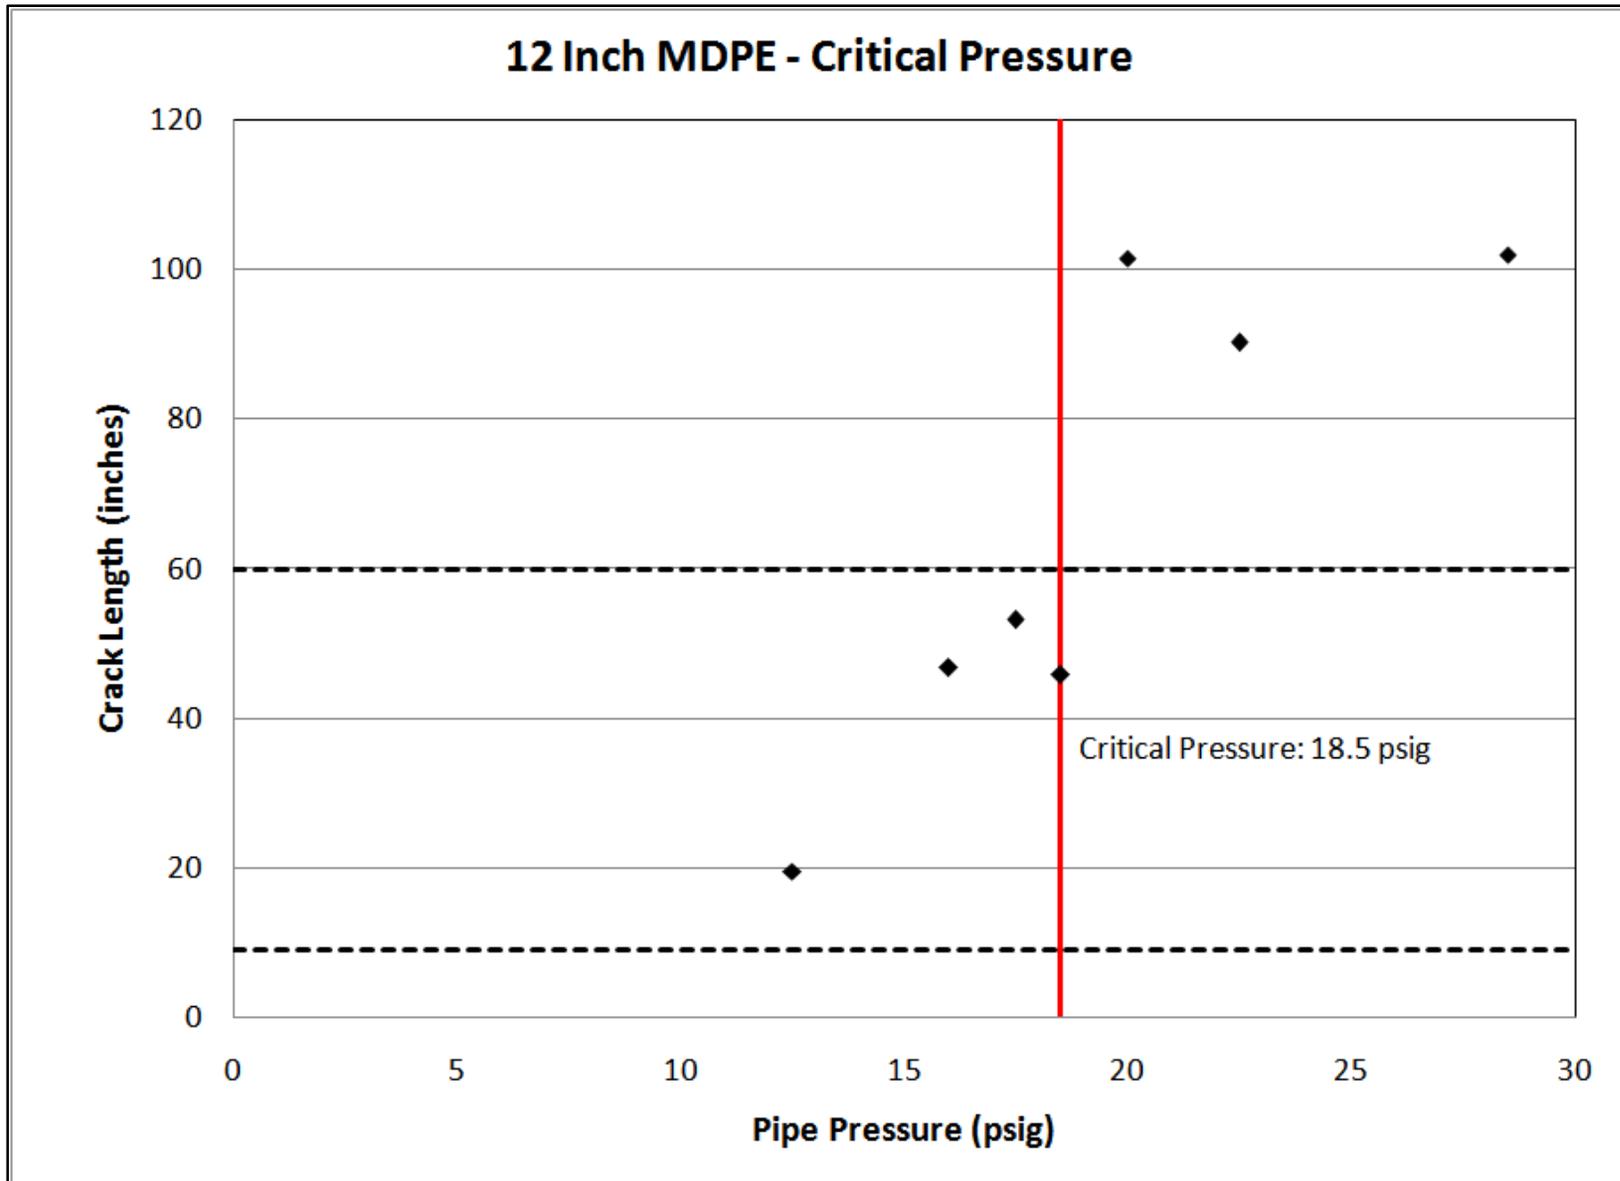
Figure 329: 12" MDPE Critical Pressure Test Results: Critical Pressure: 18.5 Psig

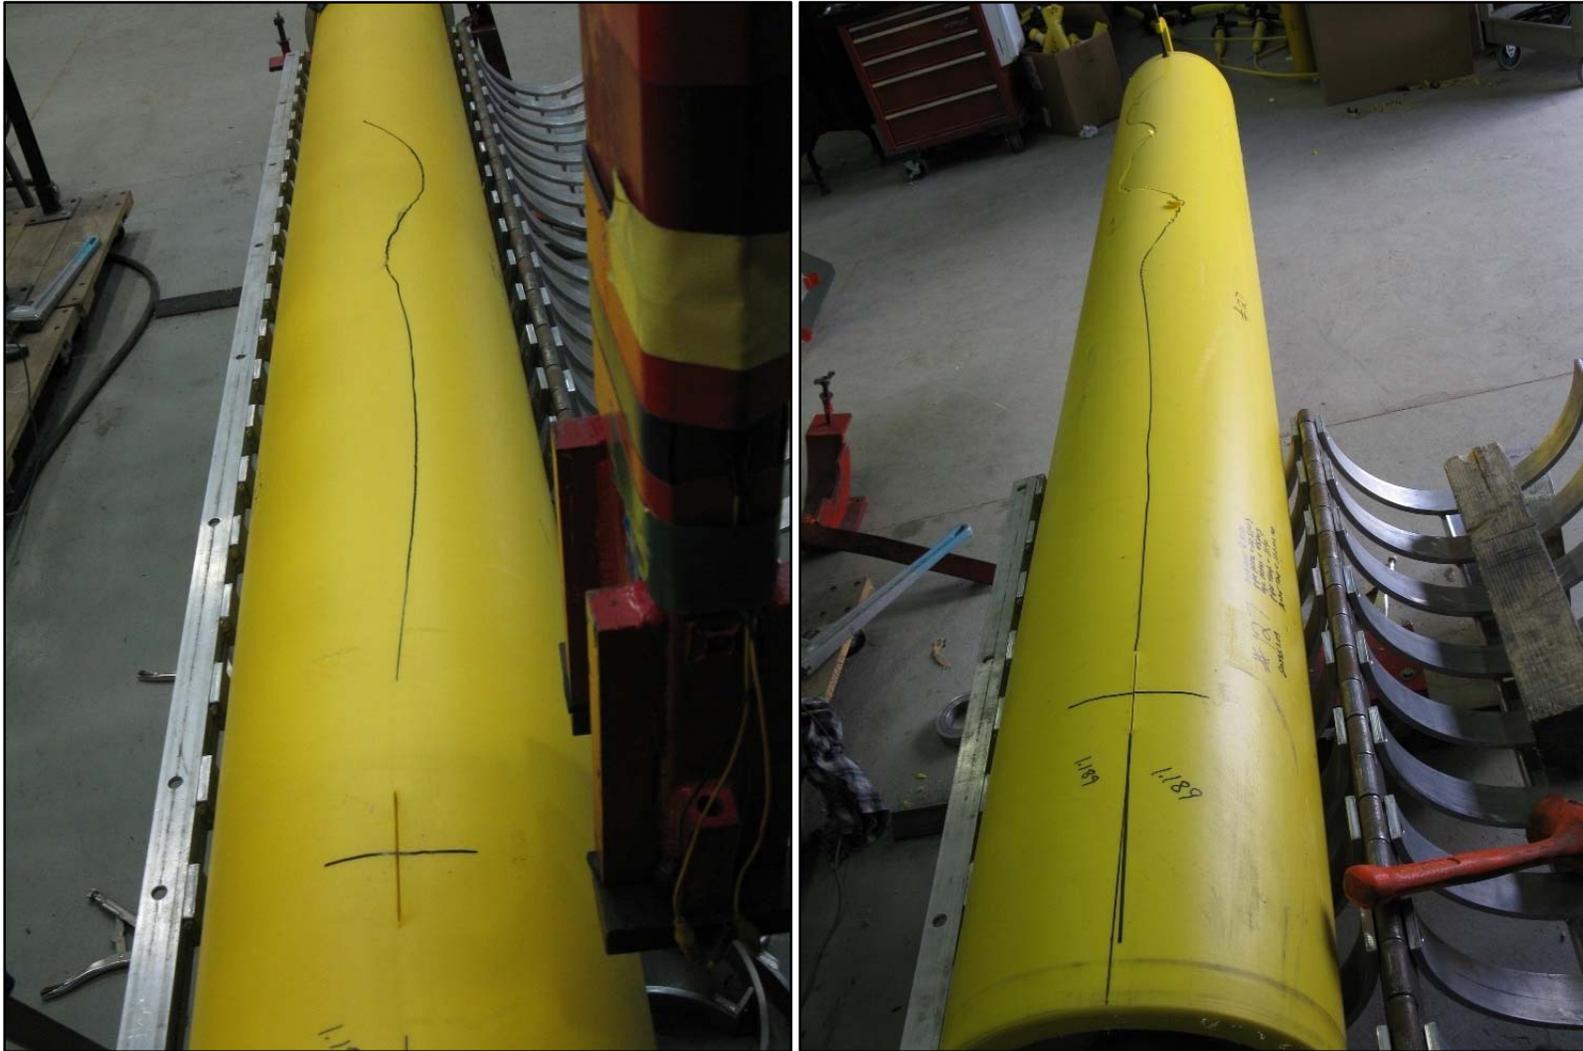
Figure 330: 12" MDPE S-4 Tests: Left, Crack Arrest; Right, Crack Propagation
