TECHNICAL REPORT - OPS 89-1

**ELECTRIC RESISTANCE WELD PIPE FAILURES
ON HAZARDOUS LIQUID AND GAS TRANSMISSION PIPELINES**

AUGUST 1989

**Office of Pipeline Safety
Research and Special Programs Administration
U.S. Department of Transportation**

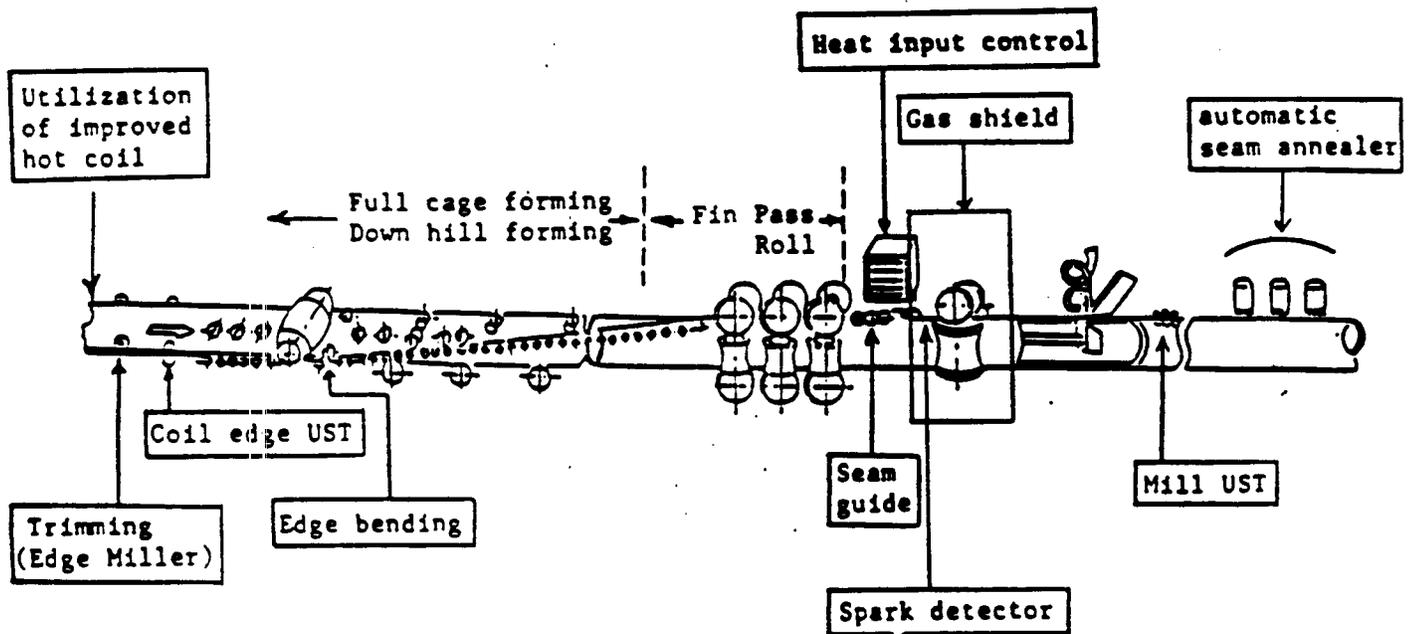
Figure 1 Schematic Representation of the Electric Resistance Welding (ERW) Process

ERW pipe is manufactured by a process wherein steel strips are continuously welded after being mechanically formed into tubular shapes. As these tubular shapes move through a series of resistance heating and forging operations, a welded seam is produced (Figure 1). The speed of pipe movement through the so-called "fins" or welding and forging heads, the frequency of the current used to heat the pipe, the amount of forging pressure, tolerances on the edges to be joined, and cleanliness are but a few of the critical variables.

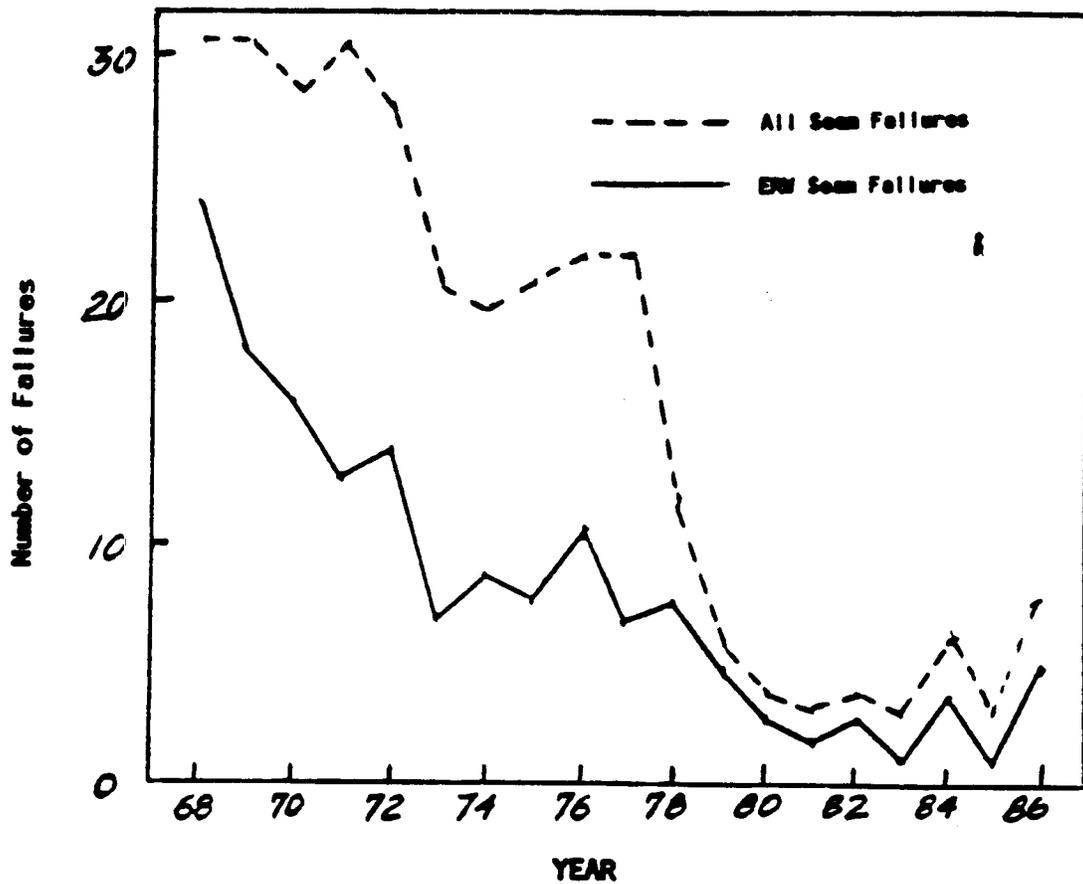
Figure 2 **Graph of Hazardous Liquid Pipeline Seam Failures (1968 - 1986)**

Figure 2 illustrates the decline in number of hazardous liquid pipeline seam failures of all kinds from 1968 to 1986. Also illustrated is the number of ERW seam failures during the same period. Some studies indicate that while the overall rate of failures of all seams, including ERW pipe, is decreasing, the relative rate of failure of pre-1970 ERW pipe to that of all seam failures has been increasing since 1978.

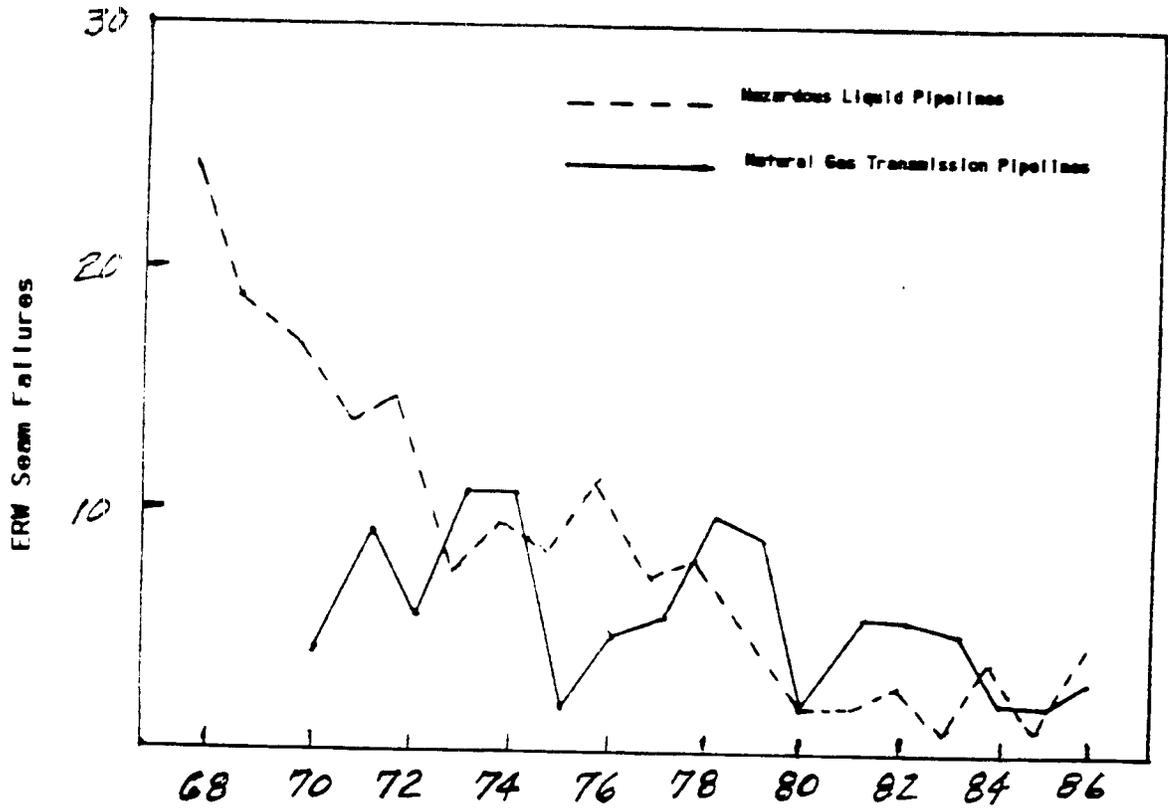
Figure 3 Graph of ERW Seam Failures (1968-1986) Hazardous Liquid and Gas Transmission Pipelines

The data collected from the RSPA Incident Reports - Gas Transmission and Gathering Systems, RSPA forms F7100.2 (1-70 and 3-84) is summarized in Table 6, "Summary of ERW Seam Failures in Gas Transmission Pipelines," showing 103 failures during the period 1970-1988. A graph of the number of ERW seam failures in hazardous liquid and natural gas transmission lines by year of occurrence is shown in Figure 3. The data for both natural gas and hazardous liquid lines illustrates a common trend; that of a generally decreasing number of incidents by year. Table 7 illustrates that about 95 percent of the ERW seam failures occurred on pipelines constructed prior to 1970.
