Final Report

ERW and Flash Weld Seam Failures

J.F. Kiefner and K.M. Kolovich

September 24, 2012

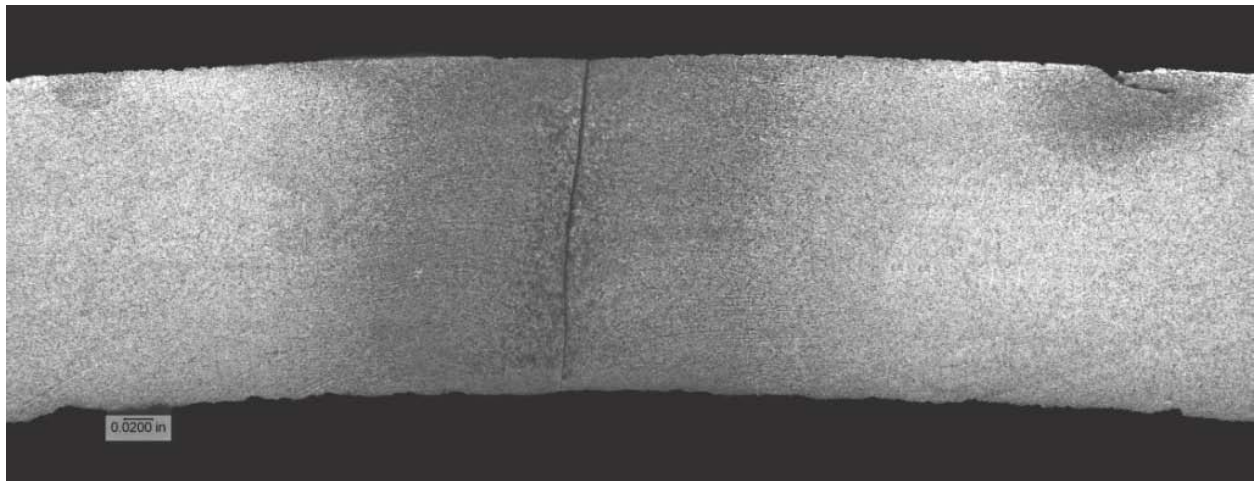
Figure 11. Another Section across a Cold Weld in LF-ERW Pipe

Many of the cold welds were through-wall anomalies as manufactured. Examples were shown previously in Figure 8, Figure 9, Figure 11, and Figure 14. The fact that they did not leak until the pipes had been in service for years suggests that leakage was initially blocked by a coherent oxide. Alternatively, it is possible that the initial oxide that formed while the material was still hot after welding (probably Fe_3O_4) can be converted in the soil environment or by a chemical reaction with the product inside the pipeline to a less coherent oxide that eventually gives way and allows leakage. It seems likely that at least some of the cold weld leaks were facilitated by previous hydrostatic tests. It is speculated that a test can cause plastic deformation at the ends of the defect allowing it to open slightly, possibly dislodging or degrading the oxide thereby creating a leakage path. The anomaly in CW Case Number 9 exhibits the kind of deformation that is suspected of facilitating leakage (see Figure 16).

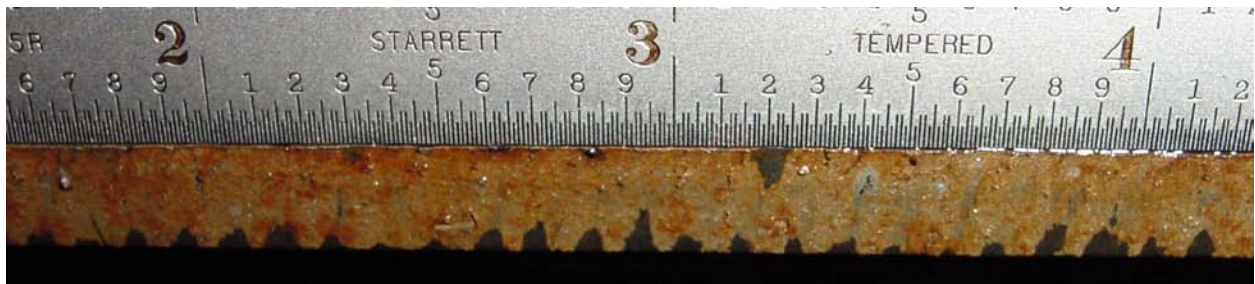
Figure 12. Periodic Cold Welds (coincident with the stitch pattern) on a Surface Broken after Chilling (LF-ERW Pipe)

The term “stitching” refers to a repetitive pattern that appears on the surfaces of a fracture along the bondline of a low-frequency-welded ERW seam. Such an appearance was seen previously in Figure 8 and Figure 12 in conjunction with cold welds, but the phenomenon can be seen on fracture surfaces where no cold weld exists as shown in Figure 38 below. The stitching phenomenon is attributed to variations in the strength of the bond resulting from variable heat input either from power fluctuations or too high a travel speed during welding. The power delivered by alternating current fluctuates because the voltage and current vary and are out of phase with one another. The phenomenon of stitching is associated only with low-frequency current because the rate of power variation is in the range where it can affect the bonding strength as the pipe moves through the welding stand. The power fluctuations of a high-frequency welder are much too fast to cause periodic variations in bonding, and the absence of power fluctuations associated with DC welding and flash welding eliminate the possibility of stitching in DC-welded or flash-welded pipe.

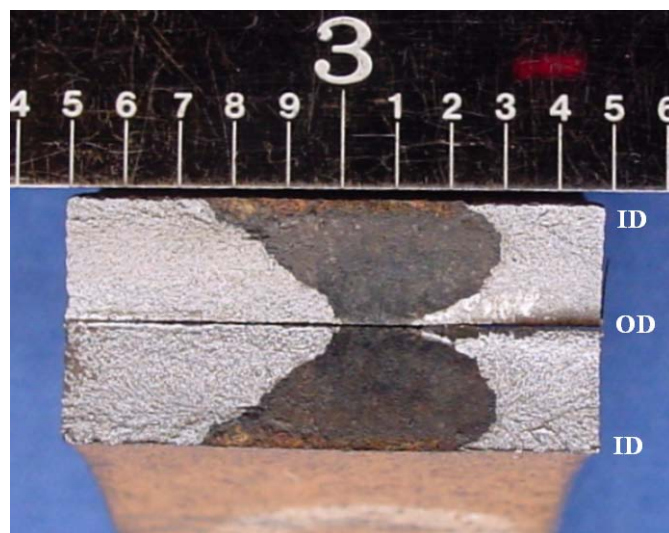
Figure 14. Appearance of a "Penetrator" on a Surface Broken after Chilling (HF-ERW Pipe)

The picture of a penetrator, shown on a fracture surface (Figure 25) illustrates that a penetrator is a through-wall cold weld much like the one shown Figure 14. Just like short, through-wall cold welds, penetrators caused leaks at low stress levels, levels sometimes well below the level of a prior hydrostatic test.

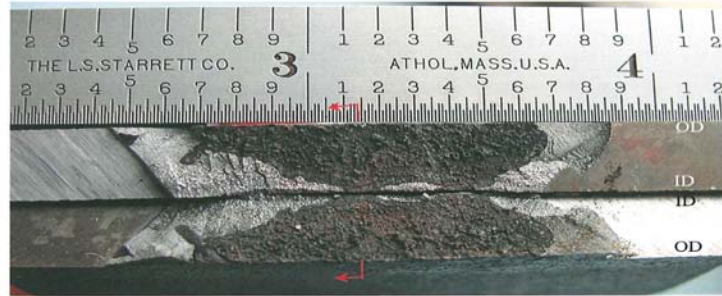
Figure 15. Surface Broken After Chilling Showing a Cold Weld Leak in DC-ERW Pipe

CW Case Number 9 involved a 20-inch-OD, 0.250-inch-wall, Grade B DC-welded pipe manufactured by Youngstown in 1969. The failure mode was a leak in-service discovered while the pipeline was being operated at a hoop stress level of 40 percent of SMYS. The anomaly had survived a pre-service hydrostatic test to 96.6 percent of SMYS. The anomaly was about 1 inch long at the OD surface and 0.5 inch long at the ID surface (see Figure 15). Note that no stitching is present because this seam was DC-welded. The anomaly is believed to have extended 100 percent through the wall initially. The stretched-open appearance of the anomaly (see Figure 16) suggests that the original pre-service hydrostatic test caused some extension of the anomaly but not enough to cause it to leak during the test. It is possible that the leak developed later as the result of a pressure reversal.

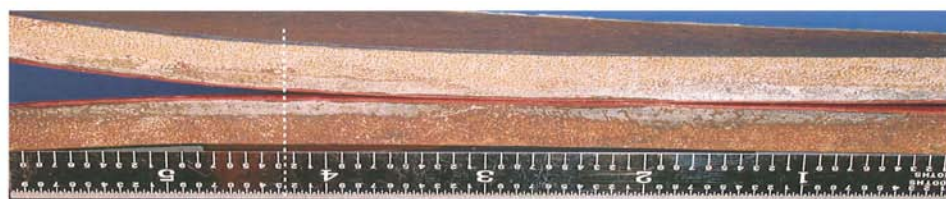
Figure 20. Fracture Surface of a Rupture at a Cold Weld in HF-ERW Pipe Showing Relatively Brittle Behavior

The other failure originated at one or both of a pair of OD-surface-connected defects both about 3 inches long and 33 percent through the wall, separated by about 0.5 inch. This combination of cold welds ruptured at a stress level of 71.2 percent of SMYS which is only about 50 percent of the level that one would predict for a rectangular-shaped flaw using the Modified Ln-Sec Equation with 240 ft lb of Charpy energy. This failure appeared to have occurred in a brittle manner (see Figure 20 and Figure 21).

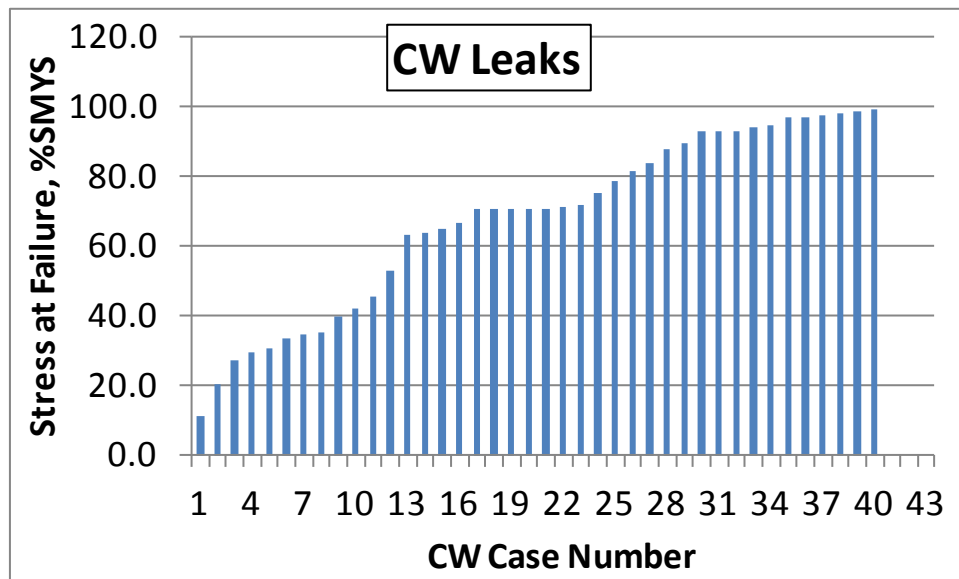
As can be seen in Figure 22 and Figure 23, the stress levels at which the cold weld failures occurred, many leaks and, in some cases, ruptures from cold welds occurred within the operating stress ranges of pipelines, even though such anomalies had survived a hydrostatic test by the manufacturer or an in-situ test after installation of the pipeline.

Figure 22. Stress at Failure for CW Leaks

Twenty of the cold weld leaks occurred at stress levels ranging from 11 percent of SMYS to 72 percent of SMYS, and 7 of the cold weld ruptures occurred at stress levels ranging from 51 percent of SMYS to 71 percent of SMYS.

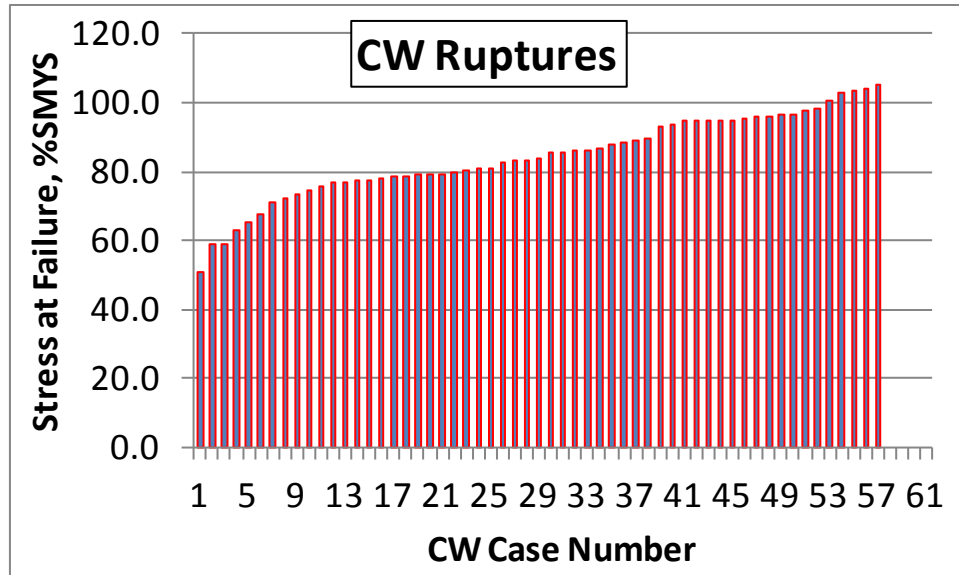
Figure 23. Stress at Failure for CW Ruptures

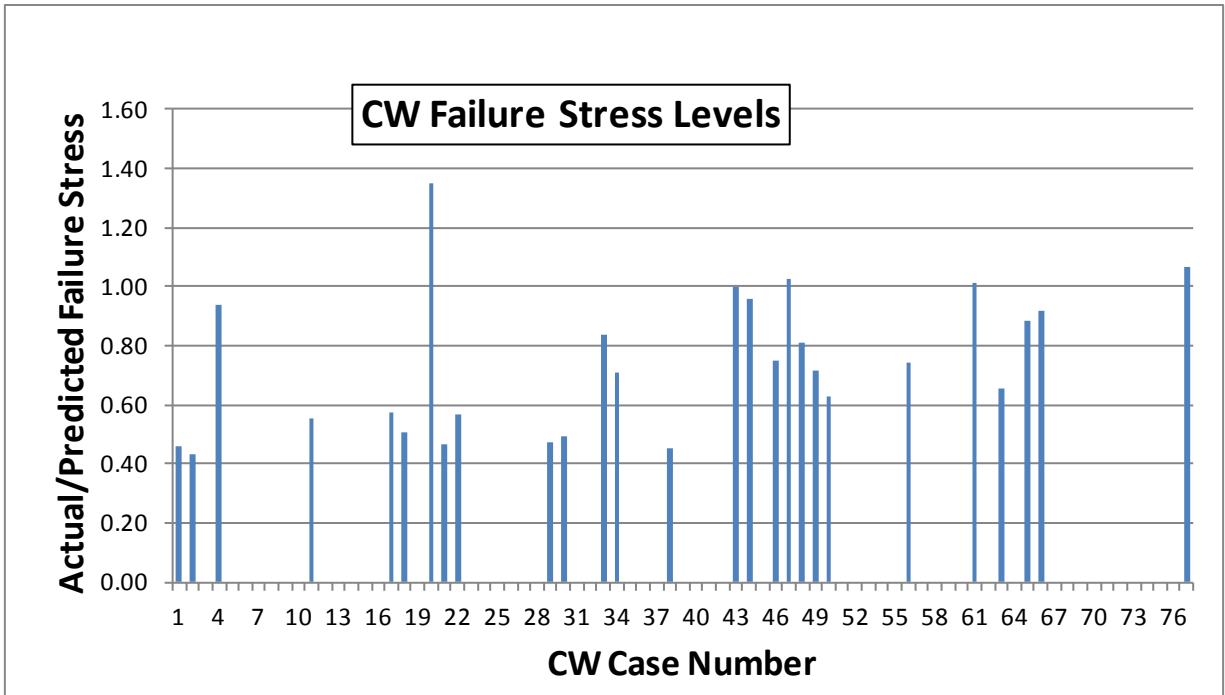
Figure 24. Actual Failure Stress Levels of Cold Welds Compared to Failure Stress Levels Predicted Using Base Metal Properties

Calculations were made only for the 27 cases where the length and depth of the cold weld could be clearly established, and no calculations were made for through-wall cold welds. The comparisons illustrated in Figure 24 show that for 22 of the 27 cases, the ratios of actual to predicted failure stress were less than 1, and for 16 of the 27 cases the ratios were less than 0.8, meaning that the actual failure stress was less, in most cases appreciably less, than the predicted failure stress. This outcome is believed to be the result of most of the cold weld failures initiating in a brittle or quasi-brittle manner. In such cases it is not surprising that a ductile crack model such as the Modified Ln-Sec model over-estimates the failure stress.

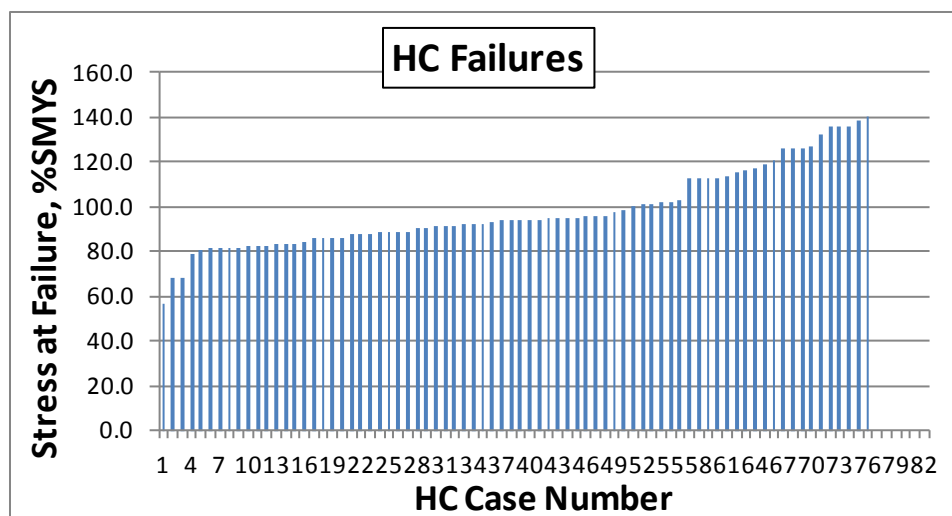
Seventy-five of the 76 hook crack failures were ruptures; only one failed as a leak. The failure stress levels of the hook cracks as a percent of SMYS are shown in Figure 33. Thirteen of these 76 hook cracks failed at stress levels either below that of the mill test or a previous field hydrostatic test. It is seen that four of the hook crack failures occurred at stress levels less than 80 percent of SMYS.

Figure 33. Stress Levels of Hook Crack Failures

As discussed above, whether the rupture with the lowest failure stress level failed in-service or in a hydrostatic test is not known. The other three ruptures that occurred at stress levels below 80 percent of SMYS occurred during hydrostatic tests. The failure investigations of two of the four cases with failure stress levels below 80 percent of SMYS (Case Numbers 1 and 2) indicate that some sort of crack growth (ductile tearing in prior pressurizations or possibly fatigue) is believed to have occurred leading to reduced failure pressures. It is believed that some amount of crack growth must have occurred in Case Number 3 as well, but no information was available to that effect. In Case Number 4, the mill test pressure is believed to have been only to the 60-percent-of-SMYS level, so the fact that the failure occurred at a pressure level of 78.8 percent of SMYS is not surprising.

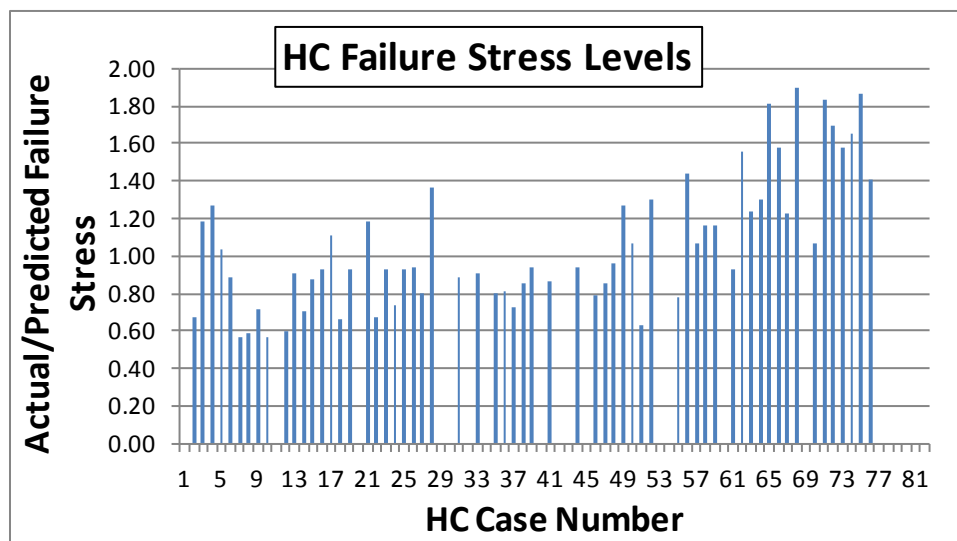
The ability of a ductile fracture model (the Modified Ln-Sec Elliptical CEQ model) to predict the failure stress levels of hook cracks using base metal flow stress and Charpy energy is illustrated in Figure 34. Values of the ratio “actual/predicted” failure stress ranged from below 0.6 to more than 1.8. The average value is 1.06, but the standard deviation is 0.35 and the R-squared coefficient is only 0.07 suggesting a poor correlation.

Figure 34. Ratio of Actual Failure Stress to Predicted Failure Stress

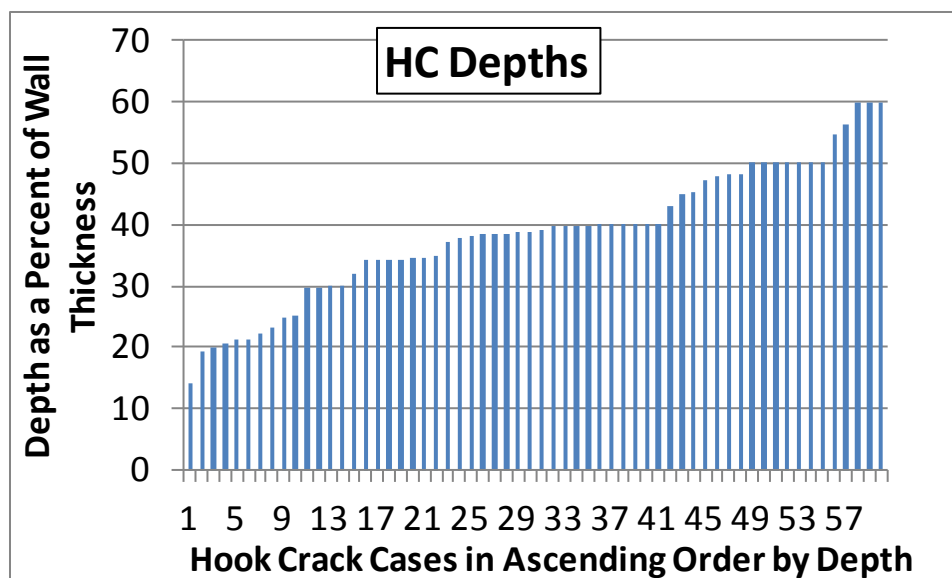
The depths of the hook cracks in the database varied from 14 percent to 60 percent of the wall thickness as shown in Figure 35. In view of the way hook cracks are formed, it is surprising to see depths greater than 50 percent of the wall thickness. Pictures of the deepest cracks were not available. However, one explanation could be that some of the depths given included apparent crack extension. Without seeing the pictures, one can only speculate as to the reasons for some hook cracks being deeper than 50 percent of the wall thickness. In some rare cases, none of which appeared in the database, hook cracks have been known to reverse curvature upon some type of erratic upsetting. In those cases the effective depth of a hook crack could exceed 50 percent of the wall thickness.

Figure 35. Depths of Hook Cracks

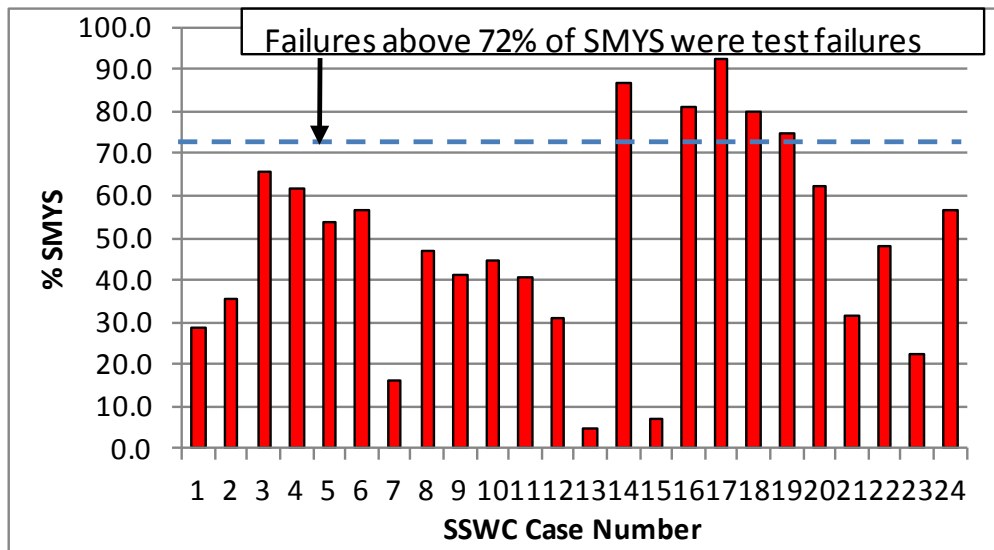
The significance of the data can be understood in terms of Figure 45 through Figure 47. First, consider Figure 45. Selective seam corrosion failures in the database occurred at failure stresses ranging from 7.3 to 92.3 percent of SMYS, and the one that occurred a 7.3 percent of SMYS occurred as a rupture in a gas pipeline in service. What that suggests is that selective seam weld corrosion, if not arrested and/or remediated, will eventually lead to a leak or a rupture regardless of the hoop stress level in the pipe. Because of the likelihood of low fracture resistance of the low-frequency-welded, DC-welded, and flash-welded seams, such failures are prone to occur as ruptures.

Figure 45. Failure Stress Levels of Selective Seam Weld Corrosion Failures

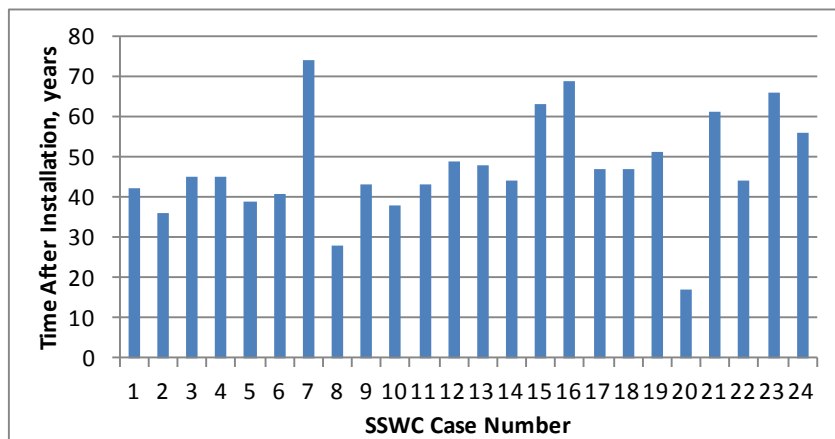
The times to failure after the pipelines were installed for selective seam weld corrosion anomalies in the database are shown in Figure 46. They range from 17 to 74 years. The mean value is 47 years. The standard deviation is 13 years. The median value is 45 years.

Figure 46. Times to Failure after Pipeline Installation for Selective Seam Corrosion Anomalies

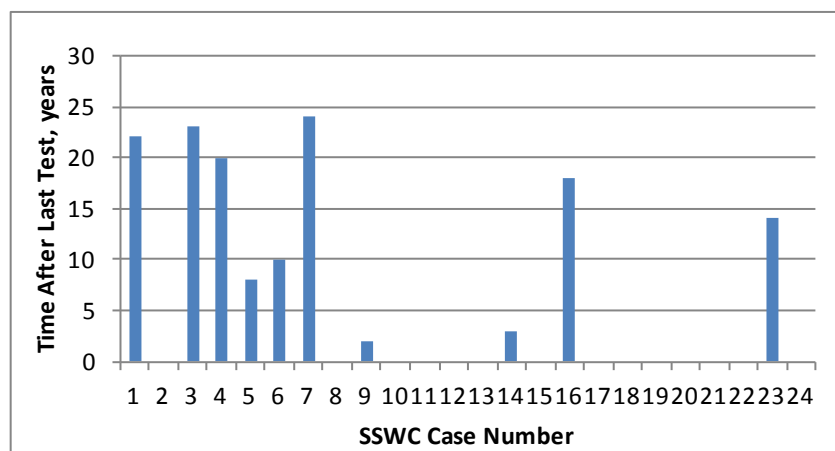
Another significant time factor in selective seam weld corrosion failures relates to the time to failure after the most recent hydrostatic test. For 10 of the cases information on a prior hydrostatic test after the original pre-service test was available. The times are shown in Figure 47. These times varied over a wide range (2 years to 24 years). The most likely explanation for this is that the corrosion rates varied widely.

Figure 47. Times to Failure after the Most Recent Hydrostatic Test for Selective Seam Corrosion Anomalies

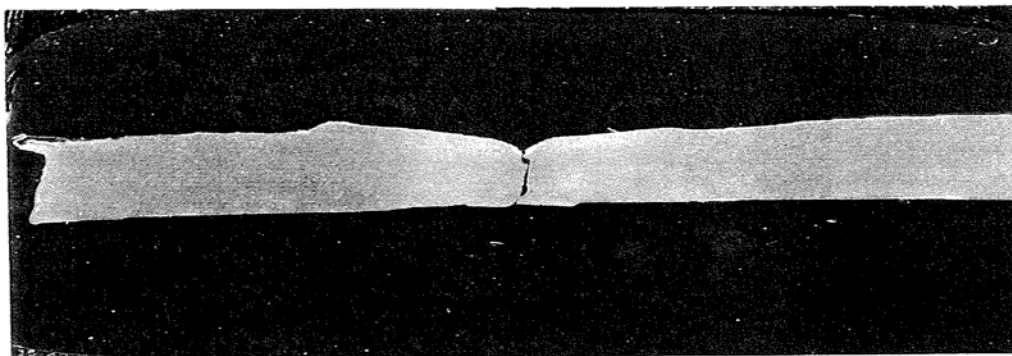
In this case the 10.75-inch-OD, 0.279-inch-wall X46 low-frequency-welded pipe ruptured in-service at a stress level of 28.5 percent of SMYS 22 years after a test to a stress level of 62.9 percent of SMYS. The test-pressure-to-failure-pressure-ratio was 2.21. A metallographic section across the rupture is shown in Figure 49 and at a higher magnification in Figure 50.

Figure 49. Selective Seam Weld Corrosion Case Number 1

The v-shaped groove is not centered on the bondline. However, the failure involves the bondline through a shearing path from the tip of the corrosion anomaly into the bondline.

The initiating defect was 5 inches long, and it had penetrated to a maximum depth of 59 percent of the wall thickness. Using the Modified Ln-Sec EllipticalCEQ model, with the base metal flow stress of 67,000 and the full-size-equivalent Charpy upper shelf energy of 21 ft lb, one calculates a hoop stress at failure of 75.2 percent of SMYS. The actual failure stress, 28.5 percent of SMYS, is only 40 percent of the predicted value. The bondline properties determined where the failure would occur, and those properties clearly corresponded to less fracture resistance than that of the base metal.

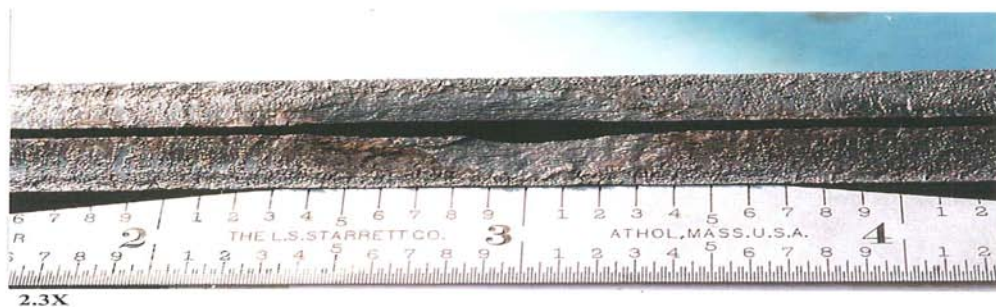
The pipe in SSWC Case Number 9 was an 8.625-inch-OD, 0.250-inch-wall, X42 material with a low-frequency-welded ERW seam. It ruptured in-service at a stress level of 41.1 percent of SMYS two years after a test to a stress level of 67.2 percent of SMYS. The test-pressure-to-failure-pressure-ratio was 1.64. The anomaly that initiated the rupture as it appeared on the fracture surfaces is shown in Figure 52 and a metallographic section through it is shown in Figure 53. A metallographic section through a nearby intact anomaly is shown in Figure 54.

Figure 52. SSWC Case Number 9 Anomaly as It Appeared on the Fracture Surfaces

The selective seam weld corrosion in this case appears to have an exceptionally high grooving ratio. An intact anomaly shown in Figure 54 exhibits a similarly deep, narrow groove, but also has cracking at its tip. The cause of the cracking is unknown, but the fact that was associated with a corrosive environment suggests that SCC may have been occurring as well as corrosion-caused metal loss. In any case the anomaly that initiated the failure was about 1 inch long and had penetrated 70 percent of the wall thickness.

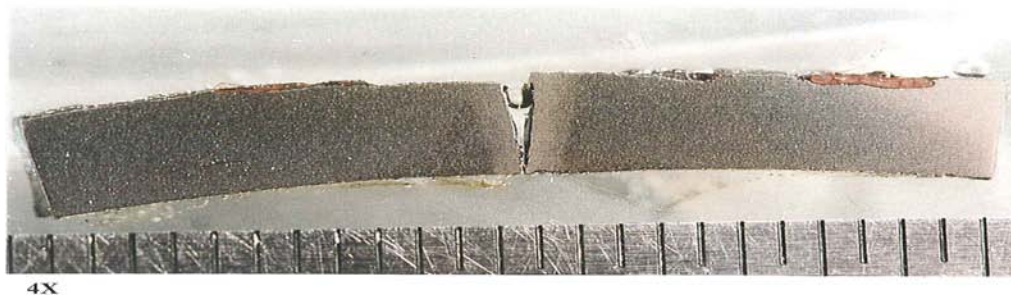
Figure 53. Cross Section of SSWC Case Number 9 Anomaly

Using the Modified Ln-Sec EllipticalCEQ model, with the base metal flow stress of 67,000 and an assumed full-size-equivalent Charpy upper shelf energy of 25 ft lb, one calculates a hoop stress at failure of 115.6 percent of SMYS. The actual failure stress, 41.1 percent of SMYS, is only 36 percent of the predicted value.

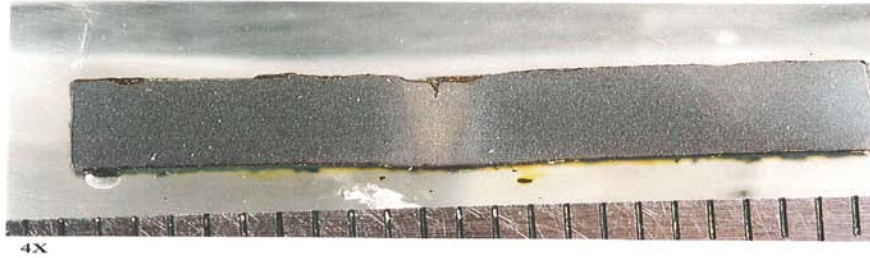
Figure 54. Cross Section of a Nearby Intact SSWC Anomaly

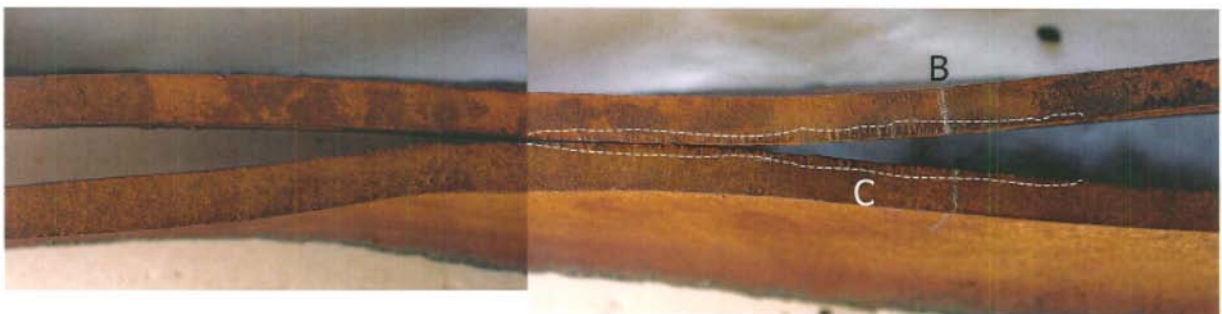
In this case the pipe was an 18-inch-OD, 0.250-inch-wall, X42 material with a DC-welded ERW seam. The pipe ruptured in service at a stress level of 31.2 percent of SMYS 49 years after a test to a stress level of 64.3 percent of SMYS. The test-pressure-to-prior-test-pressure-ratio was 2.06. The nature of the anomaly is shown in Figure 55 and Figure 56.

Figure 55. SSWC Case Number 12 Anomaly as it Appeared on the Fracture Surfaces

The anomaly is relatively shallow and sharp, but it was apparently created by selective seam corrosion. It is speculated that the narrowness and deepness may indicate that a cold weld was present initially and that the corrosion enlarged it and removed the evidence of its existence. It was 3.3 inches in length and had penetrated 30 percent of the wall thickness.

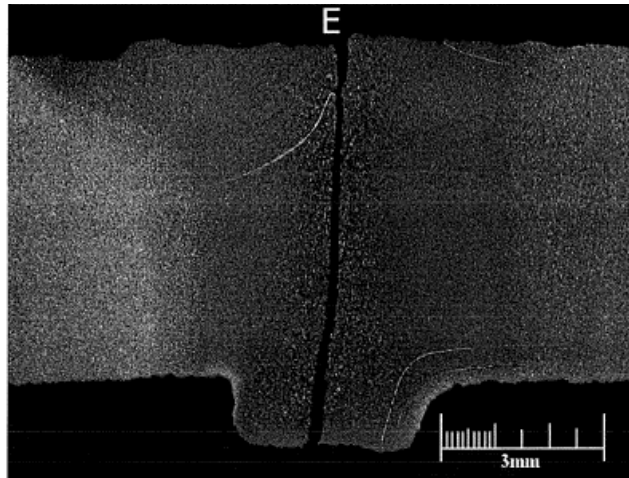
Figure 56. Cross Section of SSWC Case Number 12 Anomaly

Using the Modified Ln-Sec EllipticalCEQ model, with the base metal flow stress of 67,000 and an assumed full-size-equivalent Charpy upper shelf energy of 25 ft lb, one calculates a hoop stress at failure of 132.6 percent of SMYS. The actual failure stress, 31.2 percent of SMYS, is only 24 percent of the predicted value. The pipe in which this anomaly existed was of the vintage of Youngstown pipe that often possessed excessively hard heat affected zones. Although hardness was not measured in this instance, it is possible the weld zone possessed high hardness, and therefore, it may have been especially susceptible to failure in the presence of a sharp notch.

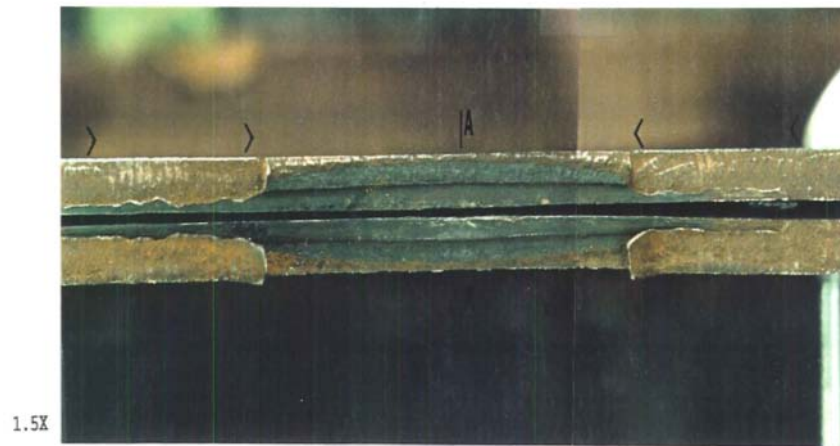
The initiating anomaly was a 7.5-inch-long, 45-percent-through-wall, semi-elliptically-shaped hook crack. The predicted failure stress level of this defect by itself based on the Modified Ln-Sec Elliptical C-equivalent model with a flow stress of 77,000 psi and the base metal full-size Charpy upper shelf energy of 26 ft lb is 88.4 percent of SMYS. That is consistent with its having survived the mill hydrostatic test to 85 percent of SMYS. The maximum depth of this defect plus the subsequent fatigue crack growth is 90 percent of the wall thickness. Using the Modified Ln-Sec Elliptical C-equivalent model with a flow stress of 77,000 psi and the base metal full-size Charpy upper shelf energy of 26 ft lb, one would predict the failure stress of the anomaly to be 19.1 percent of SMYS. Hence, the actual failure stress was larger than the predicted failure stress by a factor of 3.51.

The hook crack and fatigue crack growth as they appeared on the fracture surfaces are shown in Figure 65. A metallographic section across the hook crack and fatigue crack growth is shown in Figure 66. Note that the tip of the hoop crack and the fatigue crack growth lie in the heat-affected zone of the seam and not on the bondline line.

Figure 65. Fracture Surfaces of Fatigue Case Number 2 Anomaly

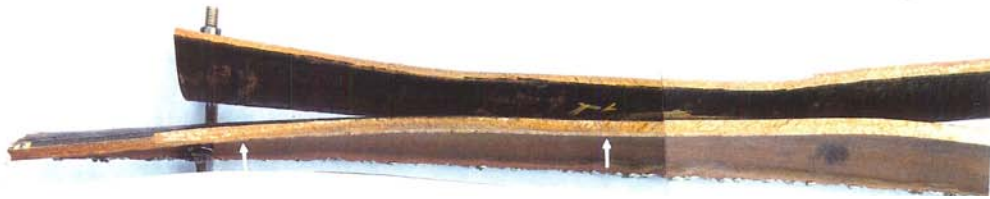
Fatigue Case Number 5 involved a rupture in a 10.75-inch-OD, 0.250-inch-wall, X46 pipe with a flash-welded seam. The rupture of this defect occurred during a hydrostatic test at a hoop stress level of 79.8 percent of SMYS. No information on a prior hydrostatic test was available, but the anomaly failed 46 years after installation. Therefore, the initiating anomaly had at least survived the mill hydrostatic test to 85 percent of SMYS.

There was evidence of fatigue crack growth on the fracture surfaces of the pipe as shown in Figure 71. The apparent crack is visible as the dark elliptically-shaped area between the two arrows in the photograph. Note that the thicknesses of the two pieces in the photograph are obviously not the same. That is because the initiating anomaly was a mismatched plate edge at the ID surface. The mismatch is clearly shown on the metallographic section in Figure 72. Note that the fatigue crack growth lies in the base metal of the pipe.

Figure 71. Fracture Surfaces of Fatigue Case Number 5 Anomaly

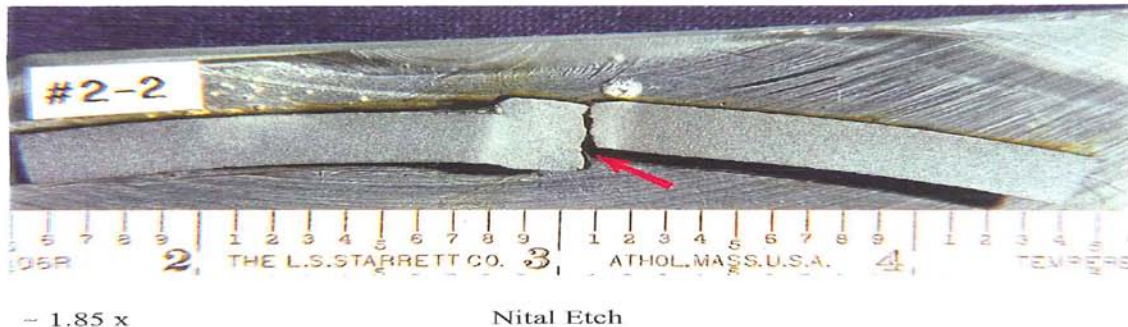
Figure 72. Cross Section of Fatigue Case Number 5 Anomaly

The anomaly including the initiating mismatch and the dark elliptically-shaped area has an overall length of 7 inches and penetrates 70 percent of the wall thickness at the deepest point. Using the Modified Ln-Sec Elliptical C-equivalent model with a flow stress of 72,000 psi and the base metal full-size Charpy upper shelf energy of 29 ft lb, one would predict the failure of the final anomaly to be 58.1 percent of SMYS. Hence, the actual failure stress was larger than the predicted failure stress by a factor of 1.37.

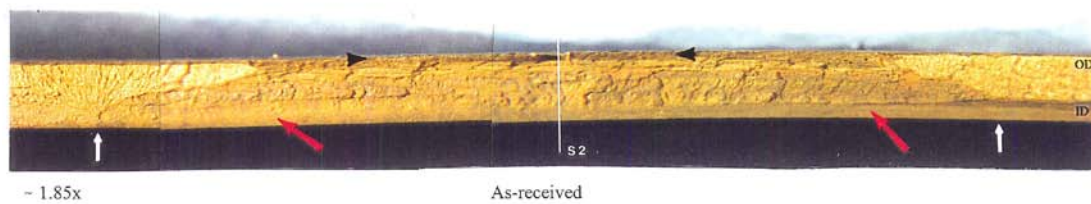
There was evidence of fatigue crack growth on the fracture surfaces of the pipe as shown in Figure 73. The apparent crack is visible as the dark, semi-elliptically-shaped area between the two arrows in the photograph. The initiating anomaly was an ID-surface-connected hook crack that penetrated only about 10 to 15 percent of the wall thickness along its length. The hook crack is visible as the dark, smooth area in Figure 73. The hook crack and the fatigue crack

Figure 73. Fracture Surfaces of Fatigue Case Number 6 Anomaly

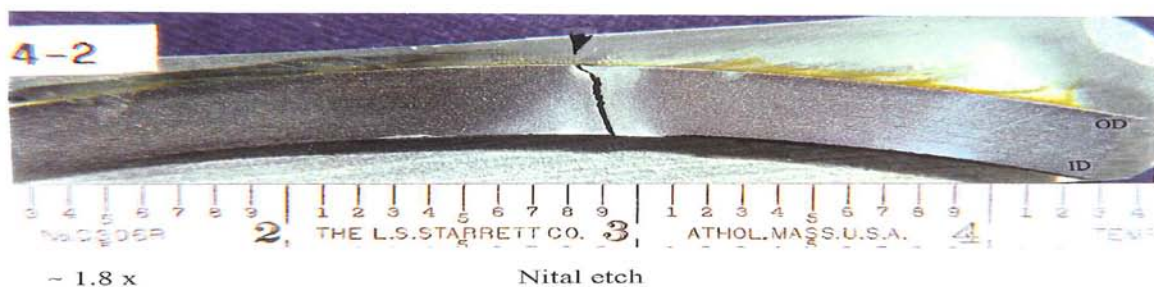
growth are shown on the metallographic section in Figure 74. The fatigue crack growth lies near to but not on the bondline of the ERW seam.

Figure 74. Cross Section of Fatigue Case Number 6 Anomaly

The anomaly including the initiating hook crack and the dark elliptically-shaped area has an overall length of 4.2 inches and penetrates 75 percent of the wall thickness at the deepest point. Using the Modified Ln-Sec Elliptical C-equivalent model with a flow stress of 64,500 psi and the base metal full-size Charpy upper shelf energy of 27 ft lb, one would predict the failure stress of the anomaly to be 61.3 percent of SMYS. Hence, the actual failure stress was larger than the predicted failure stress by a factor of 1.33.

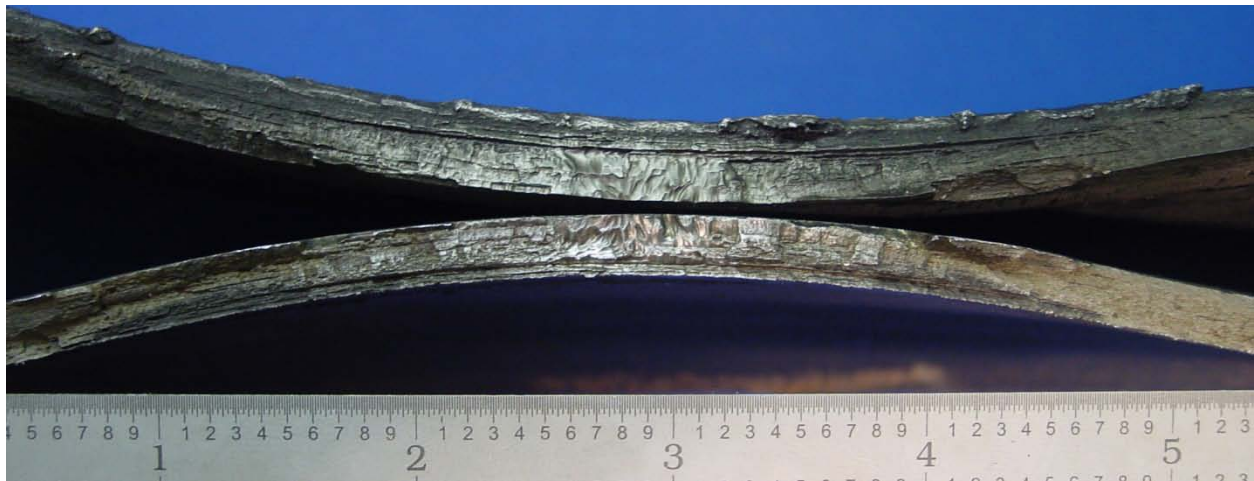
Fatigue Case Number 7 involved a rupture in a 12.75-inch-OD, 0.250-inch-wall, X45 pipe with a flash-welded seam. The rupture of this defect occurred in service at a hoop stress level of 61.7 percent of SMYS, but the operator believes that it was probably leaking up to 36 hours before the rupture occurred. This failure occurred within 3 years of a hydrostatic test to a stress level of 90.8 percent of SMYS, 1.5 times the stress level at failure. The fracture surfaces of this rupture, shown in Figure 75, reveal two halves of apparently different thickness (as is typical with mismatched edges), clear evidence that crack growth has taken place, and an unusual appearance in the central portion that was caused by erosion during the period when a high-pressure leak

Figure 75. Fracture Surfaces of Fatigue Case Number 7 Anomaly

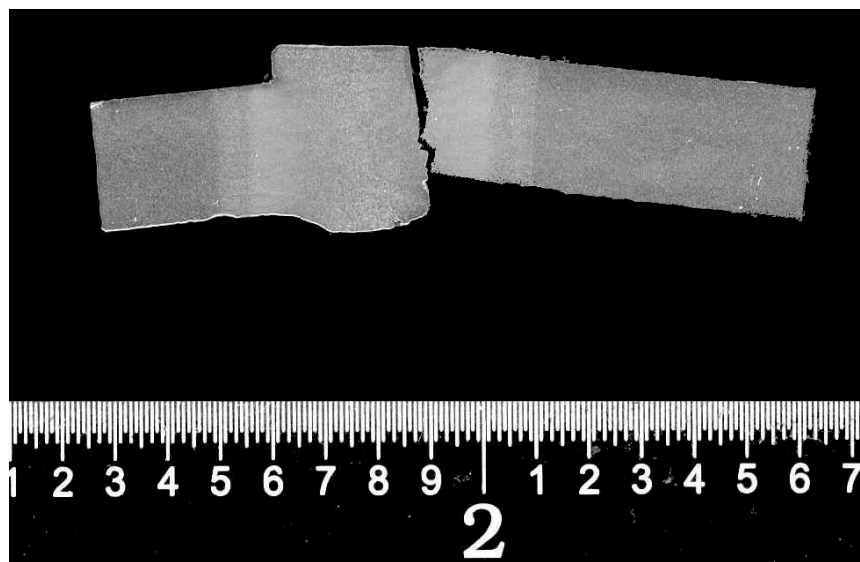
existed. The mismatch is clearly shown on the metallographic section in Figure 76. Note that the fatigue crack growth lies in the base metal of the pipe.

Figure 76. Cross Section of Fatigue Case Number 7 Anomaly

The length of the fatigue growth area is about 4 inches, but the erosion has obliterated the area where one might have seen the maximum depth of the crack. One benchmark on the depth is provided by the fact that this defect had survived a hydrostatic test to 90.8 percent of SMYS three years prior to its failing in service. Using the Modified Ln-Sec Elliptical C-equivalent model with a flow stress of 70,500 psi and the base metal full-size Charpy upper shelf energy of 36 ft lb, one would predict that for the defect to have survived the previous test, it could have been no deeper than about 63 percent of the wall thickness. Using the same type of calculation one would predict that the defect should have failed at a stress level of 61.7 percent of SMYS if it were to have grown to a depth of 79 percent of the wall thickness. It can be shown that the

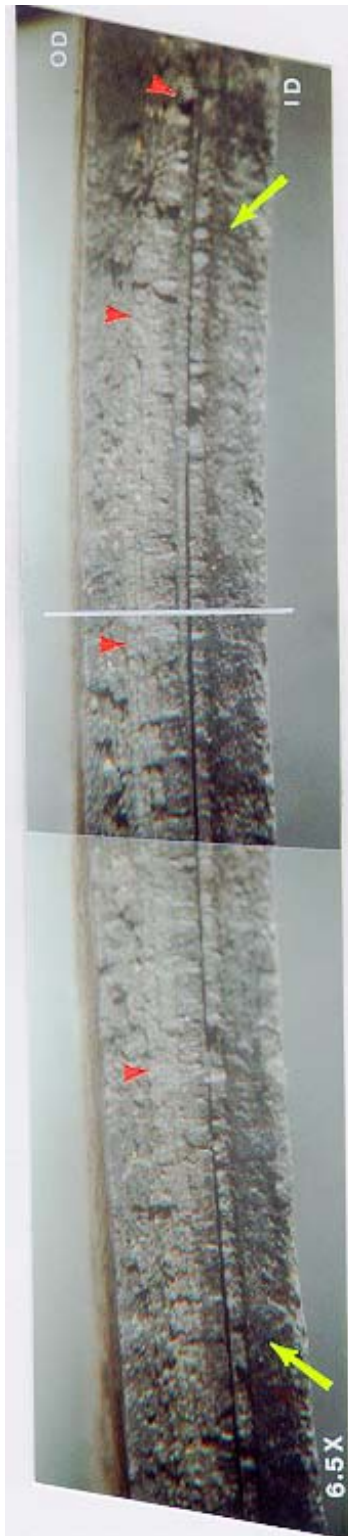
Fatigue Case Number 8 involved a rupture in an 8.625-inch-OD, 0.188-inch-wall, X52 pipe with a low-frequency welded ERW seam. The seam failed in service at a hoop stress level of 69.7 percent of SMYS. As seen in Figure 77 and Figure 78 the cause was fatigue crack growth from a mismatched plate edge. Note that in Figure 77 the fracture edges are obviously different as expected with mismatched edges. The crack growth occurred in the heat-affected base metal adjacent to the bondline.

Figure 77. Fracture Surfaces of Fatigue Case Number 8 Anomaly

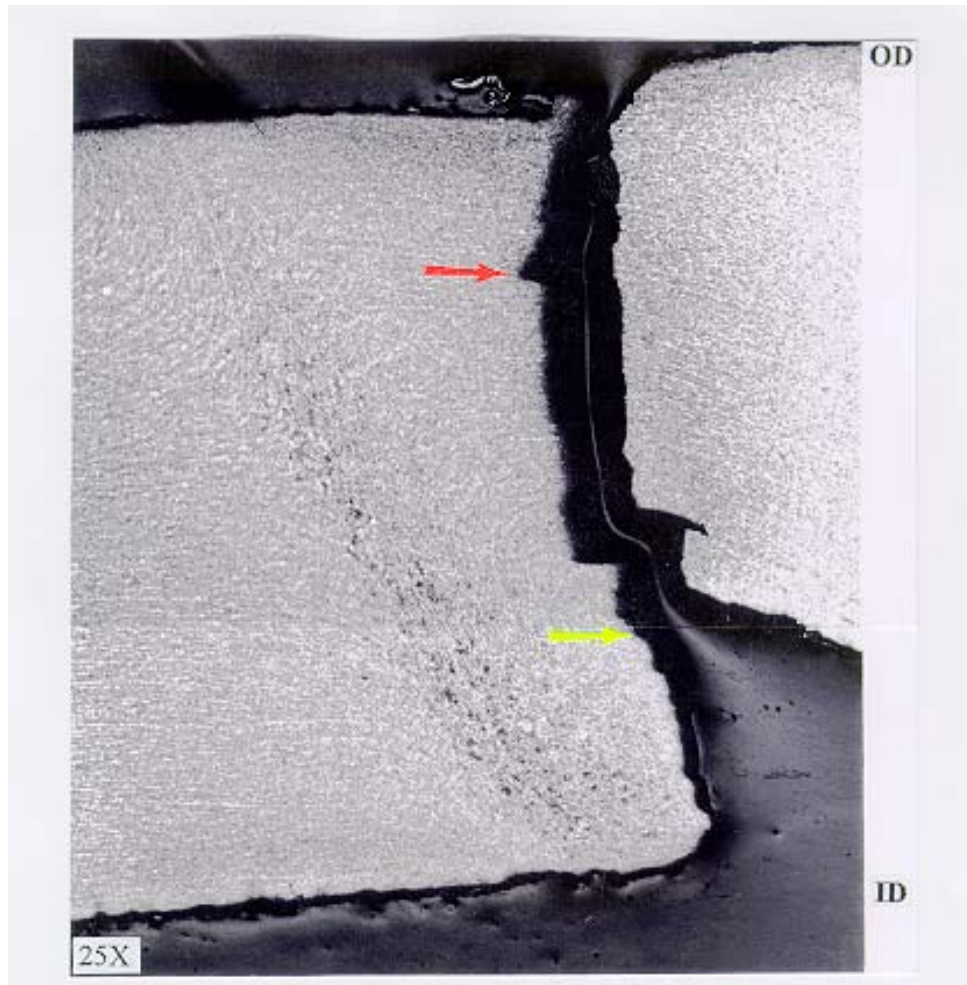
Figure 78. Cross Section of Fatigue Case Number 8 Anomaly

The area of fatigue crack growth has an overall length of 6.75 inches. Together with the mismatch, the anomaly penetrates 69 percent of the wall thickness at the deepest point. Using the Modified Ln-Sec Elliptical C-equivalent model with a flow stress of 60,000 psi and the base metal full-size Charpy upper shelf energy of 18 ft lb, one would predict the failure stress of the anomaly to be 41 percent of SMYS. The actual failure stress was larger than the predicted failure stress by a factor of 1.70.

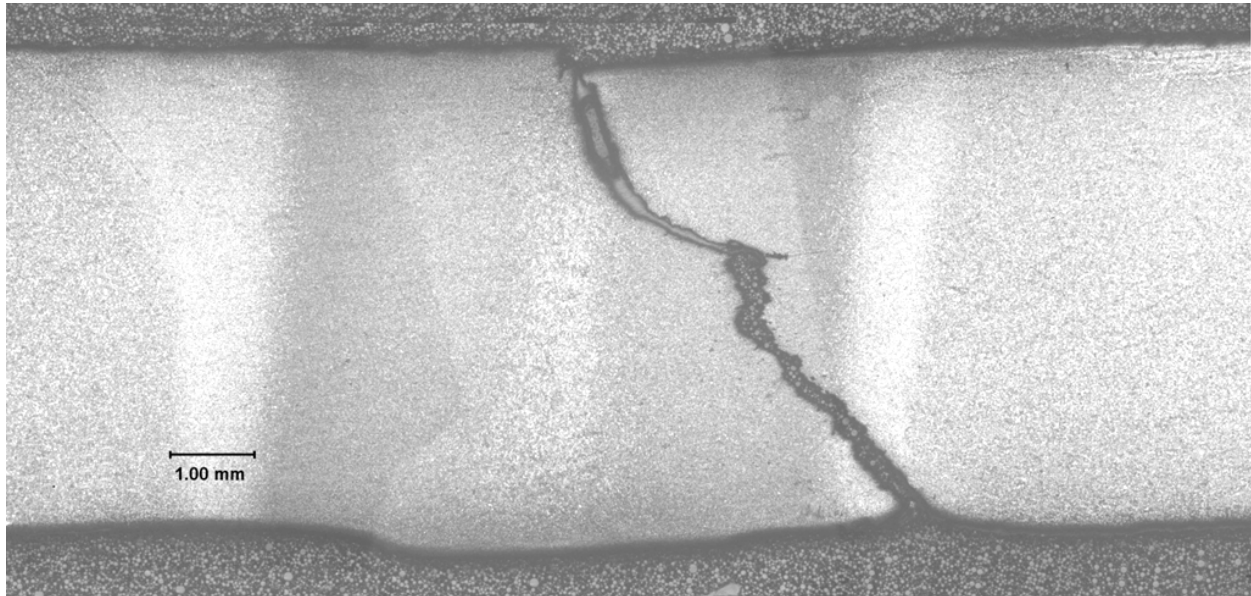
Fatigue Case Number 9 involved a rupture in a 10.75-inch-OD, 0.219-inch-wall, X52 pipe with a low-frequency-welded seam. The rupture of this defect occurred during a hydrostatic test at a hoop stress level of 81.8 percent of SMYS. The analysis of this failure was made difficult because the sample was allowed to sit outdoors for months after it had been removed from the pipeline. The investigators picked two possible origins, but in retrospect, the origin is most likely the hook crack shown in Figure 79. This hook crack was 5 inches long and penetrated 40

percent of the wall thickness. Note that the fracture extends approximately in the radial direction from the bottom of the hook crack to a depth of about 57 percent of the wall thickness. Ductile tearing during the test makes up the remainder of the fracture. Although the fracture surface characteristics had been obliterated by corrosion, it is reasonable to believe based on other similar hook crack/fatigue crack failures that fatigue was the cause of this failure.

Figure 79. Cross Section of Fatigue Case Number 9 Anomaly

Using the Modified Ln-Sec Elliptical C-equivalent model with a flow stress of 76,500 psi and the base metal full-size Charpy upper shelf energy of 57 ft lb, one would predict the failure stress of the anomaly to be 84.7 percent of SMYS. Hence, the actual failure stress was 97 percent of this predicted failure stress.

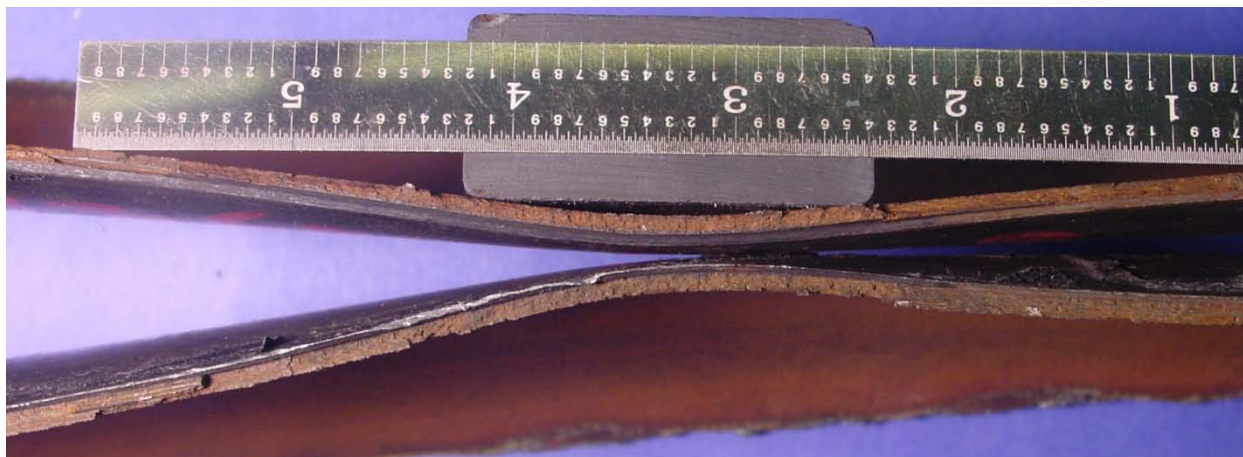
Fatigue Case Number 10 involved a rupture in a 6.625-inch-OD, 0.125-inch-wall, X60 pipe with a high-frequency-welded seam. The rupture of this defect occurred during a hydrostatic test at a hoop stress level of 93.7 percent of SMYS. A 6-inch-long, 25-percent-through hook crack was found to be the initiator of fatigue crack growth. The hook crack is visible in Figure 80 and the possible fatigue crack extension of it is shown in Figure 81. The total defect depth (hook crack plus fatigue) was 56 percent of the wall thickness. The anomaly failed as a 3.1 percent pressure reversal from a previous high pressure test cycle just prior to the failure.

Figure 80. Fracture Surfaces of Fatigue Case Number 10 Anomaly

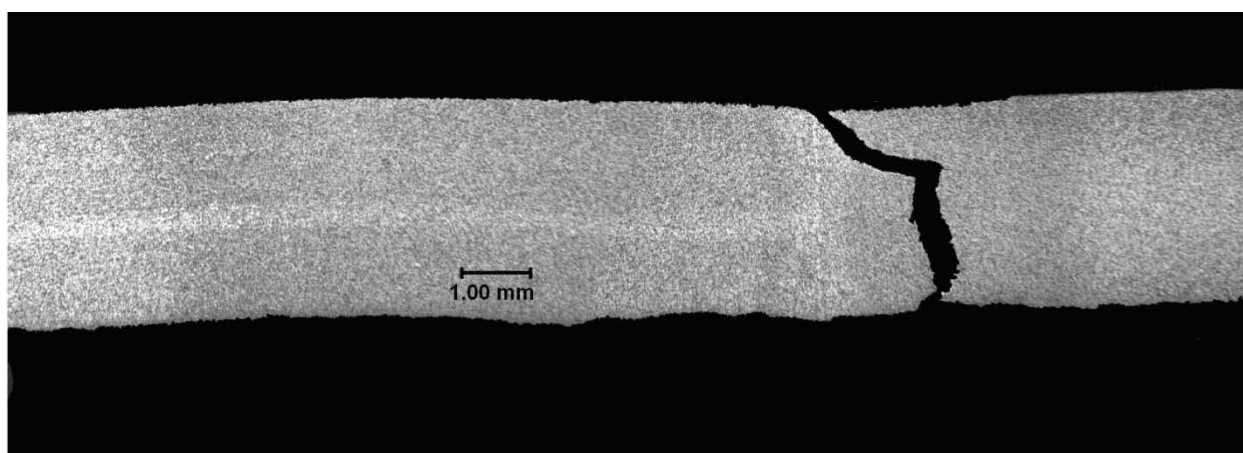
Figure 81. Cross Section of Fatigue Case Number 10 Anomaly

Using the Modified Ln-Sec Elliptical C-equivalent model with the flaw length of 6 inches and depth of 56 percent of the wall, a flow stress of 78,500 psi, and the base metal full-size Charpy upper shelf energy of 30 ft lb, one would predict the failure stress of the anomaly to be 63.1 percent of SMYS. The actual failure stress was 97 percent of this predicted failure stress. Hence, the actual failure stress was larger than the predicted failure stress by a factor of 1.48.
