Final Report

ERW and Flash Weld Seam Failures

J.F. Kiefner and K.M. Kolovich

September 24, 2012

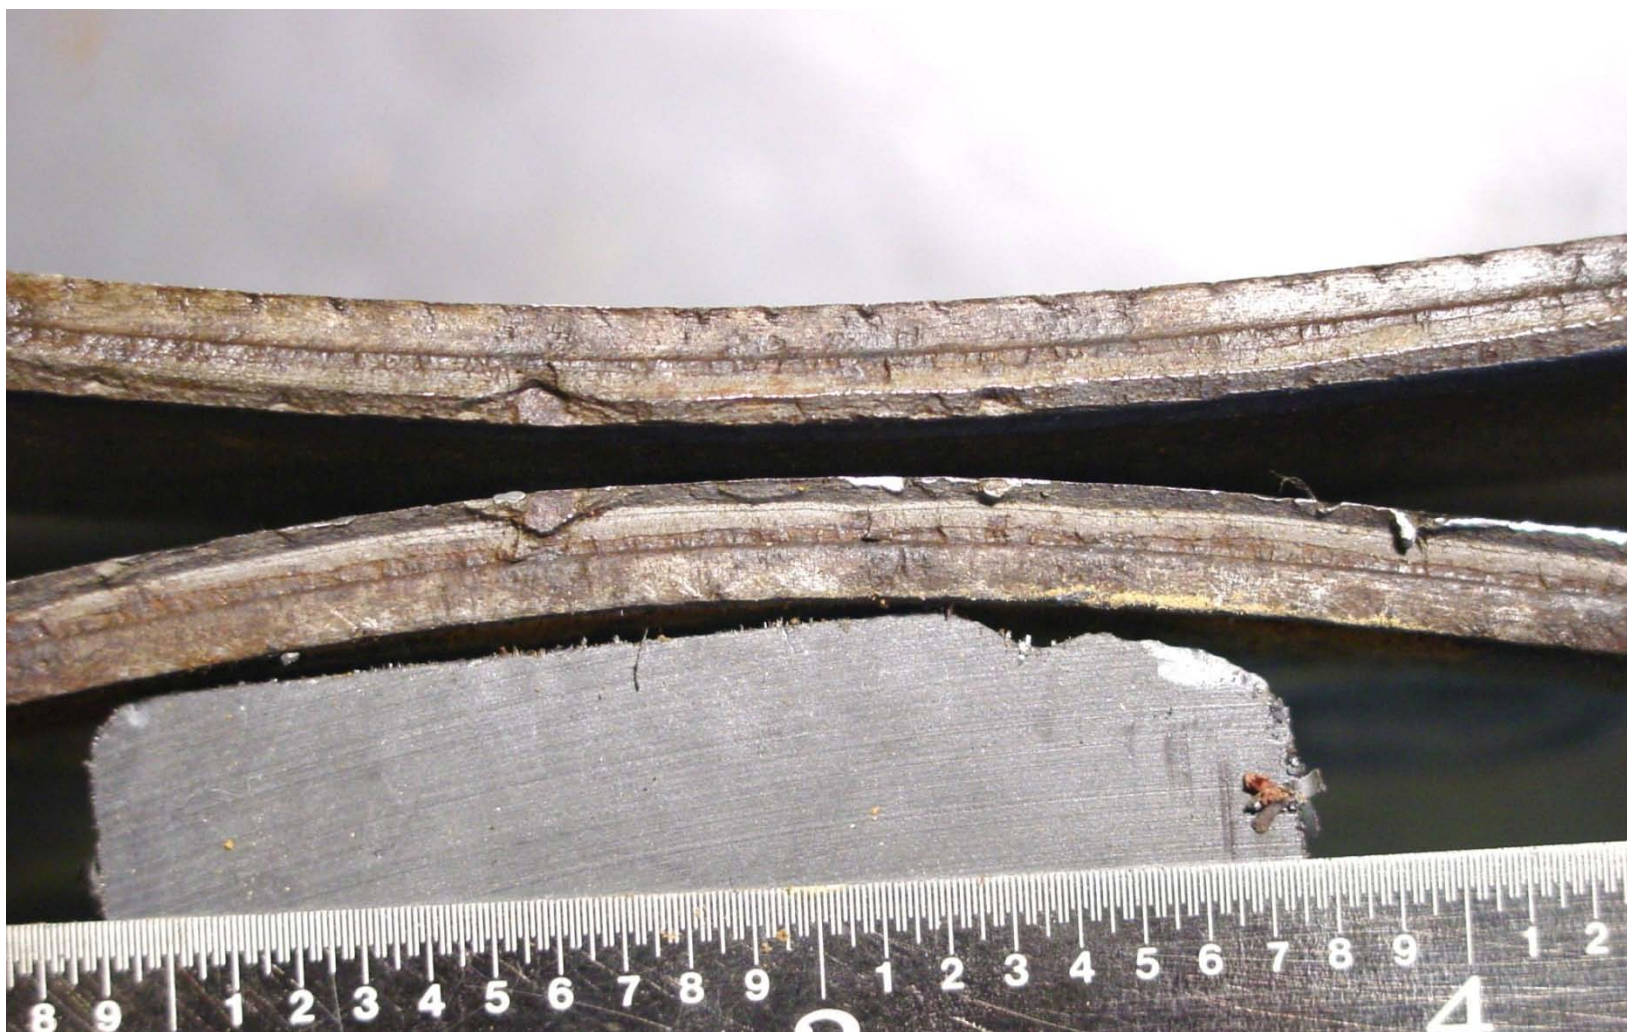
Fatigue Case Number 11 involved an in-service rupture in a 12.75-inch-OD, 0.203-inch-wall X52 pipe with a low-frequency-welded seam. The failure occurred at a hoop stress level of 59.8 percent of SMYS. The initial defect was a 9.5-inch-long, rectangular-shaped, ID-surface-connected hook crack that penetrated 45 percent of the wall thickness (see Figure 82 and Figure 83). Fatigue cracking occurred in two stages. Stage 1, which had probably occurred prior to a hydrostatic test to 82.1 percent of SMYS 9 years prior to the failure, took the depth to 60 percent of the wall thickness. The second stage took the total crack depth to 80 percent of the wall

thickness. It appeared that the fatigue cracking did not propagate along the entire tip of the hook crack. Visual inspection of the photographs of the fracture surfaces suggest the Stage 1 cracking did not extend more than about 6 inches and that Stage 2 cracking did not extend more than about 4 inches. This anomaly apparently was not identified as a serious anomaly during a circumferential MFL tool run a year before the failure, and it was also not identified as a serious anomaly during an ultrasonic crack-detection tool run a few months before the failure.

Figure 82. Fracture Surfaces of Fatigue Case Number 11 Anomaly

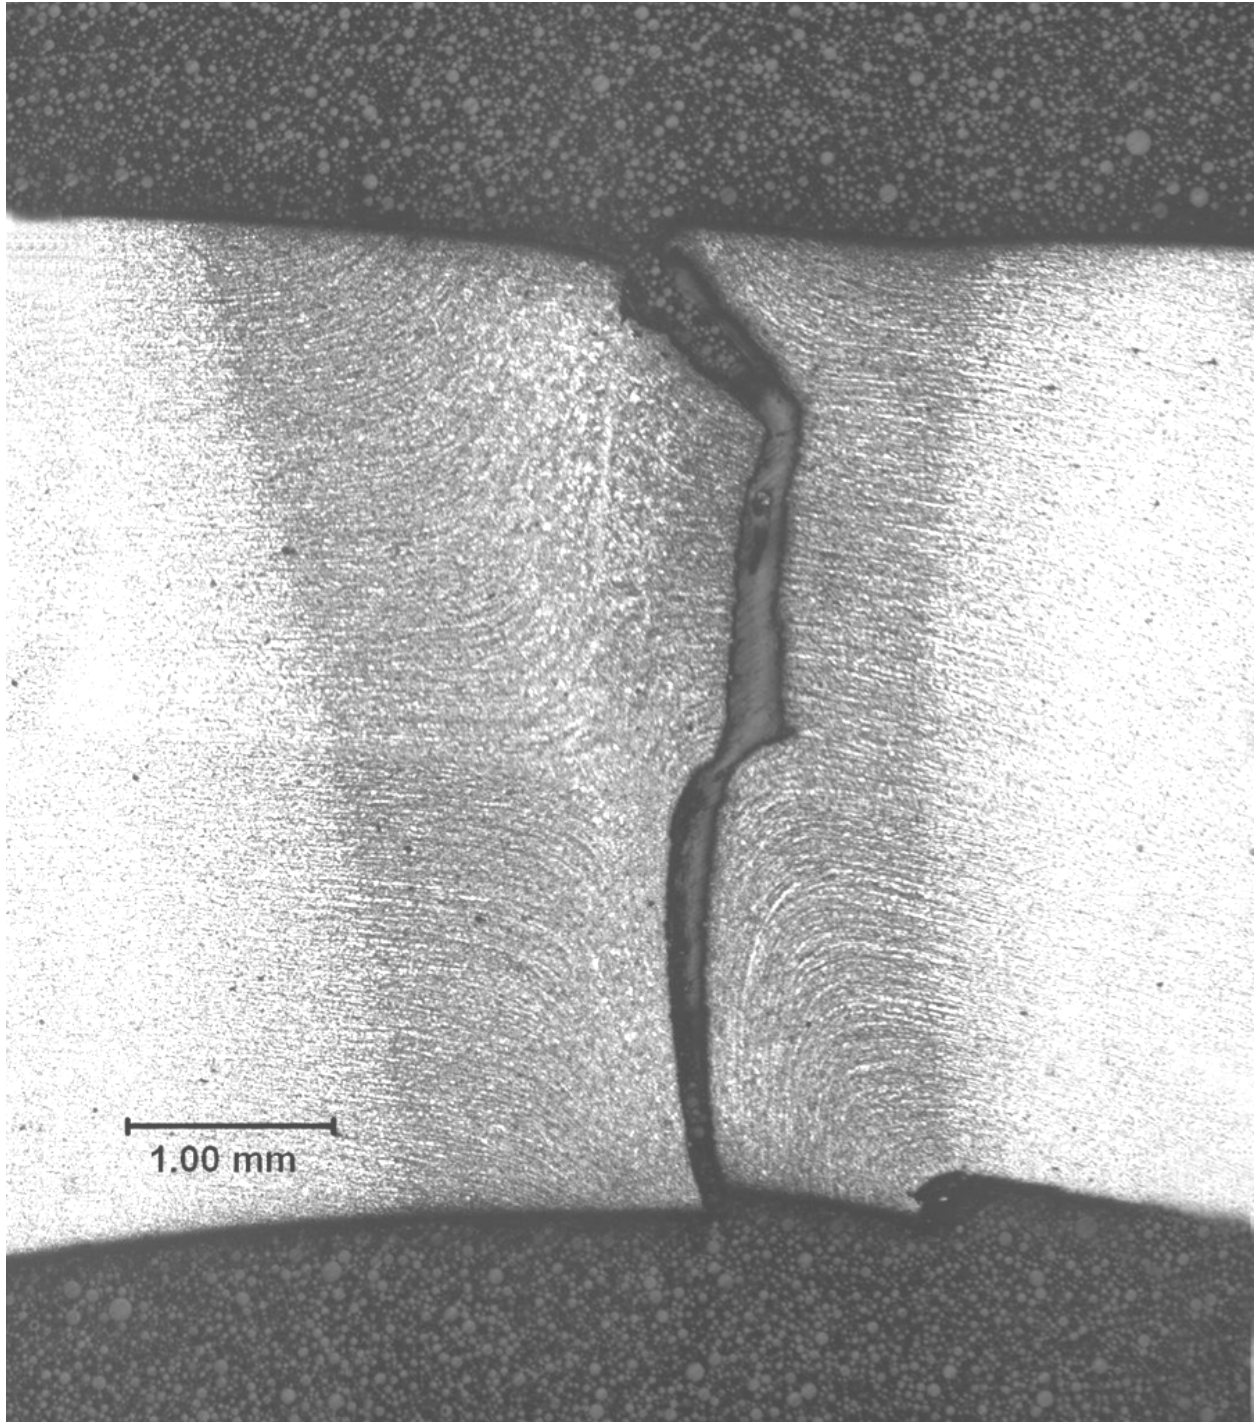
Figure 83. Cross Section of Fatigue Case Number 11 Anomaly

Using the Modified RECTANG model with the hook crack length of 9.5 inches and depth of 49 percent of the wall, a flow stress of 63,000 psi, and the base metal full-size Charpy upper shelf energy of 49 ft lb, one would predict the failure stress of the hook crack by itself to be 66 percent of SMYS. This suggests that the hook crack itself would not have survived the prior hydrostatic test to 82.1 percent of SMYS or the mill test to 85 percent of SMYS. A benchmark for the actual

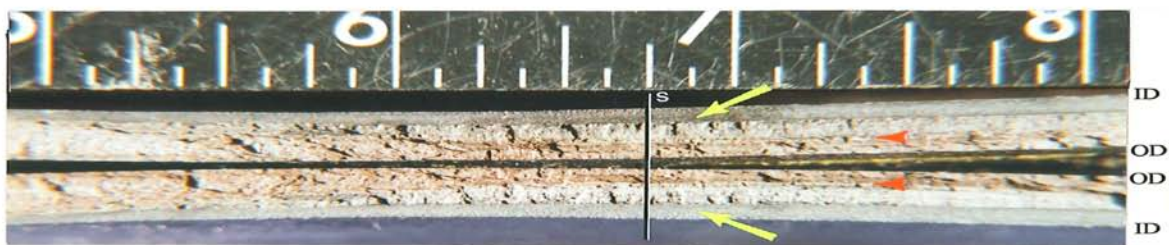
Fatigue Case Number 12 involved a hydrostatic test rupture in a 16-inch-OD, 0.250-inch-wall, X52, DC-welded ERW seam. The rupture occurred at a hoop stress level of 81.6 percent of SMYS. The initiator was a 4.5-inch-long ID-surface-connected hook crack that penetrated about 1/3 of the way through the wall thickness. The fatigue crack plus the hook crack penetrated 70 percent through the wall (see Figure 84).

Figure 84. Fracture Surfaces of Fatigue Case Number 12 Anomaly

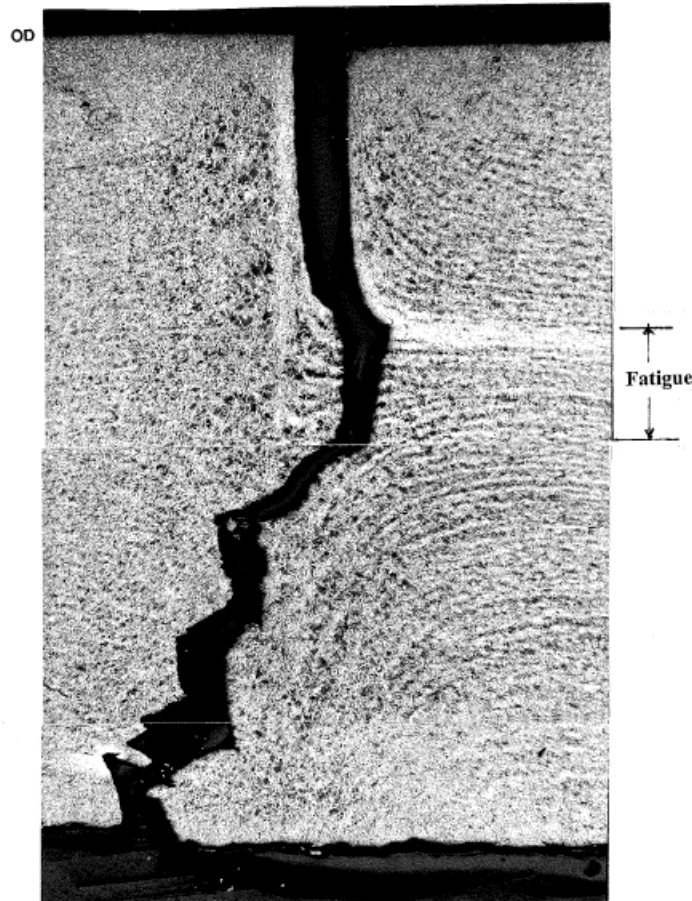
Figure 85 shows that a fatigue crack had propagated from the tip of the relatively deep OD-surface-connected hook crack to a total depth of 50 percent of the wall thickness. On the basis of the Modified Ln-Sec EllipticalCEQ model with a flow stress of 66,000 psi and a full-size-equivalent Charpy upper shelf energy of 28 ft lb, one predicts that the combined defect would fail at a stress level of 116 percent of SMYS. The actual failure stress was 97 percent of SMYS, so the actual failure stress was only 83 percent of the predicted failure stress.

(d) Enlargement of section at fracture showing zone of fatigue

Figure 85. Cross Section of Fatigue Case Number 15 Anomaly

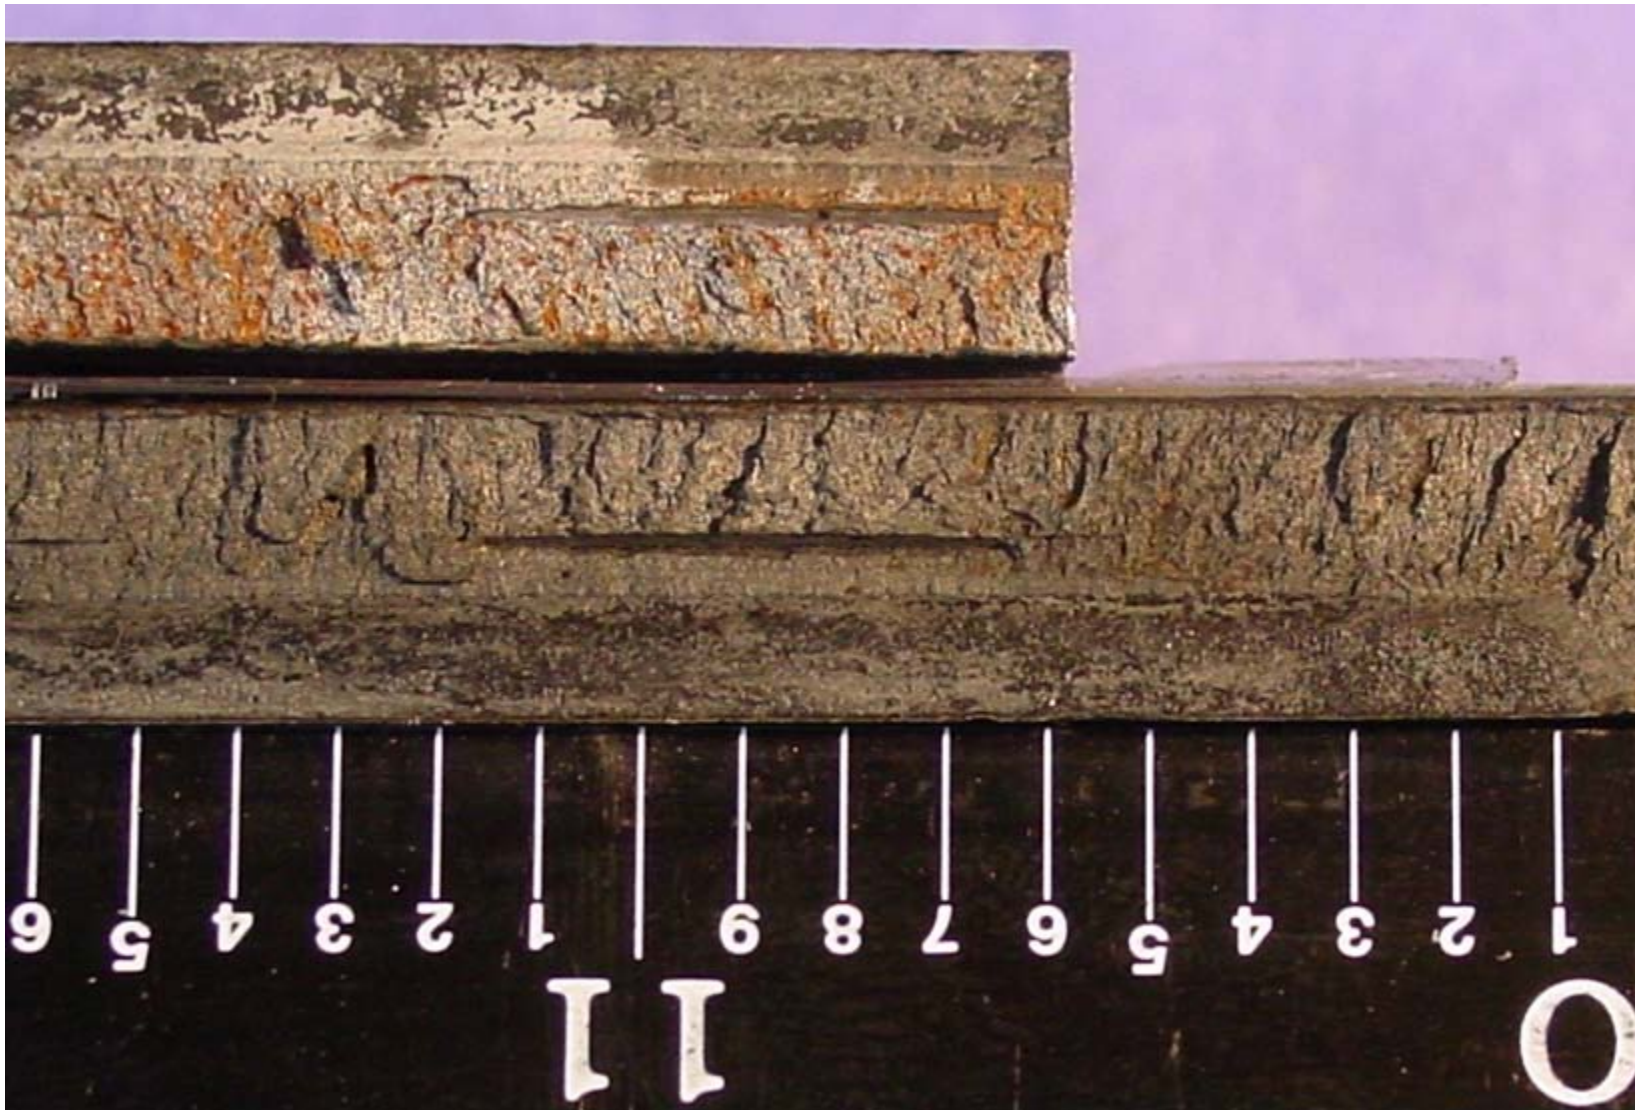
As can be seen in Figure 87, there was evidence of fatigue crack growth at the tip of the hook crack on the fracture surfaces of the ruptured pipe (see arrows). It appears that there is a crack arrest mark even deeper than the apparent fatigue region. Perhaps the two regions represent fatigue crack growth before and after the test conducted 13 years prior to the failure. A metallographic section across the failure origin is shown in Figure 88. It shows the initiating hook crack, the apparent fatigue crack growth to a total depth of about 55 percent of the wall thickness, and some apparent ductile tearing that joins the crack to an embedded hook crack. On the basis of the Modified Ln-Sec EllipticalCEQ model with a flow stress of 59,600 psi and a full-size-equivalent Charpy upper shelf energy of 34 ft lb, one predicts that the hook crack plus fatigue crack would fail at 96.4 percent of SMYS. The actual failure stress was only 81 percent of this predicted value. The effect of the embedded hook crack was not taken into account in the calculation.

Figure 87. Fracture Surfaces of Fatigue Case Number 19 Anomaly

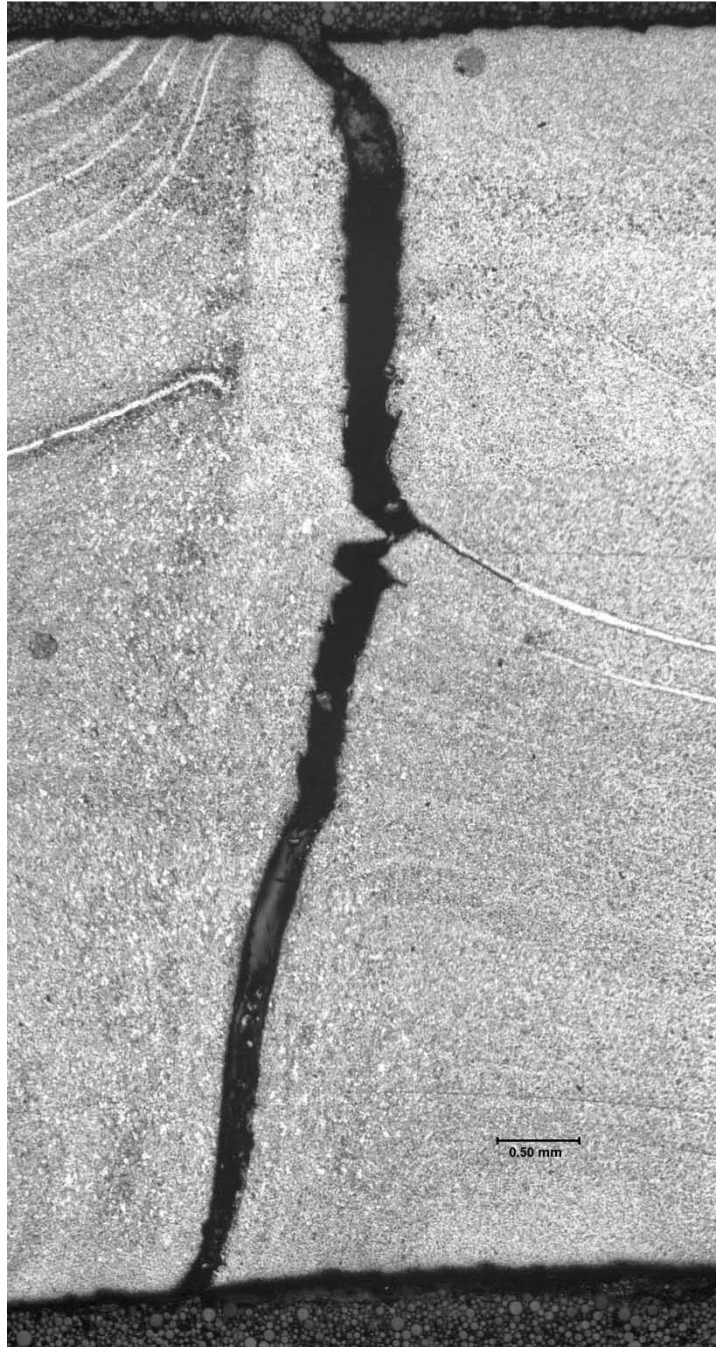
The initiating defect was a 3.6-inch-long, 37-percent-through-wall ID-surface-connected hook crack. By itself this anomaly would be predicted to fail at a stress level of 116 percent of SMYS based on a calculation using the Modified Ln-Sec EllipticalCEQ model with a flow stress of 59,600 psi and a full-size-equivalent Charpy upper shelf energy of 34 ft lb.

Figure 88. Cross Section of Fatigue Case Number 19 Anomaly

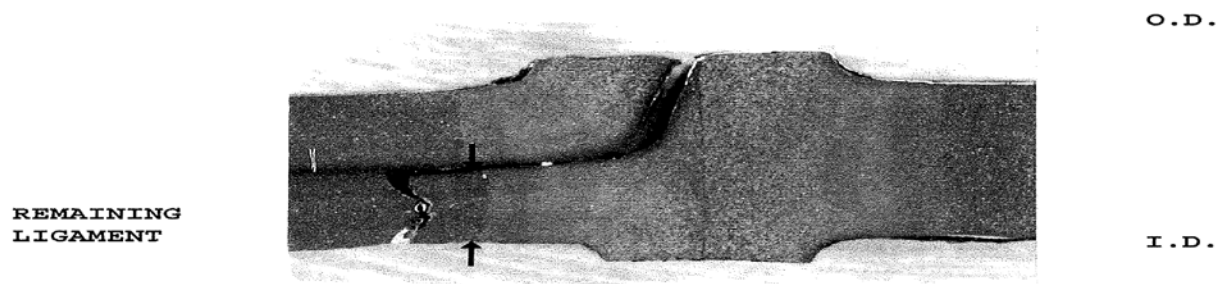
Fatigue Case Number 23 involved a hydrostatic test rupture in a 26-inch-OD, 0.281-inch-wall, X52 pipe with a flash-welded seam. The rupture occurred at a hoop stress level of 87.8 percent of SMYS. The initiating defect was an OD-connected hook crack several inches long that penetrated 50 percent of the wall thickness as shown in Figure 89. Other figures (Figure 90 and Figure 91 provided in the contributed report suggest that while the hook crack was indeed the primary cause of failure, the crack growth mechanism was probably stress corrosion cracking rather than fatigue.

Figure 89. Cross Section of Fatigue Case Number 23 Anomaly

Examples of three causes of ERW seam failures resulting from cracking other than fatigue crack growth appear in the database. These other causes include a hook crack where sulfide stress cracking took place, hook cracks where SCC had taken place, and a hook crack where a failure from hydrogen induced cracking occurred. In fact, another case of failure from a hook crack where SCC had taken place was identified previously under Fatigue Case Number 21. The report of the contributor identified the cracking as fatigue, but pictures of the cracks shown in Figure 89 through Figure 91 strongly suggest that SCC, not fatigue, was the cause of the crack growth in-service.

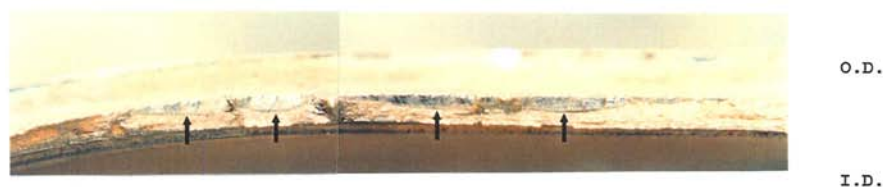
Figure 90. One Fracture Surface of the Anomaly that Raises Doubts about Fatigue Being the Crack Growth Mechanism

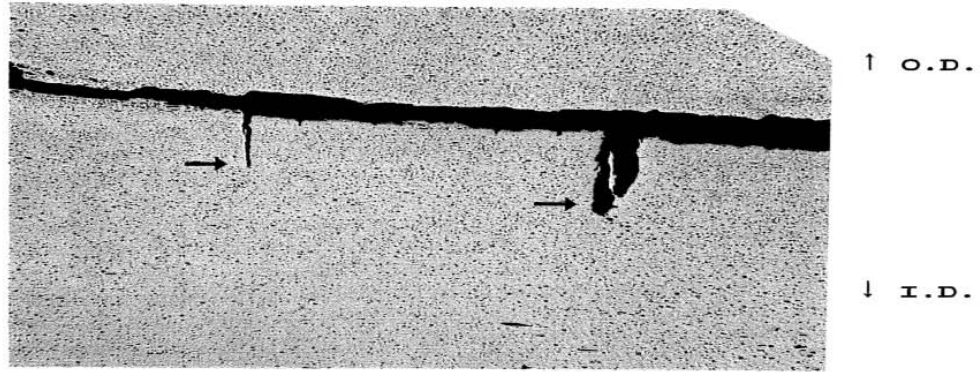
Figure 91. A Metallographic Section that Raises Doubts about Fatigue Being the Crack Growth Mechanism

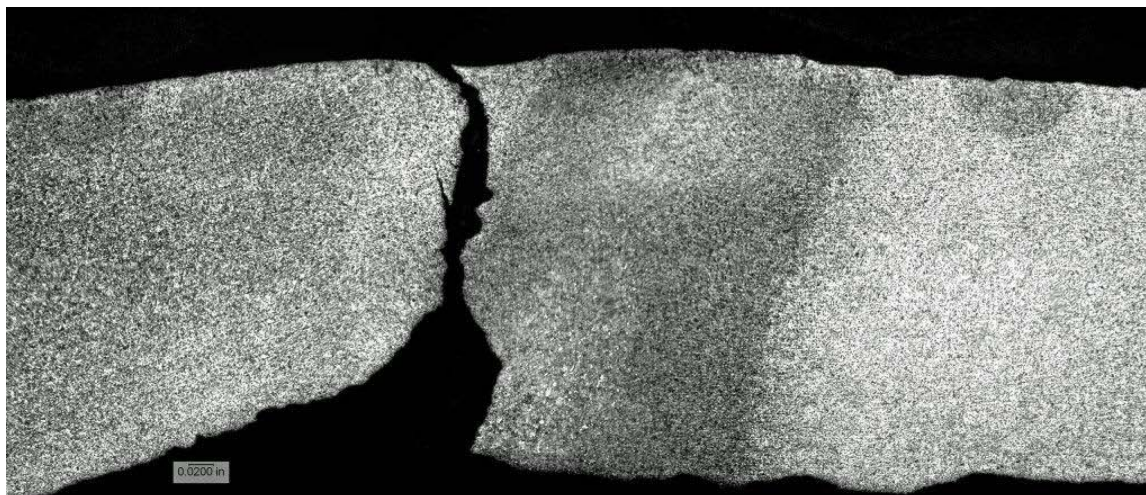
Fatigue Case Number 27 involved an in-service rupture in an 18-inch-OD, 0.219-inch-wall, X52 pipe with a DC-welded seam. The rupture of this defect occurred at a hoop stress level of 60.9 percent of SMYS. The defect had survived a prior hydrostatic test to 90.1 percent of SMYS 21 years before it failed in service. The initiator of the fatigue crack was a 27-inch-long damaged edge that left 46 percent of the wall thickness missing. The nature of the missing metal is shown in Figure 93. An 8.5-inch-long fatigue crack had propagated to a total depth (missing metal plus crack) of 86 percent of the wall thickness. This anomaly apparently was not identified as a serious anomaly during an ultrasonic crack-detection tool run a few months before the failure.

Figure 93. Cross Section of Fatigue Case Number 27 Anomaly

Using the Modified RECTANG model with the missing metal length of 27 inches and depth of 46 percent of the wall, a flow stress of 70,000 psi, and the base metal full-size Charpy upper shelf energy of 44 ft lb, one would predict the failure stress of the missing metal to be 71 percent of SMYS. This suggests that the initial mill anomaly would not have survived the mill test to 85 percent of SMYS. A benchmark for the actual properties in the zone where the missing metal existed (heat-affected material near the seam) is that if the flow stress is assumed to be 90,000 psi, the Modified Ln-Sec RECTANG model would predict that the hook crack would have survived the mill hydrostatic test.

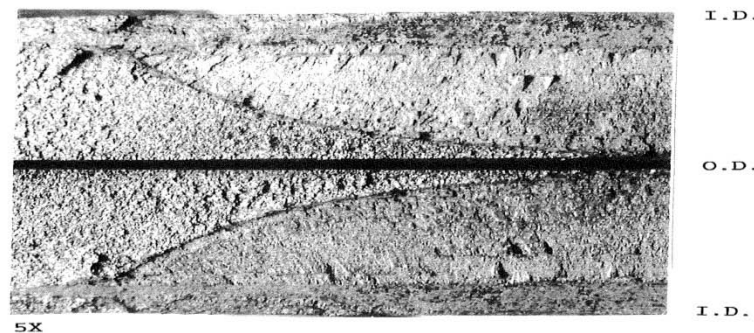
Fatigue Case Number 36 involved a leak during a hydrostatic test of a 26-inch-OD, 0.281-inch-wall, X52 pipe with a flashed-welded seam. The leak was detected at a hoop stress level of 100.0 percent of SMYS. The leak developed as the result of fatigue crack growth from a 2-inch-long, ID-surface-connected hook crack that penetrated about 27 percent of the 0.355-inch-thick raised portion of the flash-welded seam. The leak was broken open to reveal classic macro characteristics of fatigue crack propagation (ratchet marks and beach marks). These features are shown in Figure 94 and Figure 95. The propagation path through the raised flash is shown in Figure 96.

Figure 95. Close-up of Fracture Surface Showing Ratchet Marks and Beach Marks

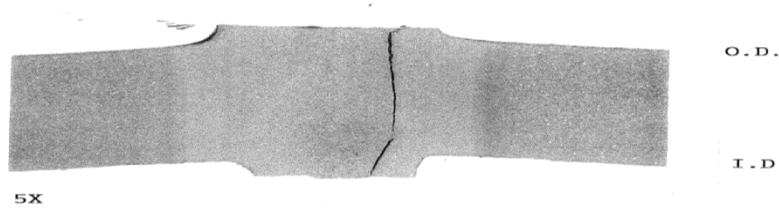
Figure 96. Cross Section of Fatigue Case Number 36 Anomaly

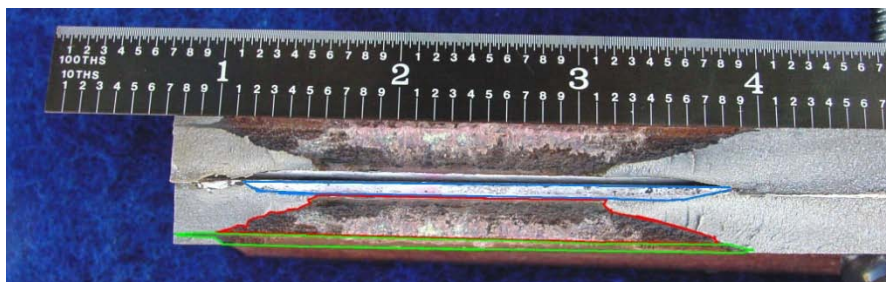
This leak appears to have been caused by sulfide-stress crack growth that started from a hook crack. A picture of the hook crack and the sulfide-stress crack as they appeared when the sample was chilled and broken is shown in Figure 97. A metallographic section across the leak is shown in Figure 98.

Figure 97. Fracture Surfaces of the Sulfide Stress Cracking that Took Place at an ID-Surface-Connected Hook Crack

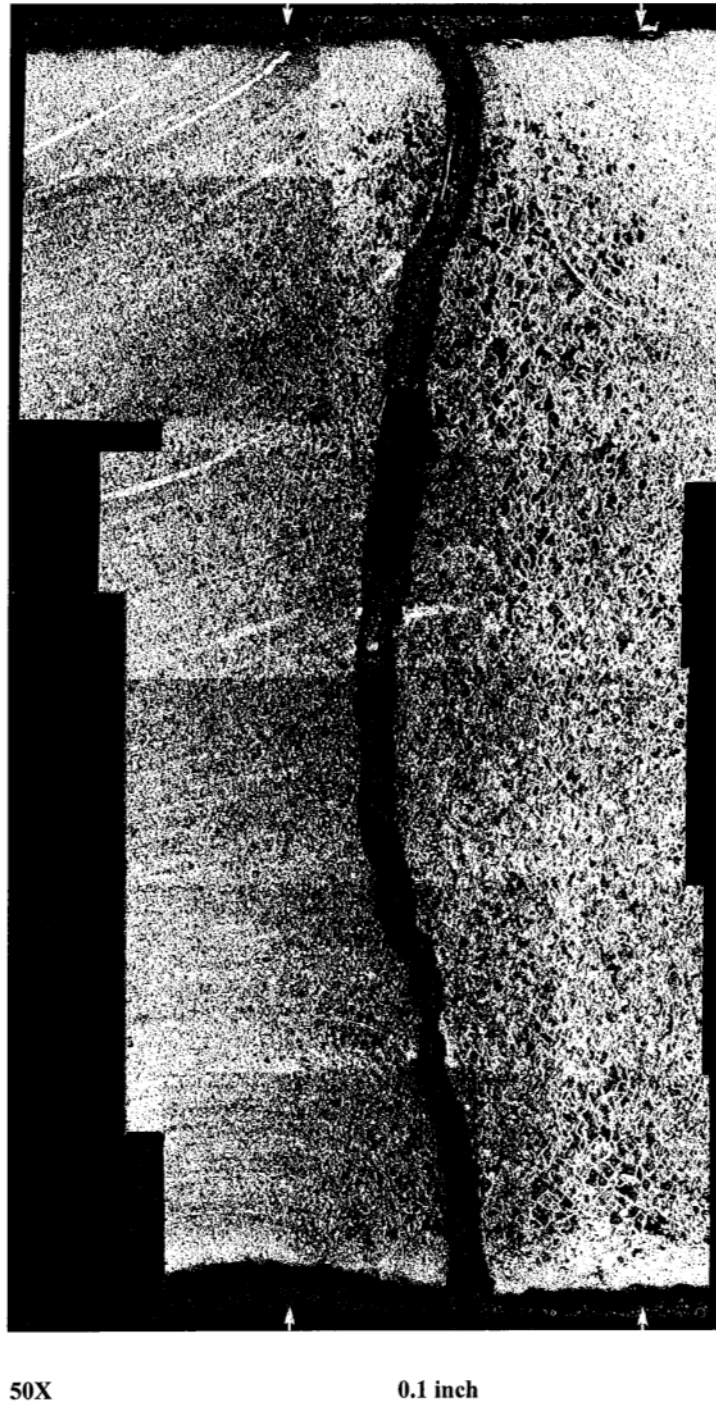
OC Case Number 4 involved a 22-inch-OD, 0.344-inch-wall, X46, DC-welded pipe manufactured by Youngtown in 1949. The failure mode was a rupture that occurred in-service at a hoop stress level of 57.5 percent of SMYS. The anomaly had survived a hydrostatic test to 82 percent of SMYS 11 years prior to the failure, and it had survived a mill test to a stress level of 85 percent of SMYS in 1949. The failure origin coincided with a hook crack that was about 0.6-inch long and penetrated about 16 percent of the wall thickness. The fracture surfaces are shown in Figure 101 and a metallographic section prepared through the origin is shown in Figure 102.

Figure 102. Metallographic Section across the Fracture

The small hook crack by itself probably would not have caused a fracture let alone a ductile fracture at a hoop stress level of 57.5 percent of SMYS. The hook crack resides, however, in a zone of material with hardness measured in the range of 35 to 45 Rockwell C. This situation is not unusual for 1949-vintage X-grade Youngtown pipe. What is believed to have happened here is the occurrence of a sudden hydrogen embrittlement failure with the hook crack providing the

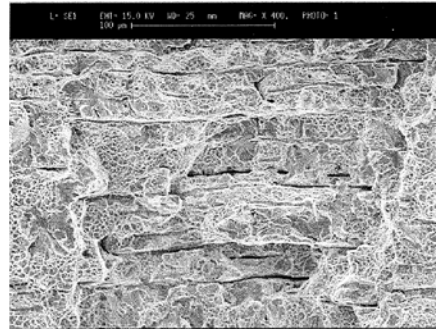
stress concentration needed for the cracking to occur. Another clue that it was a hydrogen cracking phenomenon comes from the SEM image shown in Figure 103. This image shows the type of into-the-plane cracks that often characterize a hydrogen cracking failure.

Figure 103. 400X SEM Image of Fracture Surface Showing Into-the-Plane Cracks often Associated with Hydrogen Embrittlement Cracking

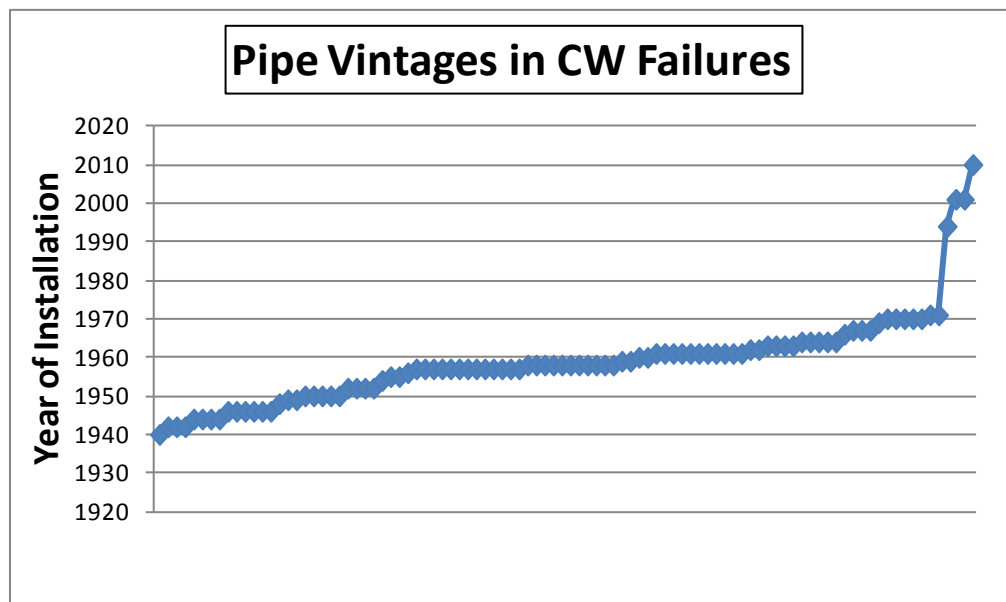
Figure 104. Pipe Vintages in Failures of Cold Welds

The year 1970 is seen to be significant. Only 6 of 96 cold weld failures occurred in pipe manufactured after 1970. Only two hook crack failures out of 77 occurred in pipe manufactured after 1970. None of the 24 selective seam weld failures occurred in pipe manufactured after 1970, and only 3 of 37 fatigue failures occurred in pipe manufactured after 1970. While it is true that somewhere around 80 percent of the pipelines in the U.S. were installed prior to 1970, the track record of failures involving pipe of pre-1970 vintage is clearly not as good as that of pipe manufactured after 1970. The reasons for the improved track record of pipe manufactured after 1970 are many.

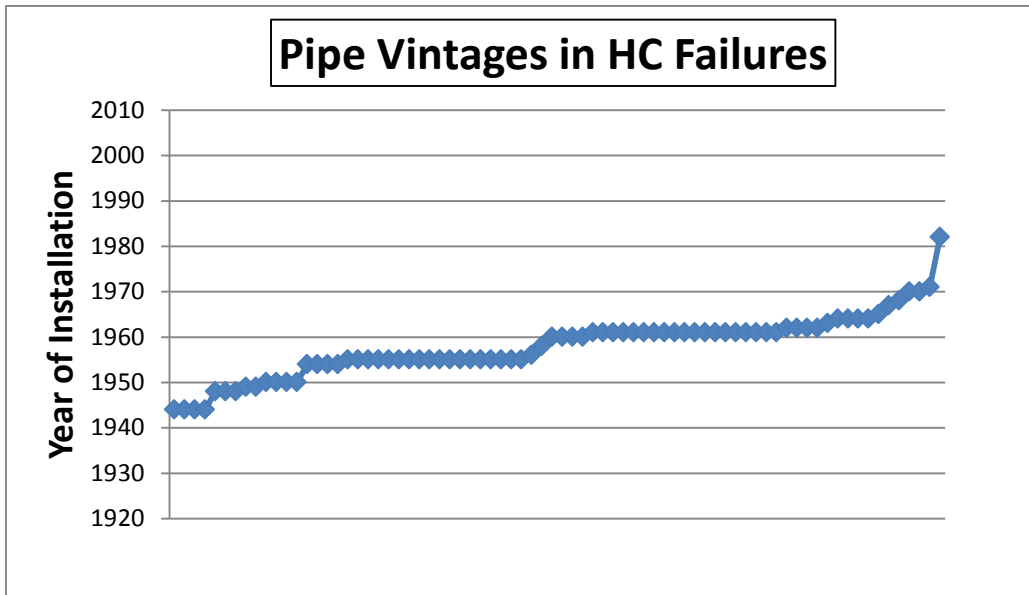
Figure 105. Pipe Vintages in Failures of Hook Cracks

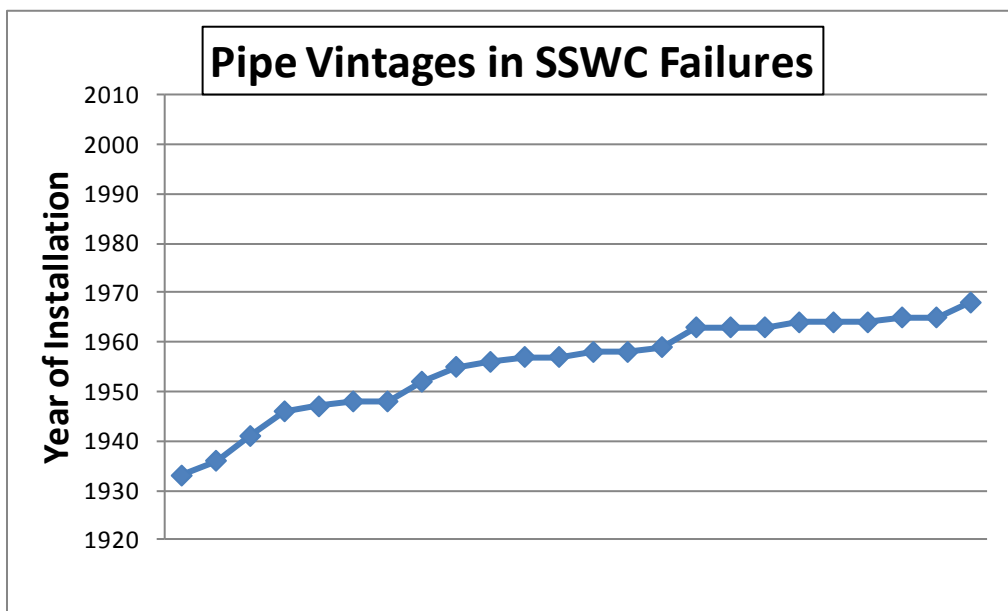
Figure 106. Pipe Vintages in Failures of Selective Seam Weld Corrosion

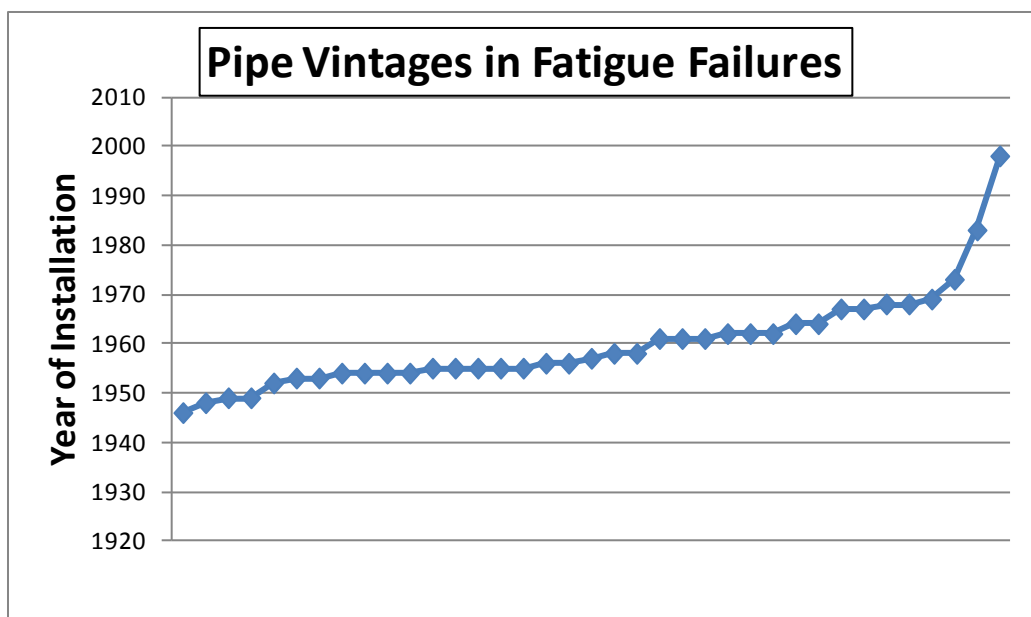
Figure 107. Pipe Vintages in Fatigue Failures
