# **Development of Dual Field Magnetic Flux Leakage (MFL) Inspection Technology to Detect Mechanical Damage**

Contract No. DTPH56-06-T-000016 (Project #203)

March 2013

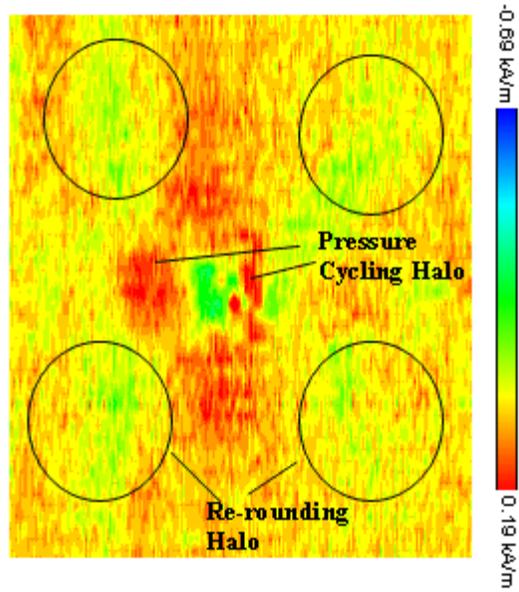
**Figure 10. Decoupled pull test results with background subtraction from pipe section with a natural dent from a former in-service pipeline. Applied high and low fields are 188 Oe and 80 Oe (15 kA/m and 6.4 kA/m) respectively. The re-rounding halo is composed of the four-circled areas**

The signal pattern, which surrounds a dent, and consists of four separate negative areas has been identified as the re-rounding halo in Figure 10 based on its position with respect to the pressure cycling halo and polarity (compare to the signal in Figure 11). This signal appears outside of the pressure cycling halo, which is in accord with the description provided by Battelle. The same type of negative signal is absent at other locations along the circumference with the same axial position as the rightmost portion of the re-rounding halos in Figure 10 other than near the dent. This supports the conclusion that this signal pattern is indeed the re-rounding halo and not noise.

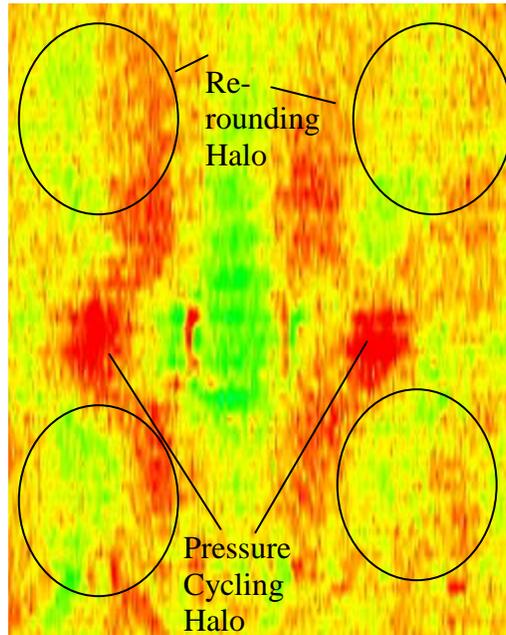
Dent 9 in Figure 12 can be compared to Dent 4 in Figure 13 to see what the effects of internal pressure and pressure cycling are on the decoupled signal, as all three dents have the same geometry and approximately the same depths, but Dent 4 was made in unpressurized pipe and did not undergo pressure cycling while Dent 9 was made while the pipe was pressurized and underwent pressure cycling. There is less of a pressure-cycling halo in Dent 9 compared to Dent 4: the average amplitude of the pressure-cycling halo in Dent 9 is approximately 50% greater than in Dent 4.

**Figure 12. Decoupled pull test results with background subtraction corresponding to Dent 9 in Figure 4 and Table 1. Applied high and low fields are 170 Oe and 73 Oe (13.5 kA/m and 5.8 kA/m) respectively. The pressure cycling and re-rounding halo signal patterns are identified. The re-rounding halo is composed of the four-circled areas.**

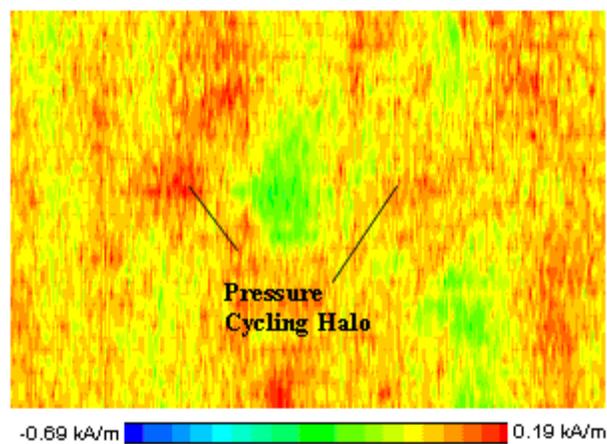
**Figure 13. Decoupled pull test results with background subtraction corresponding to Dent 4 in Figure 4 and Table 1. Applied high and low fields are 170 Oe and 73 Oe (13.5 kA/m and 5.8 kA/m) respectively.**

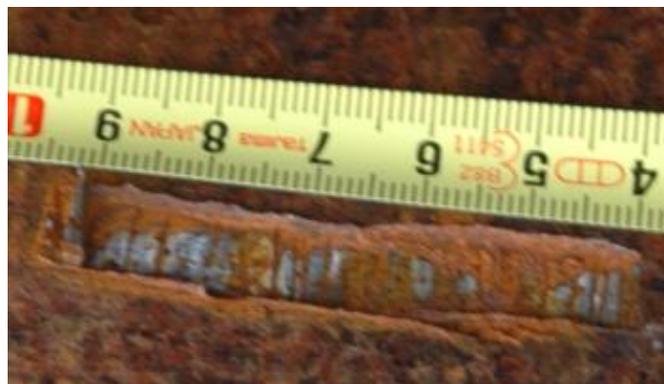
Figure 15. Photograph of gouge used in current pull tests.

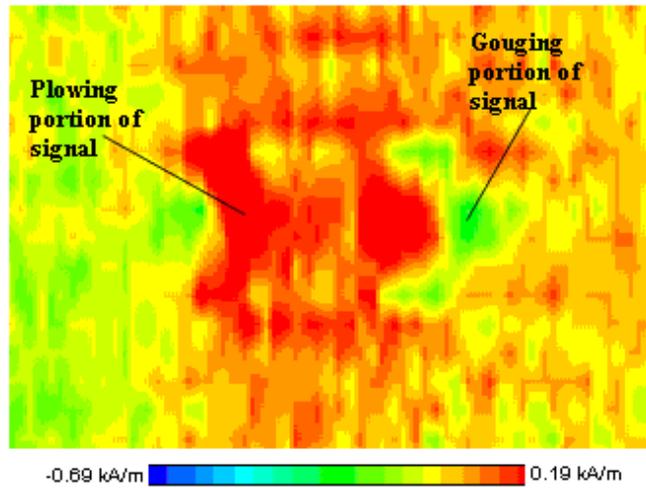
In Figures 14-16 the signal from the gouge is compared to a typical decoupled mechanical damage gouge signal obtained by Battelle. The gouge created for the pull test was made with a chisel and hammer and has several gouging and plowing portions, since it was chiseled in several steps, and not in one fluid motion. However the decoupled gouge signal from the pull test does contain a dipole, which is the decoupled signal pattern identified by Battelle as being representative of a gouge. The overall length of the gouge signal, 6.6 cm, is close to the length of the length of the actual gouge, which was about 5 cm.

**Figure 16. Decoupled pull test results with background subtraction from gouge shown in Figure 15 with the same orientation. Applied high and low fields are 170 Oe and 73 Oe (13.5 kA/m and 5.8 kA/m) respectively. The decoupled Battelle gouge signal in Figure 14 is for comparison.**

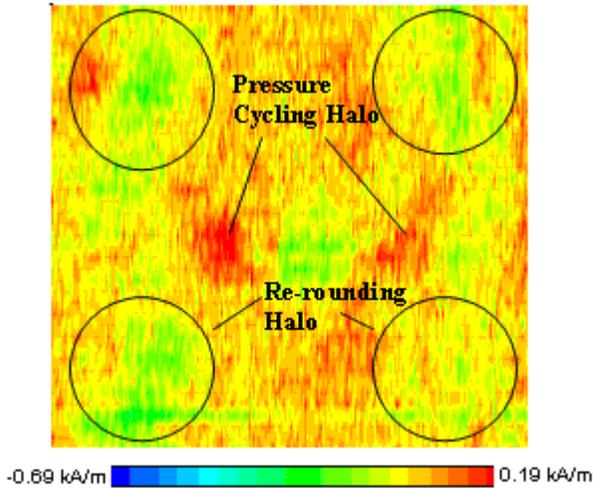
The shallowest dent in Figure 4, Dent 6 (0.5%), did in fact produce a decoupled signal with the re-rounding and pressure-cycling halos present as shown in Figure 17. This indicates that dents as shallow as 0.5% will be detectable in the decoupled inspection.

**Figure 17. Decoupled pull test results with background subtraction corresponding to Dent 6 (0.5%) in Figure 4 and Table 1. Applied high and low fields are 170 Oe and 73 Oe (13.5 kA/m and 5.8 kA/m) respectively. The pressure cycling and re-rounding halo signal patterns can be identified although the dent is shallow.**

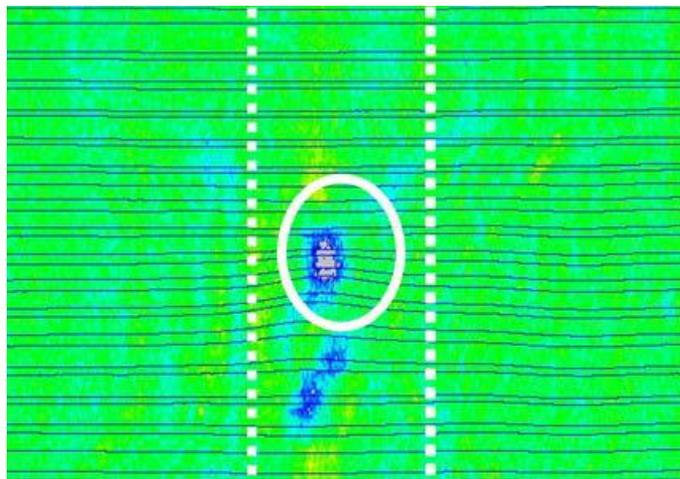
**b.) low priority anomaly**

Figure 21 shows the two ID anomalies (dents) with a high priority and low priority ranking. Decoupled signal data is shown with the color image and caliper data are overlaid in line view. The outline of the dent is shown with the solid white line. The original dent length before rerounding is indicated by the dashed vertical lines in both images, and the reround halo is only seen in the high priority anomaly. Dent depths were similar for the two dents, however, the dent strain as seen in the disturbance in line data is higher for anomaly identified as high priority in by the dual field analysis. In-the-ditch measurement methods will assist in further identifying possible micro-structural changes.

**Figure 21. Decoupled data in color scan and caliper data overlaid in the lineview.**

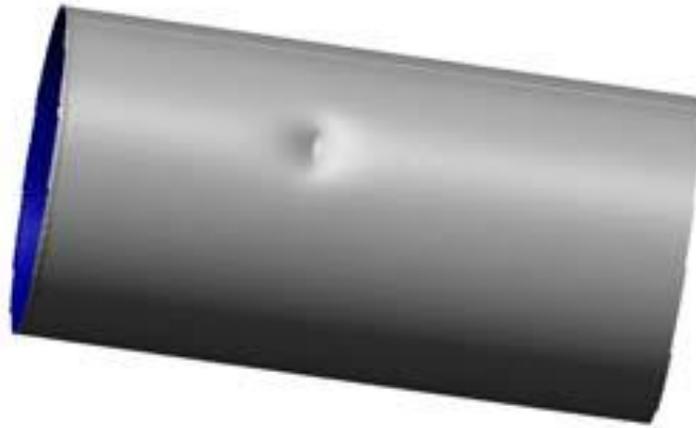
Dent 1, shown in Figure 22, is a bottom side dent with a plow/gouge signal and re-rounding halos from the ILI tool run data. The dent was marginally above 2% in depth and showed residual strains of greater than 6%. Dent 2, shown in Figure 23, was a top side dent with an adjacent hard spot and pressure cycling halos. The three dimensional (3-D) laser scan representation of dent 1 and dent 2 are shown in Figures 24 and 25 respectively. The VWA001 MWM-array scans of dent 1 and dent 2 are shown in Figures 26 and 27 respectively. The FA24 MWM-array scan was performed for dent 2 only and is shown in Figure 28.

**Figure 24. Three dimensional (3-D) laser scan representation of Dent 1.**

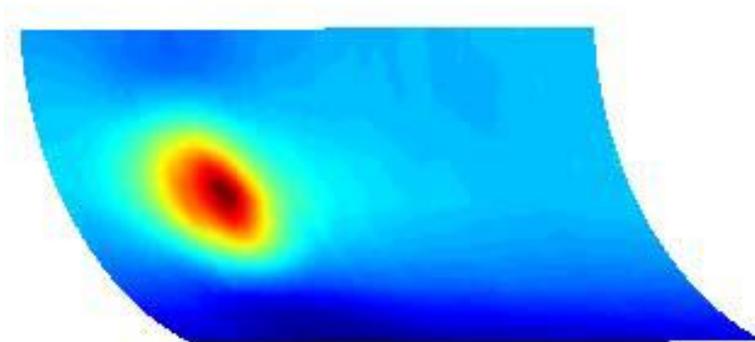
Figure 26. VWA001 MWM-array scans of Dent 1.

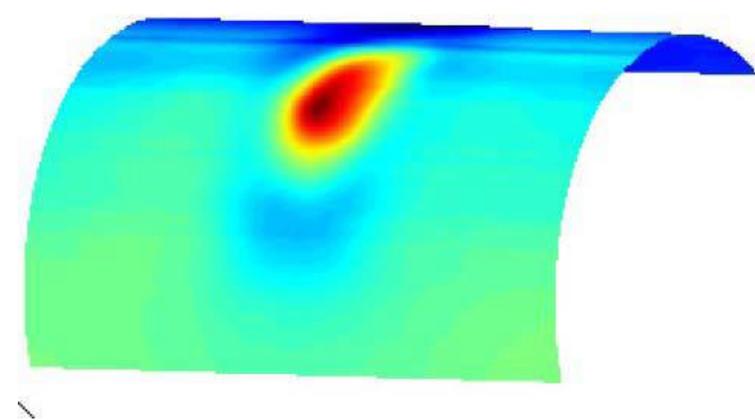
Figure 27. VWA001 MWM-array scans of Dent 2.

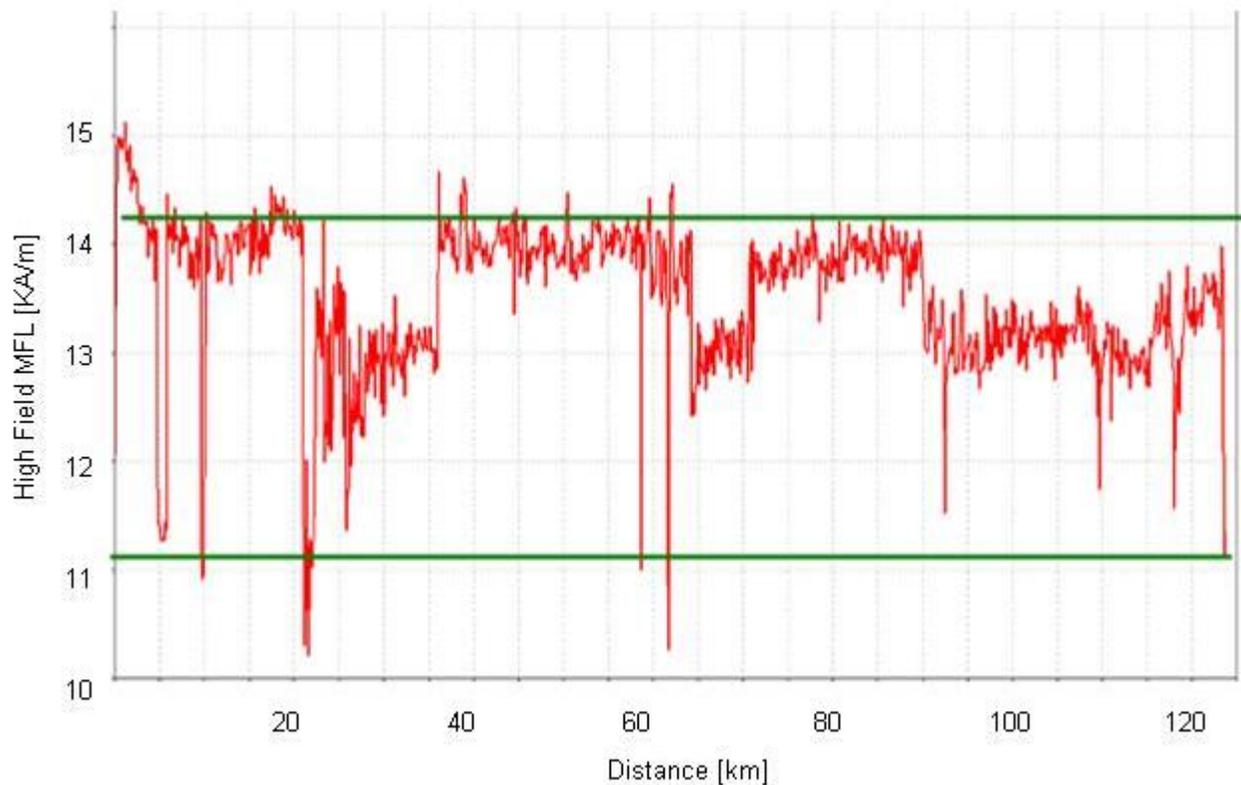
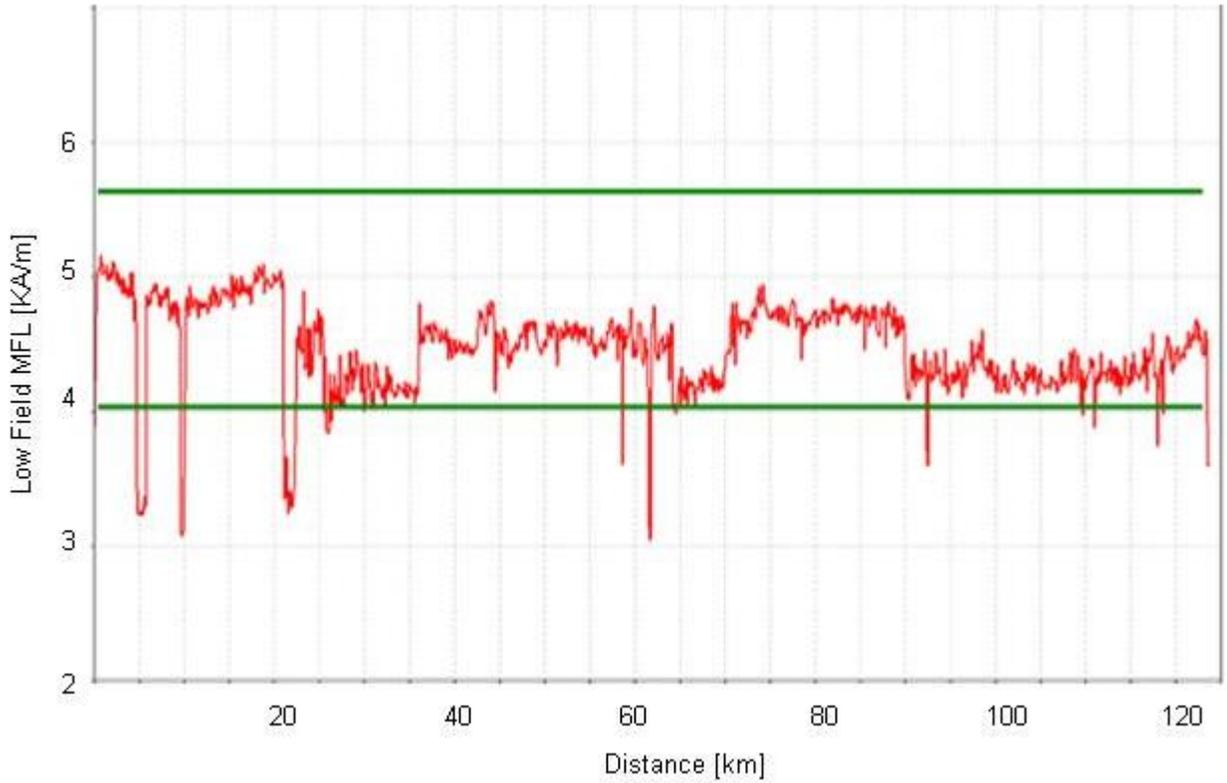
The magnetization levels achieved during the Dual Magnetization survey met the specifications for Battelle's Dual Magnetization methodology (green lines), ranging between 11.1kA/m and 14.3kA/m for the high field and between 4.0 kA/m and 5.6kA/m for the low field. Both Magnetization Level graphs display the recorded magnetization level on the pipe wall during the inspection.

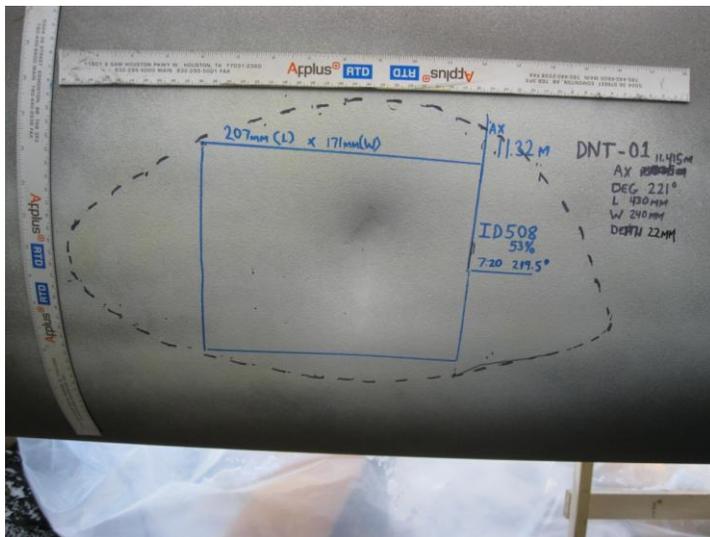
Figure 2: Actual Dent Picture (1)

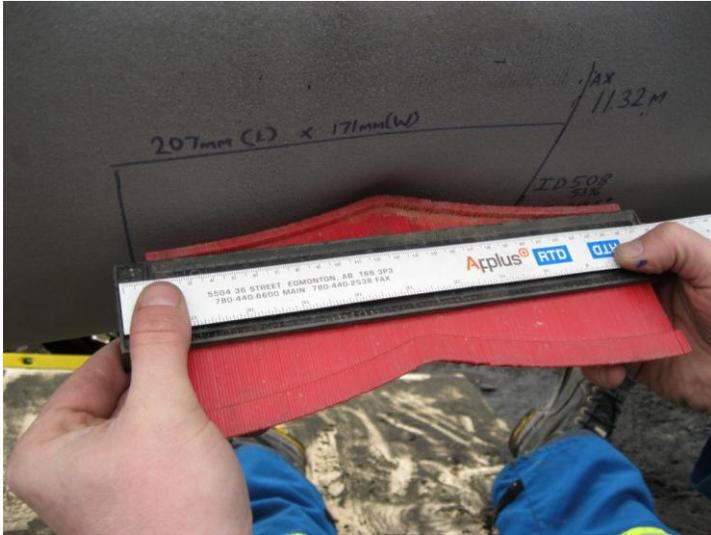
Figure 3: Actual Dent Picture (2)

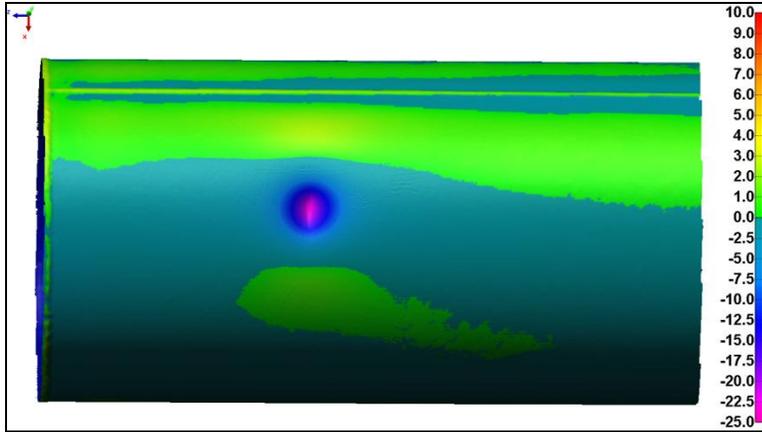
Figure 5: Color Gradient Map

The above images show the difference between the actual pipe body and a best-fit cylinder. The scale on the right (in millimeters) defines positive values as those areas that were larger than the best-fit cylinder, and negative values as those areas that were less than the best-fit cylinder. The minimum value on the scale is NOT the maximum deflection of the pipe as the best-fit cylinder is an ideal cylinder and not a true representation of the original pipe surface prior to deformation.

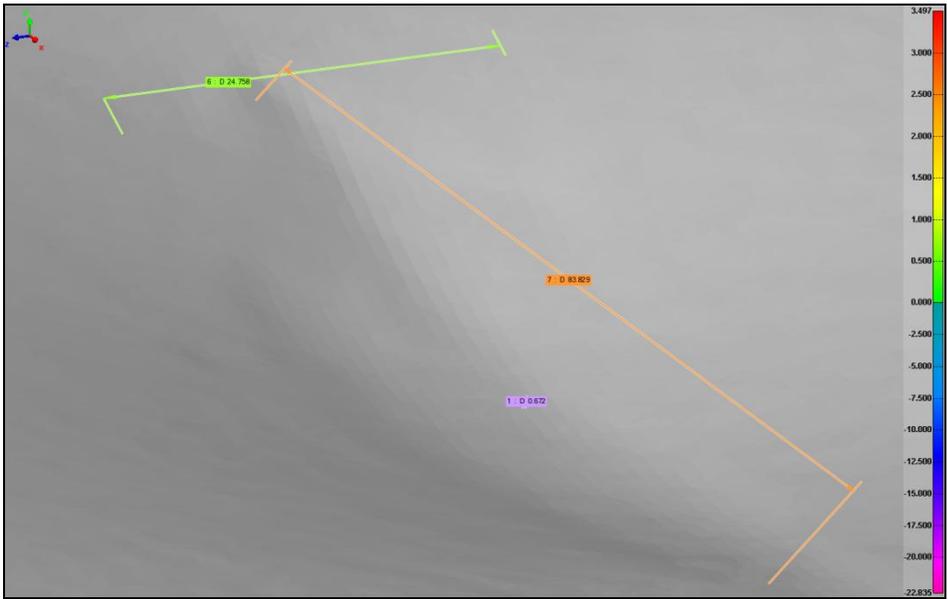
One of the key findings of in-ditch inspection was the discovery of a gouge. Its dimensions are given in Table 1.

Figure 10: Isometric View of Gouge

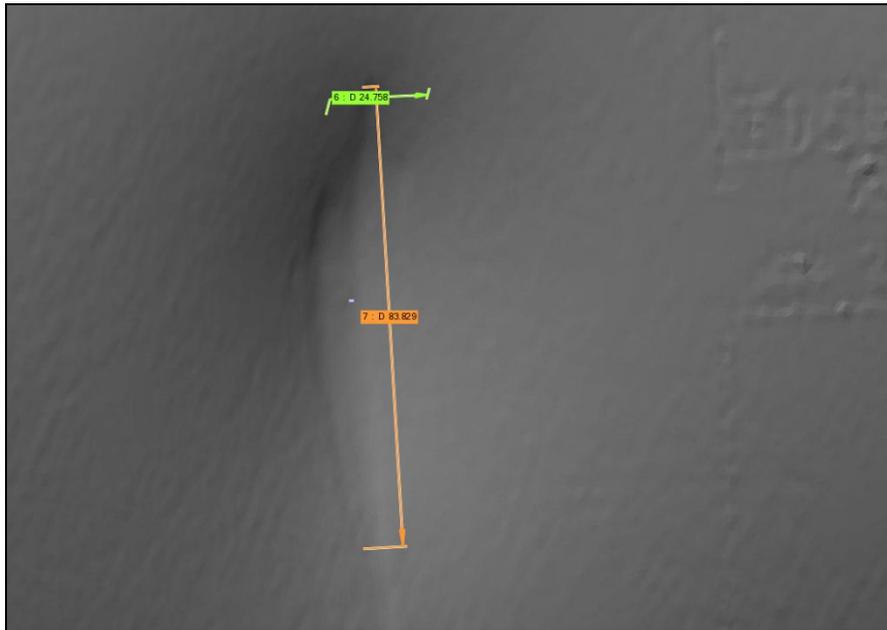
Figure: 11 Axial View of Gouge

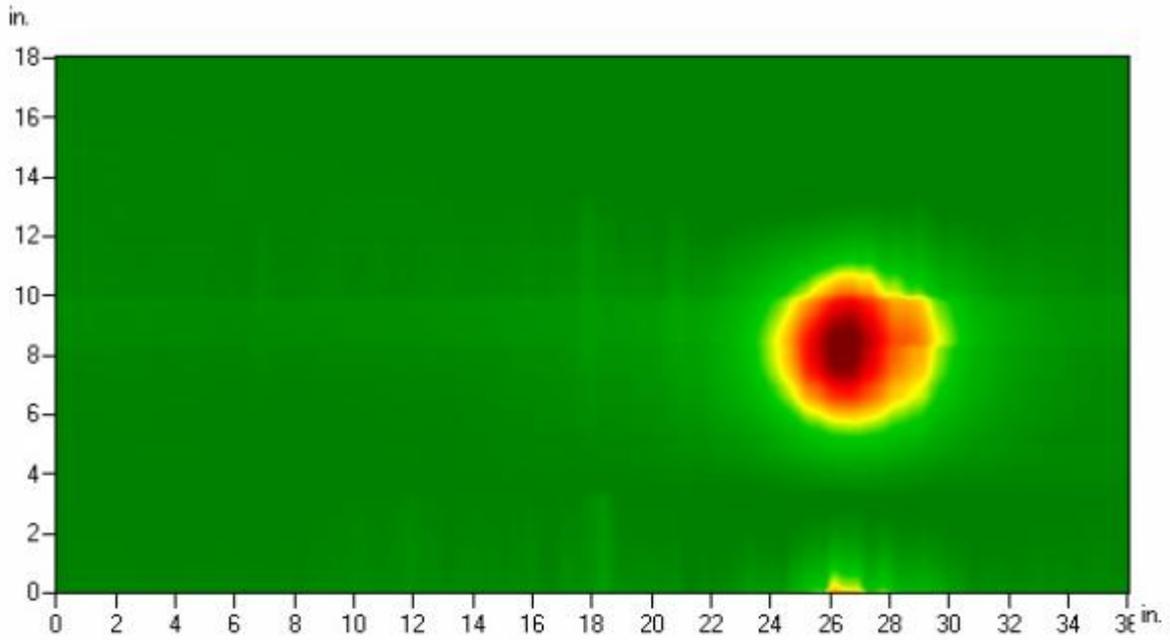
Figure 12: Dent profile image produced with the GridStation software. Color represents the depth of the dent relative to the nominal pipe surface

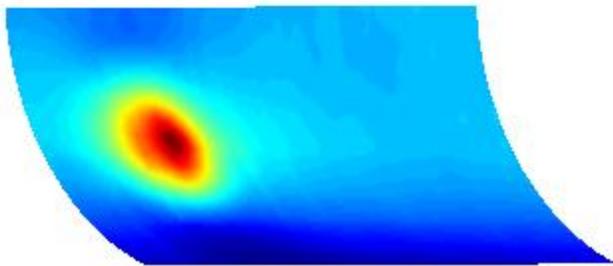
Figure 13: Dent 3D profile produced using the VWA001 data

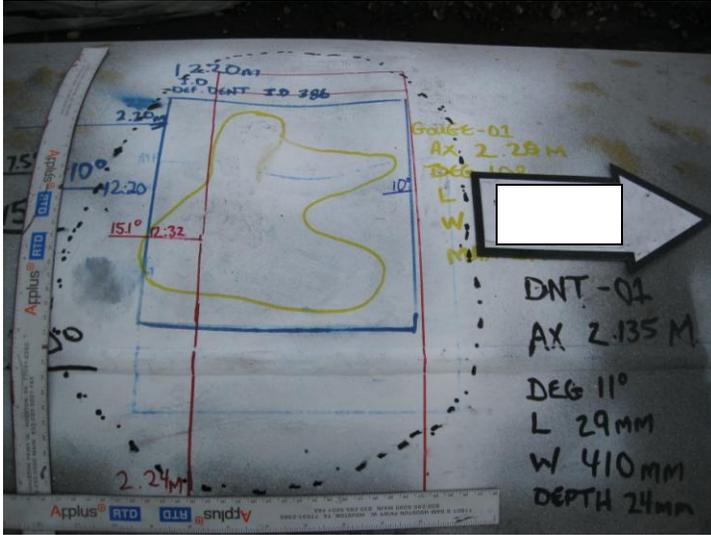
Figure 15: Actual Dent Picture (1)

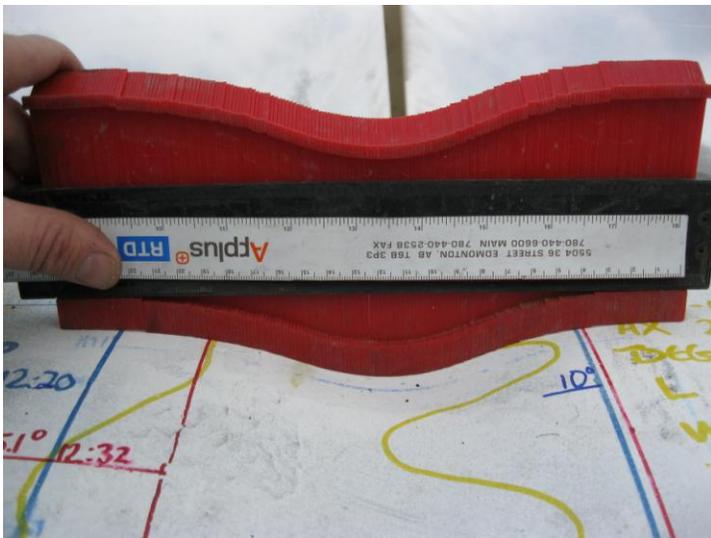
Figure 16: Actual Dent Picture (2)

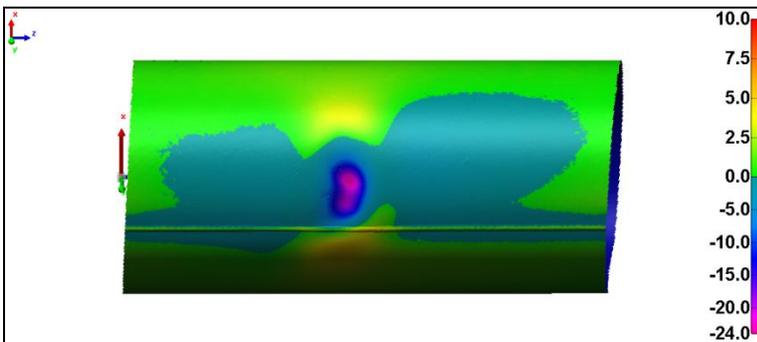
Figure 18: Color Gradient Map

The above images show the difference between the actual pipe body and a best-fit cylinder. The scale on the right (in millimeters) defines positive values as those areas that were larger than the best-fit cylinder, and negative values as those areas that were less than the best-fit cylinder. The minimum value on the scale is NOT the maximum deflection of the pipe as the best-fit cylinder is an ideal cylinder and not a true representation of the original pipe surface prior to deformation.

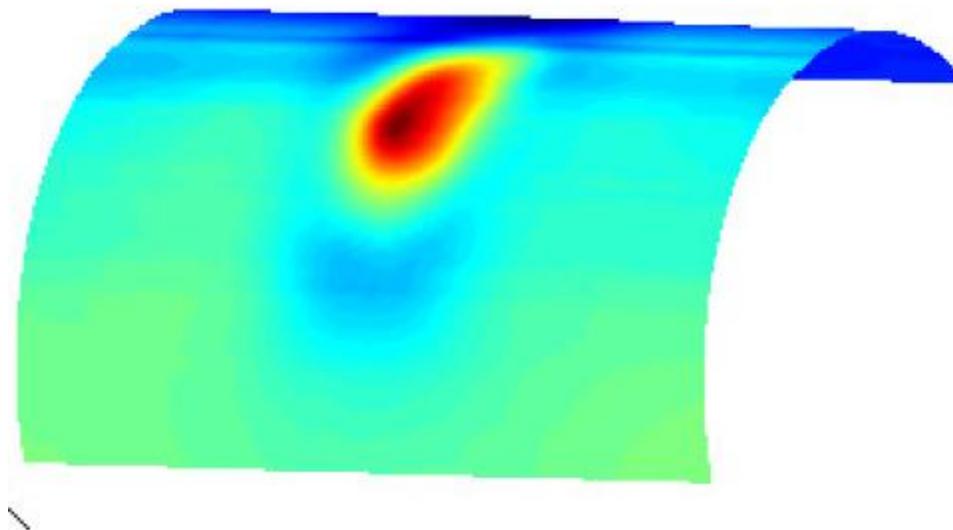
Figure 24: Dent 3D profiles produced using the VWA001 data

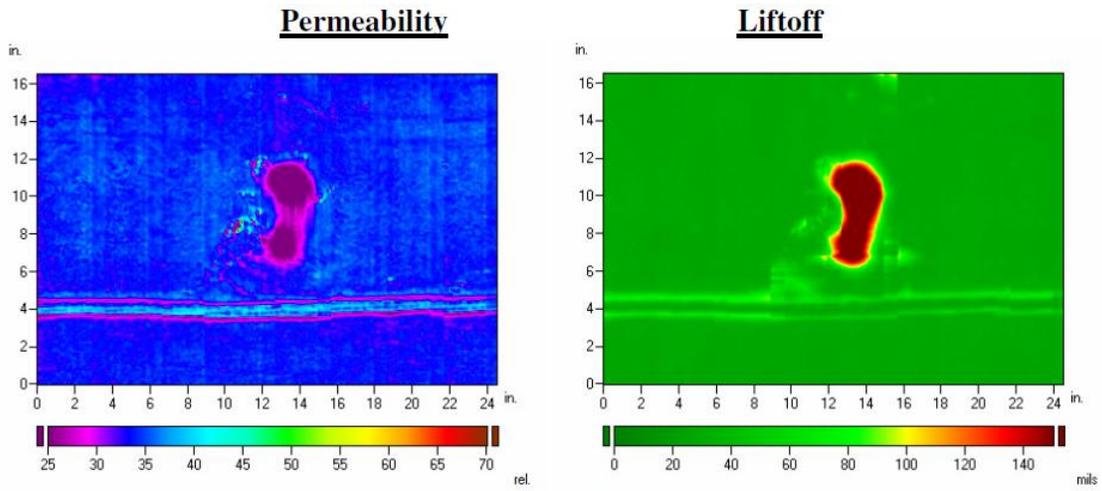
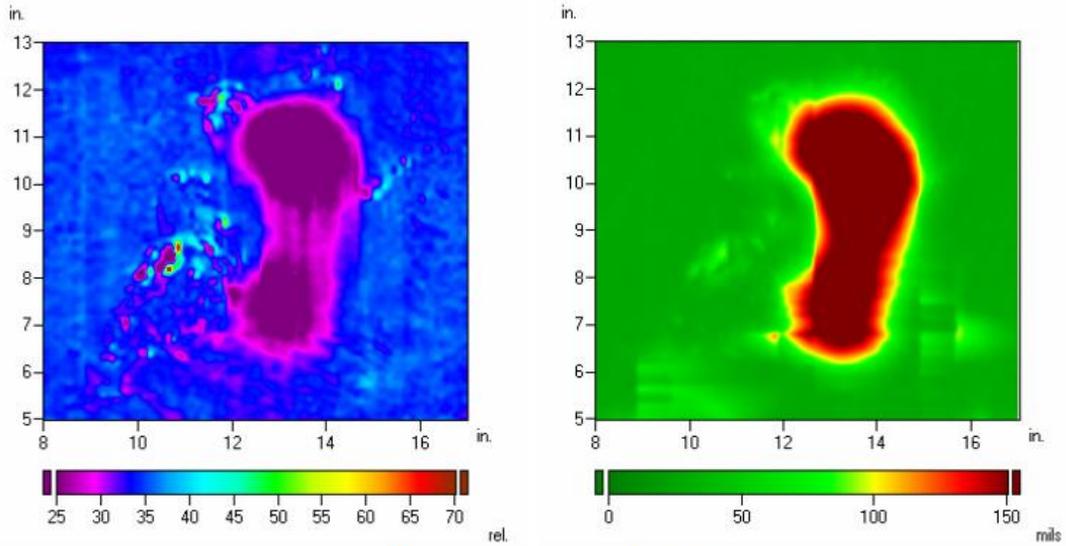
Figure 25: MWM-Array FA24 scans taken circumferentially and surrounding the dent. Variations in permeability can be indicators of stresses, material changes (hard spots), and cracks

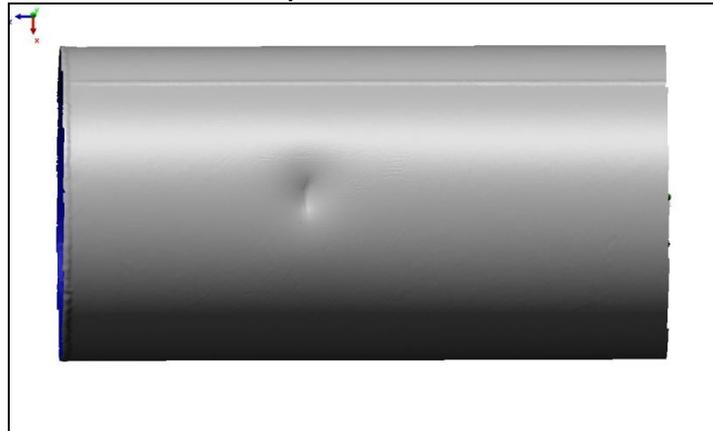
**Figure 1: Inspection Coverage**

The pipe was mapped for a length of 1.4 meters, full circumference.

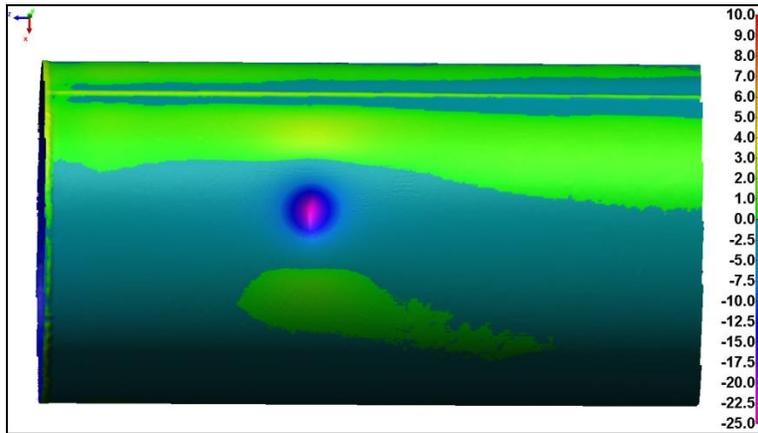
**Figure 2: Color Gradient Map**

The above images show the difference between the actual pipe body and a best-fit cylinder. The scale on the right (in millimeters) defines positive values as those areas that were larger than the best-fit cylinder, and negative values as those areas that were less than the best-fit cylinder. The minimum value on the scale is NOT the maximum deflection of the pipe as the best-fit cylinder is an ideal cylinder and not a true representation of the original pipe surface prior to deformation.

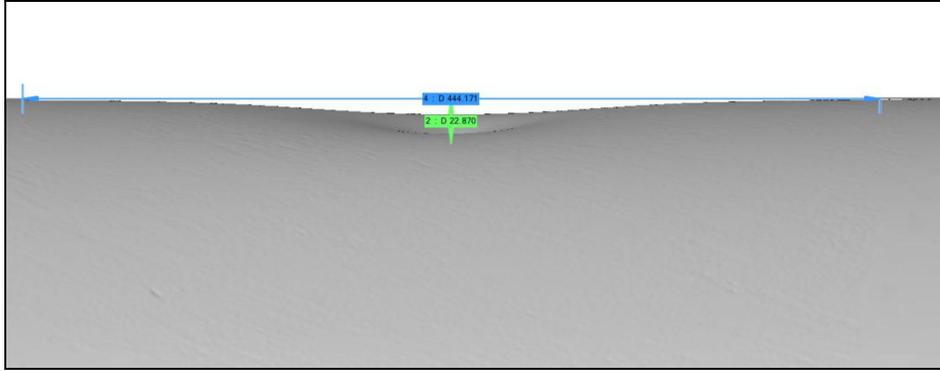
**Figure 5: Length and Depth View**

Depth is the distance from the original pipe profile, or the highest points if bulging occurred, to the deepest point in the dent and gouge. (Figure 5)

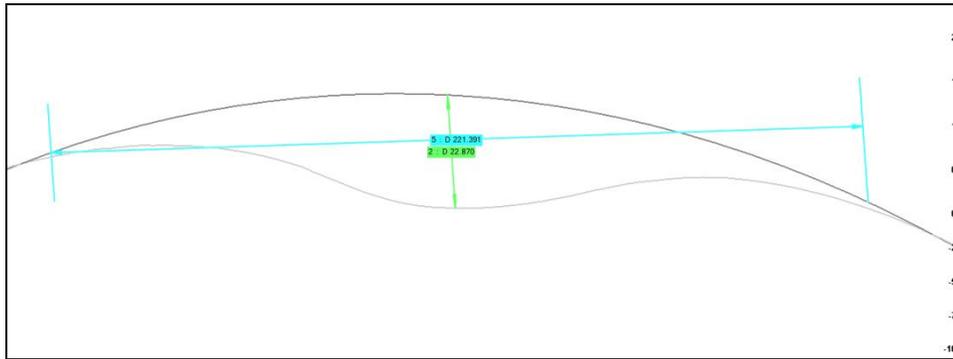
**Figure 6: Width and Depth View**

Width is measured perpendicular to the axis of the pipe and through the deepest point of the dent. This dimension does not account for the curvature of the pipe but it the absolute distance between two points in space. (Figure 6)

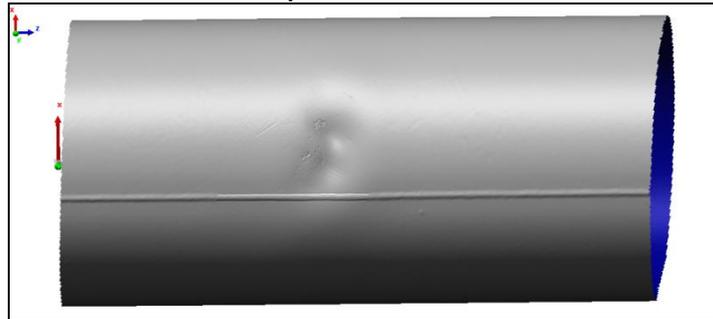
**Figure 7: Inspection Coverage**

The pipe was mapped for a length of 1.5 meters, full circumference.

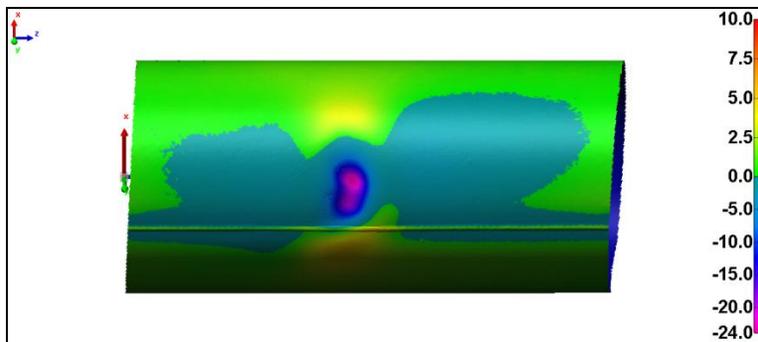
**Figure 8: Color Gradient Map**

The above images show the difference between the actual pipe body and a best-fit cylinder. The scale on the right (in millimeters) defines positive values as those areas that were larger than the best-fit cylinder, and negative values as those areas that were less than the best-fit cylinder. The minimum value on the scale is NOT the maximum deflection of the pipe as the best-fit cylinder is an ideal cylinder and not a true representation of the original pipe surface prior to deformation.
