U.S. Department of Transportation
Pipeline and Hazardous Materials
Safety Administration
1200 New Jersey Ave., SE
Washington DC 20590
RE: Contract DTPH56-11-T-000003
Comprehensive Study to Understand Longitudinal ERW Seam Failures

Final Interim Report – Task 2.6

Characterizing Failure in ERW Line Pipe

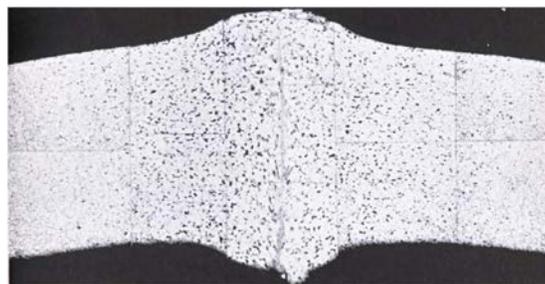
Figure 1. Cross-section montage through an ERW seam produced prior to 1934⁽¹⁰⁾

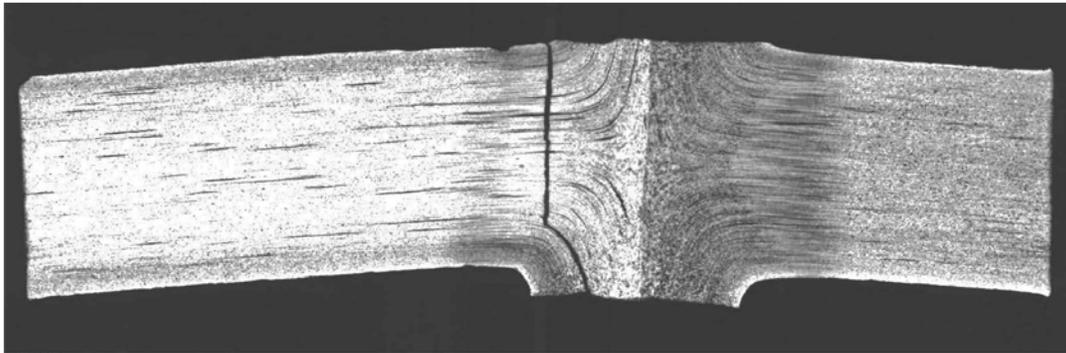
Figure 7 shows a macro-etched view of a cross-section through a failure in a FW seam in pipe made using 0.281-inch semi-killed steel. While the history of the skelp is unclear, views as shown in Figure 7 tend to reflect differences between the edges and the centerline characteristics of skelp that has been split from a much wider coil, to provide the width required. Although nominally the same skelp with the same base chemistry and processing is involved either side of the FW bondline, and the same etch was swabbed over this area for the same time period prior to washing and drying the mount, it is clear from this image that use of a given macro-etchant can give rise to significantly different results. As such, choosing an etchant and the exposure time can be a trial and error process whose results can depend on the samples being evaluated, and on the purpose of each metallographic cross-section. Thus, it is difficult to offer standardized guidance in such applications.

Figure 7. Differing effects of the same etchant in otherwise identical skelp: t = 0-281”

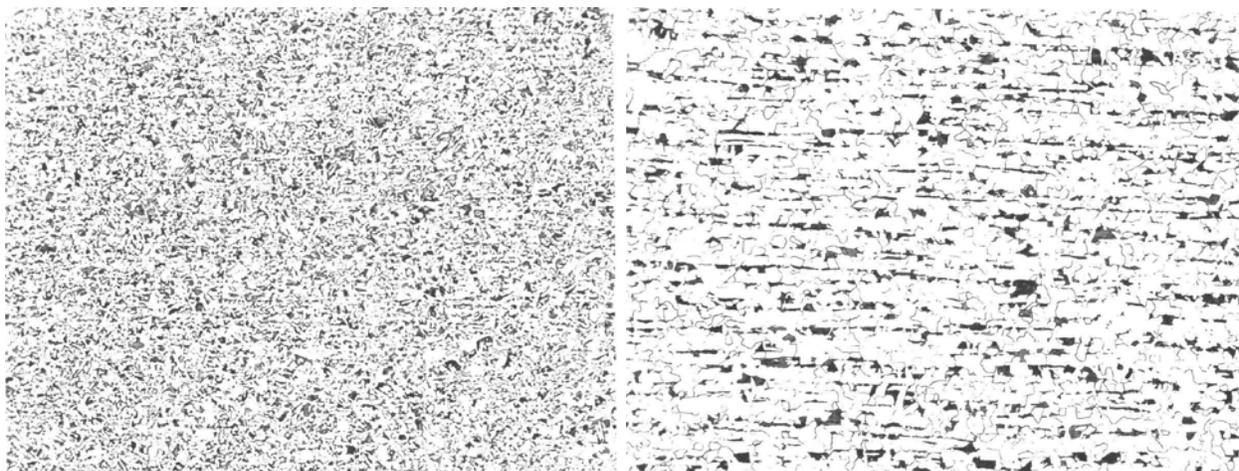
In contrast, Figure 8 illustrates results developed by way of a micro-etchant, which for these views is Picral applied to early 1960s samples of skelp. Detailed study indicates that both views present ferritic-pearlitic microstructures that otherwise differ in terms of grain size and uniformity. Such differences are not unusual between skelp producers, as is the case here, with the differences in uniformity and grain size tracing to aspects such as rolling practices, finishing temperature, and temperature in the coil. Also in contrast to Figure 7, largely because microscopic images capture a relatively small area over which the chemistry and processing are more uniform than across a bondline, such results tend to produce more uniform pictures of the structure.

a) skelp supply A

b) skelp supply B

Figure 8. Comparable effects of the micro-etchant Picral, both shown at ~100X

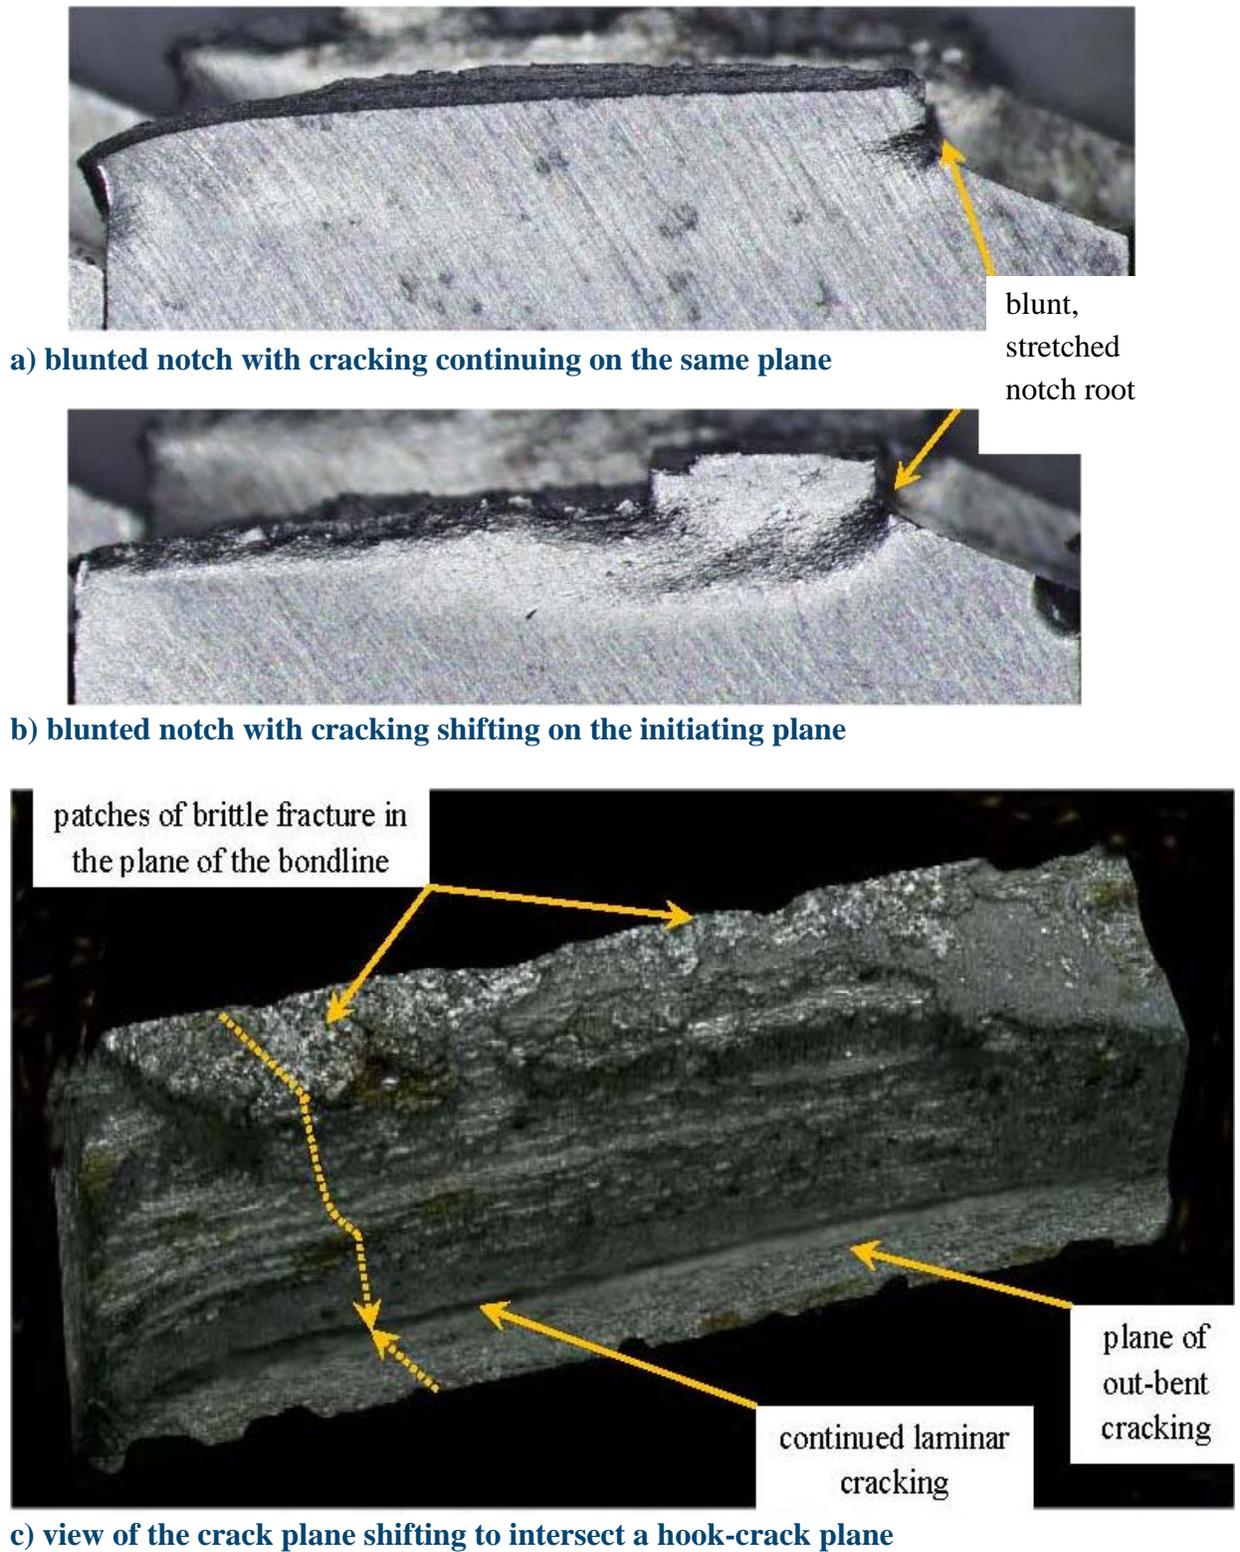
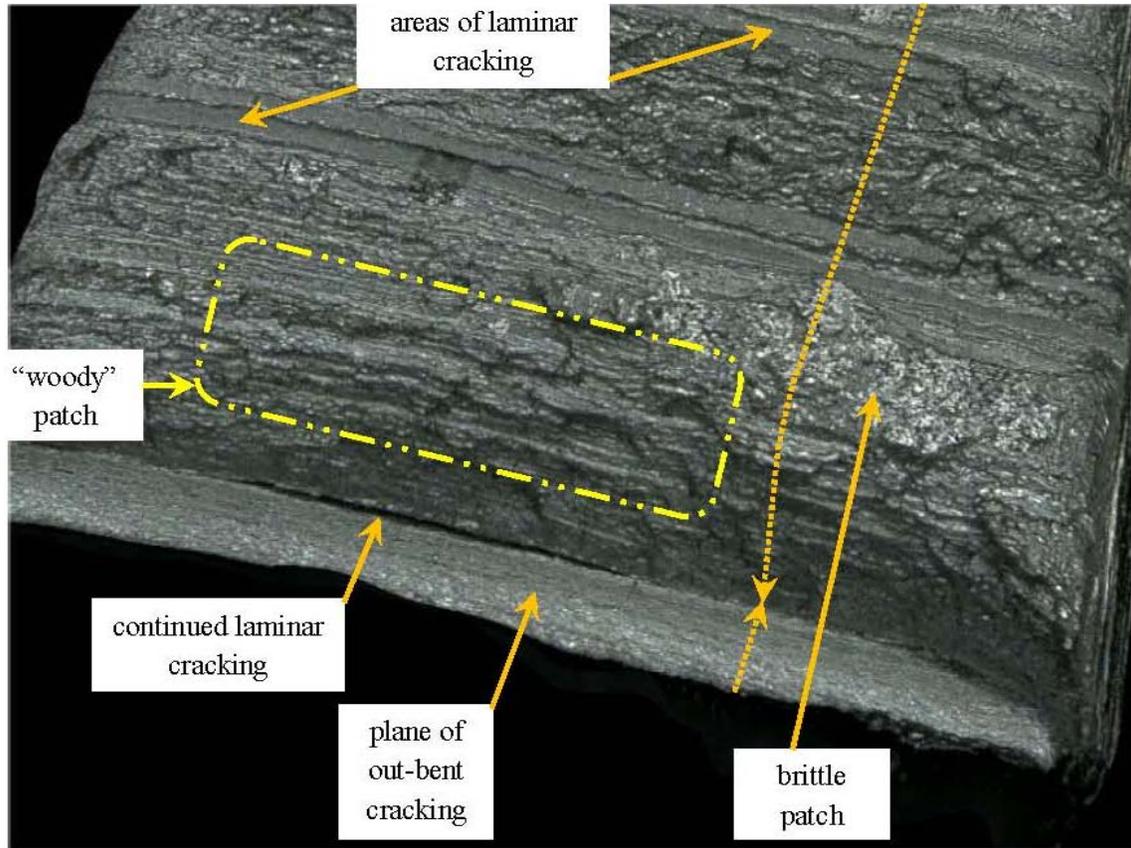
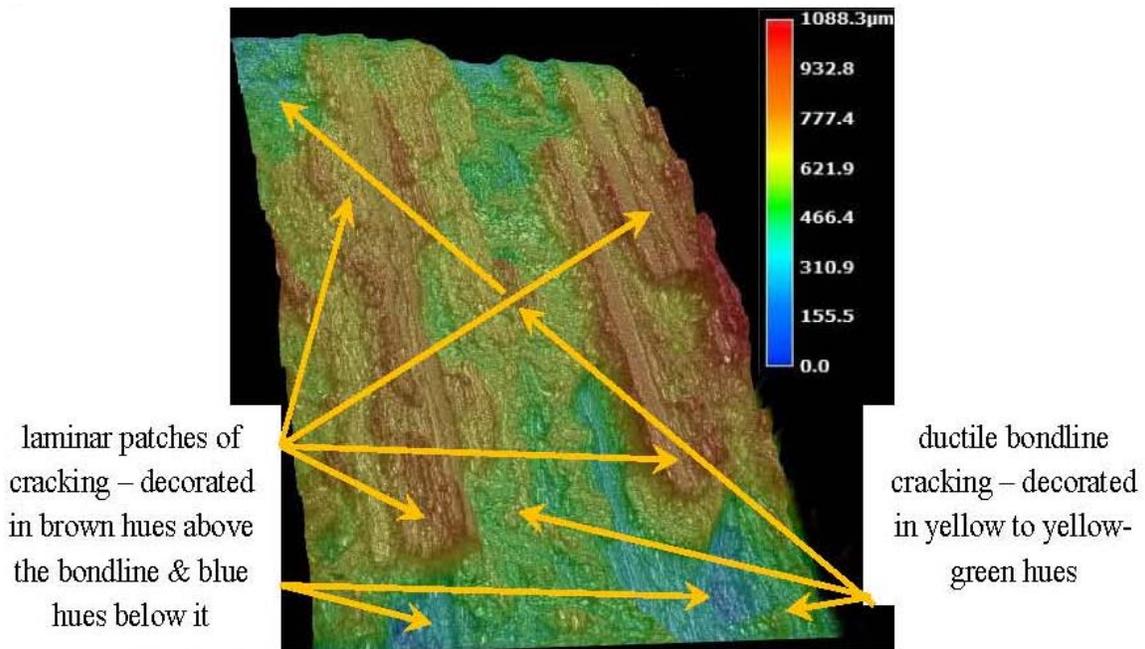
Evidence of blunting is clear in Figures 20a and 20b. The origin for the image in Figure 20a is slightly up the flank from the more highly stressed notch-root, with the cracking in this case tracking the bondline over the full depth of the sample, but only over a portion of the specimen's thickness. The origin for the image in Figure 20b is somewhat closer to the more highly stressed notch-root than in the prior case. Whereas for Figure 20a the cracking continued along the same plane, it is clear from Figure 20b that the crack quickly shifts cracking planes. It is clear from Figures 20a and 20b that the blunting causes local lateral contraction along the root of the notch. In turn, this lateral contraction can appreciable change the energy dissipation in a sub-size specimen, and cause nonlinearity in the usual linear scaling of the sub-size energy to determine its FSE energy⁽¹⁸⁾. While for more homogeneous metals this tends to be less significant for the lower toughness steels, its influence in the context of an ERW seam has not yet been explored.

Transitions between planes reflects the tendency for the crack to select the path of least resistance along the crack tip – which can be influenced by the resistance offered by different microstructures over the thickness of the CVN specimen. Weak interfaces, as can occur between differing phases, separate easily, and show no evidence of deformation. Figure 20c is a good example of a strong shift in crack path. This view shows just a portion of the fracture plane, as it has been taken after the specimen half has been sectioned along its mid-thickness. The cracking in this image developed from the notch-root, which lies at the right-hand side of this image and propagates toward the left side of the view. The primary crack plane for this case lay in the bondline, which is the plane along the upper edge of this image. Some brittle patches are evident on this plane as is a patch of laminar cracking near the notch root. In addition to this primary plane there is a secondary plane of cracking, which grew in from the surface of the CVN specimen, and undercuts that plane. As this secondary plane deepened, its effects on the stress field in the specimen were recognized by the primary crack, such that it transitions from the primary plane down to this secondary plane – as indicated by the dashed crack path. Given the toughness of the brittle patches, cracking along the primary crack plane must be considered a path of minimal resistance. Its transition onto an out-bent-fiber interface suggests that such interfaces have even less resistance, and form as precursors to the primary crack – as implied by the undercutting of the primary plane by the out-bent plane.

Figure 20d provides another view of a complex crack path and the related features, which formed under similar test conditions to that for Figure 20c. As for Figure 20c, the origin of this cracking is to the RHS of the picture, although the orientation is slightly shifted, and the primary crack plane lies partially in the bondline, as evident in the presence of the brittle patches and a cross-section made on the other half of this CVN specimen. As above, there is clear evidence of a laminar crack that developed on an out-bent plane along the side of this CVN specimen, which runs from below the notch to the back face of the specimen. It is clear from this orientation that

Figure 20. Views illustrating the complex nature of ERW seam cracking

d) view of a transition comparable to that shown in part c)

e) vertically colorized 3D view; ductile cracking mostly in the bondline
(20 ft-lb FSE, 98 %SA @245°F) – scale in microns covers a ~0.044 inch vertical slice

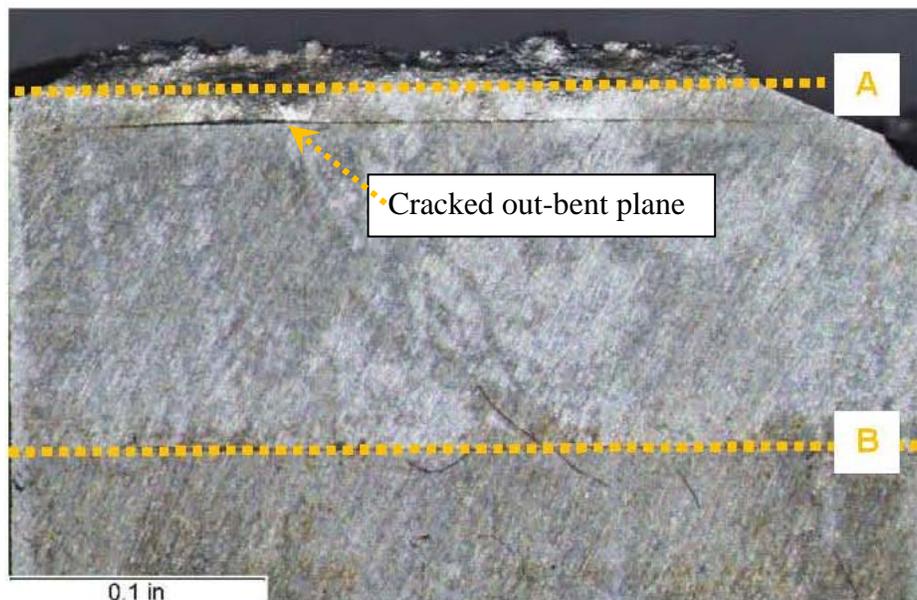
OES continues to be the primary technique for the production analysis of solid metallic samples. While an established practice in that context, it makes use of a relatively large sampling area in a standard sized blank. This requirement precludes its use to quantify the chemistry differences in the pipe body, or in the upset/HAZ, versus that local to a fracture plane that is as small, as occurs for a half-size CVN specimen – unless this scale constraint can be offset. For present purposes, data was sought on local chemistry immediately below the fracture surface, which was removed for such analysis using a wafer saw with a 0.012-inch thick blade. In reference to Figure 21, the cut-plane to remove the fracture surface was perpendicular to the face of the specimen, and located as indicated by the line designated ‘A’ in this image. This plane was located to just remove the fracture features intact, but no deeper. Given that failure of the many CVN specimens tested fell on paths that ranged from in the bondline through well out into the upset region it was expected that this plane would intersect those microstructures. As such, it was anticipated that approach would quantify the nature of the near-seam chemistry, which could then be contrasted with the nominal chemistry, which was measured on the cut-plane designated as ‘B’ in Figure 21, which lay well remote to any of the heating or the upset used to create the seam.

Figure 21. CVN sample sectioning planes for local chemistry comparative analysis

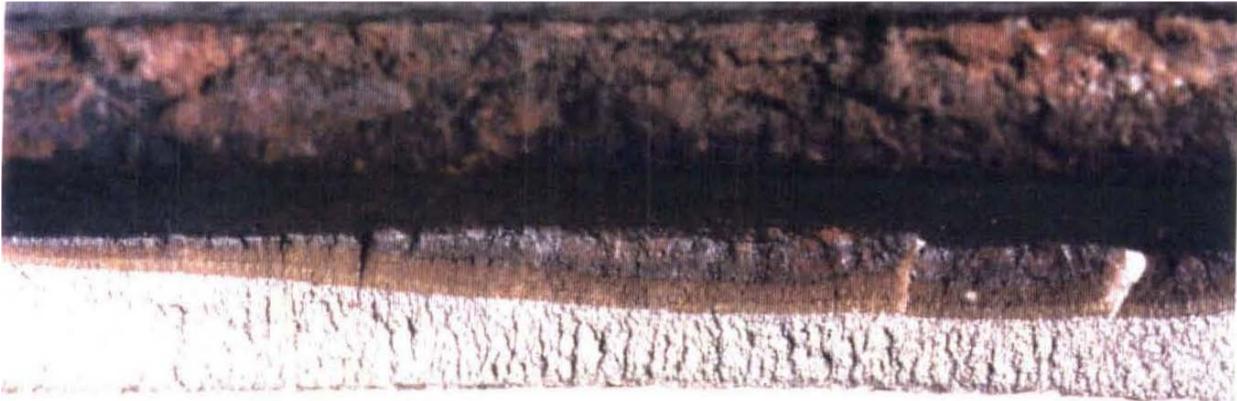
Figure A5. Detail in the boxed area of Figure A4

Figure A5 shows detail in the boxed region in Figure A4, and covers the full wall thickness. This view is centered at the origin for this long semielliptical thumbnail crack, which as evident from Figure A4 is one of such features that formed where the original defect grew from the mid-wall depth of the original defect toward the inside surface of the pipe. The features in this figure are comparable to those in the second similar feature. The gradation in the color of the corrosion products indicates that this growth occurred over different intervals. The steps within this growth that run from mid-wall to the ID surface of the pipe indicate that several cracks initiated on slightly different planes and linked as they grew.

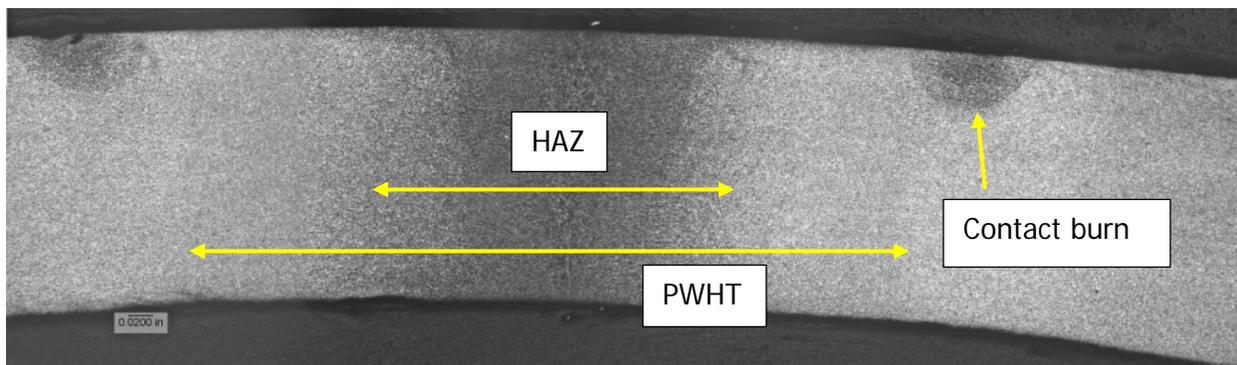
Figure 1. Morphology of a typical LF-ERW seam shown at 10X magnification

The bond line of this seam lies at the center of the photograph, but it is not readily visible in this material at this magnification. The visible features are the dark-colored rectangular weld heat affected zone (HAZ - about one wall thickness in extent) centered on the bond line, the moderately dark area extending about 1 wall-thickness-distance on either side of the heat affected zone represents material transformed by post-weld heat treatment (PWHT), and the two semi-circular dark areas at the outside surface of the pipe represent "contact burns". The latter arise from local heat generated where the low-frequency electric current was introduced by rolling contact wheels for the purpose of welding.

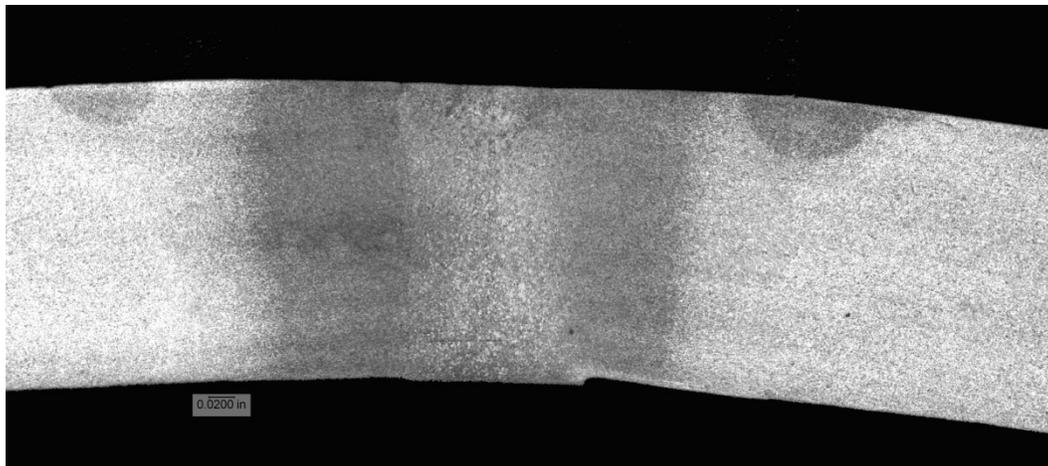
Figure 2. Morphology of a typical DC-ERW seam shown at 10X magnification

The morphology of this DC-ERW seam differs little from that of the LF-ERW seam shown in Figure 1 because the processes were quite similar. The only visible difference is that, in the case of the DC-ERW seam shown in Figure 2, the bond line region is more obvious. It is characterized by larger grain size. The coarse grain structure such as visible in Figure 2 was an unavoidable and undesirable consequence of the deep heat penetration created by low-frequency or direct current. The coarse-grained microstructure typically led to the bond line regions of LF-ERW and DC-ERW seams having high ductile-to-brittle fracture transition temperatures. The resulting bond line regions thus tended to have significantly lower defect resistance at normal ambient temperature than the base metal of the pipe.

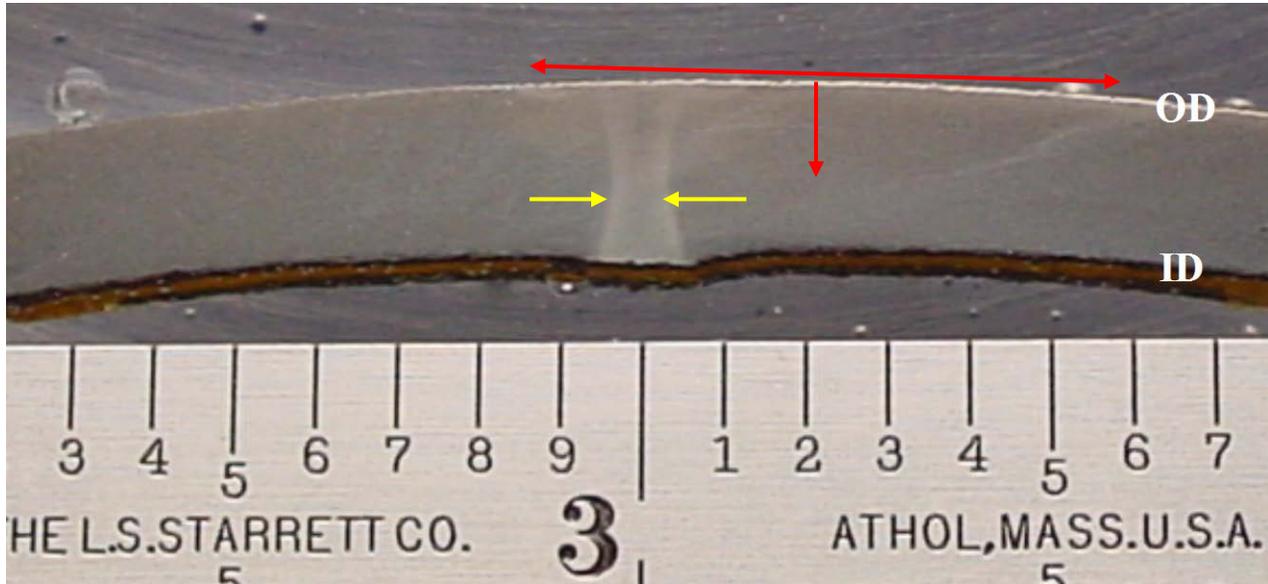
Figure 3. Morphology of a typical HF-ERW seam shown at 4X magnification

The yellow arrows in Figure 3 denote the hour-glass-shaped heat-affected zone typical of an HF-ERW seam. The heat affected zone is much narrower than that of an LF-ERW or DC-ERW seam because of the tendency of the high-frequency current to penetrate less deeply than a low-frequency or direct current. The red arrows show the extent of a slightly shadowed area that is believed to represent the zone of post-weld heat treatment (PWHT).

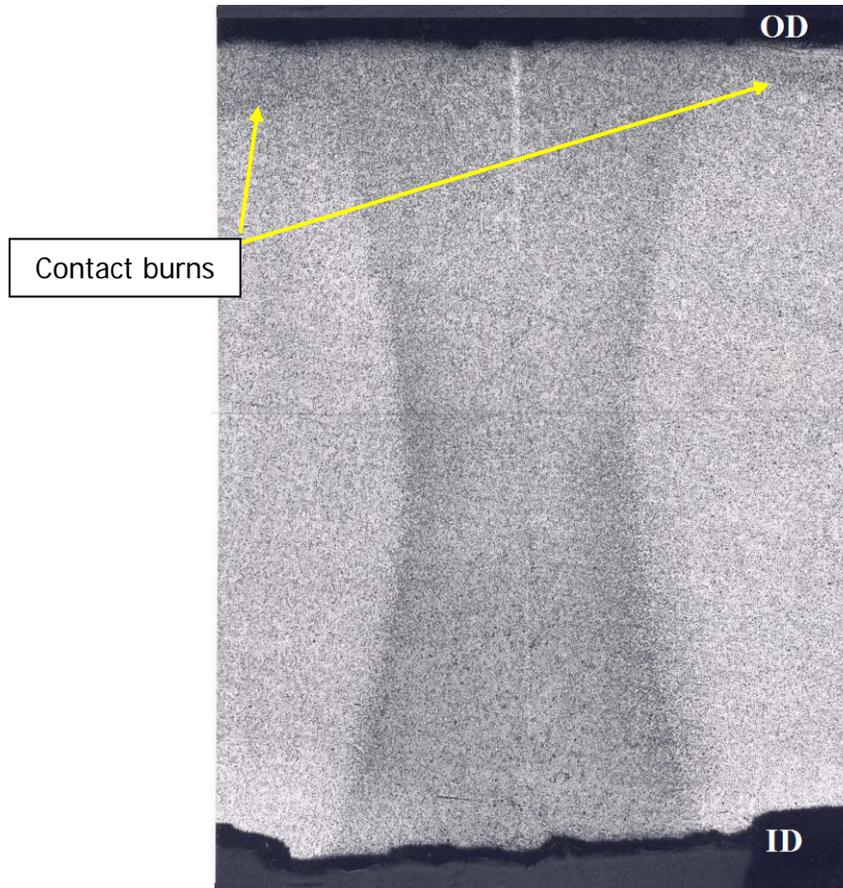
Figure 4. Close-up of a typical HF-ERW seam shown at 12.5X magnification

The bond line of this HF-ERW seam is clearly visible as a narrow white line at the center of the photograph. The white color is attributable to decarburization of the faying surfaces immediately before bonding. Such decarburization does not always appear in the bond line. The contact burns are denoted by arrows. Note that these are much shallower than the contact burns associated with the LF-ERW and DC-ERW seams because of the inability of the high-frequency current to penetrate deeply into the material.

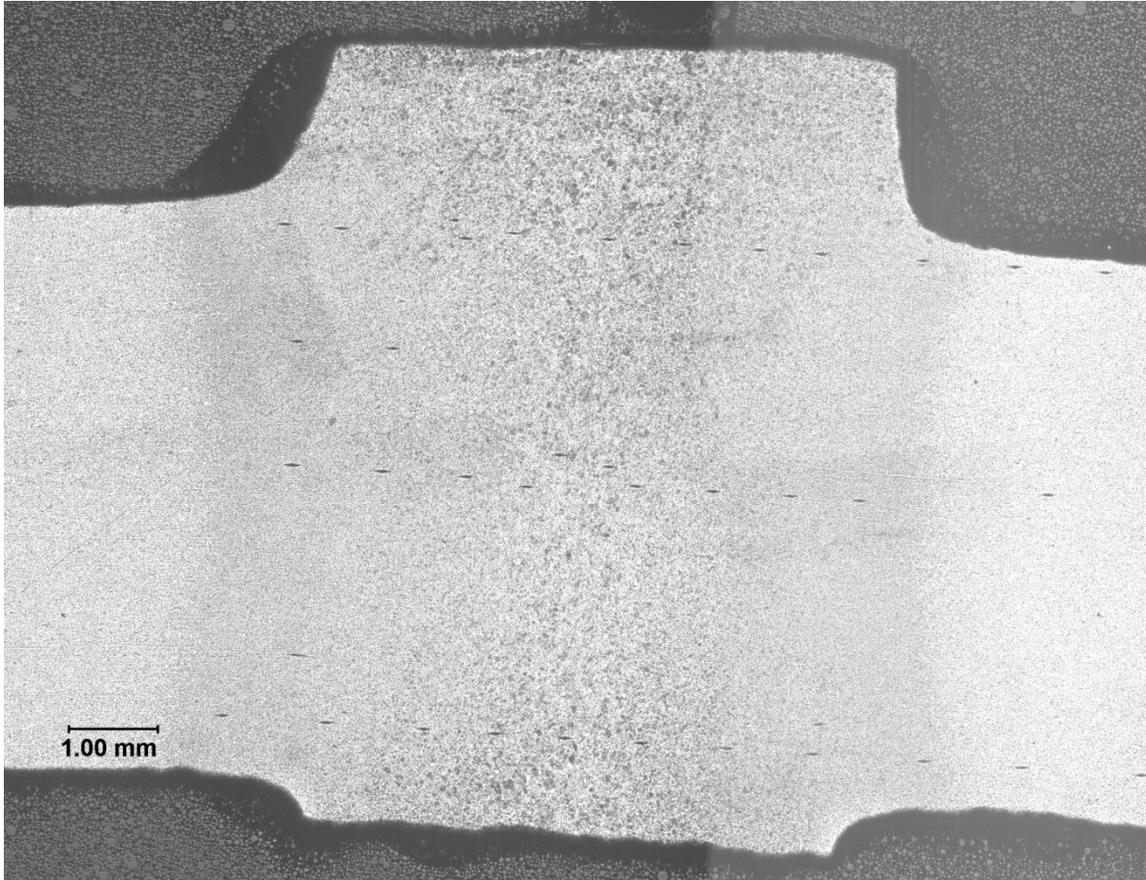
Figure 5. Morphology of a typical flash-welded seam shown at 12X magnification (Note that lines of hardness indentations are visible near both surfaces and at mid-wall. No excessively hard regions were found in this sample.)

The heat affected zone shown for this flash-welded seam is typically wide and contains a band of grain-coarsened material around the bond line region. As stated previously, the grain-coarsened material often translates into high ductile-to-brittle fracture transition temperatures and toughness properties inferior to those of the base metal. Flash-welds typically were not subjected to post-weld heat treatment.

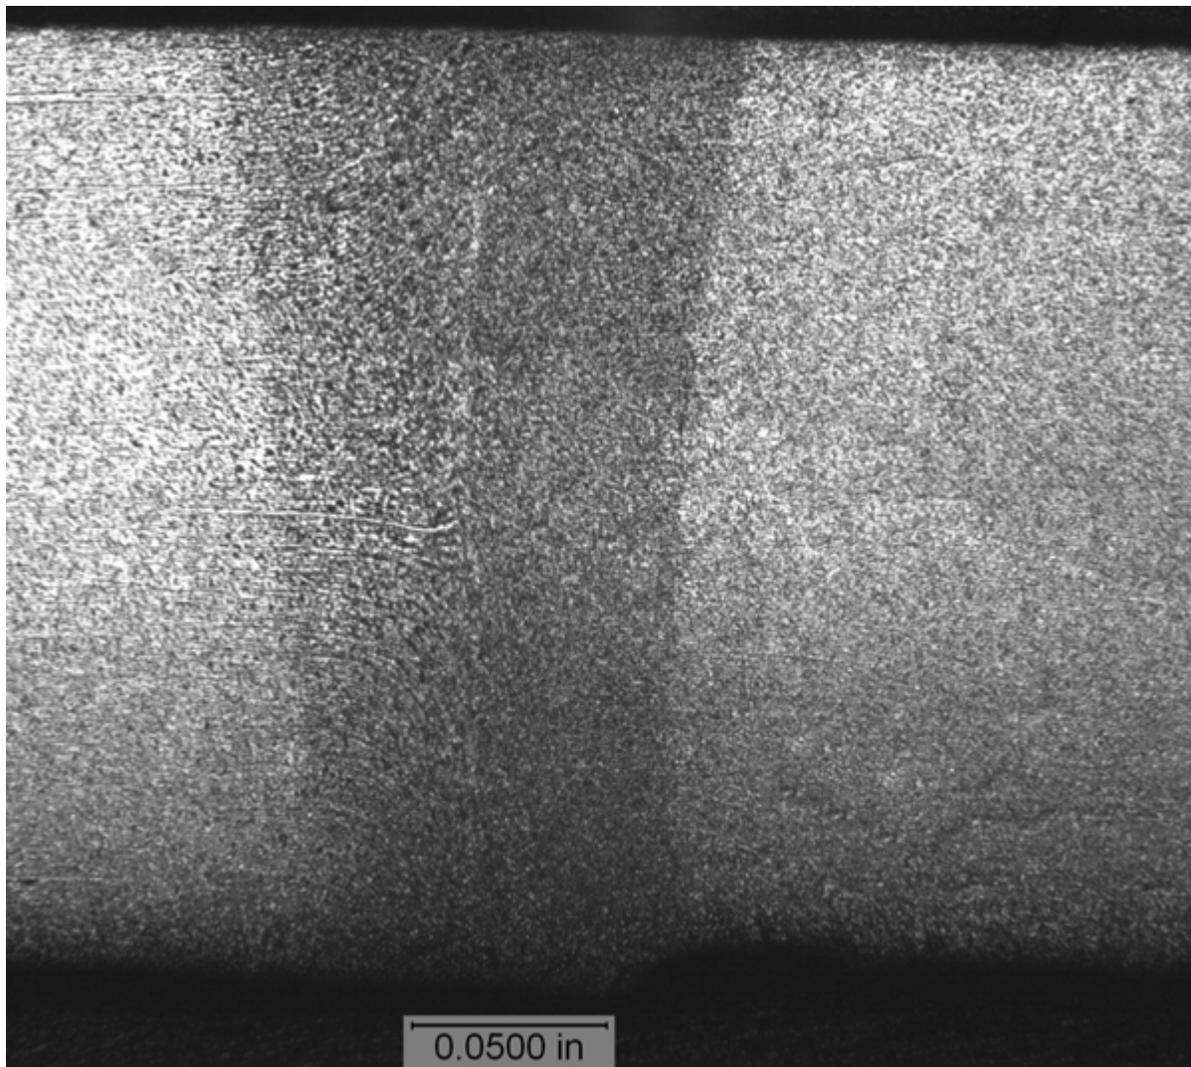
Figure 14. Section across intact portion of the seam of Sample 1 at 20X

This section of the weld exhibits no defects. On the left side of the bond line one can see the flow lines indicative of the upsetting process during welding. The material on the other side looks slightly different suggesting that this pipe may have been made from a slit coil rather than a full-width coil.
