Appendix B – Task 2
Catalog of Seam Weld Defect Types

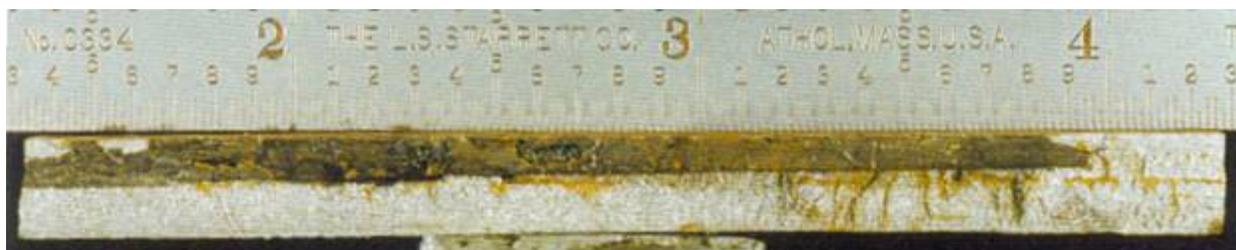
Catalog #: 134
 Report #: 12
 Defect #: 68C

Photograph of Fracture Surface.

NDE technique(s): TOFD, MPI
 NDE result(s): 99%, 2.25 inch
 (57.2 mm) OD-
 Connected Non-
 Fusion

Visual: OD Hook Crack
 L
 $\text{depth}/t_{\text{weld}}$: > 2.7 inch (69 mm)
 52%
 depth: 0.130 inch (3.30 mm)
 t_{weld} : 0.248 inch (6.30 mm)

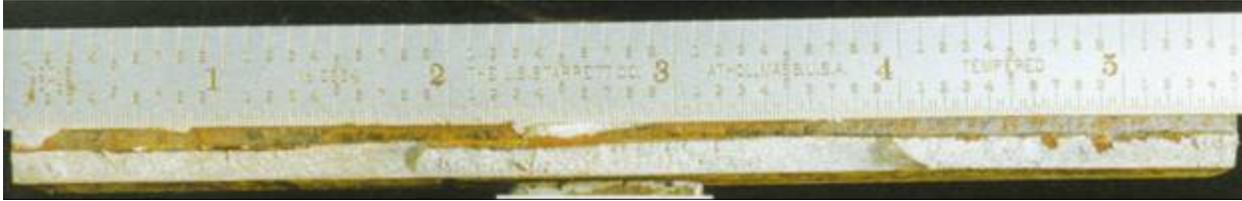
Catalog #: 126
 Report #: 12
 Defect #: 67A

Photograph of Fracture Surface.

Visual: OD Hook Crack
 L
 depth/ t_{weld} : 43%
 depth: 0.106 inch (2.69 mm)
 t_{weld} : 0.147 inch (3.73 mm)

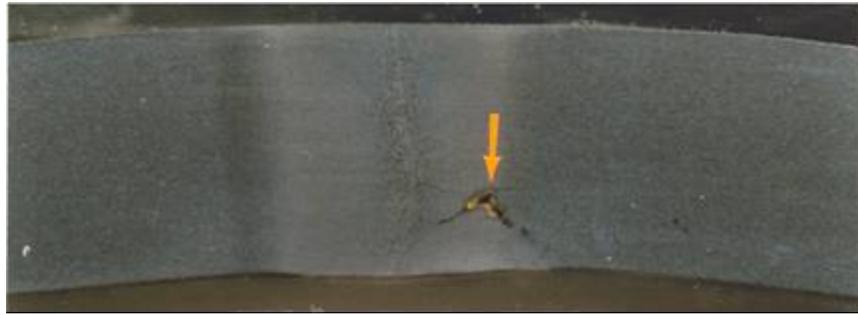
Photograph and Photomicrograph of Metallographic Section.

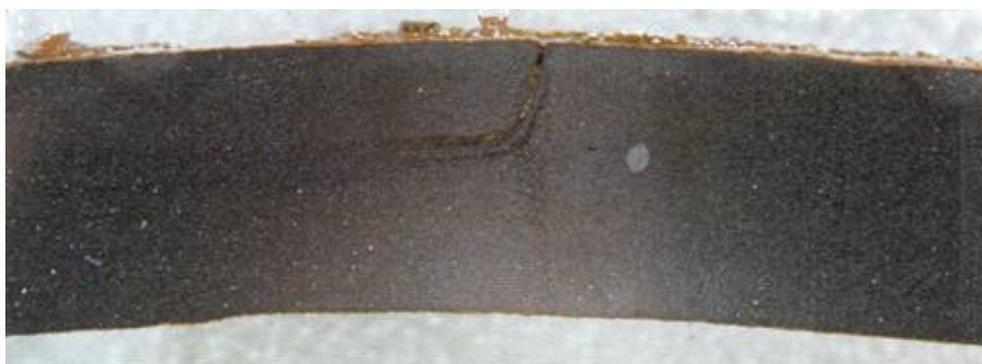
Catalog #: 140
 Report #: 12
 Defect #: 73D

Photograph and Photomicrograph of Metallographic Section.

NDE technique(s): TOFD, MPI
 NDE result(s): 48%, 6.5 inch (165 mm)
 OD-Connected Non-Fusion

Visual: OD Hook Crack
 L: Not Determined
 depth/ t_{weld} : 38%
 depth: 0.090 inch (2.29 mm)
 t_{weld} : 0.236 inch (5.99 mm)

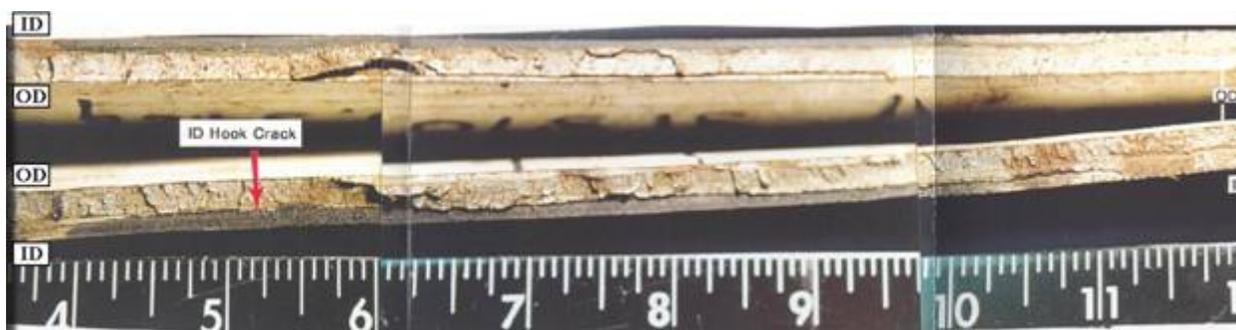
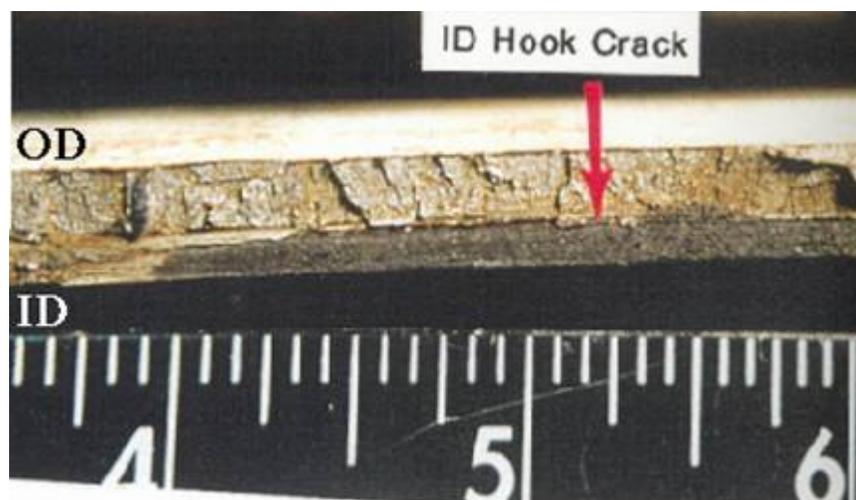
Catalog #: 23
 Report #: 2
 Defect #: 551-38.8.b

Photographs of Fracture Surfaces.

NDE technique(s): UT
 NDE result(s): 20%, 2.5 inch (64 mm)
 ID crack like
 Visual: ID Hook crack
 L: 6.0 inch (152 mm)
 depth/ t_{weld} : 35%
 depth: 0.120 inch (3.05 mm)
 t_{weld} : 0.346 inch (8.79 mm)

(*) Burst test failed two adjacent hook cracks at one pressure.

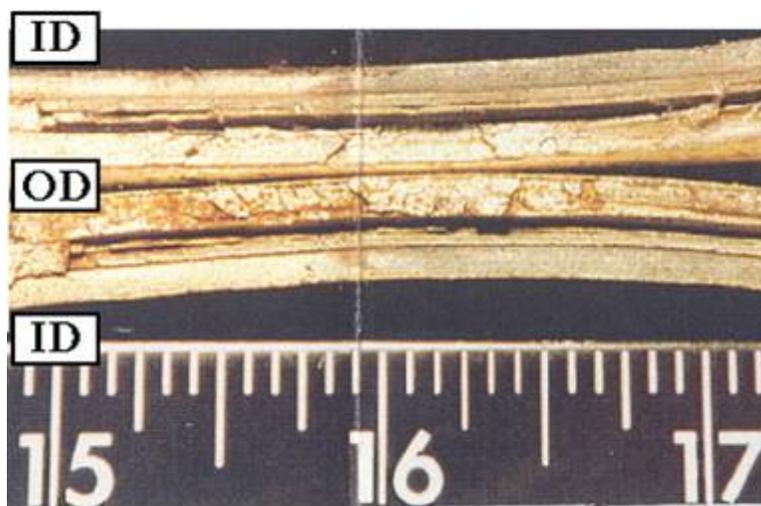
Catalog #: 24
 Report #: 2
 Defect #: 551-39.6.b

Photographs of Fracture Surfaces.

NDE technique(s): UT
 NDE result(s): 80%, 5.5 inch (140 mm)
 ID crack like
 Visual: ID Hook crack
 L: 7.0 inch (178 mm)
 $\text{depth}/t_{\text{weld}}$: 35%
 depth: 0.120 inch (3.05 mm)
 t_{weld} : 0.346 inch (8.79 mm)

(*) Burst test failed two adjacent hook cracks at one pressure.

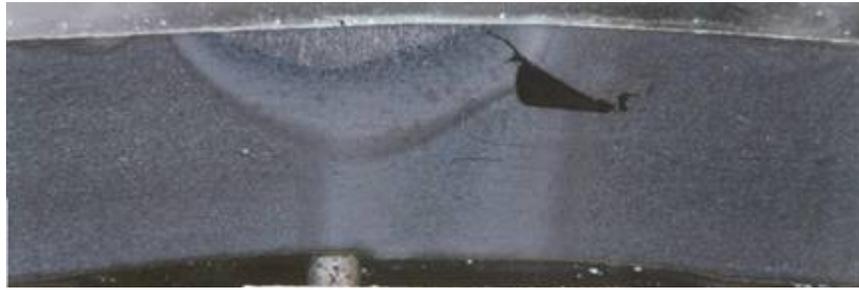
Photograph and Photomicrograph of Metallographic Section.

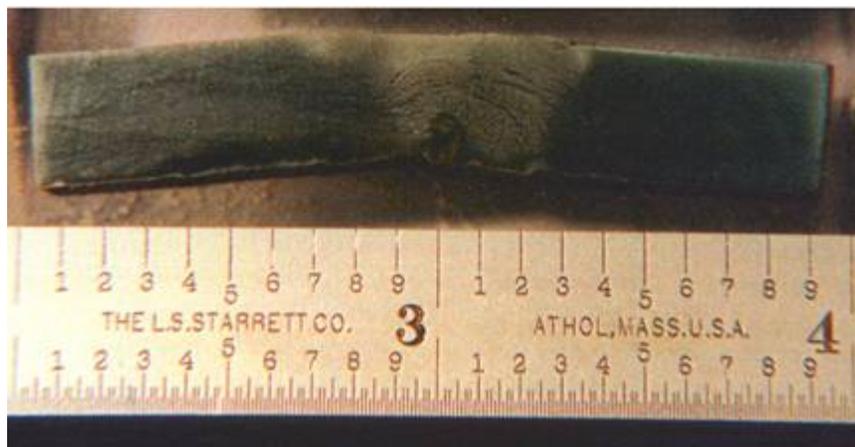
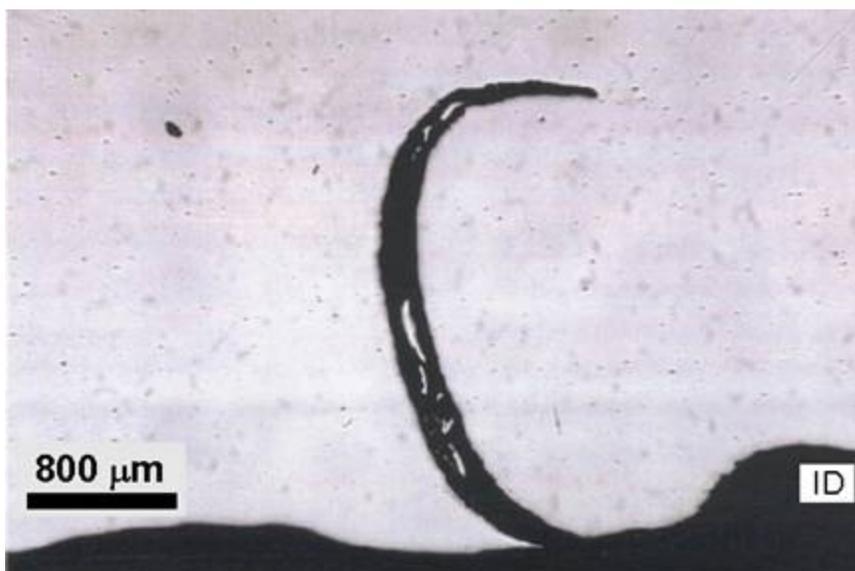
Photograph and Photomicrograph Metallographic Section.

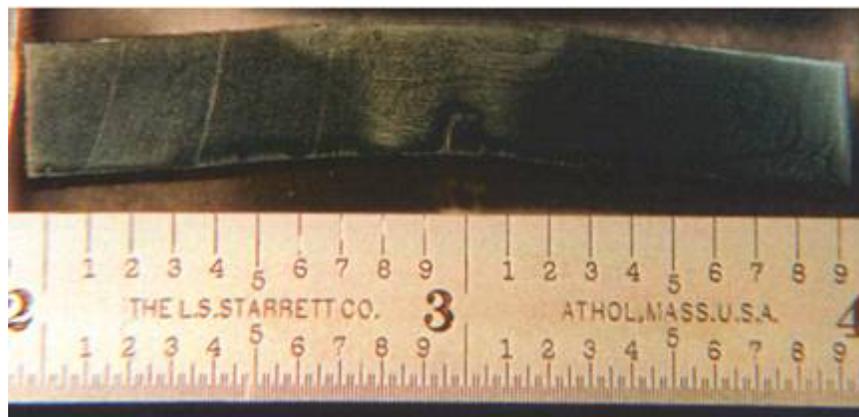
Photograph and Photomicrograph of Metallographic Section.

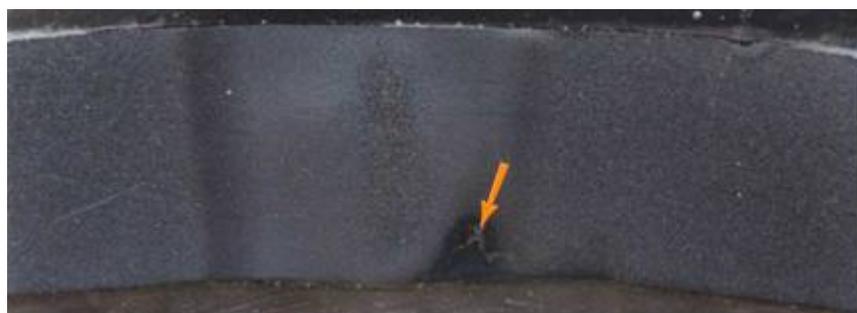
Catalog #: 106
 Report #: 11
 Defect #: 3D

Photograph and Photomicrograph of Metallographic Section.

NDE technique(s): Fast UT
 NDE result(s): 30%, 2.5 inch (63 mm) ID Crack
 ID Hook Crack Mid-wall Void
 Visual: Not Determined
 depth/ t_{weld} : 24.2% (ID Hook Crack)
 depth: Not Determined
 t_{weld} : Not Determined

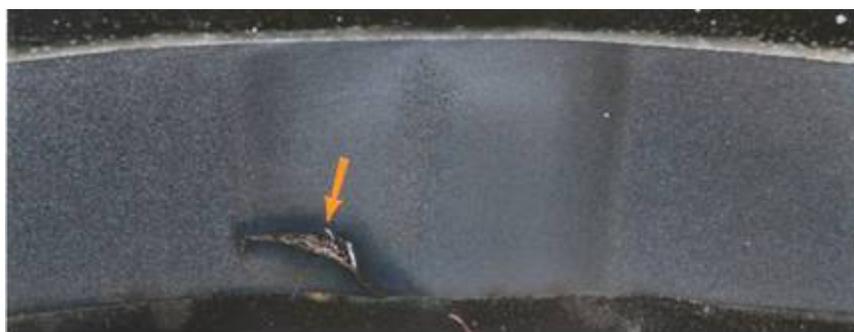
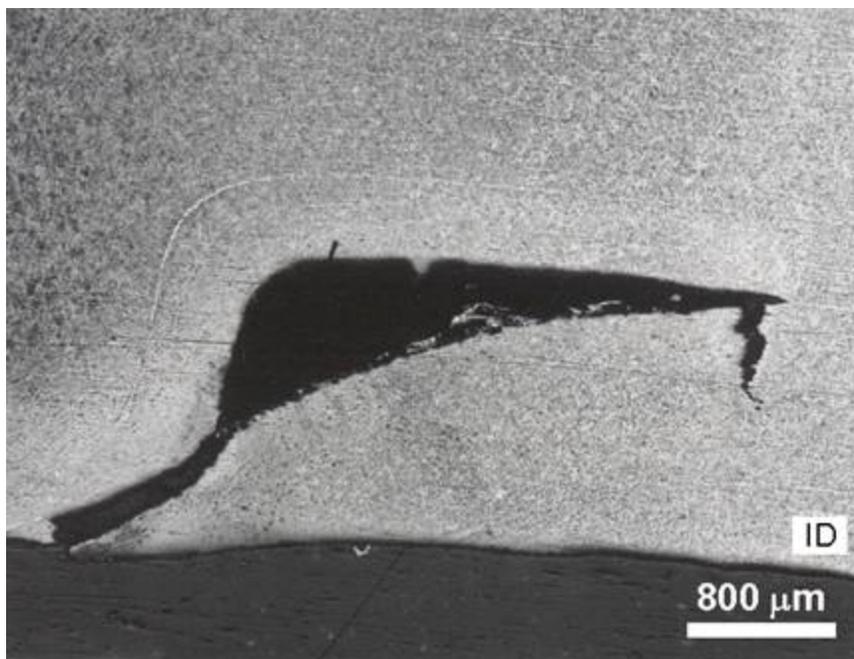
Catalog #: 103

Photograph and Photomicrograph of Metallographic Section.

NDE result(s): 25%, 4 inch
(102 mm) ID Crack
ID Hook Crack Mid-
Wall Void

L depth/ t_{weld} : 24% (ID Hook Crack)

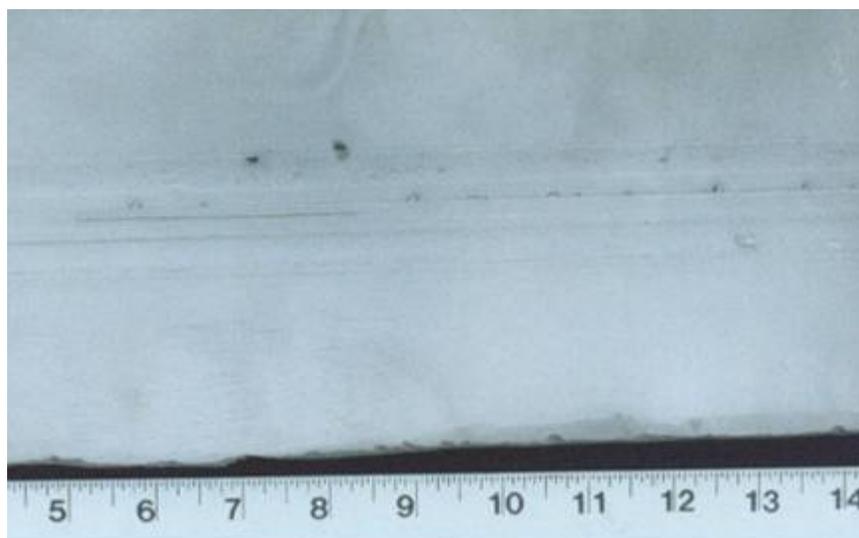
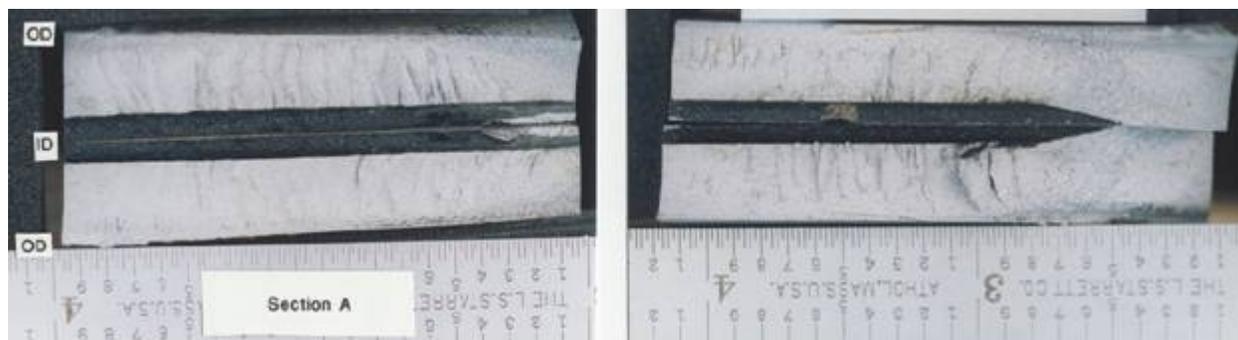
Catalog #: 32
 Report #: 3
 Defect #: 16

Photographs of ID Pipe Surface and of Fracture Surfaces.

NDE technique(s): UT
 NDE result(s): 40%, 4 inch (102 mm)
 ID hook crack
 Visual: ID Hook crack
 >3.64 inch (92.5 mm)
 depth/ t_{weld} : 23%
 depth: 0.083 inch (2.1 mm)
 t_{weld} : 0.365 inch (9.27 mm)

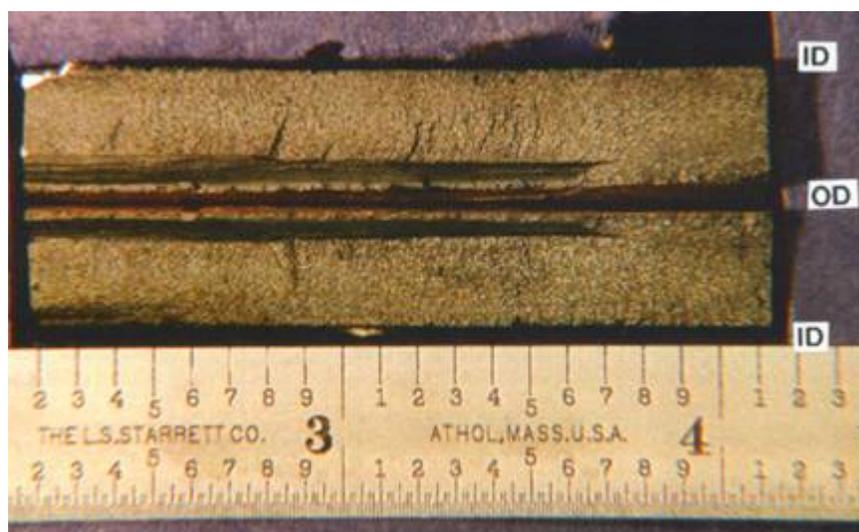
Catalog #: 10
 Report #: 1
 Defect #: 490

Photograph of Fracture Surfaces.

NDE technique(s): UT
 NDE result(s): 30% x 2.63 inch
 (66.7 mm) OD crack
 OD hook crack
 ~ 3.1 inch (79 mm)
 depth/ t_{weld} : 23%
 depth: 0.096 inch (2.44 mm)
 t_{weld} : 0.340 inch (8.64 mm)

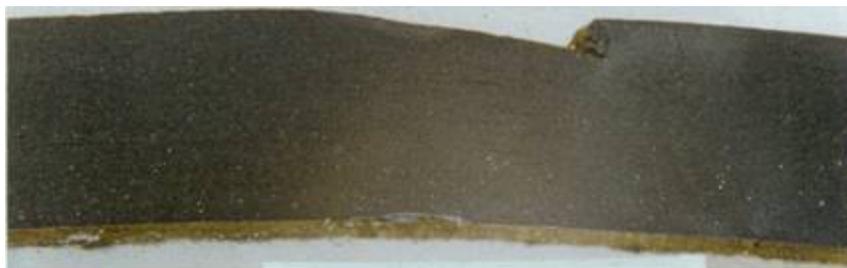
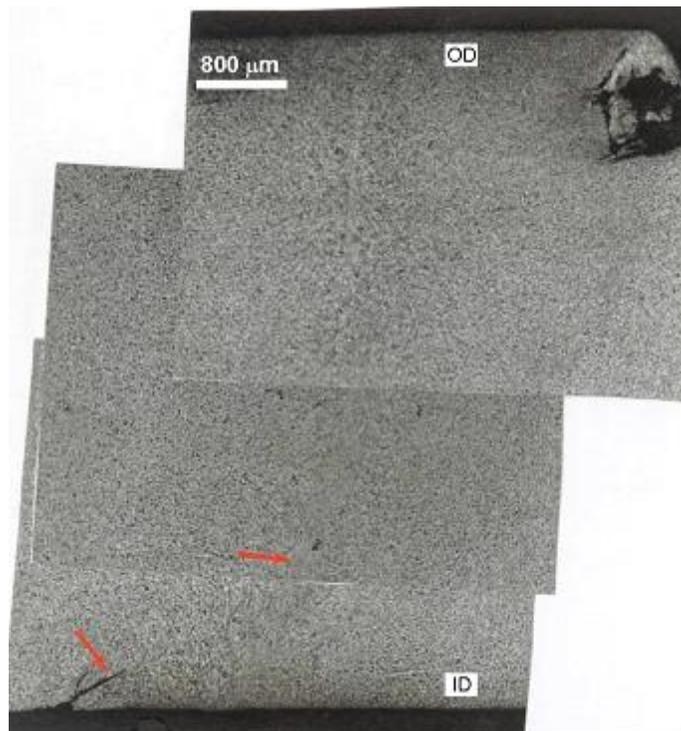
Catalog #: 125
 Report #: 12
 Defect #: 62A

Photograph and Photomicrograph of Metallographic Section.

Visual: Non-Fusion or Lamination
 Misalignment + Hook Crack + Alloy Segregation

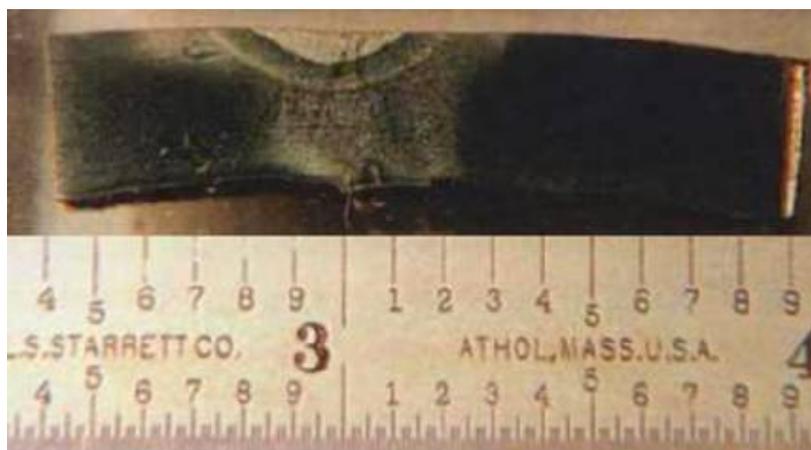
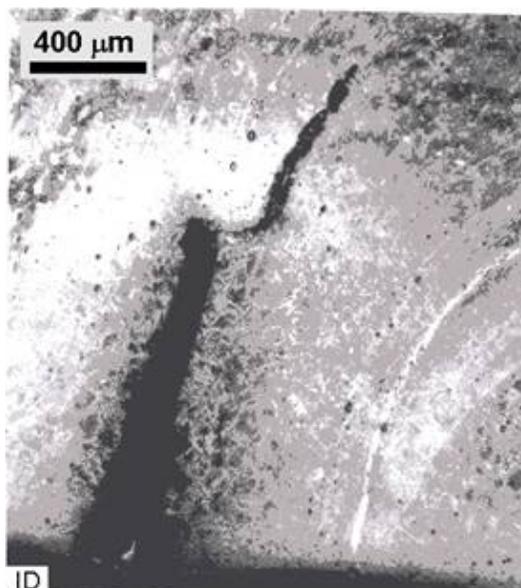
Catalog #: 8
 Report #: 1
 Defect #: 451

Photograph and Photomicrograph of Metallographic Section.

NDE technique(s): UT
 NDE result(s): 7% x 2.5 inch
 (63 mm) grind area on seam
 Visual: ID hook crack
 L: N/A
 $\text{depth}/t_{\text{weld}}$: 4.3%
 depth: 0.0136 inch (0.35 mm)
 t_{weld} : 0.319 inch (8.10 mm)

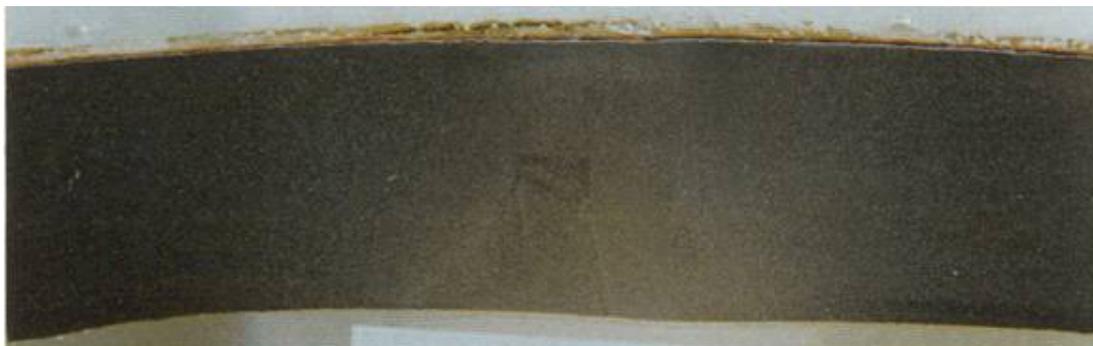
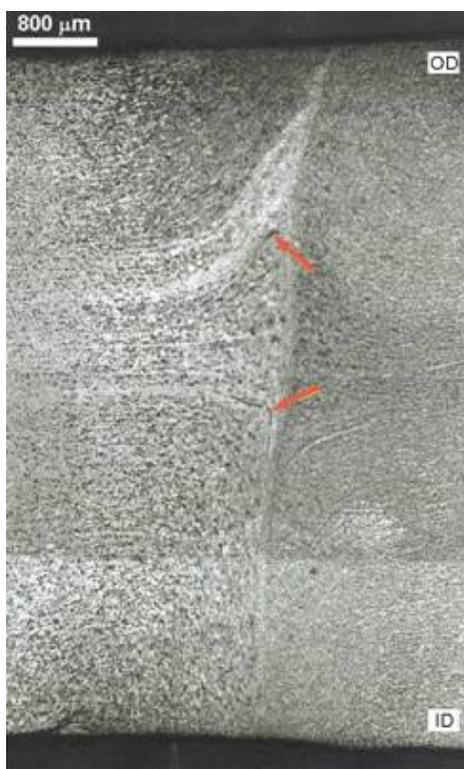
Catalog #: 112
 Report #: 12
 Defect #: 46B-B

Photograph and Photomicrograph of Metallographic Section.

NDE technique(s): Fast UT, MPI
 NDE result(s): N/A
 Visual: Hook Crack + Alloy Segregation

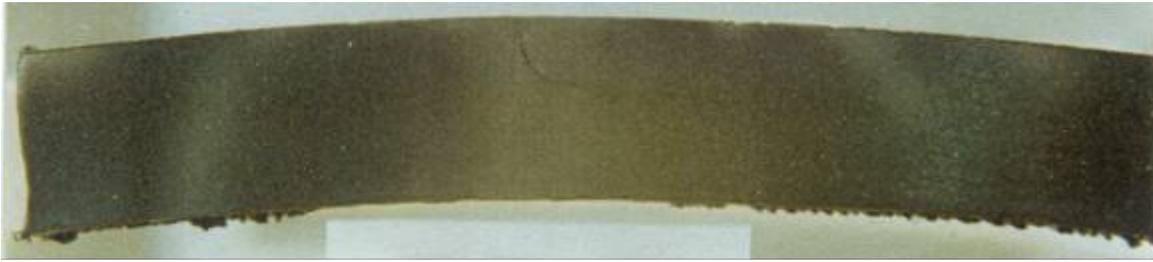
Catalog #: 143
 Report #: 12
 Defect #: 79B

Photograph and Photomicrograph of Metallographic Section.

NDE technique(s): TOFD, MPI
 NDE result(s): N/A
 Visual: Hook Crack + Alloy Segregation

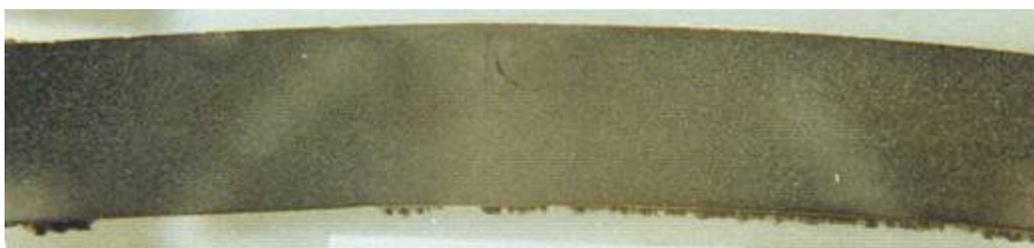
Catalog #: 144
 Report #: 12
 Defect #: 79C

Photograph and Photomicrograph of Metallographic Section.

Visual: OD Non-Fusion
 Hook Crack + Alloy Segregation

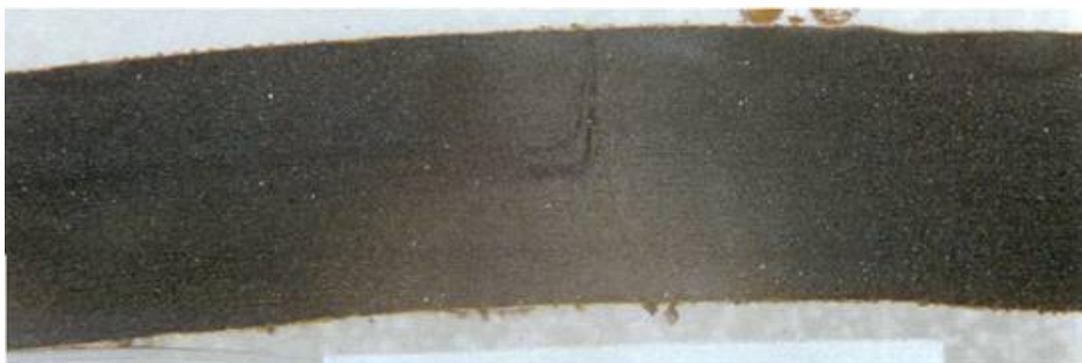
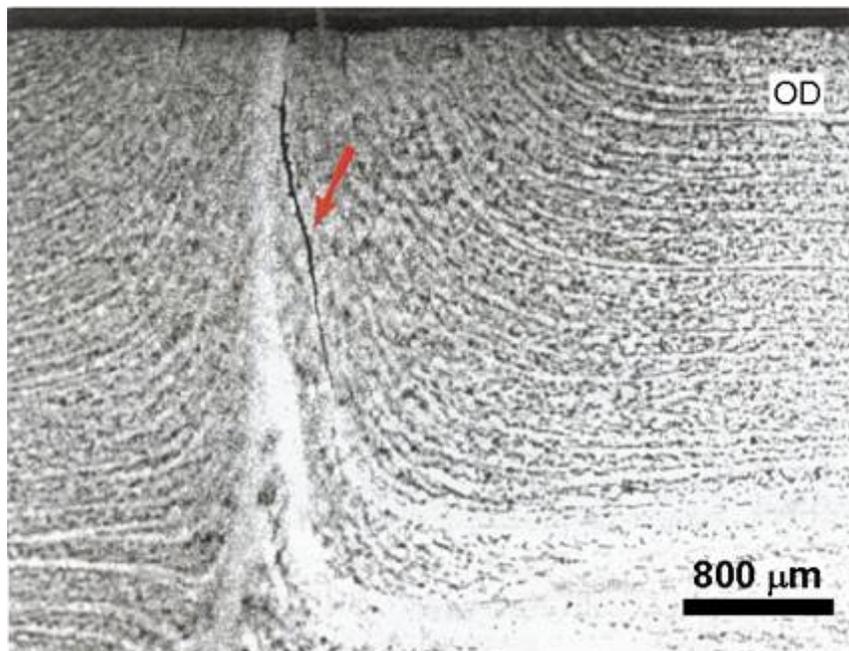
Catalog #: 141

Photograph and Photomicrograph of Metallographic Section.

Visual: OD Hook Crack + Alloy Segregation

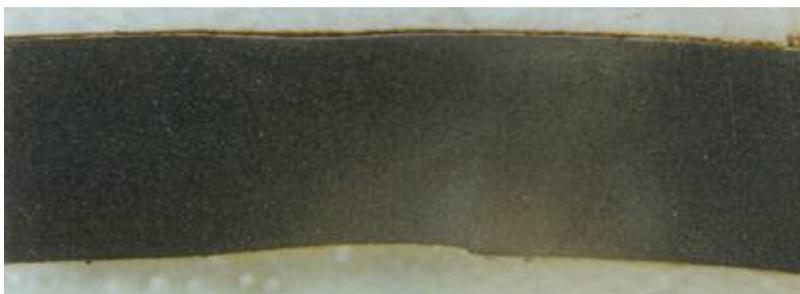
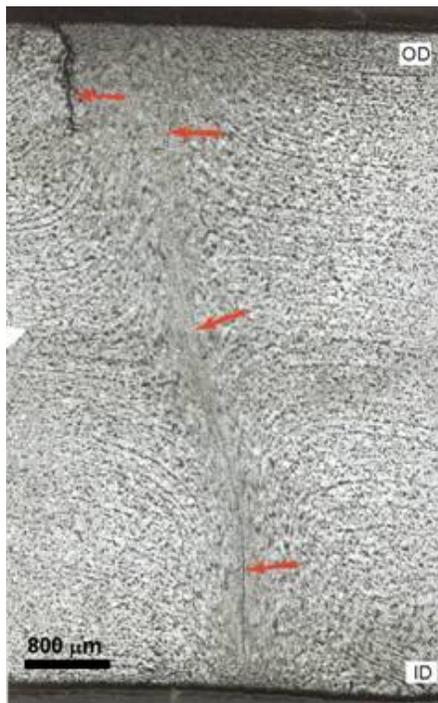
Catalog #: 145

Photograph and Photomicrograph of Metallographic Section.

Visual: Weld Area Crack, Weld

Crack + Misalignment +

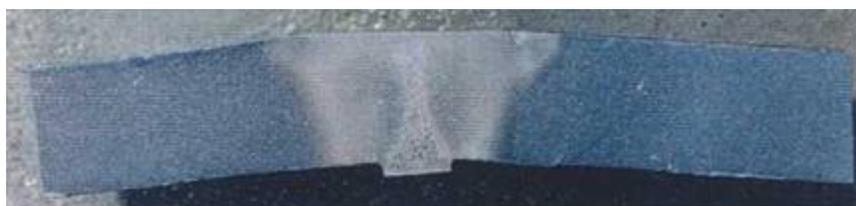
Catalog #: 100
 Report #: 10
 Defect #: CY-9

Photograph and Photomicrograph of Metallographic Section.

NDE technique(s): N/A
 NDE result(s): N/A
 Visual: OD Crack at Contact Mark + ID Under-trim
 Not Determined
 L
 $\text{depth}/t_{\text{weld}}$: < 7.0% (OD Crack)
 depth: < 0.024 inch (0.61 mm)
 t_{weld} : 0.344 inch (8.74 mm)

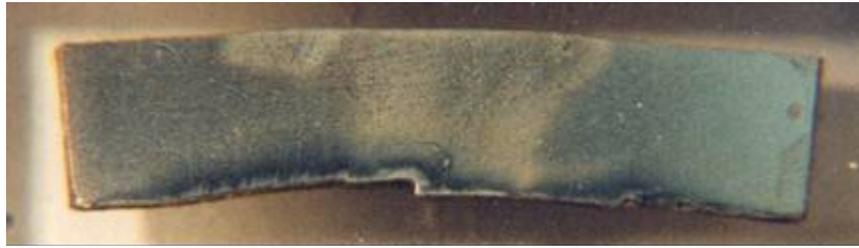
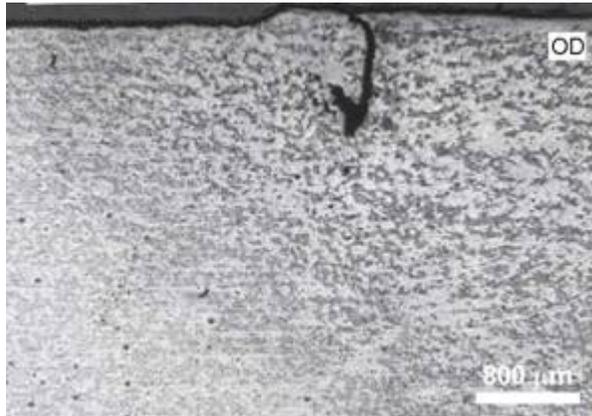
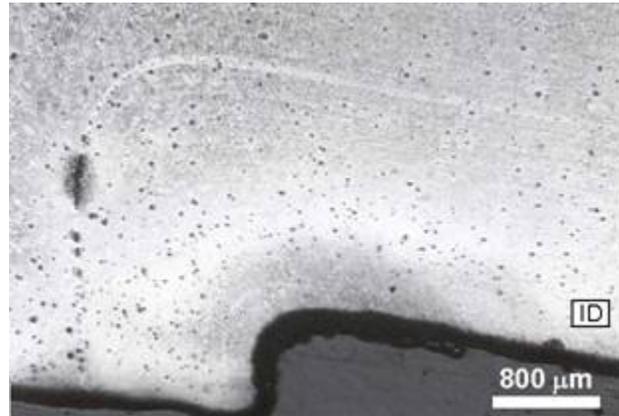
Catalog #: 63
 Report #: 7
 Defect #: 432-4.09

Photograph and Photomicrographs of Metallographic Section.

Visual: OD Crack + ID
 Outbent fiber +
 Contact Marks

Not Determined
 depth/ t_{weld} : 11% (OD Crack)
 depth: 0.036 inch (0.91 mm)
 (OD Crack)

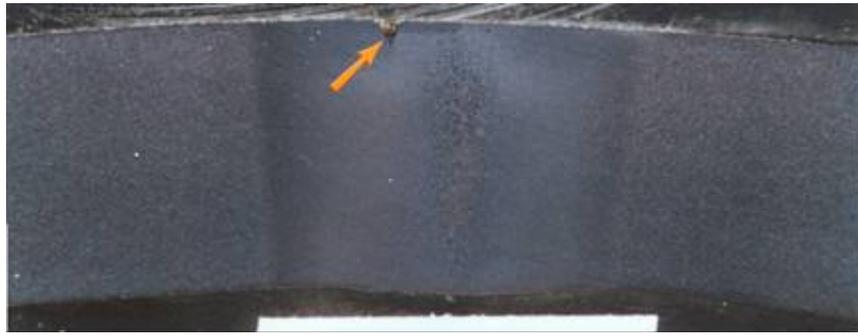
Catalog #: 107
 Report #: 11
 Defect #: 3E

Photograph and Photomicrograph of Metallographic Section.

NDE technique(s): Fast UT
 NDE result(s): 50%, 5 inch (127 mm)
 OD Crack
 Visual: OD Crack
 L: 5 inch (127 mm)
 depth/ t_{weld} : 9.2%
 depth: Not Determined
 t_{weld} : Not Determined

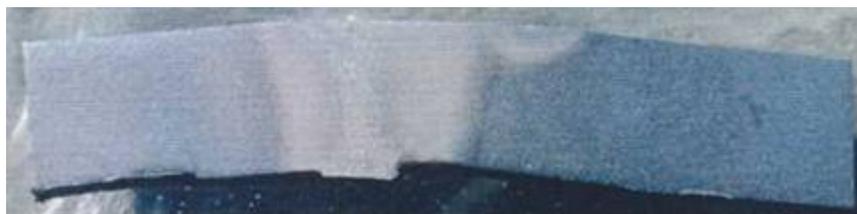
Catalog #: 93
 Report #: 10
 Defect #: CY-2

Photograph and Photomicrograph of Metallographic Section.

NDE technique(s): N/A
 NDE result(s): N/A
 Visual: OD Crack
 L: Not Determined
 $\text{depth}/t_{\text{weld}}$: 8.8%
 depth: 0.031 inch (0.79 mm)
 t_{weld} : 0.353 inch (8.97 mm)

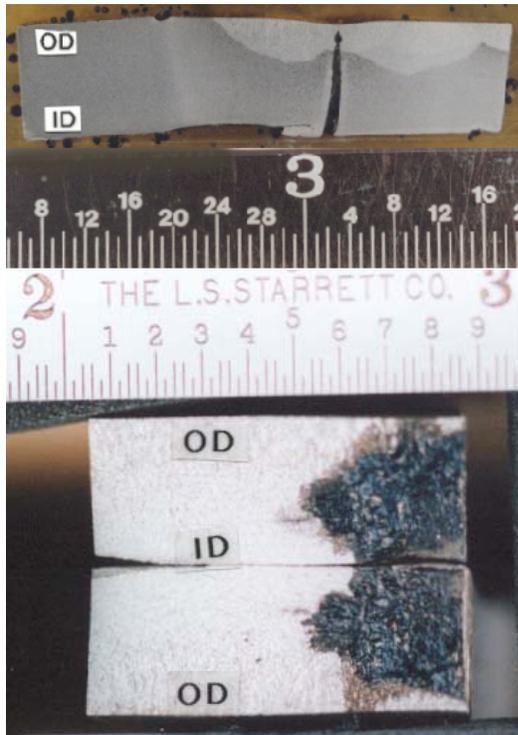
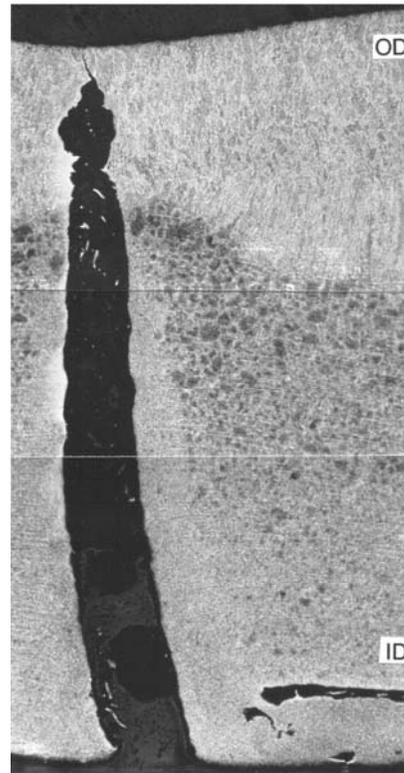
Catalog #: 29
 Report #: 3
 Defect #: 12A

Photographs and Photomicrograph of Metallographic Section, and Fracture Surfaces.

NDE technique(s): UT, MT, and Fast UT
 12 x 7 inch (305 x 178 mm)
 OD seam grind area (UT) +
 11 x 1.0 inch (280 x 25.4 mm)
 OD weld repair (UT) +
 0.4 x 0.1 inch (10.2 x 2.5 mm)
 OD grind area (UT) +
 0.25 inch (6.35 mm) OD crack (MT) +
 100%, 1.9 inch (48.3 mm) ID hook crack (Fast UT)
 ID Lack of Fusion & Small crack
 1.9 inch (48 mm)
 99%
 depth: 0.317 inch (8.05 mm)
 t_{weld} : 0.332 inch (8.43 mm)

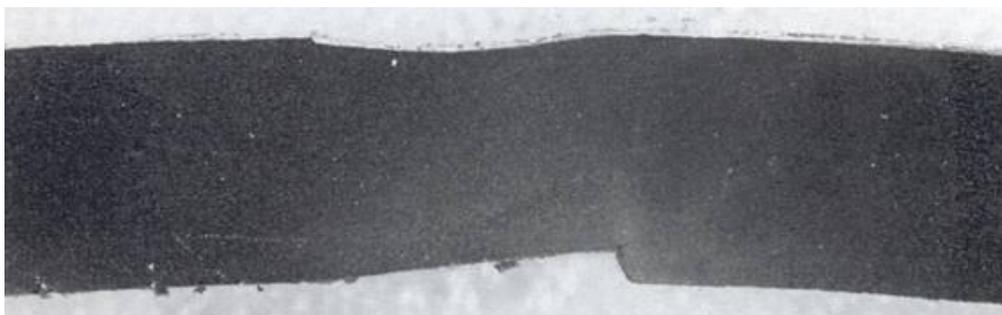
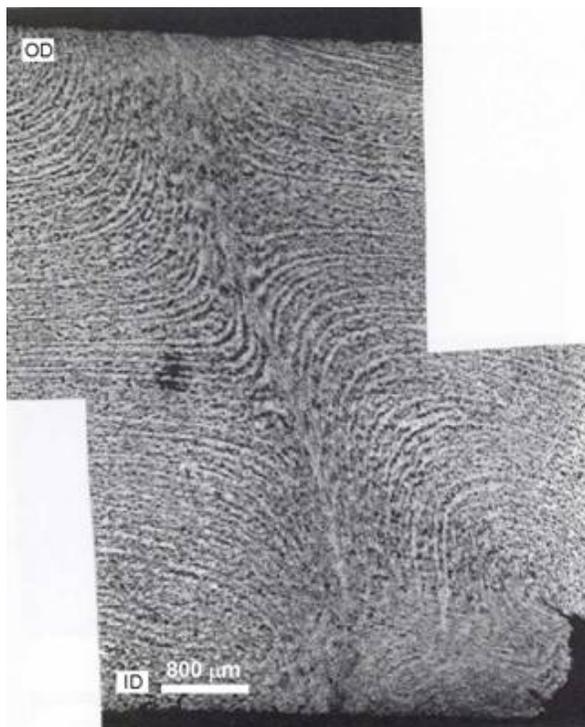
Catalog #: 139
 Report #: 12
 Defect #: 73B

Photograph and Photomicrograph of Metallographic Section.

Visual: ID Extrusion Cracks +
 Alloy Segregation +
 Misalignment
 Not Determined
 L
 $\text{depth}/t_{\text{weld}}$: 16% (Misalignment)
 depth: 0.043 inch (1.1 mm)
 t_{weld} : 0.262 inch (6.65 mm)

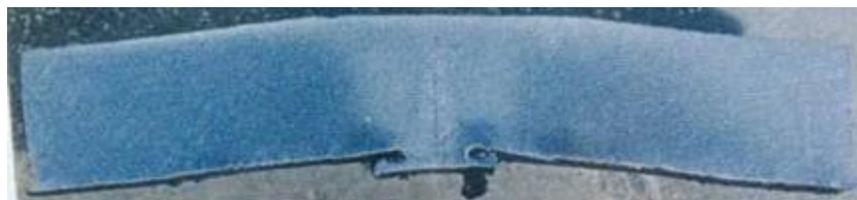
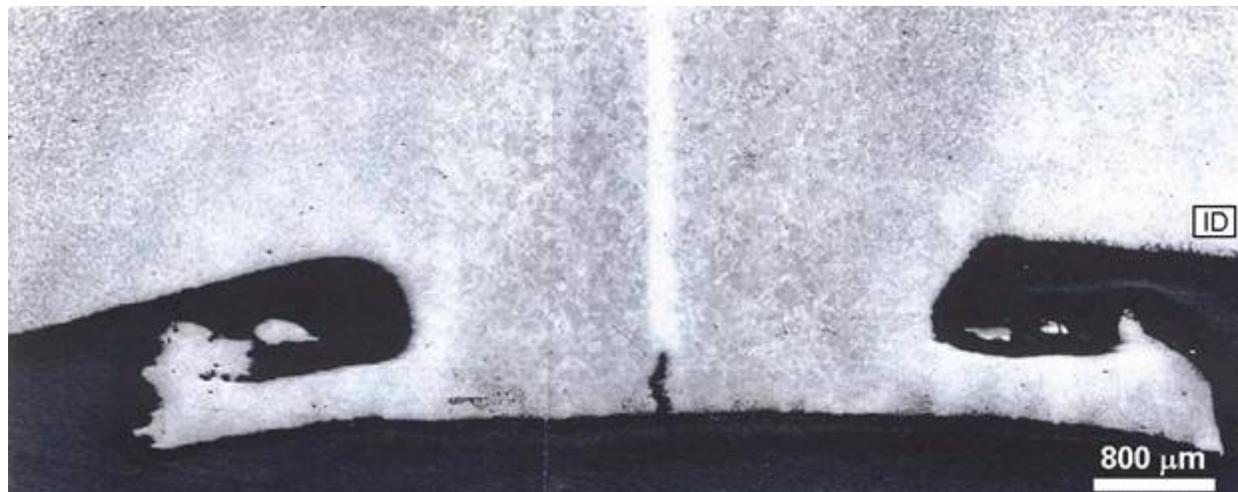
Catalog #: 101
 Report #: 10
 Defect #: CY-10

Photograph and Photomicrograph of Metallographic Section.

NDE technique(s): N/A
 NDE result(s): N/A
 Visual: ID Crack + ID Under-trim
 L: Not Determined
 $\text{depth}/t_{\text{weld}}$: 4.2% (ID Crack)
 depth: 0.015 inch (0.38 mm)
 t_{weld} : 0.350 inch (8.89 mm)

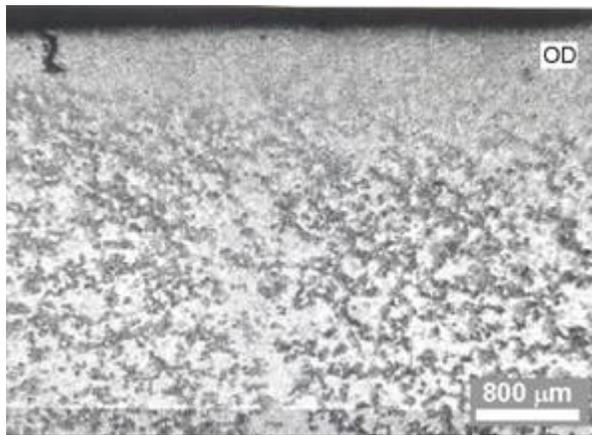
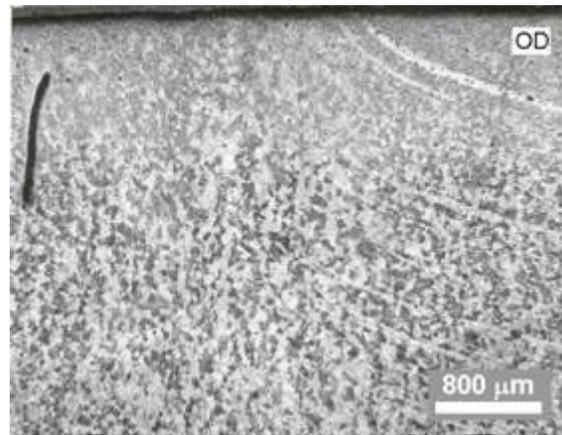
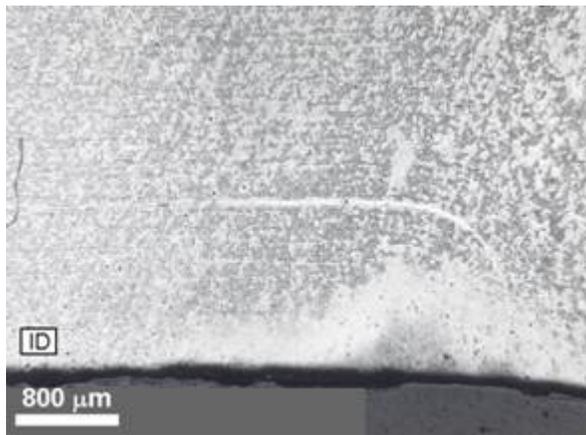
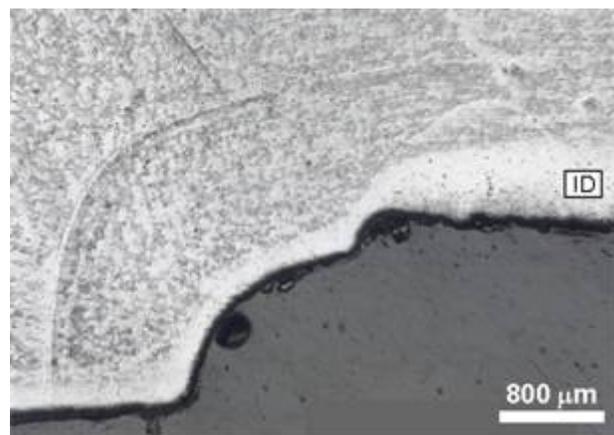
Catalog #: 64
 Report #: 7
 Defect #: 432-23/32/36/48

Photomicrographs of Metallographic Sections.

NDE technique(s): Fast UT
 NDE result(s): No Anomaly Revealed
 Visual: ID & OD Outbent fibers + OD Crack + Contact Marks
 L: N/A
 depth/ t_{weld} : N/A
 depth: N/A
 t_{weld} : 0.319 inch (8.1 mm)

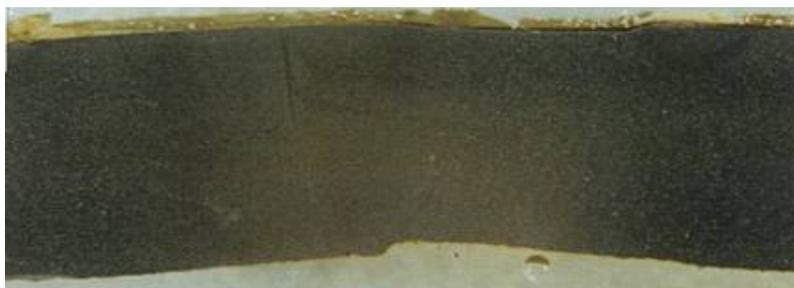
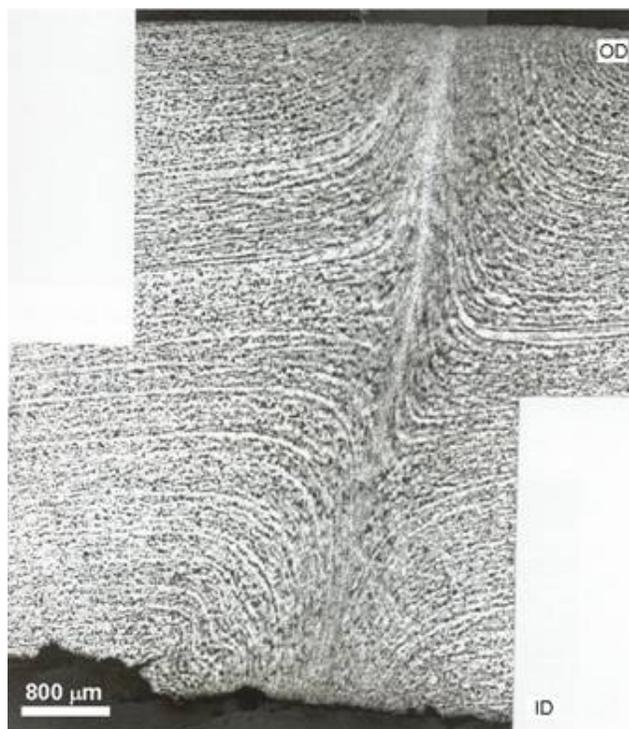
Catalog #: 130

Photograph and Photomicrograph of Metallographic Section.

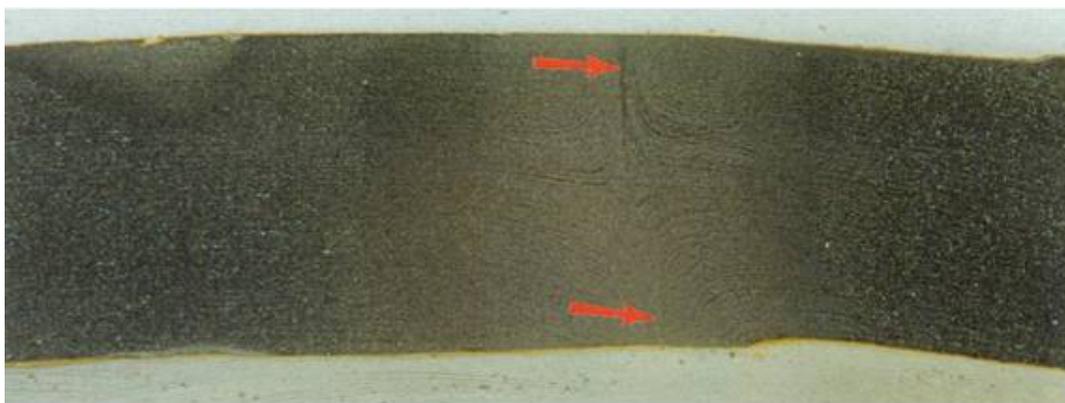
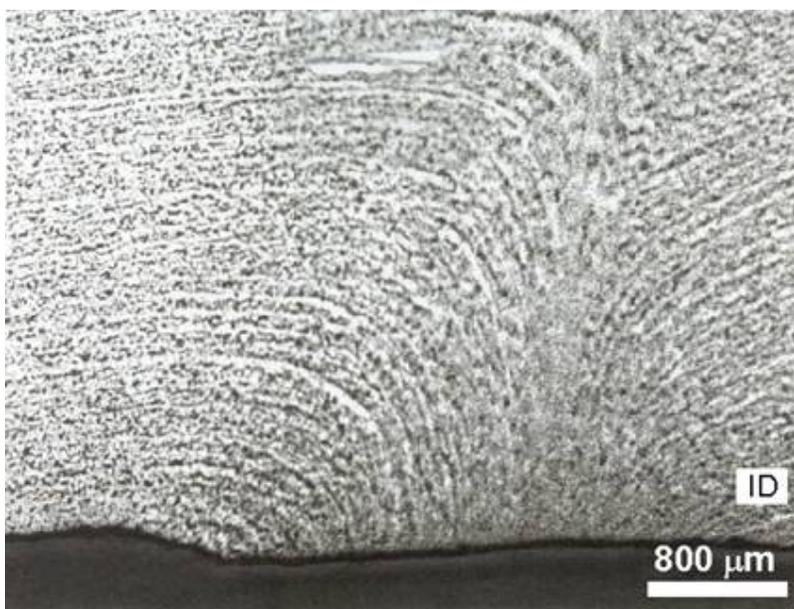
Catalog #: 129

Photograph and Photomicrograph of Metallographic Section.

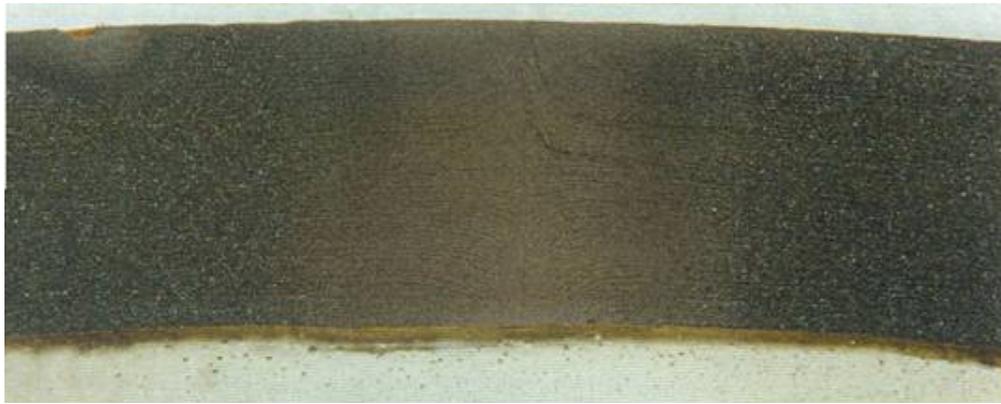
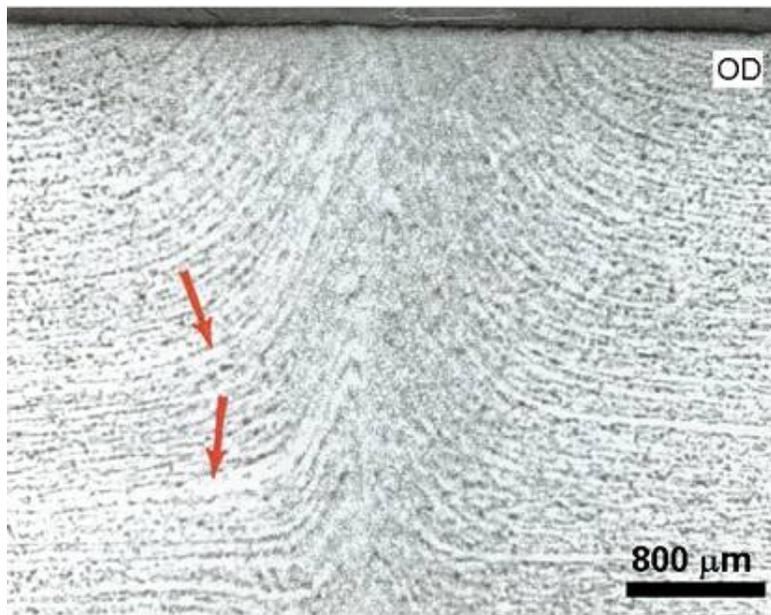
Catalog #: 131
 Report #: 12
 Defect #: 67F

Photograph and Photomicrograph of Metallographic Section.

Mid-Wall Non-Fusion
 Misalignment + Alloy
 Segregation

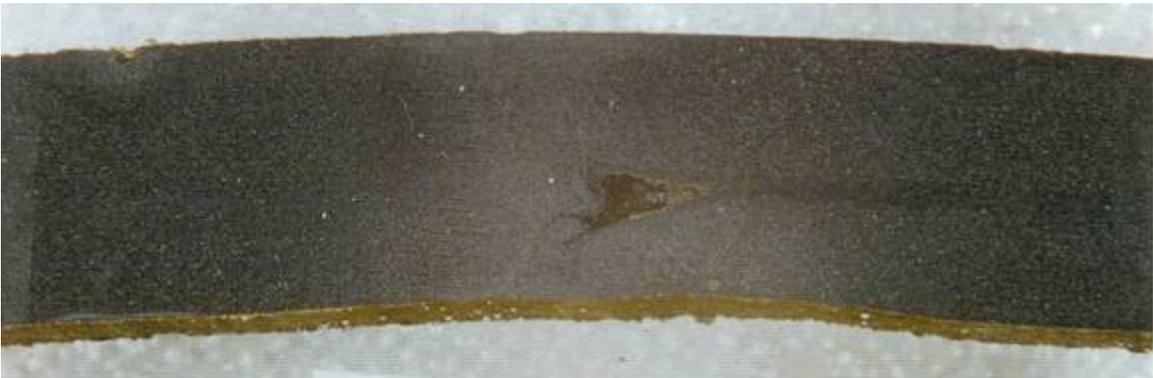
Catalog #: 127

Photograph of Metallographic Section.

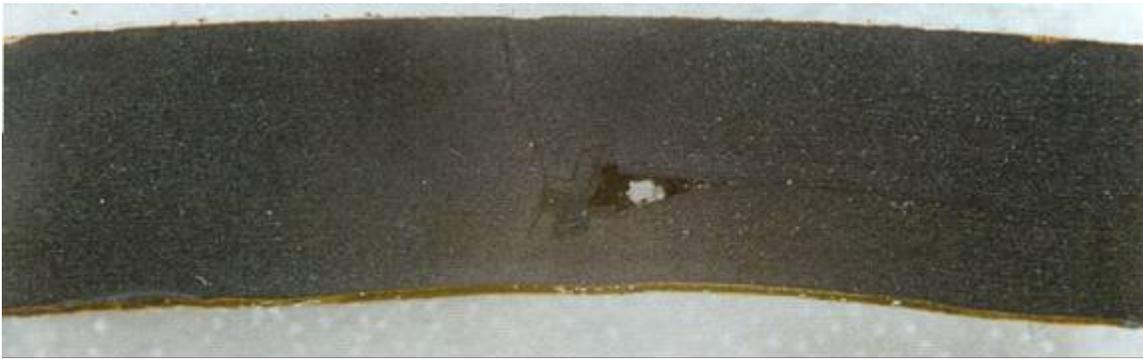
Catalog #: 128
 Report #: 12
 Defect #: 67C

Photograph of Metallographic Section.

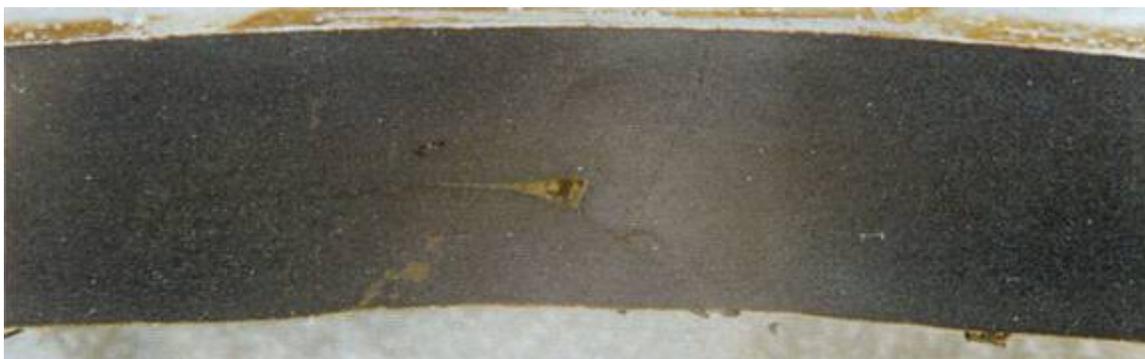
Catalog #: 132

Photograph of Metallographic Section.

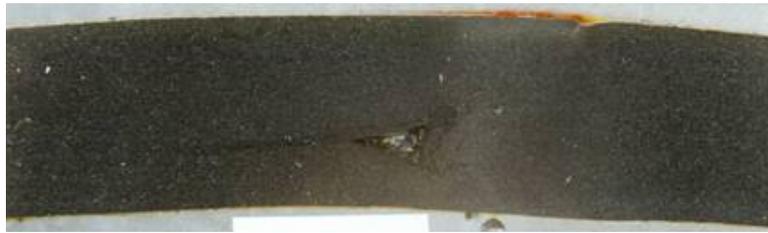
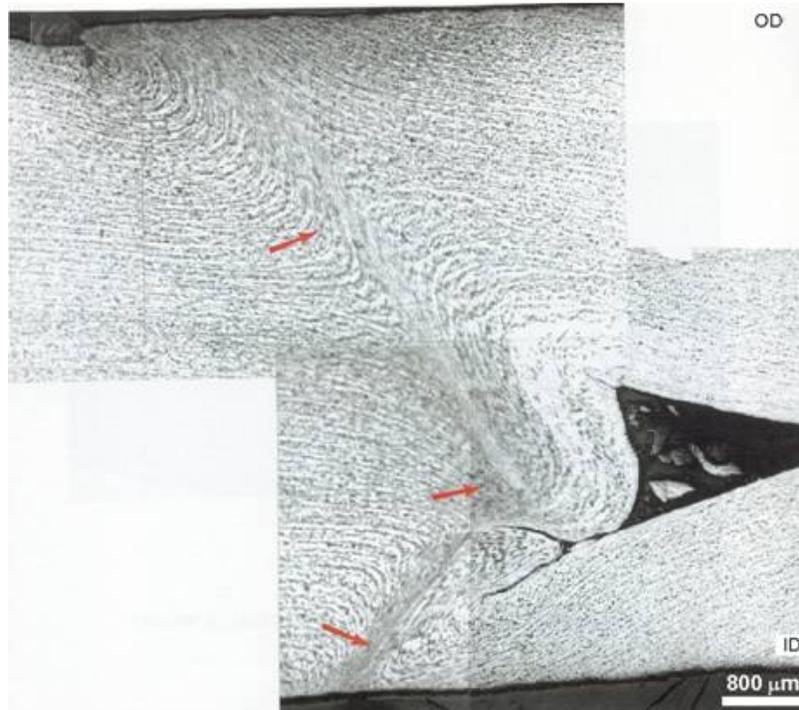
Catalog #: 117
 Report #: 12
 Defect #: 52B

Photograph and Photomicrograph of Metallographic Section.

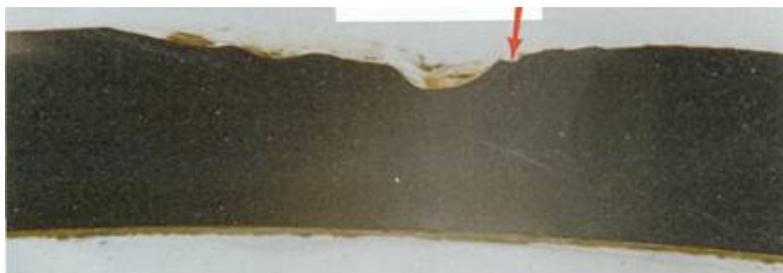
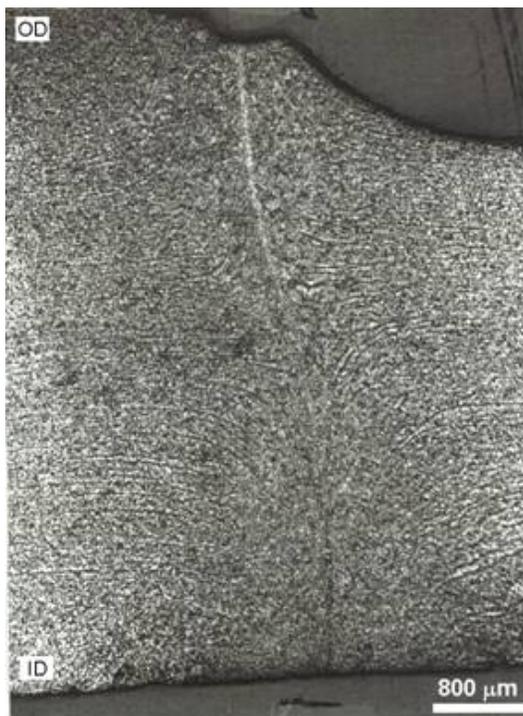
Catalog #: 119
 Report #: 12
 Defect #: 53A

Photograph and Photomicrograph of Metallographic Section.

Visual: External Corrosion on Seam + Alloy Segregation + Misalignment

L
 $\text{depth}/t_{\text{weld}}$: Not Determined
 depth : 29% (Corrosion)
 t_{weld} : 0.075 inch (1.9 mm)
 0.257 inch (6.98 mm)

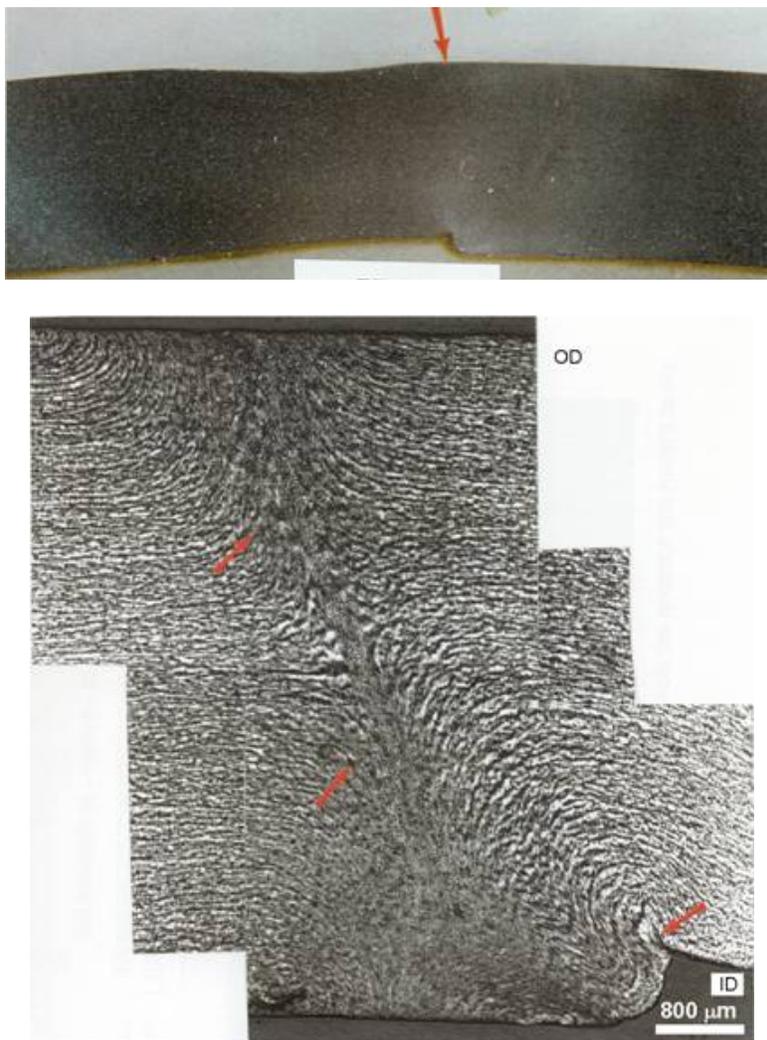
Catalog #: 121
 Report #: 12
 Defect #: 57B

Photograph and Photomicrograph of Metallographic Section.

Visual: Gouge (Near Seam)
 Alloy Segregation + Misalignment

L: Not Determined
 $\text{depth}/t_{\text{weld}}$: 14%
 depth: 0.038 inch (0.96 mm)
 t_{weld} : 0.263 inch (6.68 mm)
