Appendix B – Task 2
Catalog of Seam Weld Defect Types

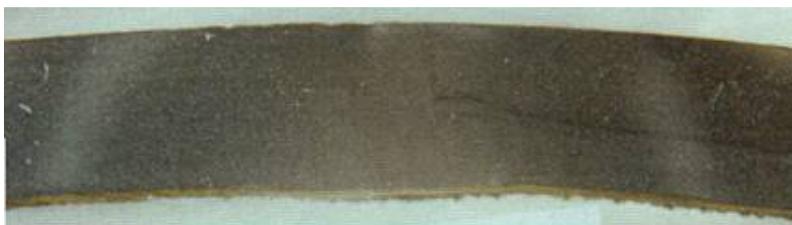
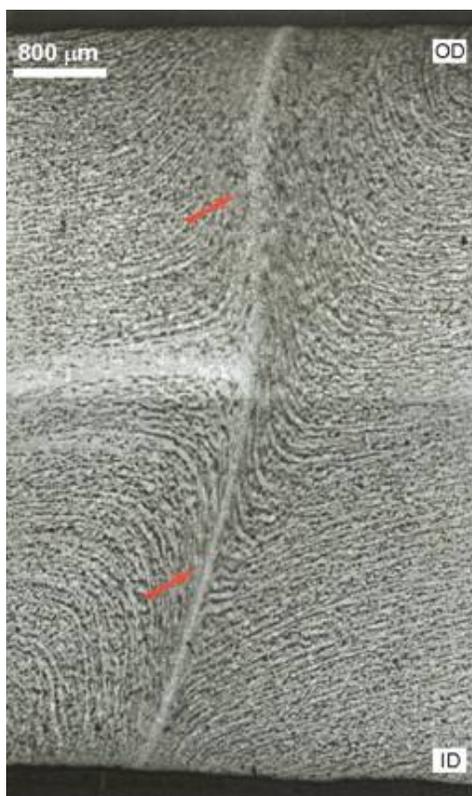
Catalog #: 116
 Report #: 12
 Defect #: 52A

Photograph and Photomicrograph of Metallographic Section.

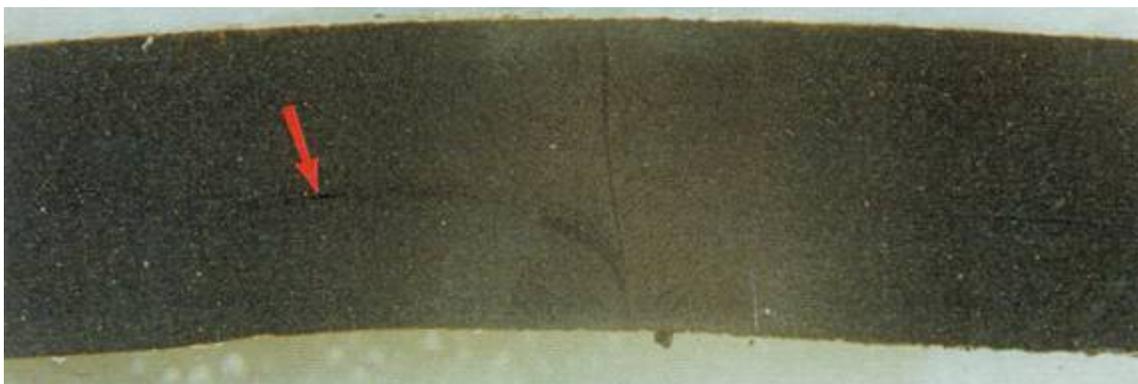
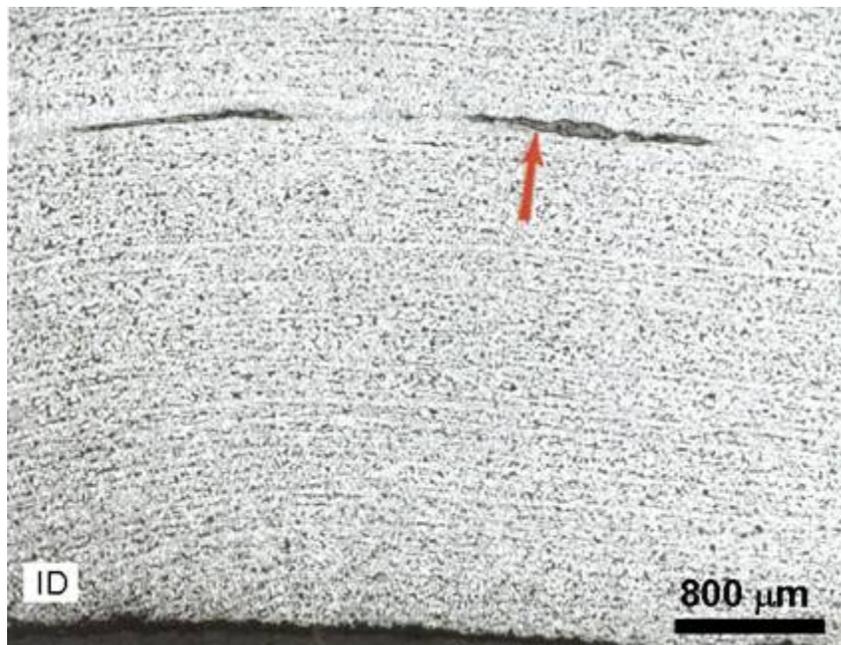
Catalog #: 133
 Report #: 12
 Defect #: 68B

Photograph and Photomicrograph of Metallographic Section.

Visual: Alloy Segregation +
 Misalignment

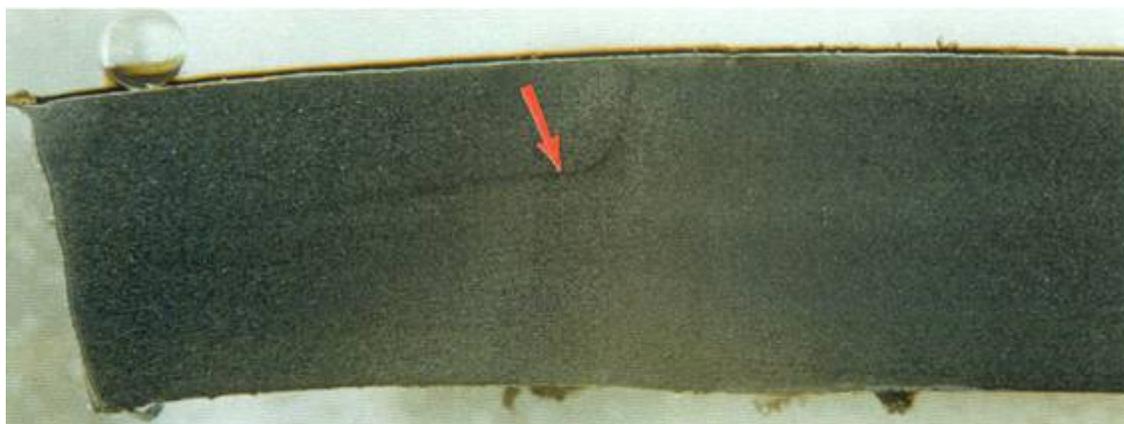
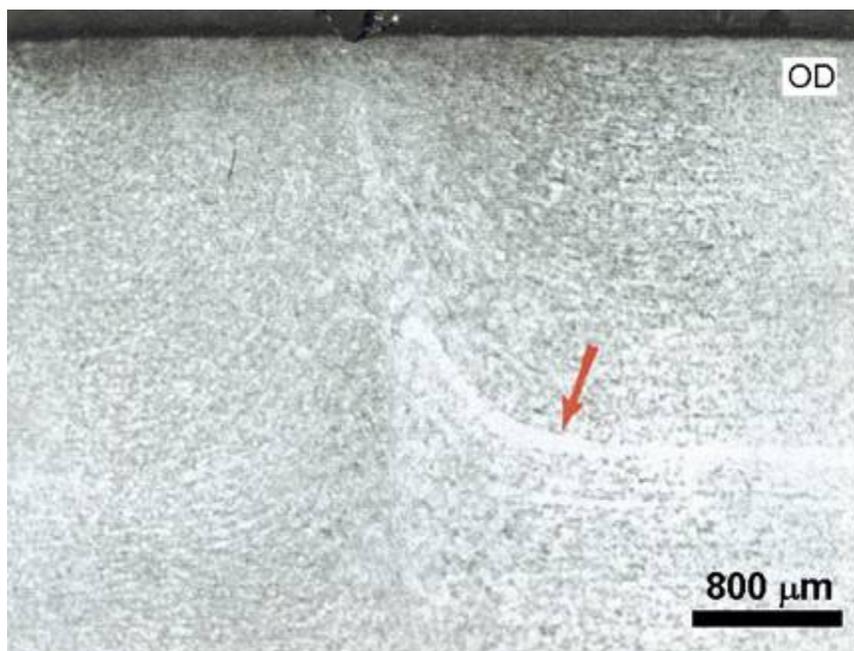
Catalog #: 113
 Report #: 12
 Defect #: 46B-C

Photograph and Photomicrograph of Metallographic Section.

NDE technique(s): Fast UT, MPI
 NDE result(s): N/A
 Visual: Alloy Segregation
 L: Not Determined
 depth/ t_{weld} : Not Determined
 depth: Not Determined
 t_{weld} : Not Determined

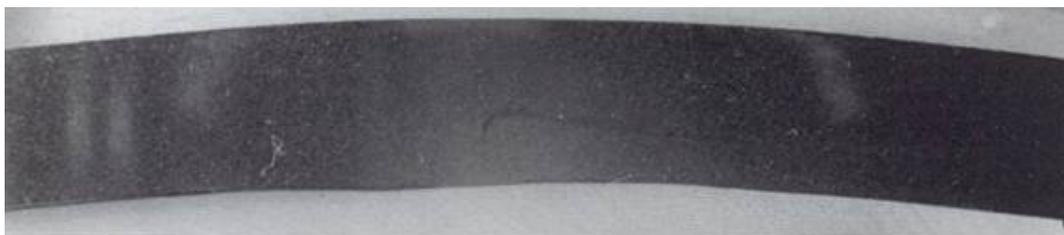
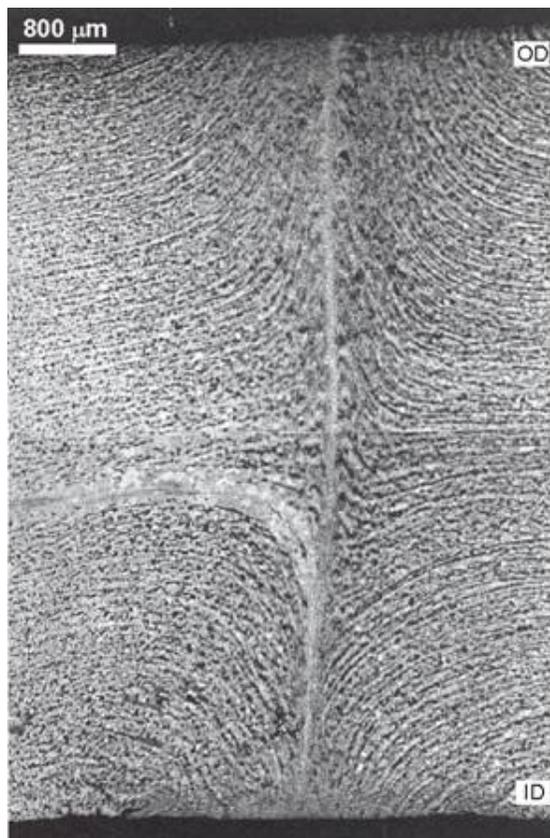
Catalog #: 118
 Report #: 12
 Defect #: 52C

Photograph and Photomicrograph of Metallographic Section.

NDE technique(s): Fast UT, MPI
 NDE result(s): N/A
 Visual: Alloy Segregation
 L: Not Determined
 depth/ t_{weld} : Not Determined
 depth: Not Determined
 t_{weld} : Not Determined

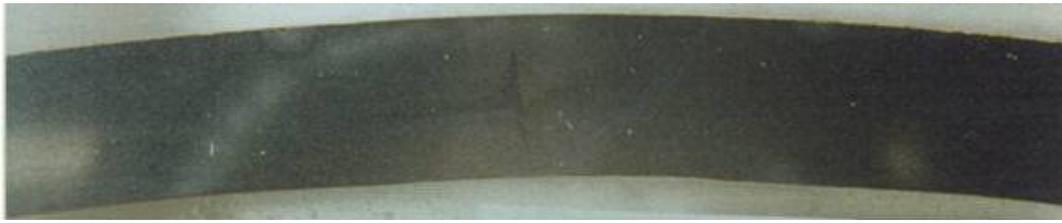
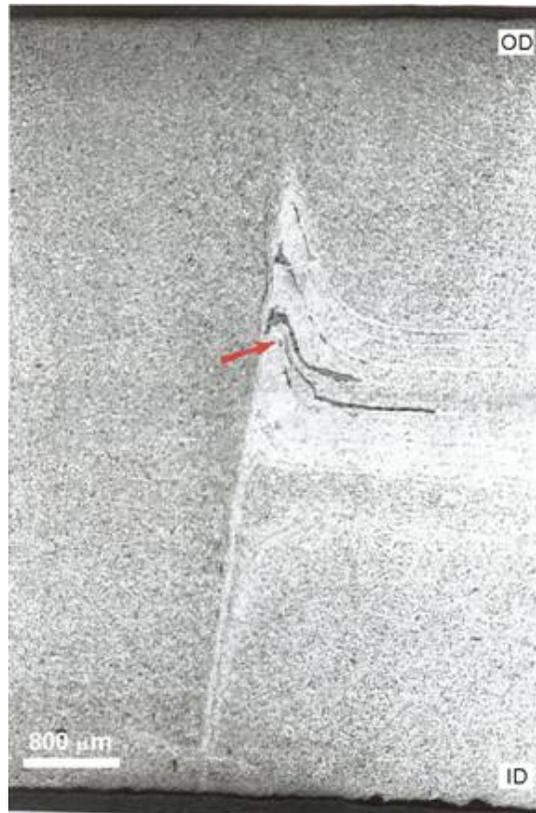
Catalog #: 137
 Report #: 12
 Defect #: 72C

Photograph and Photomicrograph of Metallographic Section.

Visual: Alloy Segregation
 L: Not Determined
 depth/ t_{weld} : Not Determined
 depth: Not Determined
 t_{weld} : Not Determined

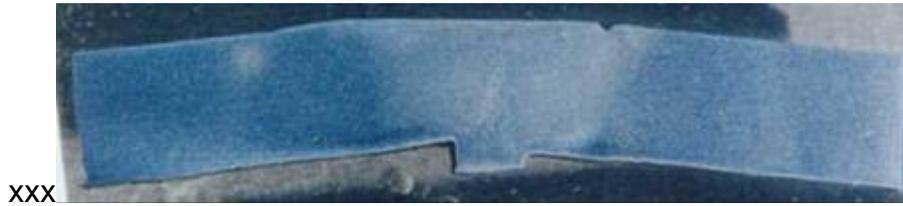
Photograph of Metallographic Section.

Catalog #:	95		
Report #:	10		
Defect #:	CY-4		
<u>Pipe</u>		<u>Defect</u>	
Vintage:	circa 1950	NDE technique(s):	N/A
Manufacturer:	Youngstown	NDE result(s):	N/A
Seam Type:	ERW	Visual:	Offset Plate Edges + OD Notch
Grade:	X52	L	Not Determined
D_{nominal}	20 inch (508 mm)	depth/ t_{weld}	Not Determined
t_{nominal}	0.312 inch (7.92 mm)	depth:	Not Determined
t_{pipe}	0.280 inch (7.11 mm) (at offset)	t_{weld}	Not Determined
Failure:	N/A

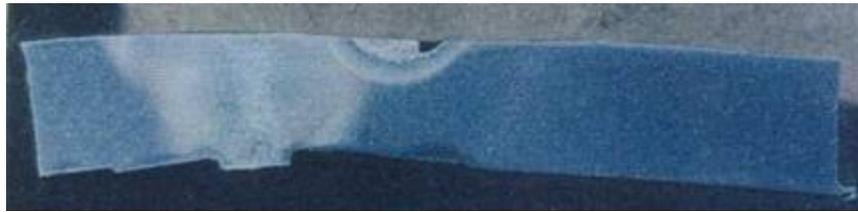
Photograph and Photomicrograph of Metallographic Section.

Catalog #:	96		
Report #:	10		
Defect #:	CY-5		
Pipe		Defect	
Vintage:	circa 1950	NDE technique(s):	N/A
Manufacturer:	Youngstown	NDE result(s):	N/A
Seam Type:	ERW	Visual:	Offset Plate Edges + OD Notch
Grade:	X52	L	Not Determined
D_{nominal}	20 inch (508 mm)	depth/ t_{weld}	Not Determined
t_{nominal}	0.312 inch (7.92 mm)	depth:	Not Determined
t_{pipe}	0.260 inch (6.60 mm) (at offset)	t_{weld}	Not Determined
Failure:	N/A

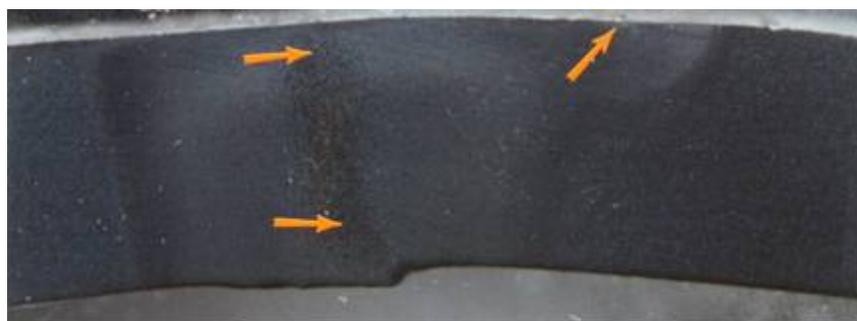
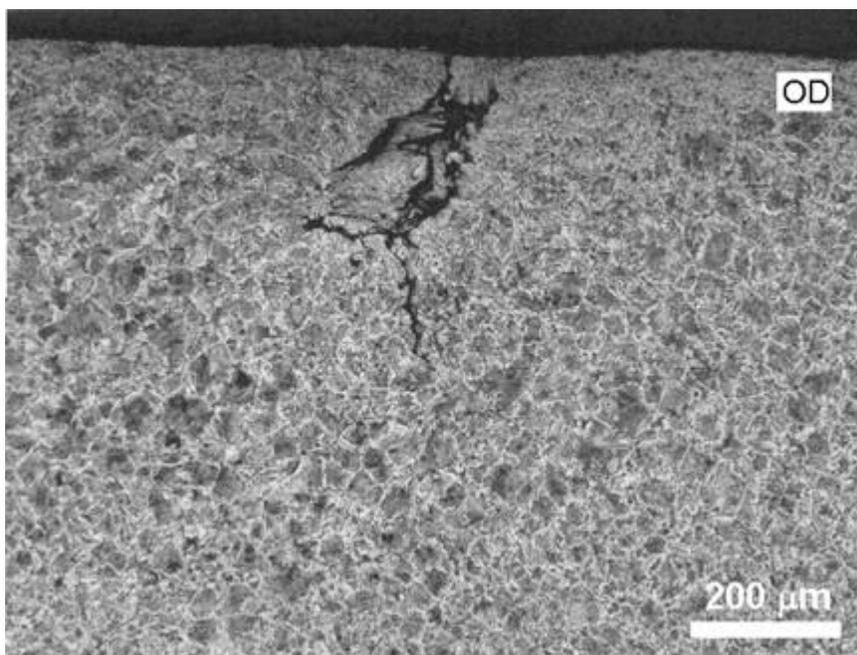
Catalog #: 102

Photograph and Photomicrograph of Metallographic Section.

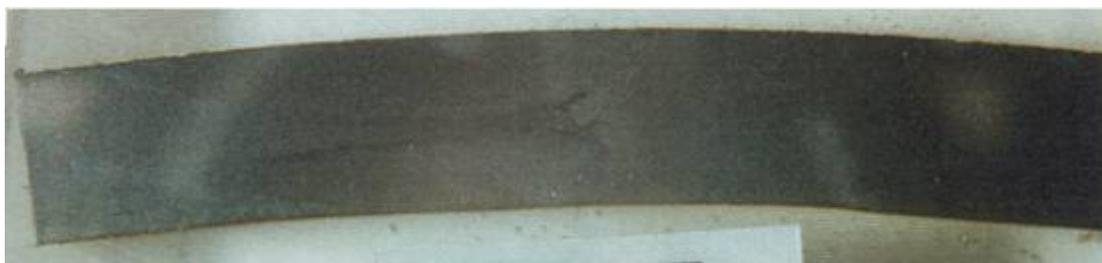
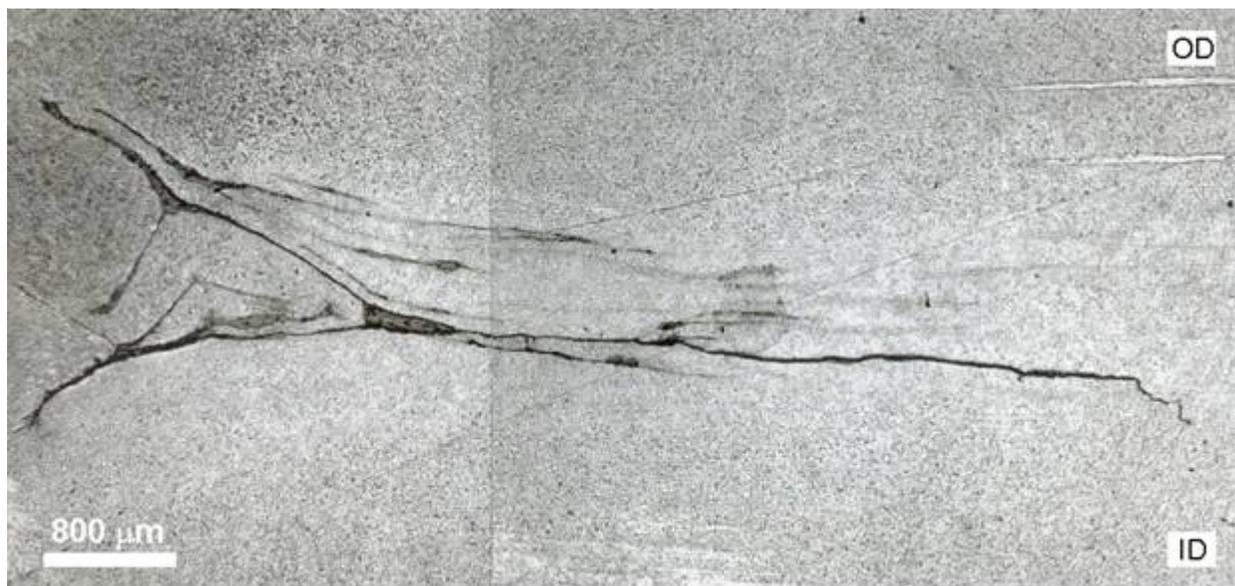
Catalog #: 138

Photograph and Photomicrograph of Metallographic Section.

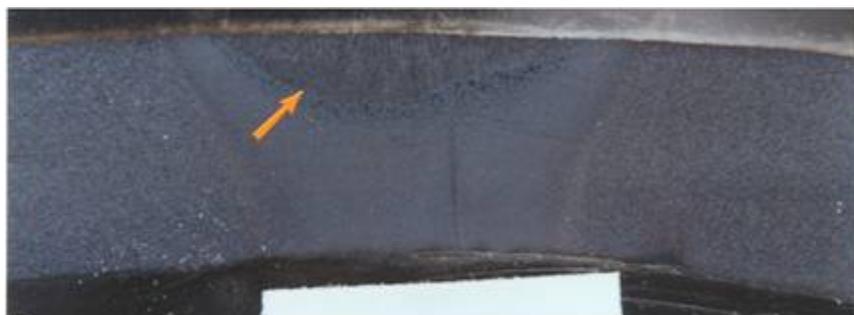
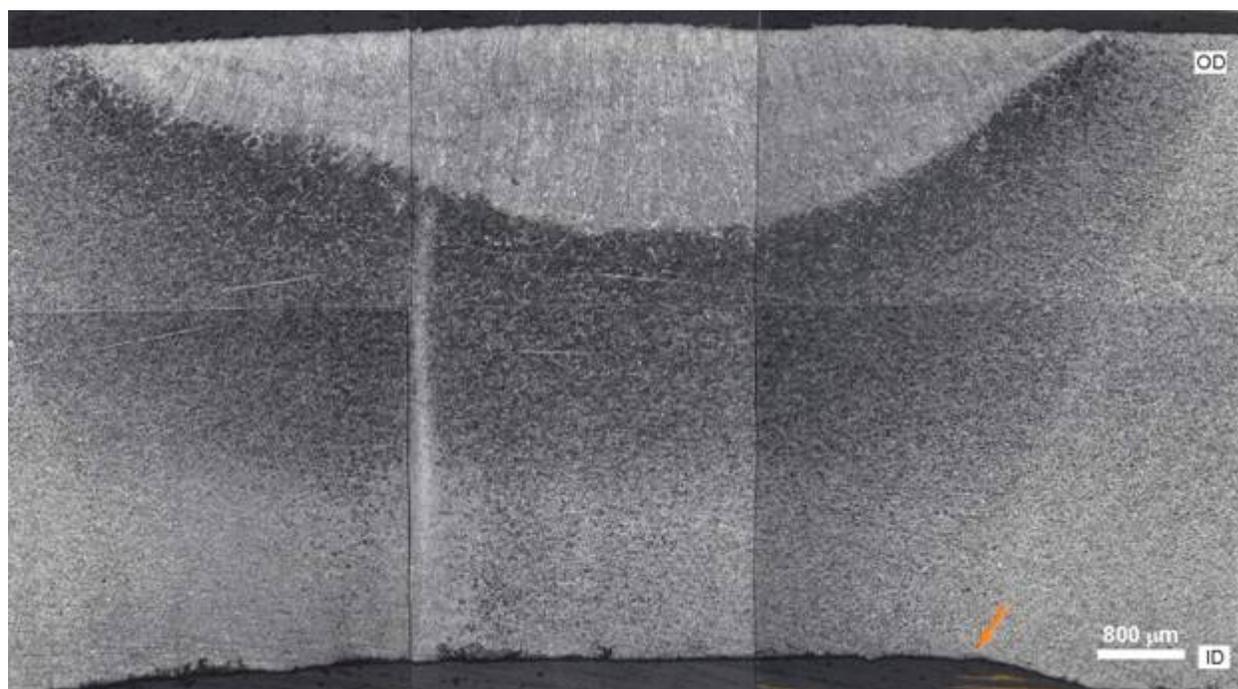
Photograph and Photomicrograph of Metallographic Section.

Catalog #:	109		
Report #:	11		
Defect #:	5A		
<u>Pipe</u>		<u>Defect</u>	
Vintage:	1953	NDE technique(s):	Fast UT
Manufacturer:	Unknown	NDE result(s):	15%, 4 inch (102 mm) ID Gouge
Seam Type:	LF-ERW	Visual:	ID Over-trim + OD Weld Repair
Grade:	API 5L X42	L	Not Determined
D _{nominal}	12.75 inch (324 mm)	depth/t _{weld}	8.3% (Over-Trim) + 45% (Weld Repair)
t _{nominal}	0.250 inch (6.35 mm)	depth:	Not Determined
t _{pipe}	Not Determined	t _{weld}	Not Determined
Failure:	N/A

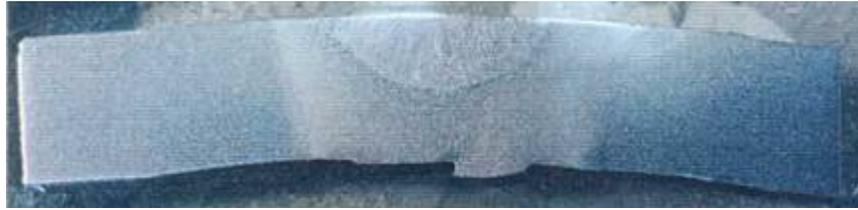
Catalog #: 92
 Report #: 10
 Defect #: CY-1

Photograph of Metallographic Section.

NDE technique(s): N/A
 NDE result(s): N/A
 Visual: ID Under-trim +
 Weld Repair
 Not Determined
 L
 $\text{depth}/t_{\text{weld}}$: 55% (Weld Repair)
 depth: Not Determined
 t_{weld} : Not Determined

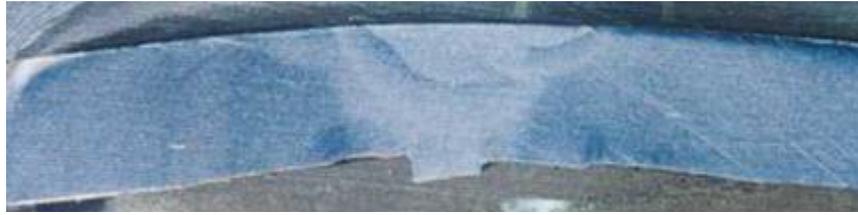
Catalog #: 99
 Report #: 10
 Defect #: CY-8

Photograph of Metallographic Section.

NDE technique(s): N/A
 NDE result(s): N/A
 Visual: ID Under-trim + OD
 Weld Repair
 Not Determined
 $\text{depth}/t_{\text{weld}}$: 45% (Weld Repair)
 depth: Not Determined
 t_{weld} : Not Determined

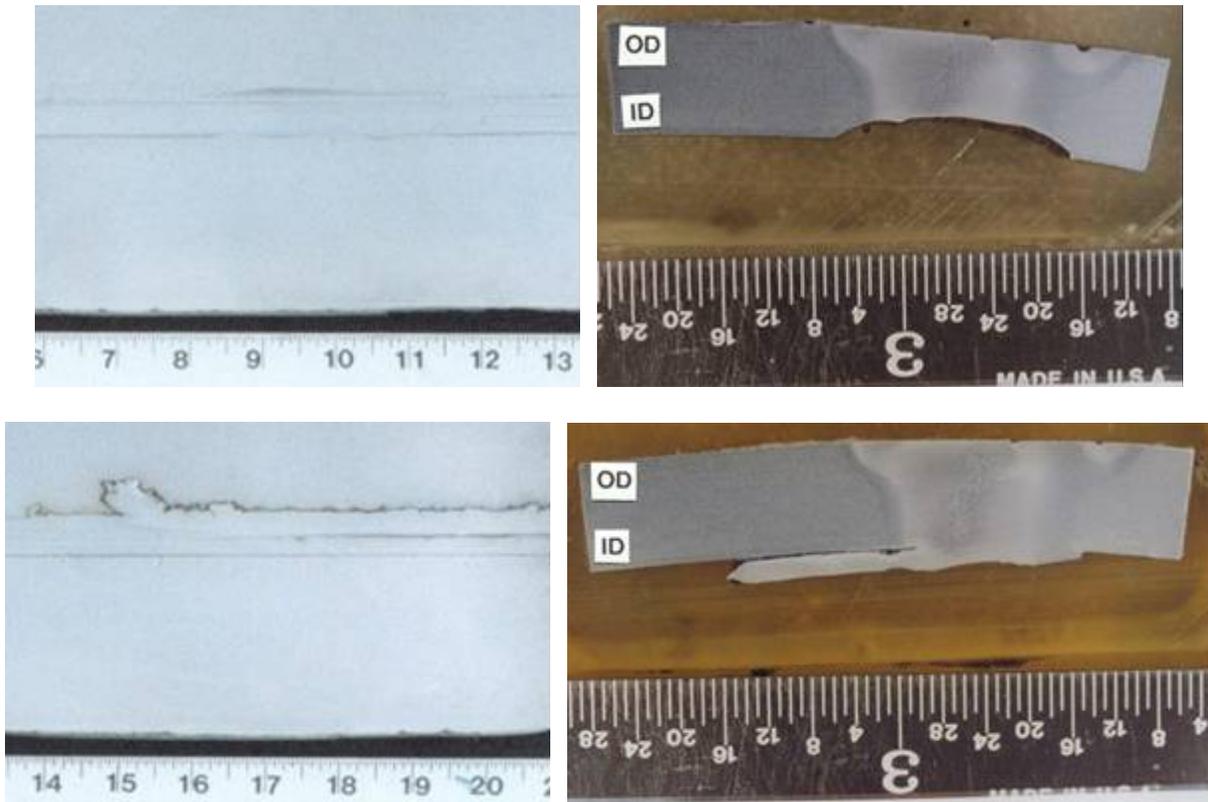
Catalog #: 31
 Report #: 3
 Defect #: 15A/B

Photographs of ID Pipe Surface and Metallographic Sections.

NDE technique(s): UT & HiLo MT
 NDE result(s): 5.5 x 0.5 inch (140 x 12.7 mm) ID Gouge from Overtrim (UT) + 12 inch OD (HiLo MT)
 Visual: ID gouge (Overtrim)
 L: 5.5 inch (140 mm)
 Width: 0.5 inch (12.7 mm)
 depth/ t_{weld} : 26%
 depth: 0.084 inch (2.13 mm)
 t_{weld} : 0.234 inch (5.94 mm)

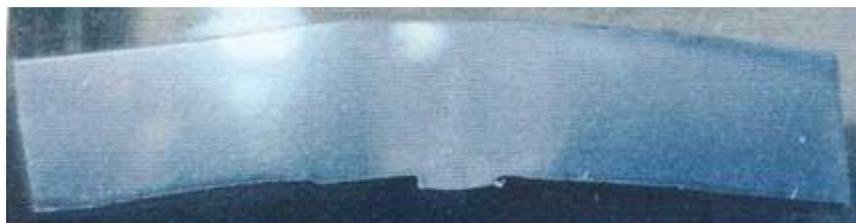
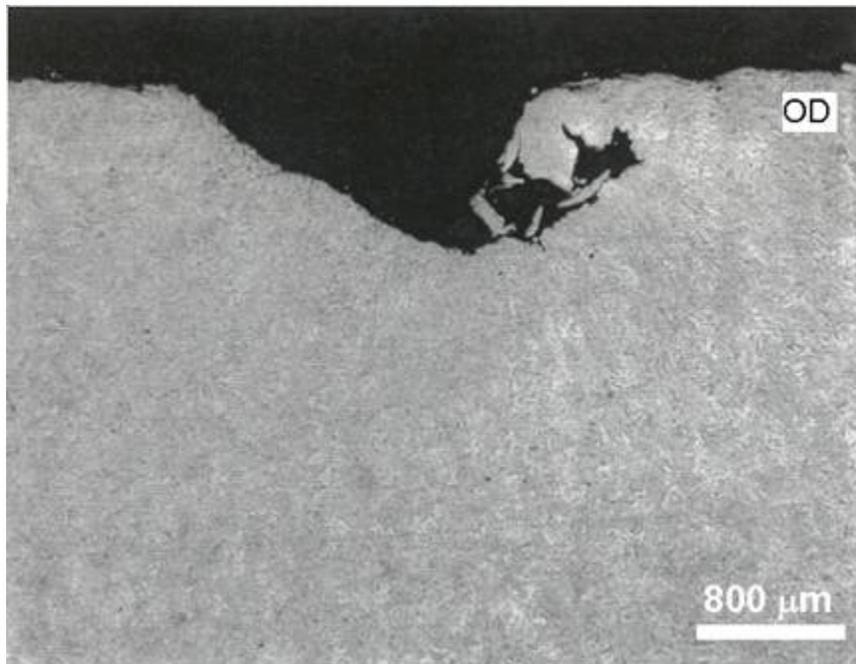
Photograph and Photomicrograph of Metallographic Section.

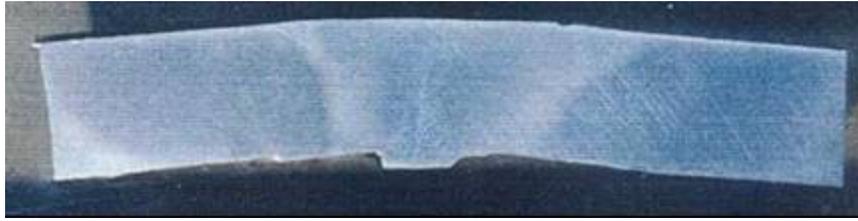
Catalog #: 97
 Report #: 10
 Defect #: CY-6

Photograph of Metallographic Section.

NDE technique(s): N/A
 NDE result(s): N/A
 Visual: ID Under-trim + OD Notch
 L: Not Determined
 $\text{depth}/t_{\text{weld}}$: Not Determined
 depth: 0.031 inch (0.79 mm)
 t_{weld} : Not Determined

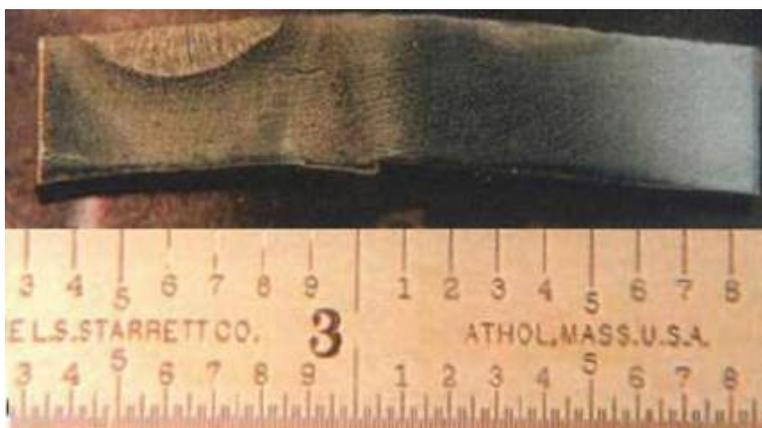
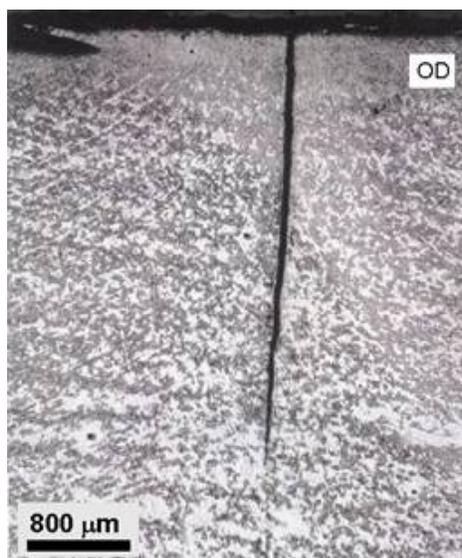
Photograph and Photomicrograph of Metallographic Section.

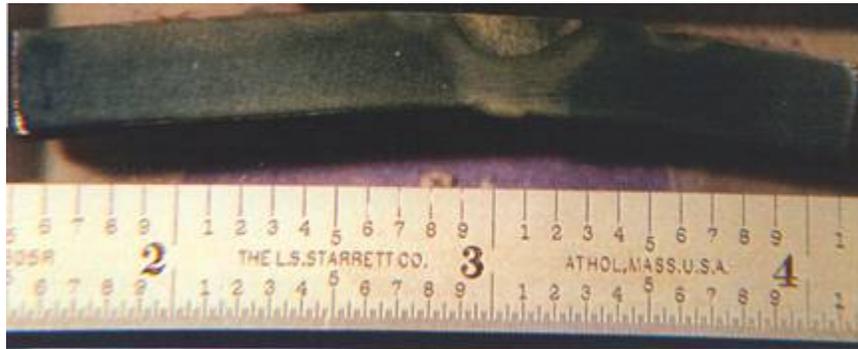
Catalog #: 11
 Report #: 1
 Defect #: 573-5.1

Photograph of Metallographic Section.

NDE technique(s): UT
 NDE result(s): 10% x 2 inch (51 mm)
 grind area on seam
 OD repair weld
 Visual: OD repair weld
 L: N/A
 depth/ t_{weld} : N/A
 depth: N/A
 t_{weld} : 0.330 inch (8.38 mm)

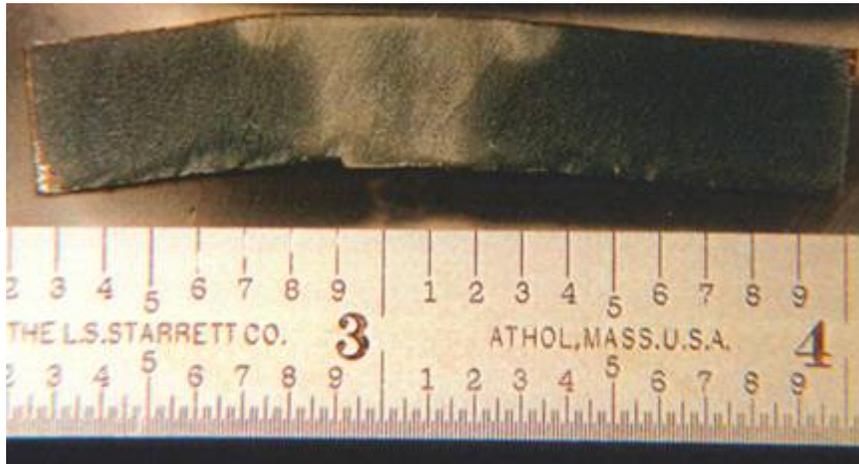
Catalog #: 14
 Report #: 1
 Defect #: 598

Photograph of Metallographic Section.

NDE technique(s): UT
 NDE result(s): <10% multiple minor
 cracks at weld toe

Visual: OD repair weld
 L N/A
 depth/ t_{weld} N/A
 depth: N/A
 t_{weld} 0.330 inch (8.38 mm)

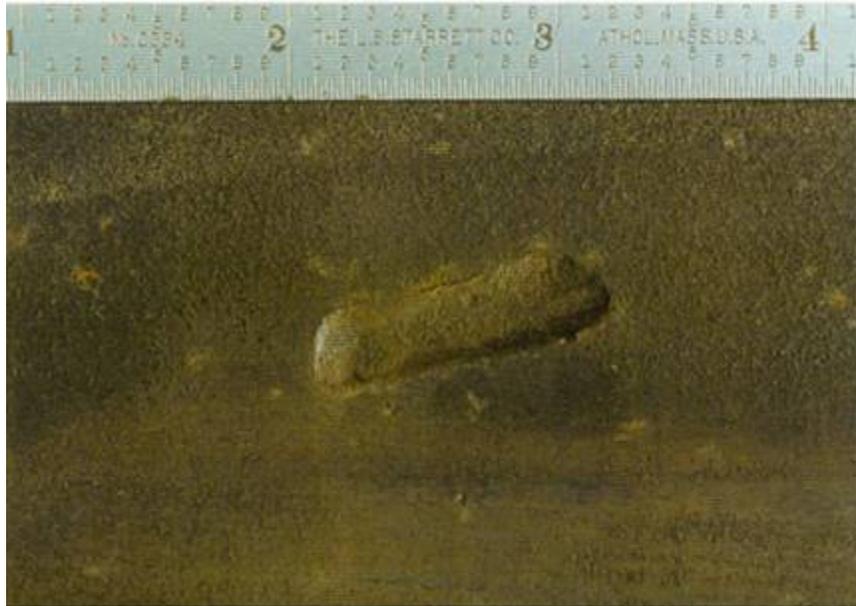
Catalog #: 111
 Report #: 12
 Defect #: 45A

Photograph of ID Pipe Surface Near Seam Weld.

NDE technique(s): Fast UT, MPI
 NDE result(s): 24%, 1.25 inch (31.7 mm)
 ID Gouge (Metal Loss)
 ID Pit
 Visual: 1.15 inch (29.2 mm)
 L
 depth/ t_{weld} : 28%
 depth: 0.068 inch (1.73 mm)
 t_{weld} : 0.245 inch (6.22 mm)

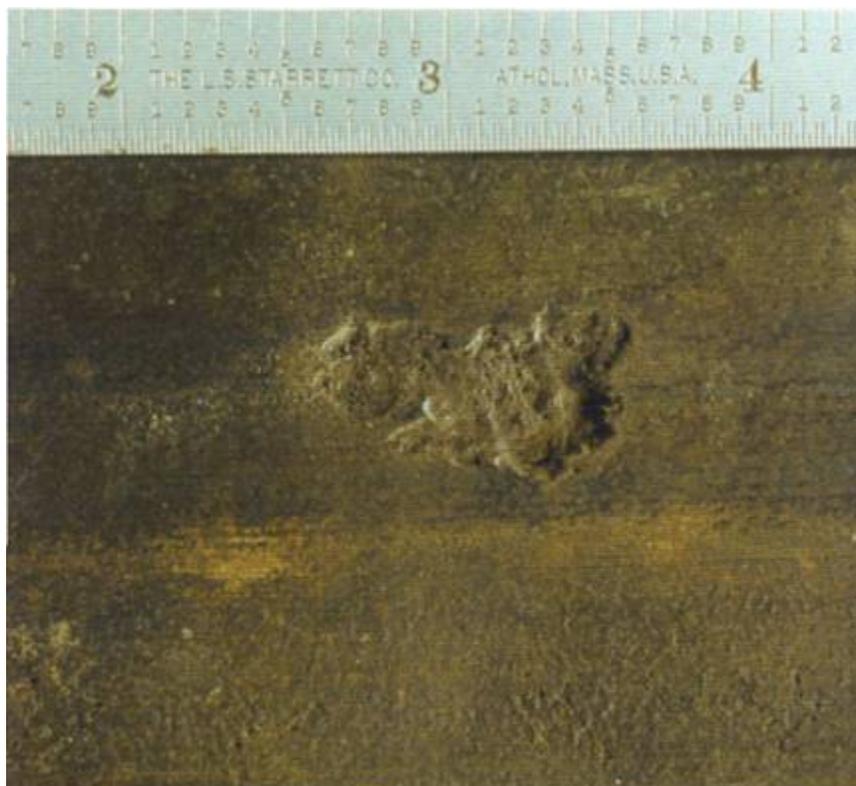
Catalog #: 115
 Report #: 12
 Defect #: 49A

Photograph of ID Pipe Surface Near Seam Weld.

NDE technique(s): Fast UT, MPI
 NDE result(s): 24%, 0.6 inch (15.2 mm)
 ID Gouge (Metal Loss)

Visual: ID Pit
 L: 1 inch (25.4 mm)
 depth/ t_{weld} : 22%
 depth: 0.058 inch (1.47 mm)
 t_{weld} : 0.258 inch (6.55 mm)

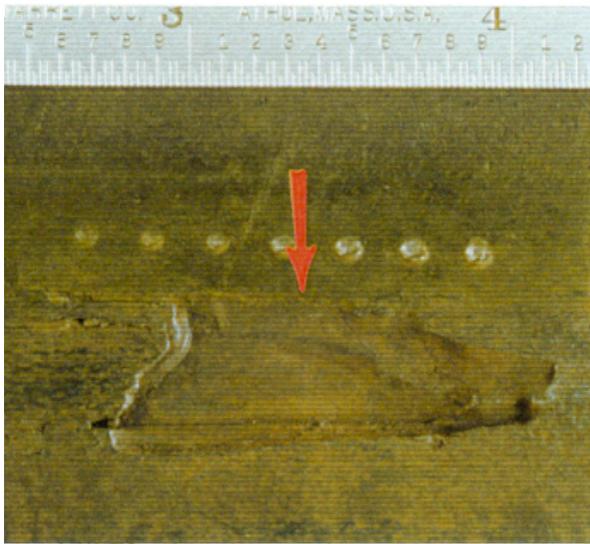
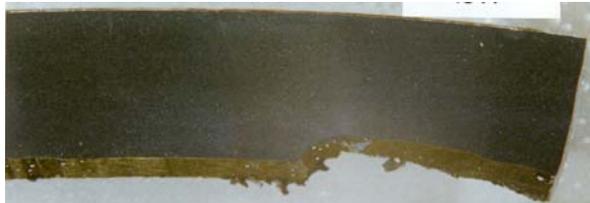
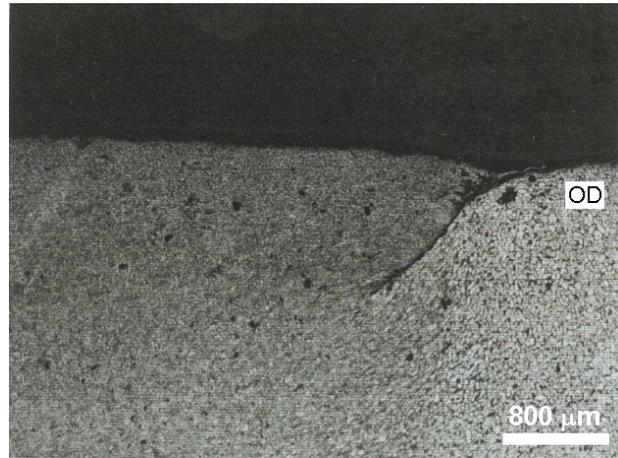
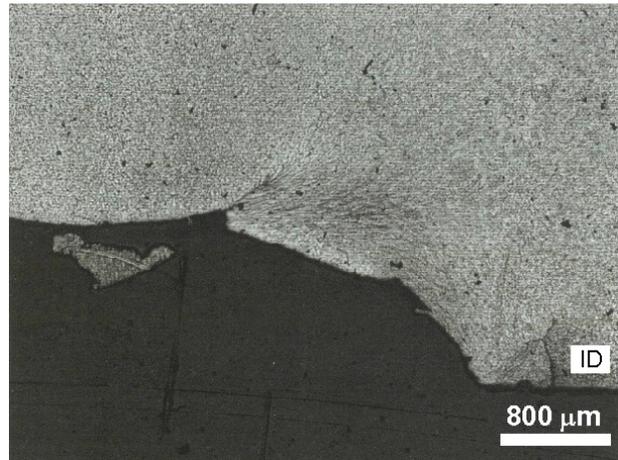
Catalog #: 110
 Report #: 12
 Defect #: 43A

Photographs and Photomicrographs of Pipe Seam ID Surface and Metallographic Sections.

NDE technique(s): Fast UT, MPI
 NDE result(s): 88%, 3 inch (76 mm)
 ID & OD-Connected
 Non-Fusion
 ID Pit
 1.72 inch (43.7 mm)
 17%
 depth/ t_{weld} : 0.046 inch (1.17 mm)
 depth: 0.266 inch (6.76 mm)
 t_{weld} : 0.266 inch (6.76 mm)

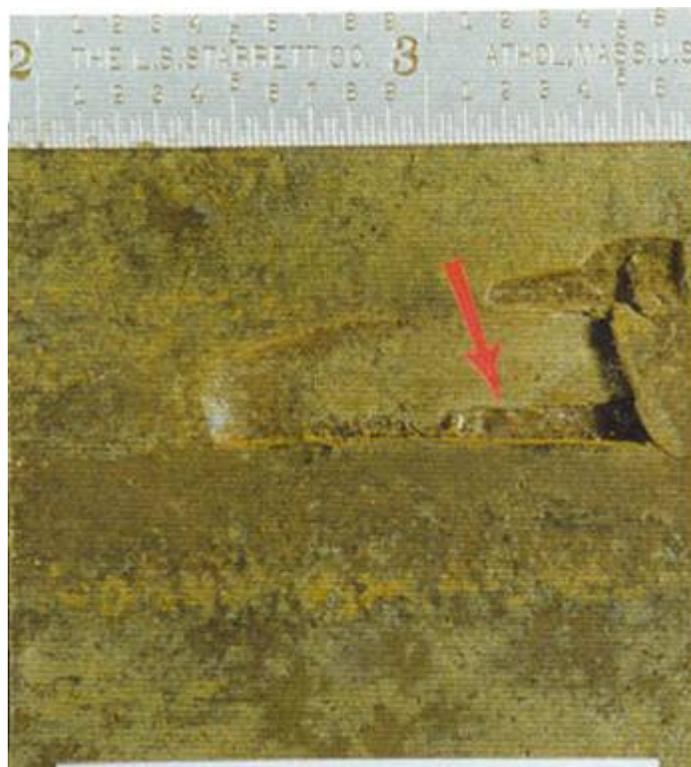
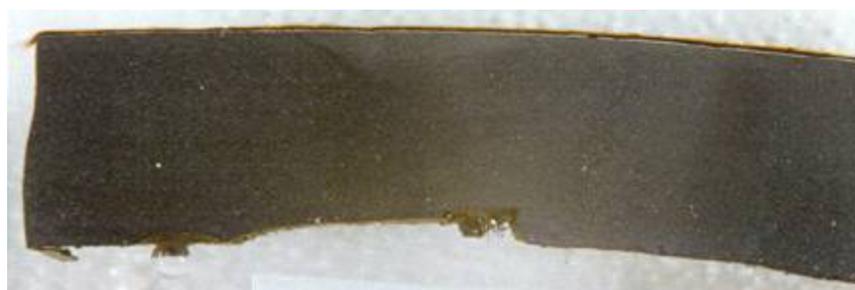
Catalog #: 123
 Report #: 12
 Defect #: 59A

Photographs of Pipe Seam ID Surface and Metallographic Section.

Visual: ID Pit
 L: 1 inch (25.4 mm)
 depth/ t_{weld} : 15%
 depth: 0.037 inch (0.94 mm)
 t_{weld} : 0.252 inch (6.4 mm)

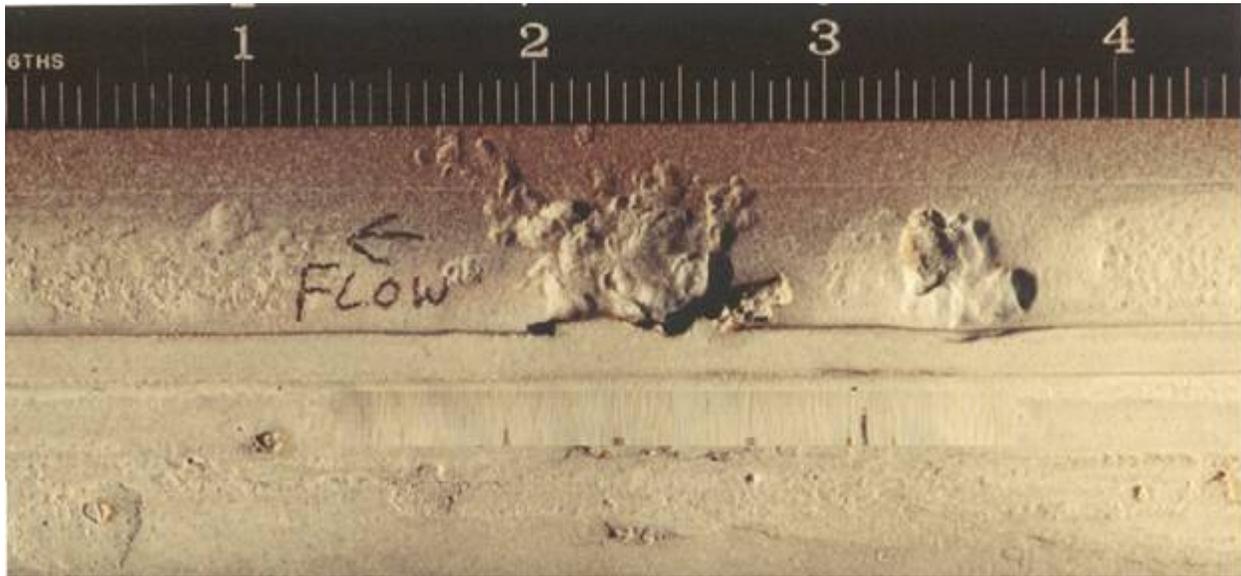
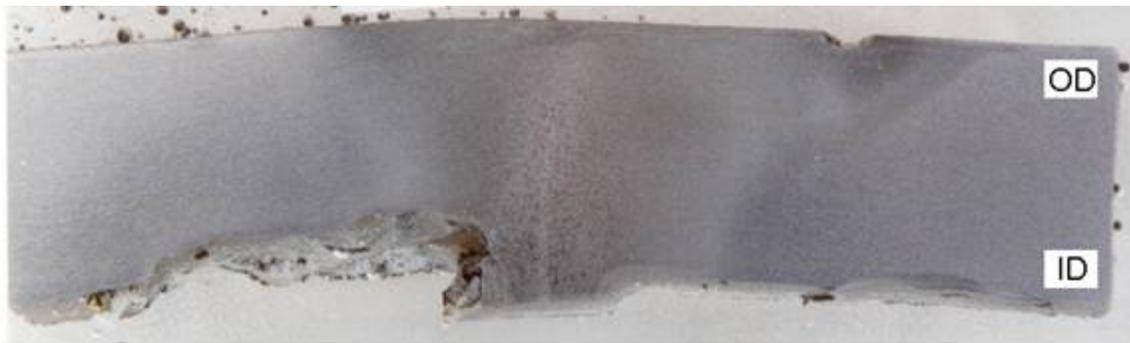
Catalog #: 73
 Report #: 7
 Defect #: 1084

Photographs of Weld Seam ID Surface and Metallographic Section.

NDE technique(s): Fast UT
 NDE result(s): ID Gouges
 Visual: ID Plate Edge Defect (Roll-in) + Contact Location Arc

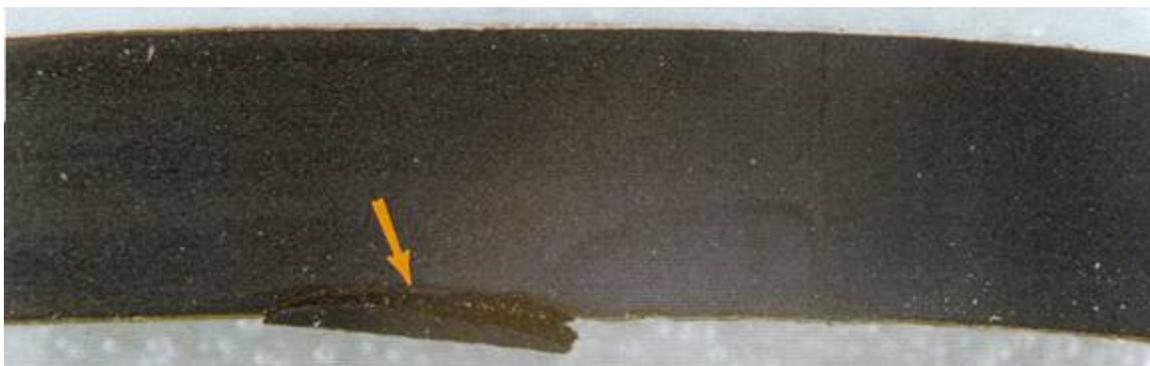
Catalog #: 136
 Report #: 12
 Defect #: 72B

Photograph of Metallographic Section.

NDE technique(s): TOFD, MPI
 NDE result(s): 48%, 1.25 inch (31.7 mm)
 OD Hook Crack

Visual: Roll-in
 L: Not Determined
 $\text{depth}/t_{\text{weld}}$: 6%
 depth: 0.017 inch (0.43 mm)
 t_{weld} : 0.262 inch (6.65 mm)

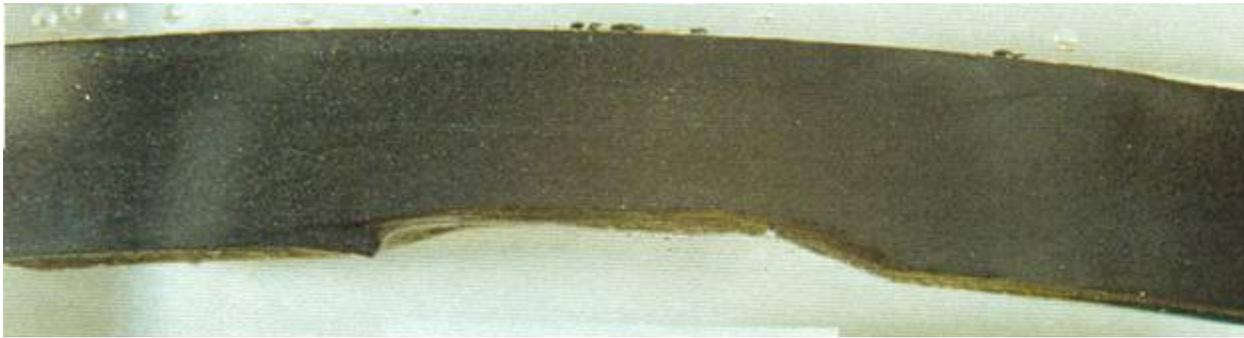
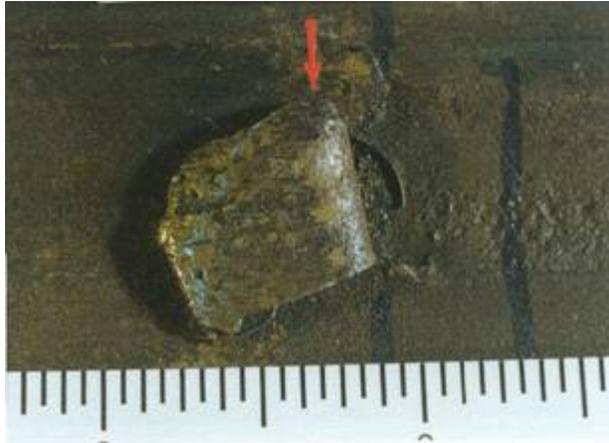
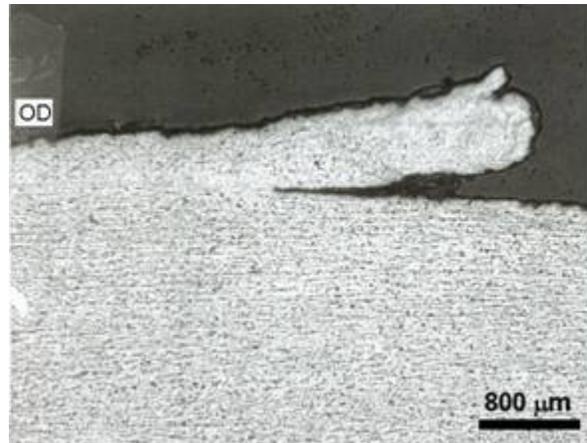
Catalog #: 120
 Report #: 12
 Defect #: 54B

Photograph and Photomicrograph of Pipe Seam ID Surface and Metallographic Section.

NDE technique(s): TOFD, MPI
 NDE result(s): 24%, 2 inch (51 mm)

Visual: ID Gouge
 ID Scab
 L: Not Determined
 depth/ t_{weld} : Not Determined
 depth: Not Determined
 t_{weld} : Not Determined

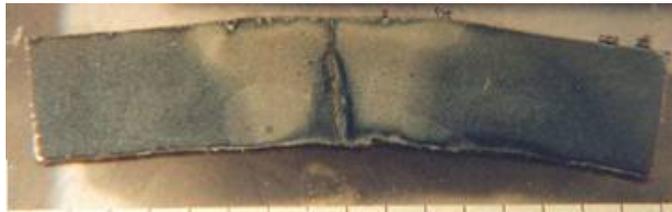
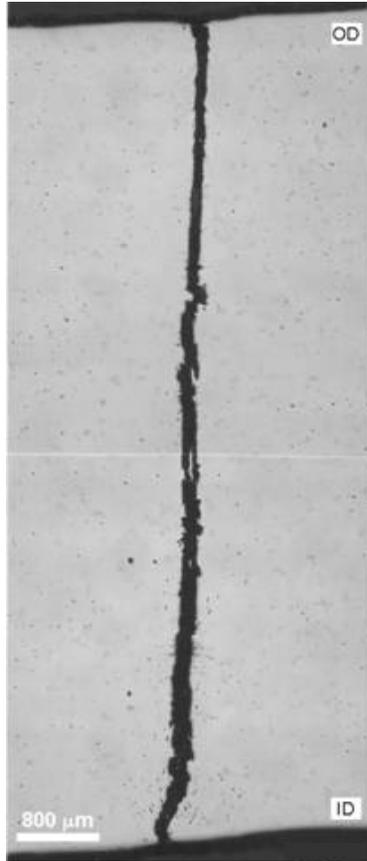
Catalog #: 65
 Report #: 7
 Defect #: 553

Photograph and Photomicrograph of Metallographic Section.

NDE technique(s): Seeper found during dig
 NDE result(s): 100%, 0.25 inch (6.35 mm)
 (Seeper)

Visual: Lack of Fusion
 L: Not Determined
 $depth/t_{weld}$: 100%
 $depth$: 0.330 inch (8.38 mm)
 t_{weld} : 0.330 inch (8.38 mm)

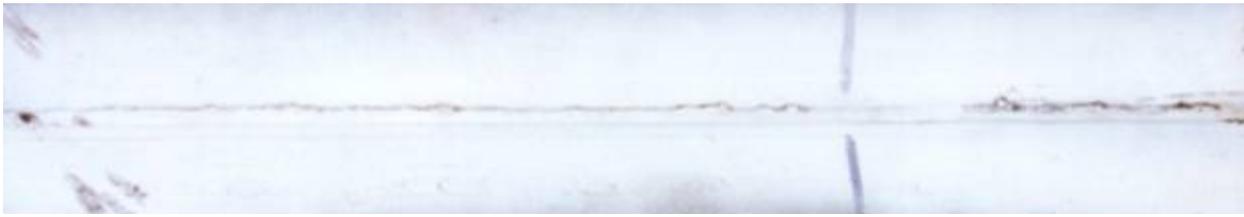
Catalog #: 82
 Report #: 7
 Defect #: 1640

Photograph of Weld Seam ID Surface.

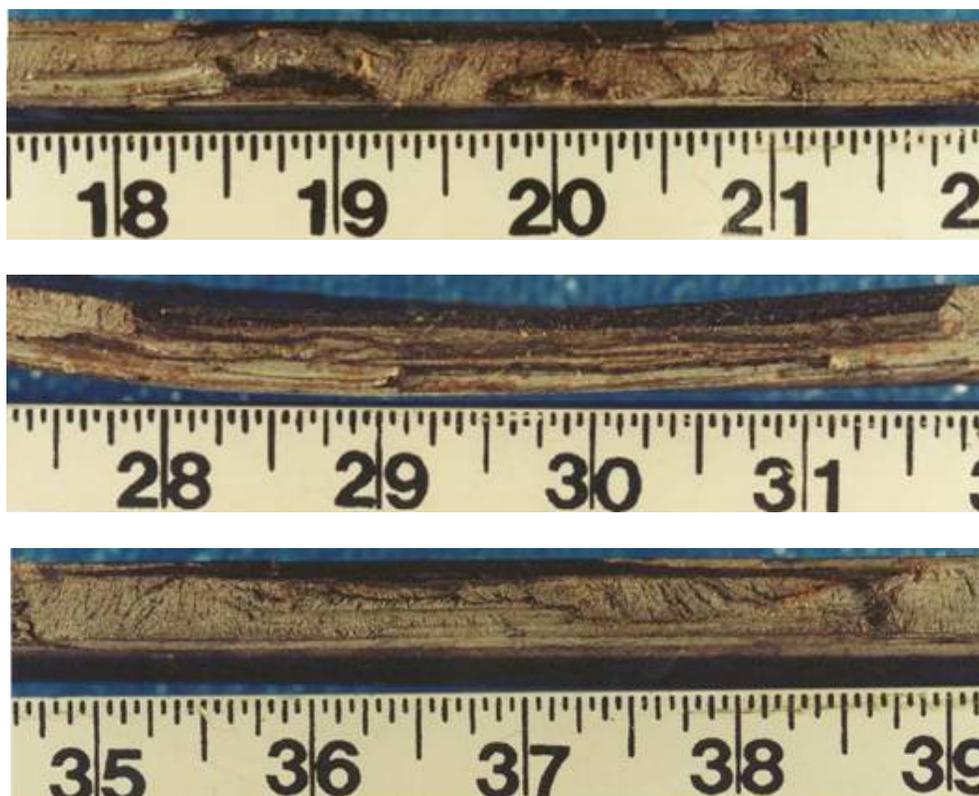
Catalog #: 61
 Report #: 6
 Defect #: 1012

Photographs of Fracture Surfaces.

NDE technique(s): Fast UT
 NDE result(s): 50% ID + 20% OD Crack
 Visual: 3 ID + 1 OD Hook Cracks
 L > 2 inch (51 mm) (ID Crack #1)
 + > 4 inch (102 mm) (ID Crack #2)
 + > 4 inch (ID Crack #3)
 43% (ID Crack #1) + 31% (ID Crack #2) + 31% (ID Crack #3) + 11% (OD Crack)
 depth: 0.171 inch (4.34 mm) (ID Crack #1)
 + 0.125 inch (3.17 mm) (ID Crack #2) + 0.125 inch (ID Crack #3)
 + 0.044 inch (1.19 mm) (OD Crack)
 t_{weld} 0.397 inch (10.1 mm)

t_{pipe} Not Determined
 Failure: Burst test failure at
 1,825 psig (12.58
 MPa) (112% of
 SMYS)

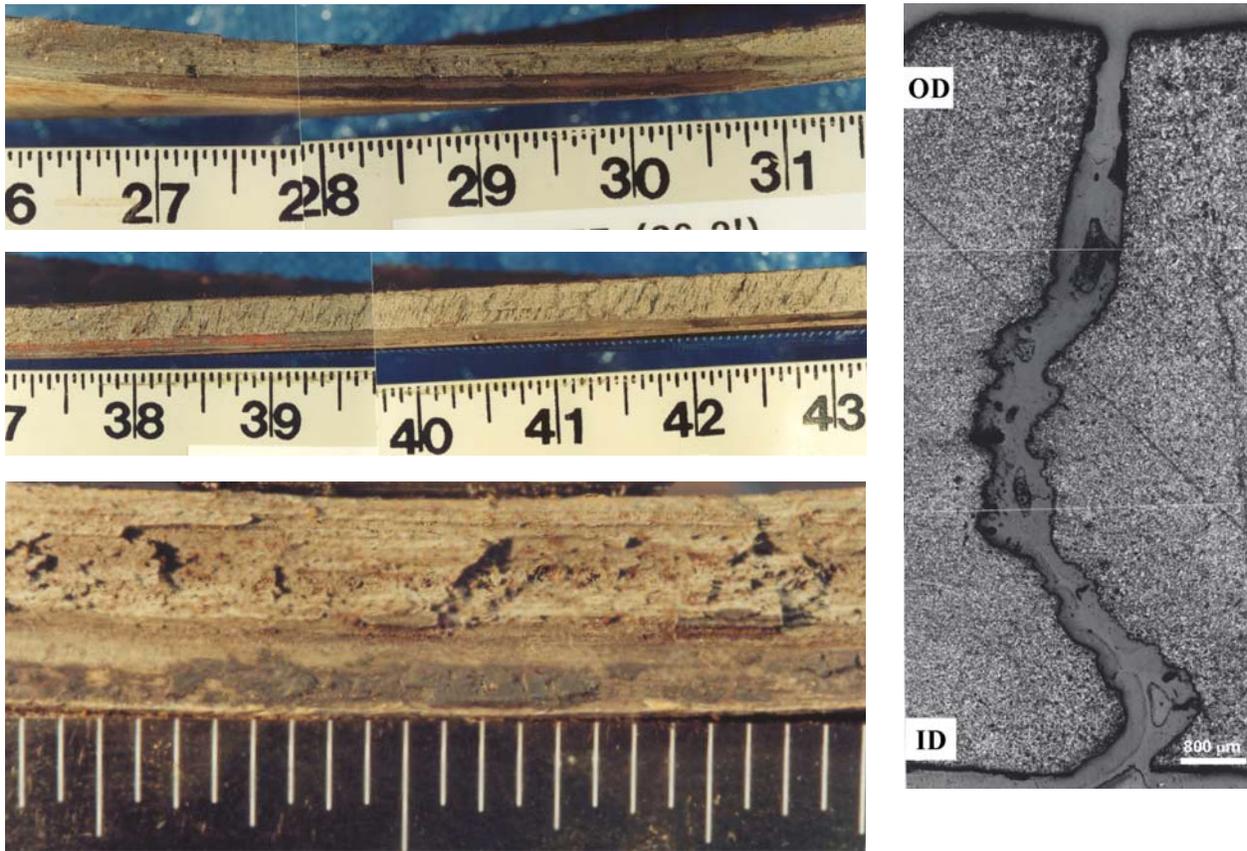
Catalog #: 56
 Report #: 6
 Defect #: 757

Photographs of Fracture Surface and Photomicrograph of Metallographic Section.

NDE technique(s): Fast UT
 NDE result(s): 65% OD Crack
 Visual: Two OD Hook cracks
 L 4.5 inch (114 mm)
 (Crack #1) + 12 inch
 (305 mm) (Crack #2)
 40% (Crack #1) (incl.
 5% fatigue growth)
 + 28% (Crack #2)
 depth/t_{weld} 0.156 inch (3.96 mm)
 depth: (Crack #1) (incl. 0.020
 inch (0.51 mm)
 fatigue) + 0.109 inch
 (2.77 mm) (Crack #2)
 t_{weld} 0.390 inch (9.91 mm)

D_{nominal} 20 inch (508 mm)
 t_{nominal} 0.312 inch (7.92 mm)
 t_{pipe} Not Determined
 Failure: Burst test failure at
 1,875 psig (12.93
 MPa) (116% of SMYS)

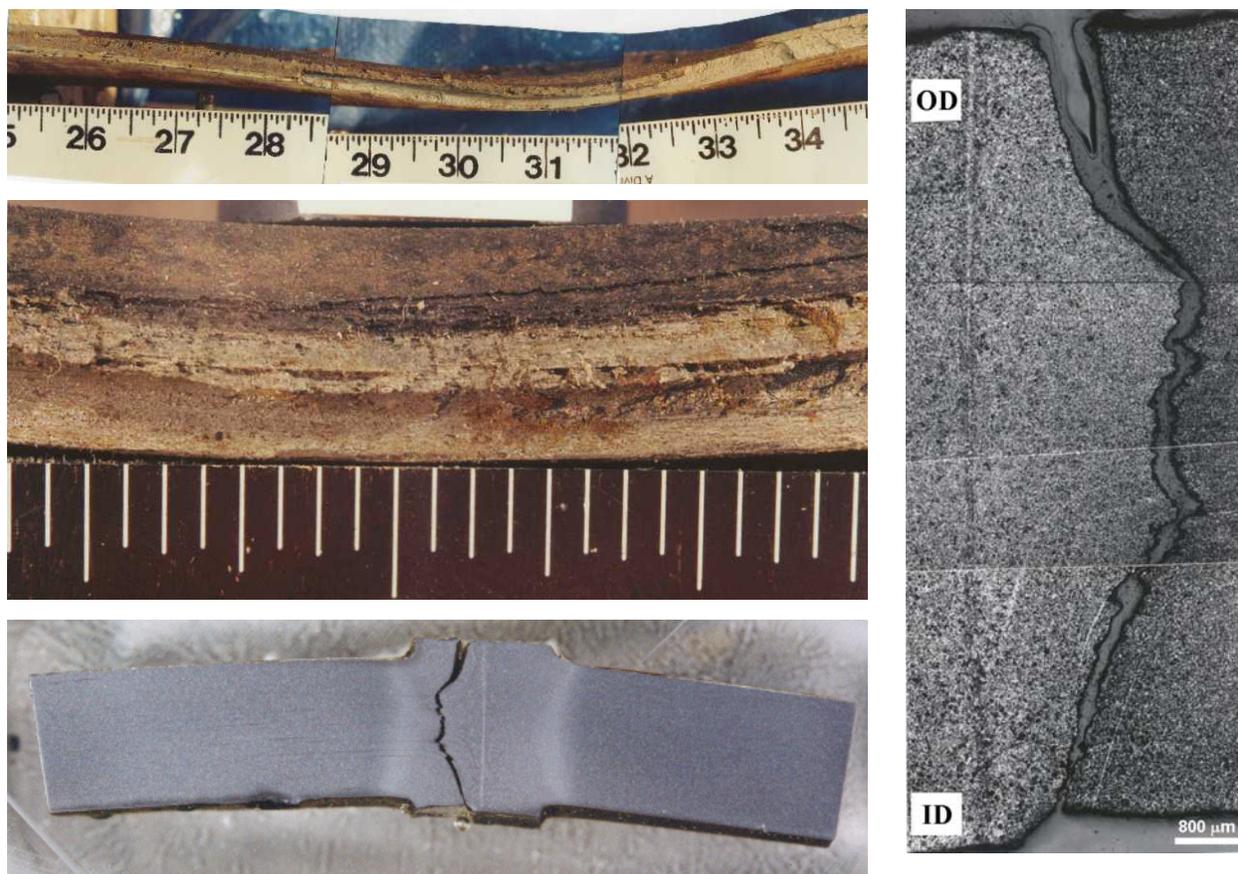
Catalog #: 59
 Report #: 6
 Defect #: 939

Photographs and Photomicrograph of Metallographic Section and Fracture Surfaces.

NDE technique(s): Fast UT
 NDE result(s): 40% ID Crack
 Visual: Two ID Hook Cracks
 L 4 inch (102 mm)
 (Crack #1) + > 8 inch
 (203 mm) (Crack #2)
 depth/ t_{weld} 24% (Crack #1)
 + 40% (Crack #2)
 depth: 0.093 inch (2.36 mm)
 (Crack #1) + 0.156 inch
 (3.96 mm) (Crack #2)
 t_{weld} 0.388 inch (9.85 mm)

$D_{nominal}$ 20 inch (508 mm)
 $t_{nominal}$ 0.312 inch (7.92 mm)
 t_{pipe} Not Determined
 Failure: Burst test failure at
 2,050 psig (14.13 MPa)
 (126% of SMYS)
