Appendix B – Task 2
Catalog of Seam Weld Defect Types

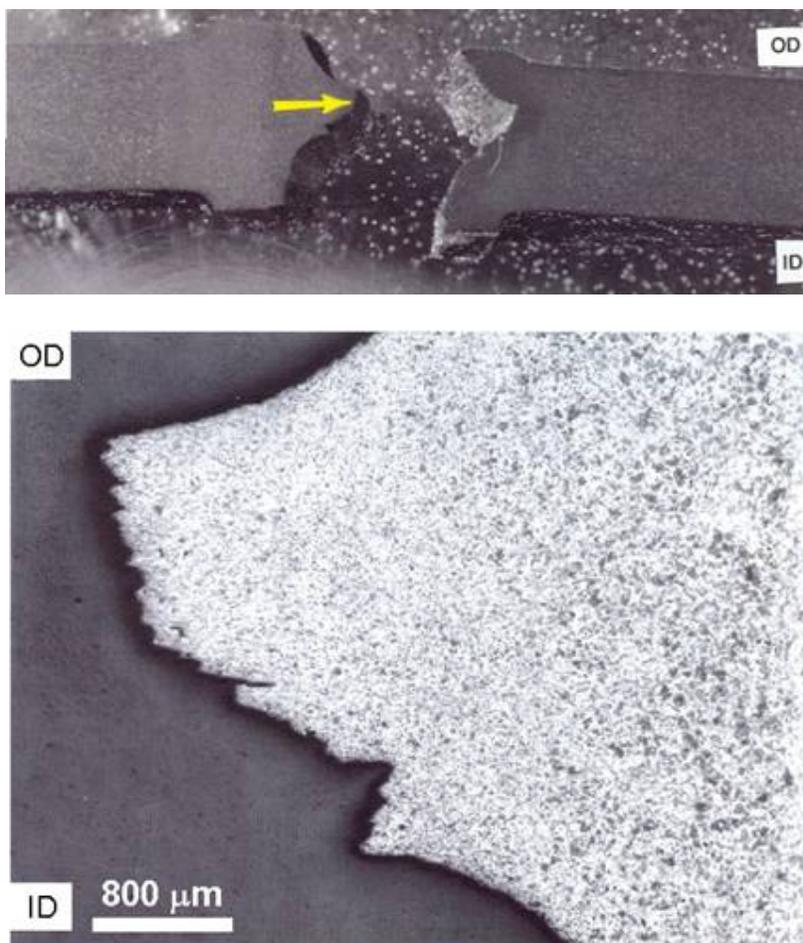
Catalog #: 44
 Report #: 5
 Defect #: 22

Photographs and Photomicrograph of Metallographic Section and Fracture Surfaces.

NDE technique(s): Fast UT
 NDE result(s): 2 overlapping cracks: 85%,
 10.5 inch
 (267 mm) total length

Visual: ID & OD hook cracks
 L: 14 to 19 inch (356 to 483 mm)
 depth/ t_{weld} : 75% (33% OD + 42% ID)
 depth: 0.129 inch (3.28 mm) (OD) +
 0.164 inch
 (4.17 mm) (ID)
 t_{weld} : 0.390 inch (9.91 mm)

t_{pipe} : 0.309 inch (7.85 mm)
 Failure: Burst Test Failure at
 2,050 psig (14.13
 MPa) (126% of SMYS)

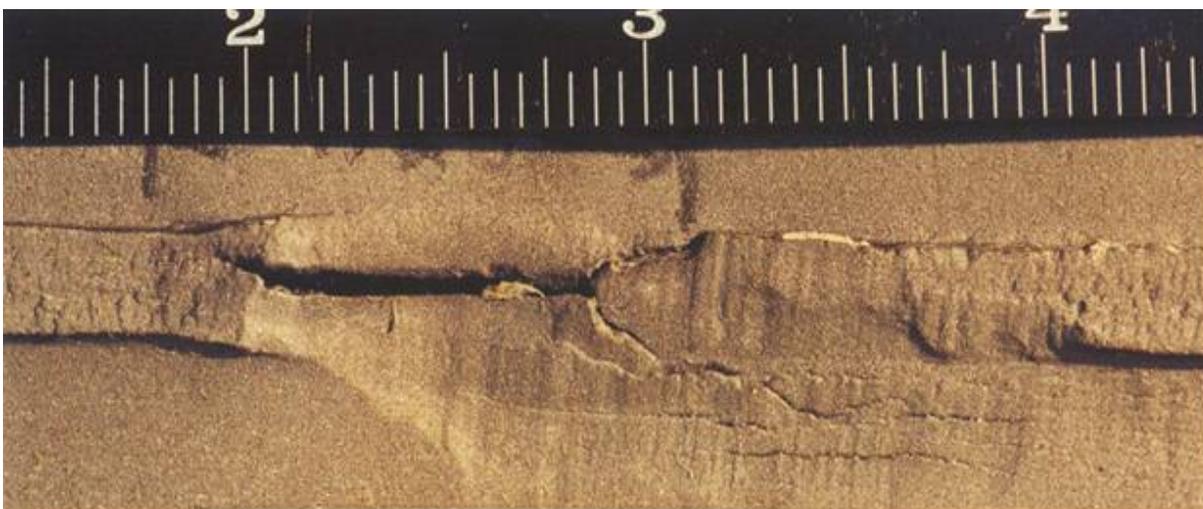
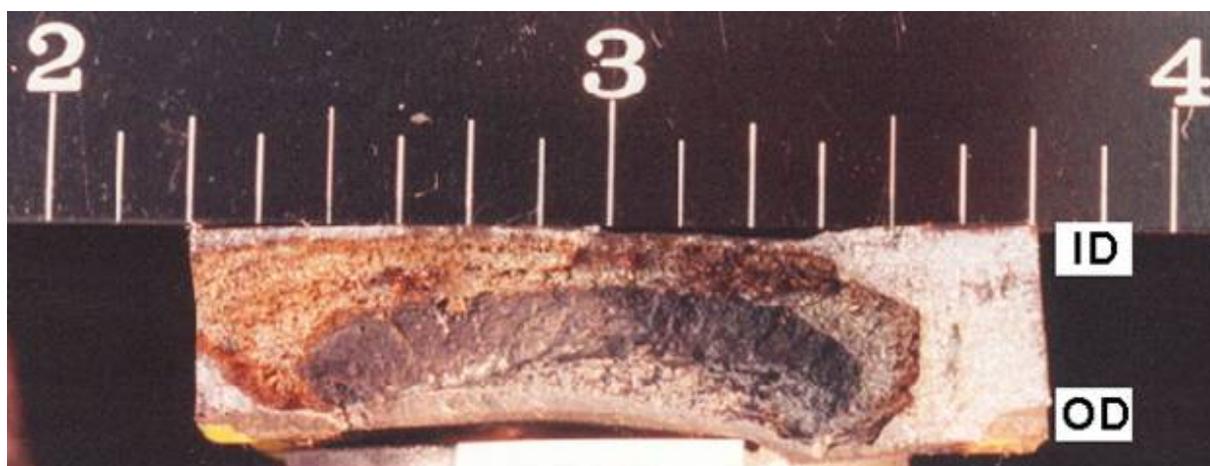
Catalog #: 62
 Report #: 6
 Defect #: 1450

Photographs/Micrographs of Weld Seam OD Surface and Fracture Surface.

NDE technique(s): Fast UT
 NDE result(s): 0.300 inch (7.62 mm)
 RDI Mechanical
 Damage + 70%, 1 inch
 (25.4 mm) OD Crack
 Dent and Hook Crack
 1 inch (25.4 mm)
 Visual:
 L
 depth/ t_{weld} 70%
 depth: 0.312 inch (7.92 mm)
 t_{weld} 0.445 inch (11.3 mm)

Seam Type: FW
 Grade: X52
 $D_{nominal}$ 20 inch (508 mm)
 $t_{nominal}$ 0.312 inch (7.92 mm)
 t_{pipe} Not Determined
 Failure: Leak at 2,250 psig (15.51
 MPa) (138% of SMYS)

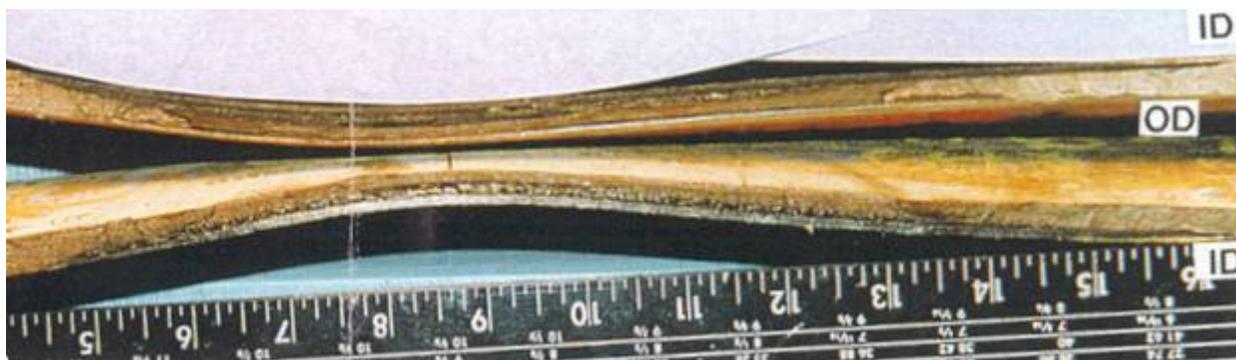
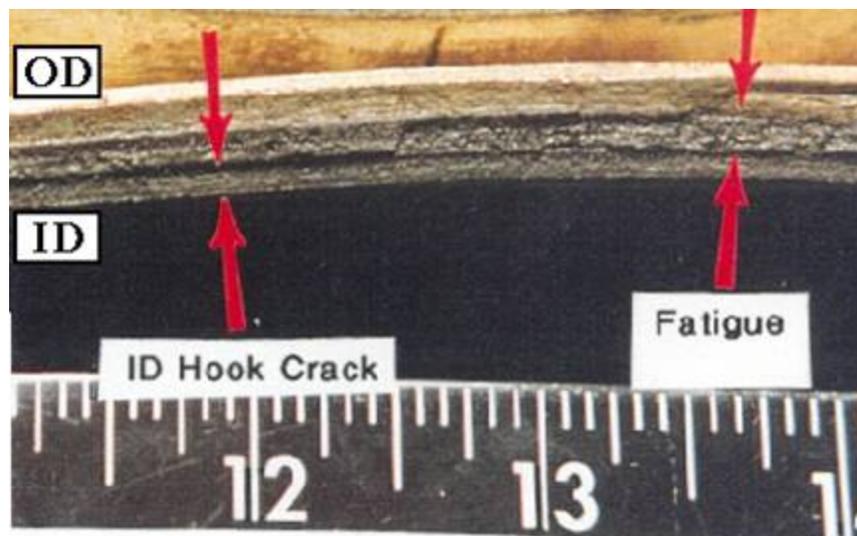
Catalog #: 26
 Report #: 2
 Defect #: 640

Photographs of Fracture Surfaces.

t_{nominal} : 0.312 inch (7.92 mm)
 t_{pipe} : 0.315 inch
 Failure: Burst test rupture at
 1,550 psig (10.69 MPa)
 (95% of SMYS)

NDE technique(s): UT
 NDE result(s): 50% ID Crack like
 Visual: ID Hook crack
 L: 12.0 inch (305 mm)
 $\text{depth}/t_{\text{weld}}$: 63% (30% hook +
 33% fatigue)
 depth: 0.250 inch (6.35 mm)
 t_{weld} : 0.394 inch (10.1 mm)

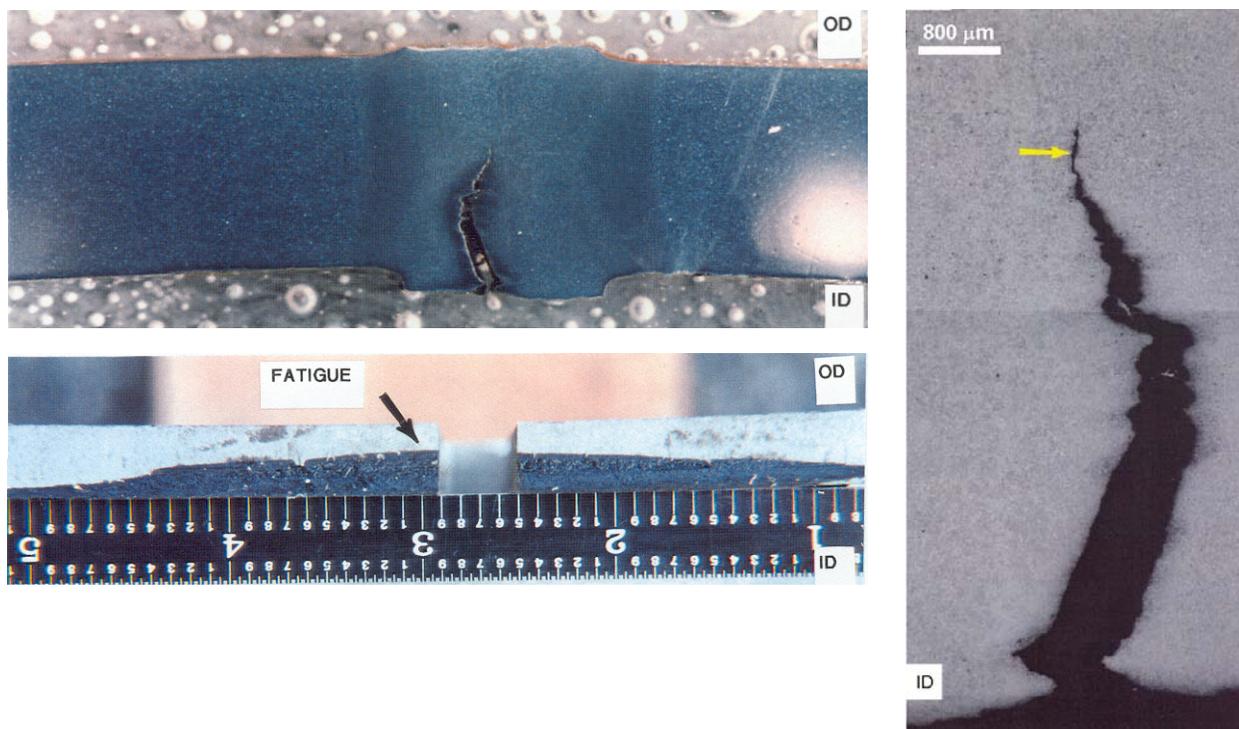
Catalog #: 37
 Report #: 5
 Defect #: C9

Photographs and Photomicrograph of Metallographic Section and Fracture Surfaces.

NDE technique(s): UT, MT, and Fast UT
 NDE result(s): ID-connected crack-like (UT) + Intermittently dispersed minor inclusions (UT) + Crack-like (UT) + OD Sub-surface crack-like (MT) + NF with associated crack-like (Fast UT)
 ID hook crack (with crack extension)
 > 4.25 inch (108 mm)
 62%
 0.227 inch (5.77 mm) (incl. 0.020 inch (0.51 mm) crack extension)
 0.366 inch (9.3 mm)

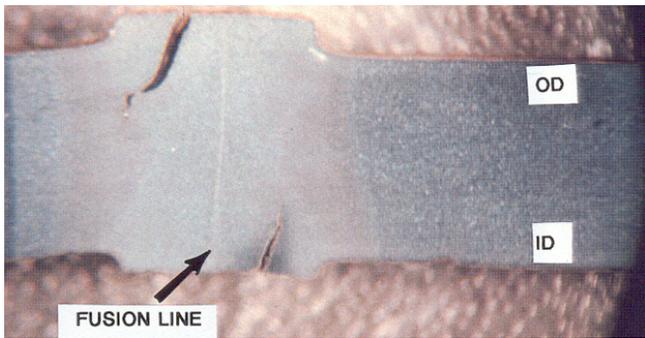
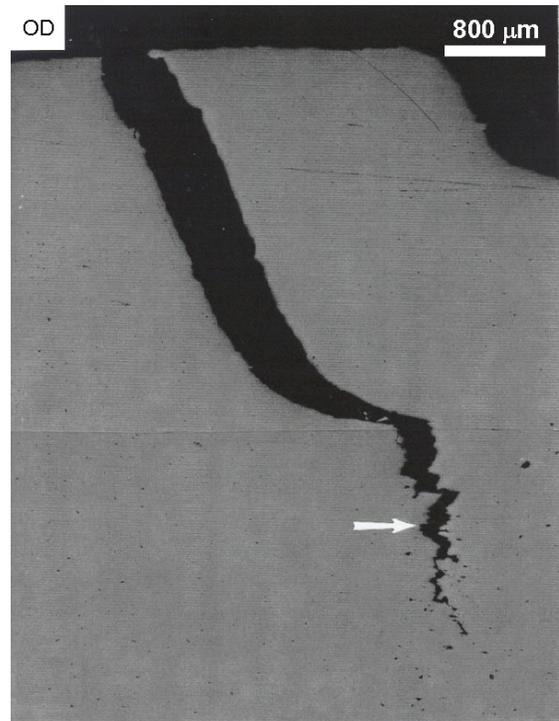
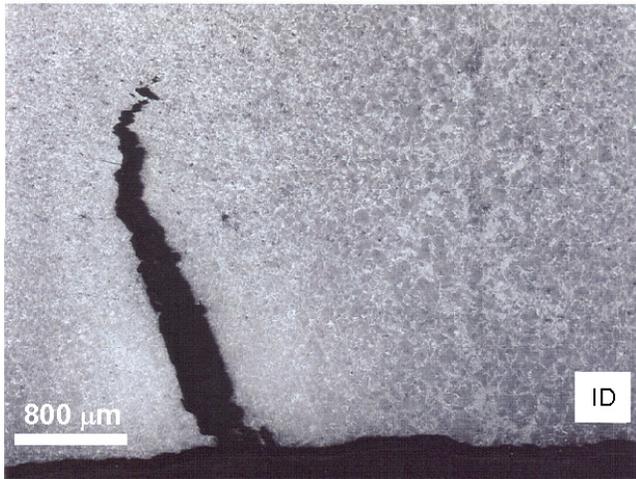
Catalog #: 35
 Report #: 5
 Defect #: C5A

Photographs and Photomicrograph of Metallographic Section and Fracture Surfaces.

t_{pipe} : 0.320 inch (8.13 mm)
 Failure: Burst Test: No failure at 2,000 psig (13.79 MPa) (123% of SMYS)

NDE technique(s): UT, MT, and Fast UT
 NDE result(s): ID Connected, Crack like (UT) + OD Crack-like (MT) + ID Connected, Crack-like + Some LOF (Fast UT)
 Visual: ID & OD Hook Cracks
 L: N/A
 depth/ t_{weld} : 57% (32 + 25%)
 depth: 0.204 inch (5.18 mm) (0.115 + 0.089 inch) (2.92 mm + 2.26 mm)
 t_{weld} : 0.358 inch (9.09 mm)

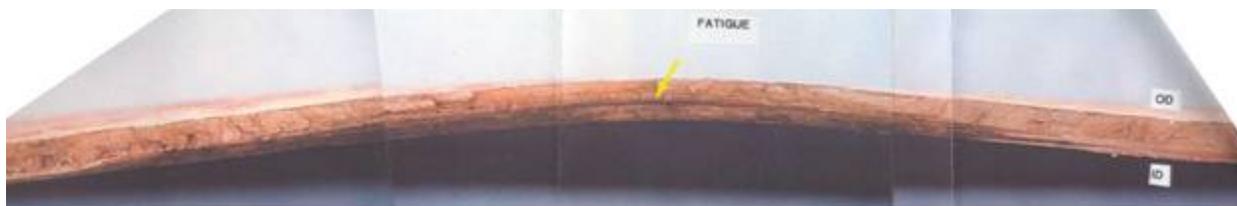
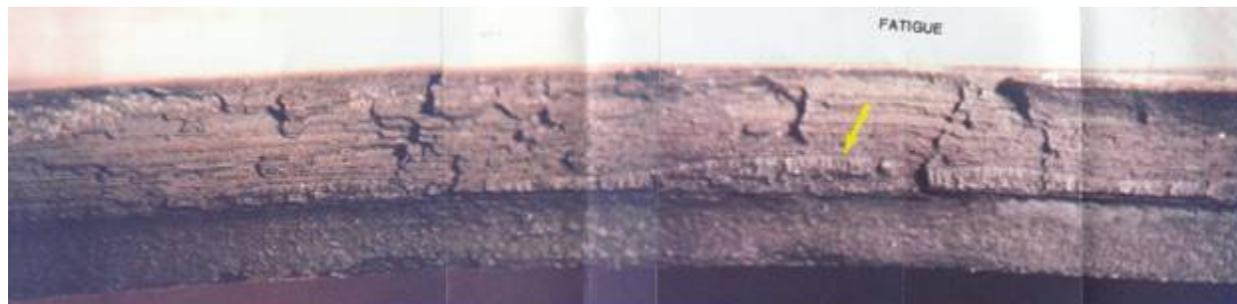
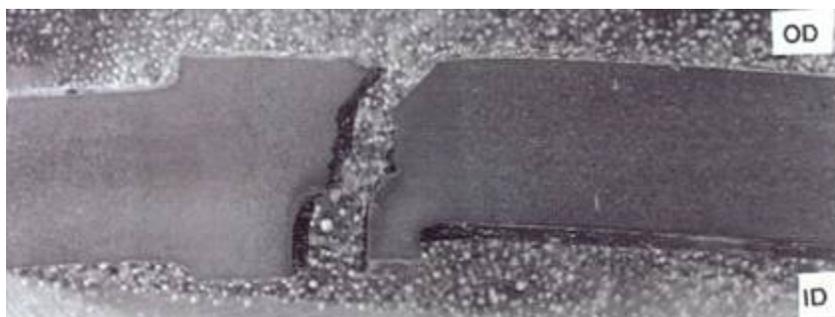
Catalog #: 51

Photographs of Fracture Surface and Metallographic Section.

NDE result(s): 35%, 8 inch (203 mm),
ID-connected crack-like +

Visual: ID Hook Crack + Crack
extension

D_{nominal} 20 inch (508 mm) t_{nominal} 0.312 inch (7.92 mm)L > 19.5 inch (495 mm)
depth/ t_{weld} 54% (incl. 15% fatigue)
depth: < 0.218 inch (5.54 mm) t_{pipe} 0.306 inch (7.77 mm)Failure: Burst test rupture at
1,750 psig (12.07 MPa)
(108% of SMYS) t_{weld} 0.404 inch (10.3 mm)

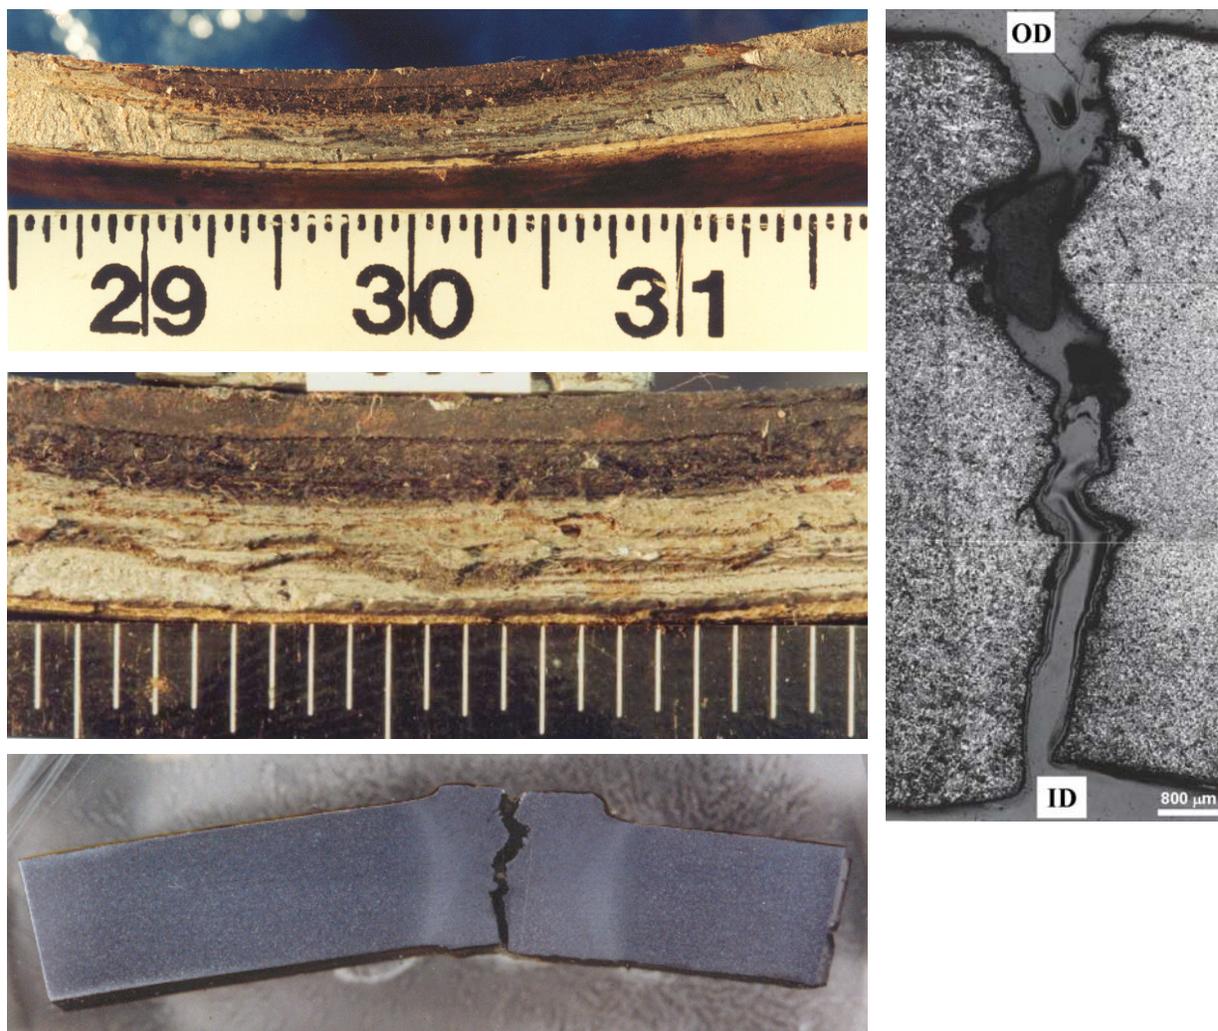
Catalog #: 58
 Report #: 6
 Defect #: 858

Photographs of Weld Seam ID Surface and Metallographic Section.

Vintage: circa 1950
 Manufacturer: AO Smith
 Seam Type: FW
 Grade: X52
 D_{nominal} : 20 inch (508 mm)
 t_{nominal} : 0.312 inch (7.92 mm)
 t_{pipe} : Not Determined
 Failure: Burst test failure at
 2,275 psig (15.69 MPa)
 (140% of SMYS)

NDE technique(s): Fast UT
 NDE result(s): 75% ID Crack
 Visual: ID Hook Crack
 L: 2.25 inch (57.1 mm)
 depth/ t_{weld} : 50%
 depth: 0.187 inch (4.75 mm)
 t_{weld} : 0.377 inch (9.58 mm)

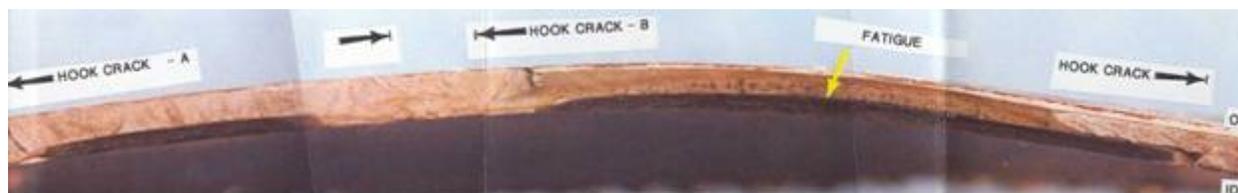
Catalog #: 48

Photograph of Fracture Surface.

ID Hook Crack
(evidence of crack
extension)

D_{nominal} 20 inch (508 mm)depth/ t_{weld} > 12 inch (305 mm)
48% (incl. 11% crack
extension) t_{nominal} 0.312 inch (7.92 mm)

0.189 inch (4.8 mm)
(incl. 0.043 inch
(1.09 mm) crack
extension) t_{pipe} 0.312 inch (7.92 mm) t_{weld}

Failure: Burst test failure at
1,950 psig (13.44 MPa)
(120% of SMYS)

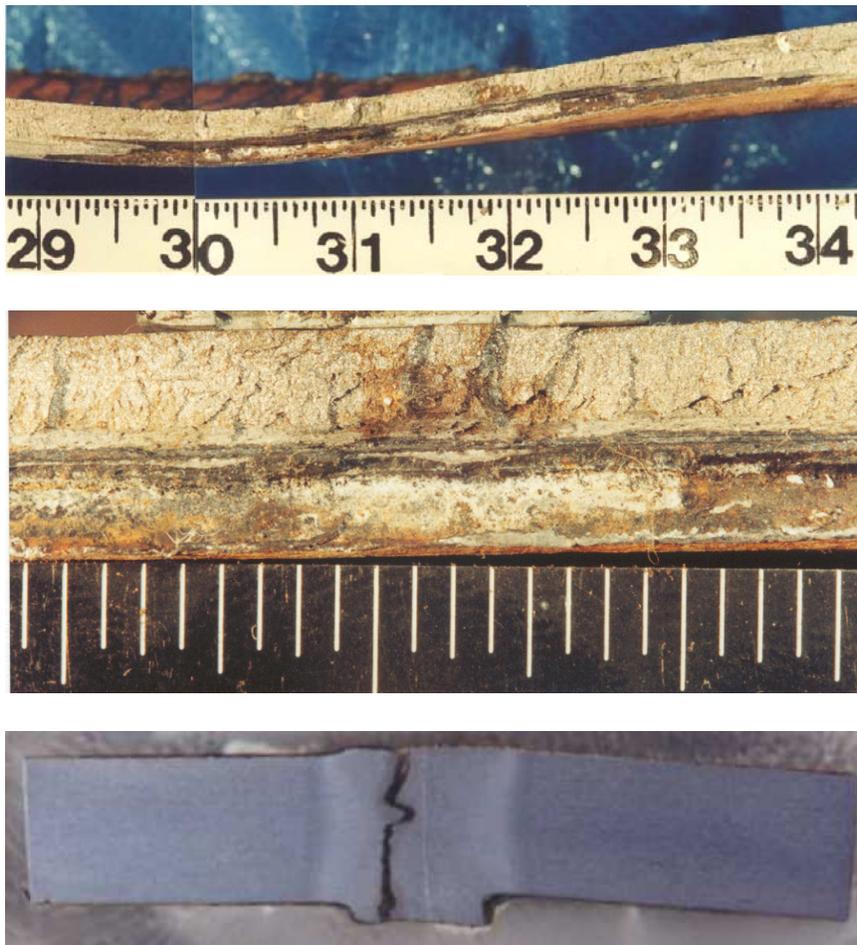
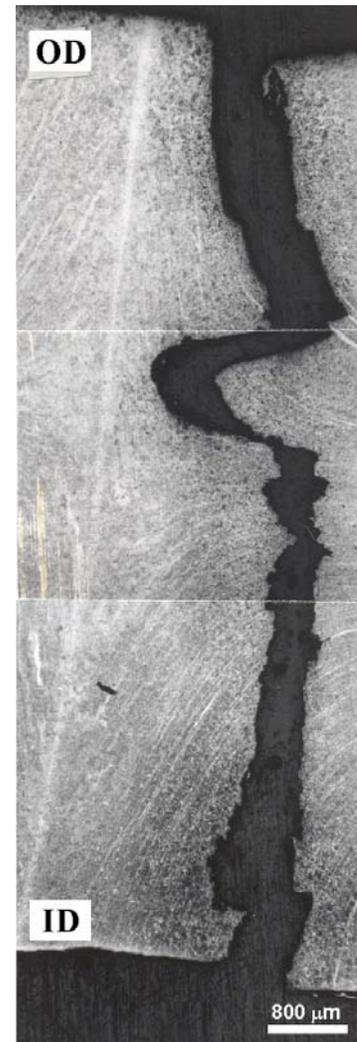
Catalog #: 55
 Report #: 6
 Defect #: 707

Photographs and Photomicrograph of Fracture Surface and Metallographic Section.

Vintage: circa 1950
 Manufacturer: AO Smith
 Seam Type: FW
 Grade: X52
 D_{nominal} : 20 inch (508 mm)
 t_{nominal} : 0.312 inch (7.92 mm)
 t_{pipe} : Not Determined
 Failure: Burst test failure at
 1,675 psig (11.55 MPa)
 (103% of SMYS)

NDE technique(s): Fast UT
 NDE result(s): 75% OD Crack
 Visual: OD Hook Crack
 L: > 5 inch (127 mm)
 depth/ t_{weld} : 47%
 depth: 0.187 inch (4.75 mm)
 t_{weld} : 0.400 inch (10.2 mm)

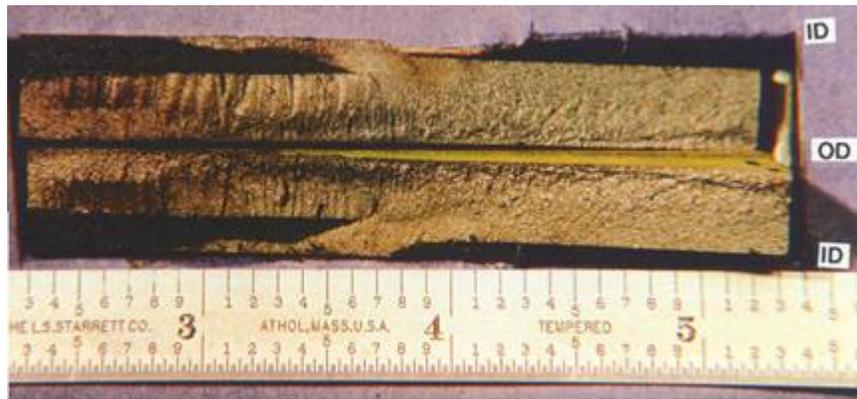
Photograph of Fracture Surfaces.

Catalog #:	6		
Report #:	1		
Defect #:	299		
Pipe		Defect	
Vintage:	1950s	NDE technique(s):	UT
Manufacturer:	AO Smith	NDE result(s):	60% x 6.0 inch (152 mm) ID crack
Seam Type:	FW	Visual:	ID hook crack
Grade:	X52	L	> 2.8 inch (71 mm)
D_{nominal}	20 inch (508 mm)	depth/ t_{weld}	43%
t_{nominal}	0.344 inch (8.74 mm)	depth:	0.1875 (3/16 inch) (4.76 mm)
t_{pipe}	0.345 inch (8.76 mm)	t_{weld}	0.435 inch (11.1 mm)
Failure:	None at 2,300 psig (15.86 MPa) (129% of SMYS)

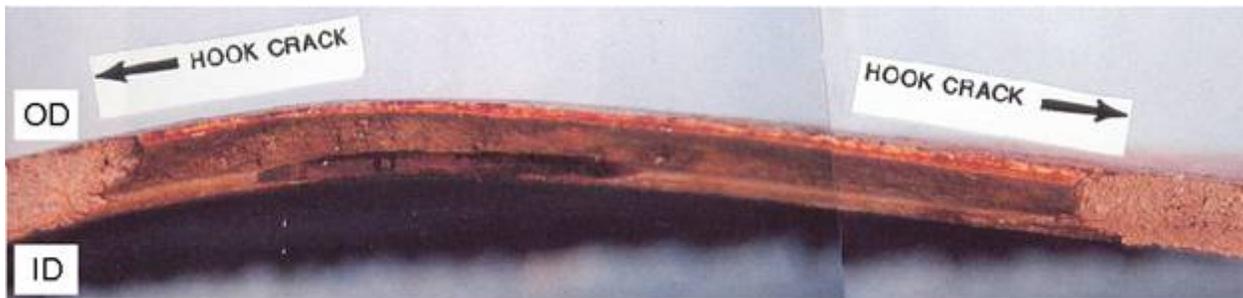
Catalog #: 45
 Report #: 5
 Defect #: 24

Photograph of Fracture Surface.

Seam Type: FW
 Grade: X52
 D_{nominal} : 20 inch (508 mm)
 t_{nominal} : 0.312 inch (7.92 mm)
 t_{pipe} : 0.310 inch (7.87 mm)
 Failure: Burst Test: No failure at
 2,200 psig (15.17 MPa)
 (136% of SMYS) +
 Yielding at 2,175 psig
 (15.00 MPa) (134% of
 SMYS)

NDE technique(s): Fast UT
 NDE result(s): 2.4 inch (61 mm)
 long, 50% crack-like
 ID Hook Crack
 Visual: > 5 inch (127 mm)
 L
 depth/ t_{weld} : 40%
 depth: 0.158 inch (4.01 mm)
 t_{weld} : 0.394 inch (10.1 mm)

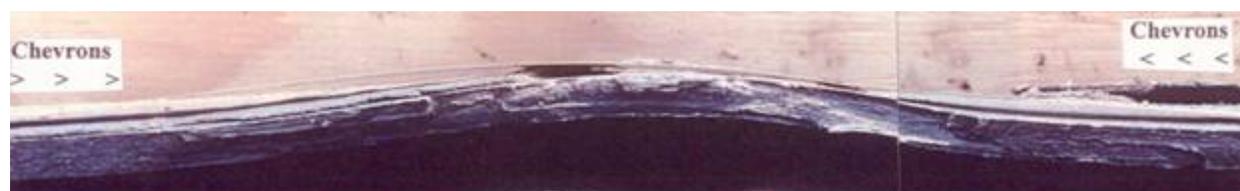
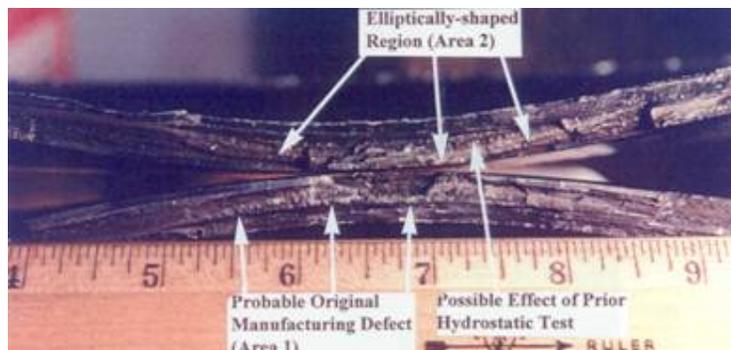
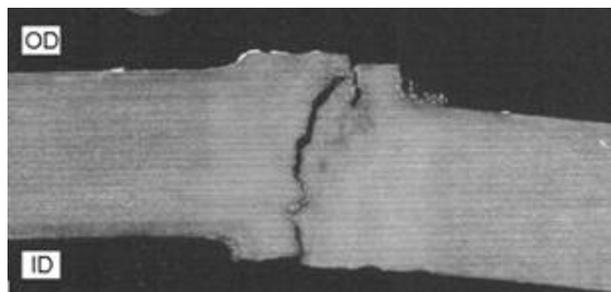
Catalog #: 84
 Report #: 4
 Defect #: 964+53

Photographs of Fracture Surfaces and Metallographic Section.

D_{nominal} 20 inch (508 mm)
 t_{nominal} 0.312 inch (7.92 mm)
 t_{pipe} 0.321 inch (8.15 mm)
 Failure: In-Service rupture at 897 psig (6.18 MPa) (55% of SMYS) Hydrotested at 1,460 psig (10.07 MPa) (90% of SMYS) 32 to 35 years earlier

NDE technique(s): N/A
 NDE result(s): N/A
 Visual: ID Overtrim + ID Hook Crack + Fatigue Crack
 L 11 feet long, 5.875 inch (149 mm) wide
 depth/ t_{weld} 40% (Hook Crack)
 depth: 0.162 inch (4.11 mm)
 t_{weld} 0.405 inch (10.3 mm)

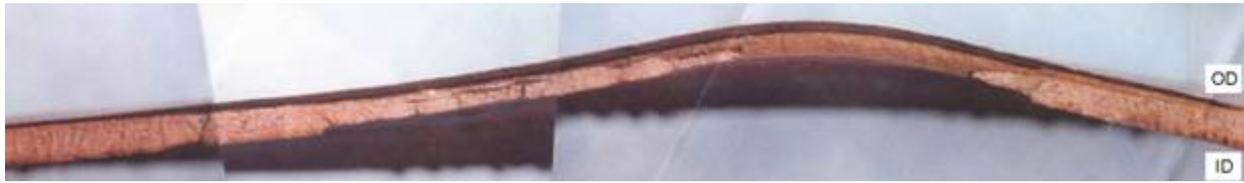
Catalog #: 49
 Report #: 5
 Defect #: 45B

Photograph of Fracture Surface.

Seam Type: FW
 Grade: X52
 D_{nominal} : 20 inch (508 mm)
 t_{nominal} : 0.312 inch (7.92 mm)
 t_{pipe} : 0.308 inch (7.82 mm)
 Failure: Burst test rupture at
 2,150 psig(*) (14.82 MPa)
 (133% of SMYS)

NDE technique(s): Fast UT
 NDE result(s): 65%, 14 inch (356 mm)
 crack-like
 Visual: OD Hook crack
 L: 6.63 inch (168 mm)
 depth/ t_{weld} : 40%
 depth: 0.156 inch (3.96 mm)
 t_{weld} : 0.390 inch (9.91 mm)

(*) This and a nearby hook crack together produced the failure at this pressure.

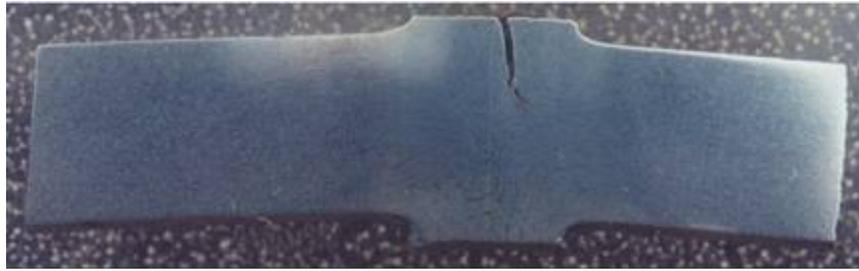
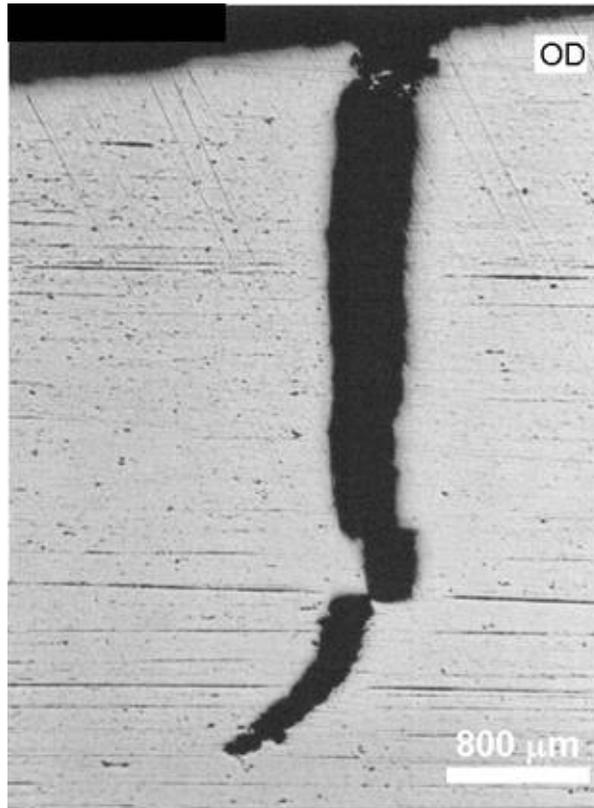
Catalog #: 76
 Report #: 7
 Defect #: 1328

Photograph and Photomicrograph of Metallographic Section.

Seam Type: FW
 Grade: X52
 D_{nominal} : 20 inch (508 mm)
 t_{nominal} : 0.312 inch (7.92 mm)
 t_{pipe} : 0.318 inch (8.08 mm)
 Failure: N/A

NDE technique(s): Fast UT
 NDE result(s): 40% (0.158 inch (4.01 mm))
 OD Crack
 Visual: OD Hook Crack
 L: Not Determined
 $\text{depth}/t_{\text{weld}}$: 39%
 depth: 0.155 inch (3.94 mm)
 t_{weld} : 0.398 inch (10.1 mm)

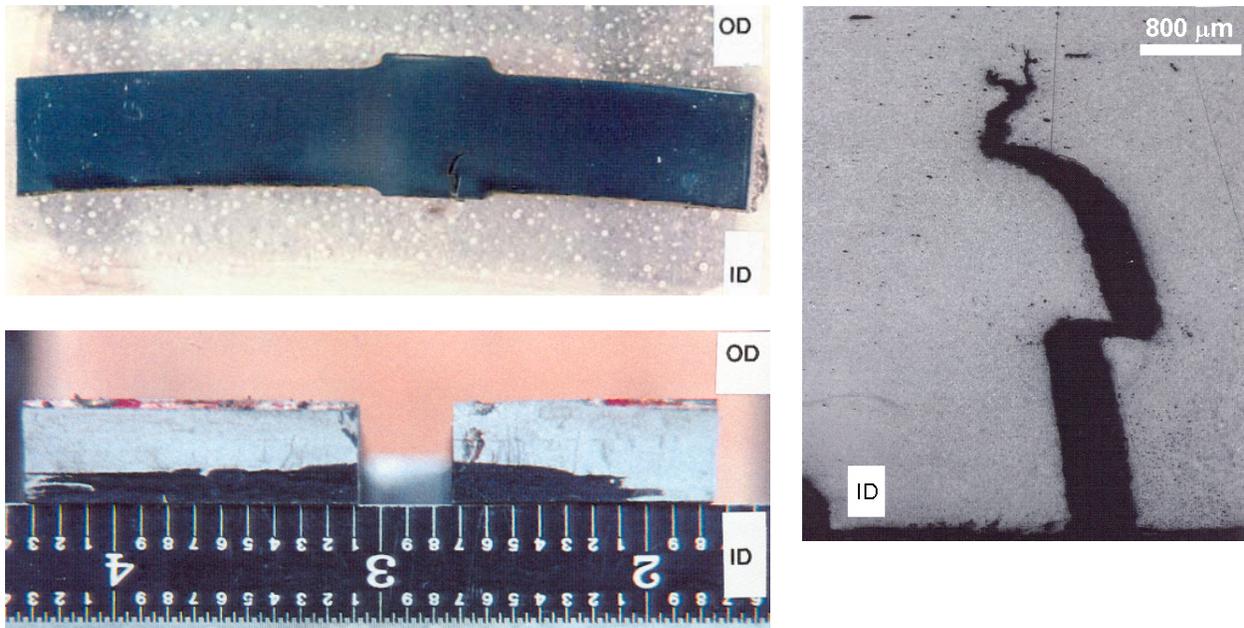
Catalog #: 38
 Report #: 5
 Defect #: C10

Photographs and Photomicrograph of Metallographic Section and Fracture Surfaces.

NDE technique(s): UT & Fast UT
 NDE result(s): Minor Inclusions (UT)
 + Minor Inclusions (Fast UT) + Crack-like (Fast UT)

Visual: ID hook crack (with crack extension)
 > 2.5 inch (63 mm)

L depth/ t_{weld} : 38%
 depth: 0.148 inch (3.76 mm)
 (incl. 0.028 inch (0.71 mm) crack extension)

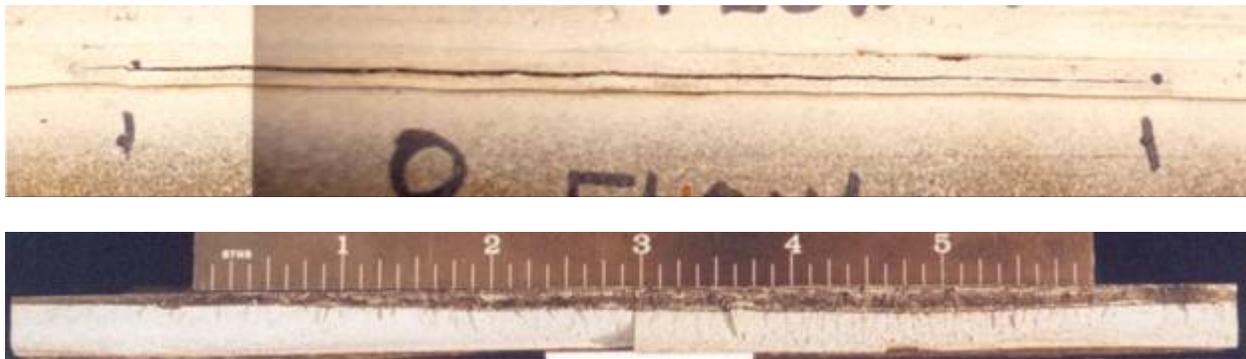
Catalog #: 67
 Report #: 7
 Defect #: 841

Photographs of Weld Seam ID Surface and Fracture Surface.

Seam Type: FW
 Grade: X52
 D_{nominal} : 20 inch (508 mm)
 t_{nominal} : 0.312 inch (7.92 mm)
 t_{pipe} : Not Determined
 Failure: N/A

NDE technique(s): Fast UT
 NDE result(s): 40% (0.170 inch (4.32 mm)) ID Crack
 ID Hook Crack
 > 8 inch (203 mm)
 Visual: ID Hook Crack
 L
 $\text{depth}/t_{\text{weld}}$: 37%
 depth: 0.156 inch (3.96 mm)
 t_{weld} : 0.425 inch (10.8 mm)

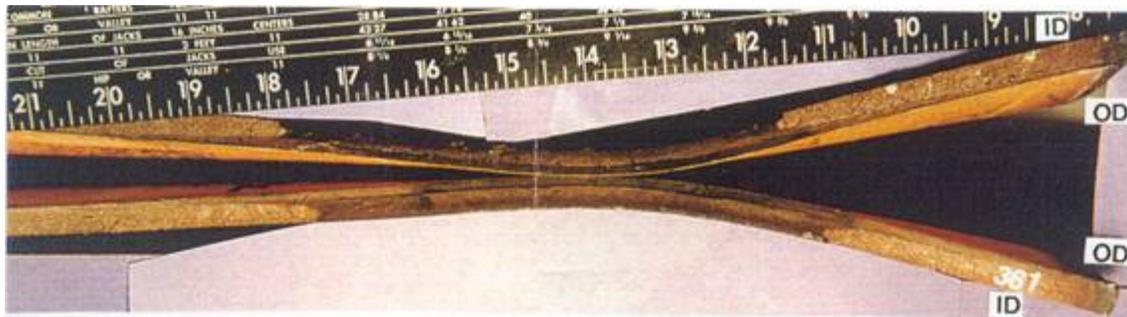
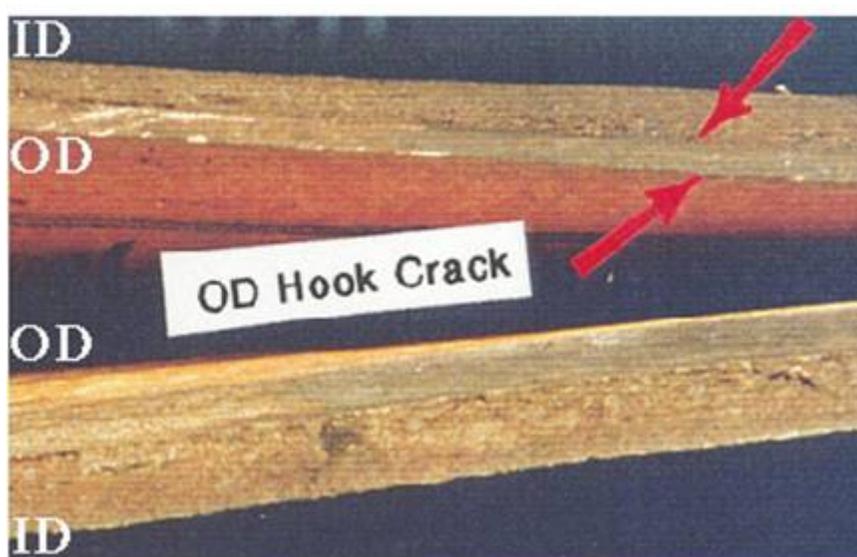
Catalog #: 21
 Report #: 2
 Defect #: 361

Photographs of Fracture Surfaces.

Seam Type: FW
 Grade: X52
 D_{nominal} : 20 inch (508 mm)
 t_{nominal} : 0.312 inch (7.92 mm)
 t_{pipe} : 0.303 inch (7.7 mm)
 Failure: Burst test rupture at
 1,925 psig (13.27 MPa)
 (119% of SMYS)

NDE technique(s): UT
 NDE result(s): 30%, 8.5 inch (216 mm)
 OD crack like
 Visual: OD Hook crack
 L: 10.5 inch (267 mm)
 depth/ t_{weld} : 36%
 depth: 0.140 inch (3.56 mm)
 t_{weld} : 0.389 inch (9.88 mm)

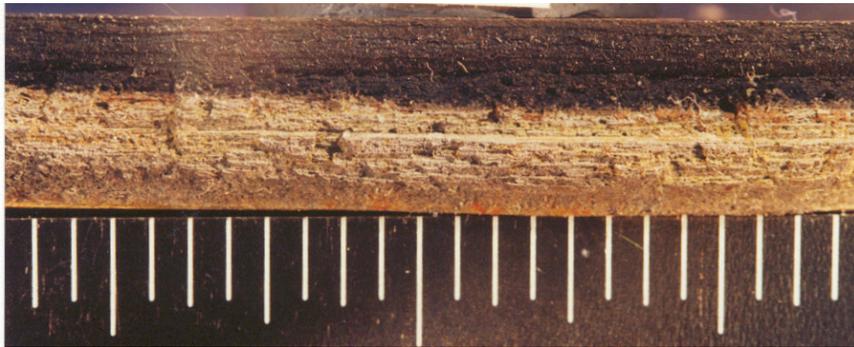
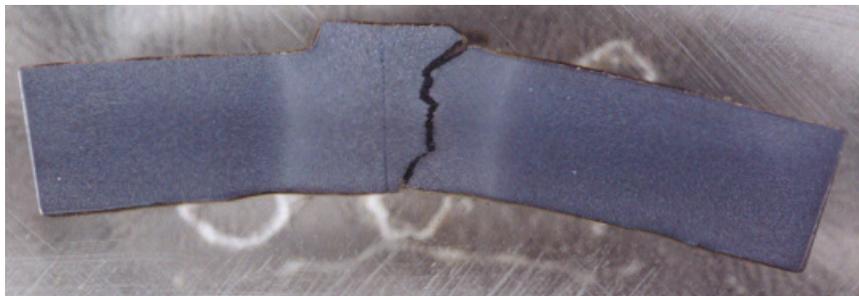
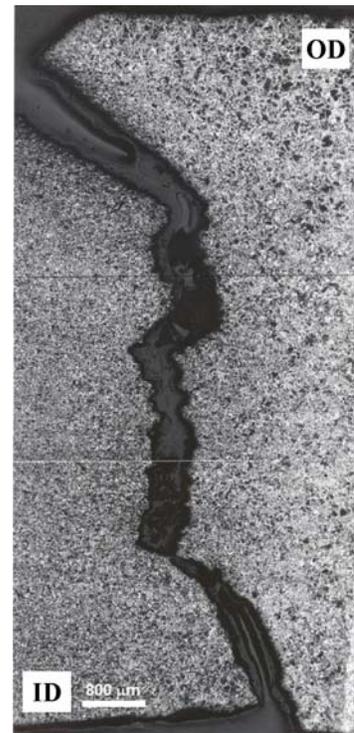
Catalog #: 60
 Report #: 6
 Defect #: 968

Photographs and Photomicrograph of Metallographic Section and Fracture Surfaces.

Vintage: circa 1950
 Manufacturer: AO Smith
 Seam Type: FW
 Grade: X52
 D_{nominal} : 20 inch (508 mm)
 t_{nominal} : 0.312 inch (7.92 mm)
 t_{pipe} : Not Determined
 Failure: Burst test failure at
 1,950 psig (13.44 MPa)
 (120% of SMYS)

NDE technique(s): Fast UT
 NDE result(s): 65% ID Crack
 Visual: ID Hook Crack
 L: 8.25 inch (210 mm)
 depth/ t_{weld} : 34%
 depth: 0.125 inch (3.17 mm)
 t_{weld} : 0.371 inch (9.42 mm)

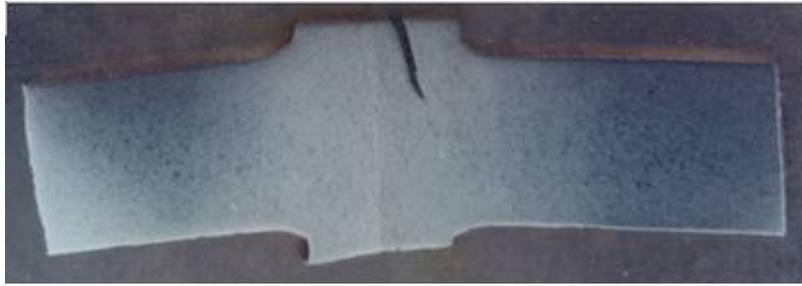
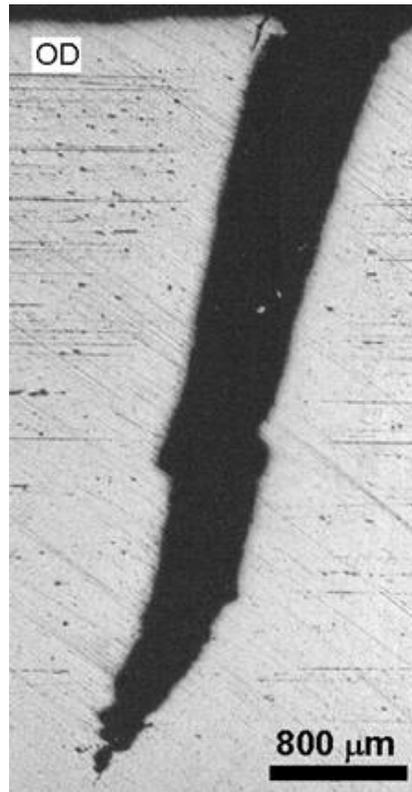
Photograph and Photomicrograph of Metallographic Section.

Catalog #:	78		
Report #:	7		
Defect #:	1381		
Pipe		Defect	
Vintage:	circa 1950	NDE technique(s):	Fast UT
Manufacturer:	AO Smith	NDE result(s):	30% (0.128 inch (3.25 mm)) OD Crack-Like
Seam Type:	FW	Visual:	OD Hook Crack
Grade:	X52	L	Not Determined
D_{nominal}	20 inch (508 mm)	depth/ t_{weld}	34%
t_{nominal}	0.312 inch (7.92 mm)	depth:	0.145 inch (3.68 mm)
t_{pipe}	0.306 inch (7.77 mm)	t_{weld}	0.425 inch (10.8 mm)
Failure:	N/A

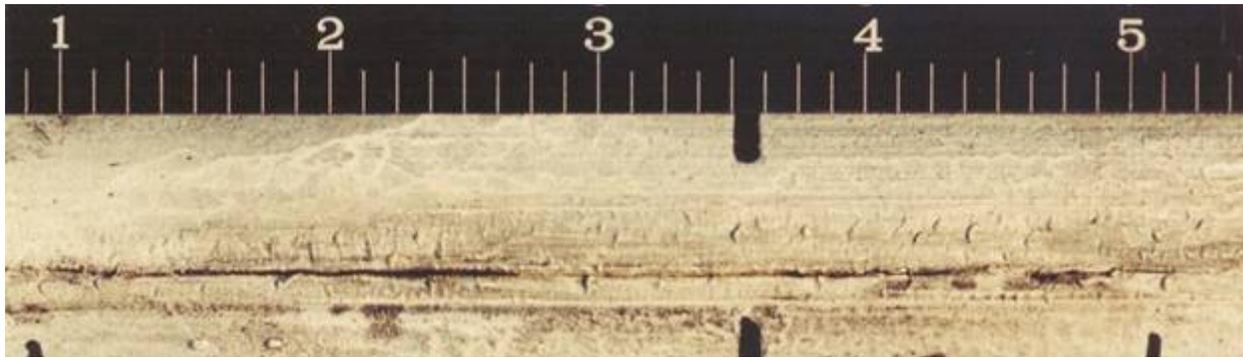
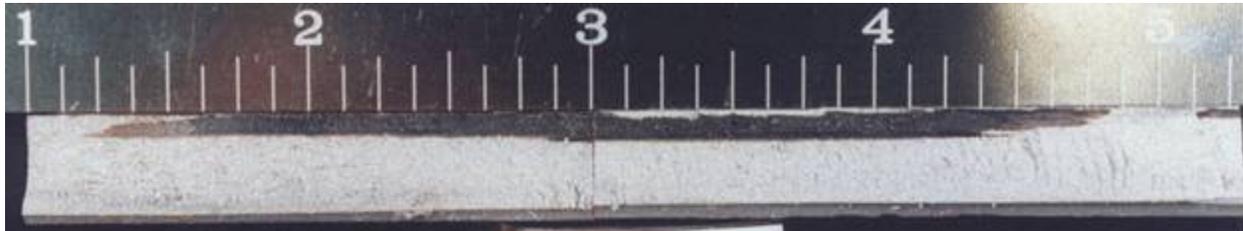
Catalog #: 72
 Report #: 7
 Defect #: 1017

Photographs of Weld Seam ID Surface and Fracture Surface.

Vintage: circa 1950
 Manufacturer: AO Smith
 Seam Type: FW
 Grade: X52
 D_{nominal} : 20 inch (508 mm)
 t_{nominal} : 0.312 inch (7.92 mm)
 t_{pipe} : Not Determined
 Failure: N/A

NDE technique(s): Fast UT
 NDE result(s): 30% ID Crack
 Visual: ID Hook Crack
 L: 3.5 inch (89 mm)
 $\text{depth}/t_{\text{weld}}$: 32%
 depth: 0.116 inch (2.95 mm)
 t_{weld} : 0.365 inch (9.27 mm)

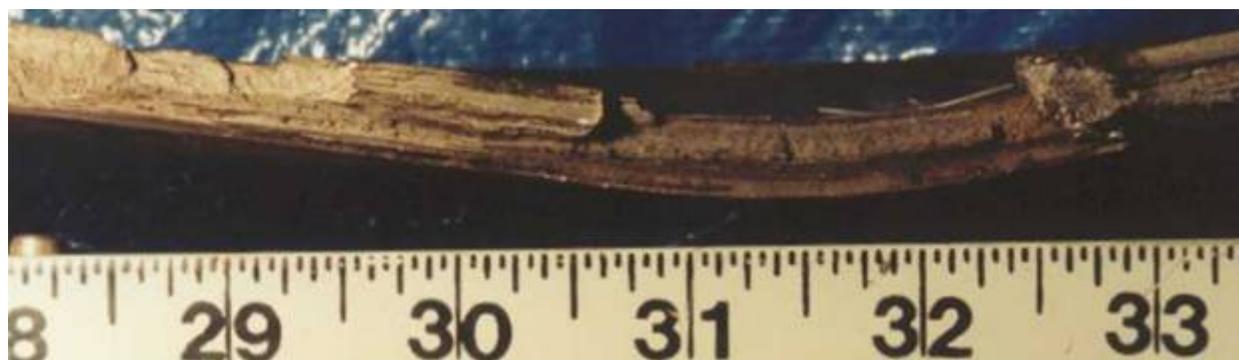
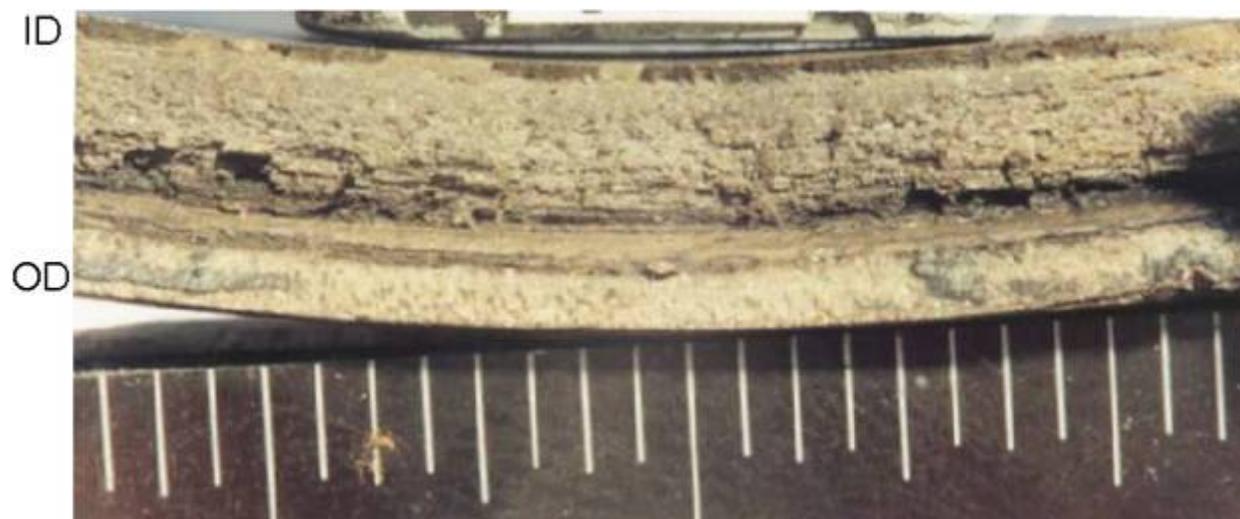
Catalog #: 57
 Report #: 6
 Defect #: 808

Photographs of Fracture Surface.

Grade: X52
 D_{nominal} : 20 inch (508 mm)
 t_{nominal} : 0.312 inch (7.92 mm)
 t_{pipe} : Not Determined
 Failure: Burst test failure at
 1,900 psig (13.10 MPa)
 (117% of SMYS)

NDE technique(s): Fast UT
 NDE result(s): 65% OD Crack
 Visual: OD Hook Crack +
 inclusions
 L: 5 inch (127 mm)
 $\text{depth}/t_{\text{weld}}$: 32%
 depth: 0.125 inch (3.17 mm)
 t_{weld} : 0.385 inch (9.78 mm)

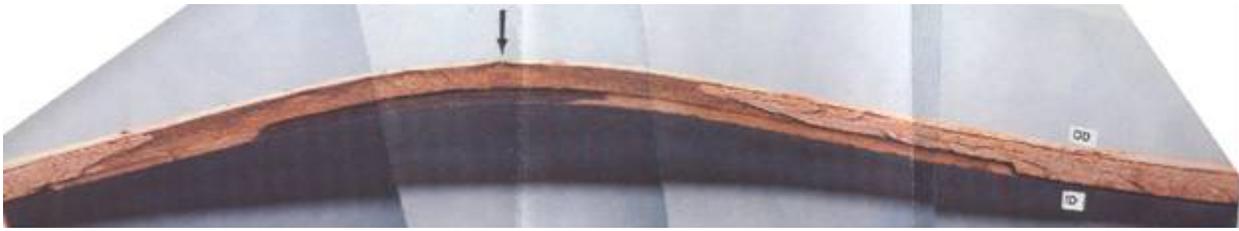
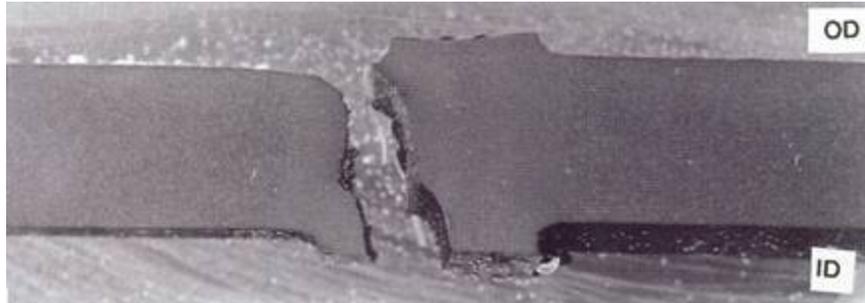
Photographs of Fracture Surface and Metallographic Section.

Catalog #:	50		
Report #:	5		
Defect #:	46		
<u>Pipe</u>		<u>Defect</u>	
Vintage:	circa 1950	NDE technique(s):	Fast UT
Manufacturer:	AO Smith	NDE result(s):	4.8 inch (122 mm) crack-like, ID connected
Seam Type:	FW	Visual:	ID Hook crack
Grade:	X52	L	> 9 inch (229 mm)
D_{nominal}	20 inch (508 mm)	depth/ t_{weld}	31%
t_{nominal}	0.312 inch (7.92 mm)	depth:	0.124 inch (3.15 mm)
t_{pipe}	0.314 inch (7.98 mm)	t_{weld}	0.400 inch (10.2 mm)
Failure:	Burst test rupture at 2,250 psig (15.51 MPa) (139% of SMYS)

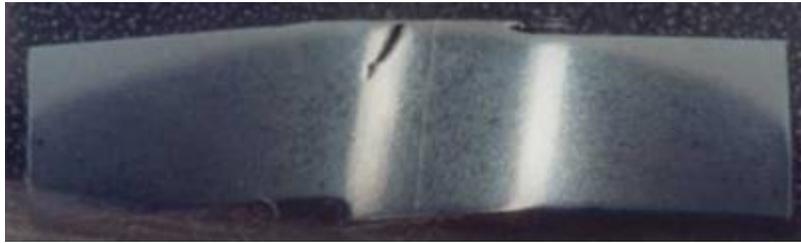
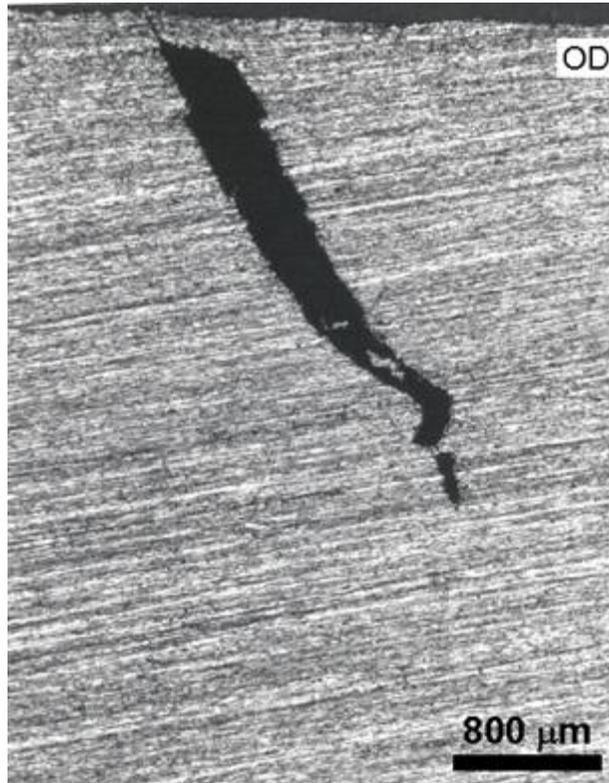
Catalog #: 77
 Report #: 7
 Defect #: 1339

Photograph and Photomicrograph of Metallographic Section.

NDE technique(s): Fast UT
 NDE result(s): 30% (0.105 inch (2.67 mm)) OD
 Crack-like

Seam Type: FW
 Grade: X52
 D_{nominal} : 20 inch (508 mm)
 t_{nominal} : 0.312 inch (7.92 mm)
 t_{pipe} : 0.306 inch (7.77 mm)
 Failure: N/A

Visual: OD Hook Crack
 L: Not Determined
 $\text{depth}/t_{\text{weld}}$: 29%
 depth: 0.100 inch (2.54 mm)
 t_{weld} : 0.349 inch (8.86 mm)

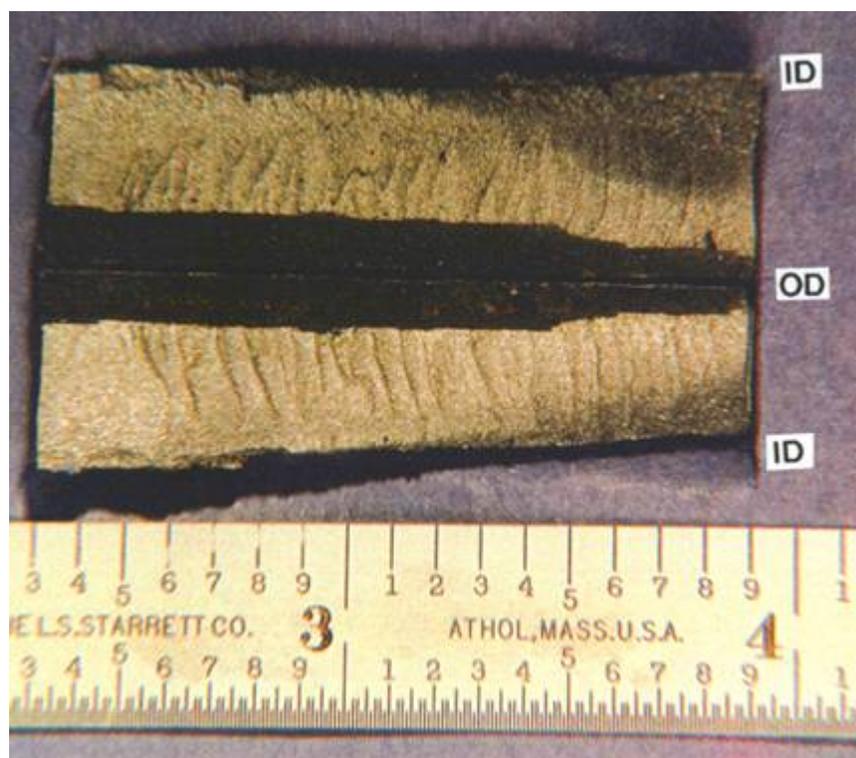
Photograph of Fracture Surfaces.

Catalog #:	5		
Report #:	1		
Defect #:	282		
<u>Pipe</u>		<u>Defect</u>	
Vintage:	1950s	NDE technique(s):	UT
Manufacturer:	AO Smith	NDE result(s):	66% x 3.5 inch (89 mm) OD crack
Seam Type:	FW	Visual:	OD hook crack
Grade:	X52	L	~ 3.4 inch (86 mm)
D_{nominal}	20 inch (508 mm)	depth/ t_{weld}	27.7%
t_{nominal}	0.344 inch (8.74 mm)	depth:	0.125 (1/8 inch (3.17 mm))
t_{pipe}	0.341 inch (8.66 mm)	t_{weld}	0.450 inch (11.4 mm)
Failure:	None at 2,300 psig (15.86 MPa) (129% of SMYS)

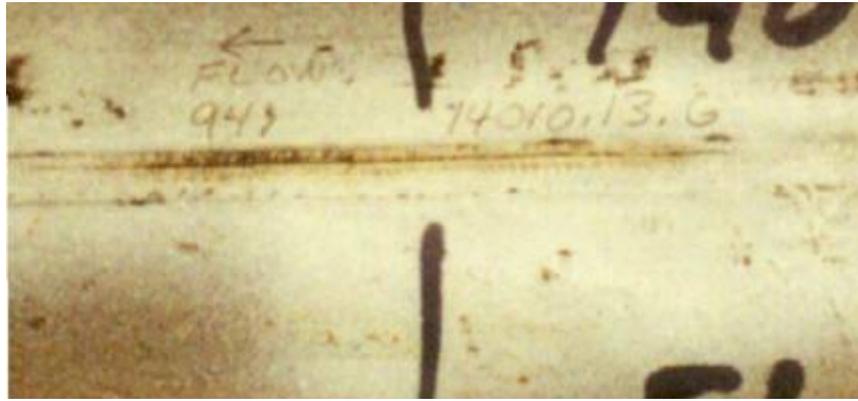
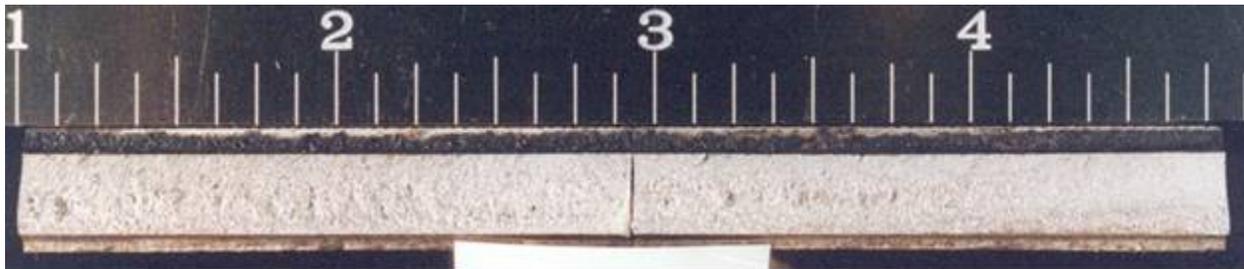
Catalog #: 69
 Report #: 7
 Defect #: 941

Photographs of Weld Seam ID Surface and Fracture Surface.

Vintage: circa 1950
 Manufacturer: AO Smith
 Seam Type: FW
 Grade: X52
 D_{nominal} : 20 inch (508 mm)
 t_{nominal} : 0.312 inch (7.92 mm)
 t_{pipe} : Not Determined
 Failure: N/A

NDE technique(s): Fast UT
 NDE result(s): 20% ID Crack
 Visual: ID Hook Crack
 L: > 5 inch (127 mm)
 depth/ t_{weld} : 25%
 depth: 0.086 inch (2.18 mm)
 t_{weld} : 0.344 inch (8.74 mm)

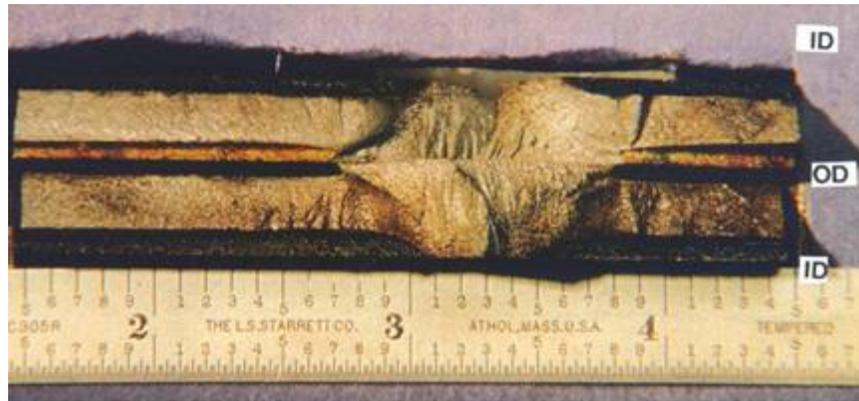
Catalog #: 4
 Report #: 1
 Defect #: 169

Photograph of Fracture Surfaces.

t_{pipe} : 0.310 inch (7.87 mm)
 Failure: None at 2,275 psig
 (15.69 MPa) (140% of
 SMYS)

NDE technique(s): UT
 NDE result(s): 40% x 5.5 inch (140 mm)
 crack

Visual: ID hook crack
 L > 6 inch (152 mm)
 depth/ t_{weld} : 24.4%
 depth: 0.09375 (3/32 inch (2.38
 mm))

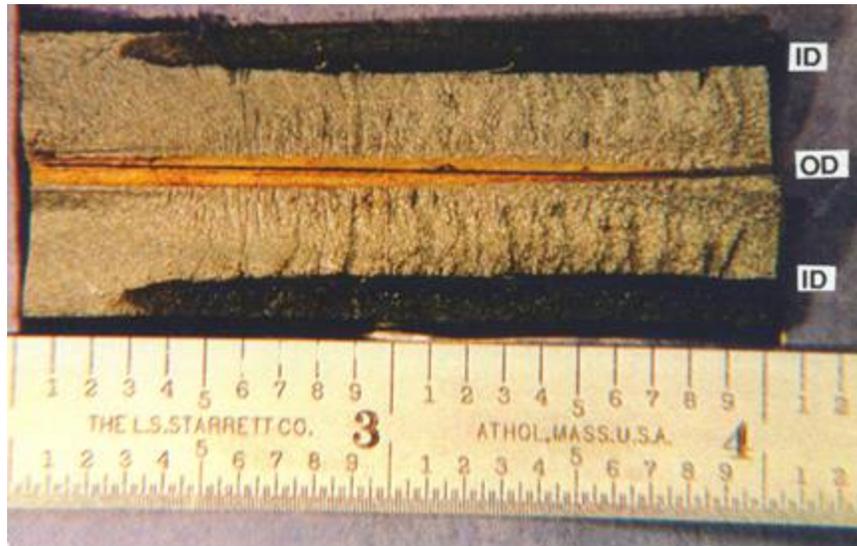
Catalog #: 16
 Report #: 1
 Defect #: 643

Photograph of Fracture Surfaces.

Seam Type: FW
 Grade: X52
 D_{nominal} : 20 inch (508 mm)
 t_{nominal} : 0.312 inch (7.92 mm)
 t_{pipe} : 0.315 inch (8.00 mm)
 Failure: None at 2,300 psig
 (15.86 MPa) (140%
 of SMYS)

NDE technique(s): UT
 NDE result(s): 50% x 5.0 inch (127 mm) ID
 crack
 Visual: ID hook crack
 L ~ 3.4 inch (86 mm)
 depth/ t_{weld} : 23.4%
 depth: 0.09375 inch (3/32) (2.38 mm)
 t_{weld} : 0.400 inch (10.2 mm)
