Appendix B – Task 2
Catalog of Seam Weld Defect Types

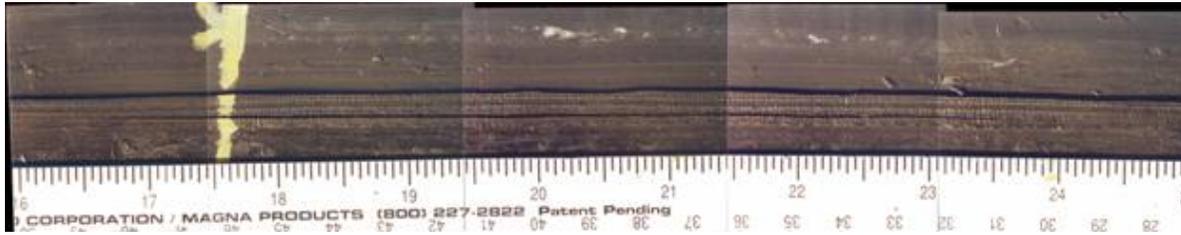
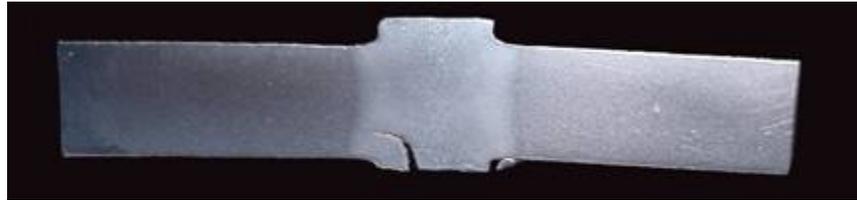
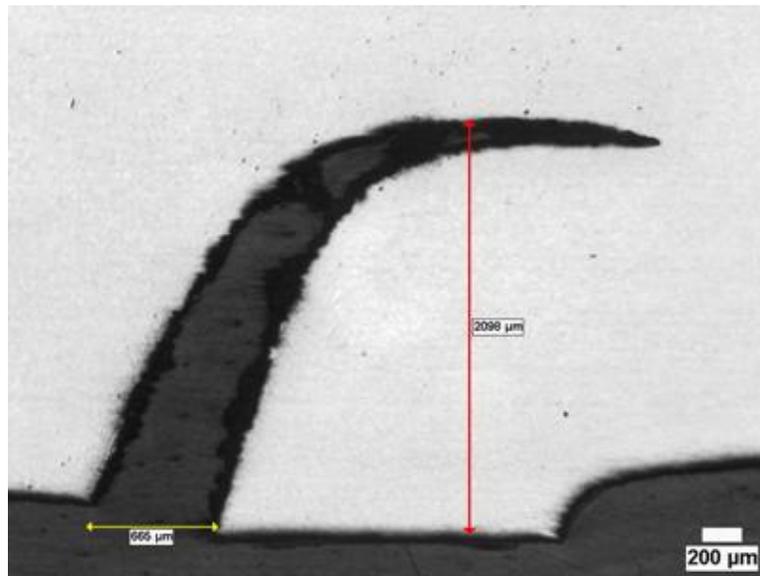
Catalog #: 17
 Report #: 13
 Defect #: 1

Photographs and Photomicrograph of Pipe ID Surface and Metallographic Section.

Vintage: 1954
 Manufacturer: AO Smith
 Seam Type: FW
 Grade: API 5L X52
 D_{nominal} : 26 inch (660 mm)
 t_{nominal} : 0.281 inch (7.14 mm)
 t_{pipe} : 0.275 inch (6.98 mm)
 Failure: N/A
 MOP: 809 psig (5.58 MPa)

NDE technique(s): Shear wave UT
 NDE result(s): 30% x 8.1 inch (206 mm)
 ID-connected crack
 Visual: ID hook crack
 L: ~ 7 inch (178 mm)
 Width: 0.026 inch (0.66 mm)
 depth/ t_{weld} : 22.6%
 depth: 0.083 inch (2.1 mm)
 t_{weld} : 0.365 inch (9.27 mm)

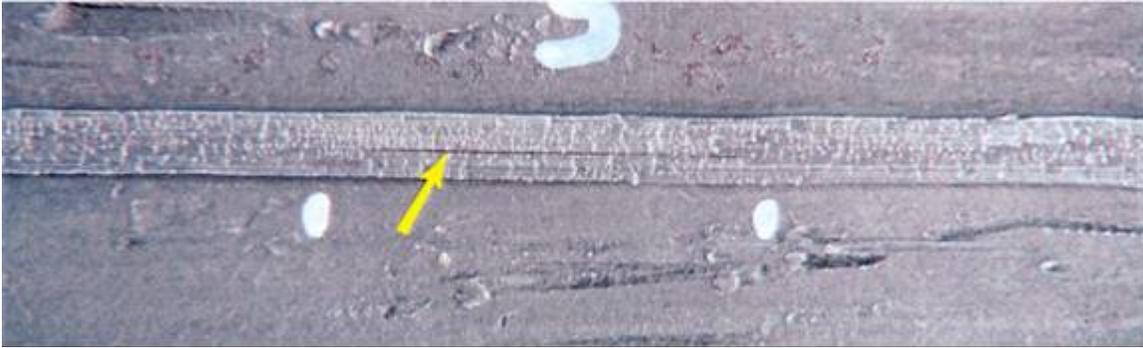
Catalog #: 40
 Report #: 5
 Defect #: 3

Photograph of Weld Seam ID Surface.

NDE technique(s): Fast UT
 NDE result(s): 2 interacting, ID-connected crack-like indications: combined L = 3.6 inch (91 mm), 25% radial extent

Visual: ID hook crack (surmised, defect not exposed)

Grade: X52
 $D_{nominal}$: 20 inch (508 mm)
 $t_{nominal}$: 0.312 inch (7.92 mm)
 t_{pipe} : 0.309 inch (7.85 mm)
 Failure: Burst test: No failure at 2,250 psig (15.51 MPa) (139% of SMYS) + Yielding at 2,175 psig (15.00 MPa) (134% of SMYS)

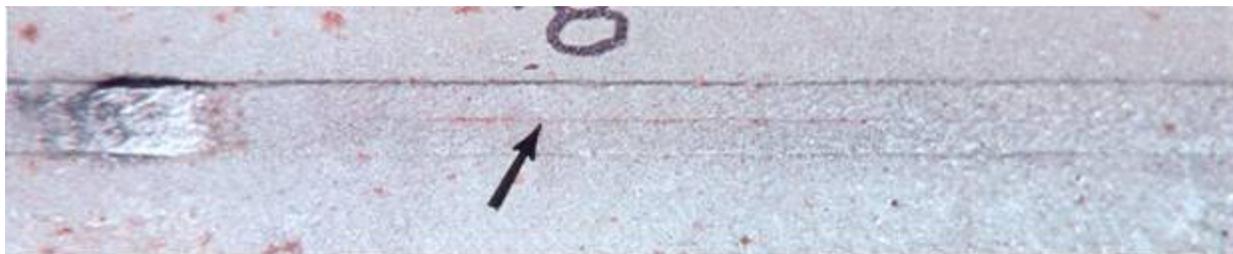
Catalog #: 41

Photograph of Weld Seam OD Surface.

NDE technique(s): Fast UT
 NDE result(s): 50%, 3.7 inch (94 mm)
 crack-like, OD-
 connected

Visual: OD hook crack
 (surmised, defect not
 exposed)

Failure: Burst Test: No failure at
 2,300 psig (15.86 MPa)
 (142% of SMYS) +
 Yielding at 2,250 psig
 (15.51 MPa) (139% of
 SMYS)

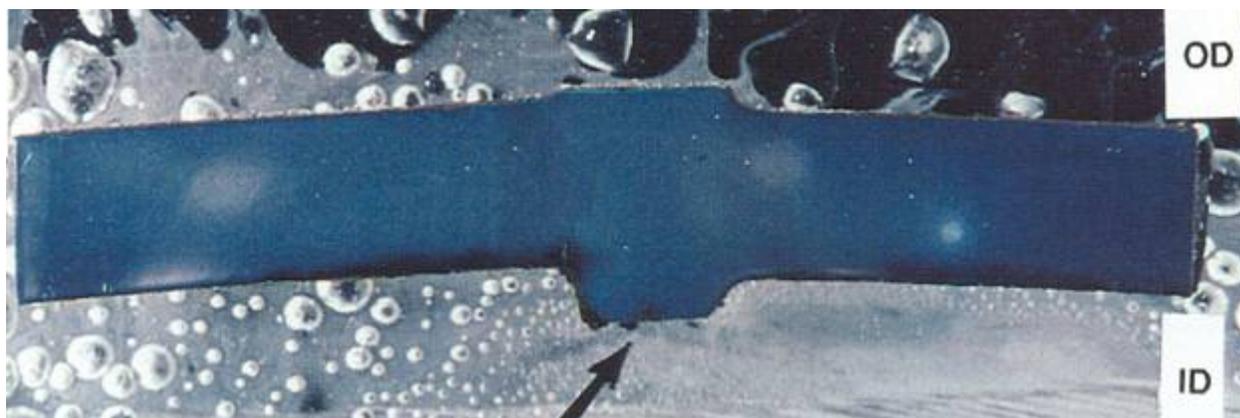
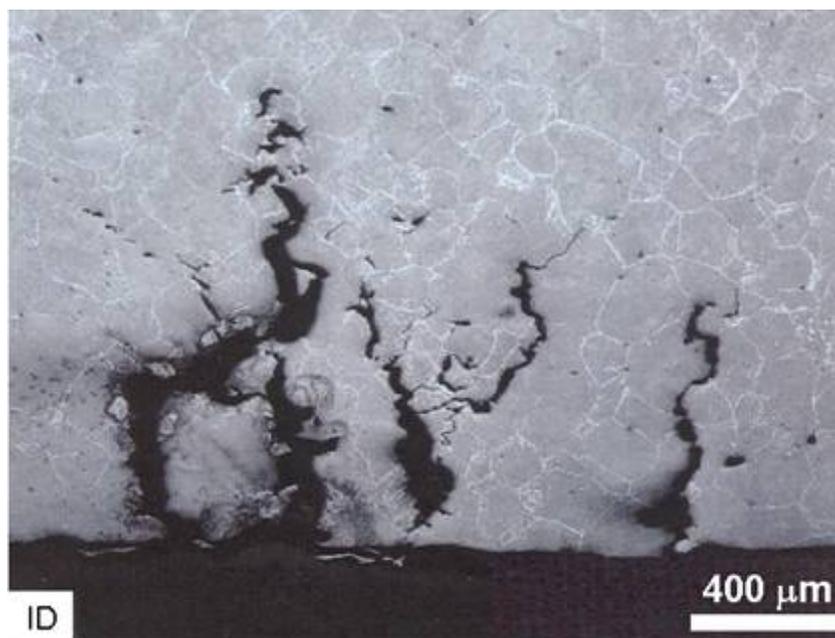
Catalog #: 36

Photograph and Photomicrograph of Metallographic Section.

ID Shrinkage Crack

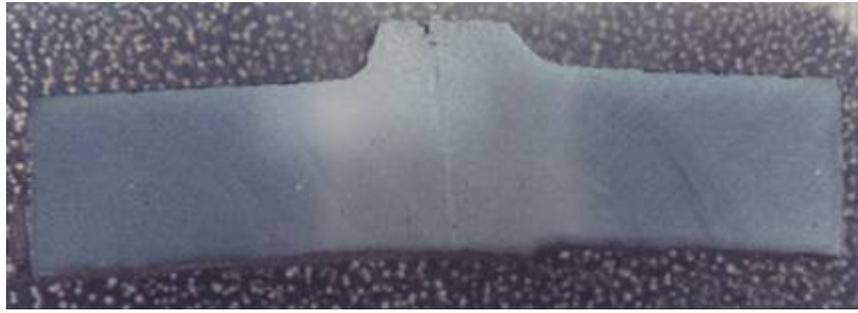
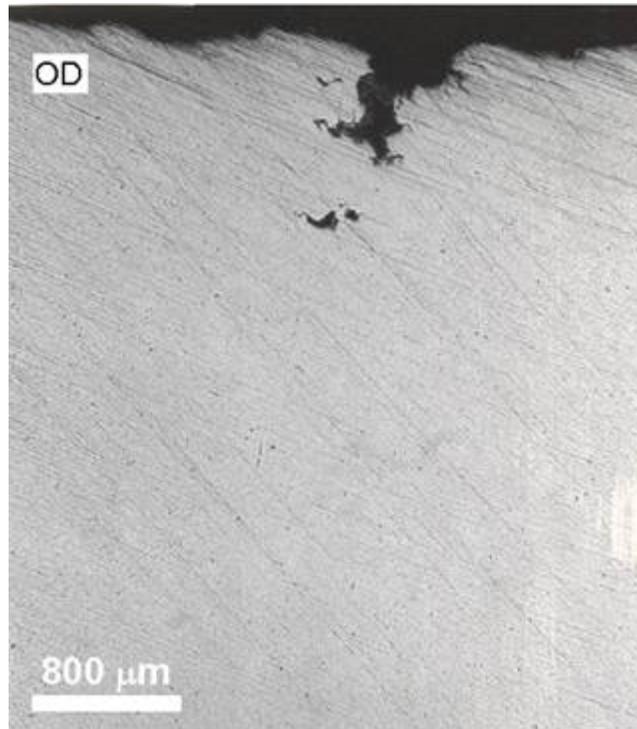
Catalog #: 68
 Report #: 7
 Defect #: 904

Photograph and Photomicrograph of Metallographic Section.

NDE technique(s): Fast UT
 NDE result(s): 20% OD Crack-Like
 Visual: OD Shrinkage Crack
 L: Not Determined
 $\text{depth}/t_{\text{weld}}$: 10%
 depth: 0.040 inch (1.02 mm)
 t_{weld} : 0.396 inch (10.1 mm)

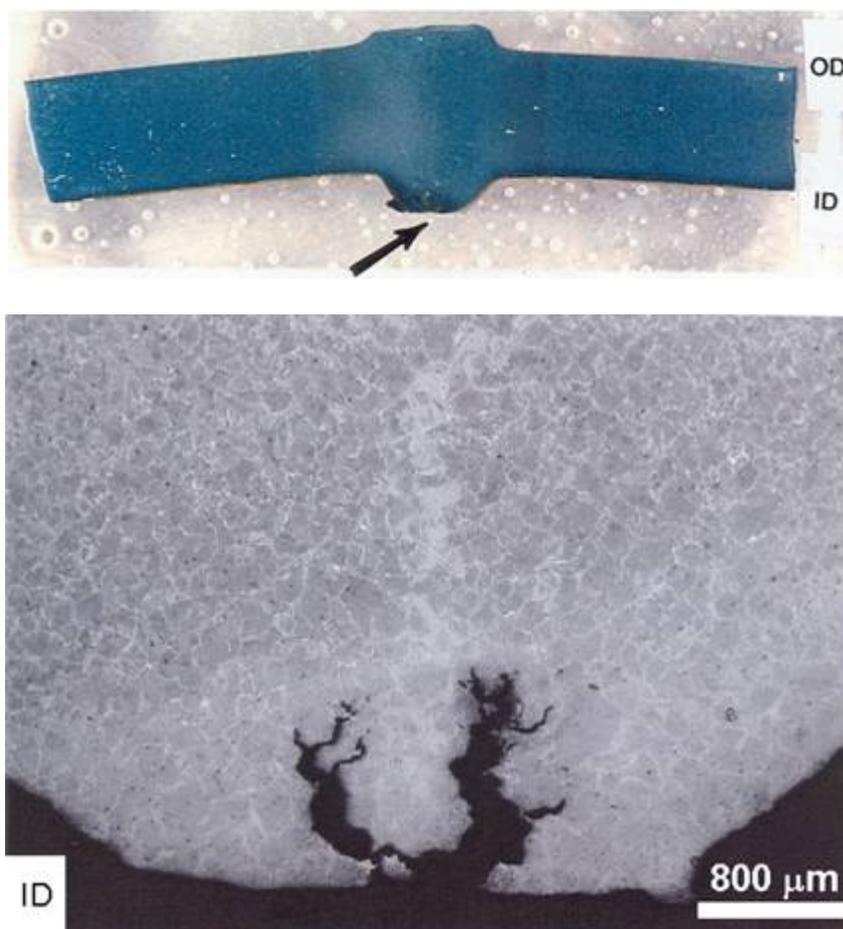
Catalog #: 33

Photograph and Photomicrograph of Metallographic Section.

Visual: Shrinkage Crack (Weld trim defect)

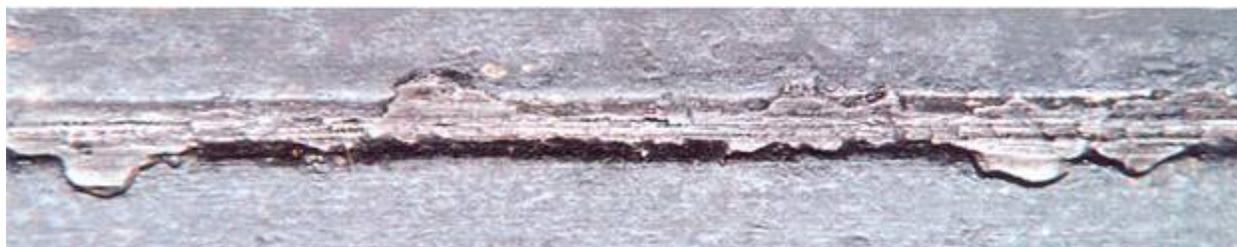
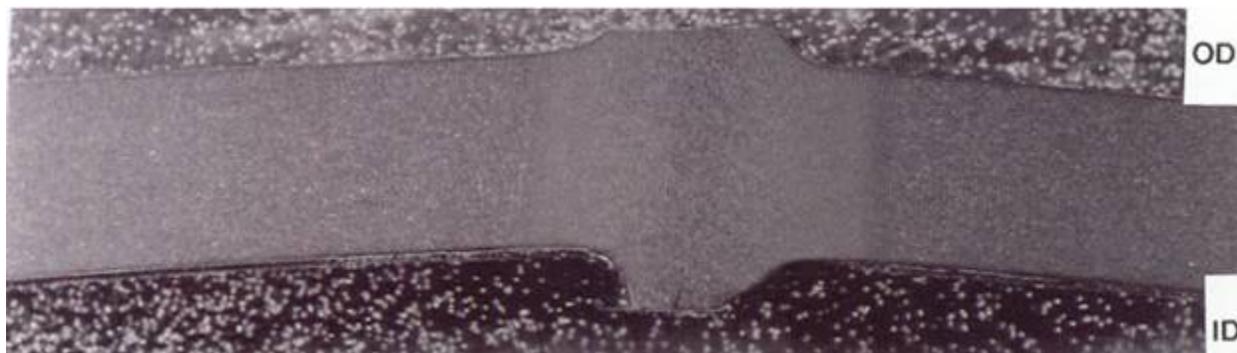
Catalog #: 39

Photographs of Weld Seam ID Surface and Metallographic Section.

Visual: ID Shrinkage Crack (Under-trim)

Failure: Burst test: No failure at 2,250 psig (15.51 MPa)
 + Yielding at 2,250 psig (15.51 MPa) (139% of SMYS)

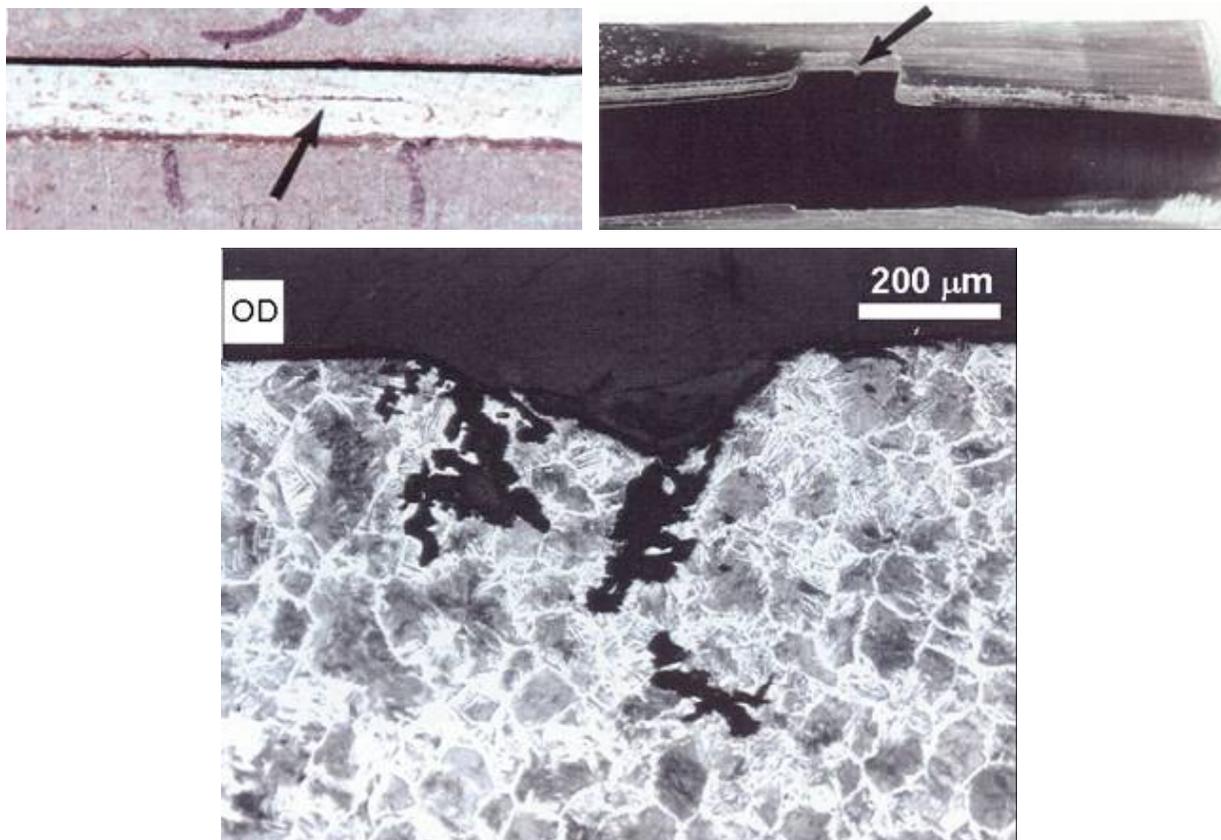
Catalog #: 47
 Report #: 5
 Defect #: 26

Photographs/Micrographs of Weld Seam OD Surface and Metallographic Section.

Grade: X52
 D_{nominal} : 20 inch (508 mm)
 t_{nominal} : 0.312 inch (7.92 mm)
 t_{pipe} : 0.316 inch (8.03 mm)
 Failure: Burst test: No failure at 2,200 psig (15.17 MPa) (136% of SMYS) + Yielding at 2,000 psig (13.79 MPa) (123% of SMYS)

NDE technique(s): Fast UT
 NDE result(s): <10%, 3.75 inch (95 mm) crack-like, OD-connected OD shrinkage crack (inadequate trim)
 Visual: N/A
 L: N/A
 $\text{depth}/t_{\text{weld}}$: < 5%
 depth: 0.020 inch (0.51 mm)
 t_{weld} : 0.390 inch (9.91 mm)

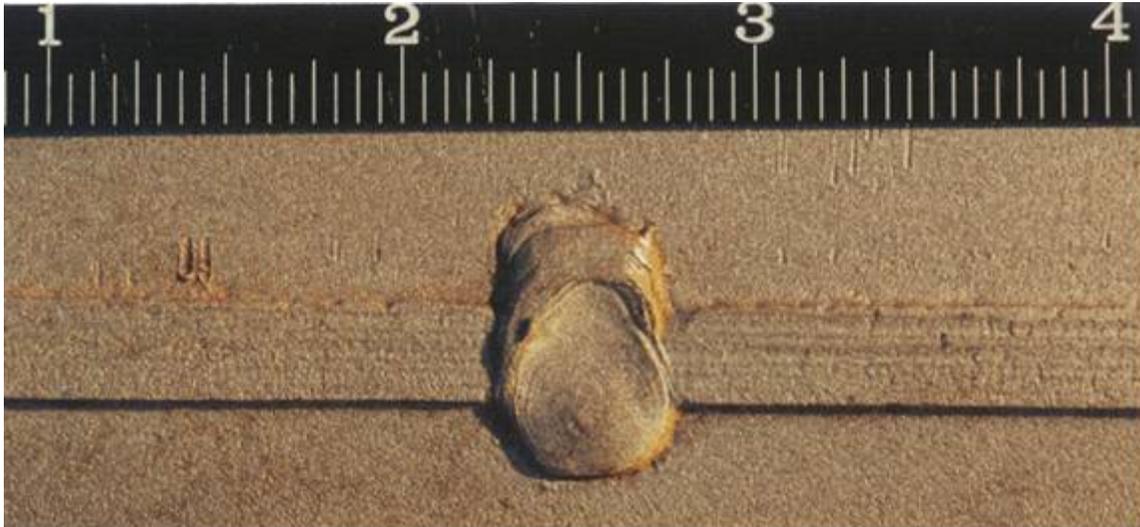
Catalog #: 79
 Report #: 7
 Defect #: 1422

Photograph of Weld Seam OD Surface.

NDE technique(s): Visual
 NDE result(s): OD Weld repair
 Visual: OD Weld repair + No
 cracking visible from
 ID surface

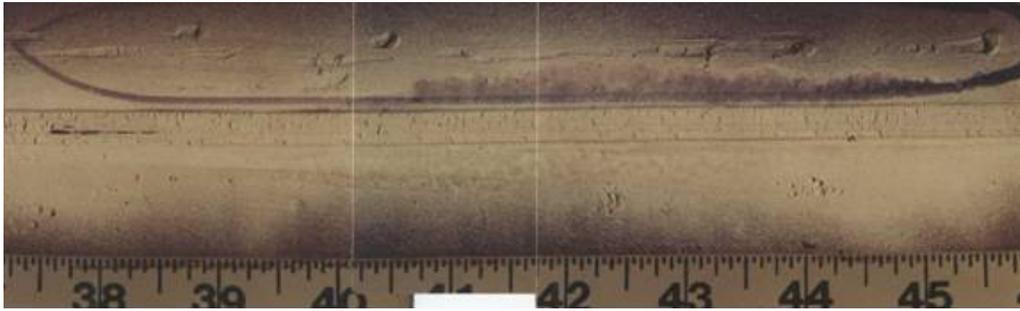
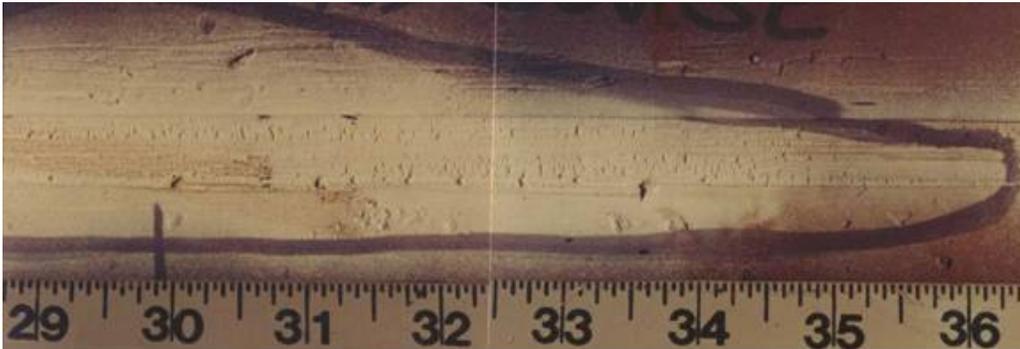
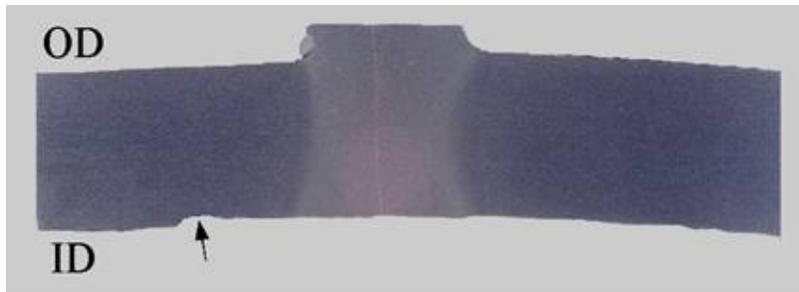
Photographs of Weld Seam ID Surface and Metallographic Section.

Catalog #:	71		
Report #:	7		
Defect #:	1003		
Pipe		Defect	
Vintage:	circa 1950	NDE technique(s):	Fast UT
Manufacturer:	AO Smith	NDE result(s):	< 10% ID Gouge + < 0.060 inch (1.52 mm) RDI Dent
Seam Type:	FW	Visual:	3 ID Gouges + Weld Over-trim
Grade:	X52	L	5 inch, 7 inch, 8 inch (127, 178, 203 mm)
D _{nominal}	20 inch (508 mm)	depth/t _{weld}	Not Determined
t _{nominal}	0.312 inch (7.92 mm)	depth:	Not Determined
t _{pipe}	Not Determined	t _{weld}	Not Determined
Failure:	N/A

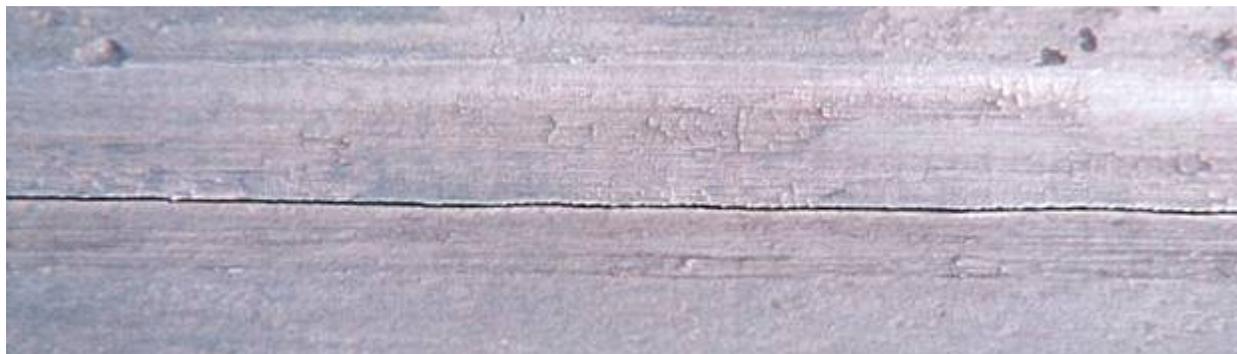
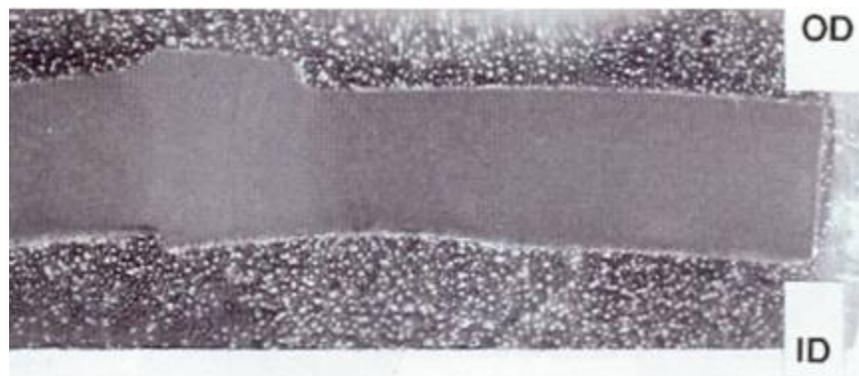
Catalog #: 52

Photographs of Weld Seam ID Surface and Metallographic Section.

NDE result(s): 9.2 inch (234 mm)
linear indications + < 5% two small cracks
0.1"(1.6")0.3" (1.54 mm(41 mm)7.6mm)

Failure: Burst test: No failure at 2,300 psig (15.86 MPa) (142% of SMYS) +
Yielding at 2,000 psig (13.79 MPa) (123% of SMYS)

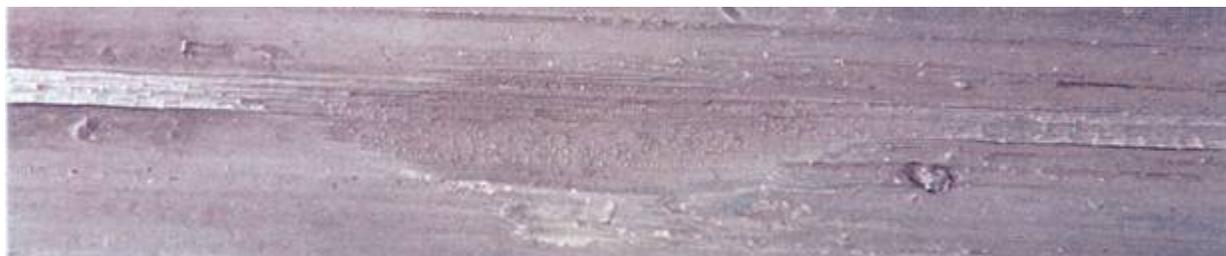
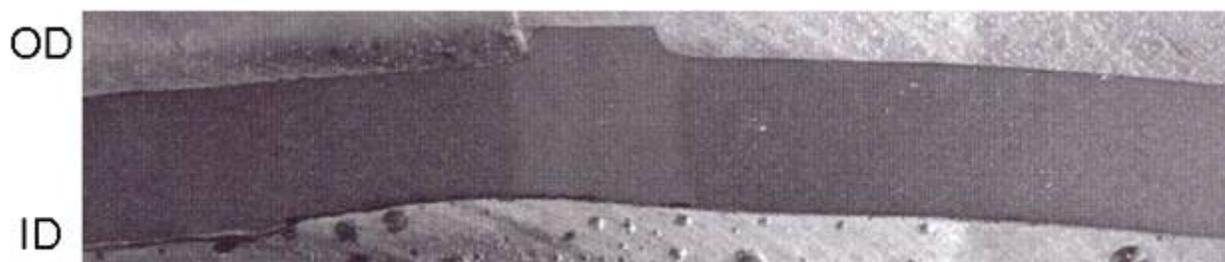
Catalog #: 53

Photographs of Weld Seam ID Surface and Metallographic Section.

NDE technique(s): Fast UT
 NDE result(s): < 5%, 3.1 inch (79 mm)
 OD crack-like + 1.4
 inch (36 mm) NF +
 10%, 7.8 inch (198
 mm) linear indications
 (over 9.5 inches (241
 mm))

Failure: Burst test: No failure at
 2,300 psig (15.86 MPa)
 (142% of SMYS)

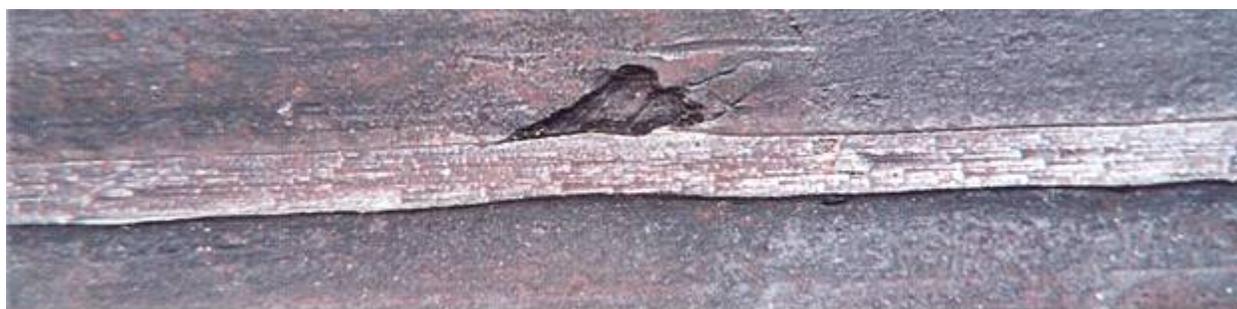
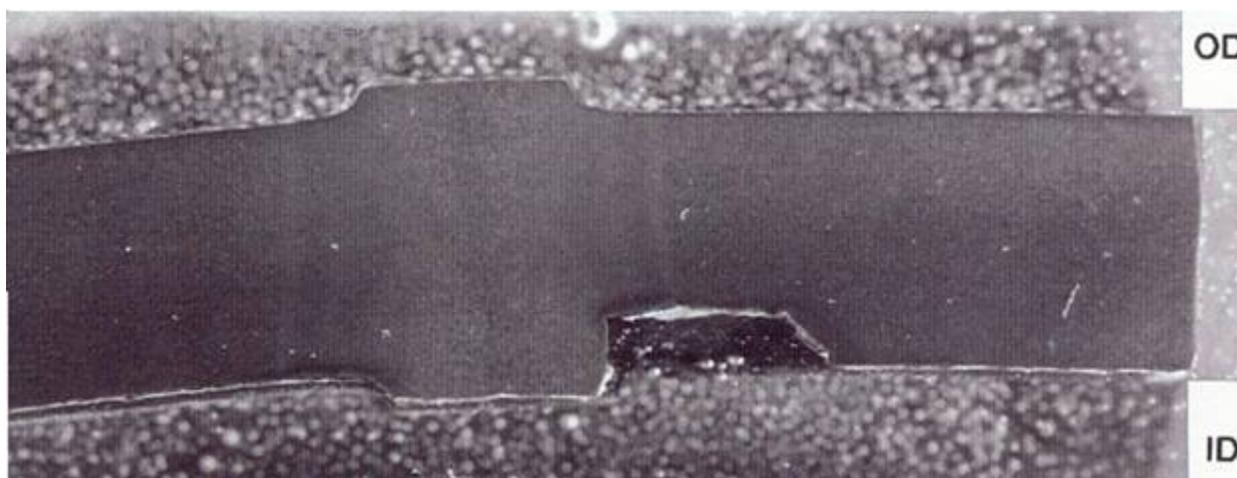
Catalog #: 46
 Report #: 5
 Defect #: 26

Photographs of Weld Seam ID Surface and Metallographic Section.

Seam Type: FW
 Grade: X52
 D_{nominal} : 20 inch (508 mm)
 t_{nominal} : 0.312 inch (7.92 mm)
 t_{pipe} : 0.319 inch (8.1 mm)
 Failure: Burst test: No failure at
 2,300 psig (15.86 MPa)
 (142% of SMYS) +
 Yielding at 2,175 psig
 (15.00 MPa) (134% of
 SMYS)

NDE technique(s): Fast UT
 NDE result(s): 50%, 1.25 inch (31.7 mm)
 ID-connected
 Visual: Plate roll-in
 L: N/A
 $\text{depth}/t_{\text{weld}}$: 40%
 depth: 0.167 inch (4.24 mm)
 t_{weld} : 0.417 inch (10.6 mm)

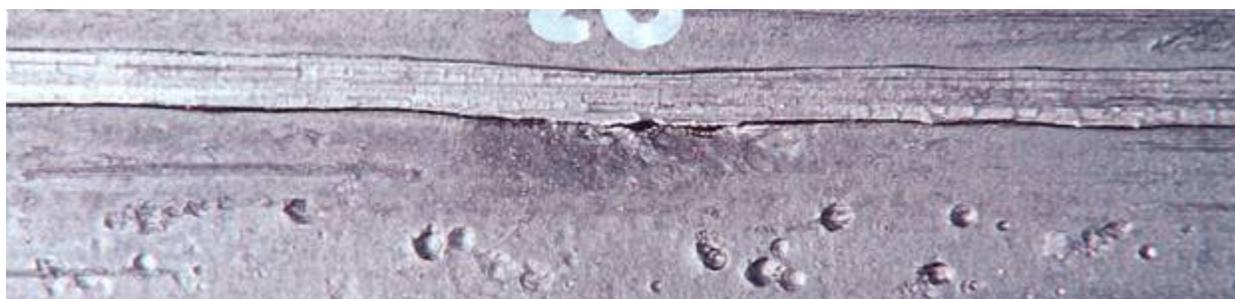
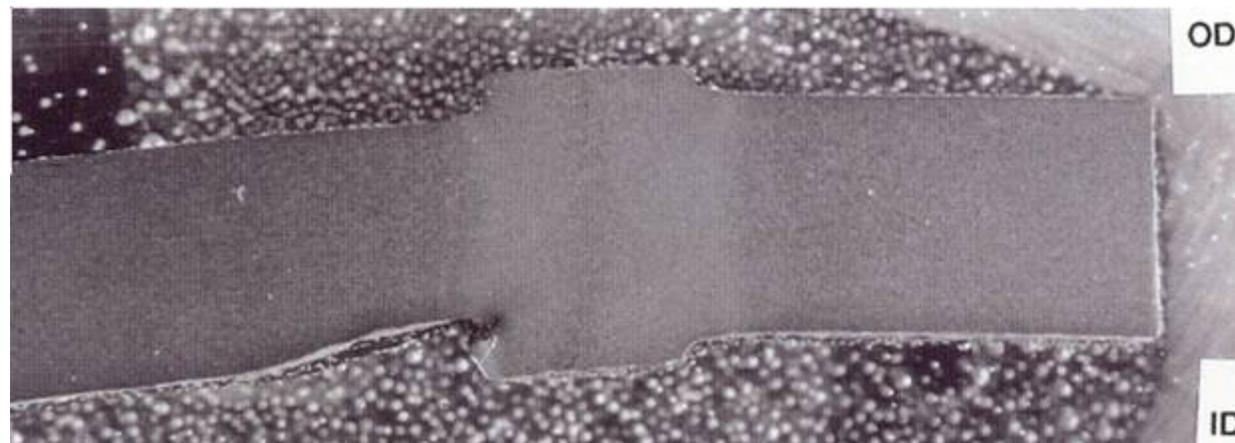
Catalog #: 43
 Report #: 5
 Defect #: 20

Photographs of Weld Seam ID Surface and Metallographic Section.

Seam Type: FW
 Grade: X52
 D_{nominal} : 20 inch (508 mm)
 t_{nominal} : 0.312 inch (7.92 mm)
 t_{pipe} : 0.312 inch (7.92 mm)
 Failure: Burst Test: No failure at 2,250 psig (51.51 MPa) (139% of SMYS) + Yielding at 2,200 psig (15.17 MPa) (136% of SMYS)

NDE technique(s): Fast UT
 NDE result(s): 5%, 2.4 inch (61 mm) NF
 Visual: Plate roll-in
 L: N/A
 $\text{depth}/t_{\text{weld}}$: 33%
 depth: 0.129 inch (3.28 mm)
 t_{weld} : 0.394 inch (10.1 mm)

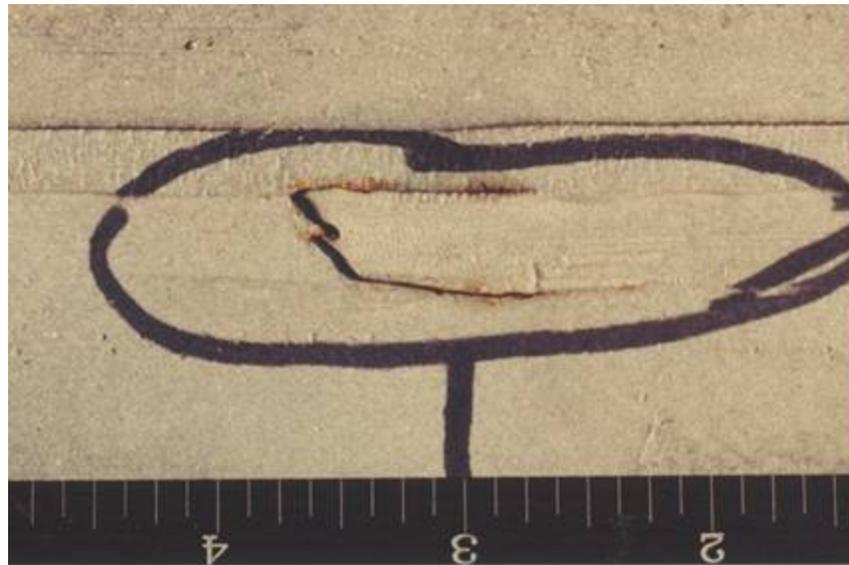
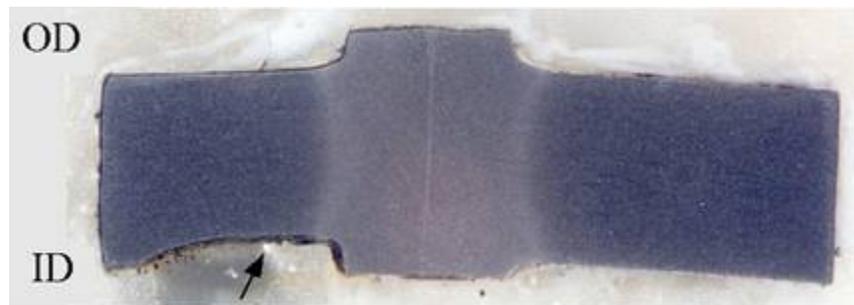
Catalog #: 70
 Report #: 7
 Defect #: 981

Photographs of Weld Seam ID Surface and Metallographic Section.

NDE technique(s): Fast UT
 NDE result(s): 20% Mid-Wall Crack
 + < 10% ID Gouge
 ID Plate Edge Defect
 (Roll-in)
 Visual: 1.1 inch (27.9 mm)
 L
 depth/ t_{weld} : Not Determined
 depth: Not Determined
 t_{weld} : Not Determined

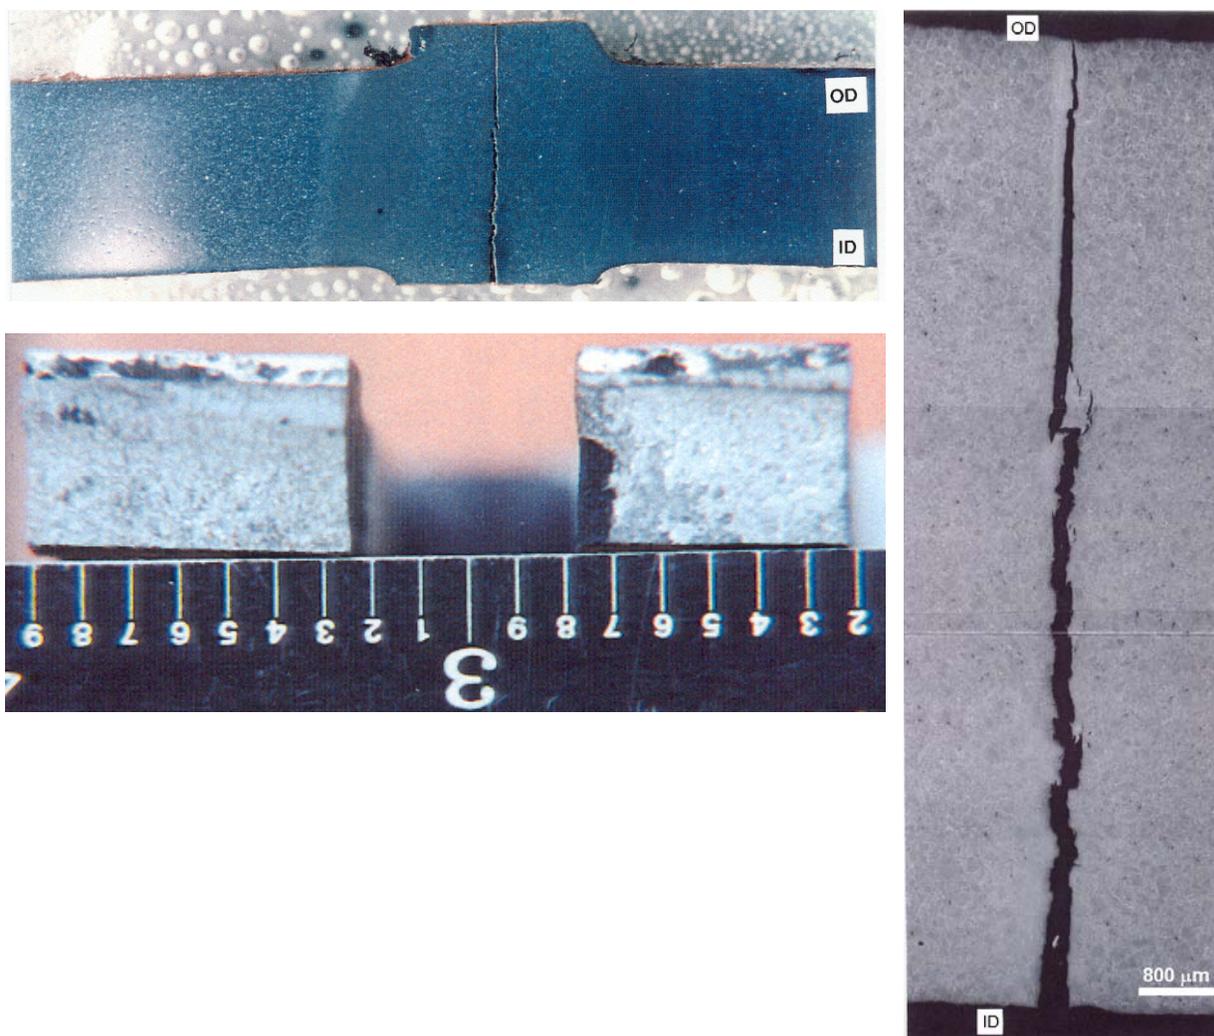
Catalog #: 34
 Report #: 5
 Defect #: C5

Photographs and Photomicrograph of Metallographic Section and Fracture Surfaces.

NDE technique(s): UT & Fast UT
 NDE result(s): ID connected crack-like (UT)
 + NF with associated crack-like (Fast UT) + Narrow band of NF (Fast UT)

Visual: Lack of Fusion
 L
 depth/ t_{weld} : 100%
 depth: 0.422 inch (10.7 mm)
 t_{weld} : 0.422 inch (10.7 mm)

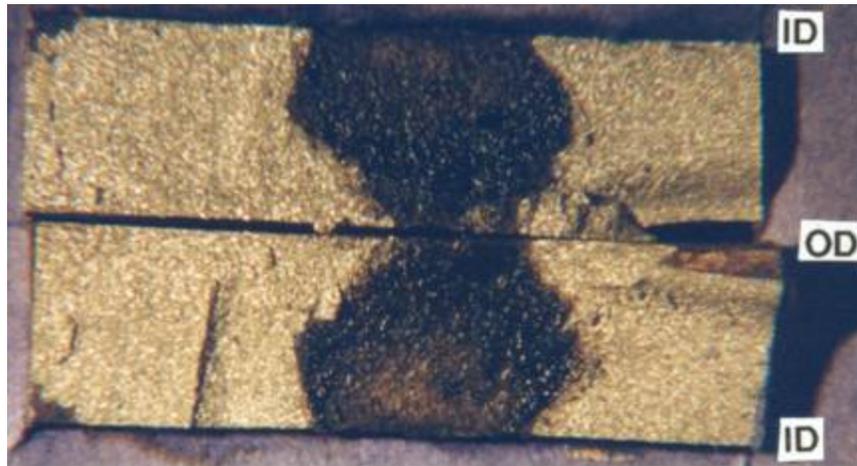
Catalog #: 66
 Report #: 7
 Defect #: 831

Photograph of Fracture Surface.

NDE technique(s): Fast UT
 NDE result(s): 100% (Seeper)
 Visual: Lack of Fusion
 L: 0.55 inch (13.8 mm)
 depth/ t_{weld} : 100%
 depth: 0.400 inch (10.2 mm)
 t_{weld} : 0.400 inch (10.2 mm)

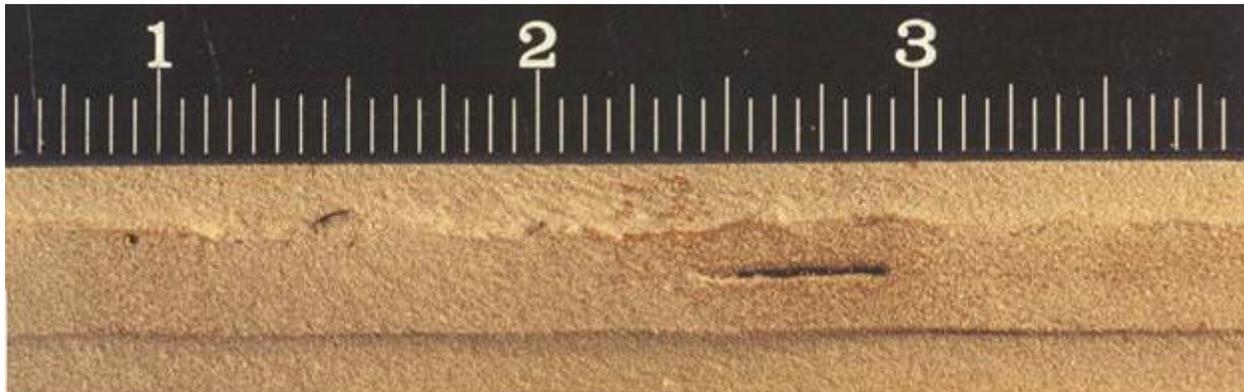
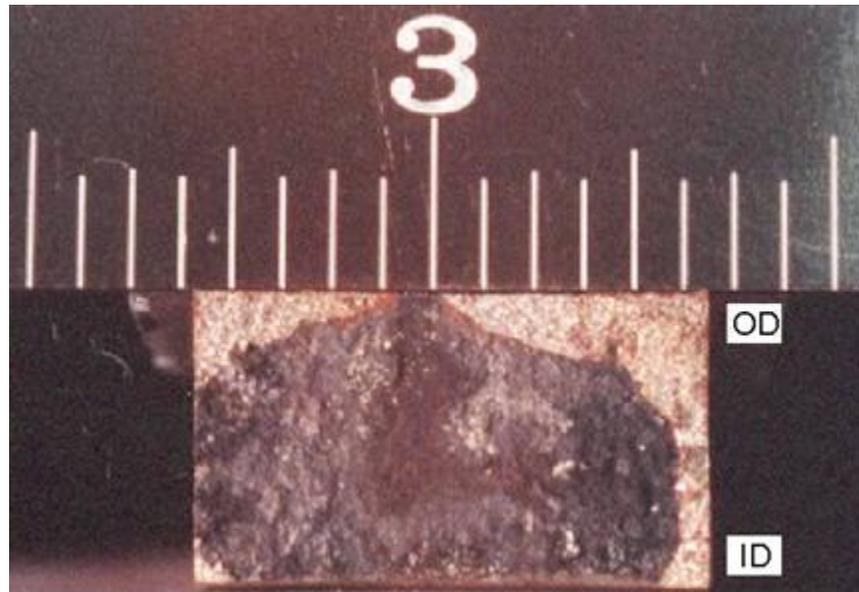
Catalog #: 80
 Report #: 7
 Defect #: 1573.1

Photographs of Weld Seam OD Surface and Fracture Surface.

NDE technique(s): Visual
 NDE result(s): 100% (Seeper)
 Visual: Lack of Fusion
 L: 0.63 inch (16 mm)
 depth/ t_{weld} : 100%
 depth: Not Determined
 t_{weld} : Not Determined

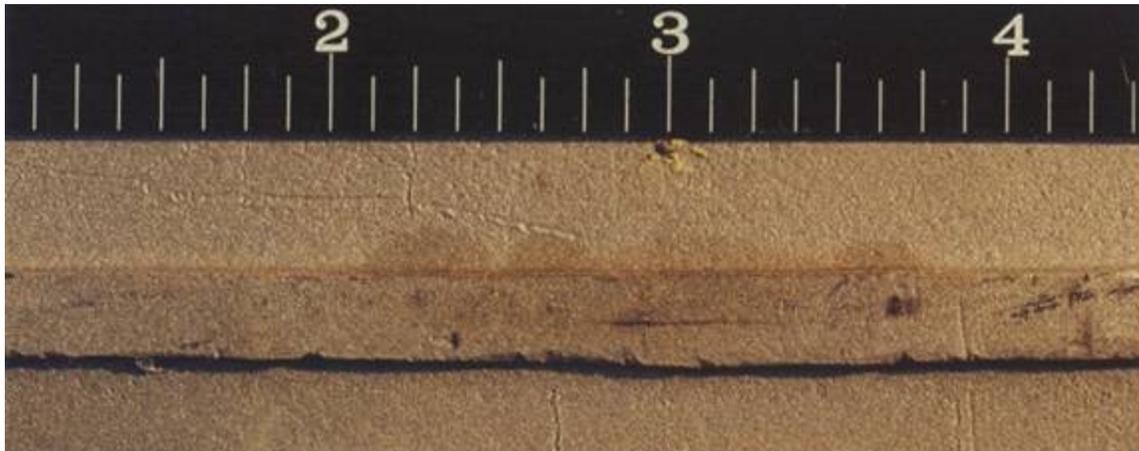
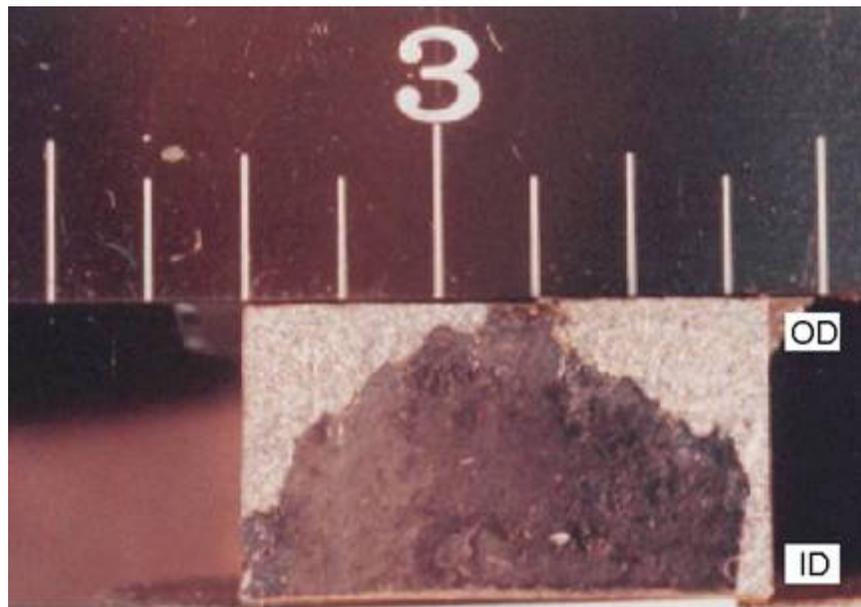
Photographs of Weld Seam OD Surface and Fracture Surface.

Catalog #:	81		
Report #:	7		
Defect #:	1577.1		
<u>Pipe</u>		<u>Defect</u>	
Vintage:	circa 1950	NDE technique(s):	Visual
Manufacturer:	AO Smith	NDE result(s):	100% (Seeper)
Seam Type:	FW	Visual:	Lack of Fusion
Grade:	X52	L	0.66 inch (16.8 mm)
D_{nominal}	20 inch (508 mm)	depth/ t_{weld}	100%
t_{nominal}	0.312 inch (7.92 mm)	depth:	Not Determined
t_{pipe}	Not Determined	t_{weld}	Not Determined
Failure:	N/A

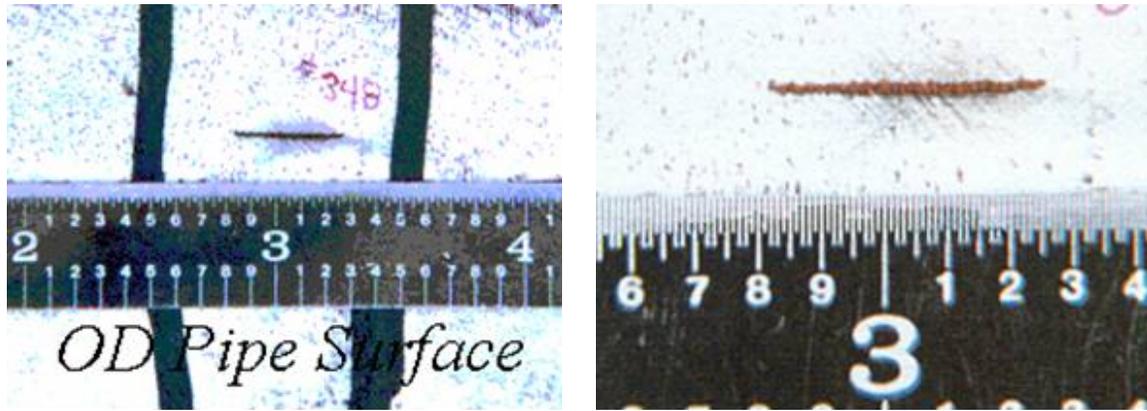
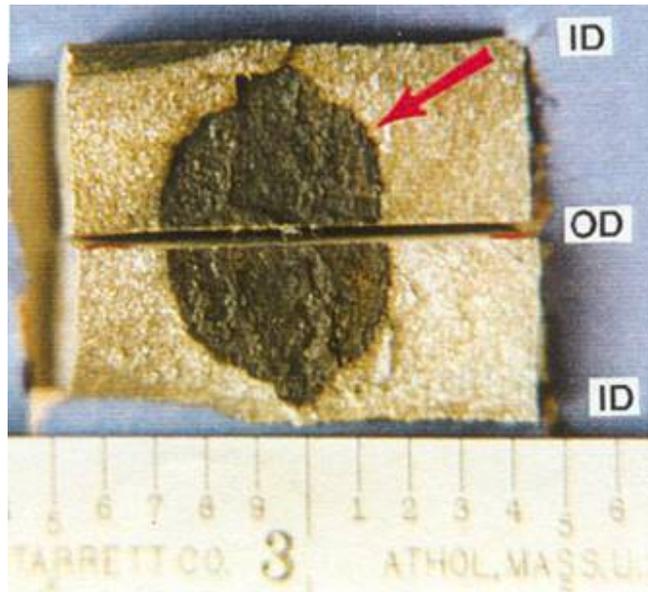
Catalog #: 19
 Report #: 2
 Defect #: 348

Photographs of Magnetic Particle Indication on Pipe OD Surface and of Fracture Surfaces.

NDE technique(s): MPI / UT
 NDE result(s): Through-wall, 1 inch (25.4 mm) long non-fusion / crack
 Visual: OD Lack of Fusion
 L 0.42 inch (10.7 mm)
 depth/ t_{weld} 91%
 depth: 0.320 inch (8.13 mm)
 t_{weld} 0.350 inch (8.89 mm)

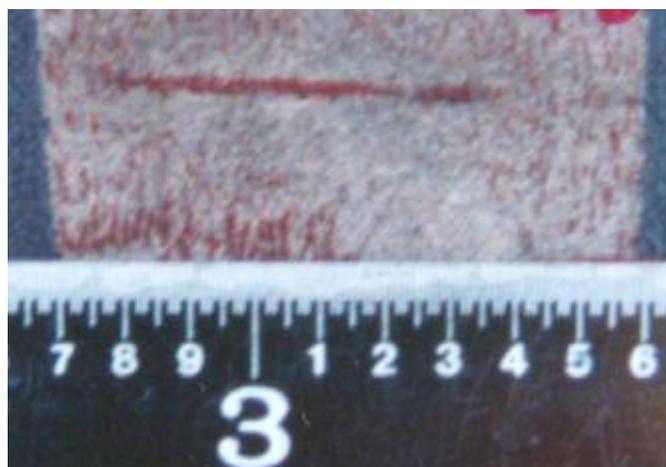
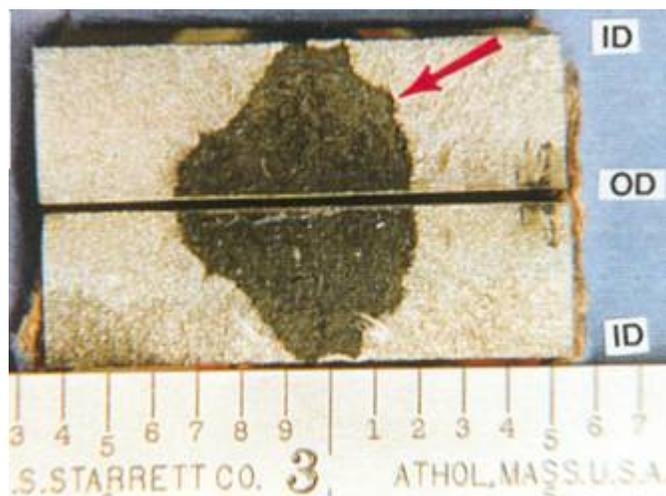
Catalog #: 20
 Report #: 2
 Defect #: 356

Photograph of Magnetic Particle Indication on Pipe OD Surface and of Fracture Surfaces.

NDE technique(s): MPI / UT
 NDE result(s): 1 inch long ID crack like
 Visual: OD Lack of Fusion
 L: 0.53 inch (13.5 mm)
 $\text{depth}/t_{\text{weld}}$: 91%
 depth: 0.320 inch (8.13 mm)
 t_{weld} : 0.350 inch (8.89 mm)

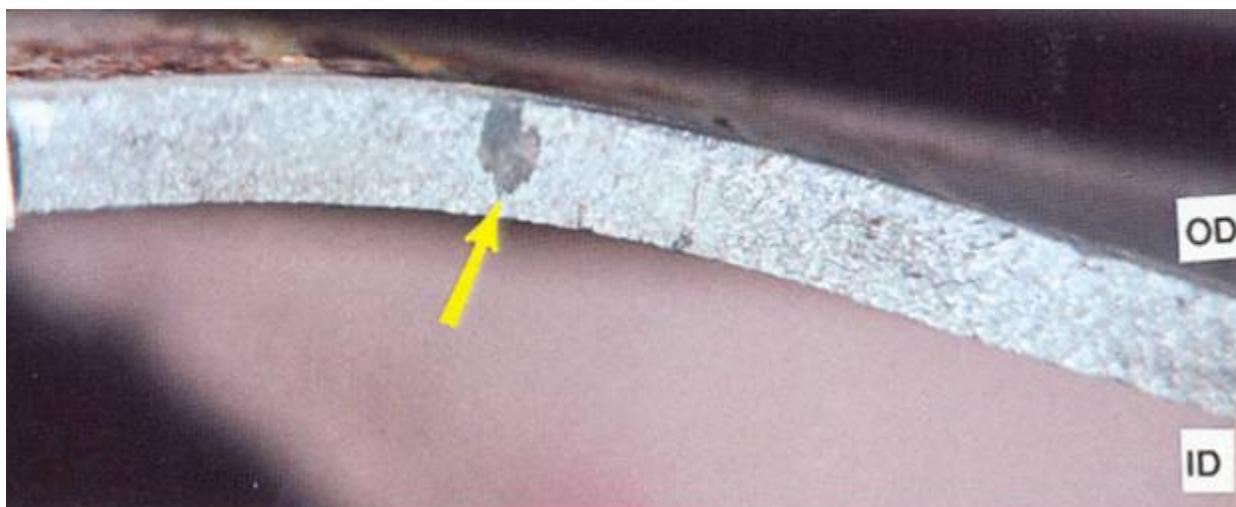
Catalog #: 42
 Report #: 5
 Defect #: 16

Photograph of Fracture Surface.

NDE technique(s): Fast UT
 NDE result(s): 3 NF indications: 10%,
 1.5 inch (38 mm) +
 10%, 2.0 inch (51
 mm) + 30%, 0.75 inch
 OD Lack of Fusion
 < 0.25 inch (6.3 mm)
 84%
 Visual: L
 depth/ t_{weld} 84%
 depth: 0.312 inch (7.92 mm)
 t_{weld} 0.372 inch (9.45 mm)

Seam Type: FW
 Grade: X52
 $D_{nominal}$ 20 inch (508 mm)
 $t_{nominal}$ 0.312 inch (7.92 mm)
 t_{pipe} 0.308 inch (7.82 mm)
 Failure: Burst Test Failure at
 2,125 psig (14.65 MPa)
 (131% of SMYS)

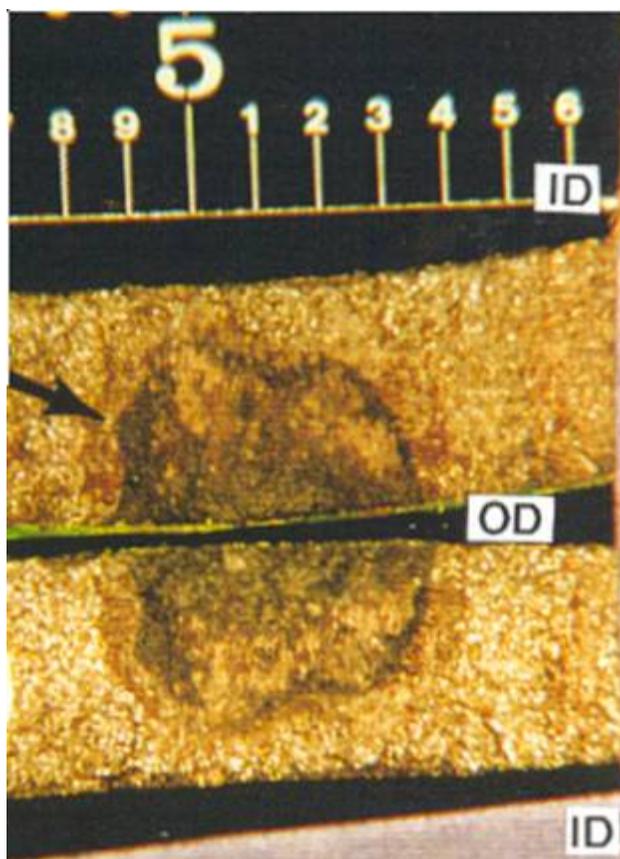
Catalog #: 18
 Report #: 2
 Defect #: 220

Photograph of Fracture Surfaces.

Seam Type: FW
 Grade: X52
 $D_{nominal}$: 20 inch (508 mm)
 $t_{nominal}$: 0.312 inch (7.92 mm)
 t_{pipe} : 0.312 inch (7.92 mm)
 Failure: Burst test rupture at
 2,225 psig (15.34 MPa)
 (137% of SMYS)

NDE technique(s): UT
 NDE result(s): >80%, 1 inch (25.4 mm)
 long crack like

Visual: OD Lack of Fusion
 L: 0.52 inch (13.2 mm)
 Width: N/A
 depth/ t_{weld} : 75%
 depth: 0.300 inch (7.62 mm)
 t_{weld} : 0.396 inch (10.1 mm)

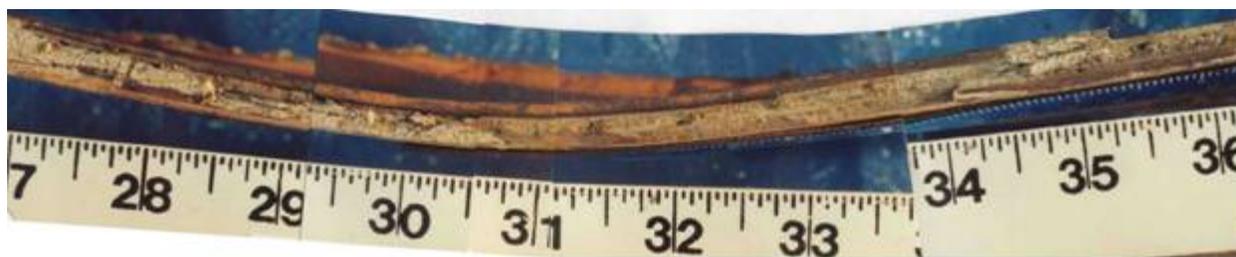
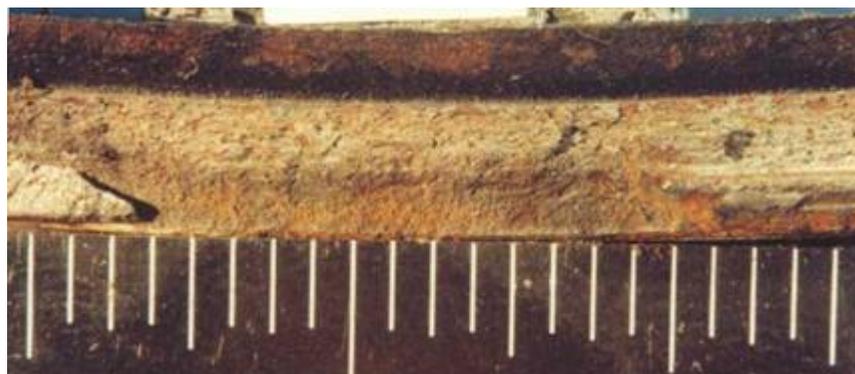
Photographs of Fracture Surface.

Catalog #:	54		
Report #:	6		
Defect #:	685		
<u>Pipe</u>		<u>Defect</u>	
Vintage:	circa 1950	NDE technique(s):	Fast UT
Manufacturer:	AO Smith	NDE result(s):	70% (0.300 inch (7.62 mm)) ID Crack + 30% (0.128 inch (3.25 mm)) OD Crack
Seam Type:	FW	Visual:	ID & Hook Cracks + Lack of Fusion
Grade:	X52	L	8.5 inch (216 mm) (ID Crack) + 4.0 inch (102 mm) (OD Crack)
D_{nominal}	20 inch (508 mm)	depth/ t_{weld}	44% (22% ID + 22% OD)
t_{nominal}	0.312 inch (7.92 mm)	depth:	0.094 inch (23.9 mm) (ID Crack) + 0.094 inch (23.9 mm) (OD Crack)
t_{pipe}	Not determined	t_{weld}	0.428 inch (10.9 mm)
Failure:	Burst test failure at 2,050 psig (14.13 MPa) (126% of SMYS)

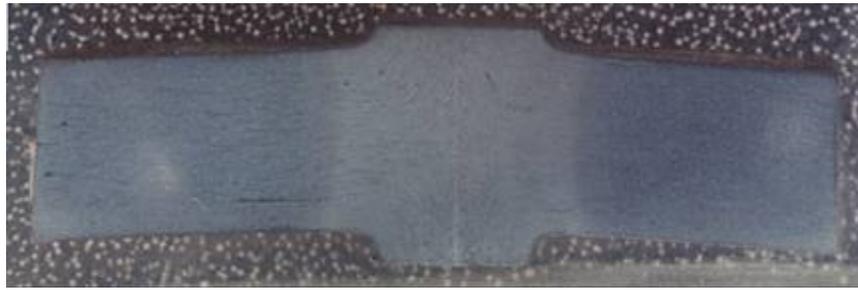
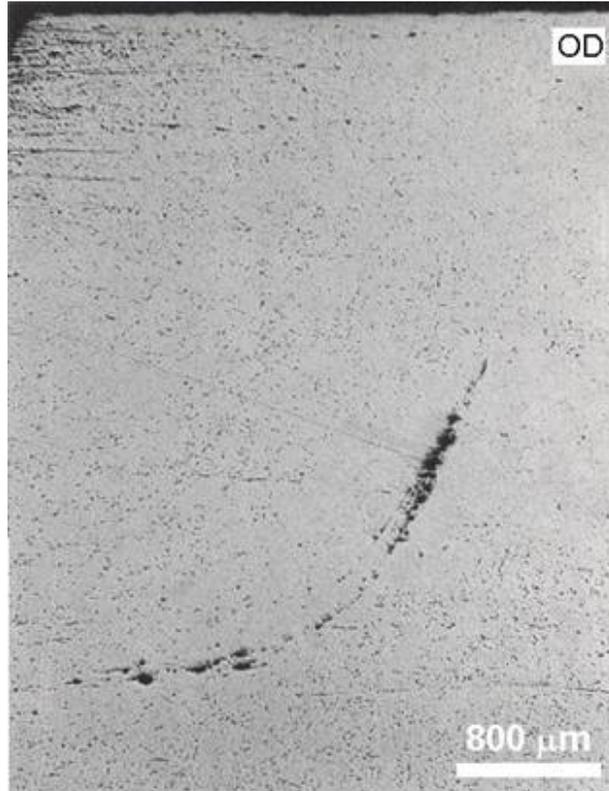
Catalog #: 74
 Report #: 7
 Defect #: 1097

Photograph and Photomicrograph of Metallographic Section.

NDE technique(s): Fast UT
 NDE result(s): 30% OD Crack-like
 Visual: OD Outbent Fiber
 L: N/A
 $\text{depth}/t_{\text{weld}}$: 33%
 depth: 0.145 inch (3.68 mm)
 t_{weld} : 0.433 inch (11 mm)

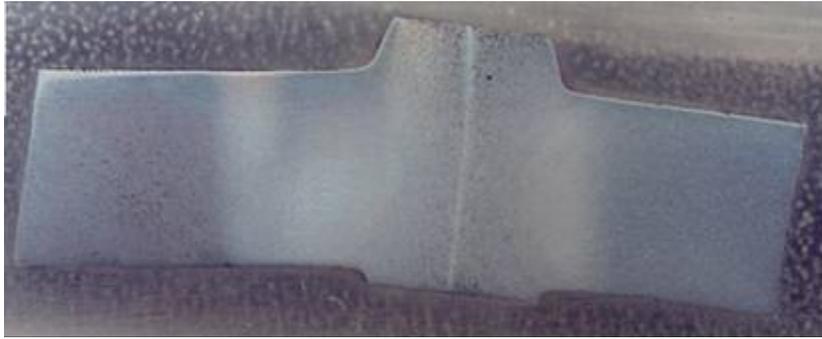
Catalog #: 75
 Report #: 7
 Defect #: 1105

Photograph of Metallographic Section.

NDE technique(s): Fast UT
 NDE result(s): <10% OD Crack-like
 Visual: No Anomaly Revealed
 L: N/A
 $\text{depth}/t_{\text{weld}}$: N/A
 depth: N/A
 t_{weld} : 0.468 inch (11.9 mm)
