Appendix B – Task 2
Catalog of Seam Weld Defect Types

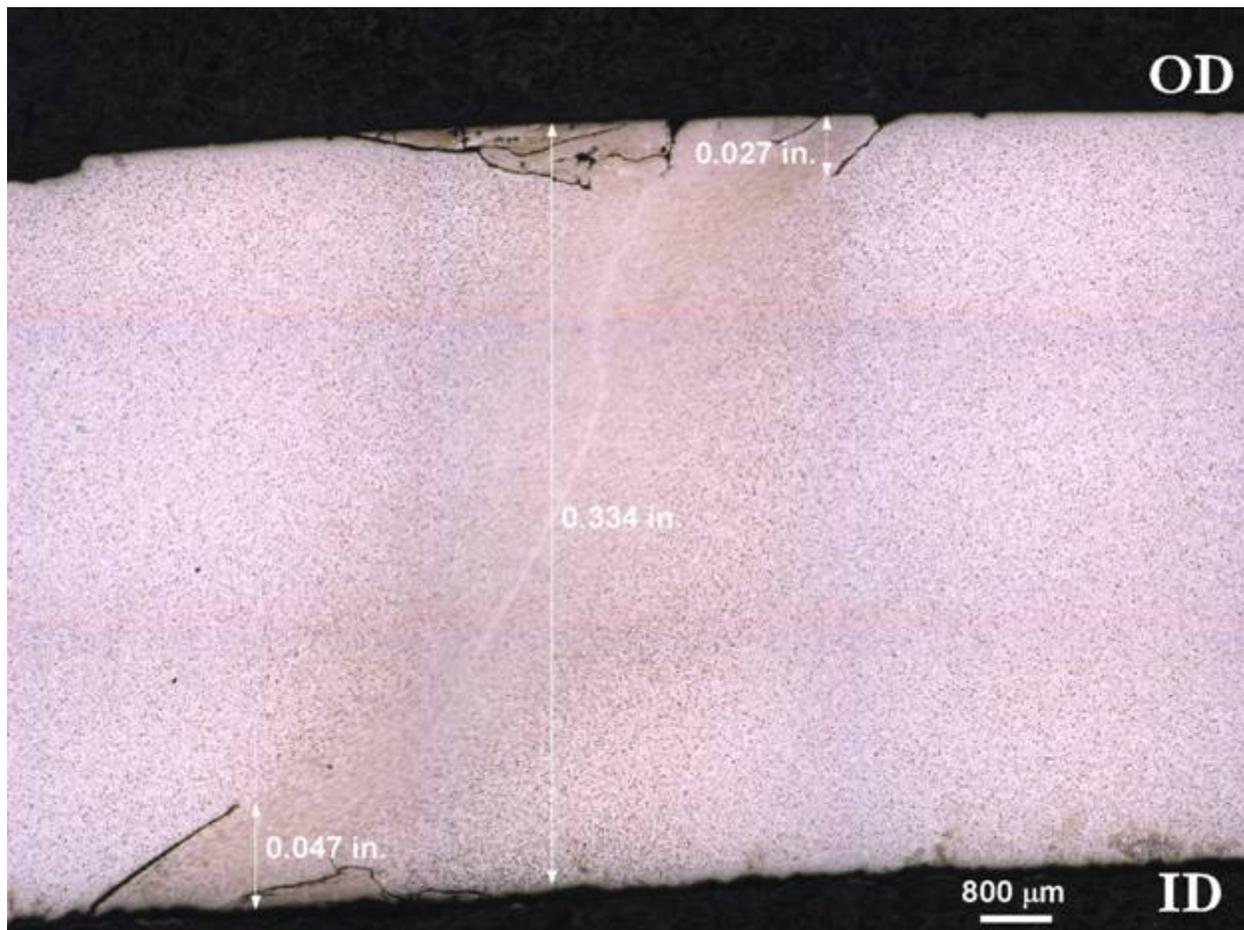
Catalog #: 3
 Report #: 8
 Defect #: TS95

Photomicrograph of Metallographic Section.

NDE technique(s): MPI on OD surface
 NDE result(s): Crack visible
 Visual: OD & ID Lack of Fusion
 L: N/A
 Width: N/A
 depth/ t_{weld} : 22.2% (LOF combined)
 depth: 0.027 inch (0.69 mm) (OD)
 + 0.047 inch (1.19 mm) (ID)
 t_{weld} : 0.334 inch (8.48 mm)

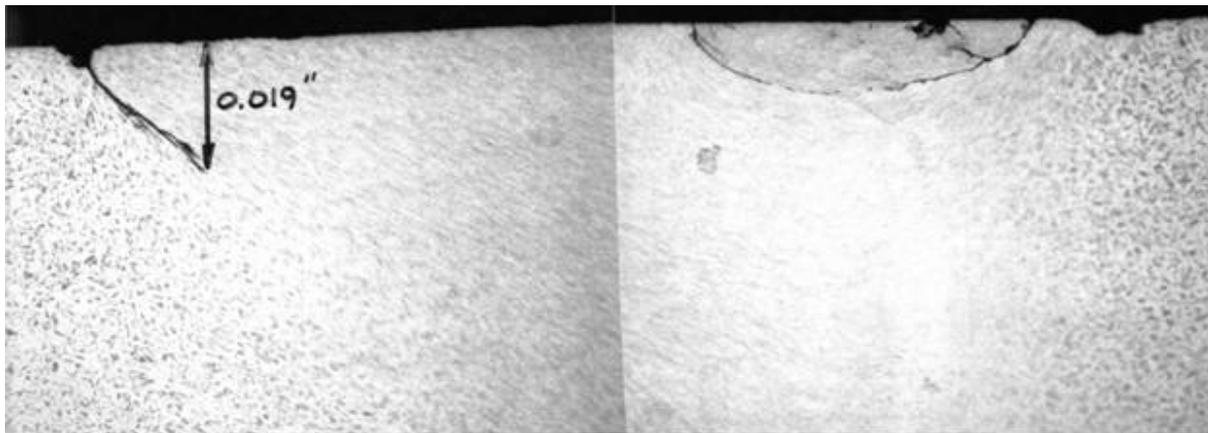
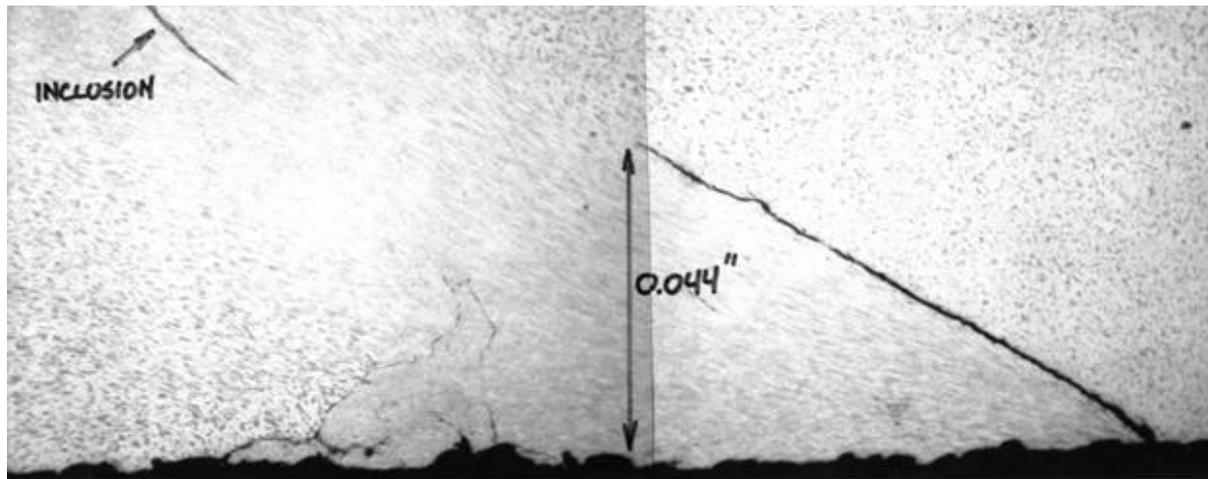
Catalog #: 1
 Report #: 8
 Defect #: Not Specified

Photomicrographs of Lack of Fusion at OD and ID Surfaces and Near Mid-Wall.

NDE technique(s): MPI on OD surface
 NDE result(s): Crack visible
 Visual: OD, Mid-wall & ID Lack of Fusion
 L: N/A
 Width: N/A
 depth/ t_{weld} : 30.8% (all LOF combined)
 depth: OD: 0.019 inch (0.48 mm) +
 Mid-wall: 0.017 inch (0.43 mm)
 + ID: 0.044 inch (1.12 mm)
 t_{weld} : 0.259 inch (6.58 mm)

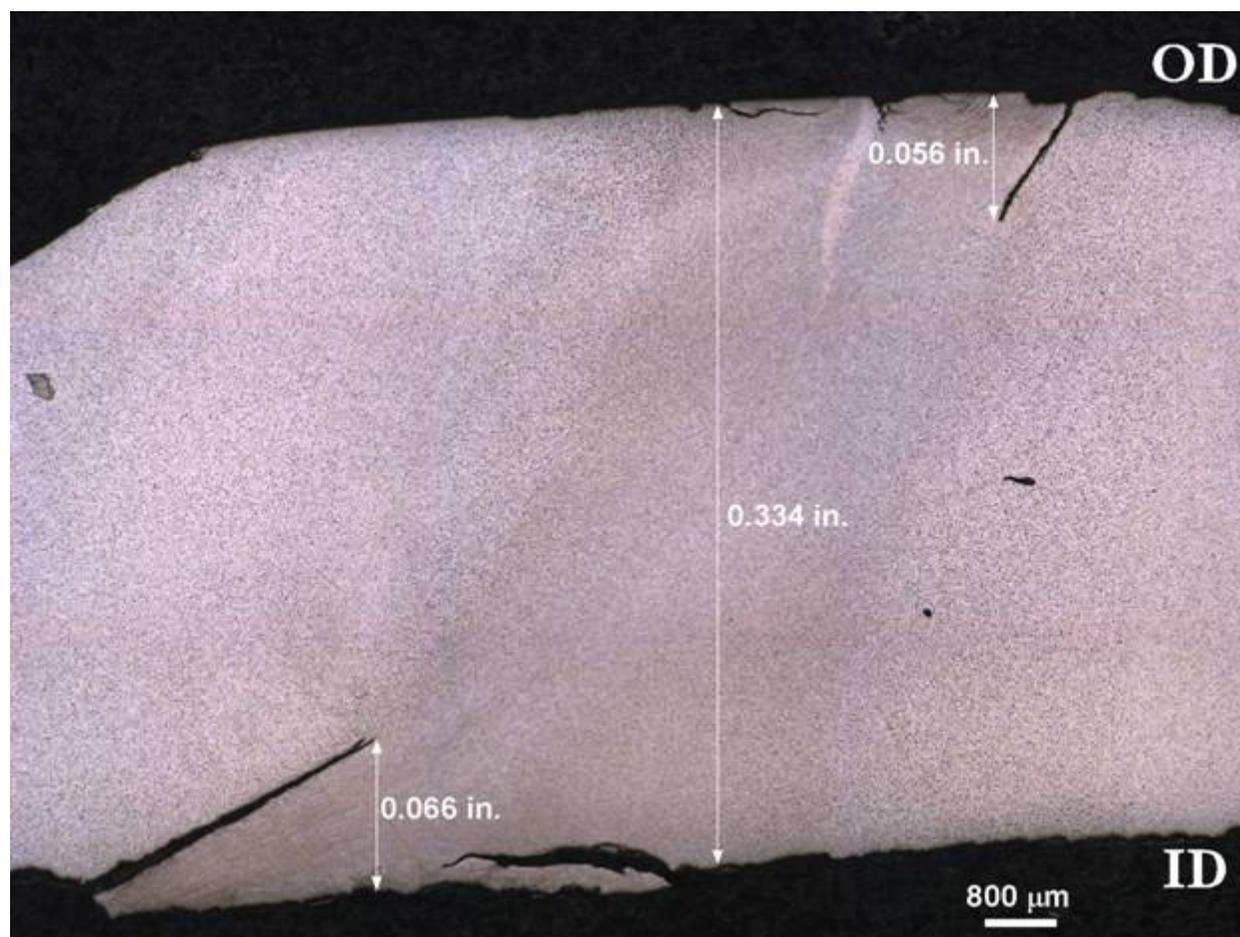
Catalog #: 2
 Report #: 8
 Defect #: L1026

Photomicrograph of Metallographic Section.

NDE technique(s): MPI on OD surface
 NDE result(s): Crack visible
 Visual: OD, Mid-wall & ID Lack of Fusion
 L: N/A
 Width: N/A
 depth/ t_{weld} : 36.5%
 depth: 0.056 inch (1.42 mm) (OD)
 + 0.066 inch (1.68 mm) (ID)
 t_{weld} : 0.334 inch (8.48 mm)

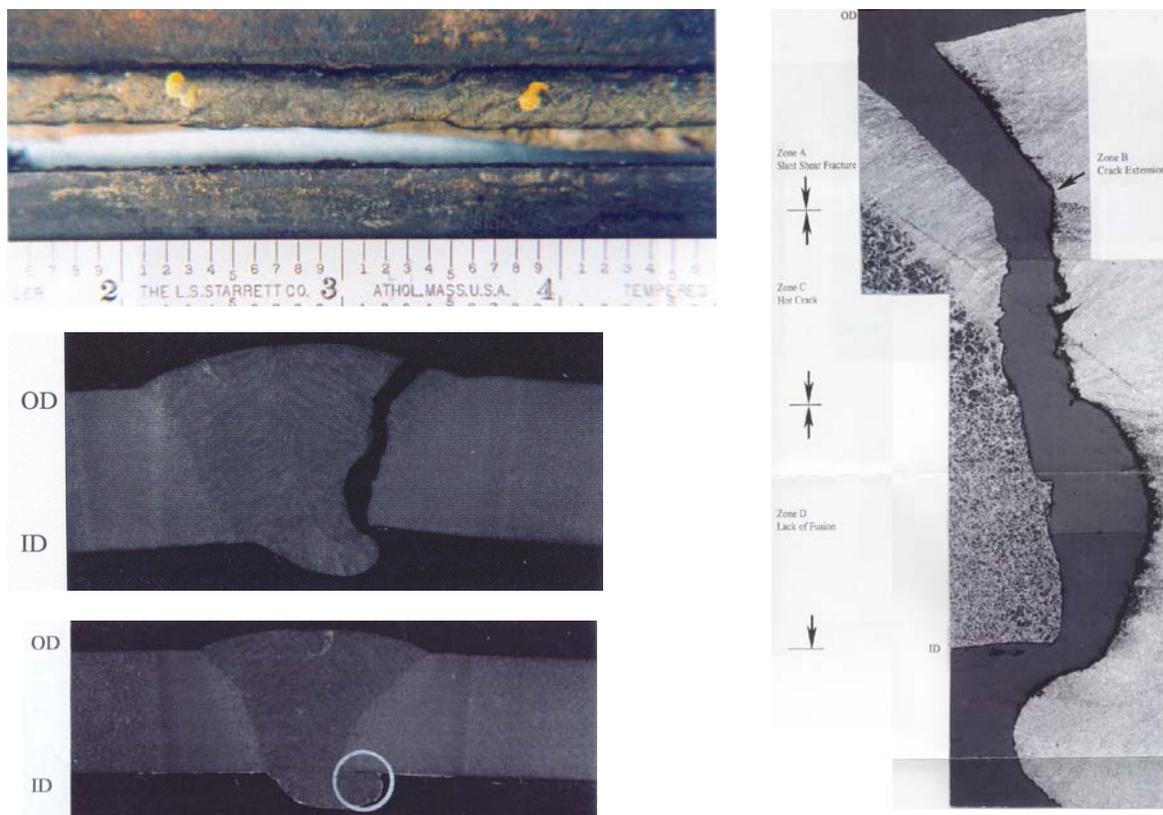
Catalog #: 85
 Report #: 9
 Defect #: 4-1

Photographs and Photomicrograph of Pipe Seam OD Surface and Metallographic Sections.

Failure: Hydrotest Rupture at
 1,520 psig (10.48
 MPa) (85% of SMYS)

Visual: Weld Penetration + Lack
 of Fusion + Hot Crack
 5 ft-9 inch (1.8 m) long
 Seam split
 50% (LOF) + 30% (Hot
 crack)
 depth: 0.177 inch (4.5 mm) (LOF)
 + 0.106 inch (2.69 mm)
 (Hot crack)
 t_{weld} 0.354 inch (8.99 mm) (At
 crack location)

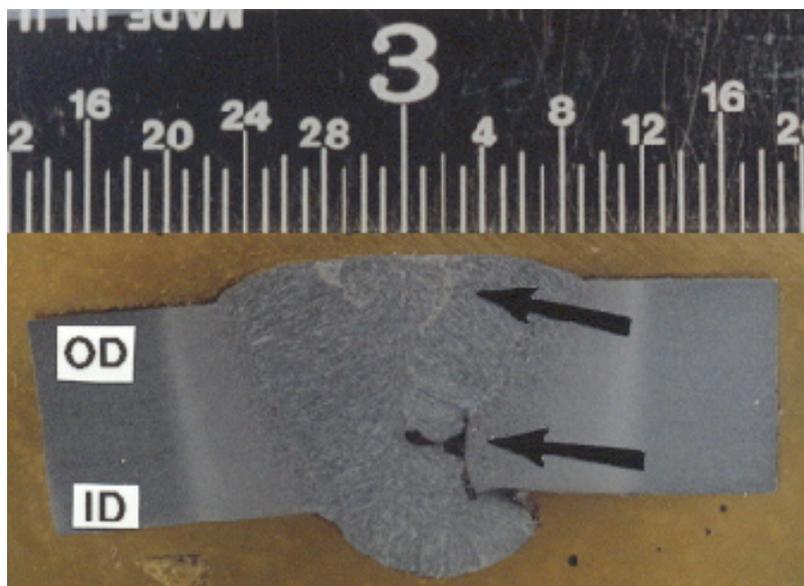
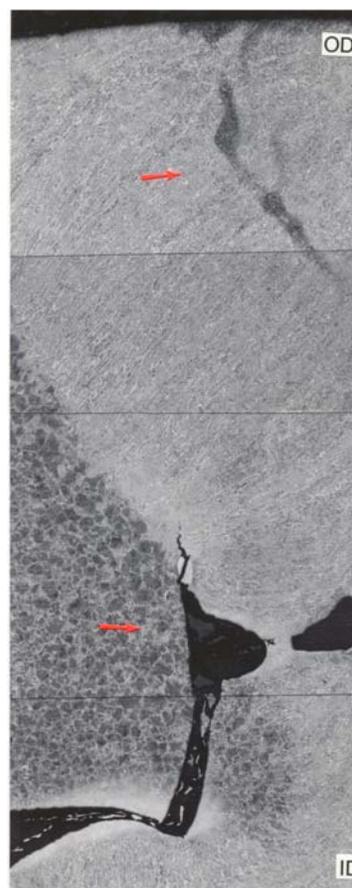
Catalog #: 27
 Report #: 3
 Defect #: 11A

Photograph and Photomicrograph of Metallographic Section.

Visual: ID Lack of Fusion + ID Crack +
 OD Slag Inclusion

depth: 21% ID Lack of Fusion + 6% ID
 Crack + 24% OD Slag Inclusion
 0.106 inch (2.69 mm) ID Lack of
 Fusion + 0.030 inch (0.76 mm)
 ID Crack + 0.124 inch (3.15
 mm) OD Slag Inclusion

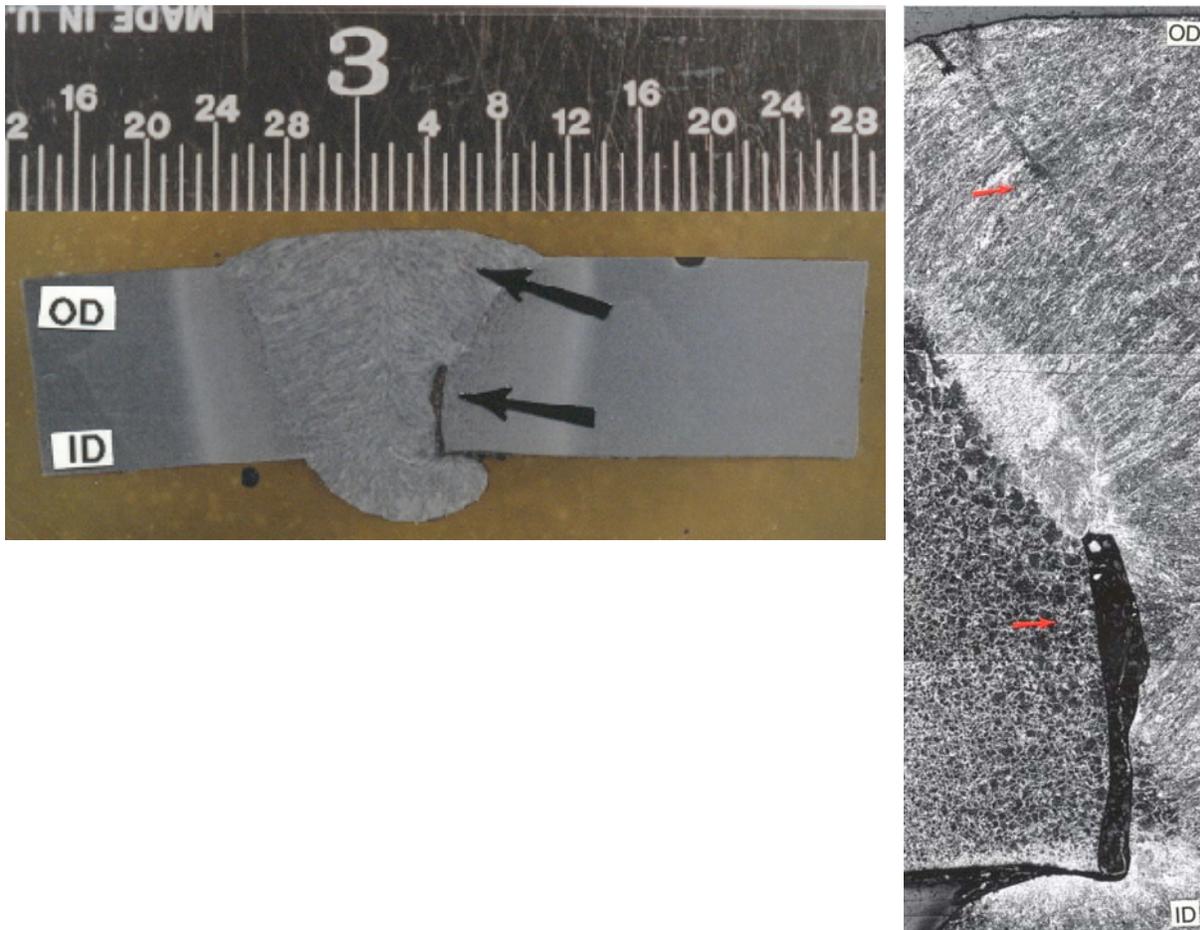
Catalog #: 28
 Report #: 3
 Defect #: 11C

Photograph and Photomicrograph of Metallographic Section.

0.154 inch (3.91 mm) ID
 Lack of Fusion + 0.154 inch
 (3.91 mm) OD Slag Inclusion
 0.525 inch (13.3 mm)

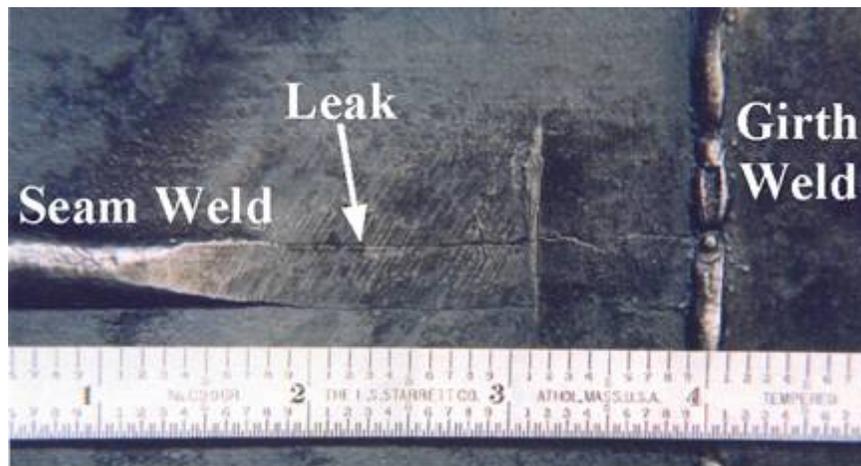
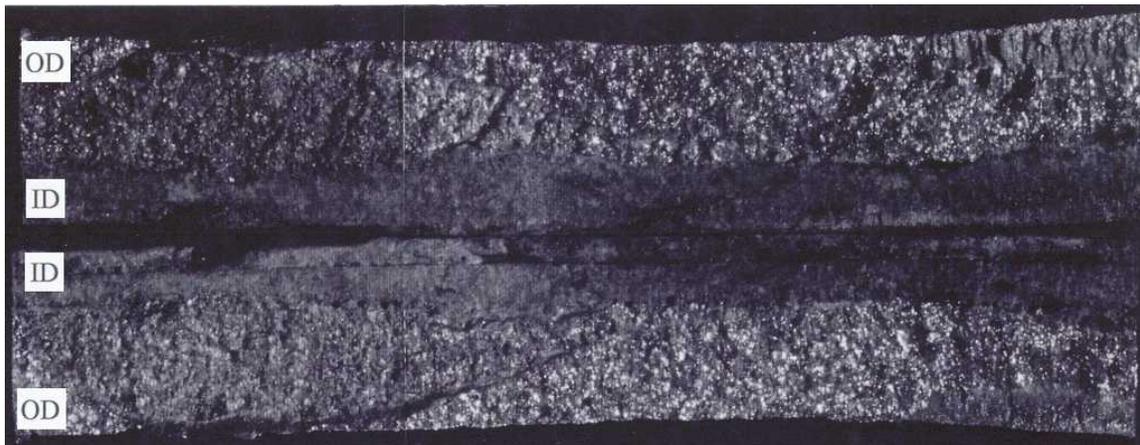
Photographs of Pipe Seam ID Surface and Fracture Surfaces.

Catalog #:	88		
Report #:	9		
Defect #:	4-3		
Pipe		Defect	
Vintage:	circa 1952	NDE technique(s):	N/A
Manufacturer:	Kaiser	NDE result(s):	N/A
Seam Type:	SSAW	Visual:	Through-wall flaw + ID seam ground flush + Lack of fusion
Grade:	API 5L X52	L	N/A
D_{nominal}	20 inch (508 mm)	depth/ t_{weld}	100% (Leak) + 30% (LOF)
t_{nominal}	0.344 inch (8.74 mm)	depth:	Not Determined
t_{pipe}	Not Determined	t_{weld}	Not Determined
Failure:	Hydrotest Leak at 1,517 psig (10.46 MPa) (85% of SMYS)

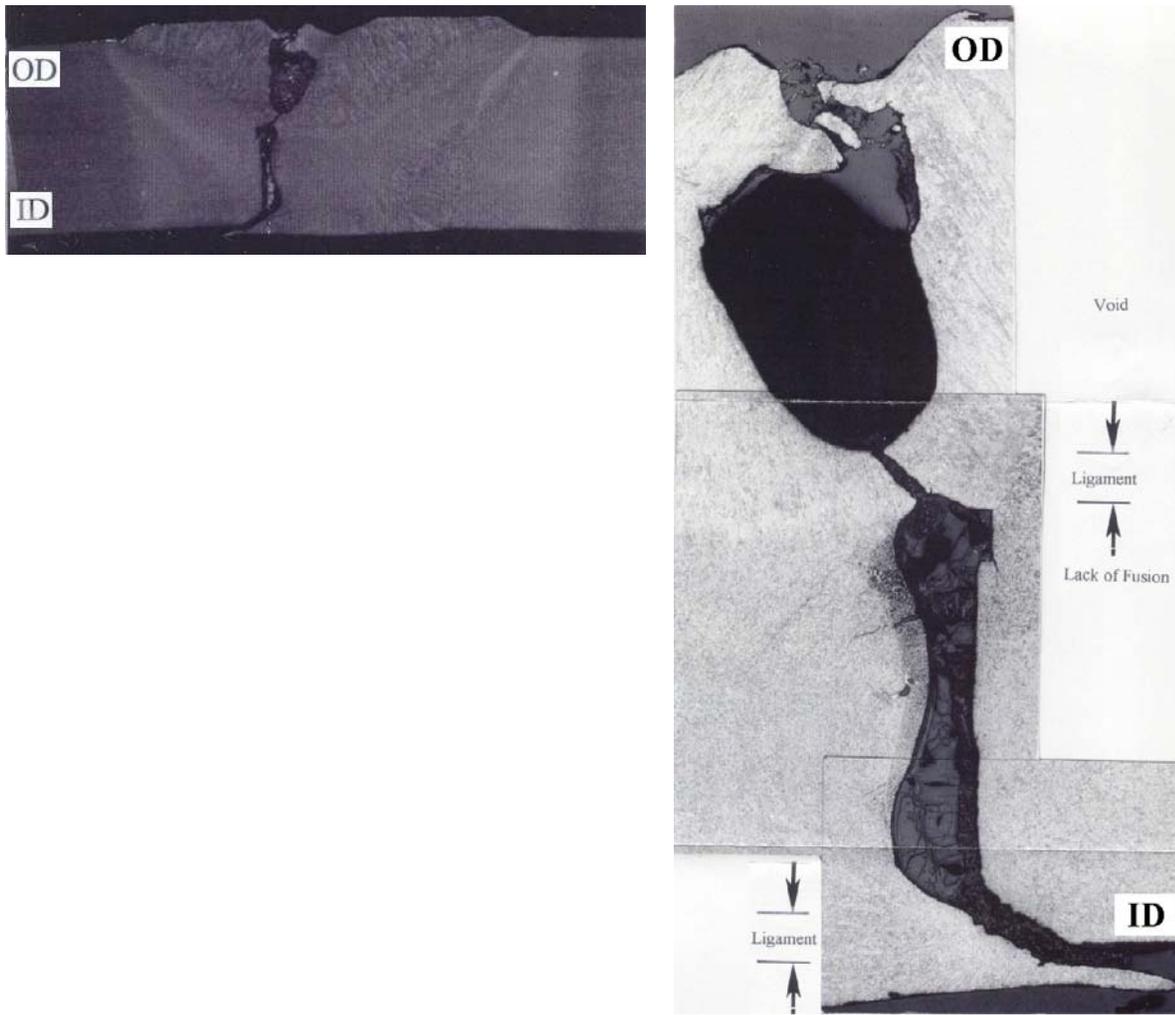
Catalog #: 89
 Report #: 9
 Defect #: 5-4

Photograph and Photomicrograph of Metallographic Section.

Vintage: circa 1952
 Manufacturer: Kaiser
 Seam Type: SSAW
 Grade: API 5L X52
 D_{nominal} : 20 inch (508 mm)
 t_{nominal} : 0.344 inch (8.74 mm)
 t_{pipe} : Not Determined
 Failure: Hydrotest Leak at
 1,559 psig (10.75 MPa)
 (87% of SMYS)

NDE technique(s): N/A
 NDE result(s): N/A
 Visual: Lack of fusion + Void
 L: N/A
 $\text{depth}/t_{\text{weld}}$: 85%
 depth: 45% (LOF) + 40%
 (Void)
 t_{weld} : Not Determined

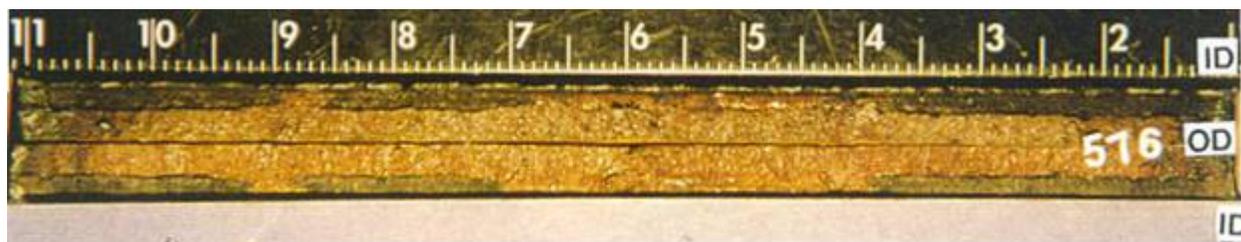
Catalog #: 25
 Report #: 2
 Defect #: 576

Photograph of Fracture Surfaces.

D_{nominal} 20 inch (508 mm)
 t_{nominal} 0.344 inch (8.74 mm)
 t_{pipe} 0.342 inch (8.69 mm)
 Failure: Burst test rupture at
 2,075 psig (14.31 MPa)
 (116% of SMYS)

NDE technique(s): UT
 NDE result(s): 20%, 9.4 feet long (2.9 m)
 ID crack like
 Visual: Intermittent ID Lack of
 Fusion
 L Entire joint, in photo: 2.0,
 1.75 & 2.9 inch
 (51, 44.5 & 74 mm)
 $\text{depth}/t_{\text{weld}}$ 45%
 depth : 0.150 inch (38 mm)
 t_{weld} N/A

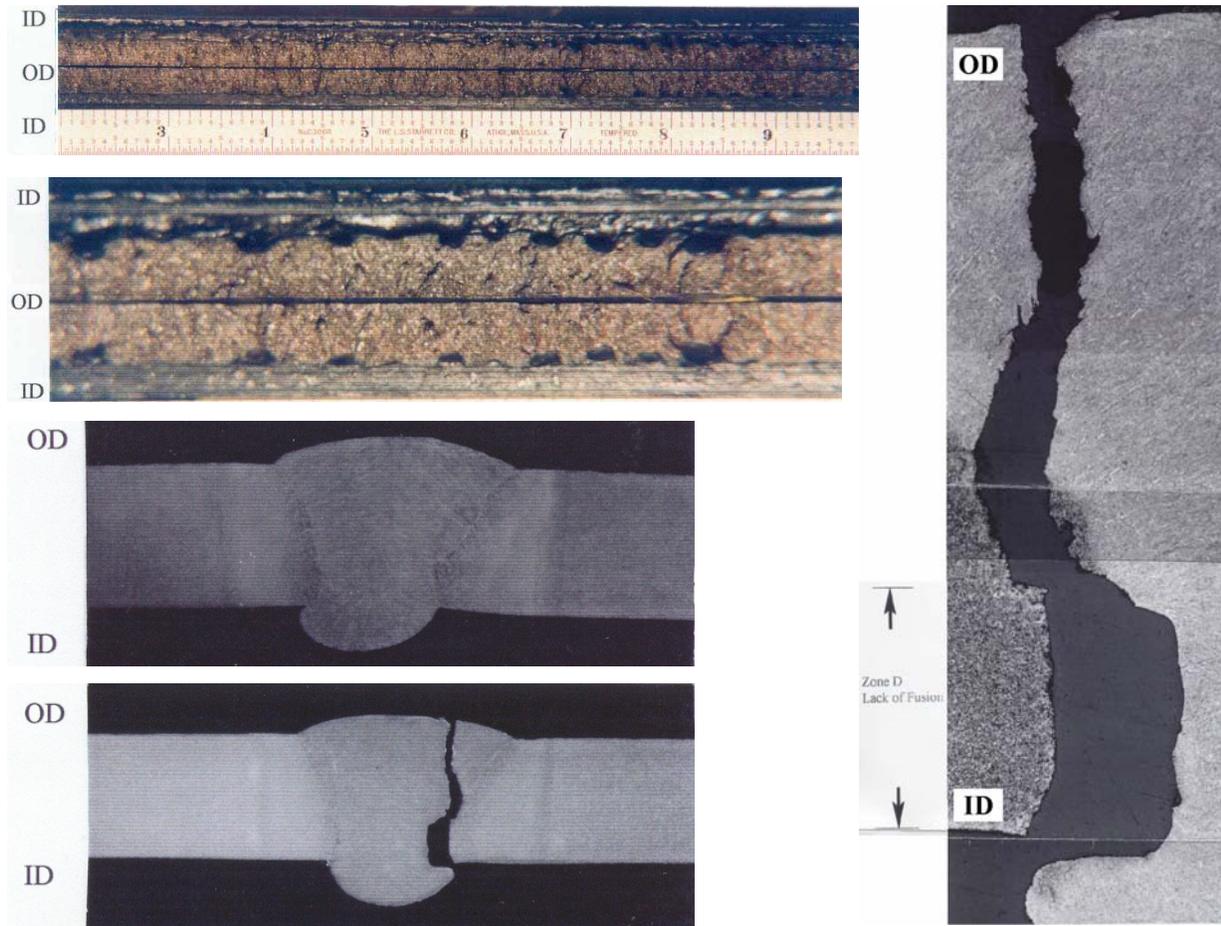
Photographs and Photomicrograph of Fracture Surfaces and Metallographic Section.

Catalog #:	86		
Report #:	9		
Defect #:	5-1		
<u>Pipe</u>		<u>Defect</u>	
Vintage:	circa 1952	NDE technique(s):	N/A
Manufacturer:	Kaiser	NDE result(s):	N/A
Seam Type:	SSAW	Visual:	Weld Penetration + Lack of Fusion
Grade:	API 5L X52	L	15 ft-4 inch (4.7 m) long Seam split
D_{nominal}	20 inch (508 mm)	depth/ t_{weld}	44% (LOF)
t_{nominal}	0.344 inch (8.74 mm)	depth:	0.150 inch (38 mm) (LOF)
t_{pipe}	Not Determined	t_{weld}	0.341 inch (8.66 mm) (At crack location)
Failure:	Hydrotest Rupture at 1,483 psig (10.22 MPa) (83% of SMYS)

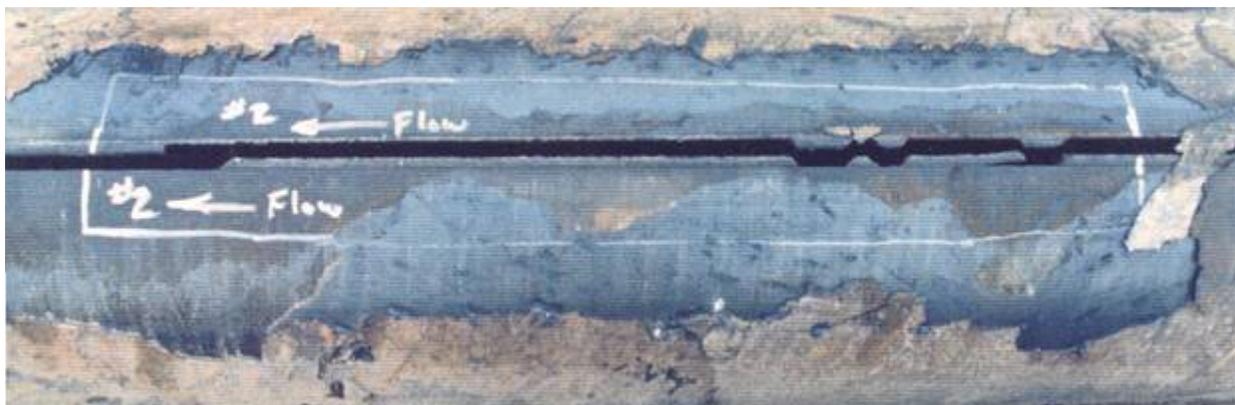
Catalog #: 90
 Report #: 9
 Defect #: 5-2

Photograph of Pipe Outside Surface.

Vintage: circa 1952
 Manufacturer: Kaiser
 Seam Type: SSAW
 Grade: API 5L X52
 D_{nominal} : 20 inch (508 mm)
 t_{nominal} : 0.344 inch (8.74 mm)
 t_{pipe} : Not Determined
 Failure: Hydrotest Leak at 1,570
 psig (10.82 MPa) (88%
 of SMYS)

NDE technique(s): N/A
 NDE result(s): N/A
 Visual: Seam Split
 L: 19 ft-5 inch (5.9 m)
 depth/ t_{weld} : Not Determined
 depth: Not Determined
 t_{weld} : Not Determined

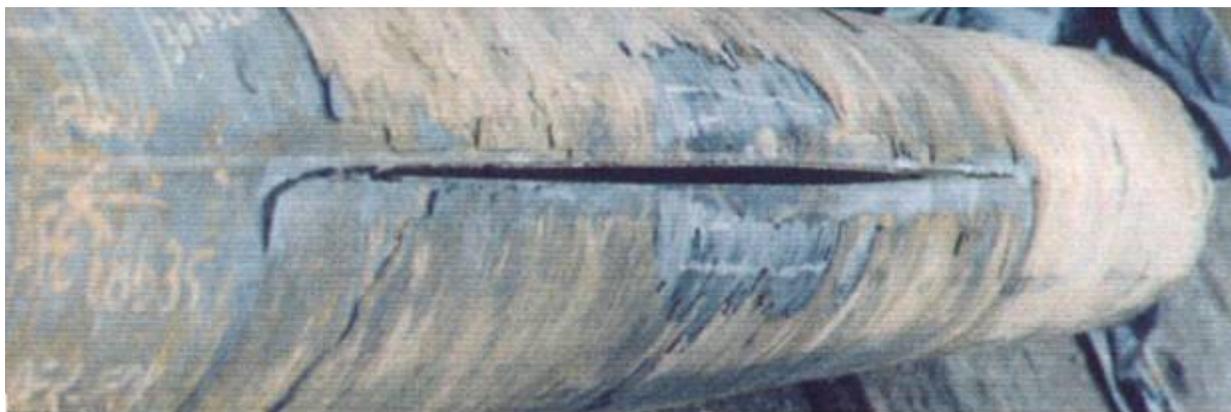
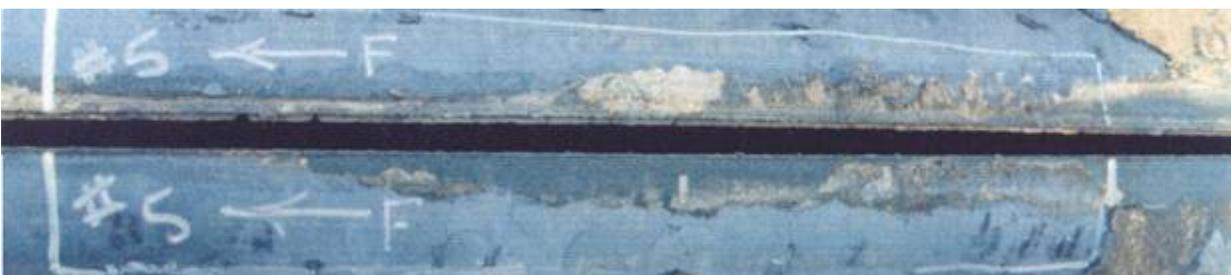
Catalog #: 91
 Report #: 9
 Defect #: 5-5

Photographs of Pipe Outside Surface.

Vintage: circa 1952
 Manufacturer: Kaiser
 Seam Type: SSAW
 Grade: API 5L X52
 D_{nominal} : 20 inch (508 mm)
 t_{nominal} : 0.344 inch (8.74 mm)
 t_{pipe} : Not Determined
 Failure: Hydrotest Leak at
 1,615 psig (11.14 MPa)
 (90% of SMYS)

NDE technique(s): N/A
 NDE result(s): N/A
 Visual: Seam split
 L: 12 ft-8 inch (3.9 m)
 $\text{depth}/t_{\text{weld}}$: Not Determined
 depth: Not Determined
 t_{weld} : Not Determined

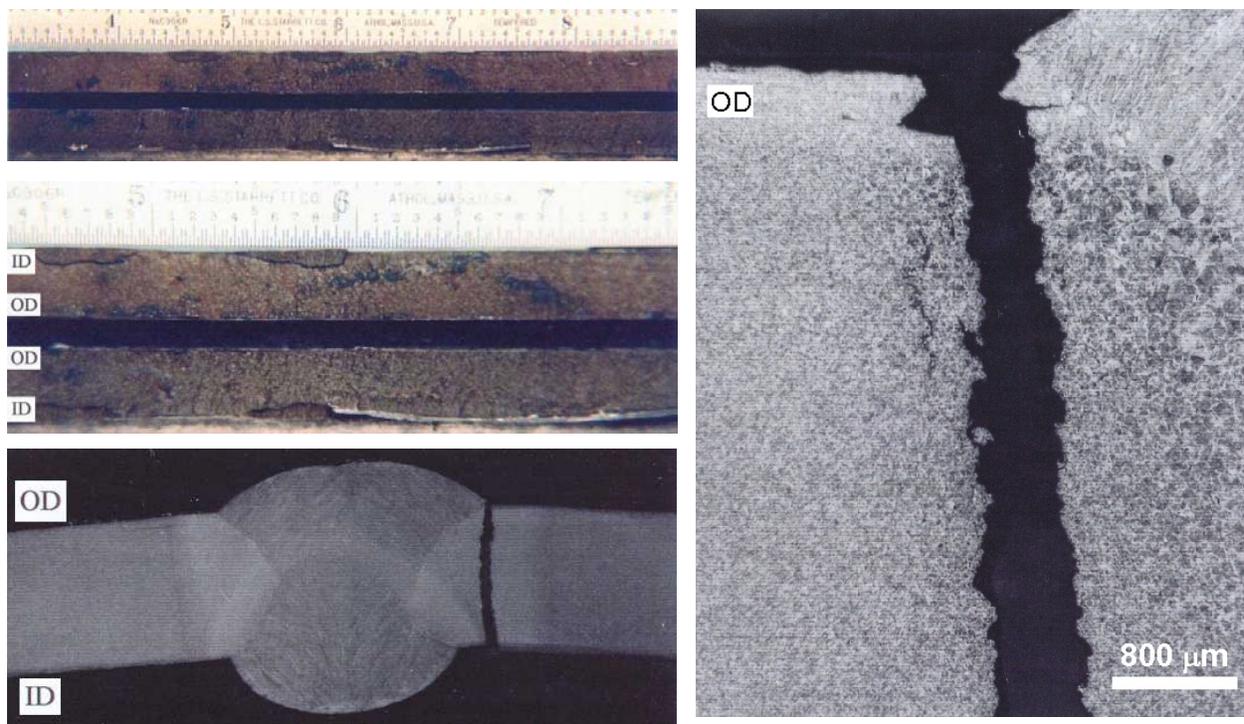
Catalog #: 87
 Report #: 9
 Defect #: 5-3

Photographs and Photomicrograph of Fracture Surfaces and Metallographic Section.

NDE technique(s): N/A
 NDE result(s): N/A
 Visual: Initiation at toe of OD weld bead + Small OD cracks parallel to main fracture

$D_{nominal}$: 20 inch (508 mm)
 $t_{nominal}$: 0.344 inch (8.74 mm)
 t_{pipe} : Not Determined
 Failure: Hydrotest Rupture at 1,538 psig (10.60 MPa) (86% of SMYS)
