In-Ditch Validation Methodology for Determination of Defect Sizing

Peter den Boer, Harvey Haines, Lars Hörchens,
Pushpendra Tomar, and Jeff Vinyard
August 23, 2016

Final Report

PHMSA

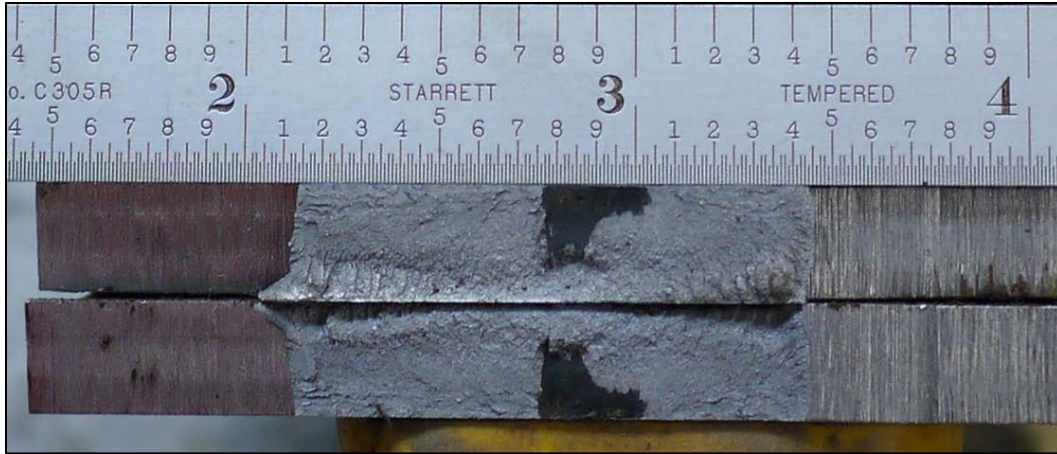
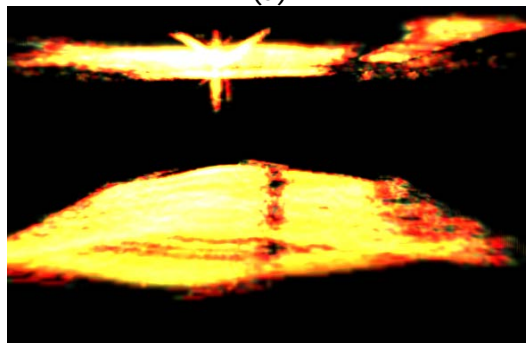
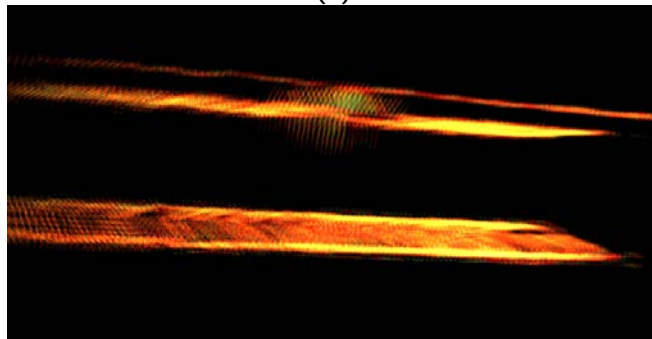
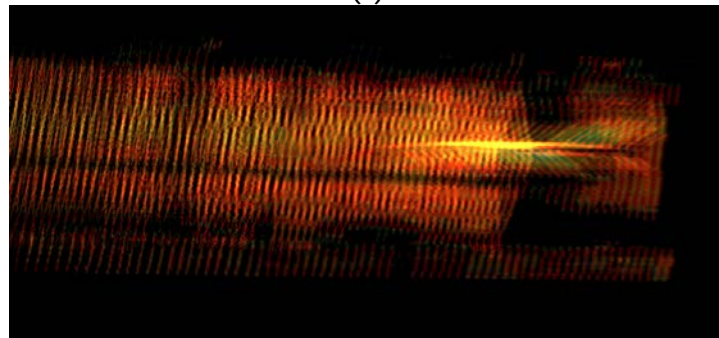
Figure 26. Reported flaw #16 (a) metallographic cross-section (b) IWEX 3D end view (c) IWEX 3D side view (d) IWEX 3D top view

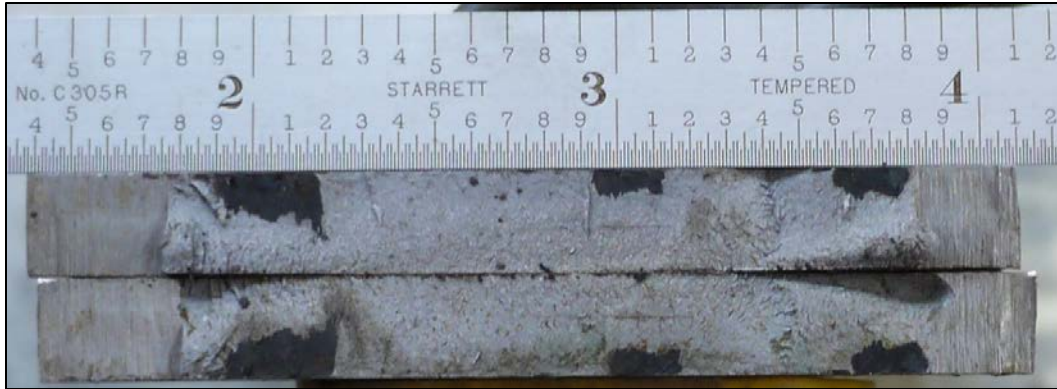
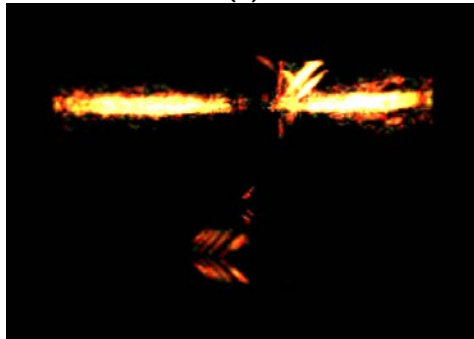
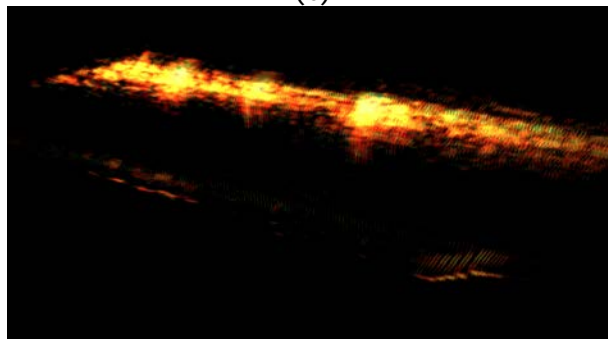
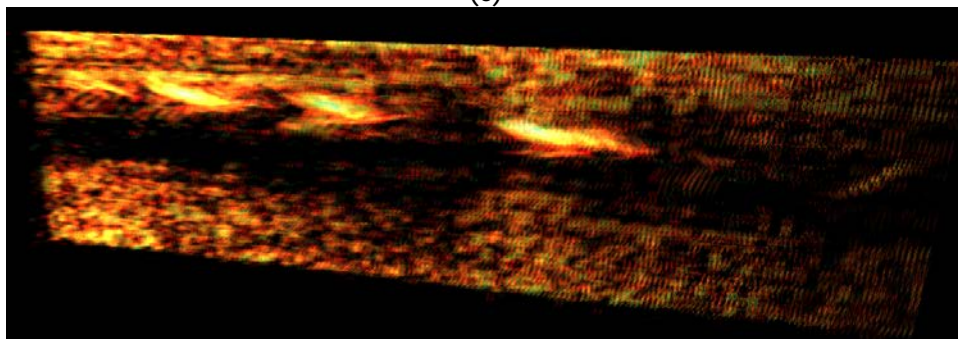
Figure 27. Reported flaw #13, #14, and #15 (a) metallographic cross-section (b) IWEX 3D end view (c) IWEX 3D side view (d) IWEX 3D top view

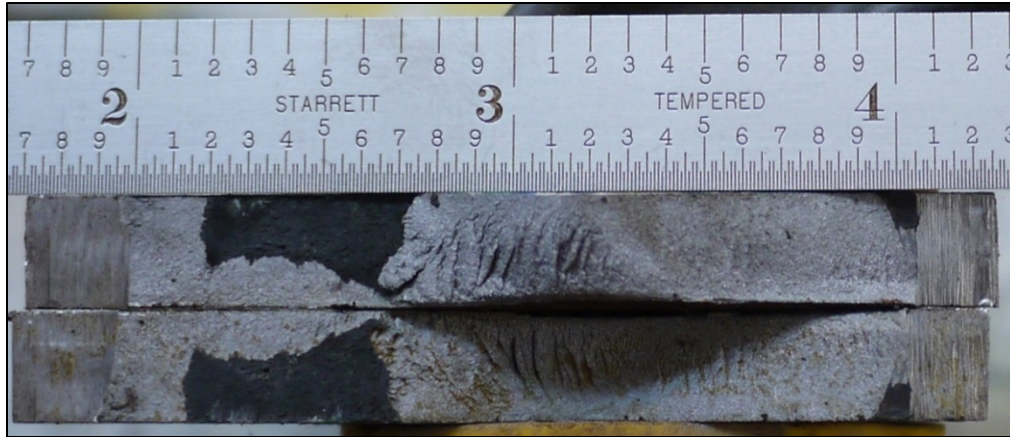
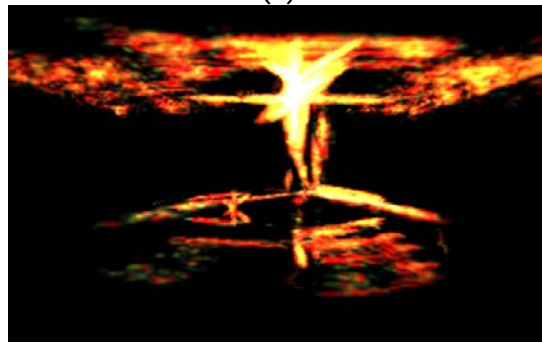
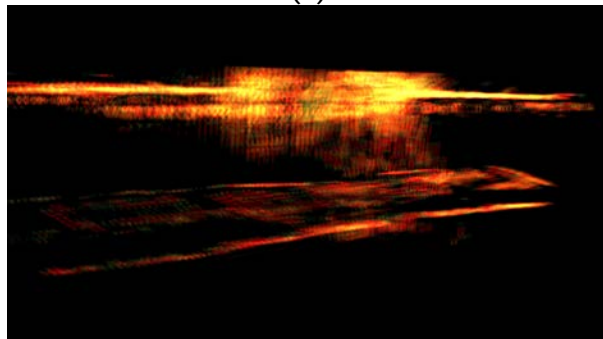
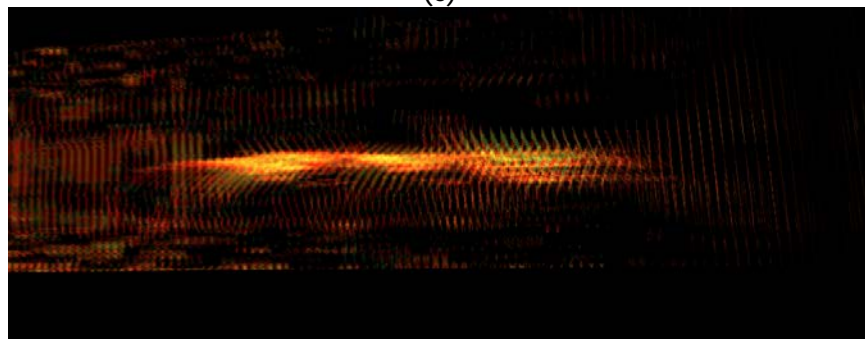
Figure 28. Reported flaw #11 (a) metallographic cross-section (b) IWEX 3D end view (c) IWEX 3D side view (d) IWEX 3D top view

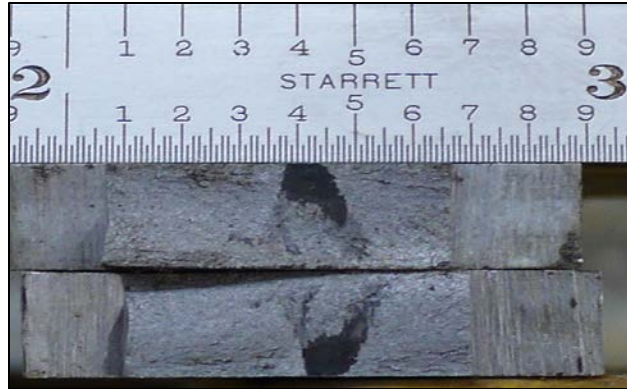
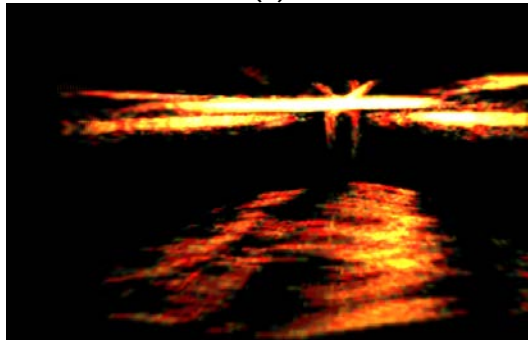
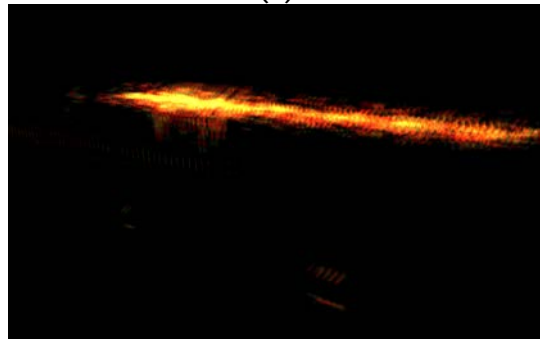
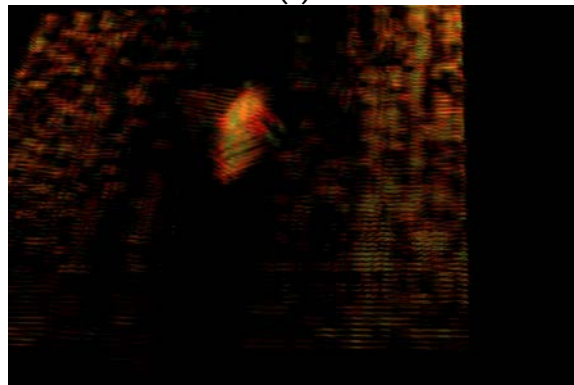
Figure 29. Reported flaw #10 (a) metallographic cross-section (b) IWEX 3D end view (c) IWEX 3D side view (d) IWEX 3D top view

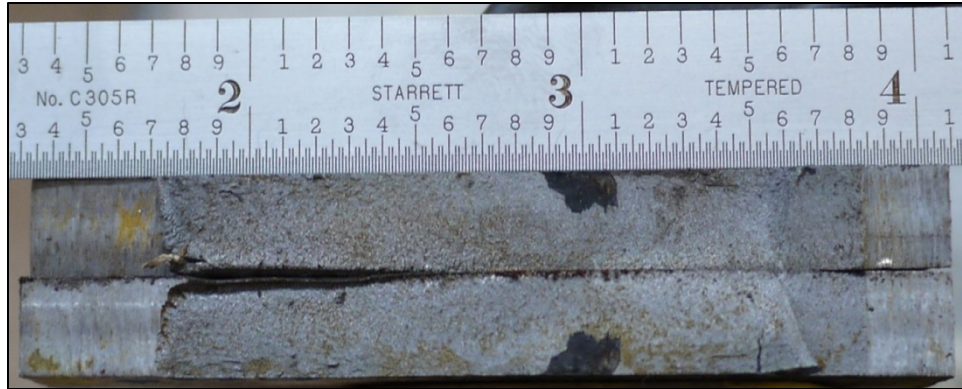
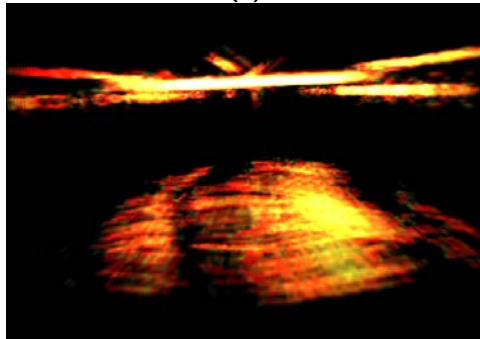
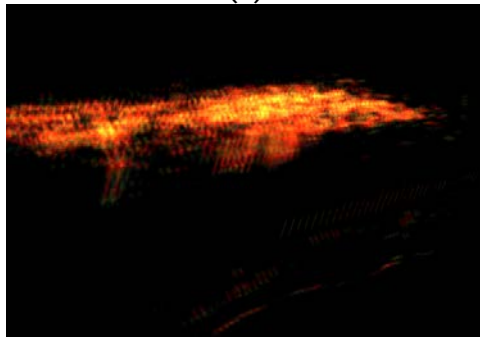
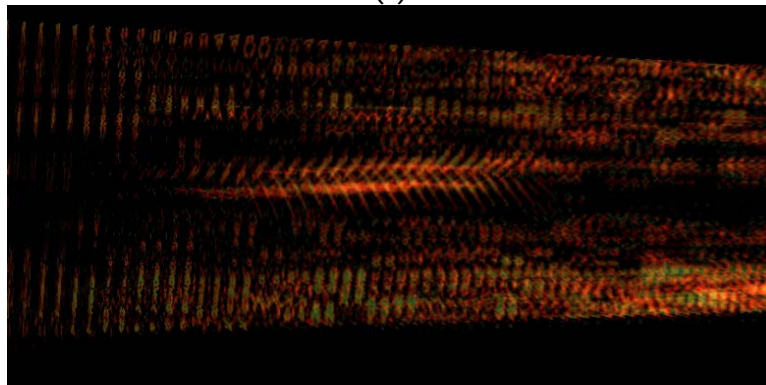
Figure 30. Reported flaw #10 (a) metallographic cross-section (b) IWEX 3D end view (c) IWEX 3D side view (d) IWEX 3D top view

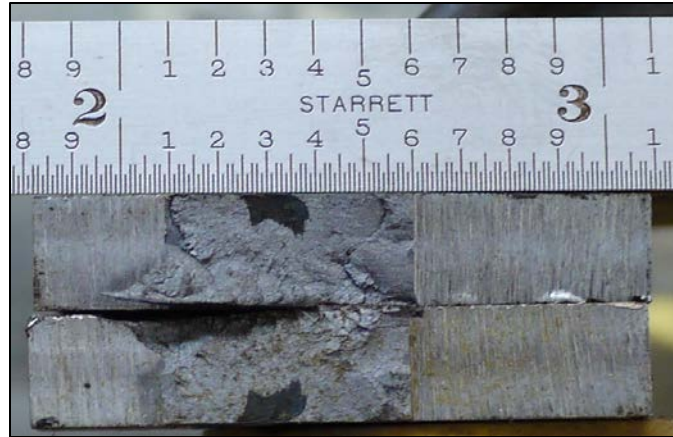
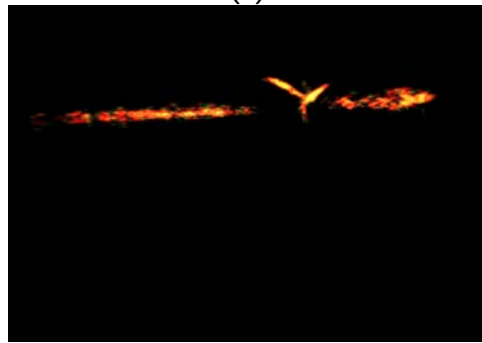
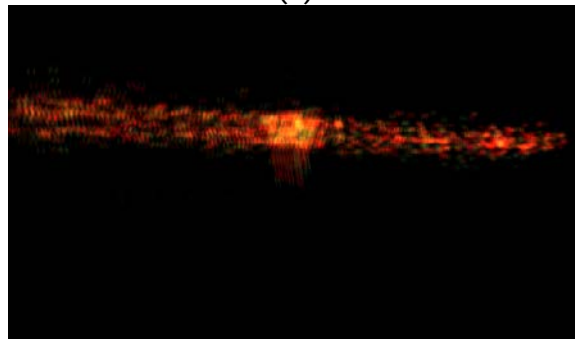
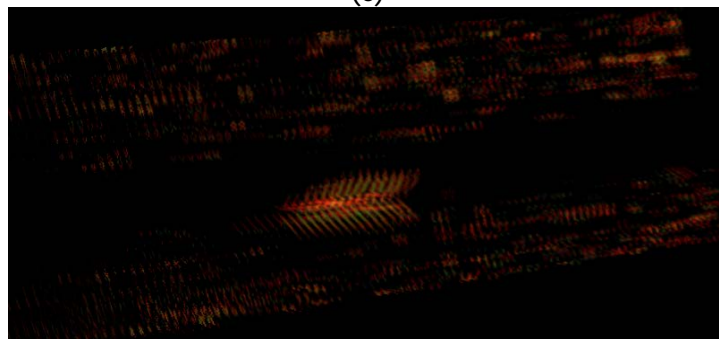
Figure 31. Reported flaw #6 (a) metallographic cross-section (b) IWEX 3D end view (c) IWEX 3D side view (d) IWEX 3D top view

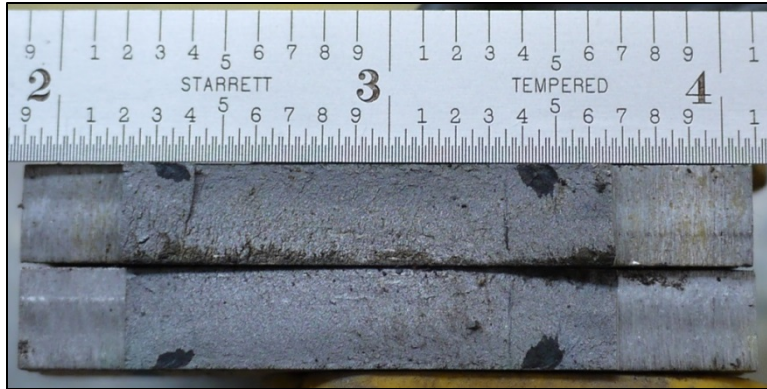
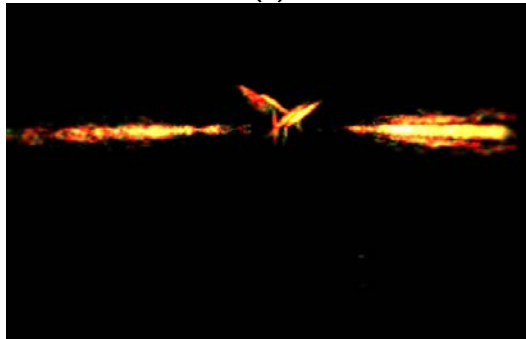
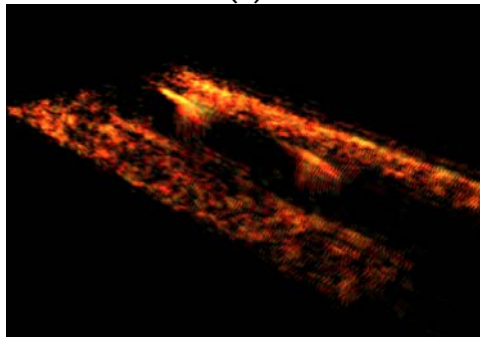
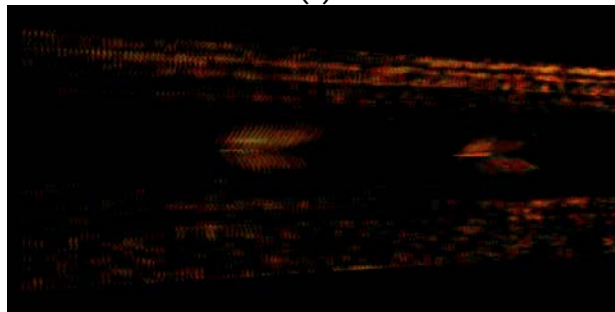
Figure 32. Reported flaws #4 and #5 (a) metallographic cross-section (b) IWEX 3D end view (c) IWEX 3D side view (d) IWEX 3D top view

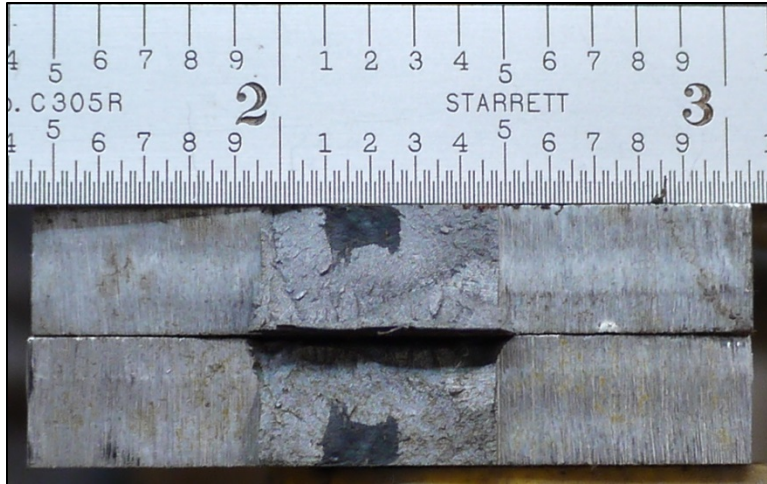
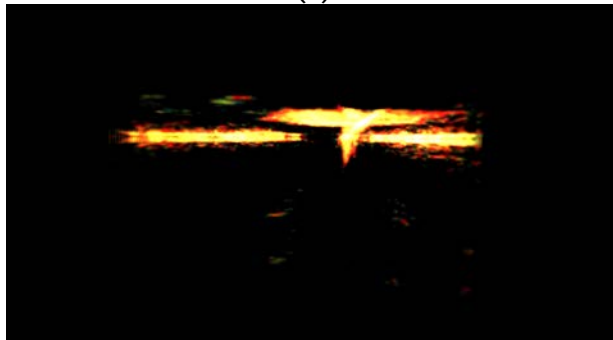
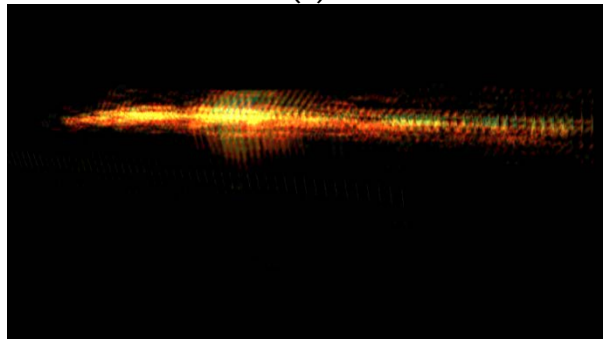
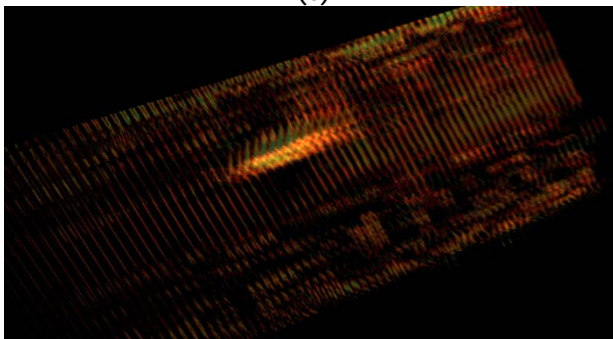
Figure 33. Reported flaw #3 (a) metallographic cross-section (b) IWEX 3D end view (c) IWEX 3D side view (d) IWEX 3D top view

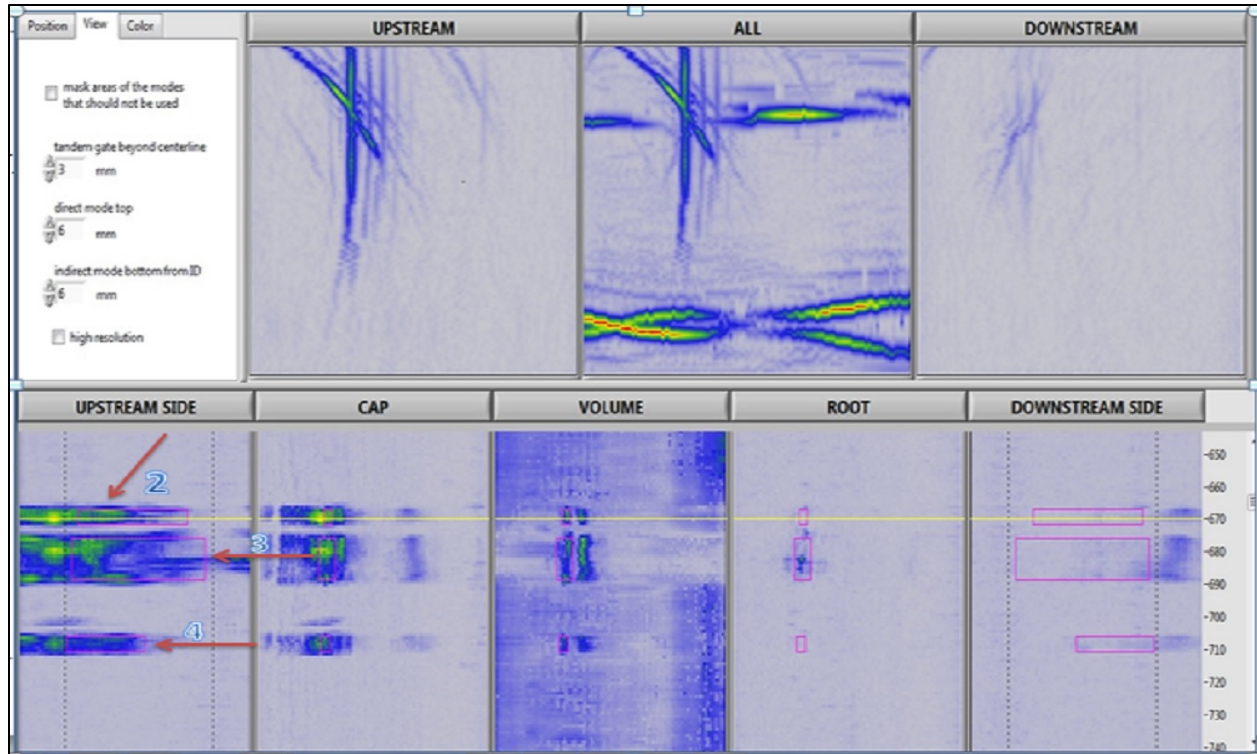
The 16-in ERW samples were inspected a third time, this time using focused wedges. The first set of inspections produced good signals on the five samples but had problems with the software associated with the encoder. The second set of trials on the remaining four samples were inspected using the original unfocused wedges used for the initial 2012 seam weld inspections which predated this PHMSA R&D project. Although good signals were obtained and lack of fusion anomalies were easily identified the sizing was less than optimal. The beam width on the original wedges was approximately 10 mm, which is wider than all but one or two of the lack of fusion anomalies detected in the set of anomalies broken open in the trial. The third trial was performed on the remaining three samples using the focused wedges. The focused wedges have a beam width of about 3 mm and it appears from the initial results that sizing has improved. Results are presented in Table 3 with an IWEX screenshot image in Figure 34.

Figure 34. Pipe (ID: D-A) IWEX Image of Defects 2, 3 and 4

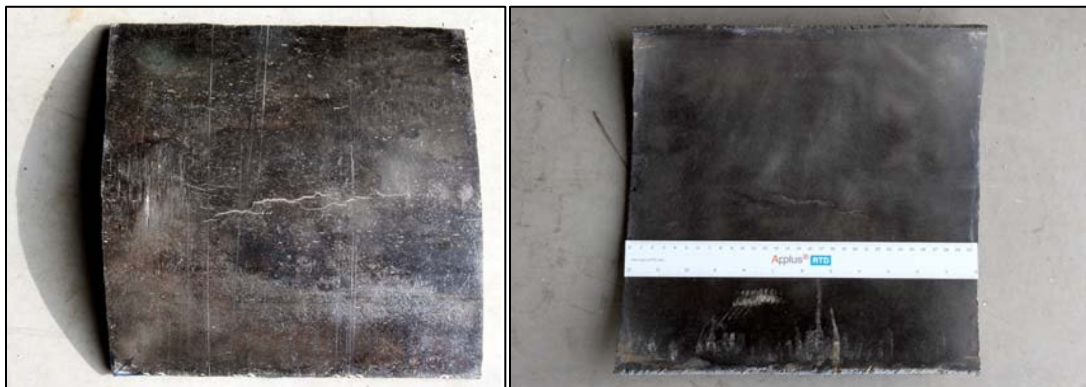
In order to test the applicability of IWEX to samples exhibiting stress corrosion cracking, experiments have been conducted with a sample containing high-pH SCC. This type of SCC is usually not associated with general corrosion of the pipe body. Therefore, the measurements are not complicated by coupling problems due to external corrosion. The sample is shown in Figure 35; it contains several visible cracks, some of which are through-wall.

Figure 35. Pipe coupon containing SCC of about 12" length, 24" diameter, wall thickness 0.33" (8.5 mm)

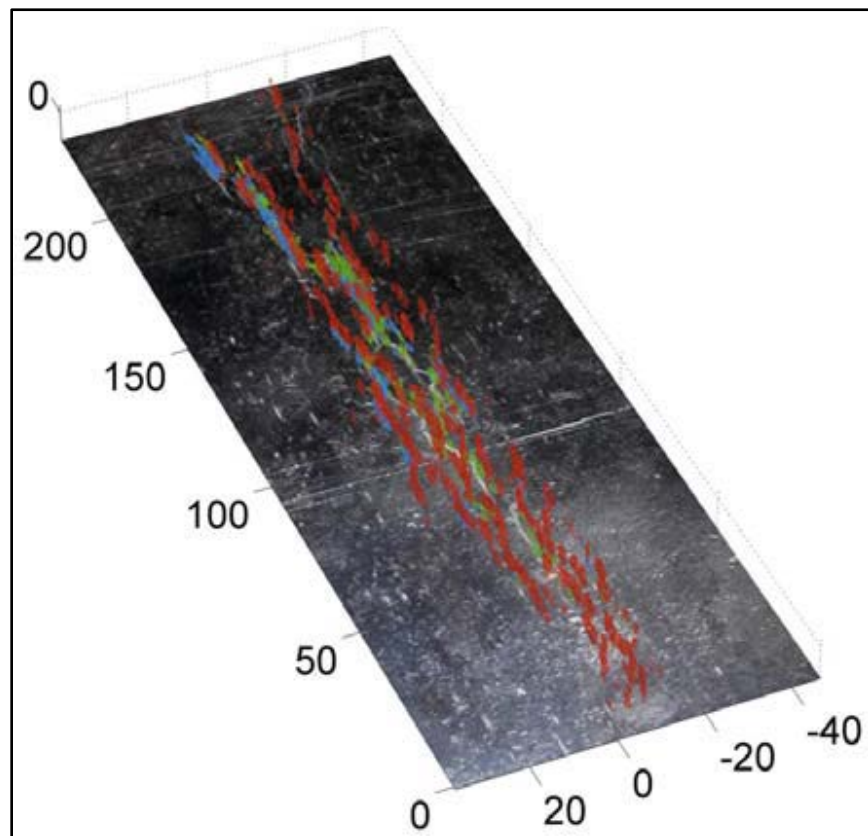
Nevertheless, the current single-stroke example provides an idea of the capabilities of this inspection technique. Figure 42 presents a photograph of the region scanned with a three-dimensional visualization of the IWEX scan result superimposed. In this case, a fixed amplitude threshold has been chosen to determine the visibility of the indications in the three-dimensional visualization. The contributions of different IWEX modes are once more represented by different colors: blue for the direct mode, green for the skip mode, and red for the tandem mode.

Figure 42. Three-dimensional visualization of the IWEX scan superimposed on a photograph of the sample (all dimensions in millimeters)

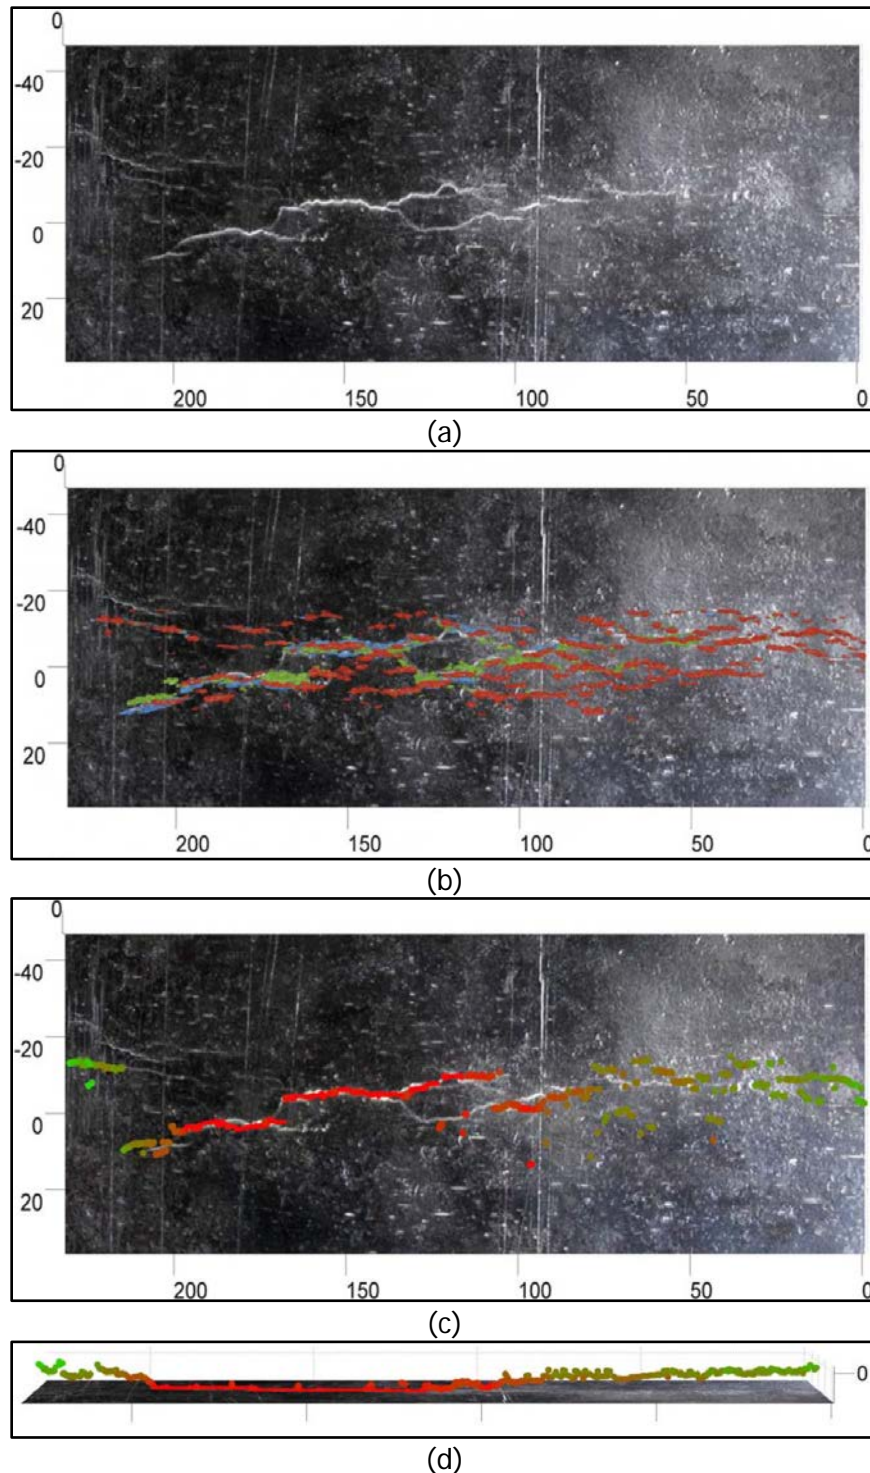
In Figure 43(b), a top view of the same visualization is shown. By comparison to the photograph of the sample depicted in Figure 43(a), the difference between visual inspection and the information provided by IWEX is demonstrated.

For the determination of the remaining strength of a material sample, the accurate sizing of the deepest crack in the colony is of interest. In an additional processing step, the scanned region is analyzed to find the deepest crack for every scan position and determine its depth. In a test implementation, the tip diffractions are combined with the tandem indications for reasons of

simplicity. The indication of greater depth is chosen to be leading, which can result in slight oversizing due to the vertical blurring of the tandem indications (compare Figure 43(a)).

Figure 43. Photograph of the sample surface (a); IWEX scan superimposed with blue representing indications picked up by the direct mode (b); superposition of the deepest crack found per scan position with green indicating a shallow crack and red indicating a through-wall crack (c); side-view of (c) showing the depth of the deepest crack per scan position (d). All dimensions are shown in millimeters.

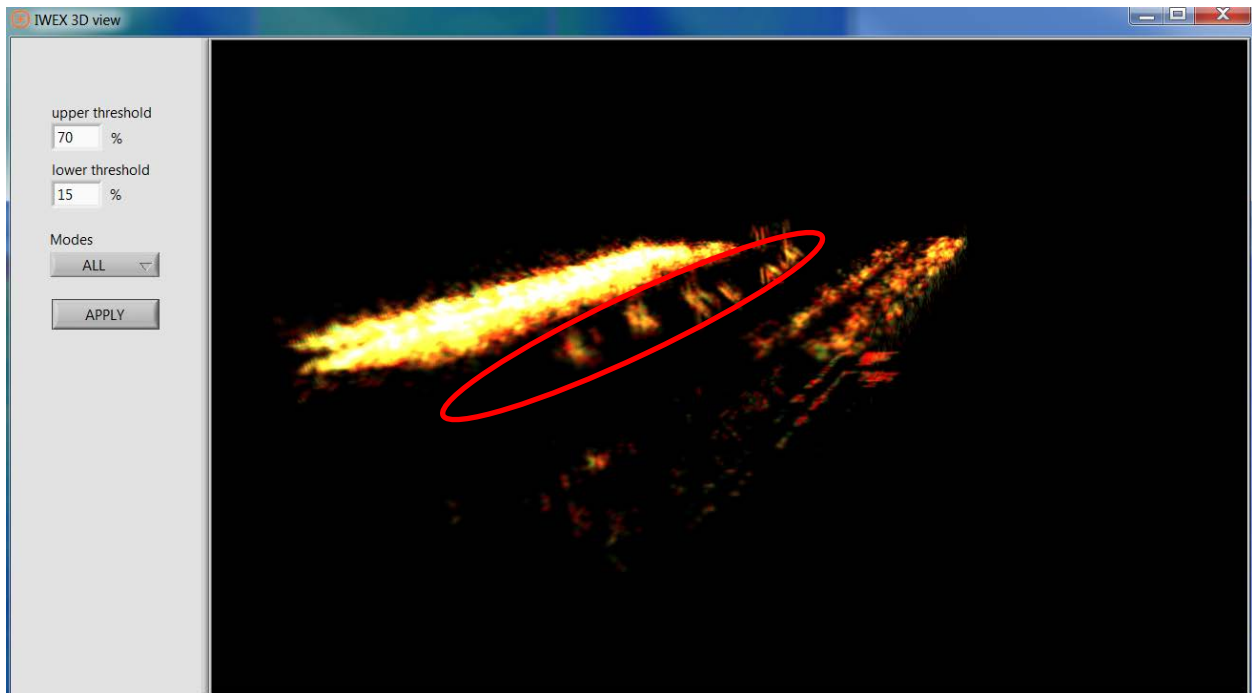
Figure 45. Part 116050, 45 + 88 mm, D 0.0 – 0.8, H 0.8mm, DS 90° Side with flow LOF OD surface

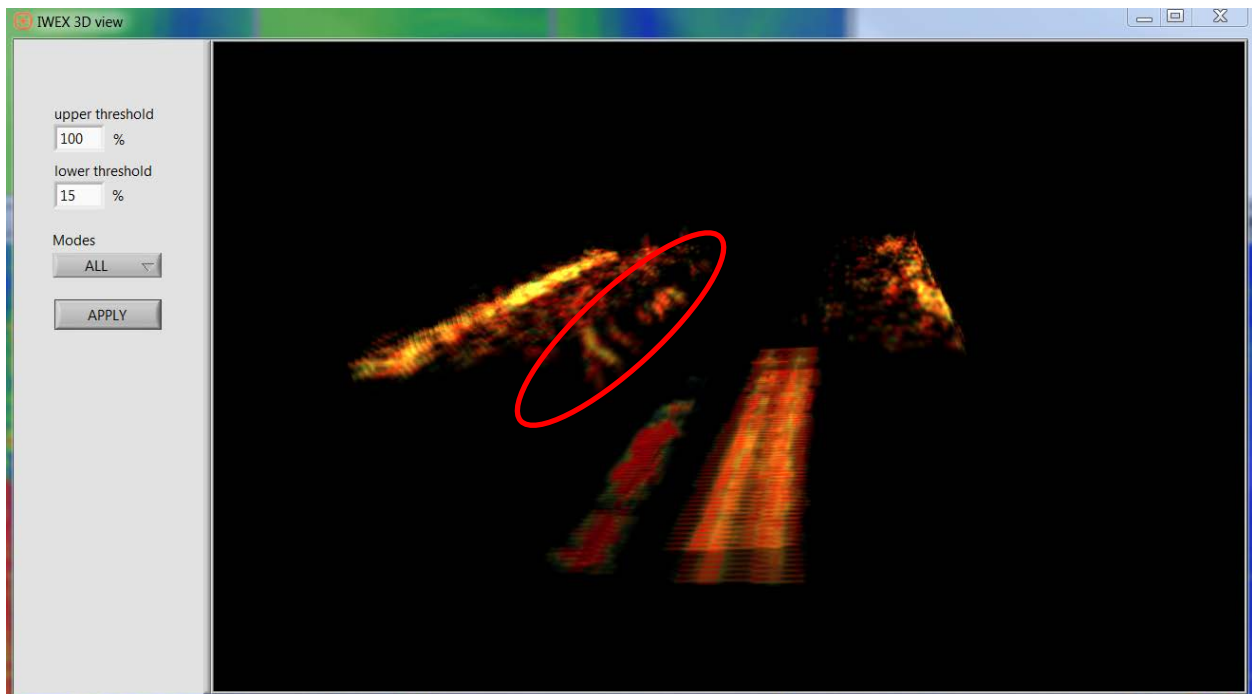
Figure 46. Part 116050, 894 + 35mm, D 0.0 – 1.1, H 1.1mm, US 270 Side with flow LOF OD surface

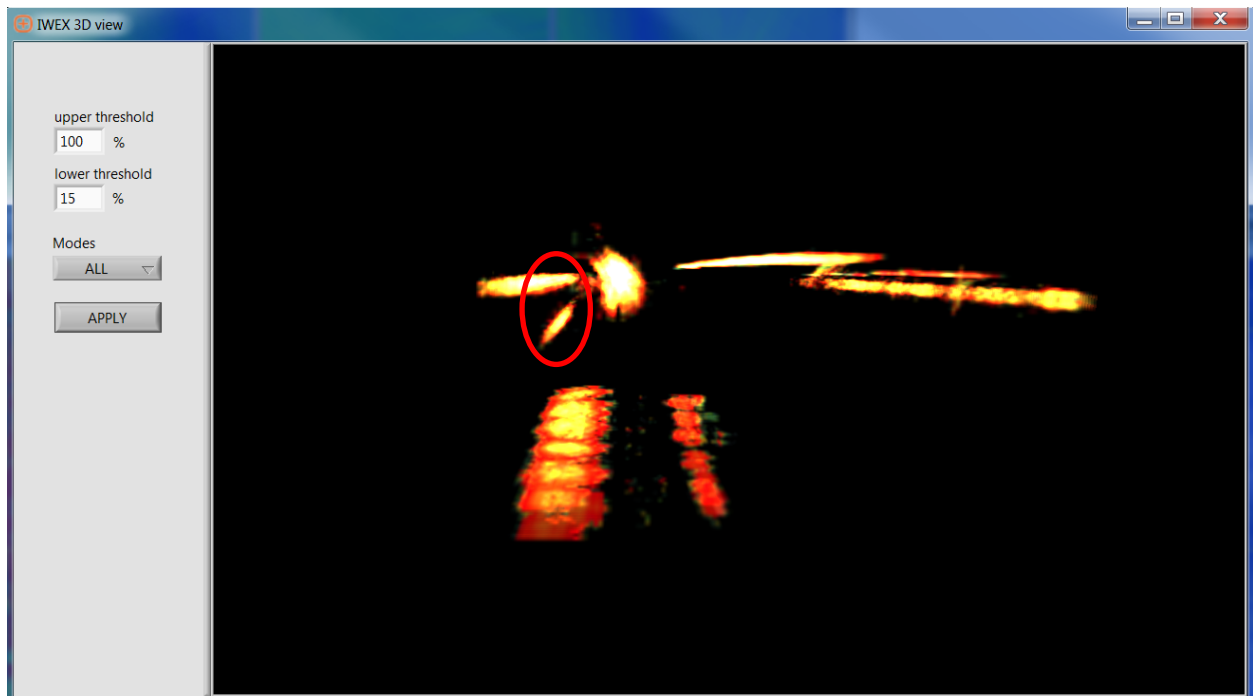
**Figure 48. Part 116050, 3025 + 77mm, D 0.0 – 1.1, H 1.1mm, US 270 Side with flow
OD surface LOF**

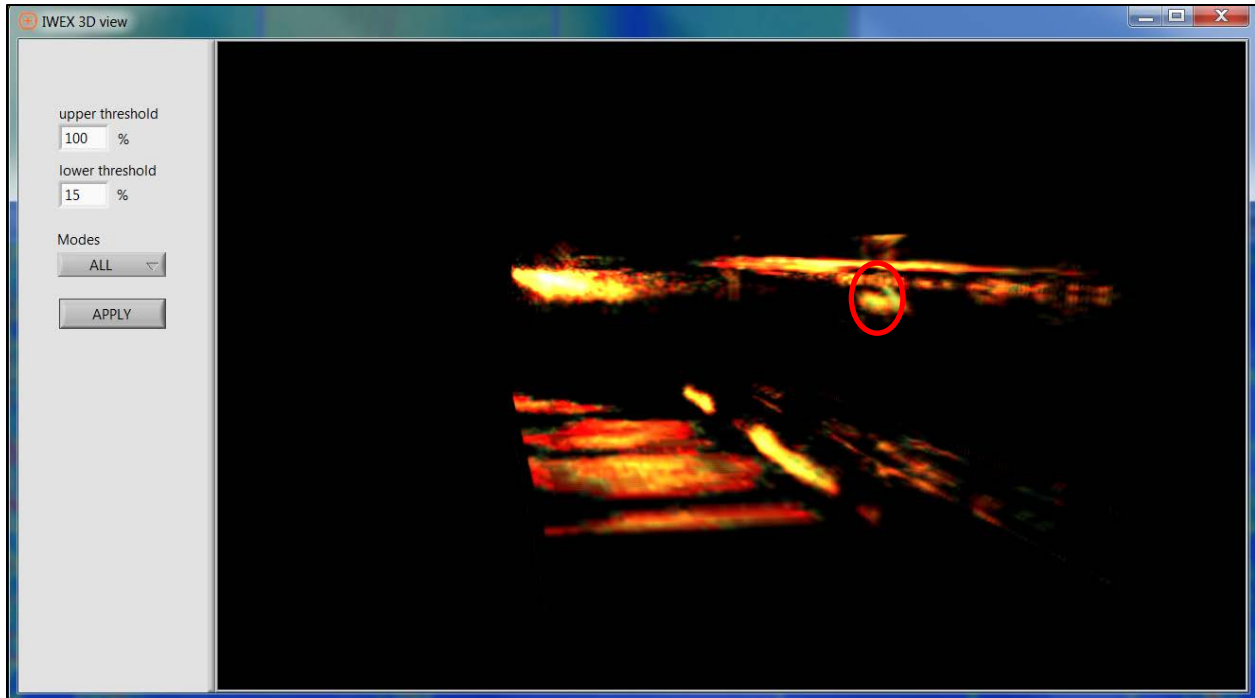
Figure 53. Pipe sample 149890, 871 + 9.0mm, D 0.0 – 1.6mm, H 1.6mm, DS 90 side with flow OD surface LOF

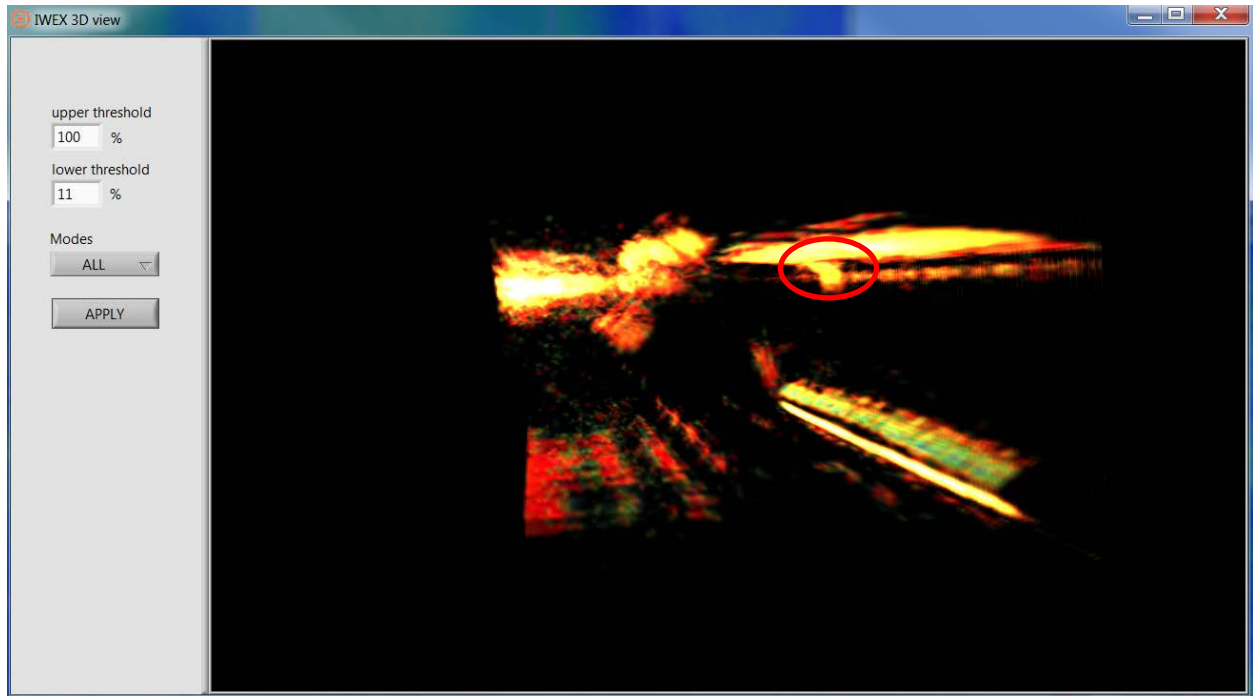
Figure 58. Pipe Sample 159070, 1258 + 5mm, D 0.0 – 0.7mm, H 0.7mm, DS 90 side with flow OD Surface

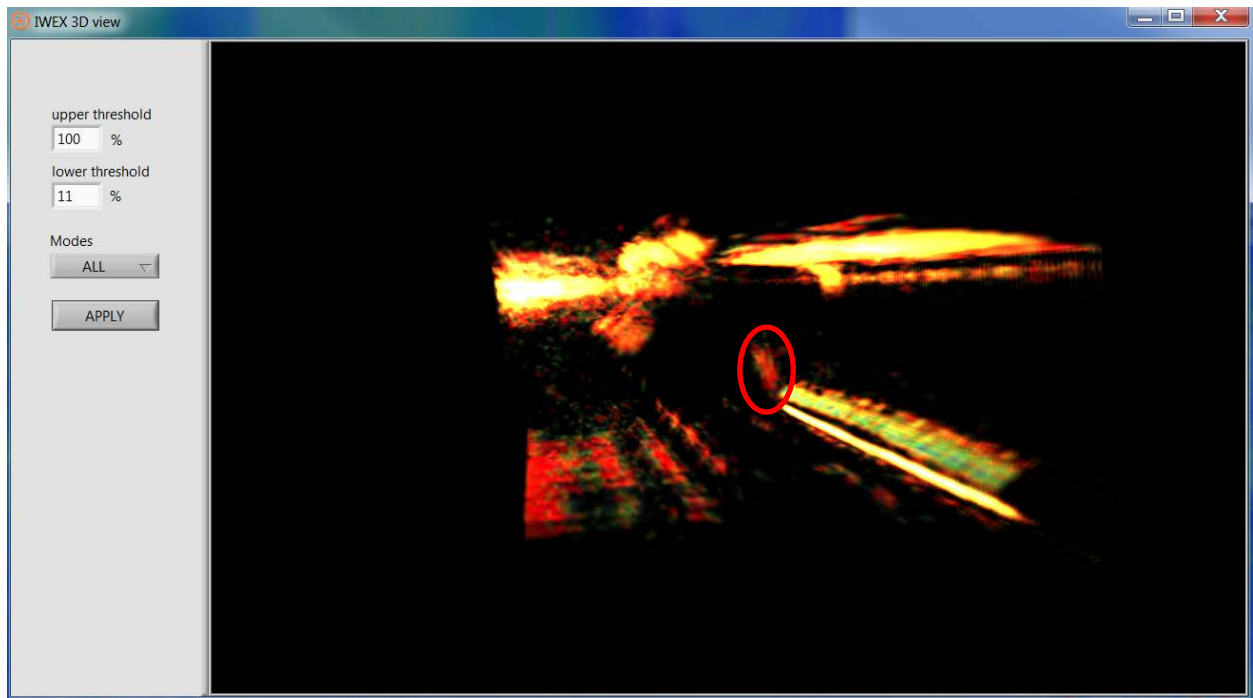
Figure 59. Pipe Sample 159070, 1258 + 5mm, D 1.6 – 2.9mm, H 0.5mm, DS 90 side with flow LOF

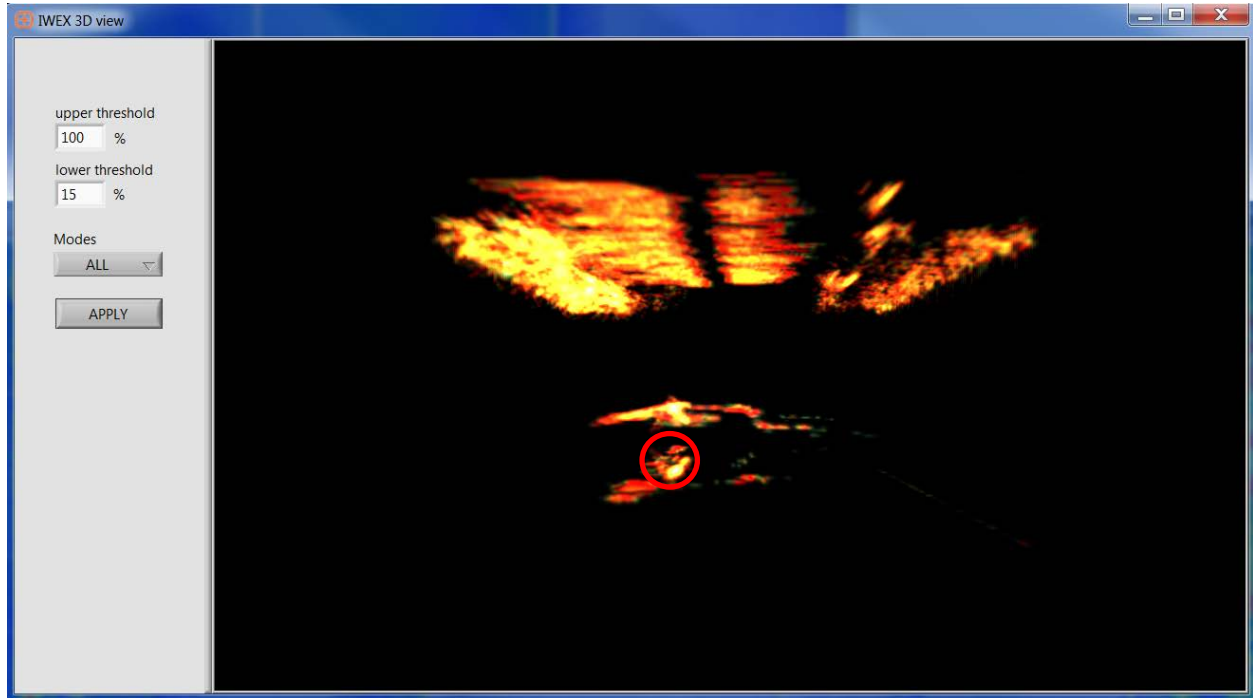
Figure 69. Pipe Sample 159070, 744 + 5.5mm, D 6.1 – 7.4, H 1.3mm, US 270° with flow ID surface LOF

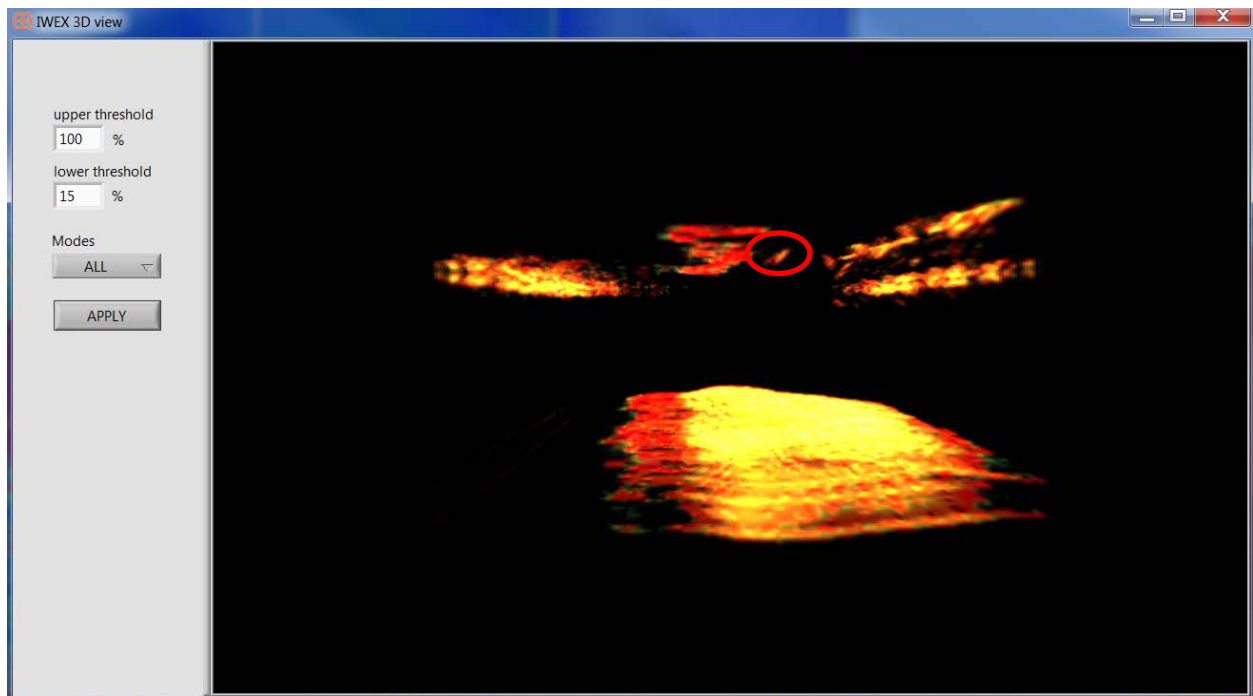
Figure 70. Pipe Sample 159070, 1086 + 7.0mm, D 0.0 – 0.8mm, H 0.8mm, DS 90° Side with flow OD LOF

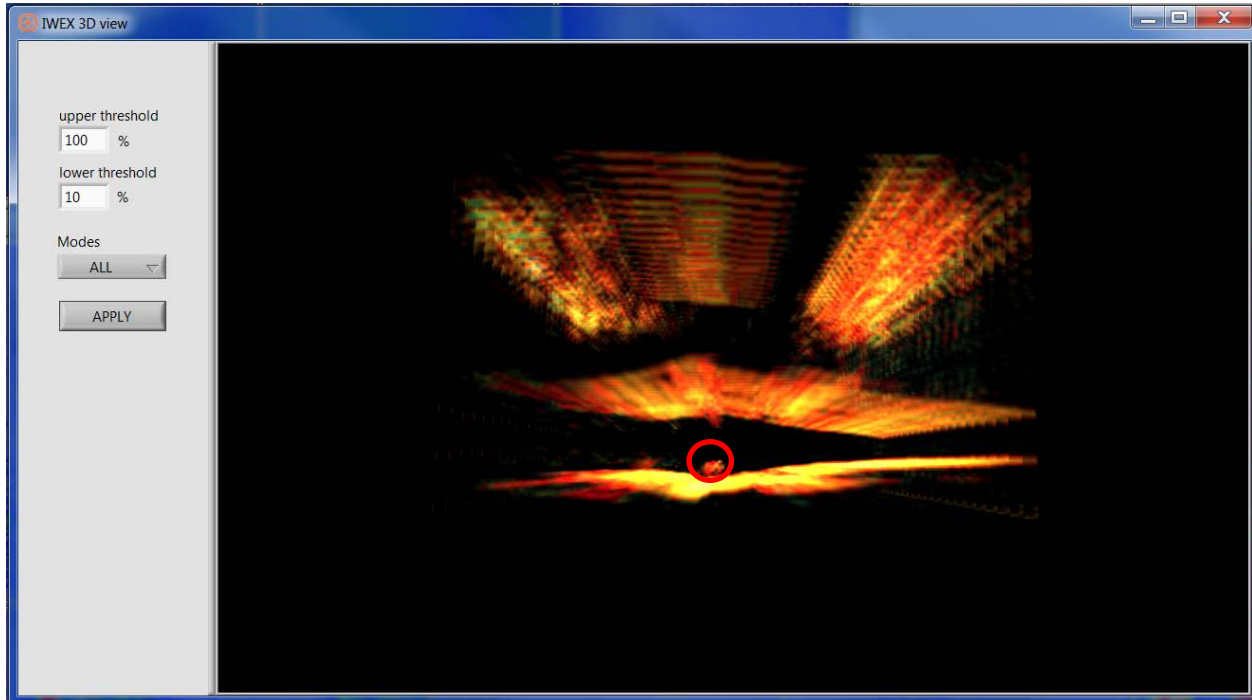
Figure 71. Pipe Sample 159070, 1490 + 4.5, D 5.0 – 7.4mm, H 1.4mm, US 270 side with flow LOF ID Surface

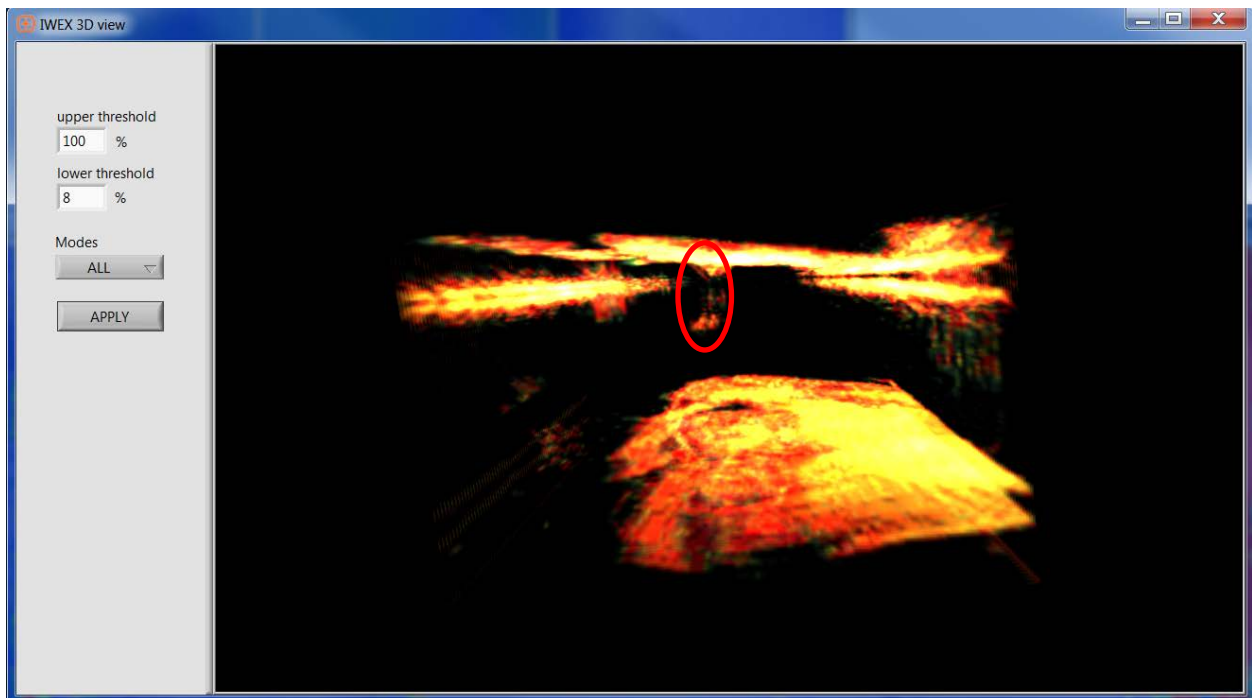
Figure 72. Pipe Sample 159070, 2188 + 6mm, D 0.0 – 1.2mm, H 1.2mm, US 270 side with flow

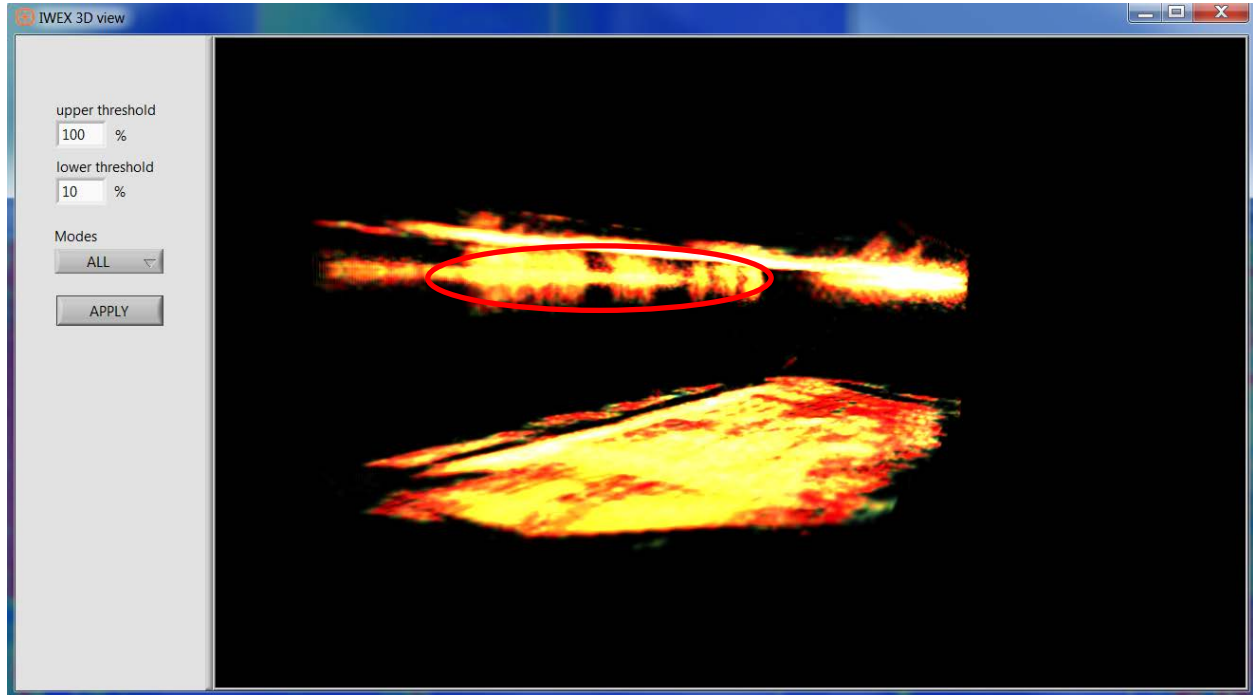
**Figure 73. Pipe Sample 159070, 3906 + 180mm, D 0.0 – 1.5mm, H 1.5mm, US 270°
with flow OD surface LOF**
