In-Ditch Validation Methodology for Determination of Defect Sizing

Peter den Boer, Harvey Haines, Lars Hörchens,
Pushpendra Tomar, and Jeff Vinyard
August 23, 2016

Final Report

PHMSA

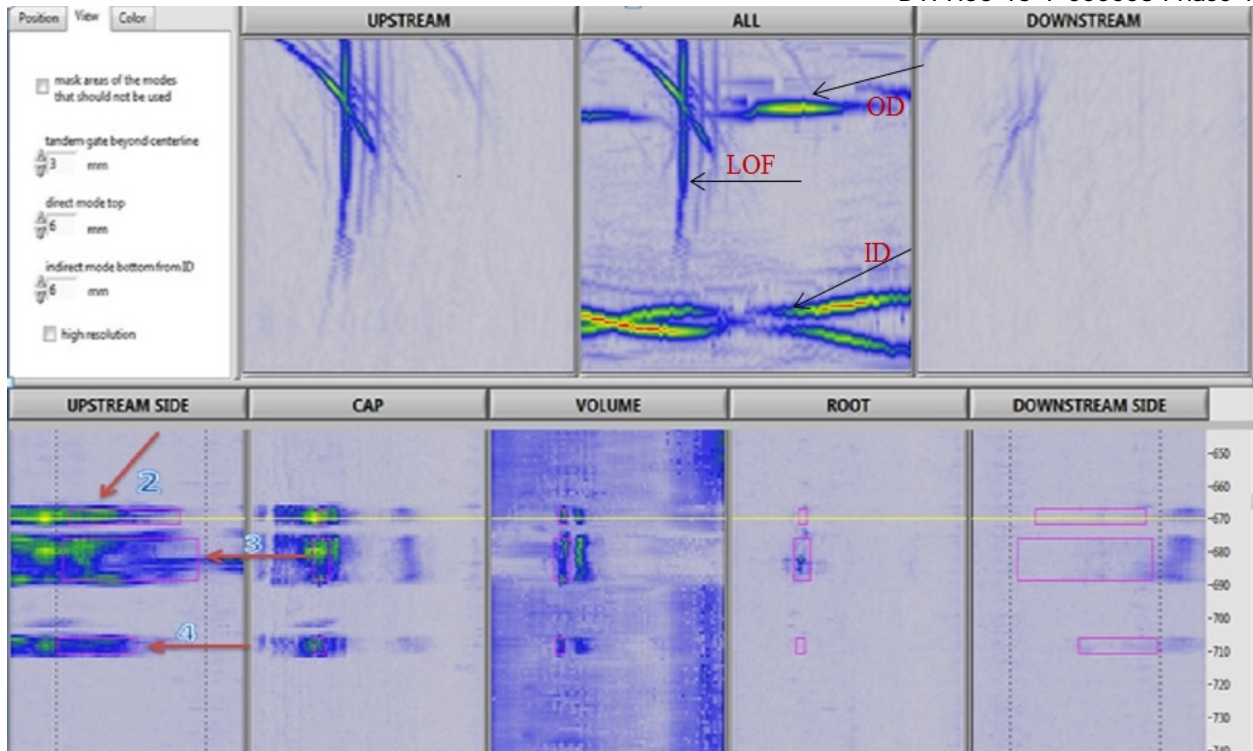
Figure 90. IWEX Image for Lack of Fusion defect (V1.75)

In earlier studies, significant improvements were obtained in analysis of Lack of Fusion (LOF) defect sizing using IWEX analysis software version 1.75. The improvements were results of improved resolution capabilities in the newer Version 1.75 (compared to Version 1.74) combined with the use of 10 MHz probes with focused wedges in place of 7.5 MHz probes with unfocused wedges. Figure 90 shows IWEX images from three LOF defects (2, 3 and 4) with the "ALL" modes picture focused on Defect 2 (Yellow cursor can be seen in the lower half of the image). Figure 91 shows these three LOF defects in the fracture surface.

As can be seen in Figure 90, IWEX images from LOF defects are very upright because of the shape of an LOF defect. It was observed from various destructive analyses results that sizing LOF defects using the amplitude of signal and selecting the complete depth of the defect in the IWEX image provided improved results. This analysis procedure was tested in a second set of destructive testing which was covered under a DOT PHMSA project. Results from this set of

testing confirmed the hypothesis that using amplitude based signal is the most accurate way to size an LOF type of defect. In the same experiments it was found that a 6 dB drop method (function build in with the IWEX analysis software) proved to be under sizing the LOF defects. Hence 6db drop method was rejected as the preferred method for sizing LOF defects.

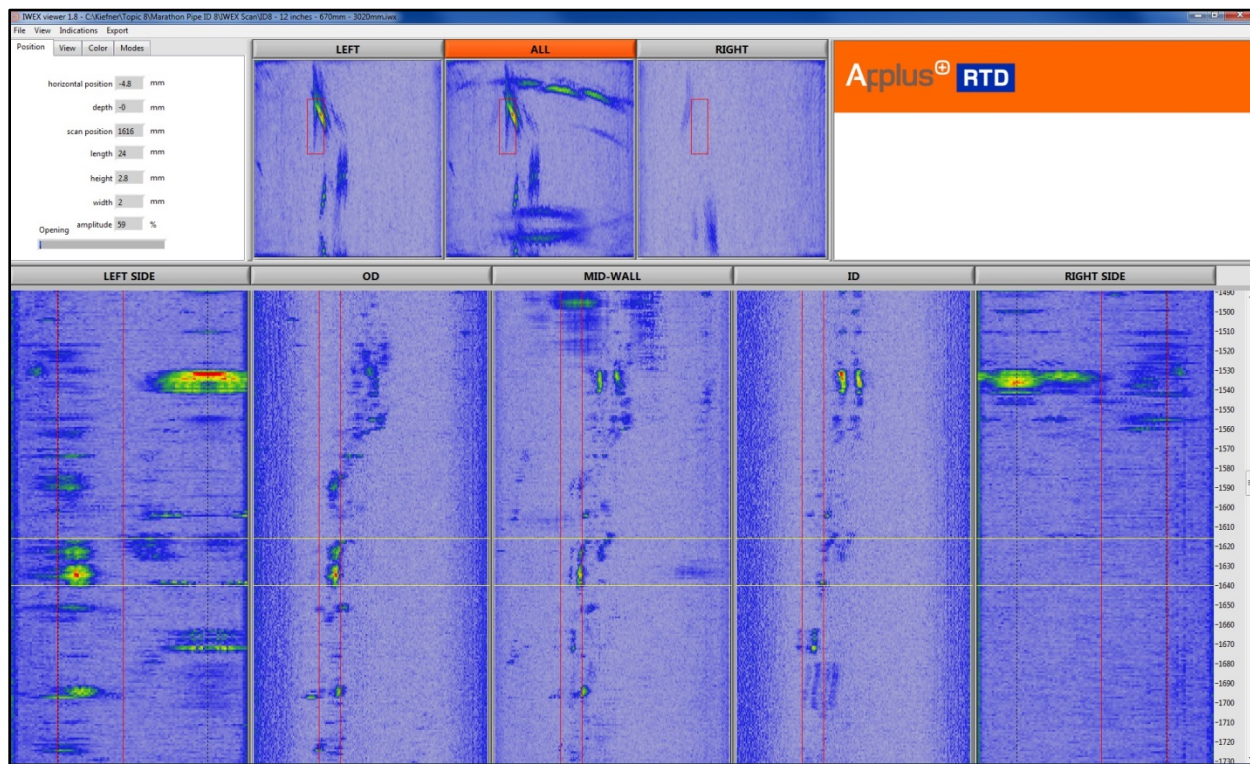
Figure 92. Break Location 11 (Sizing by amplitude method V1.8)

IWEX-1 data set was acquired by analyzing the IWEX scan for 12" Pipe ID#8 using IWEX Analysis Software Version 1.75. Analysis was performed by using the amplitude based signal/image. Unlike the previous case, defects in this pipe sample were mostly crack like indications. Further confirmation was achieved by destructive analysis that defects in this pipe sample were mostly hook cracks. Figure 92 shows analysis of Break Location 11 by using the amplitude method signal alone. Figure 93 shows analysis of the same defect using the tip diffraction method. (Length reading is different as only depth was investigated. For this purpose the cursor was pointed at the same location where destructive analysis (metallography) was performed at Break 11).

Table 4 is a comparison of depths reported by IWEX-1 and IWEX-2 with results from destructive analysis. Results suggest that the amplitude method for analysis of crack like indication provided very conservative results (IWEX-1). This proved to be true for all crack like defects. IWEX-2 data set was prepared using the tip diffraction method and results showed considerable improvements.

Figure 92, Figure 93, and Figure 94 show the improvements in sizing capability using Version 1.8 of the IWEX viewing software. By looking at the window labeled "ALL", the difference between amplitude sizing in Figure 92 and tip diffraction sizing in Figure 93 is apparent. Figure 94 shows how toggling on and off various modes can help with the interpretation.

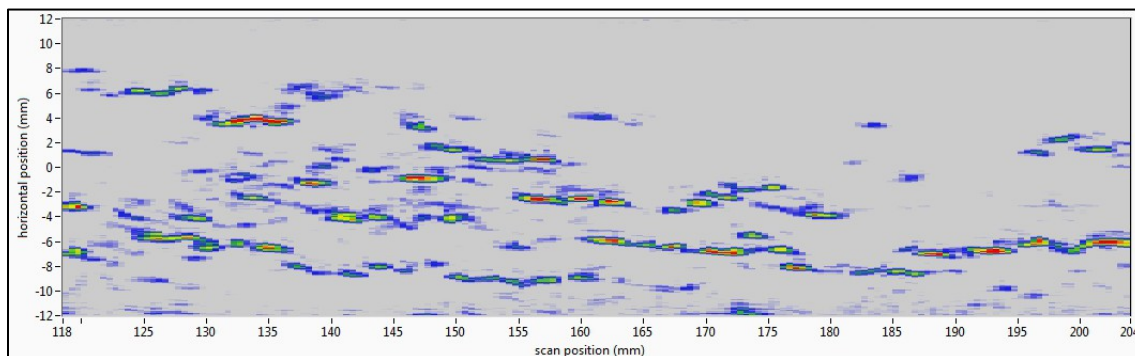
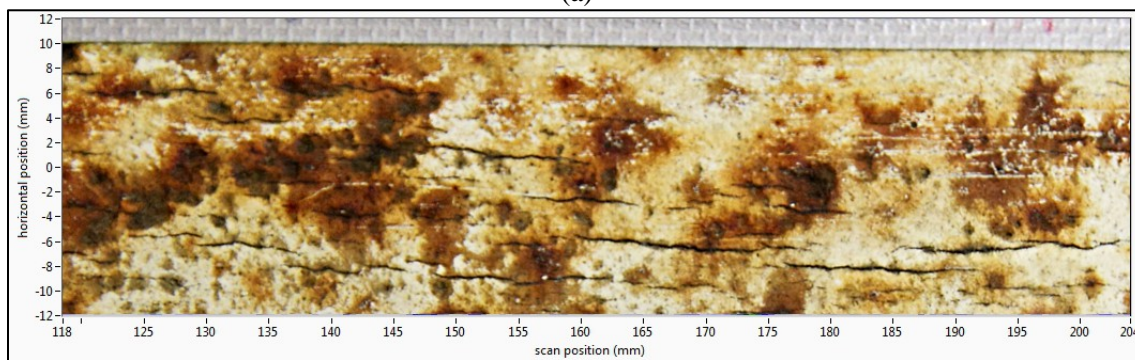
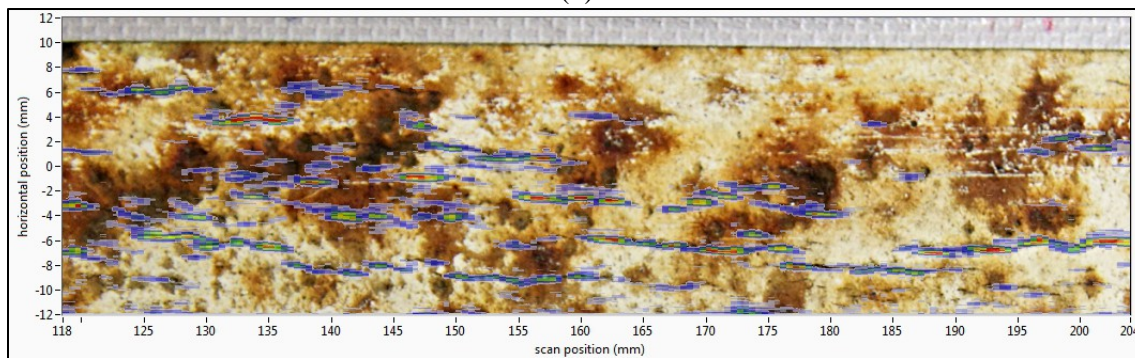
The IWEX data volume obtained from one scan can also be represented as a C-scan top view showing the detected cracks. In Figure 103, a C-scan visualization generated from a part of an

IWEX scan is shown. It is also superimposed on a photograph of the same pipe section. It can be seen that the indications detected by IWEX coincide nicely with the visible surface cracks.

Figure 103. C-scan top view of the pipe body next to the weld obtained by IWEX inspection (a); photograph of the cracks in the pipe body for the same region (b); IWEX indications superimposed on the photograph (c)

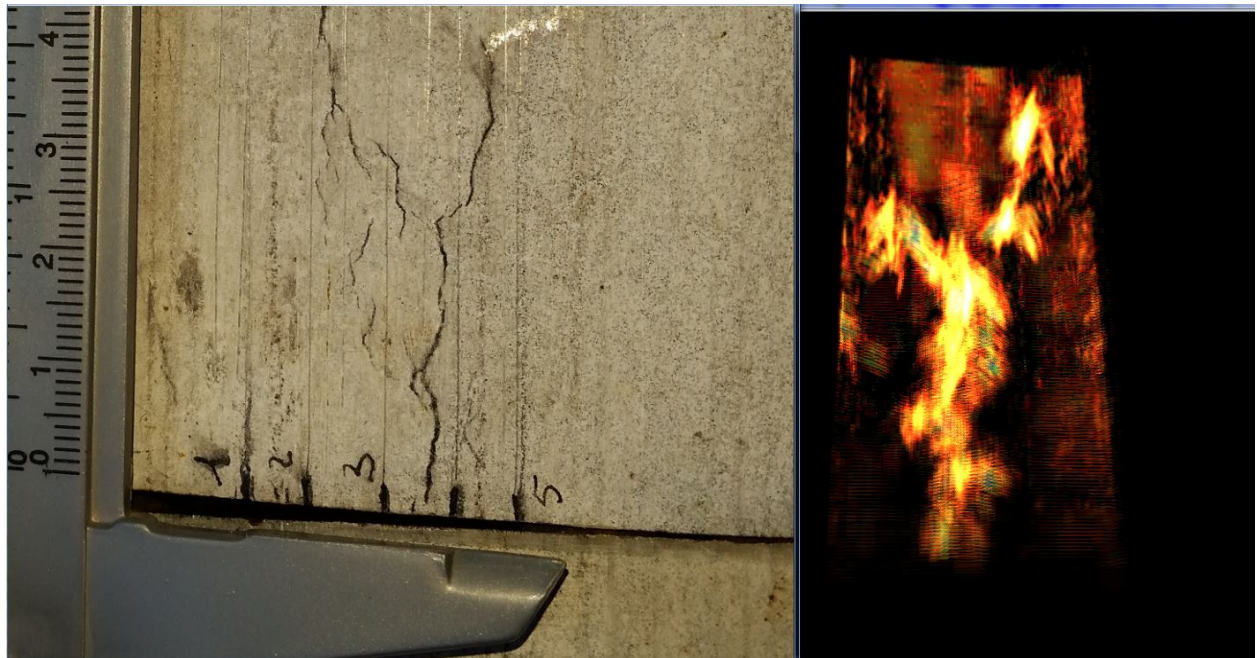
Below is the same set of cracks with a top view of the 3D imaging.

Figure 106. Mosaic image of C-scan representation over pipe sample photos

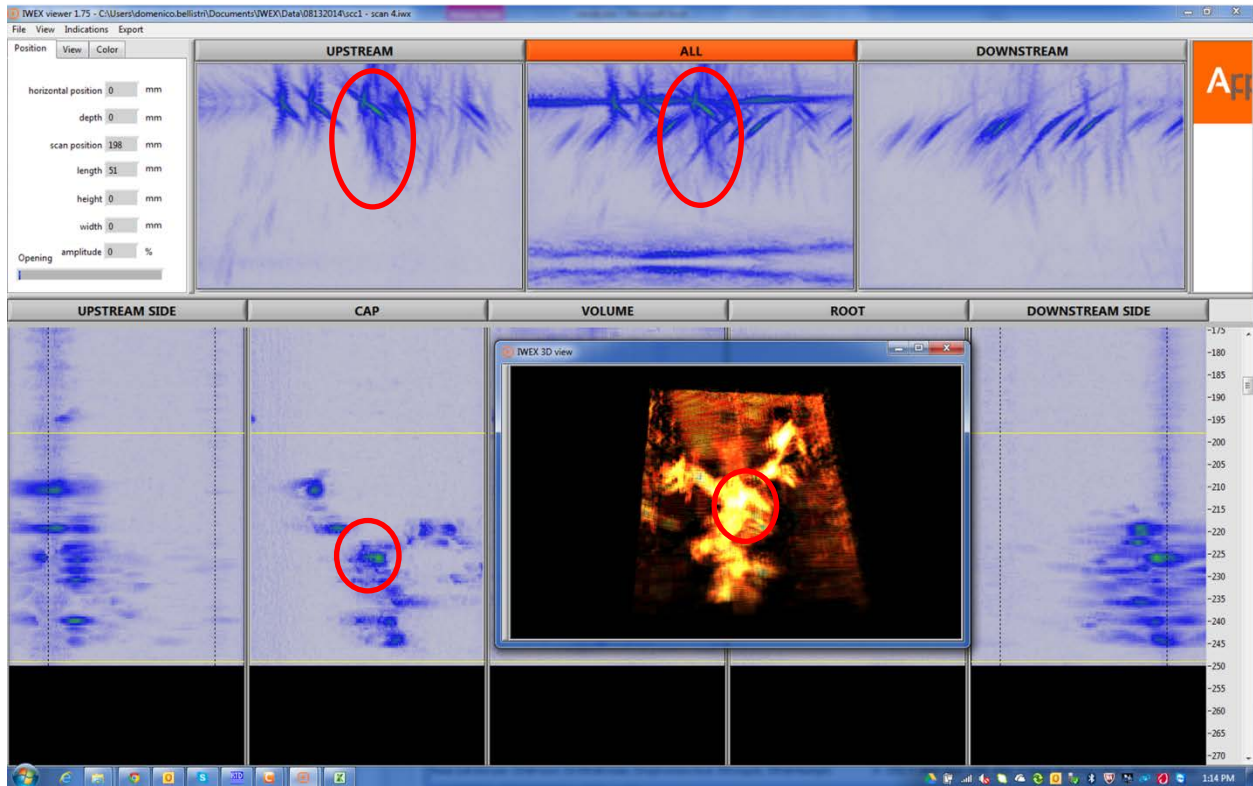
Figure 107. IWEX display

In this view we have several cracks in the image and it appears we can see a crack that is deeper than the rest. Once we display this in 3D it is easier to see the location of the deepest flaw.

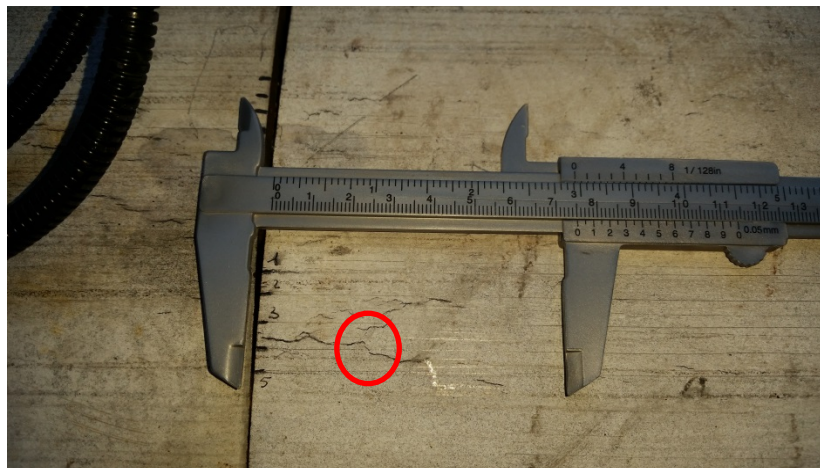
Figure 108. Image of cracking in sample

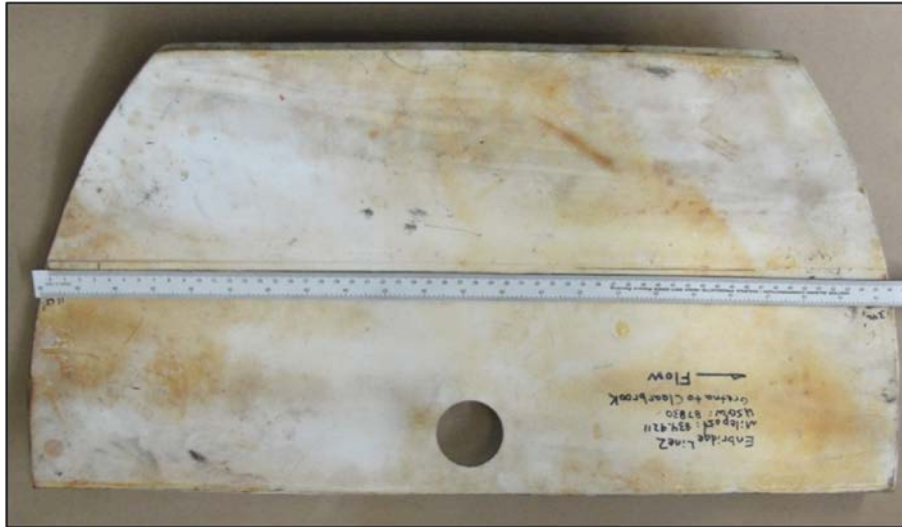
The coupon was given to Applus RTD Canada and shipped to Houston, and subsequently Columbus for inspection. One 120 mm long anomaly was visible on the ID surface. The initial IWEX inspection performed showed four anomalies. A picture of the coupon is shown in Figure 109 below. A raised seam showing a trim was present on the ID and OD typical of A.O. Smith flash welded pipe.

Figure 109. A 26-in diameter coupon with visible flaw on the ID seam weld

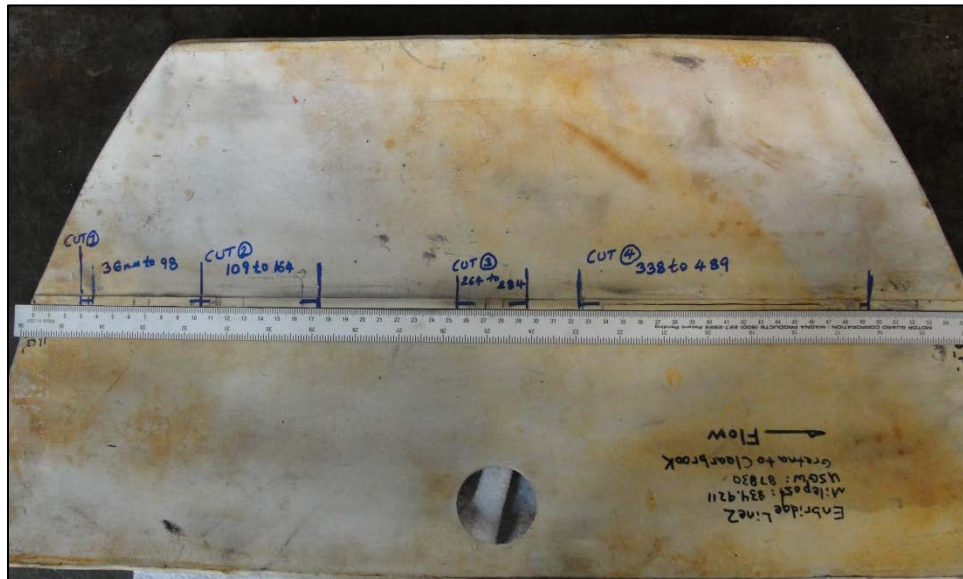
Figure 110. The 26-in diameter coupon with markings showing locations of the flaws

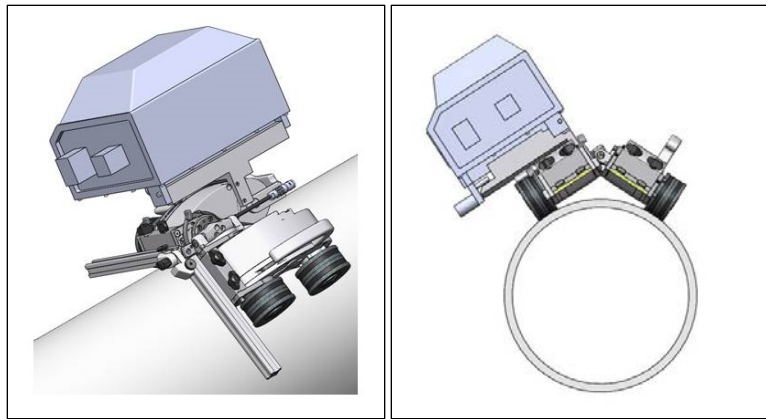
Figure 116. Magnetic wheeled scanner

The re-design work of the so called "Navic" scanner has run into issues which appear to be beyond the operation capabilities (and design) of this unit. This largely has to do with the weight of the IWEX- Imager at 17-lbs and its intended operational use in the field, at or near the 3:00 and 9:00 clock positions. The scanner is not able to maintain its position in longitudinal direction and droops down.

As shown in the above images, the Imager sits on one half of the scanner with two magnetic wheels. The hinge takes care of keeping the magnetic wheels in contact with the pipe surface and it also allows it to operate at different pipe diameters. The magnetic force/contact area cannot be further increased.

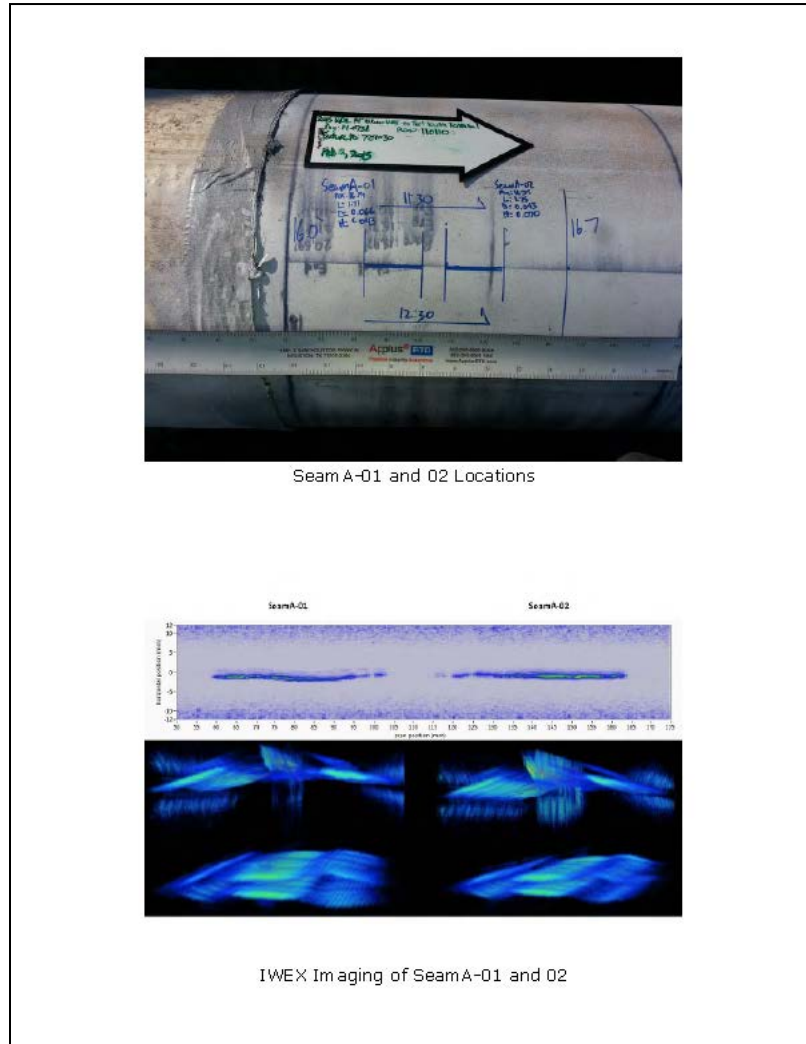
The results from these scans showed that only IWEX was used to find the Seam A-01 and Seam A-02 as shown in Figure 123, Phased Array (PA) and TOFD were not scanned at their location. Seam A-03 and Seam A-04 were found with IWEX, PA, and TOFD, and are shown in Figure 124 and Figure 125. The target anomaly for the project was found and correlated to Seam A-03. Pressure containing sleeves were used to repair the pipe.

Figure 123. Pipe location and IWEX imaging of SeamA-01 and 02

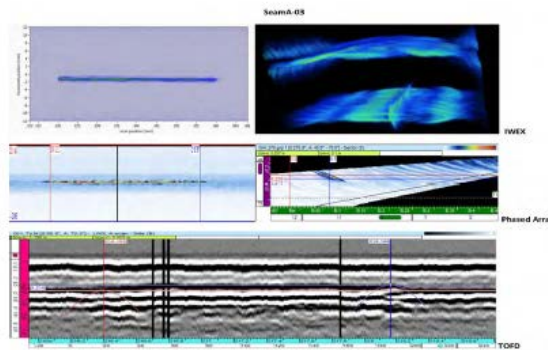
IWEX/Phased Array/TOFD Imaging of SeamA-03

Figure 124. Pipe location and IWEX/Phased Array/TOFD imaging of SeamA-03

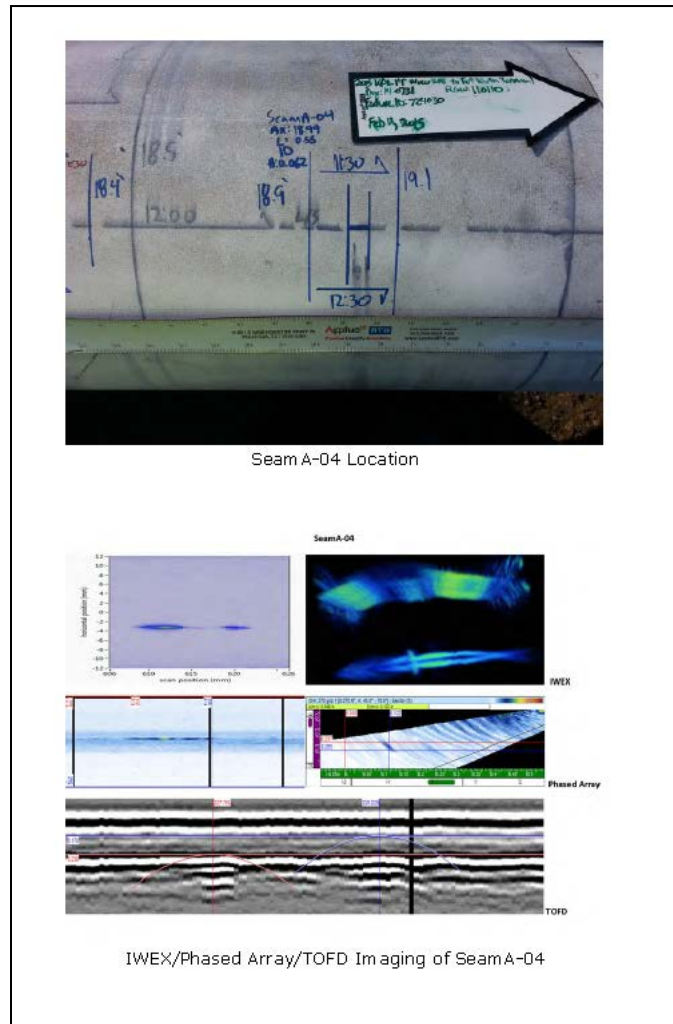
Figure 125. Pipe location and IWEX/Phased Array/TOFD imaging of SeamA-04
