Interim Report for Phase II – Task 2 of the Comprehensive Study to Understand Longitudinal ERW Seam Failures

“Pipe Inventory, Inspection by In-The-Ditch Methods and In-Line
Inspection, and Hydrostatic Tests - a Continuation of Phase 1,
Task 2”

Phase II, Tasks 2.1-2.11

Inspection by In-The-Ditch Methods and
In-Line Inspection, and Hydrostatic Tests
DTPH56-11-T-000003

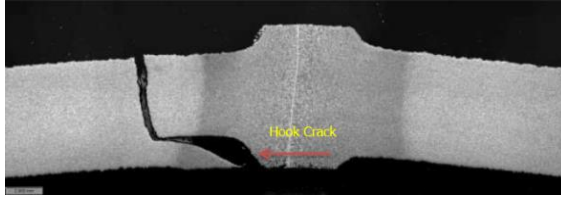
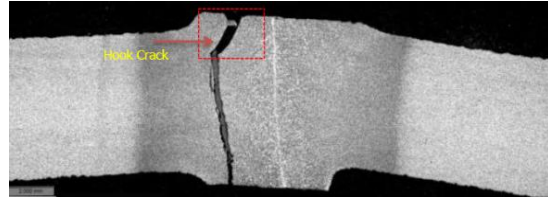
Anomaly #9
(2.64" long, 33.7% NWT deep)

Anomaly #10-1
(1.14" long, 31.8% NWT deep)

Figure 5: The Two Seam Cracks That Went Undetected by at Least One EMAT Tool Despite being within Tool Detection Specifications (Notice heavy and uneven flash, which adds unusual complexity for ILI.)

Despite the complication of varying flash thickness, EMAT technologies today are still capable of finding seam cracks when large enough. This is exemplified when comparing detected hook cracks #15 and #19 to undetected hook cracks #9 and #10-1, which were in the same uneven trim but were slightly smaller. Anomaly #19 was 14% deeper and actually slightly shorter than #9, yet was successfully detected. Anomaly #15 was the same depth as #10-1 but was 2.54" longer, which made the difference between being detected and not. Cross sections of these anomalies are shown in Figure 5 and Figure 6 for comparison. In order to conclude a minimum crack depth and length for ILI to reliably detect within uneven flash thicknesses, substantially more samples would be required than these four. In the interim it is recommended to work with the ILI providers directly as they may have past case studies with equivalent flash thicknesses, ID/OD misalignment, and indication types as the pipeline in question.

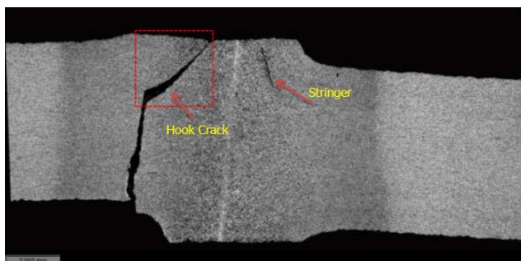
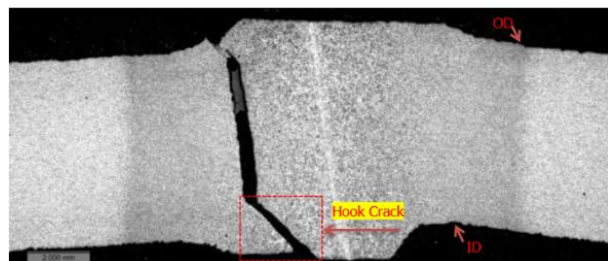
Anomaly #19
(2.30" long, 47.6% NWT deep)

Anomaly #15
(3.68" long, 31.8% NWT deep)

Figure 6: Two Example Seam Cracks That Were Detected by Both EMAT Tools

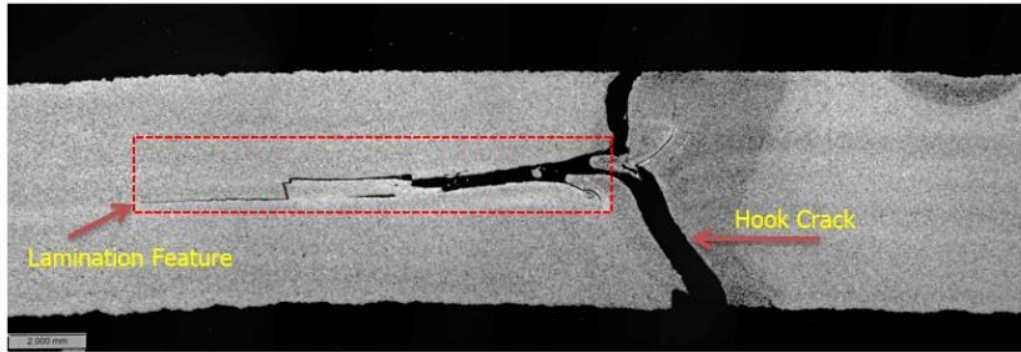
- EMAT ILI has the capability to size even complex features relatively well despite other anomalies in the same region. In the case of joint 16-36 with long laminations overlapping hook cracks, both service providers successfully detected and sized these anomalies above expectation especially with lamination detection excluded from tool specifications for pipe seams. Refer to Figure 7 for an example cross section and Figure 8 for a depth profile. Sizing details for these cracks are provided in Table 5 and are denoted with an asterisk (*). Discussions around Figure 5 and Figure 6 showcase the limitations of this capability.

Figure 7: Anomaly #3 in Joint 16-36, Which Showcases the Complex Lamination/Hook Crack Combination (EMAT was Still Capable of Sizing the Hook Crack.)

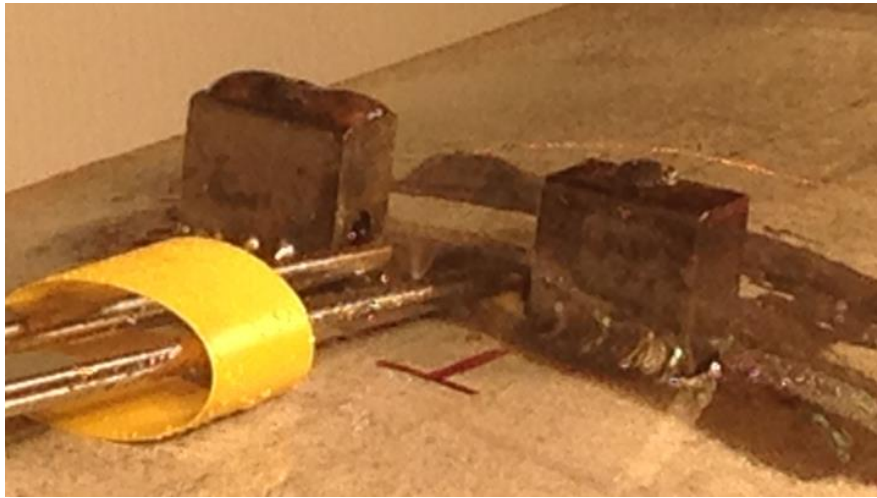
The 2016 hydrotest of this one joint, 16-37, began to leak at 820 psi at the previously identified feature #1. The initial leak was minimal; at the initiation the pressure immediately decreased 8 psi before the next pump's stroke increased pressure. It was only by visual observation moments afterwards was the leak recognized, as shown in Figure 19.

Figure 19: Feature #1 Shortly after Leak Initiation at 125%SMYS

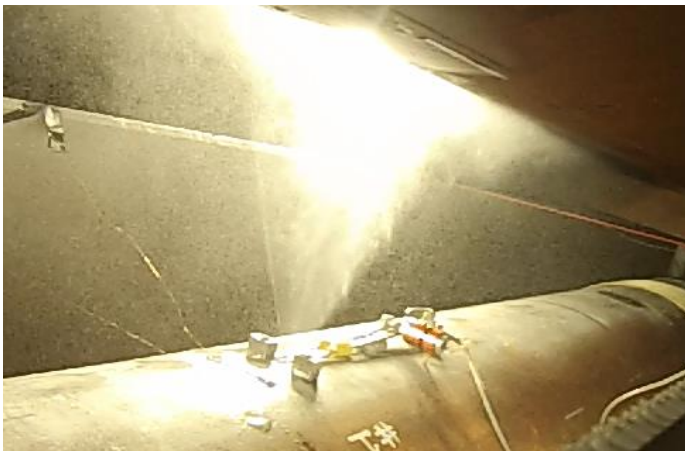
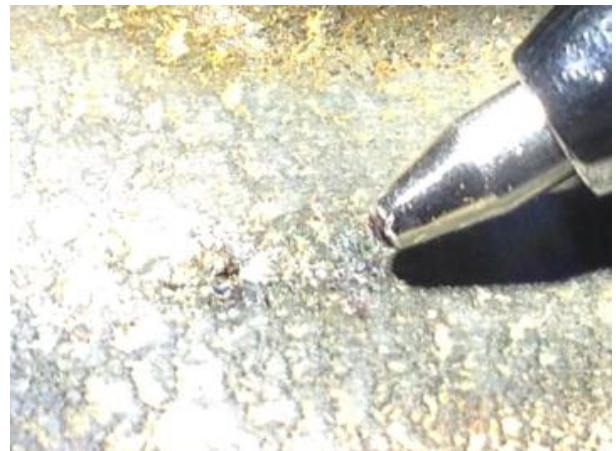
While leaking, pressure was then increased to 1420 psi (125% SMYS). The joint continued to leak but remained otherwise intact. At this point the test was terminated as

the leak rate met the pump's capacity and vessel pressure could no longer be increased. Crack opening displacement and pipe pressure measurements indicated that the crack began to reseal around 550 psi. Figure 20 shows the resealed crack in comparison to moments before at the maximum test pressure. Pressure-volume plots suggest the joint did not yield leading up to the leak.

Figure 20: Feature #1 Leaking While Pipe at Approximately 1420 psi (left) and Then Shown after De-pressurized (right)

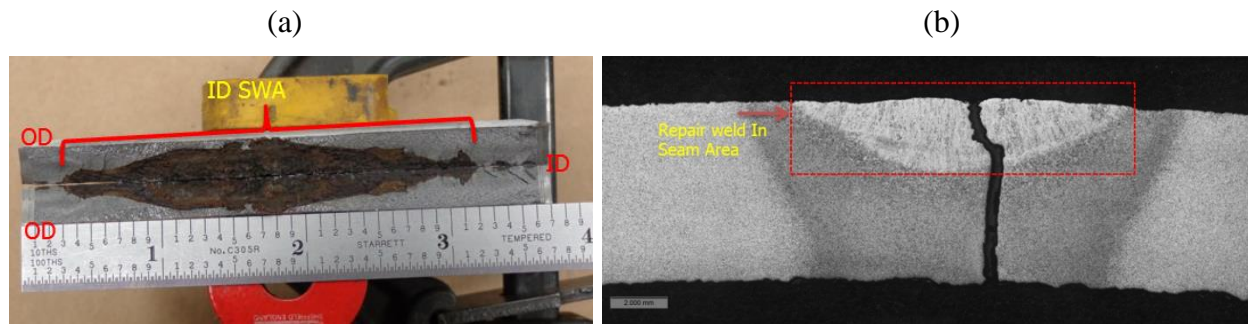
Per the latest in-the-ditch-methods this flaw was characterized as a 2.83” long, 92% deep cold weld before the burst test. Post testing the specimen underwent metallography (Figure 21) to determine actual size of the initial crack, and it exposed a 2.97” long, 99% deep cold weld. The metallurgical section (Figure 21-b) also revealed indications of a repair weld and no subsequent heat treatment. Historic records suggest this repair weld may have been conducted at the mill as nothing was found that may indicate post-construction repair in the ditch. The operator’s inspection records have no notations of coating repair, and photos of the pipe prior to the coating removal appeared to show coal tar coating consistent with the original coating. Interestingly, one EMAT service provider also noted a permeability change co-incident with this anomaly.

Figure 21: Anomaly 1 Fracture Surface (a) and Cross Section at the Deepest Point (b)

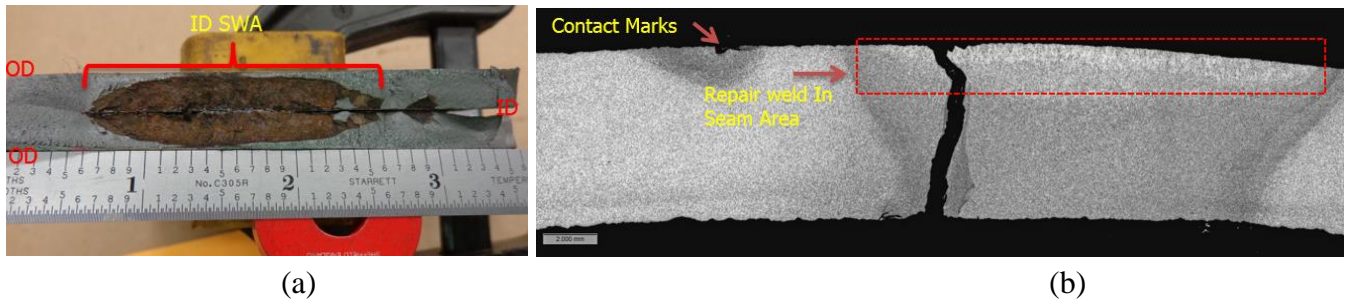
Per the latest ITDM this flaw was characterized as a 1.2" long, 81% deep OD cold weld before burst testing. Post testing the specimen underwent metallography to determine actual size of the initial crack. Freeze and break methods revealed a cold weld 2.00" long, 92% deep as shown in Figure 24 and Figure 25. Similar to Anomaly #1, a repair weld with no post weld heat treatment was observed. Again, one EMAT service provider also noted a permeability change co-incident with this anomaly.

Figure 24: Anomaly 2 Fracture Surface (a) and Cross Section at the Deepest Point (b)

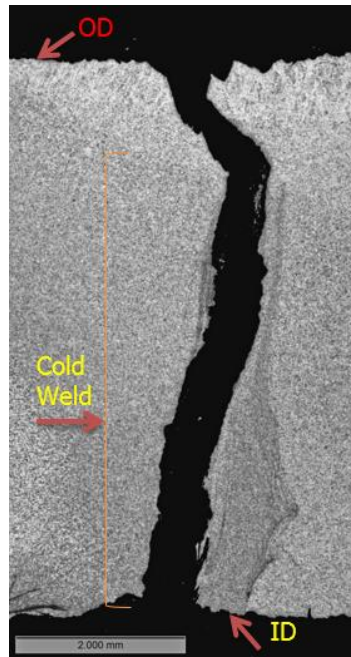
Figure 25: Cross Section at Deepest Point of #2 at 25X Magnification

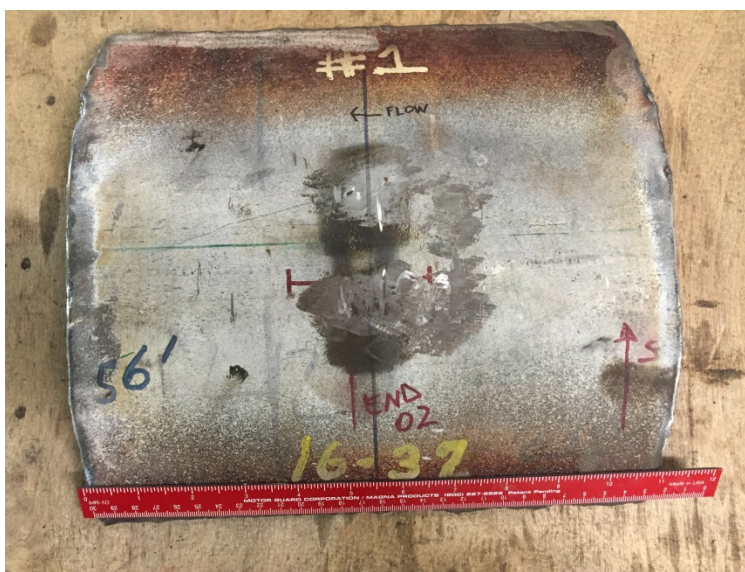
Figure 3. Break location marked on SWA #1

SWA #1: SWA #1 was located on Pipe #16-37. Metallographic examination revealed this SWA to be a cold weld. Metallographic cross sections also revealed the presence of a repair weld (possibly a mill repair) in the seam weld area. Figure 3 shows the pipe marked in preparation for the fractographic specimens. Figure 4 through Figure 6 show the metallographic, metallurgical, and fractographic results. The anomaly location details along with details of ILI and IWEX reported anomalies are presented in Figure 7.

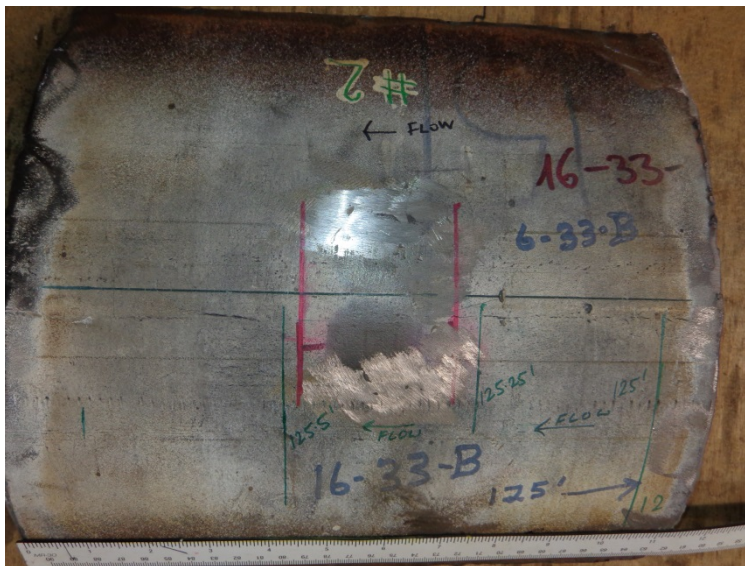
Figure 8. Break location marked on SWA #2.

SWA #2: SWA #2 was located on Pipe #16-33. Metallographic examination revealed this SWA to be a cold weld. Metallographic cross sections also revealed the presence of a repair weld (possibly a mill repair) in the seam weld area. Figure 8 shows the pipe marked in preparation for the fractography specimens. Figure 9 through Figure 11 show the metallographic, metallurgical, and fractographic results. An ID SWA can be seen in the picture on the right in Figure 9. The anomaly location details along with details of ILI and IWEX reported anomalies are presented in Figure 12.

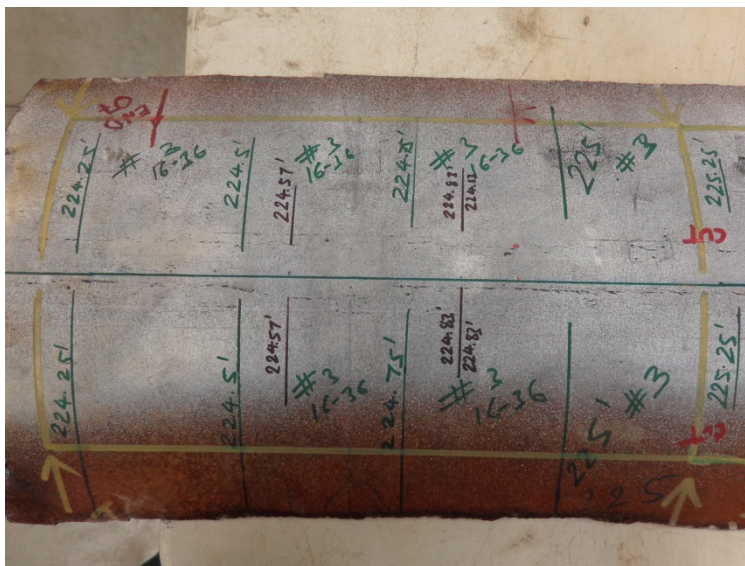
Figure 13. Break location marked on SWA #3

SWA #3: SWA #3 was located on Pipe #16-36. Metallographic examination revealed this SWA to be a hook crack. A metallographic cross section also revealed the presence of a near mid-wall lamination feature in SWA #3. The presence of a lamination feature connected to the hook crack suggests that this hook crack was formed due to the lamination feature disturbing the seam in the electric resistance weld (ERW) process. Figure 13 shows the pipe marked in preparation for the fractography specimens. Figure 14 through Figure 16 show the metallographic, metallurgical, and fractographic results. The anomaly location details along with details of ILI and IWEX reported anomalies are presented as the feature in Pipe 16-36.

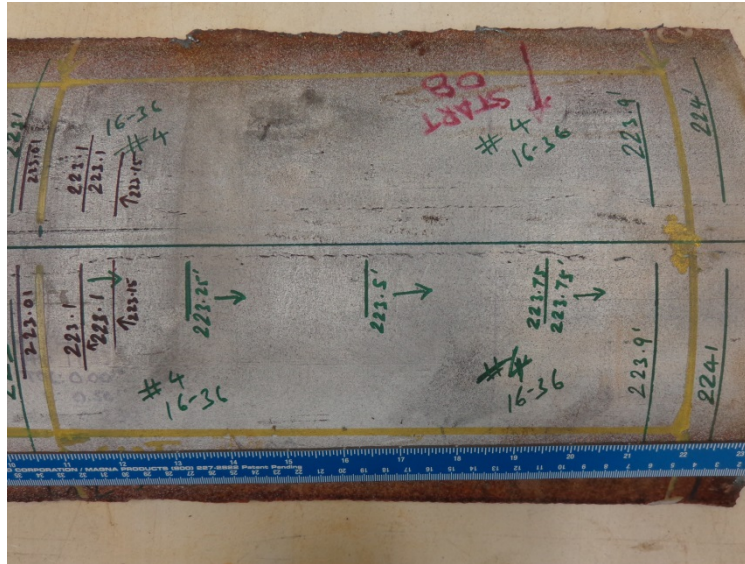
Figure 17. Break location marked on SWA #4

SWA #4: SWA #4 was located on Pipe #16-36. Metallographic examination revealed this SWA to be a hook crack. Similar to SWA#3, the presence of a lamination feature connected to the hook crack suggests that this hook crack was formed due to the lamination feature disturbing the seam in the ERW process. Figure 17 shows the pipe marked in preparation for the fractography specimens and Figure 18 shows the fractographic results. An ID SWA can be seen in the picture on the right side. The anomaly location details along with details of ILI and IWEX reported anomalies are presented as the feature in Pipe 16-36.

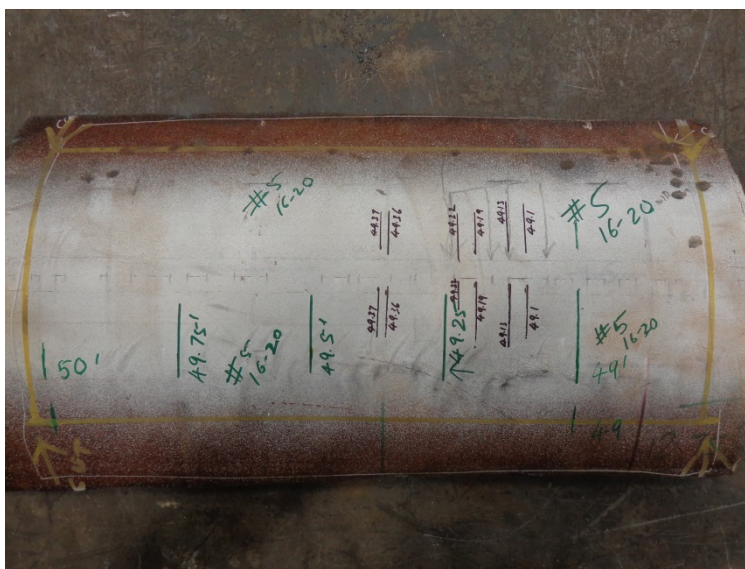
Figure 19. Break location marked on SWA #5

SWA #5: SWA #5 was located on Pipe #16-20. Metallographic examination revealed this SWA to be a cold weld. Figure 19 shows the pipe marked in preparation for the fractography specimens and Figure 20 through Figure 22 show the fractographic results. An ID SWA can be seen in the picture on the right side. The scanning electron microscope (SEM) images (Figure 23 through Figure 25) of the intact material between the surface breaking feature and non-surface breaking feature on SWA #5-3 showed characteristics of cleavage fracture suggesting the presence of intact material between the features. The anomaly location details along with details of ILI and IWEX reported anomalies are presented in Figure 28. Two OD anomalies were grouped for comparison to the ILI since they were less than an inch apart. However, the combined length of the two anomalies is less than most ILI tool specifications.

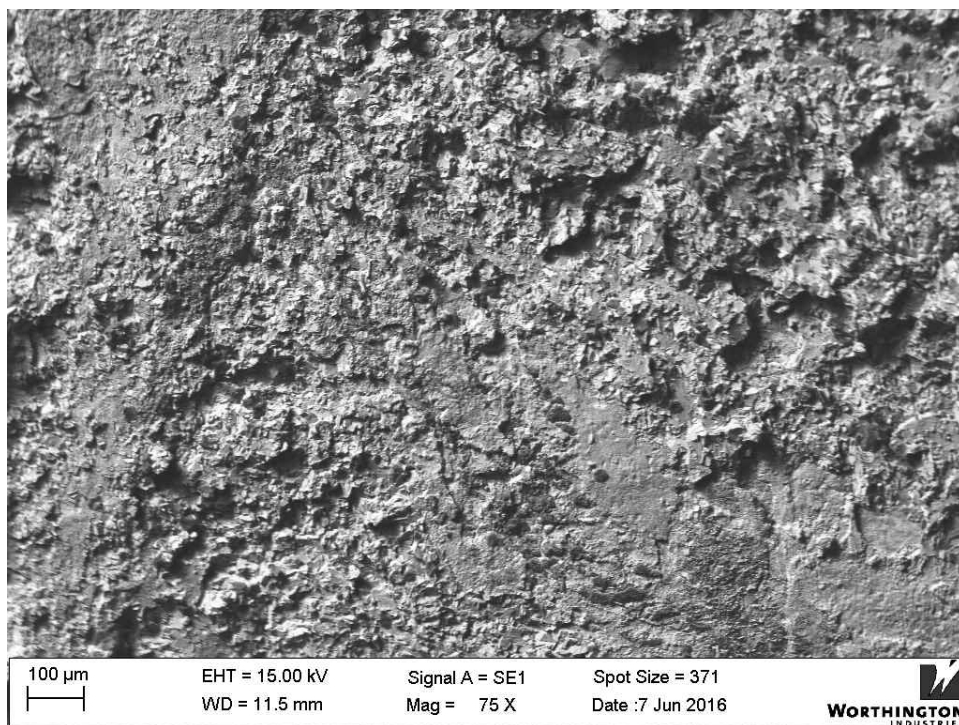
Figure 24. SEM image of intact material between cold weld features; SWA #5-3 to confirm if the surface breaking feature is connected to the non-surface breaking feature.

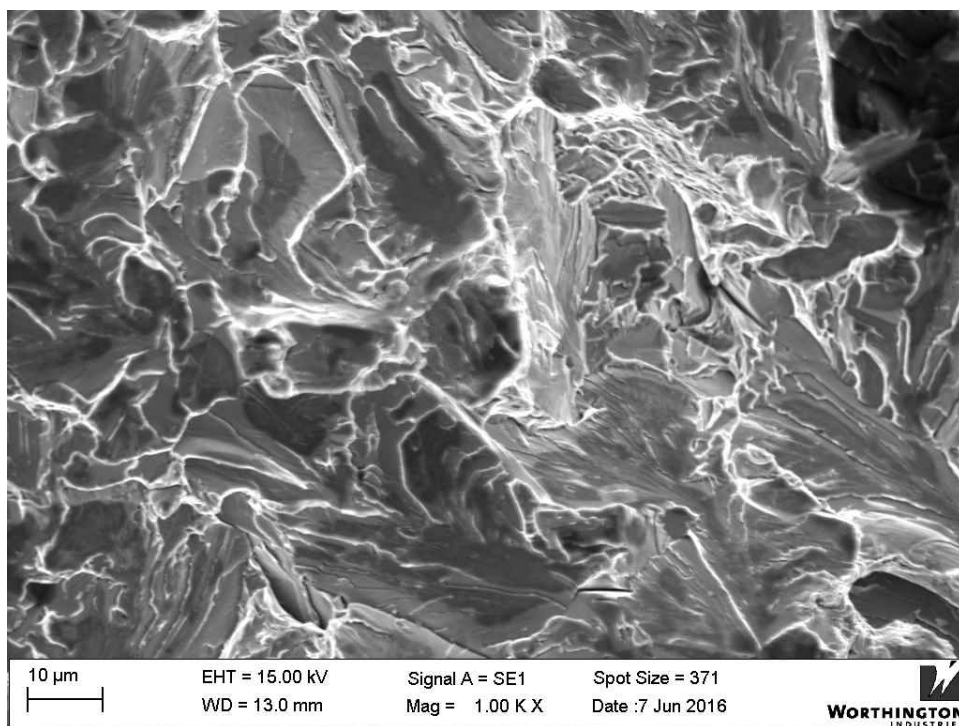
Figure 25. SEM image of non-surface breaking part of cold weld feature; SWA #5-3

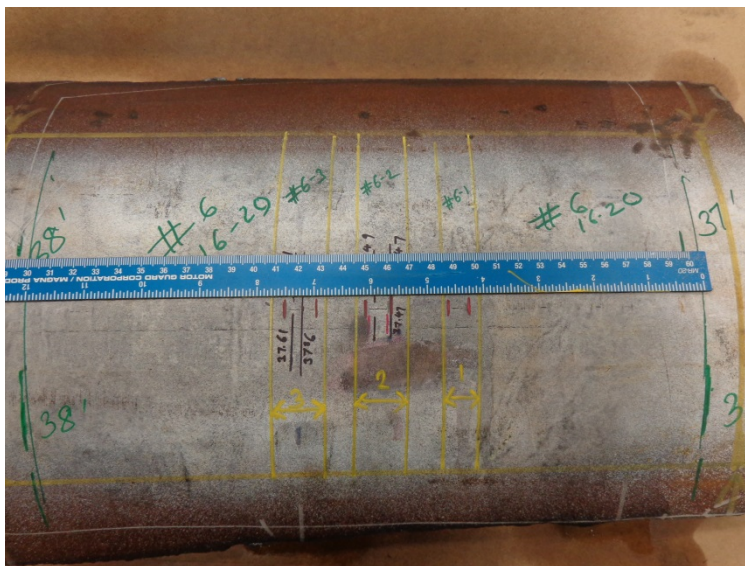
Figure 29. Break location marked on SWA #6

SWA #6: SWA #6 was located on Pipe #16-20. Metallographic examination revealed this SWA to be a cold weld. Figure 29 shows the pipe marked in preparation for the fractography specimens and Figure 30 and Figure 31 show the fractographic results. An ID SWA can be seen in the pictures on the right side. The metallographic images in Figure 32 and Figure 33 show the extent of the cold weld. The anomaly location details along with details of ILI and IWEX reported anomalies are presented in Figure 34. The two ID anomalies were grouped for comparison to ILI since they were less than an inch apart. However, the combined length of the two anomalies is less than most ILI tool specifications.

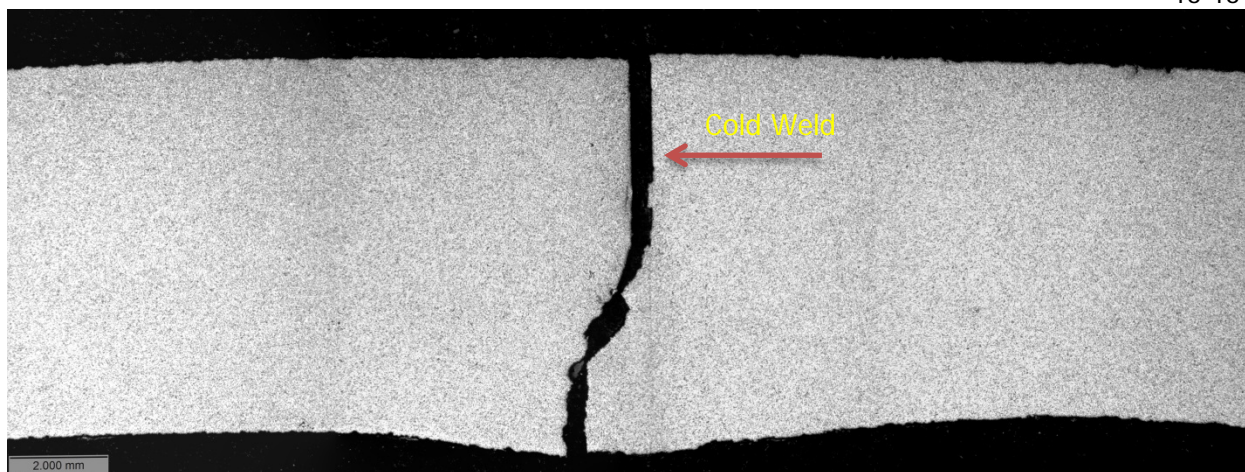
Figure 32. SWA #6-1, metallographic image of the larger cold weld 12.5X

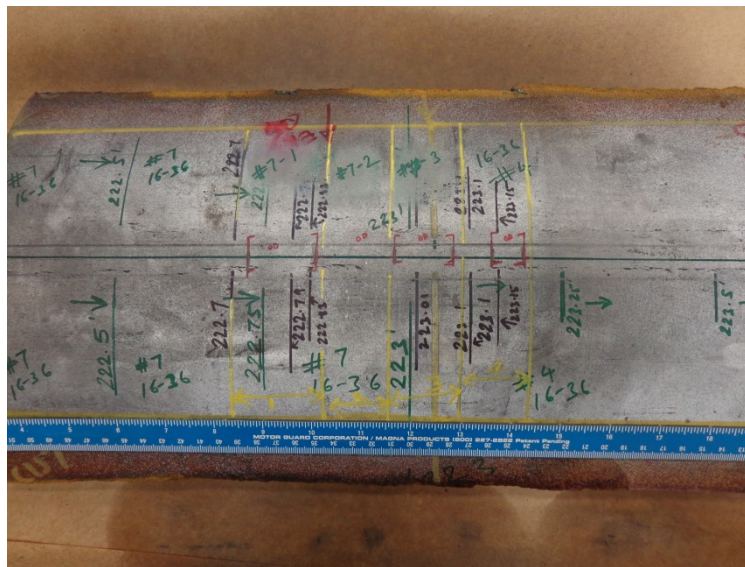
Figure 35. Break location marked on SWA #7

SWA #7: SWA #7 was located on Pipe #16-36. Metallographic examination revealed this SWA to be a hook crack. A metallographic cross section also revealed the presence of a near mid-wall lamination feature in SWA #7. The presence of a lamination feature connected to the hook crack suggests that this hook crack was formed due to the lamination feature disturbing the seam in the ERW process. A metallographic section for SWA #7 was cut before performing fractography to obtain an intact seam metallographic cross section. SWA #7 was divided into three break sections to achieve a full anomaly profile. Figure 35 shows the pipe marked in preparation for the fractography specimens and Figure 36 through Figure 38 show the fractographic results. An ID SWA can be seen in the pictures on the right side.

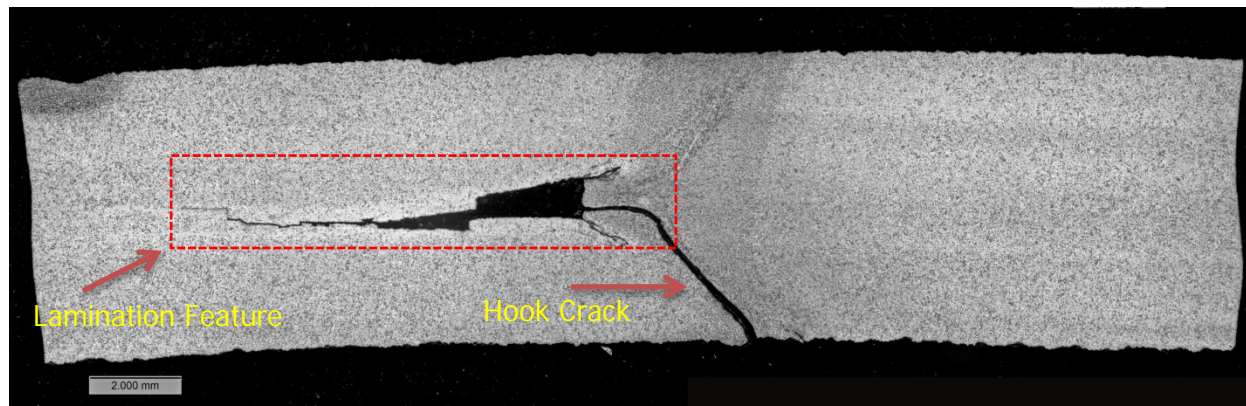
Figure 42. SWA #7, metallographic image 12.5X

The metallographic images in Figure 42 and Figure 43 show the hook crack and lamination features. The anomaly location details along with details of ILI and IWEX reported anomalies are presented with Pipe 16-36 shown in Figure 2.

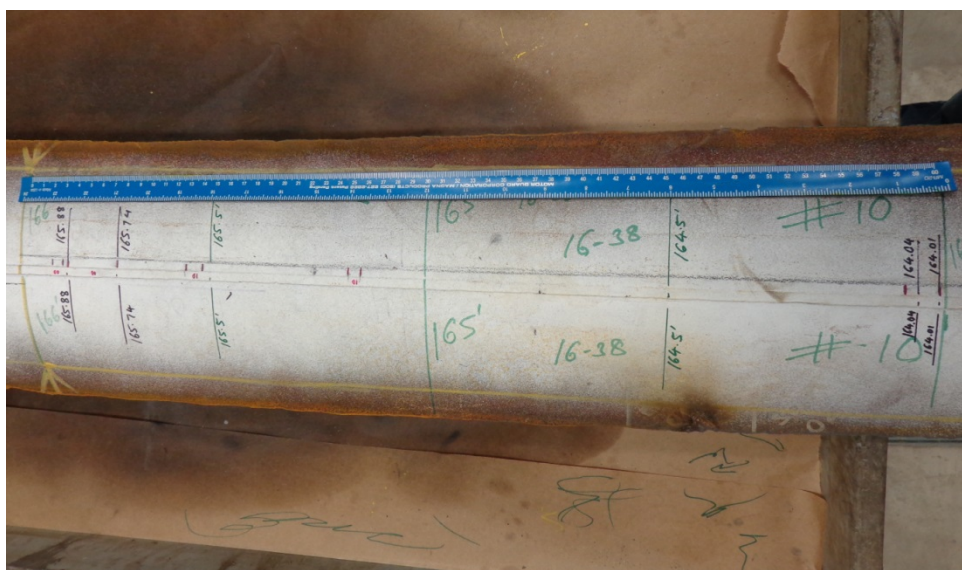
Figure 44. Break location marked on SWA #8

SWA #8: SWA #8 was located on Pipe #16-38. Metallographic examination revealed this SWA to be a mid-wall stringer as shown in the metallographic cross section. Figure 44 shows the pipe marked in preparation for the fractography specimens and Figure 45 shows the fractographic results; a midwall SWA as can be seen in the picture on the right side.

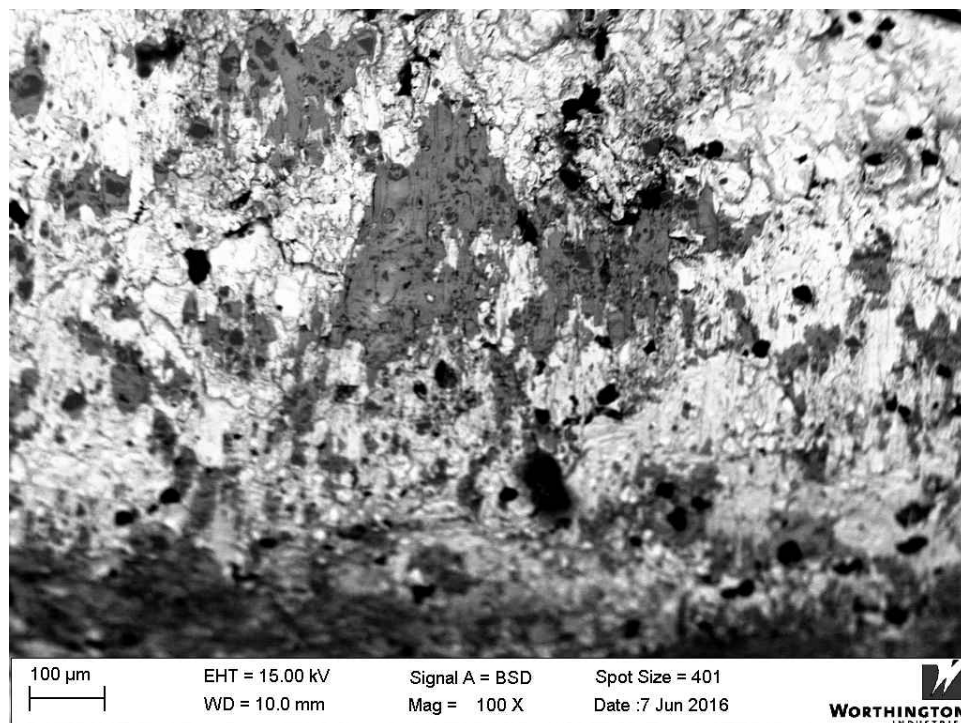
Figure 48. SEM image (100X) of mid-wall feature on SWA #8-1

The SEM image in Figure 47 and Figure 48 shows the midwall feature at 25X and 100X. EDS was performed to confirm presence of nonmetallic impurities that that may have contributed to the development of crack like features. EDS of the mid-wall feature on SWA #8 detected high levels of aluminum and silica as can be seen in Figure 49.

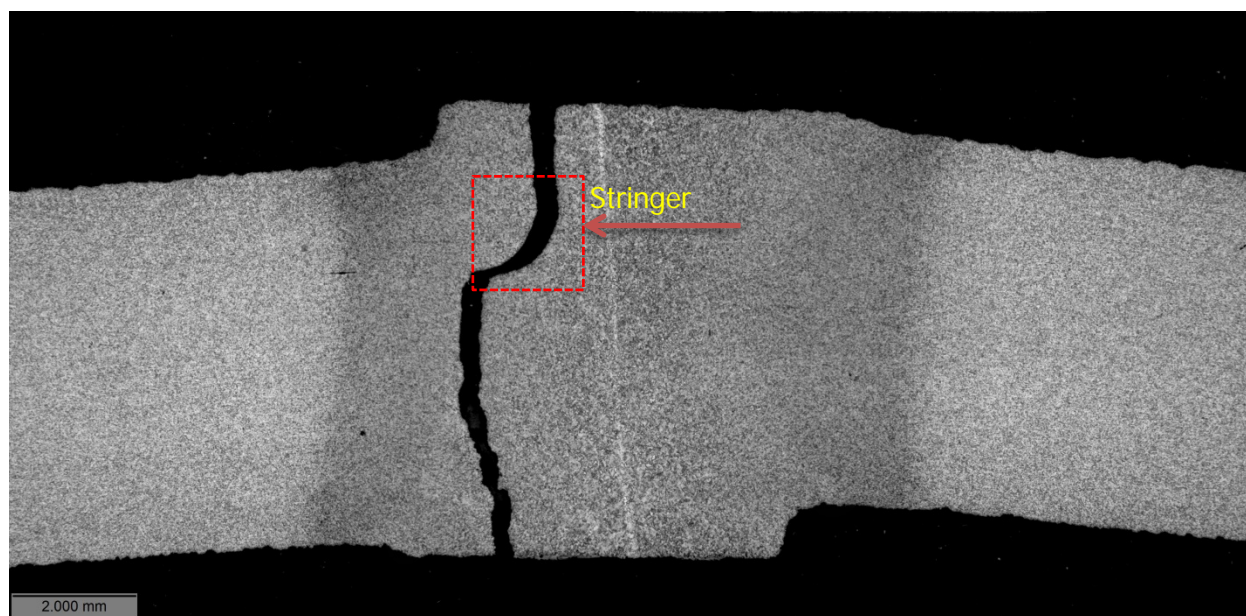
Figure 50. SWA #8-1, metallographic image 12.5X

The metallographic images in Figure 50 and Figure 51 show the hook crack and lamination features. The anomaly location details along with details of ILI and IWEX reported anomalies are presented in Figure 52. Note that additional anomalies were detected by IWEX, however these did not break in the anomaly when tested. Since they had very short length, metallographic cross section was not attempted.

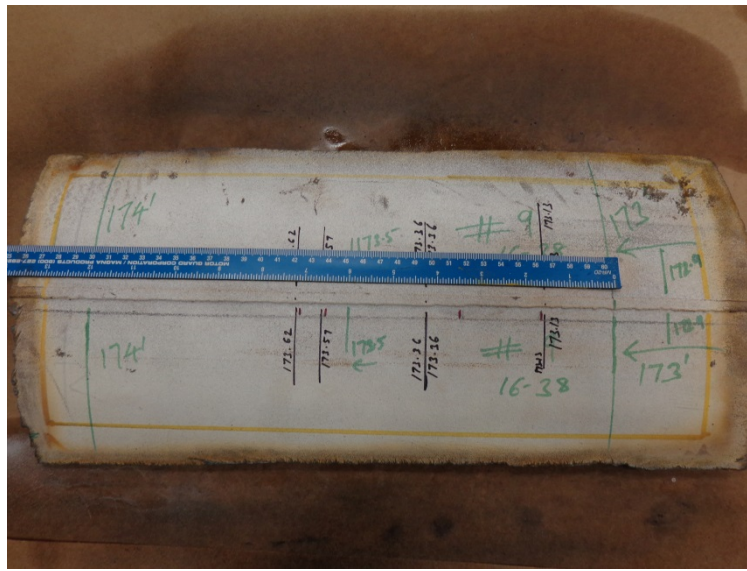
Figure 53. Break location marked on SWA #9

SWA #9: SWA #9 was located on Pipe #16-38. Metallographic examination revealed this SWA to be a hook crack. Figure 53 shows the pipe marked in preparation for the fractography specimens and Figure 54 shows the fractographic results. A hook crack can be seen in the picture on the right side. The metallographic images in Figure 55 and Figure 56 show the hook crack. The anomaly location details along with details of ILI and IWEX reported anomalies are presented in Figure 57.

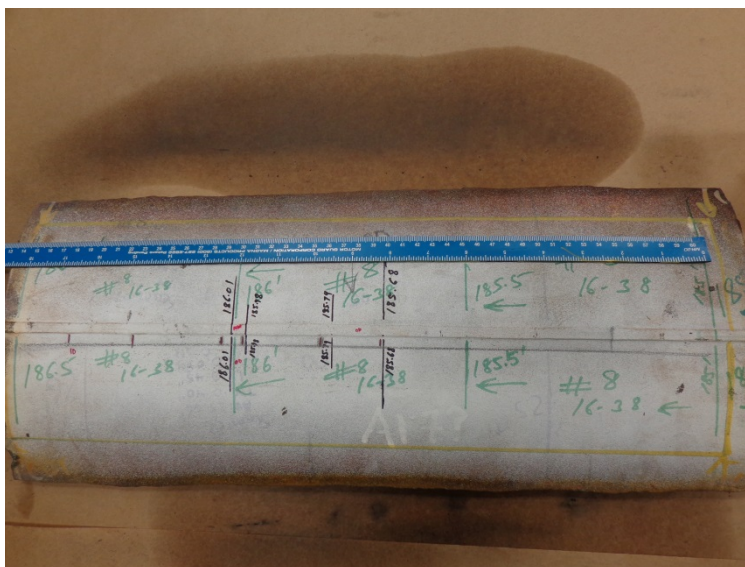
Figure 58. Break location marked on SWA #10

SWA #10: SWA #10 was located on Pipe #16-38. Metallographic examination revealed this SWA to be multiple hook cracks. Figure 58 shows the pipe marked in preparation for the fractography specimens and Figure 59 through Figure 61 show the fractographic results. A hook crack can be seen in the picture on the right side. The metallographic images in Figure 62 and Figure 63 show the hook cracks. The anomaly location details along with details of ILI and IWEX reported anomalies are presented in Figure 64.

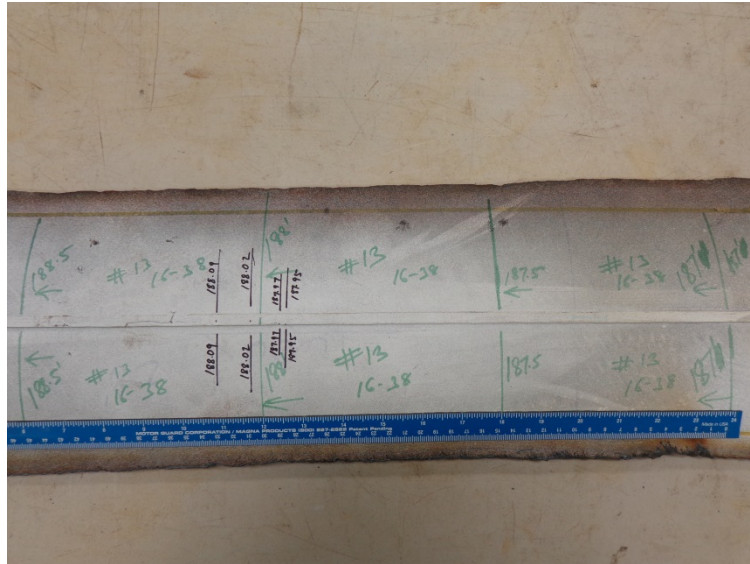
Figure 65. Break location marked on SWA #13

SWA #13: SWA #13 was located on Pipe #16-38. Metallographic examination revealed this SWA to be a non-surface breaking stringer and cold weld. Figure 65 shows the pipe marked in preparation for the fractography specimens and Figure 66 shows the fractographic results. A stringer can be seen in the picture on the right side. The metallographic image in Figure 67 shows the stringer. The anomaly location details along with details of ILI and IWEX reported anomalies are presented in Figure 68. The ILI tools appeared to conservatively group the largest anomaly by area with one 2.3 inches away.

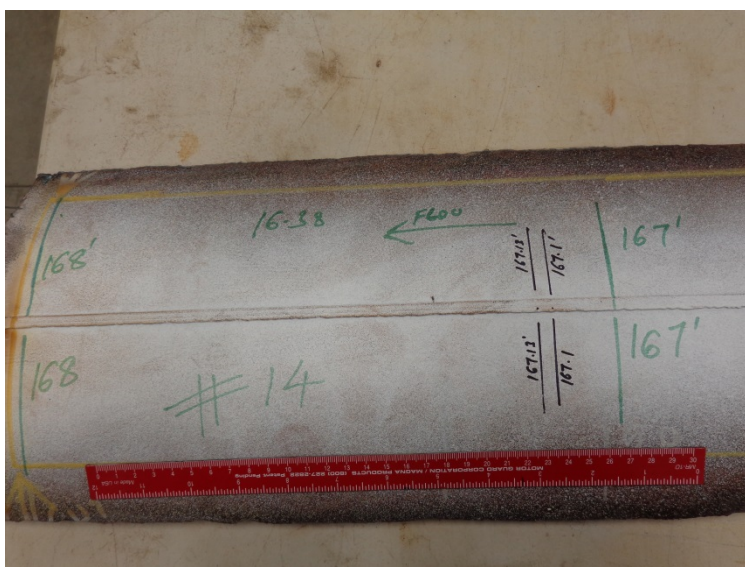
Figure 69. Break location marked on SWA #14

SWA #14: SWA #14 was located on Pipe #16-38. Metallographic examination revealed this SWA to be a stringer. A metallographic cross section shows the presence of a mid-wall stringer. Figure 69 shows the pipe marked in preparation for the fractography specimens and Figure 70 shows the fractographic results; a stringer can be seen in the picture on the right. The metallographic image in Figure 71 and Figure 72 shows the stringer. This anomaly was below the detection threshold of both ILI tools and no anomalies were reported.

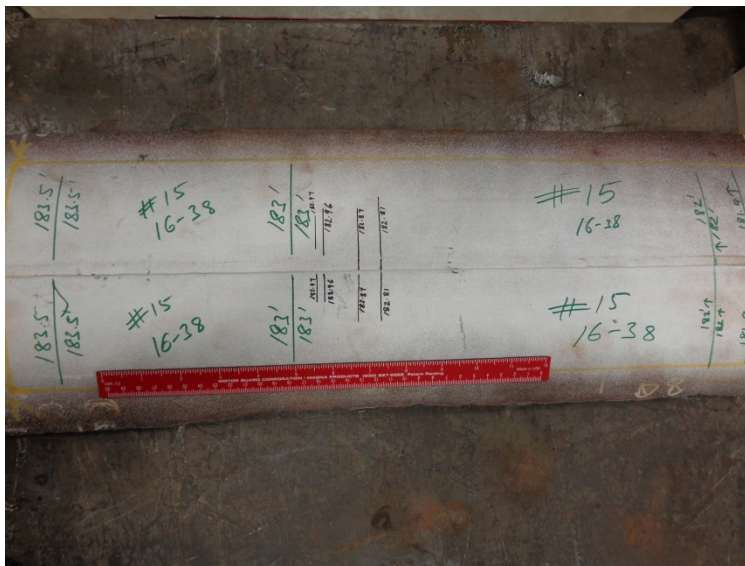
Figure 73. Break location marked on SWA #15

SWA #15: SWA #15 was located on Pipe #16-38. Metallographic examination revealed this SWA to be a hook crack. Figure 73 shows the pipe marked in preparation for the fractography specimens and Figure 75 shows the fractographic results; a hook crack can be seen in the picture on the right side. The metallographic image in Figure 77 shows the hook crack. The anomaly location details along with details of ILI and IWEX reported anomalies are presented in Figure 78. The ID anomaly and nearby mid-wall anomaly were grouped for comparison to ILI since they were less than an inch apart.

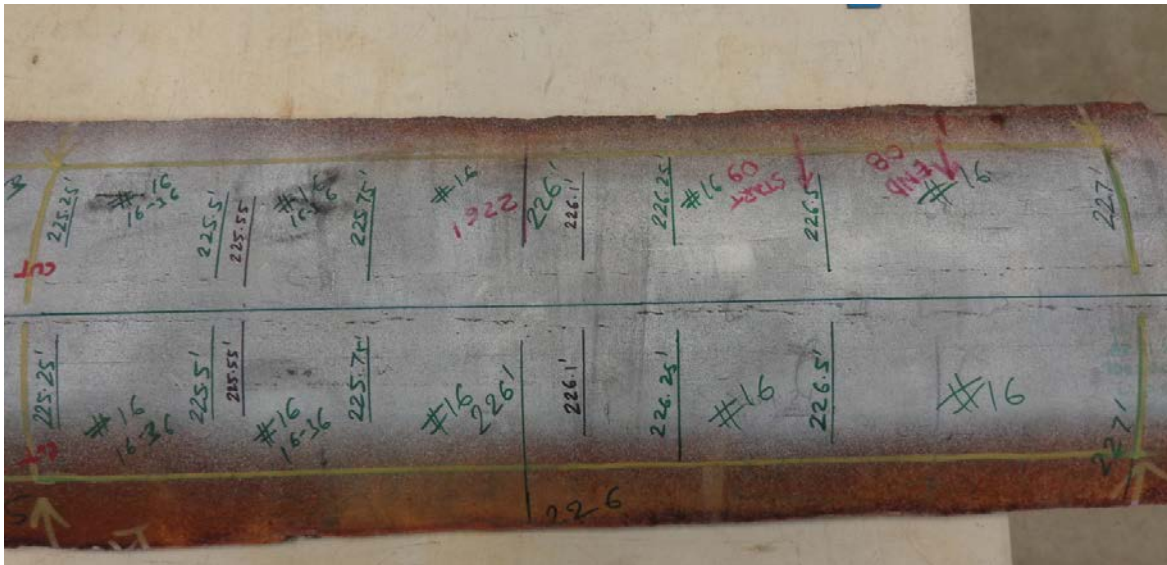
Figure 79. Break location marked on SWA #16

SWA #16: SWA #16 was located on Pipe #16-36. Metallographic examination revealed this SWA to be a hook crack. A metallographic cross section also revealed the presence of a near mid-wall lamination feature in SWA #16. The presence of a lamination feature connected to the hook crack suggests that this hook crack was formed due to the lamination feature disturbing the seam in the ERW process. This feature appears to be connected to SWA# 3, 4, 7 and 18. This feature was divided into two parts (16-1 and 16-2) to acquire a complete feature profile. Two metallographic sections were taken from this SWA. One metallographic section of the intact seam was taken at axial distance of 225.828 feet and after fractography one metallographic section at 225.70 feet axial location was obtained.

Figure 79 shows the pipe marked in preparation for the fractography specimens and Figure 80 though Figure 85 show the metallographic, metallurgical, and fractographic results. The hook cracks that originate at this lamination extend towards the ID and also the OD for a small extent; only the inner hook crack broke to the surface. This location shows an ID connected hook crack as can be seen in the picture on the right side. The anomaly location details along with details of ILI and IWEX reported anomalies are presented as the feature in Pipe 16-36.

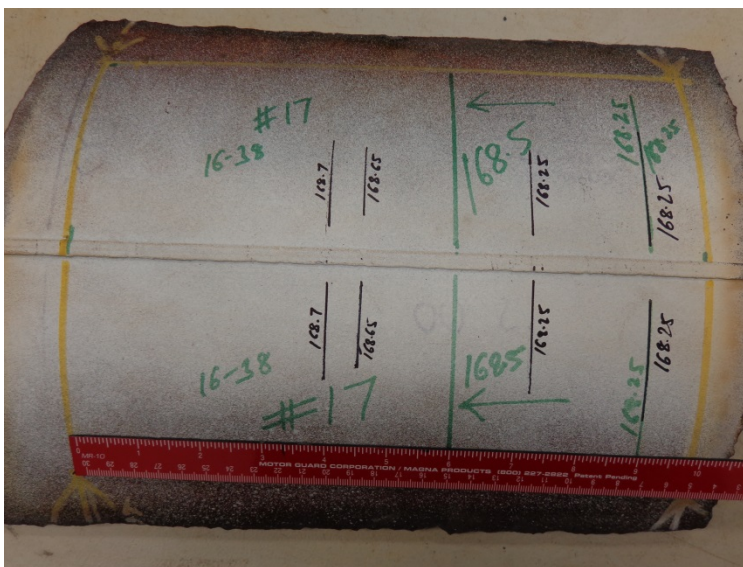
Figure 86. Break location marked on SWA #17

SWA #17: SWA #17 was located on Pipe #16-38. Metallographic examination revealed this SWA to be a hook crack. Figure 86 shows the pipe marked in preparation for the fractography specimens and Figure 87 shows the fractographic results; a hook crack can be seen in the picture on the right side. The anomaly location details along with details of ILI and IWEX reported anomalies are presented in Figure 88.

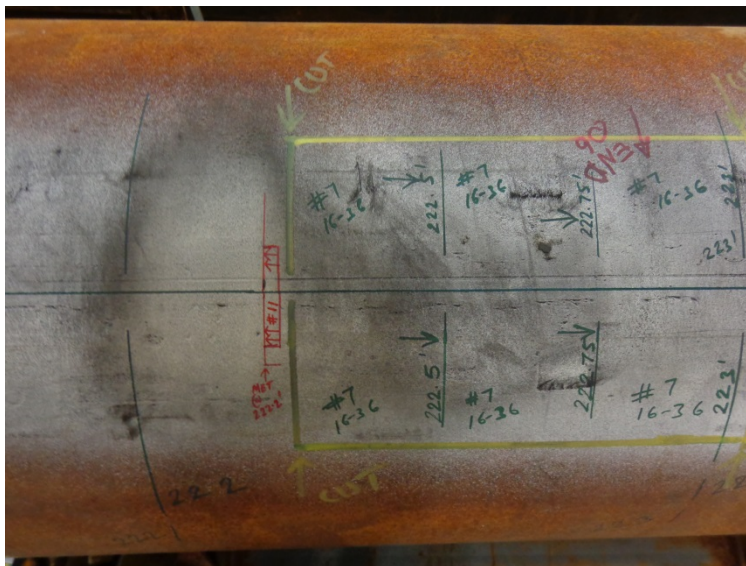
Figure 89. Break location marked on SWA #18

SWA #18: SWA #18 was located on Pipe #16-36. Metallographic examination revealed this SWA to be a mid-wall lamination. A metallographic cross section was taken at 222.2ft axial distance which shows the presence of a near mid-wall lamination. The direction of flow line and the location of the fusion line show that the metal was pushed in towards the void created by lamination during the welding process. Figure 89 shows the pipe marked in preparation for the fractography specimens. Figure 90 and Figure 91 show the metallographic results. This lamination feature is part of one continuous feature which includes SWA #3, 4, 7, 16 and 18.

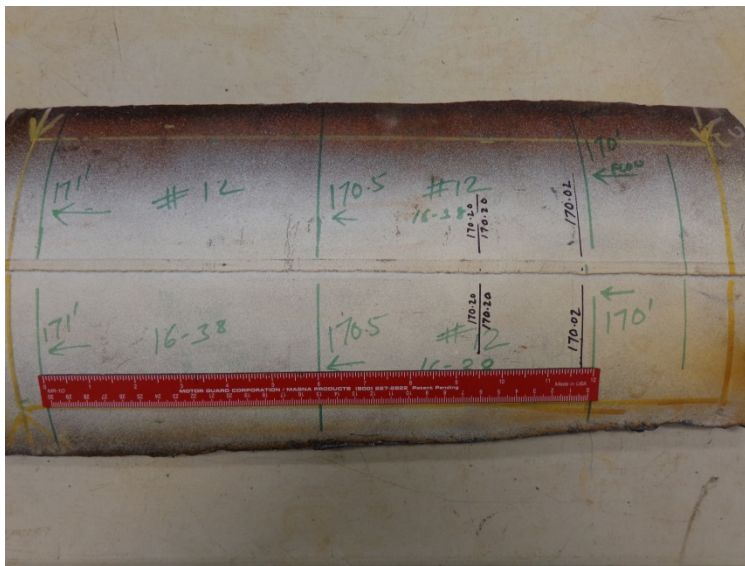
Figure 92. Break location marked on SWA #19

SWA #19: SWA #19 was located on Pipe #16-38. A metallographic cross section shows the presence of an OD hook crack and another stringer feature on the opposite side of fusion line. Figure 92 shows the pipe marked in preparation for the fractography specimens. Figure 93 shows the fractographic results; a hook crack can be seen in the picture on the right side. Figure 94 shows the metallographic results with the OD hook crack and another stringer feature. The anomaly location details along with details of ILI and IWEX reported anomalies are presented in Figure 95.
