Direct Assessment Activities by GTI

- > DOT R&D Forum
Houston, TX March 2005

Daniel Ersoy
Gas Technology Institute
daniel.ersoy@gastechnology.org
847.768.0663

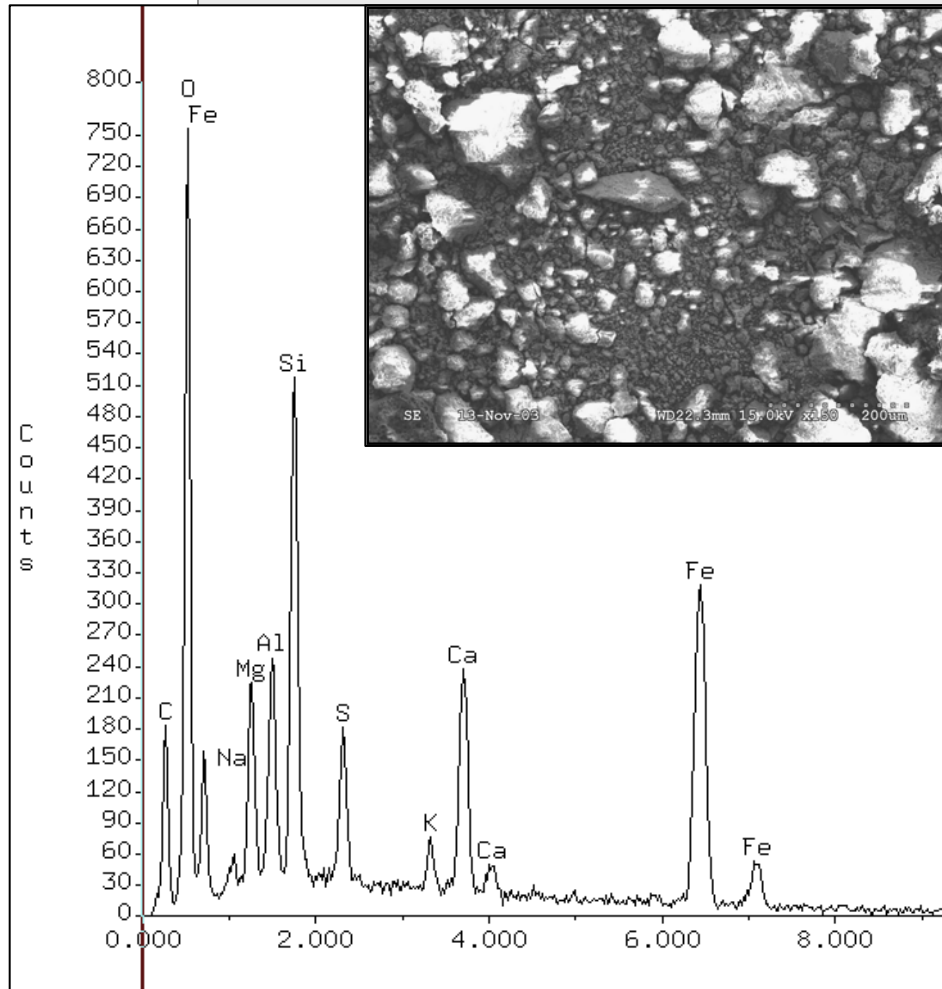
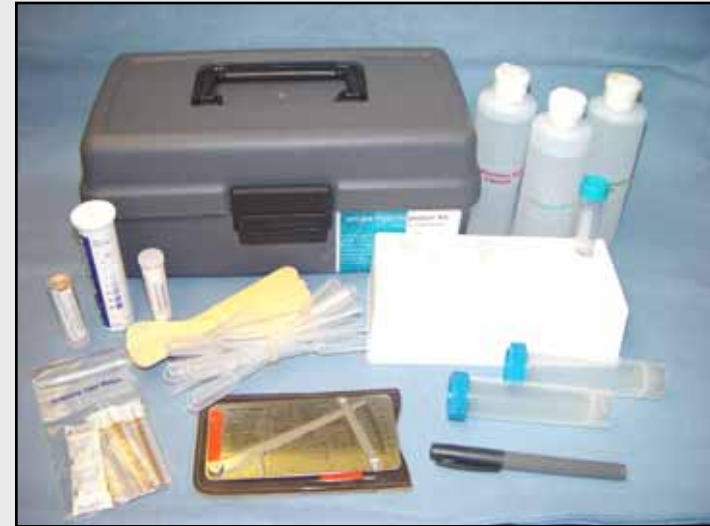
Corrosion Product & Soil Analysis

Corrosion product analysis showed very strong presence of iron oxide with moderate amounts of sand (Al, Si oxide). Minor indication of Calcium Carbonate formation.

pH: **7**

Carbonates (ppm): **positive**

Sulfides (ppm): **negative**

Total Iron (ppm): **0**

Chlorides (ppm): **0**

Nitrates (ppm): **5**

Sulfates (ppm): **29**

Moisture content (%): **15.3%**

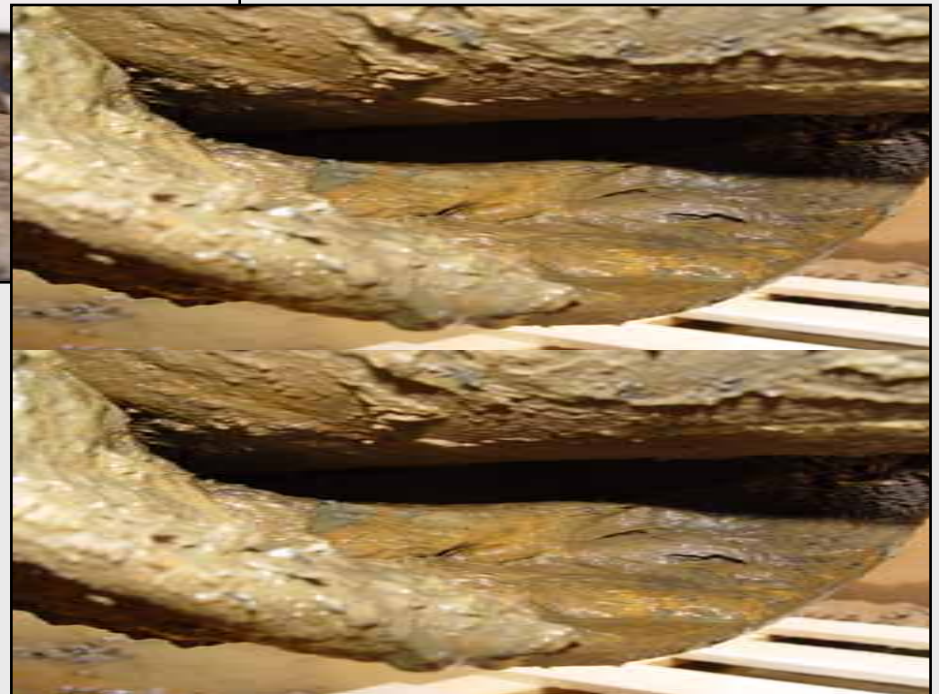
Top of casing, no seal

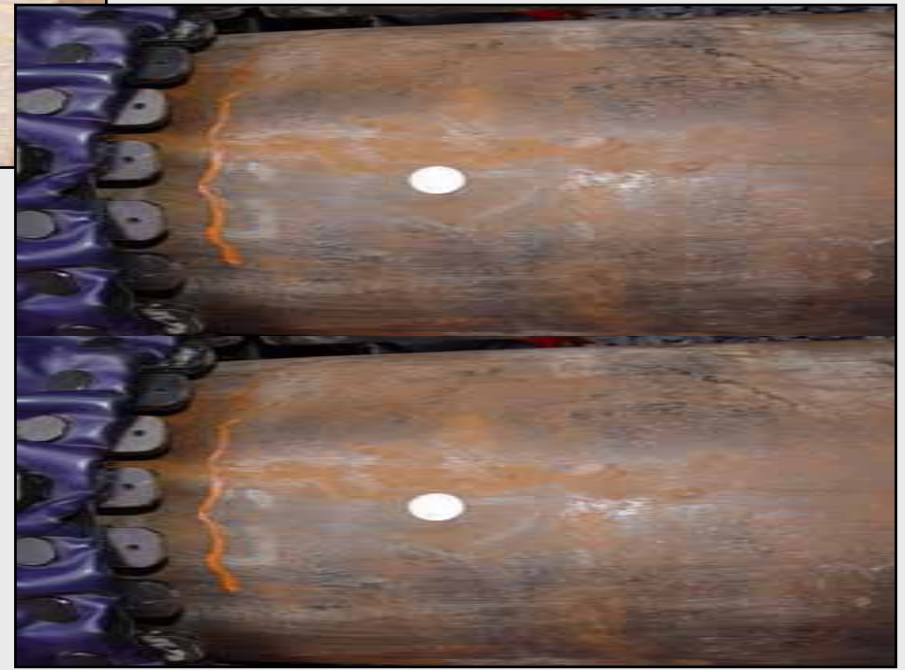
The condition of the exposed pipe (outside of the casing) was very good to excellent. Any areas of corrosion had a depth not measurable or less than 10 mils deep

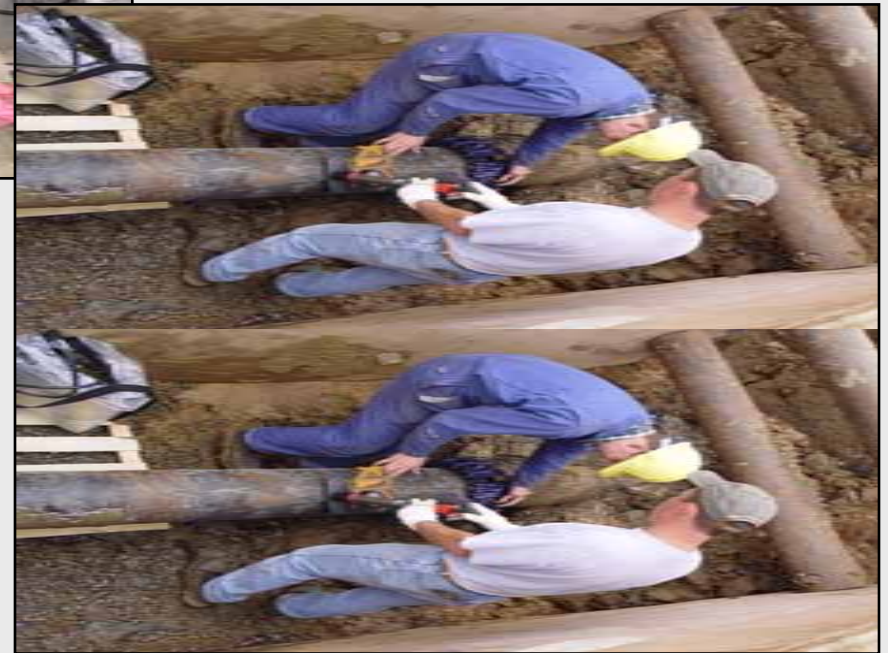
The transducer collar was inflated to ensure good contact of the transducers with the pipe wall for optimal ultrasound transmission and reception.

The pipe wall thickness was measured at all clock positions along the exposed length. It varied from 0.270" to 0.300" in the radial direction but was consistent in the axial direction (artifact of forming).

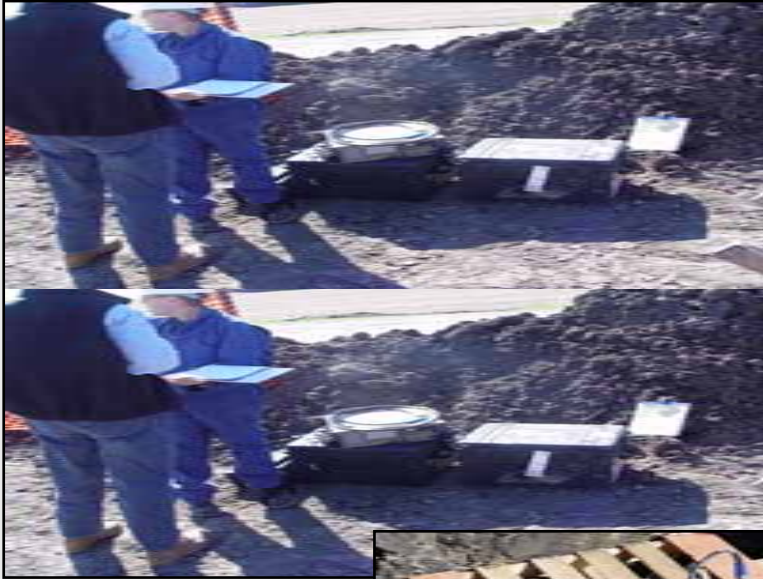
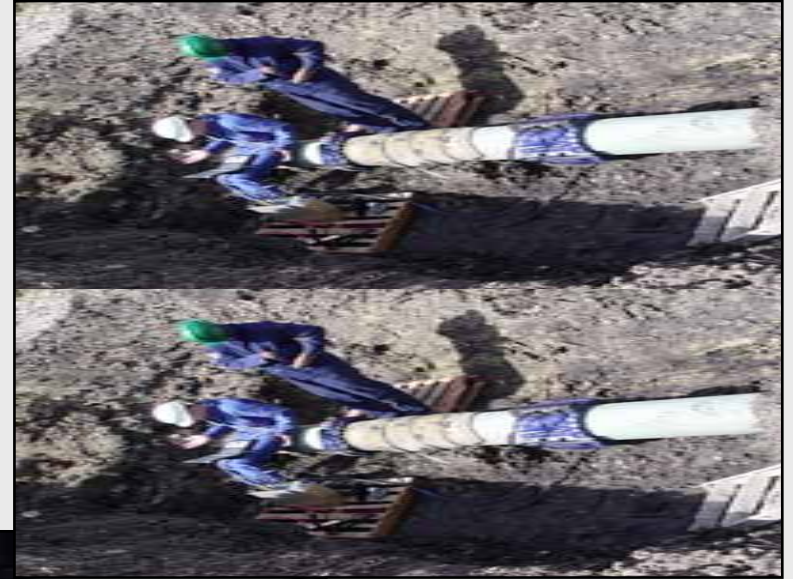
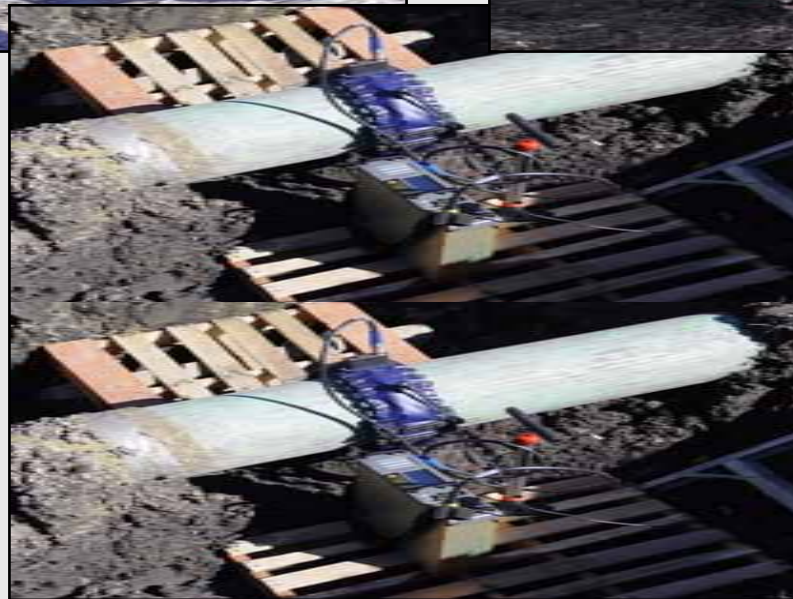
ICDA Case Study - Guided Wave

- > About 25' of pipe could be tested from a single location in both directions.
- > Two welds were clearly seen in the diagnostic length of the test and their position has been confirmed with the Pig results.
- > An area indicated as **A** was identified as a possible area of concern. The length of pipe between W3238 and W3224 (including area **A**) was identified as Class 1 by the Pig. Class 1 is assigned by the MFL pig to areas where there could be a defect in the range of 0-25% of wall loss.

Feature	Location	Class	Notes
W3238	8'0"	Weld	Weld between new FBE pipe and original section
A	15'0"	Medium	Suspected 10 percent cross sectional loss at the 6 o'clock position (MFL shows a bit of an increase in losses (from 10%wall to 25%wall))
W3224	24'2"	Weld	Where weld should be based on MFL data
B	27'8"	Minor	Center of an area of concern. However, the confidence is low because the amplitude of the reflections is very small. MFL scan shows about a 20 percent wall loss distributed wall loss

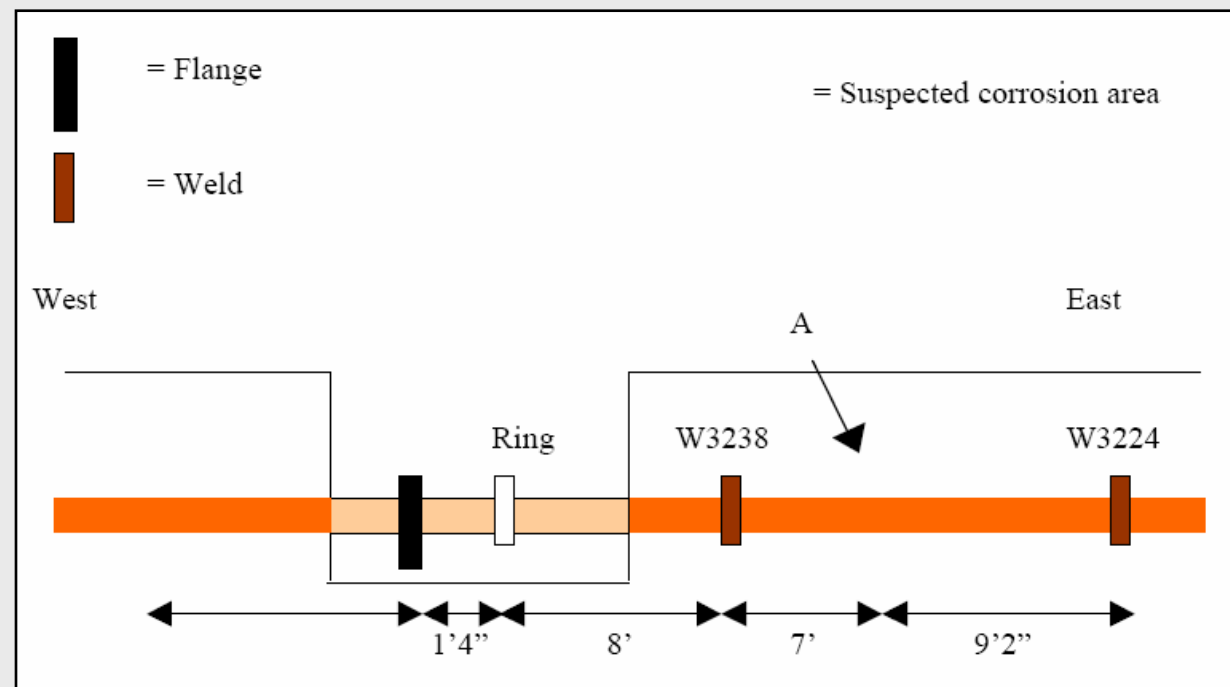
ICDA Case Study - Dig#1

- > The section of pipe shown below, between the flange and weld W3238, is a new section of FBE coated pipe. The joint to the East is the original old pipe. The only exposed pipe feature was the flange on the negative side of the ring.
