CITY OF LONG BEACH

Re: CPF 5-2015-0009M

LBGO has completed a comprehensive restructure of its DIMP in order to fully and completely respond to PHMSA's allegations of apparent inadequacy in procedural specificity, risk ranking and evaluation, and performance measures. The result is the broadly revised and improved DIMP enclosed with this letter.

DISTRIBUTION INTEGRITY MANAGEMENT PLAN

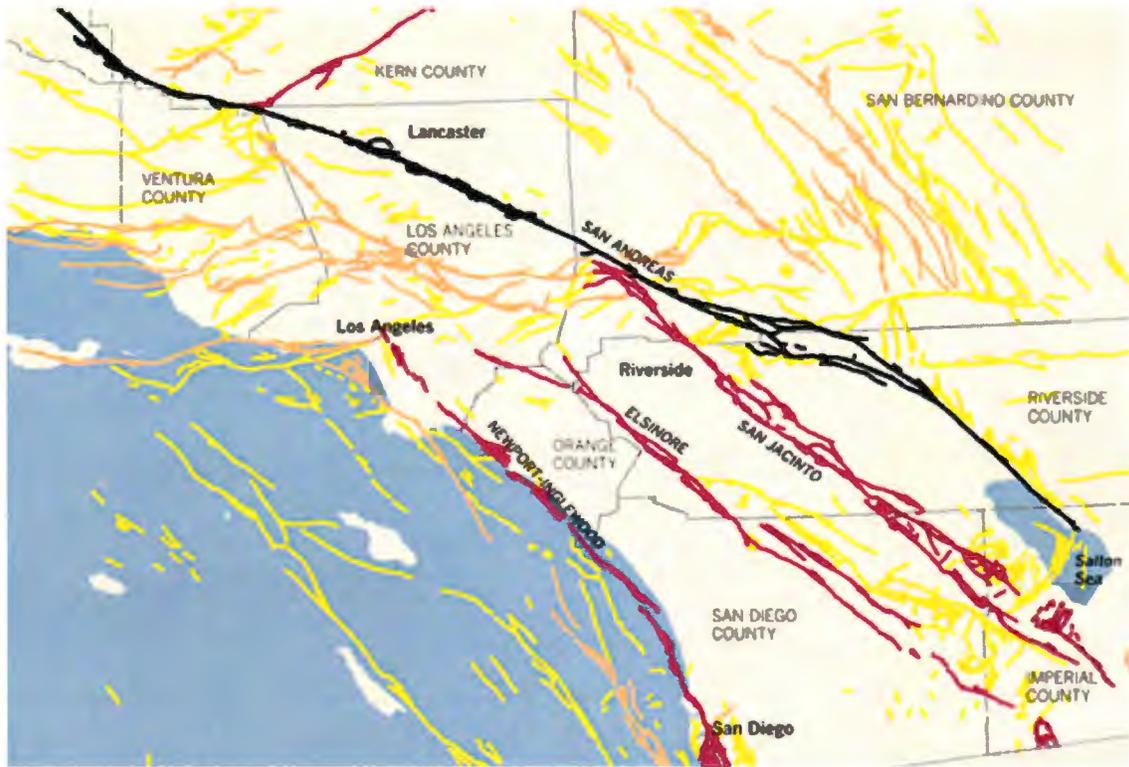
Southern California Major Fault Lines

The region's most populous areas are crisscrossed by faults capable of delivering jolts of magnitudes equal to or greater than the 1994 Northridge earthquake, which measured 6.7. Below, the latest fault map released by the California Geological Survey is coupled with earthquake scientists' estimates of the maximum magnitude of potential quakes on those faults.

— Less than 6.7 or unrated — 6.7 to 7.5 — 7.5 to 8.0 — 8.0+

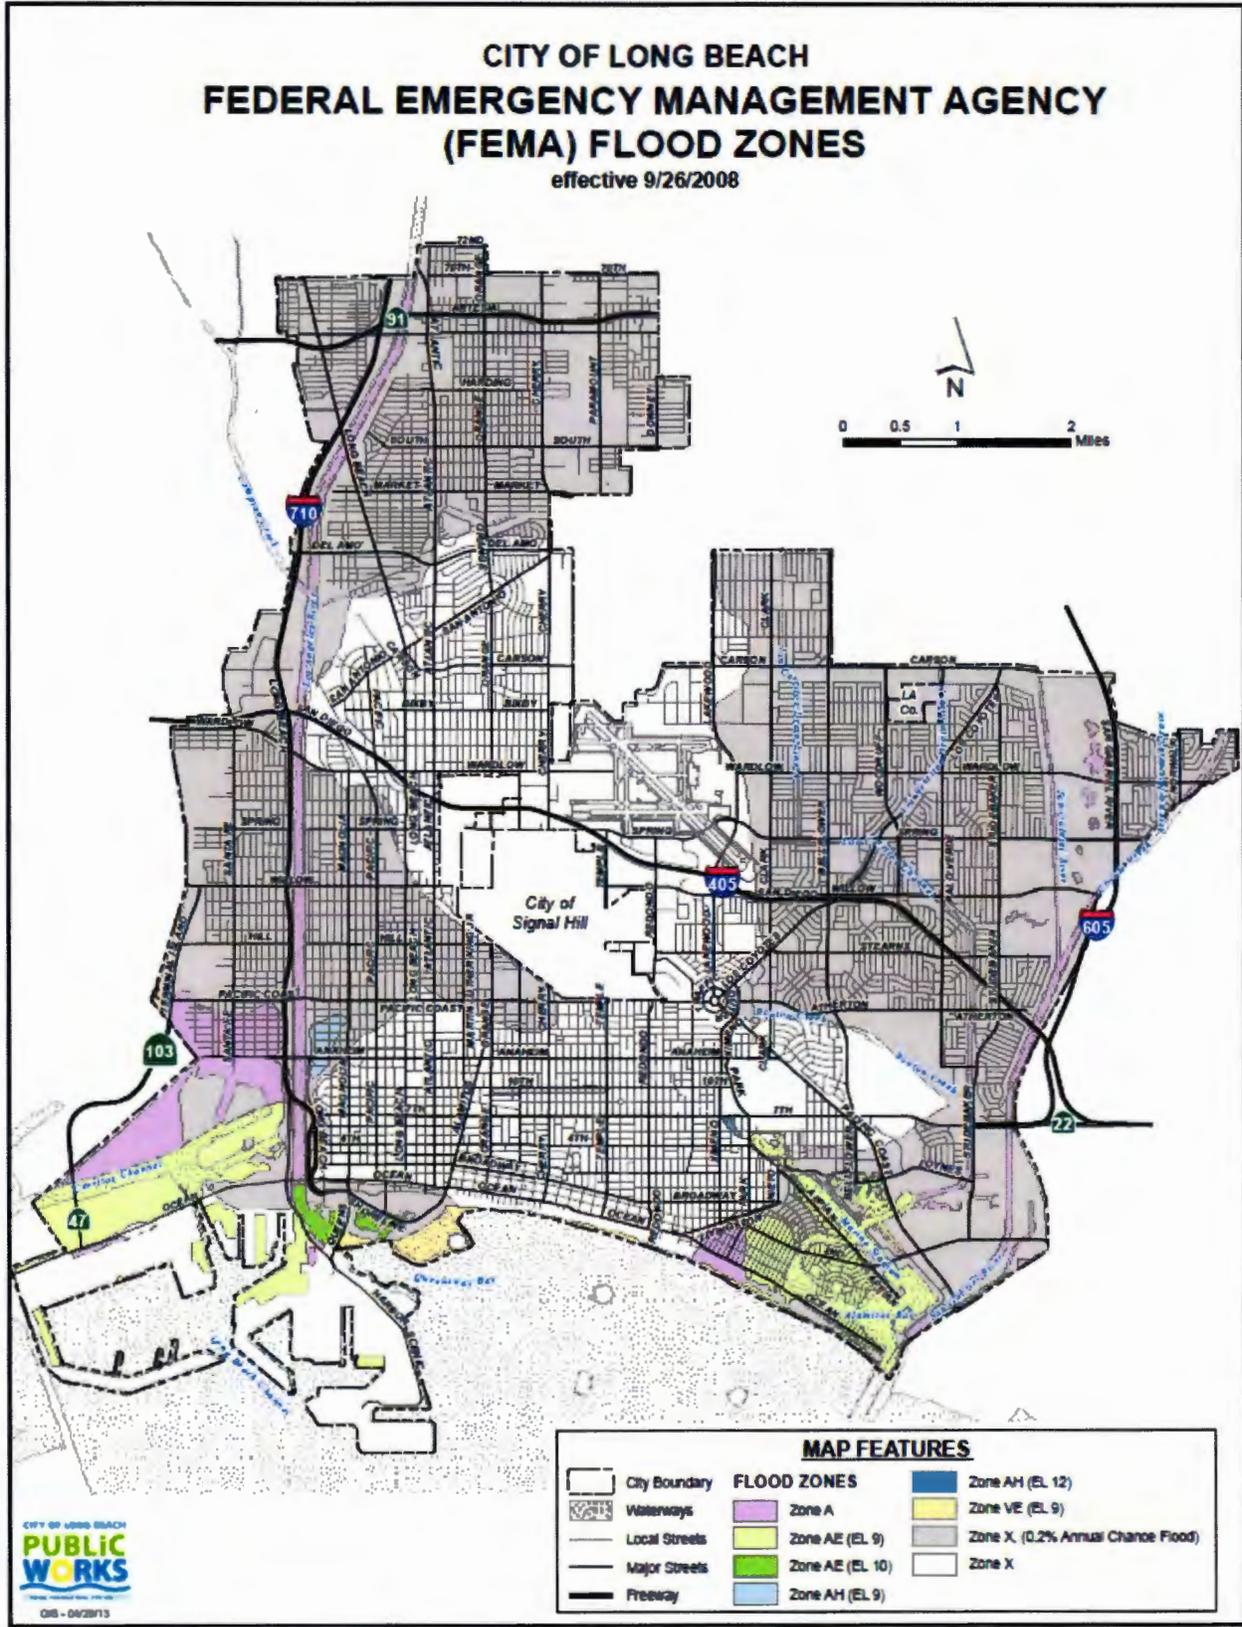
City of Long Beach Flood Zones

Moderate to Low Risk Areas
