## THIRD QUARTERLY REPORT

Date of Report: *July 8, 2005*

Project Title: *Determining Integrity Reassessment Intervals through Corrosion Rate Modeling and Monitoring*

Prepared by: *Southwest Research Institute*

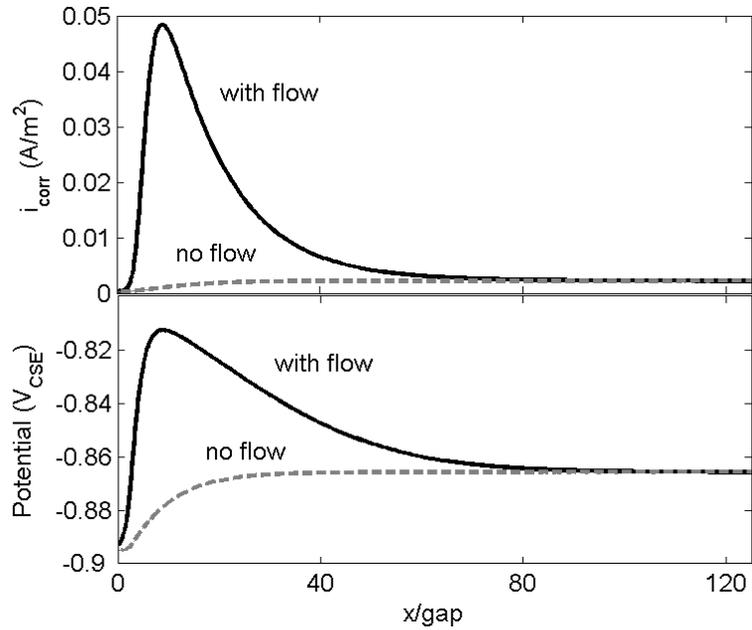
Figure 1 shows the effect of flow on the crevice corrosion rate when there is CP applied at the holiday (-0.900 V vs. CSE). The crevice gap between the coating and steel is 4 mm and the length is 0.5 m, consistent with the experimental setup being done in collaboration with Gas de France. The solution resistivity used in the computation is 25 ohm-m and the O<sub>2</sub> pressure at the holiday is 0.2 atm. The crevice geometry is shown in Figure 2 where the velocity and O<sub>2</sub> pressure distribution in the geometry are also shown. Note that the y axis in Figure 2 has been scaled up and the holiday, not labeled, is located in the upper boundary with 1 cm in length from the left corner.

Figure 1 shows that both the crevice corrosion potential and current density curves have a maximum inside the crevice. In contrast, there is no such maximum when there is no flow. The potential and current density with flow are much higher, indicating that flow can increase the crevice corrosion rate significantly inside the crevice. With flow, O<sub>2</sub> is carried inside the crevice and it cannot be reduced by cathodic current which can have only very limited penetration into the crevice near the holiday. This computational result is qualitatively consistent with the experimental finding in a Gas de France report.

Figure 1: Crevice potentials and current densities computed at a holiday potential of  $-0.900$  V vs. CSE when there are flow or no flow.

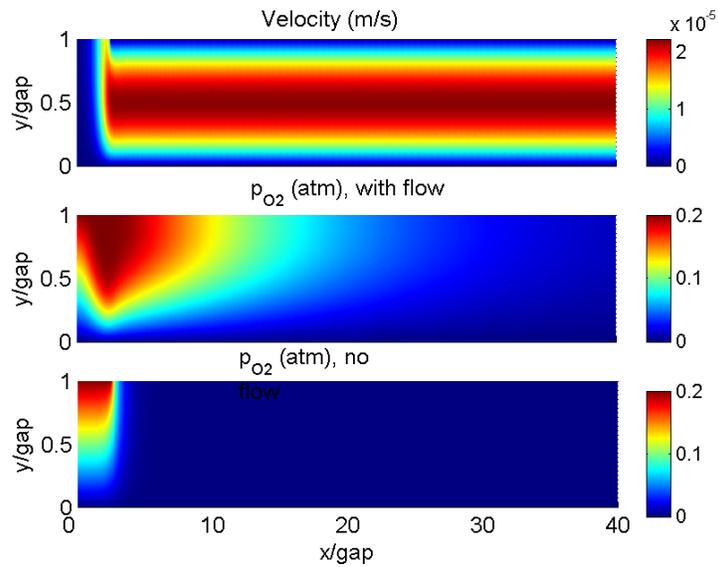
The distributions of velocity and dissolved O<sub>2</sub> pressure in the crevice, near the holiday area, are shown in Figure 2. The velocity used in the computation is low, less than 2 cm/s and hence, the flow is clearly shown laminar. It is quite clear that the flow forces O<sub>2</sub> to disperse into the crevice and distributed broadly inside. Hence, higher

corrosion rate is expected in comparison with the case of no flow where  $O_2$  can only diffuse into the crevice very near the holiday and it has a very low concentration inside the crevice.

Figure 2: Distribution of velocity and dissolved  $O_2$  pressure where there are flow and no flow.

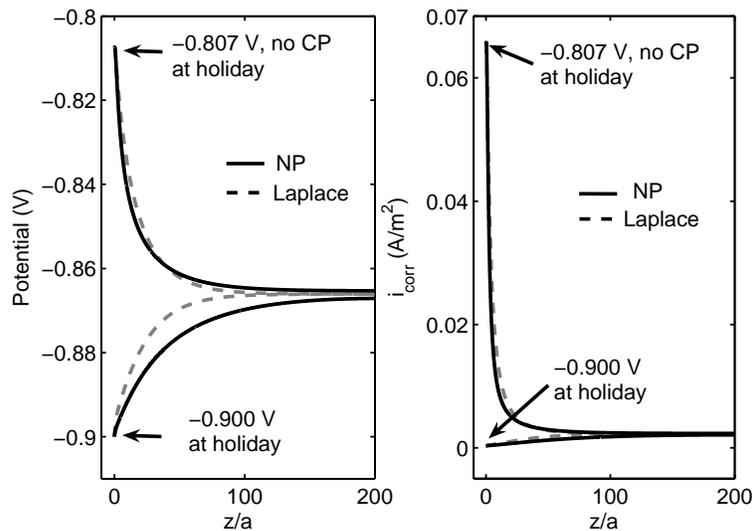
---(2) in the previous quarterly report, crevice corrosion in 2D was shown where the chemistry in the crevice was assumed uniform and Laplace's equation was used. This assumption is justified in Figure 3. The curve labeled with NP indicates results computed from Nernst-Plank transport equations. In both cases with either Laplace equation or Nernst-Plank equation, Tafel equation was used for the corrosion current density. Good agreement is shown.

Figure 3: Justification of uniform chemistry assumption when Tafel equation is used to express the steel corrosion rate. Two cases: No CP and with CP at holiday potential of  $-0.900$  V vs. CSE were computed.

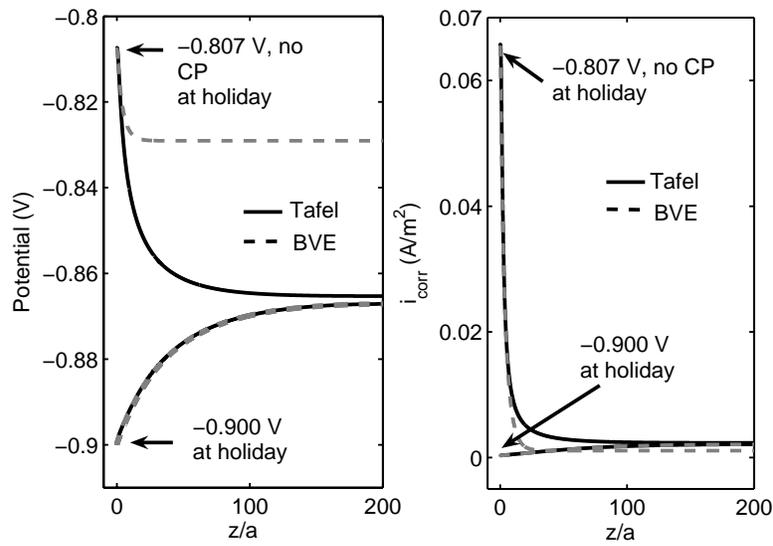
Although the Tafel equation is mostly used in the literature to express corrosion current density, this equation may however become inaccurate under certain circumstances. Then, the more accurate Butler-Volmer equation should be used. As shown in Figure 4, there is a discrepancy in the results obtained from the Tafel expression in comparison to the Butler-Volmer equation. This discrepancy is attributed by the fact that the cathodic term in the Butler-Volmer equation could become large due to increase of ferrous ion concentration inside the crevice.

Figure 4: Discrepancy is shown when Tafel equation and Butler-Volmer equation are used respectively used to express the steel corrosion current density. Two cases: no CP and with CP, are compared.

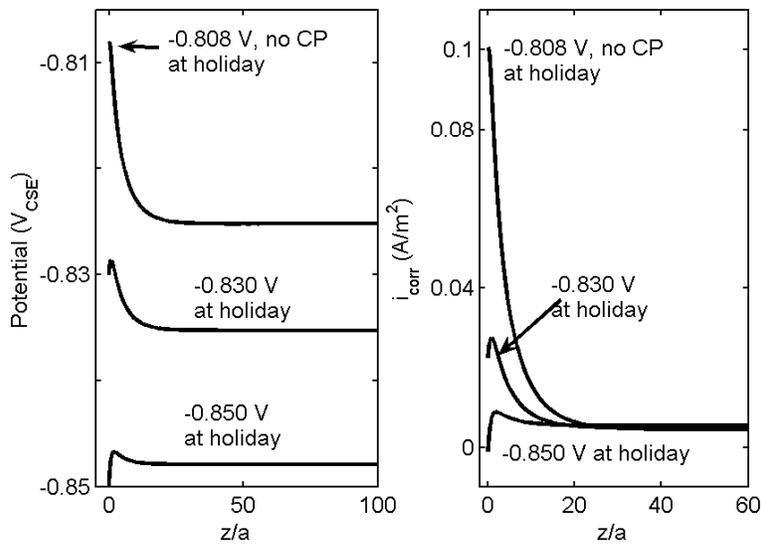
---(3) the combined effect of  $\text{CO}_2$  and  $\text{O}_2$  on the crevice corrosion of steel is investigated in 1D when there is co-precipitation of  $\text{FeCO}_3$  and  $\text{Fe}(\text{OH})_2$ . The dissolved  $\text{O}_2$  pressure at the holiday is set at 0.21 atm. The crevice corrosion rate and potential are shown in Figure 5, where the Butler-Volmer equation is used to compute the corrosion current density. The potentials at the end of the crevice are different at different holiday potentials because of the chemistry there is different. At the holiday potential of  $-0.830$  V, the corrosion rate is relatively large and hence may be considered as insufficient CP. In contrast, at the holiday potential of  $-0.850$  V the CP seems sufficient due to the low corrosion rate in the crevice and due to this rate at the holiday is smaller than in the rest of the crevice.

Figure 5: Crevice corrosion current densities and potentials with dissolved CO<sub>2</sub> in the system when FeCO<sub>3</sub> and Fe(OH)<sub>2</sub> co-precipitate and when there are CP and no CP.

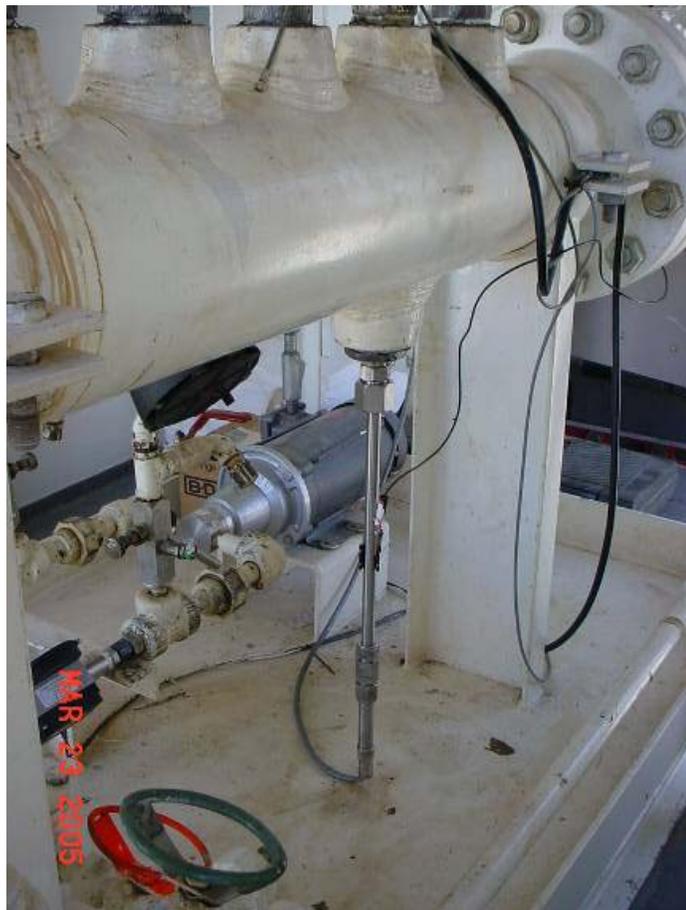
As reported before, Multielectrode Array Sensor probe was placed in the liquids pipeline side loop at two different locations of a pipeline company. First set of tests were performed in a plant (Figure 6), which is an intermediate point in the transportation of hydrocarbon liquids. The corrosion data from the MAS

**Figure 6. MAS probe installed in a liquids pipeline side loop**

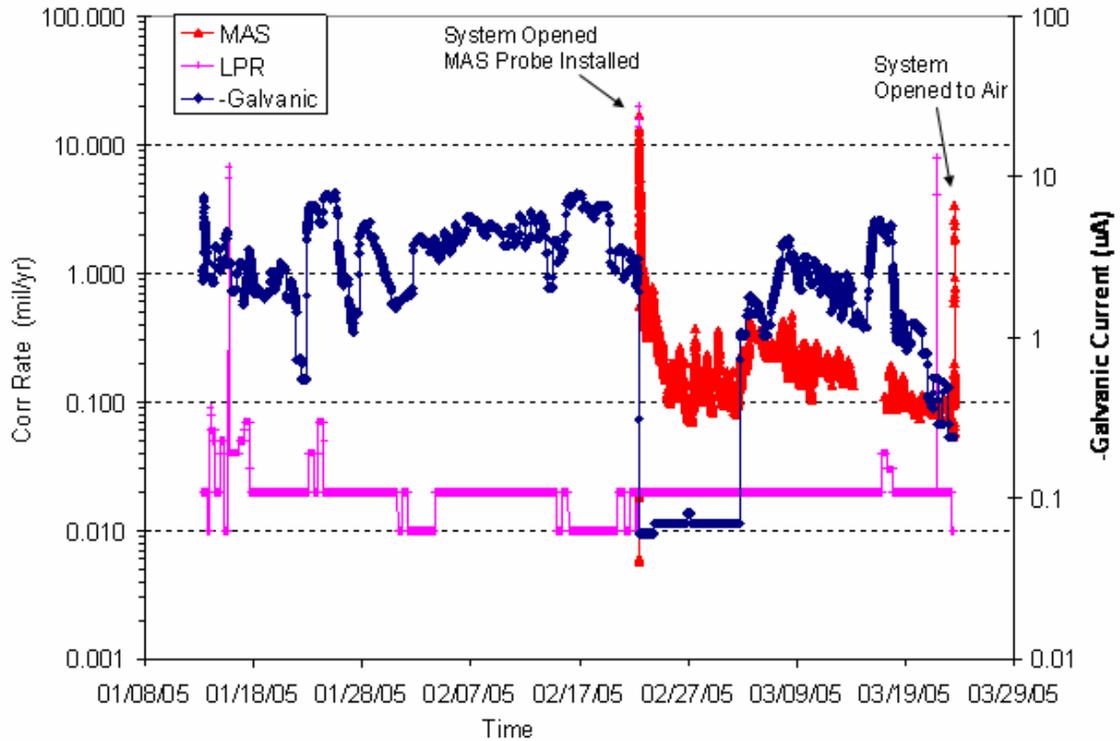
probe and the galvanic probe that was already installed by the plant (that consisted of two dissimilar metals between which a current was measured) are shown in Figure 7.

**Figure 7. The internal corrosion in the side loop of a liquids pipeline monitored by three different probes.**

The LPR readings in Figure 7 indicated a low corrosion rate because this probe was not in the lower part of the pipe where water occurs. On the other hand, both MAS probe and the galvanic sensor responded similarly to changes in pipeline conditions. Note that the MAS probe indicates a corrosion rate that is somewhat lower than the actual corrosion rate because only a portion of the sensor area undergoes anodic dissolution. However, because the corrosion rate is calculated from the 3 sigma of the current distribution, the corrosion rates measured by MAS probe may not be highly non-conservative.

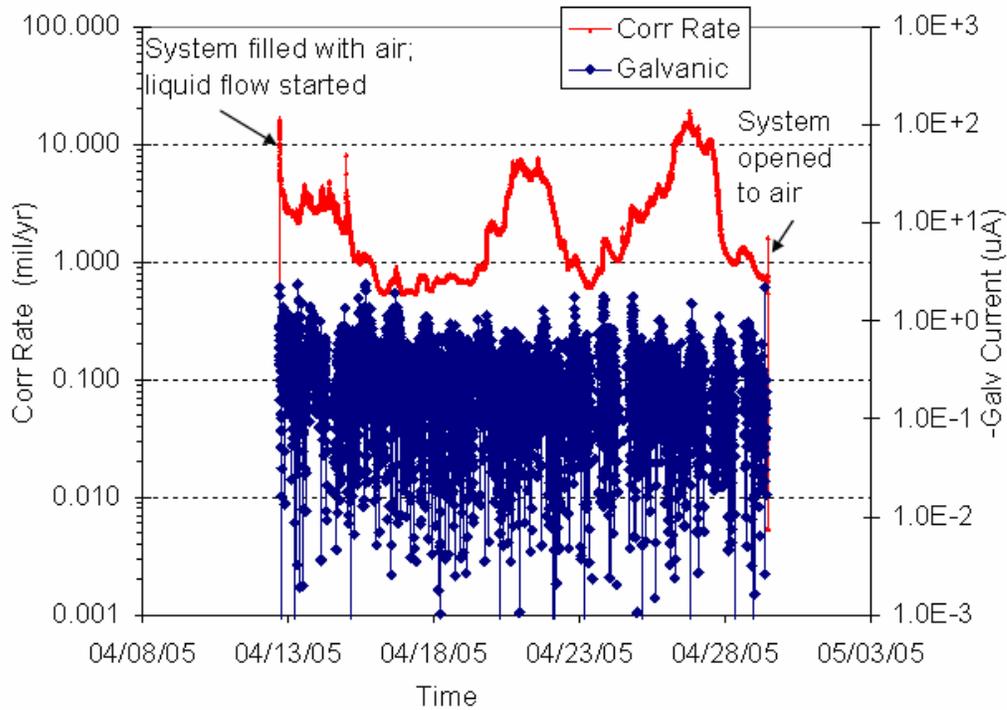
The probe was moved to another plant of the same company, which is a receiving terminal for the transmission system. The readings of both the Galvanic and MAS probes are shown in Figure 8. The variations in the corrosion rate of the MAS probe not only reflect ingress of air, but also variations in the products transported over this time period (Figure 9).

The corrosion rates can reach a value as high as 10 mm/y, but are more typically about 0.1 mm/y. A better understanding of the effect of input parameters on corrosion rates will be important in determining the corrosion rates in these liquid lines.

**Figure 8. Comparison of MAS probe versus galvanic probe in the liquids pipeline near a terminal area.**

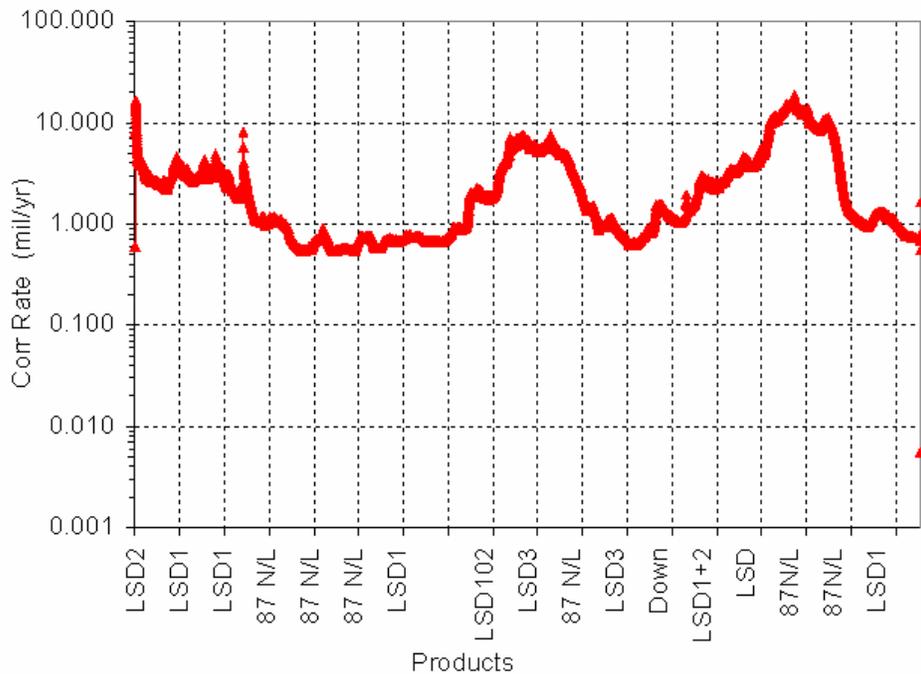
**Figure 9. Variation of corrosion rates with products transported in the pipeline. No particular correlation is observed**
