CAAP Annual Report

Project Title: *Wall Break-through in Composite Repaired Defects*

Prepared by: *The University of Tulsa*

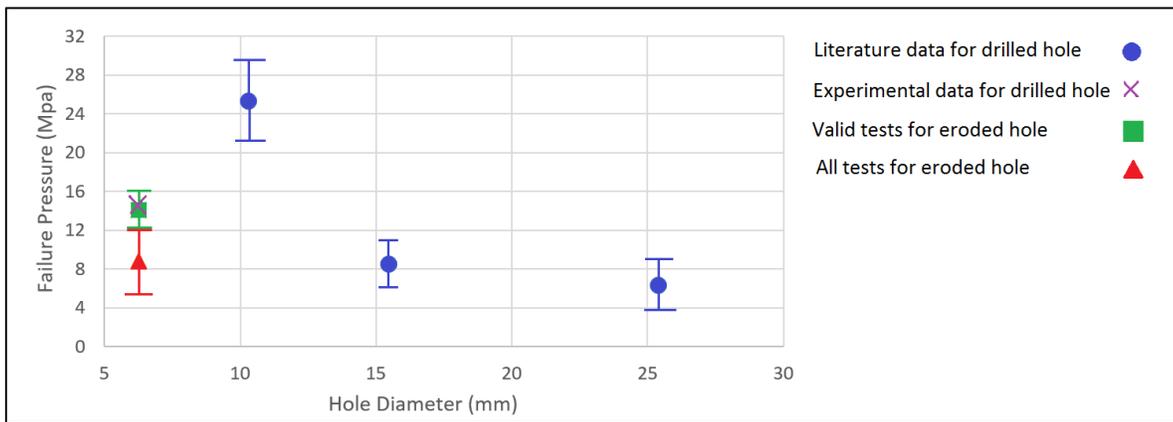
Figure 1: Comparison of failure pressures for current results (square, triangle, and x) and previous testing on the same repair system.

We have completed the straight pipe testing for repairs that consisted of two layers of composite material. The results of this burst testing are shown in Figure 1. From these results we can conclude that the current design methodology would be appropriate for flaws that have been produced from an erosion or corrosion type process. This can be determined by observing that the valid tests (n=4) for the eroded specimens had nearly identical failure pressures when compared to the drilled holes of the same diameter. However, there is one additional concern. We found that this testing tending to have a significant number of through-wrap failures, which can significantly lower the average failure pressure (triangles in Figure 1). While this failure mode can occur during drilled testing, it appears to occur more frequently in the eroded system. To investigate this failure mode more, we are preparing to run an additional set of tests using four layer repairs. Increased repair thickness has helped to reduce through-repair failures in previous drilled-hole testing.

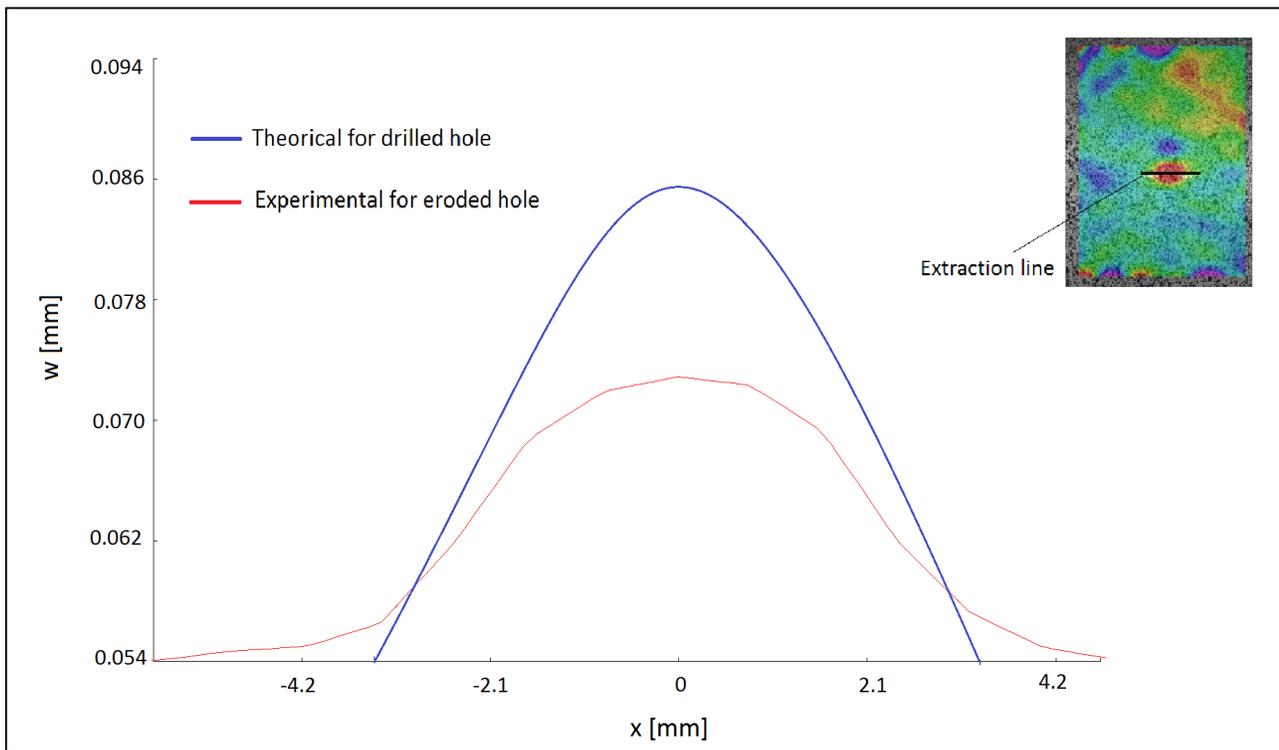
Figure 2: Comparison of theoretical and measured deformation profiles of an eroded-straight pipe flaw.

We have continued to run DIC on tests that we are conducting for both elbows and straight pipes. Last quarter we presented some results for a comparison of theoretical predictions of the deformed profile of the repair over the defect and the DIC-measured profile. Since that result, we have improved our testing process and have determined that the reference line for the experimental results was incorrect. Figure 2 shows new data for a 2-layer straight pipe specimen with the theoretical prediction and the experimentally determined profile. From the results in Figure 2, we can see that the predicted deformation profile has a maximum deflection that is significantly larger than that measured by DIC.

The over-prediction by the theoretical approach will tend to increase the crack-driving force at any given pressure and produce a more conservative prediction for failure pressure. Additional conservatism in the design could help to address the tendency for repairs installed over diffuse flaws to fail through the repair rather than at the interface. We are continuing DIC studies, which should help us to better characterize the performance of the repairs compared to the design models.
