**Final Report**

**Improvement of External Corrosion Direct Assessment  
Methodology by Incorporating Soils Data**

**U. S. Department of Transportation  
Research and Special Projects Agency  
Contract No. DTRS56-03-T-0003**

**November 2005**

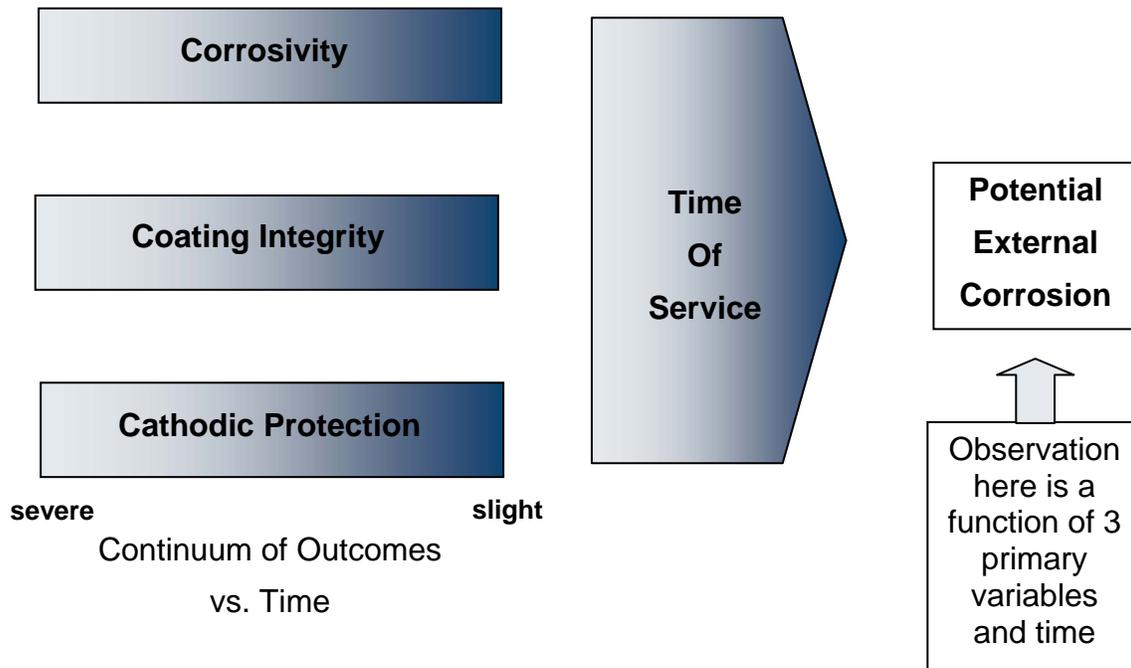
**Figure 1. Interaction of Corrosivity, Coating Integrity, and CP Controls Corrosion Susceptibility**

Figure 1 provides some perspective for the observations thus far. It schematically indicates the interplay between coating condition and the effectiveness of CP and corrosivity in producing corrosion susceptibility. On the left hand side of the figure are the three primary factors driving the observation of external corrosion. Each of soil “corrosivity”, coating integrity, and the cathodic protection system play a role over time. If the coating fails and the CP system is functioning properly, then it does not matter how corrosive the environment is, one would not expect to see corrosion. If both the coating and the CP system fail, then the corrosivity of the soil is very important to corrosion.

Figure 1 indicates that each of the primary factors can develop over time ranging from slight to severe, as shown for each of the bars for each of those factors. Whether it is slight or severe variability depends on several factors that vary over time. Seasonal variations, and CP maintenance to correct deficiencies, for example, can change the relative importance of any one of these factors, or all of them. So, at any given point in time the “environment” at the pipe surface is a combination of these three primary variables in the continuum of response possibilities. And, since this is effectively coupling the process to time, the extent of any observable or significant external corrosion will be a function of many complex variables. So, the development of a soils model, i.e., the corrosivity part of the equation, to predict external corrosion as part of ECDA is a very difficult task.

In summary, a model that is accurate enough to guide ECDA is not yet available. The modeling done as part of this project is a major step toward characterizing corrosion susceptibility, and could be instructive for ECDA if coupled with operator data regarding CP history and the insight it provides for coating condition. Additional data and field calibration will be needed to adequately address the interplay evident at a very high level in Figure 1.

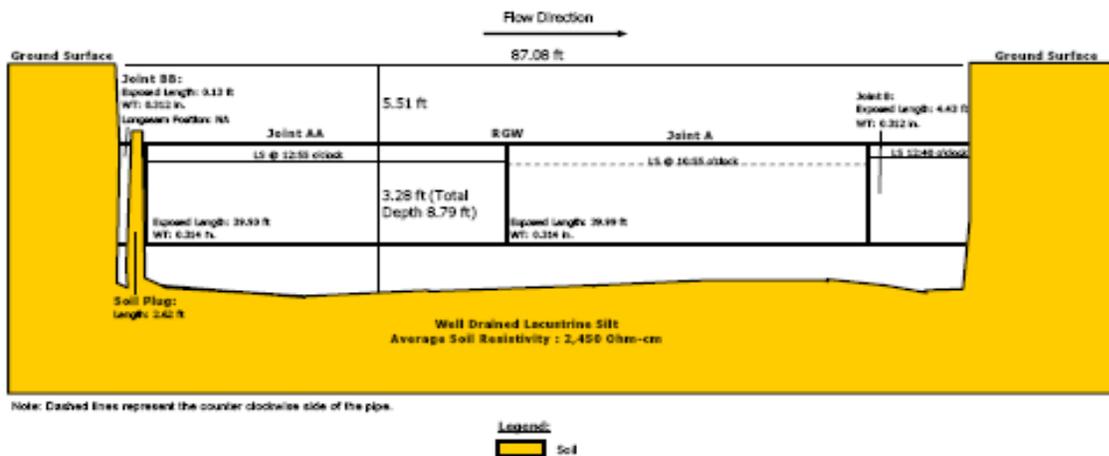
**Figure A-1. Typical Summary Graphic Illustrating the Excavation and Soils Data**

The soil classifications and description terminology described above apply to the methodology applied at each of the direct examination sites. More site-specific soils characterizations and test results were included in the form of graphics and tables that summarized the results at each site. Figure A-1 shows an example of a graphic used to describe the site along with soil conditions.
