## QUARTERLY REPORT – PUBLIC PAGE

### Development of Dual Field MFL Inspection Technology to Detect Mechanical Damage

*Date of Report:* October 31, 2007

*Contract No:* DTPH56-06-000016

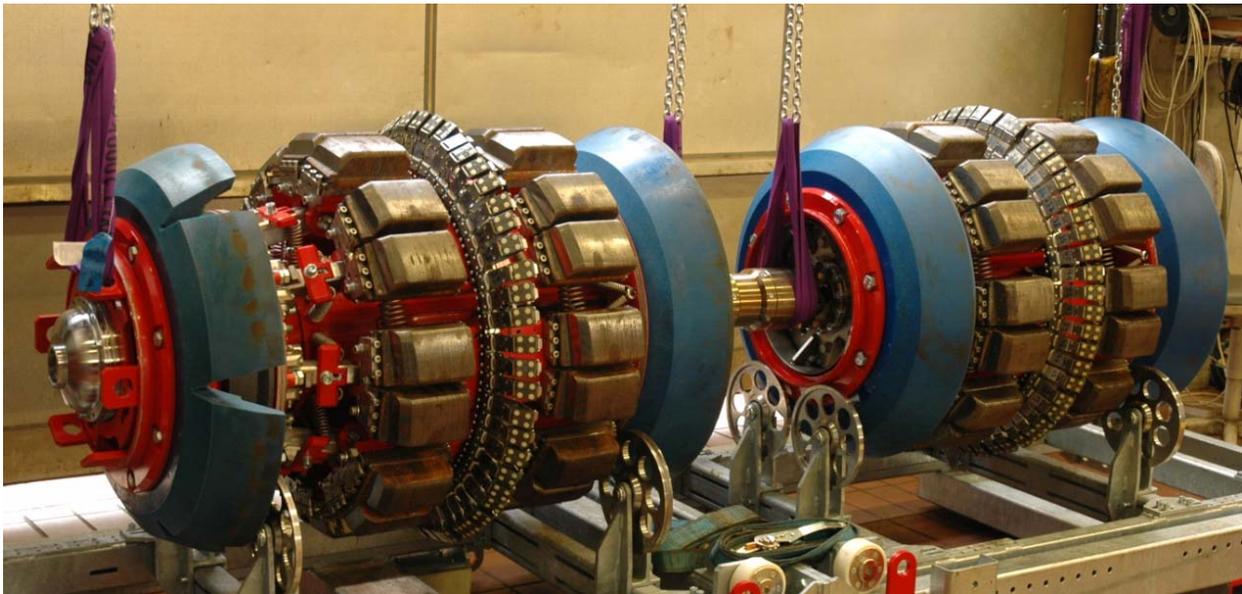
**Figure 1: Complete high and low field magnetizer segments, connected together. The high field segment is at the front.**

Figure 1 is a photograph of the completed and joined low and high field segments of the tool, Figure 2 is a photograph of the pull test assembly, and Figure 3 is a closer view of the dented pipe. A picture of the section of pipe for the pull test is in the previous quarterly report.

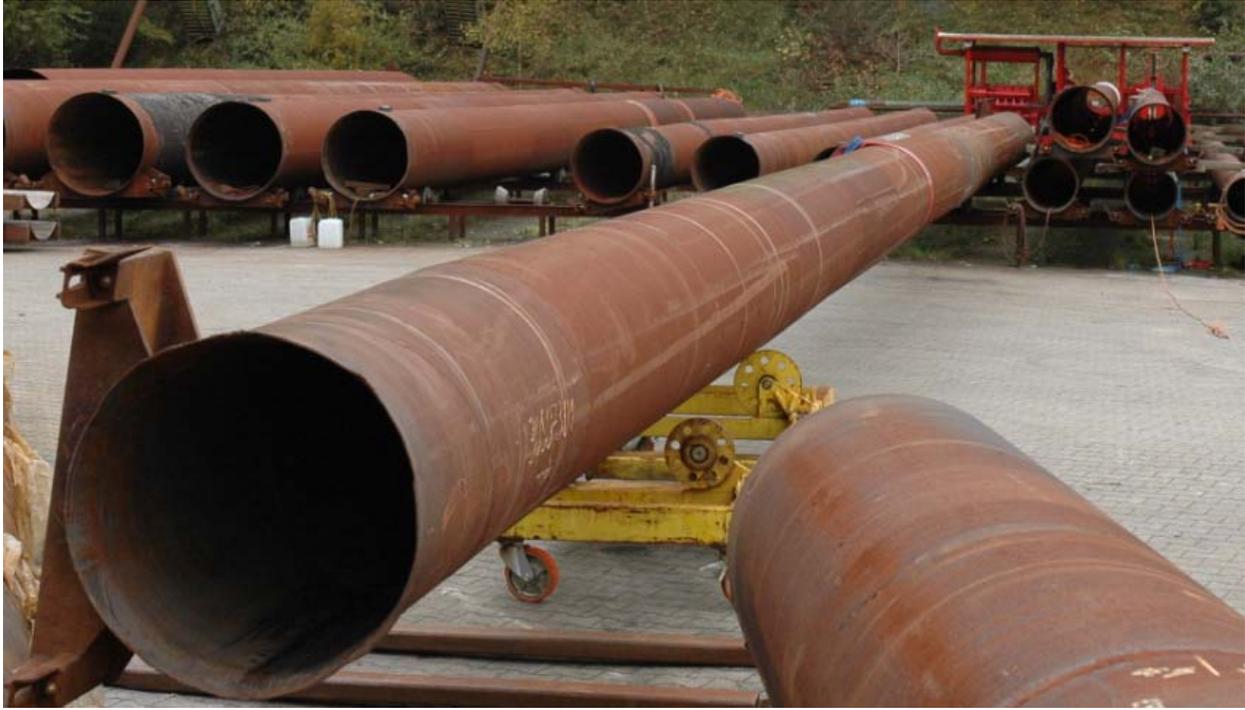
**Figure 2: The pull test pipe assembly. The three meter long section of pipe in which a series of dents is surrounded by two five meter long sections of the same pipe in order to ensure that when the pipe wall surrounding a dent is magnetized each of the magnetizer poles will be on a section of wall with the same thickness and material properties.**

As discussed in the previous quarterly report the pull tests will take place using a section of pipe with a single dent in it and a three meter long dented section of pipe. The three meter section of pipe has been welded between two five meter long sections; all three sections were cut from the same pipe. The dented section of pipe is welded onto the end of one of the five meter long sections. The pull test arrangement can be seen in Figure 2. The pipe section placement is to ensure that when the pipe wall surrounding a dent is magnetized each of the magnetizer poles will be on a section of wall with the same thickness and material properties. Additionally although the section of pipe supplied by Enbridge is at the end of the pull test pipe assembly the dent is in the middle of the Enbridge section, and thus the poles of a magnetizer section will be exposed to the pipe steel and not to air as the magnetizer is traversing the dent.

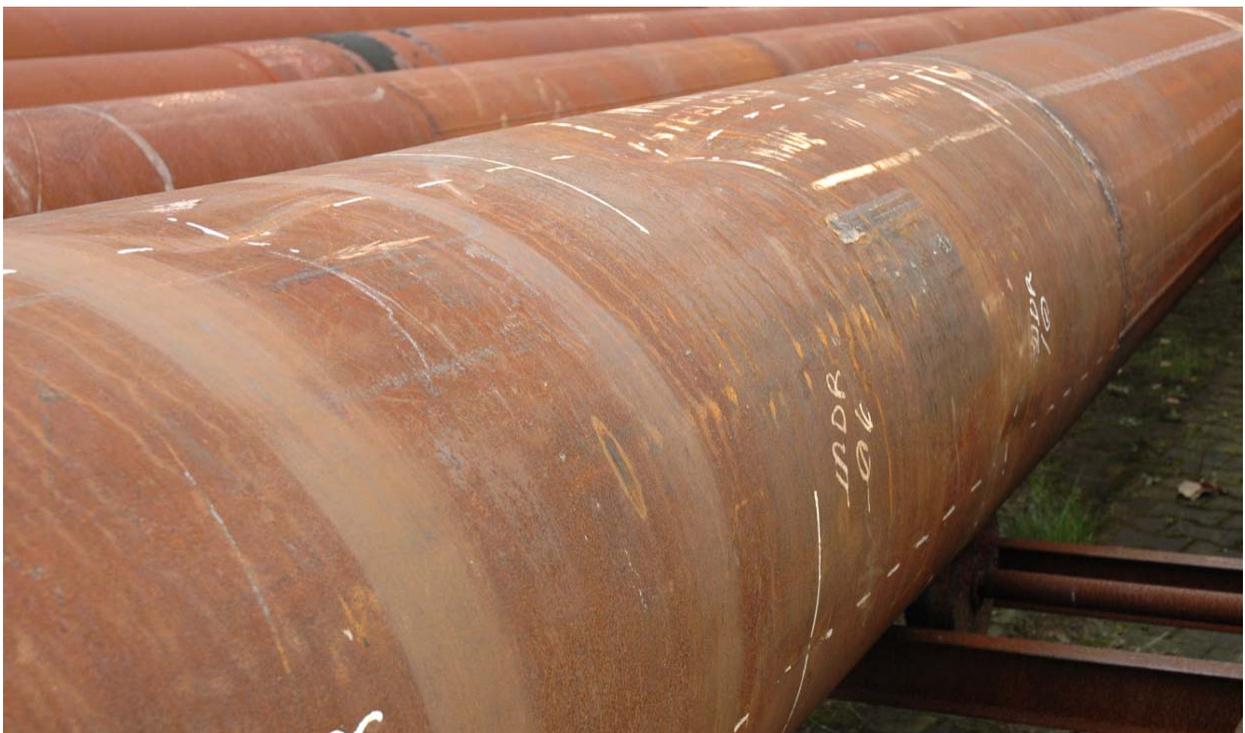
**Figure 5: A closer view of the dented section of pipe. A laser scan of the dent geometry was done by RTD for MD-1-2, and will be supplied to the MD-1-1 project.**
