# ECDA Process for Cased Transmission Pipelines

# Focus of the Presentation

- Technical Basis for ECDA Application to Cased Pipelines
- Results of Validation Efforts at the Mears Casing Test Facility
- Results of Field Indirect Inspections on Cased Pipelines
- Results of Direct Examinations

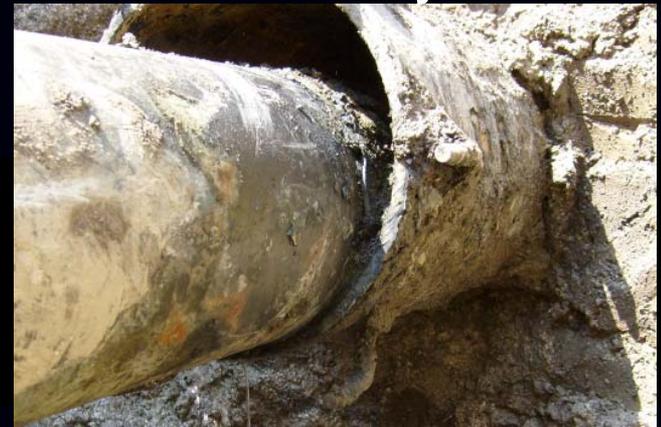
The ECDA process assesses if a corrosion cell could exist

- Anode, Cathode, Metallic Path, Electrolytic Path
- If the coating is free of holidays, an external corrosion cell cannot occur (absent disbonded coating issues).
- If a holiday is present, the highest risk of external corrosion occurs with a metallic contact and electrolyte in the casing.
- If an electrolytic contact is present, a potentially corrosive environment exists, however Cathodic Protection may be able to polarize the pipeline.
