Enbridge Pipelines (Lakehead) L.L.C.
119 N 25th Street E
Superior, WI 54880
www.enbridgepartners.com

Re: CPF 3-2012-5020 Notice of Proposed Violation, Proposed Civil Penalty and Proposed Compliance Order

Tank Management Program Update June 29, 2010

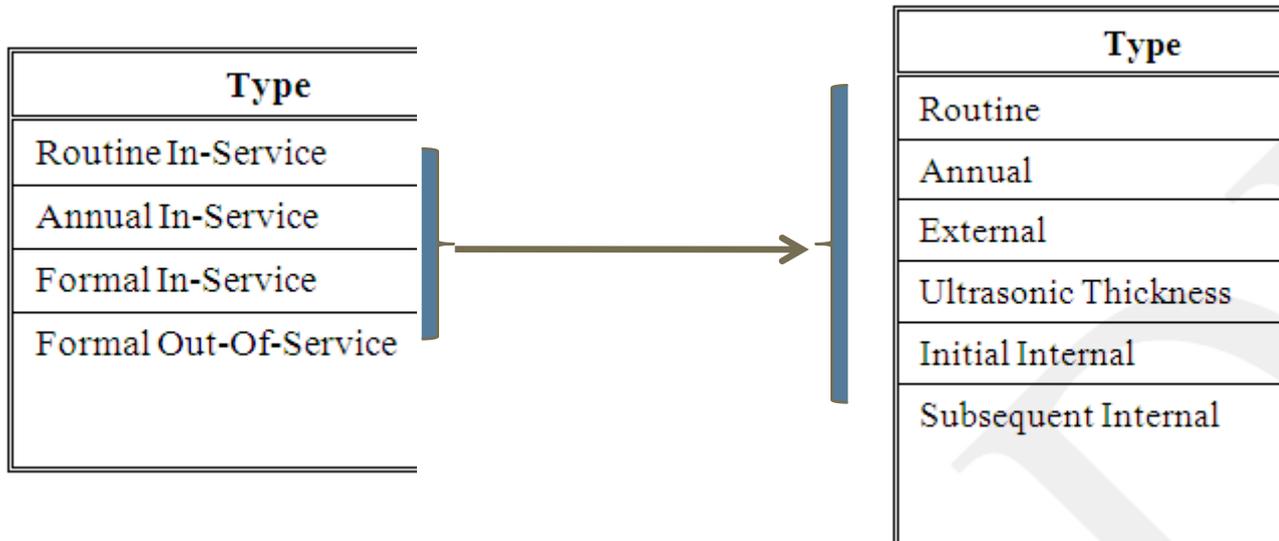
Table 1
Summary of Atmospheric Tank Inspections

- Table 1 now further breaks down the “formal” inspections and uses the inspection naming conventions of API 653.

–An Initial Internal Inspection was added with a 10 year maximum interval unless an RBI or Similar Service Assessment is performed.

–A note was added regarding unknown corrosion rates updated to reflect latest edition of the API 653.
