CAAP Quarterly Report

Date of Report: *Dec. 3, 2015*

Project Title: *Scaling and Self-Sensing in Composite Repairs of Corrosion Defects*

Prepared by: *The University of Tulsa*

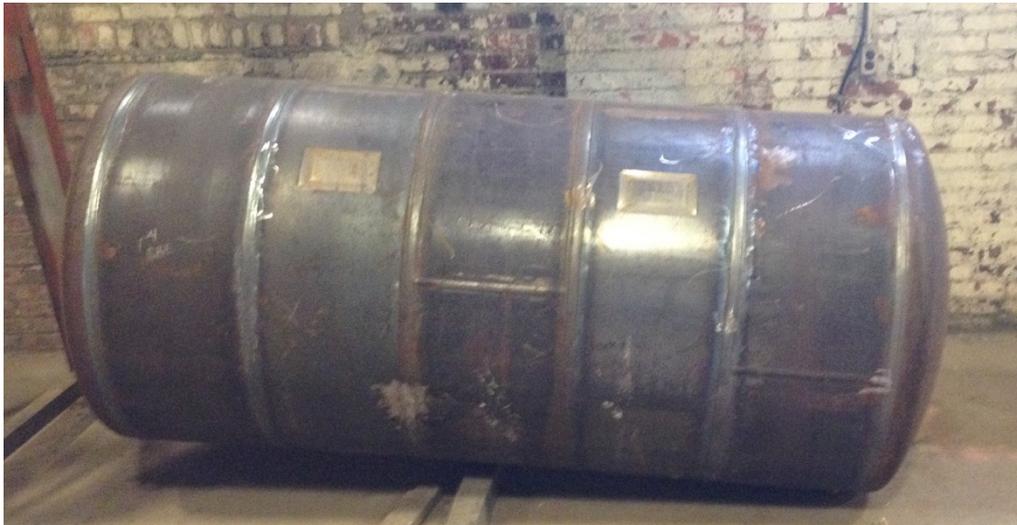
Figure 1: Picture of the as fabricated vessel. Diameter is 42 inches.

Large vessel fabrication is mostly completed as seen in Figure 1. The four patch flaws were rolled and then welded between 42 inch piping spacers. The welds are being ground flat to ensure that the installs are completed on a smooth surface. The installs of these repairs will be scheduled for the end of

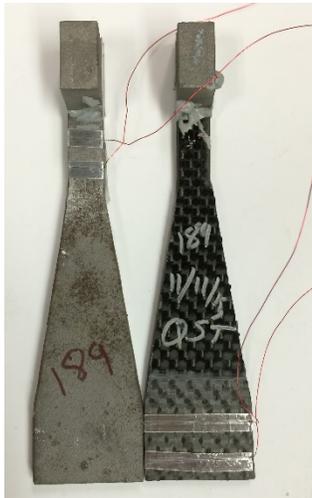
Figure 2 set-up of resistance wires

Based on our preliminary data for the resistive sensing presented in the previous quarterly report, we have been moving to make the approach more robust and repeatable. A Figures 2 and 3 show the current resistance measurement approach we are adopting and images of the failure surface of the sample.

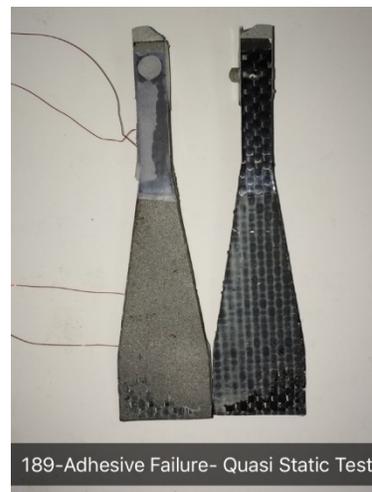
Figure 3 post test image.
