CAAP Annual Report

Project Title: *Wall Break-through in Composite Repaired Defects*

Prepared by: *The University of Tulsa*

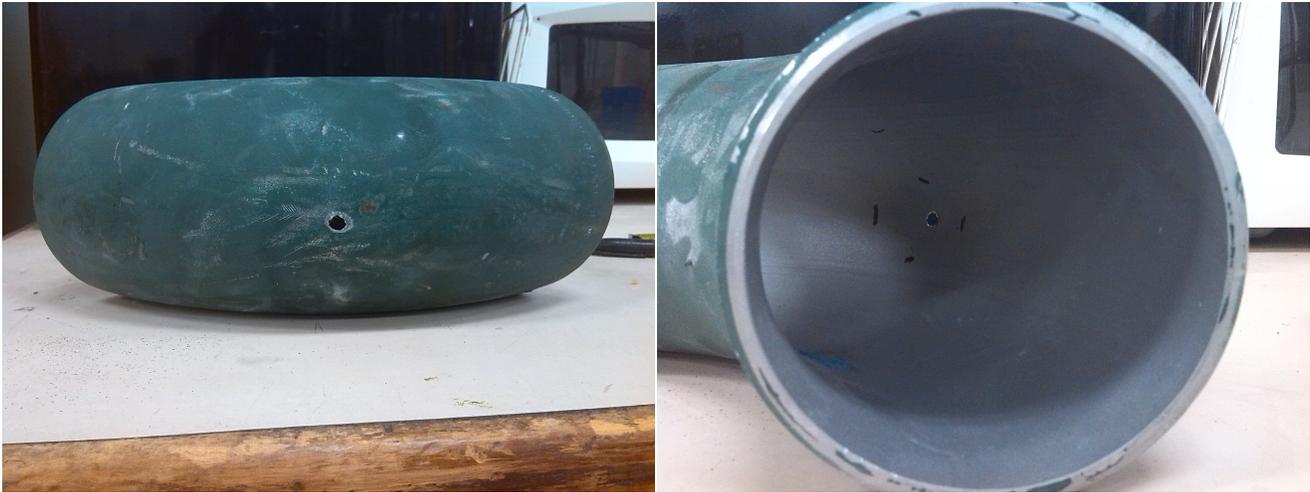
Figure 1: Images of initial test erosion of 4 inch long radius elbow. Marks on the interior of the left image indicate approximate extent of the eroded region

We have begun working on producing appropriate and repeatable erosion damage on elbows in order to investigate the impact of a diffuse flaw on repair performance. Figure 1 shows an image of a test elbow with erosion damage. Determining the total extent of the eroded region is not straight-forward, but we

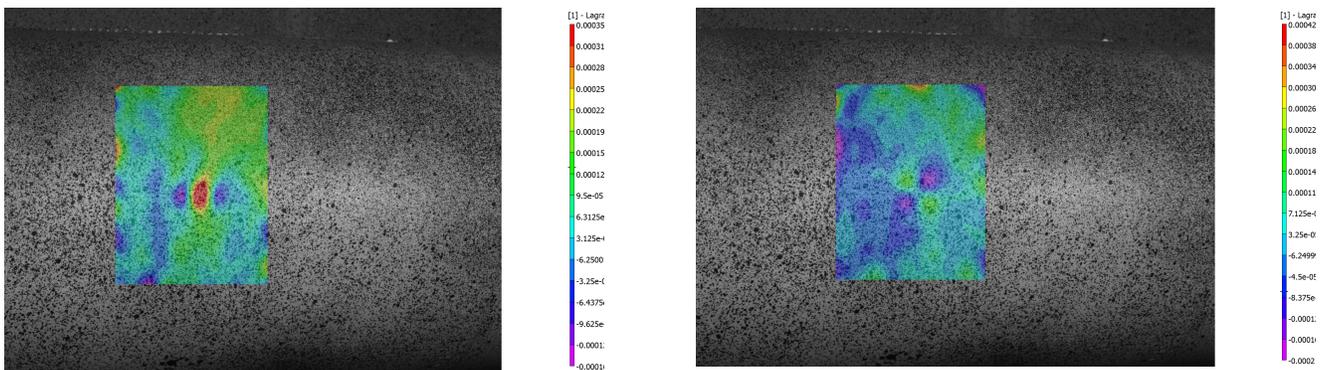
Figure 2: Strain fields for an eroded specimen with x (axial) strain on left and shear strain on the left.

Figure 2 shows the axial and shear strain fields for the eroded specimens with an internal pressure of approximately 1000 psi. The strain in the repair is clearly visible and we can see the local region of compression surrounding the tensile strain in the left image of figure 2. The right image also clearly shows the expected “cloverleaf” pattern of shear strain for a membrane-type deformation. There is still some noise in the measurements in figure 2 and we are working to reduce this and improve measurement fidelity. DIC has been shown to be nearly as accurate as strain gages when lighting and speckle pattern are good. We are still having some issues with lighting.

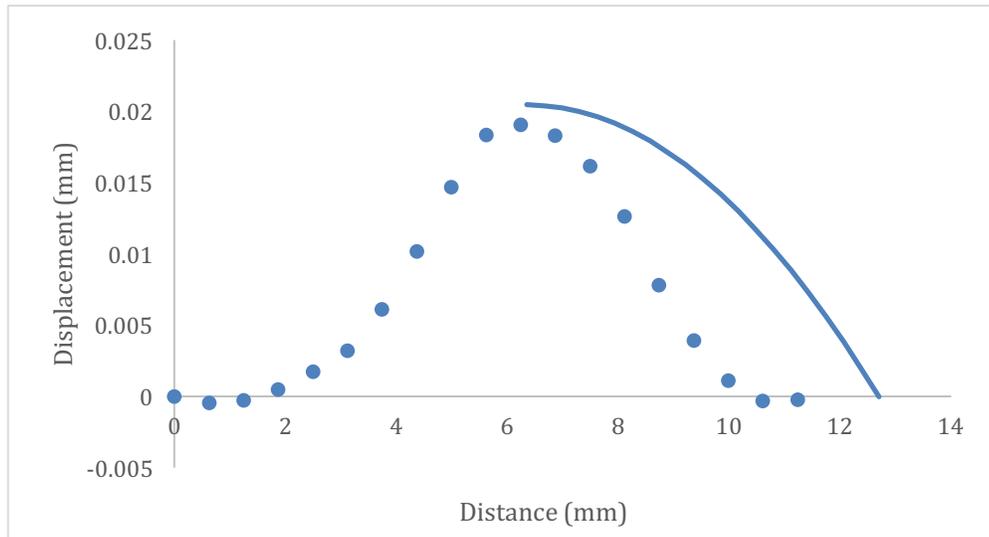
Figure 3: Preliminary comparison of analytically predicted deformation profile with profile measured from DIC.

Aside from the full-field measurements, DIC also allows us to extract profiles in displacement and strain. This is especially useful when comparing to FEA predictions. For example, extracting the out-of-plane displacement values along the centerline of the specimen allows us to make direct comparison with prediction from FEA or analytical models. For example, Figure 3 shows a preliminary comparison of the DIC-determined profile (points) with the predicted deformation profile from an

analytical prediction of displacement (solid line). The prediction and the measurement match quite closely with respect to the total displacement. However, this is a very preliminary comparison and more testing is needed to determine if the analytical model that underpins the leaking pipe design calculations actually capture the maximum deflections this accurately.
