# CAAP Quarterly Report

Project Title: *Scaling and Self-Sensing in Composite Repairs of Corrosion Defects*

Prepared by: *The University of Tulsa*

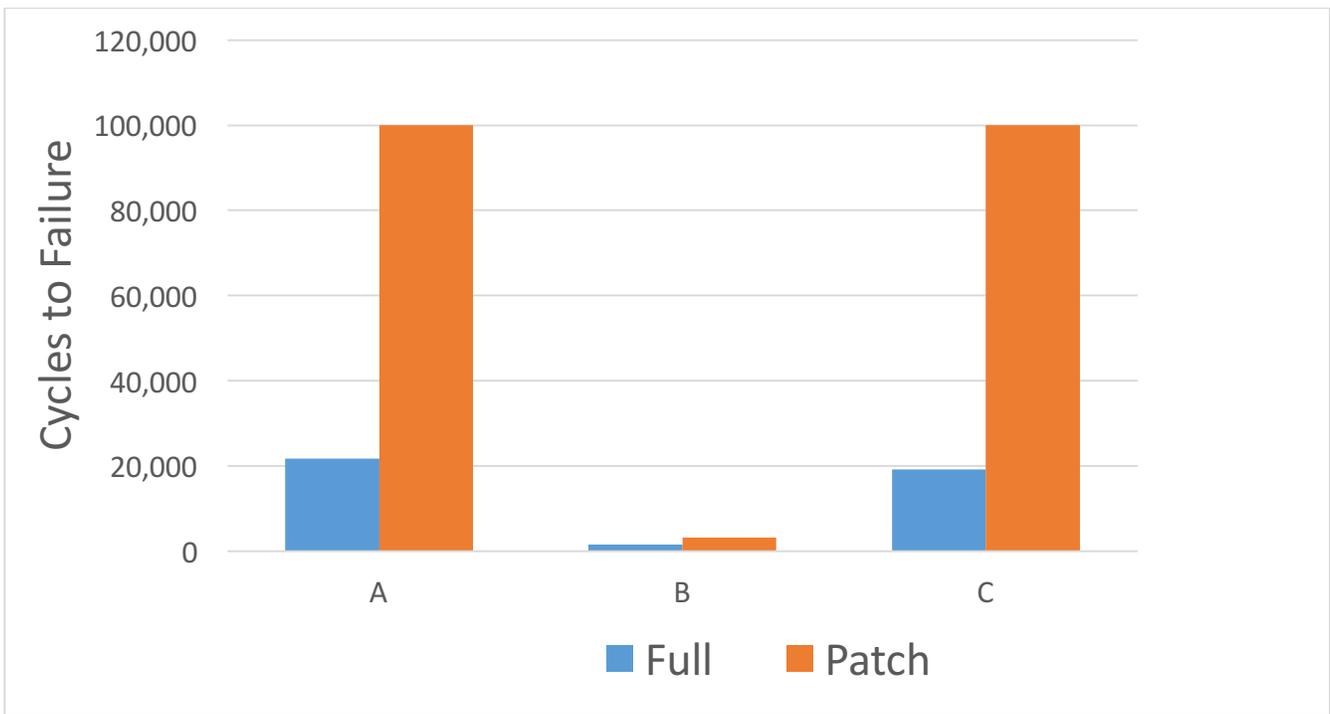
**Figure 1: Fatigue cycles to failure for patch and full encirclement repairs. Each bar represents the average of two specimens. Runout was 100,000 cycles.**

Small scale testing continued during this quarter and we have nearly completed the small scale testing for this project. The current results for the patch and full-encirclement repairs are given below in Figure 1. These results were conceptually surprising based on the initial discussion and general intuition when they were presented at a recent PCC-2 meeting. However, based on our initial FEA study, these results could be expected.

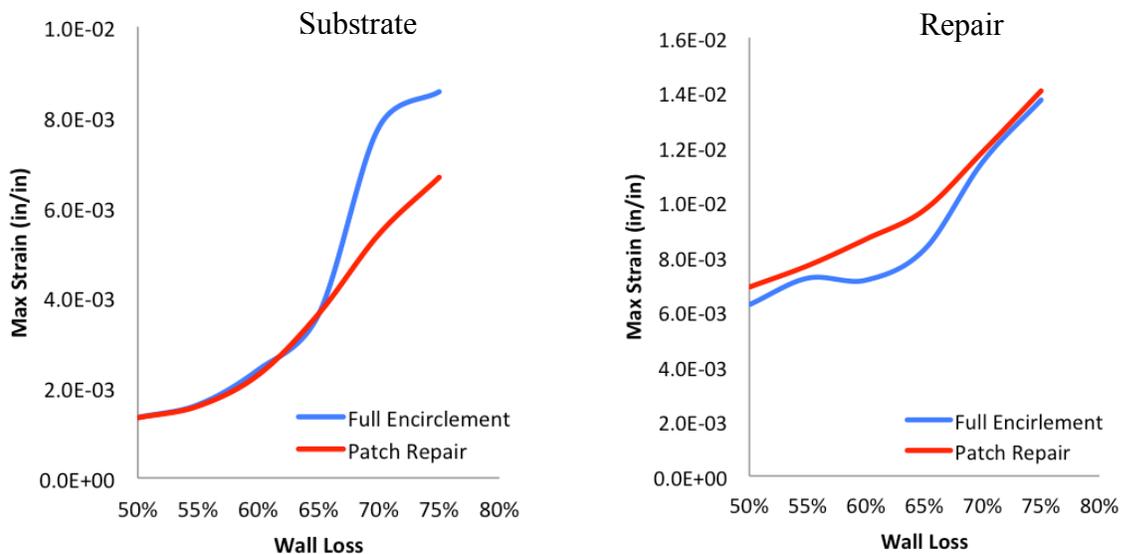
**Figure 2: Max strains in the substrate and repair as predicted by FEA.**

As can be seen from Figure 2, FEA predictions indicated that for the flaw studied in this project, 75% wall loss, the strains for full-encirclement repairs were actually higher. These same simulations indicated that the repair strains will be approximately the same for both patch and full encirclement repairs. Failure analysis on the fatigue specimens showed that pin-hole leaks formed in the damage area, which lead to the pin-hole repair failures. There were no catastrophic repair failures in this test. It appears that carbon repair systems perform better in this testing program, but the only non-carbon system does not include a primer, which may have impacted performance. We are currently running instrumented tests that should provide additional insight into the actual repair performance.

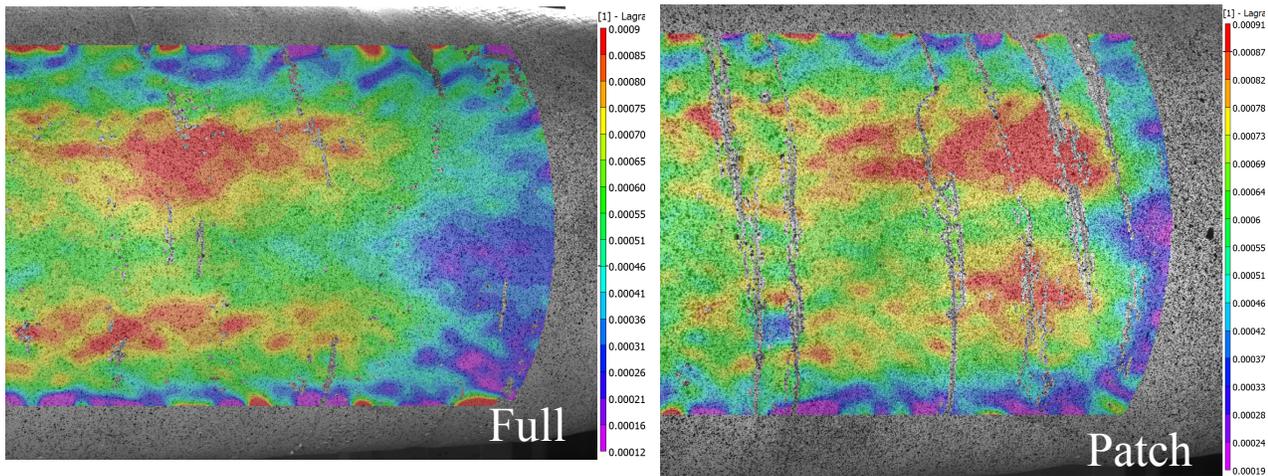
**Figure 3: Hoop strain fields for patch and full repairs at MAOP. Red color indicates a maximum strain of 0.09% in both images.**

We have completed an initial study of the full encirclement and patch repairs using digital image correlation. This was a challenging study since the repair surfaces were not particularly smooth. The impact of surface ridges can be seen in Figure 2 as uncorrelated stripes in the results. Regardless, the maximum strains measured in this analysis are approximately equivalent, which is in line with the FEA predictions in Figure 2. It is important to note that the FEA above was for a different repair thickness than the repair for which the results are presented. So while the strain trends are the same, the numerical values of the strains are different. Additionally, we see that the maximum strains are also located at the transition regions of the flaw, which would also be expected from a membrane deformation analogy. We are currently working with this data and the strain gage data that is being collected to understand the actual behavior of the repairs during fatigue.
