CAAP Annual Report

Project Title: *Patch and Full-Encirclement Repairs for Through-Wall Defects*

Prepared by: *The University of Tulsa*

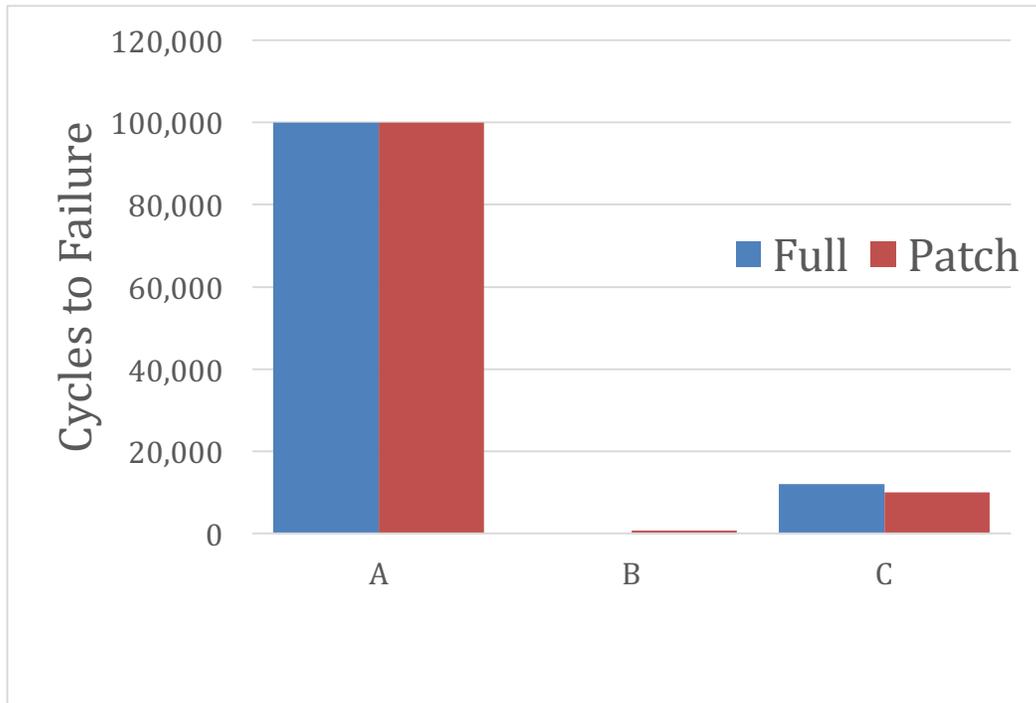
At the moment, we are testing the final specimens of the small scale testing. We had a pressure sensor failure which halted testing. We are waiting for a replacement sensor to arrive. The results of the fatigue testing to date indicate that the patch specimens do have slightly lower cycles to failure when compared to the full encirclement repairs. This behavior was captured in our earlier FEA studies that predicted the patch specimens would have higher strain levels. A summary of the testing is shown in Figure 1. One specimen set experienced runout and it is evident that each group took a different approach in determining the appropriate repair thickness. We have solicited information from all companies about their design process and are reviewing that information this quarter. At a minimum,

Figure 1: Cycles to failure of the completed specimens.

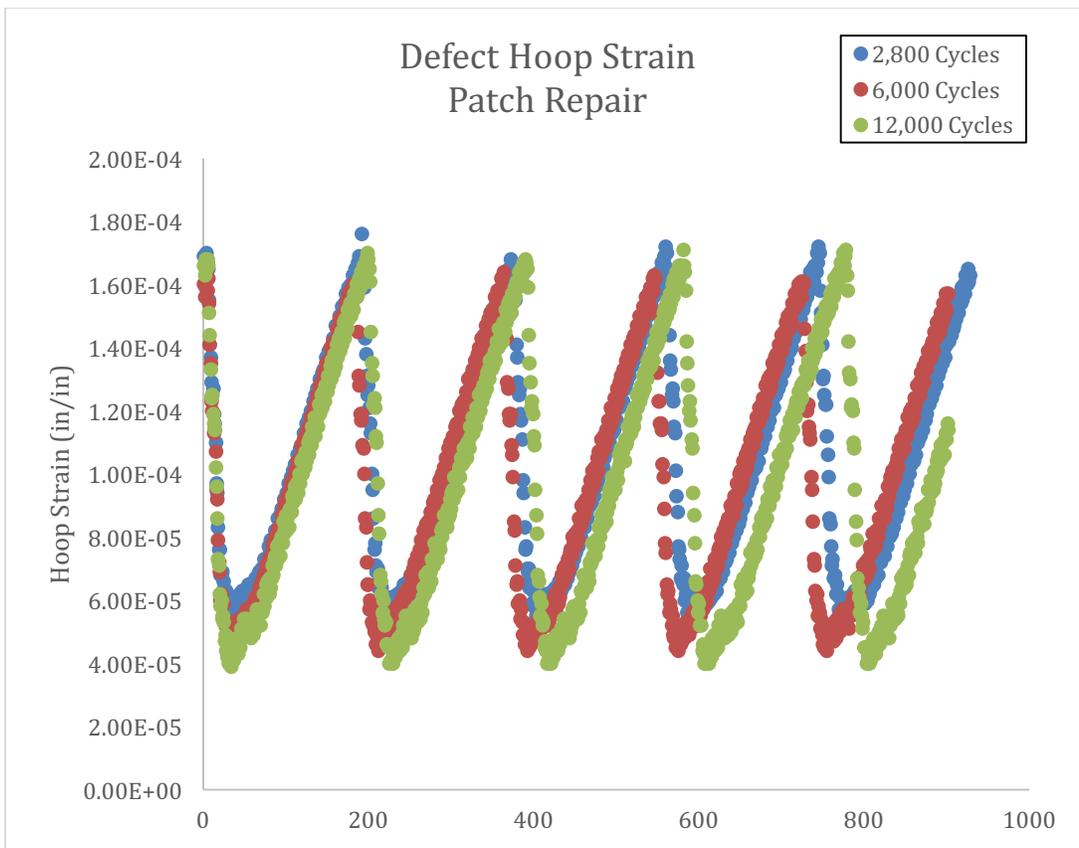
The strain gage testing is continuing as we finish up the small scale testing results. One of our main tasks is understanding the evolution of the strain levels as the testing progresses and to compare the strain levels between repairs. A representative data set for a patch specimen is shown in Figure 2. The data in this figure is for a strain gage applied over the defect region oriented in the hoop direction. Three sets of data are shown, four loops starting at 2,800 cycles, four loops at 6,000 cycles, and four loops at 12,000 cycles. The final data set is near the failure of this particular specimen. One of the interesting features of this data is that the strain appears to increase as the sample nears failure. This behavior could be consistent with a progression of an interfacial fatigue crack that does not allow the repair to return to the initial deformation state. There has been some debate about whether this repair will allow for any stable crack growth since through-wall defects are essentially in load-control fatigue. We are hoping to compare some of this data to DIC below to attempt to determine if there has been any crack growth.

Figure 2: Strain measurements for a strain gauge applied over the defect in the hoop direction for a patch repair. Each peak represents one pressure cycle.

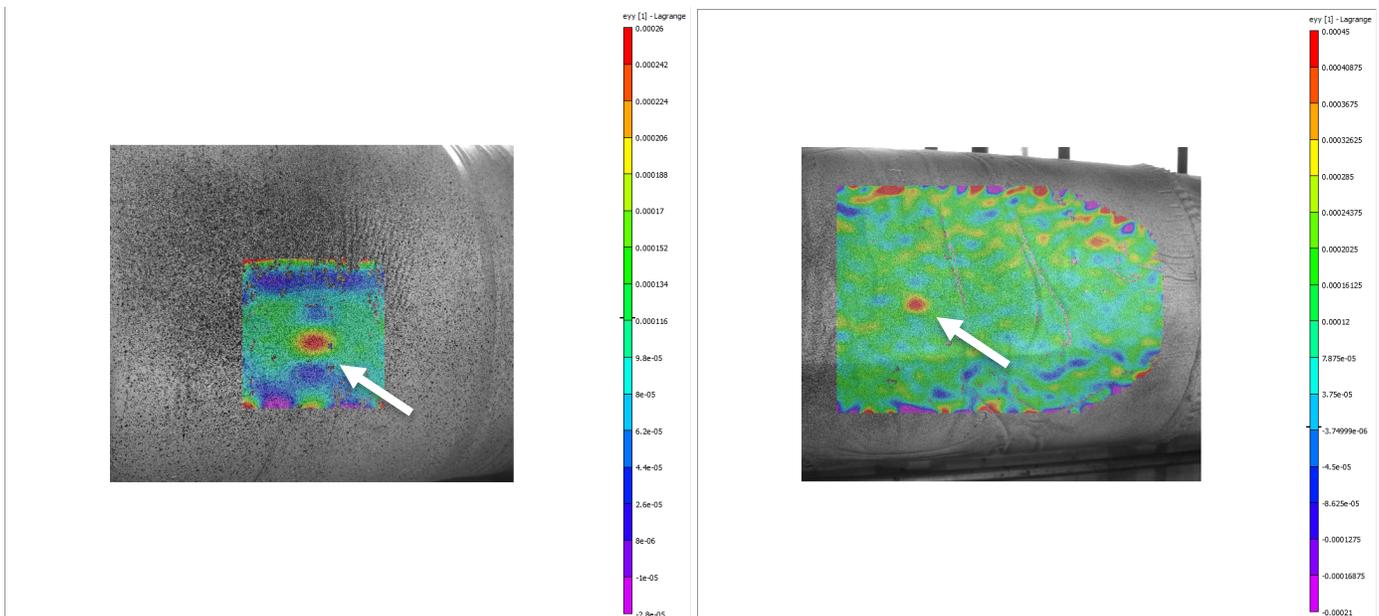
We have performed DIC testing on all three participants at this point. As expected, specimens that failed with fewer loading cycles tended to show higher strain levels during testing. For the specimen that experienced run-out, the strain levels were so low that they were not discernible above background noise during the testing. Other samples were identifiable and two representative testing images are

Figure 3: DIC results for two specimens. Through-wall defect is shown as a red spot in the center of the image. Indicated by an arrow in both images.

shown in Figure 2 with arrows indicating the location of the through-wall defect. In both images we are getting noise contamination from wrinkles in the surface of the repair. We are working on refining
