# CAAP Quarterly Report

Project Title: *Scaling and Self-Sensing in Composite Repairs of Corrosion Defects*

Prepared by: *The University of Tulsa*

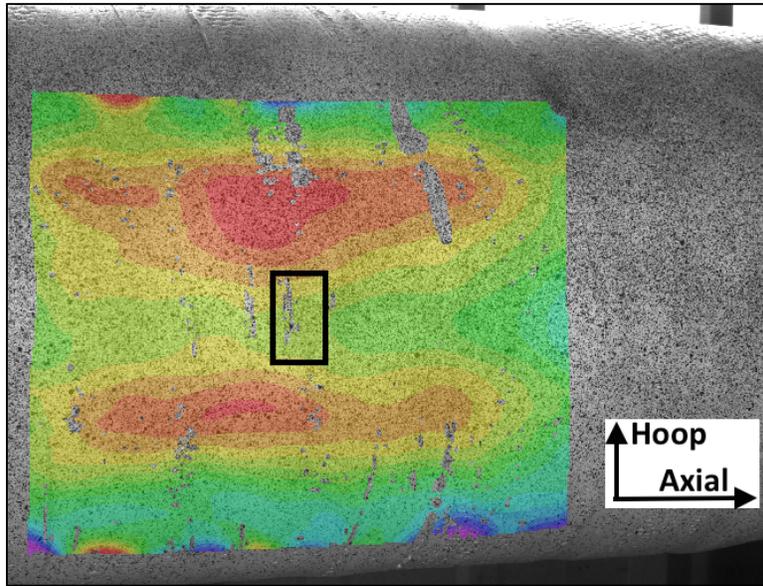
**Figure 1: DIC image of eye strain (hoop direction) from DIC analysis. Black box indicates approximate location of on-top of repair strain gage.**

The DIC study of all small scale specimens has been completed and we have had a chance to compare to strain data as well. One important point to note is that the location chosen for the strain gage was based on some historical decisions and is not the location of maximum strain. Figure 1 shows the DIC measured eye strain field for one specimen. The black box in this figure is the approximate location of the on-top-of-repair biaxial strain gage. This location is not in the region of highest strain, that region is located in the area immediately above the transitions from the thin region of the wall-loss defect to the remaining undamaged pipe. This is completely expected, but there have been several historical studies run with a gage in that location. We decided to locate the gage there to help with comparisons between the current study and historical studies.

Table 1 shows the difference between the strains measured in the region where the strain gage was located and the maximum strains in the repair. There is a large difference between these two values. These results indicate that a full-field understanding of the repair strains is helpful to identify the areas of most concern. Under-repair analysis of failure indicated that the substrate failure initiated at the transition region, as expected. Controlling the substrate strain in this region should be a priority for repair design. This is unaddressed in the design guidance at the moment. However, the large factors of safety in the repair designs do mitigate this concern.

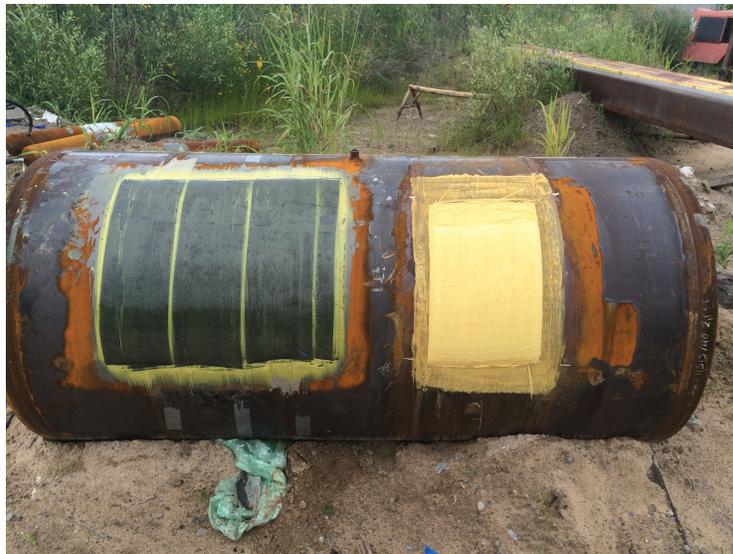
Figure 2: 42 inch vessel with installed patches.

Scheduling the repairs took longer than expected, but all companies have now installed repairs on the 42 inch vessel. Testing is expected to begin this quarter and should be completed before the end of august. Repairing failed sections is the most significant challenge, but stress analysis indicates that we can weld an 8 inch flange over the defect region to serve as a repair and to allow us to continue testing. Figure 2 shows the vessel with two of the three installed patches.
