# FINAL REPORT

Project Title: *Wall Break-through in Composite Repaired Defects*

Prepared by: *The University of Tulsa*

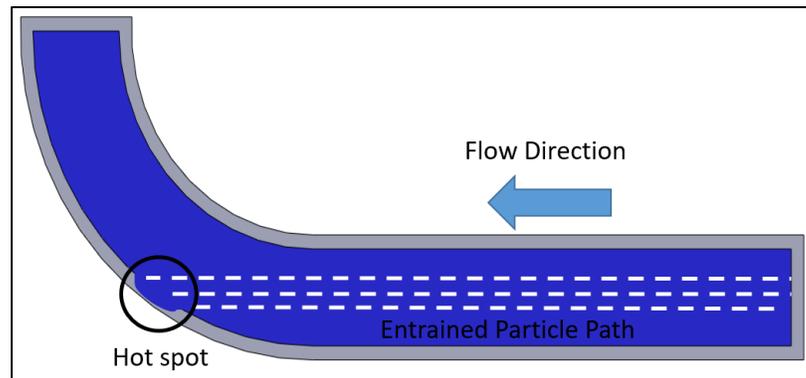
Figure 1.1: Erosion in bends

Erosion in transportation pipelines is most likely to happen in transitions and geometry changes. Bends act like concave mirrors and reflect the flow (with any entrained particles) to wear hot spots shown in Figure 1.1. Impacts between particles and bend walls can be at any angle between normal and parallel to the surface. The variation in impact angle can result in multiple erosion mechanisms which lead to cutting, deformation and ploughing wear for bends manufactured from ductile materials [1].

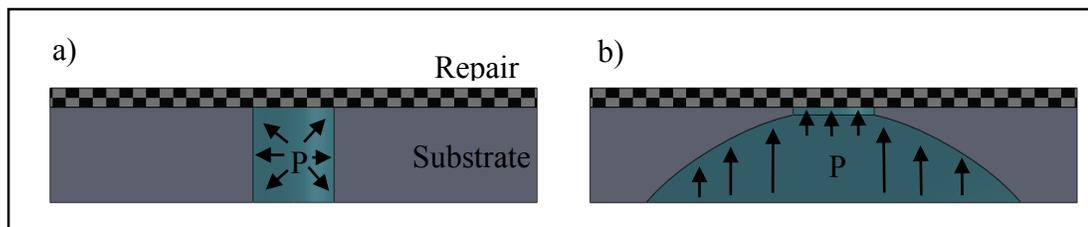
Figure 1.2: Geometries for drilled (a) and eroded defects (b)

Figure 1.2(a) shows the current model flaw geometry, which does not take into consideration that most flaws are not straight sided holes, but have regions of diffuse damage (b). The goal of this research is the comparison of repair performance on drilled and diffuse flaws generated through erosion. This comparison will be done in terms of failure pressure, out of plane displacement and strains at the defect location. To perform this comparison, both defects will be generated and repaired on straight and elbow specimens. Eroded defects will be generated using dry erosion directed to a fixed location until defect becomes through-wall. Performance of the repairs will be assessed using hydrostatic testing to determine the failure pressure for each specimen type. Digital image correlation (DIC) will be performed in the specimen in order to obtain displacements and strains to evaluate the repair response as pressure is gradually increased.

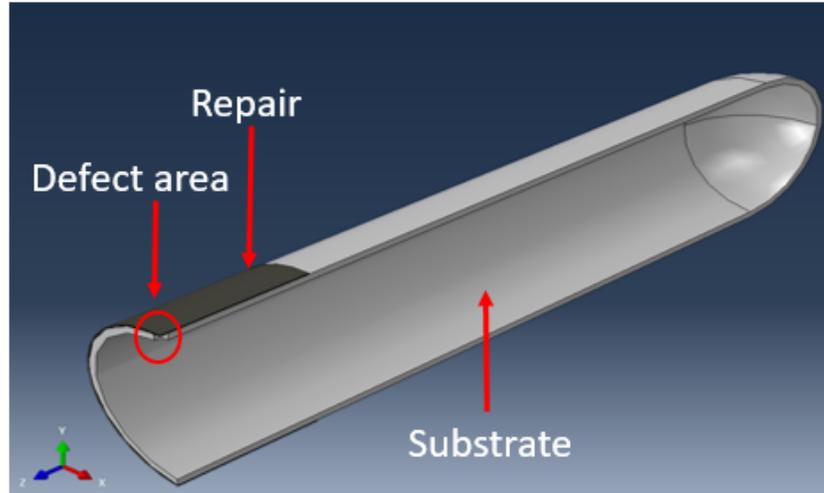
Figure 2.1: Geometry for straight specimens

The composite material was modeled as a linear-elastic, orthotropic material with material parameters taken from experimental data [16]. The steel substrate material model was a multi-linear elastic plasticity model calibrated using quasi-static tensile tests performed using coupons cut from representative pipe sections [17]. The dimensions for both straight and elbow specimens simulated corresponded to the experimental dimensions. For straight specimens, a 6 in diameter and 4 ft long pipe was simulated. In the case of elbows, a long radius 4 in diameter elbow with 1.5 ft straight sections welded at both ends was used. The composite layer that was assumed to be perfectly bonded to the substrate. Since both specimens have two axes of symmetry, a quarter model of the specimens was analyzed. Representative models are shown in Figure 2.1 for straight

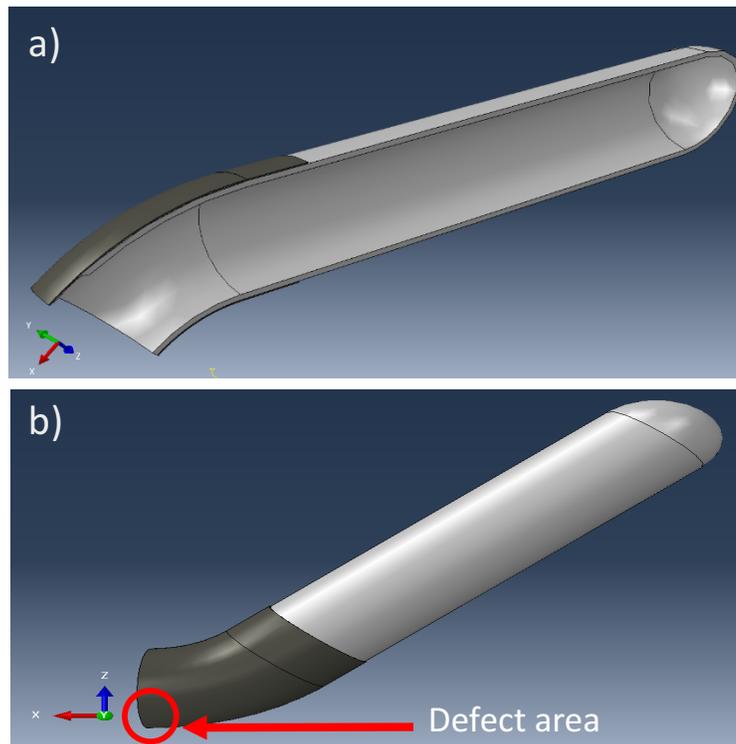
Figure 2.2: Geometry for elbow specimens. Isometric view (a) and top view (b)

specimens and Figure 2.2 for elbow specimens. Schematics of the simulated geometry for both types of defects can be seen in Figure 2.3.

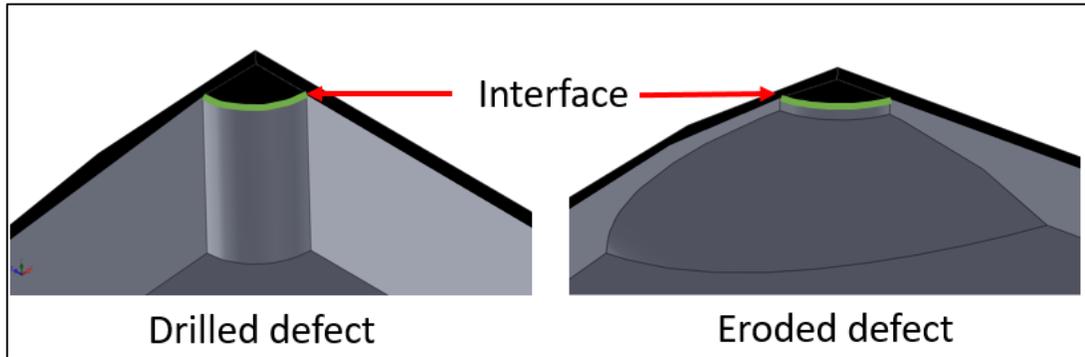
Figure 2.3: Detail in the defects

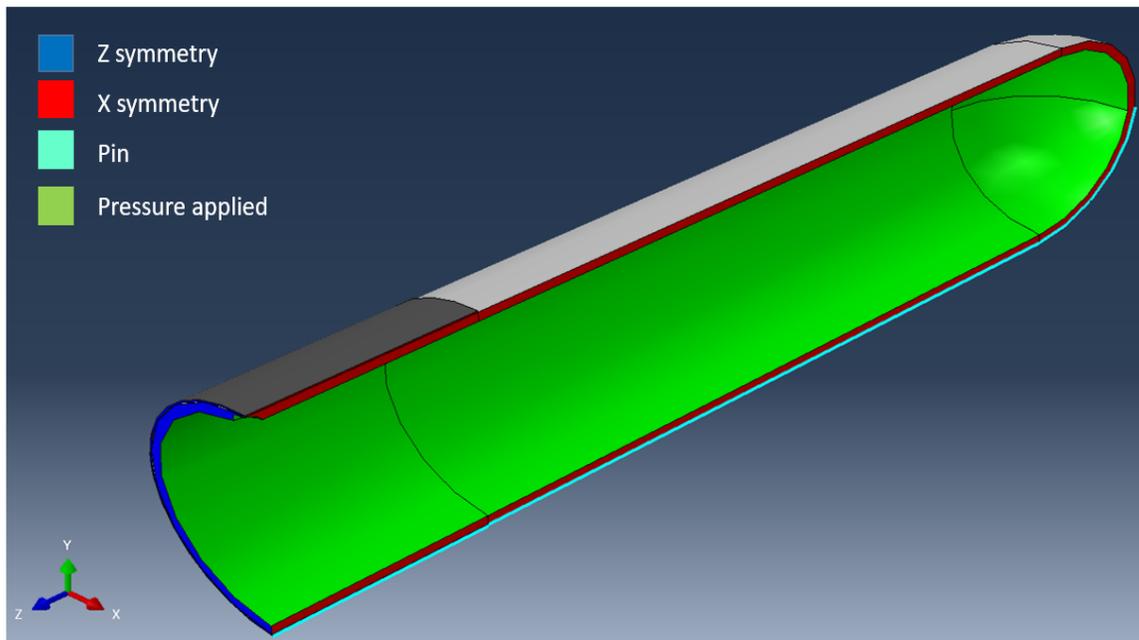
Figure 2.4: Boundary conditions and load for straight pipe

Three boundary conditions were applied to the model. Two edges were modeled with symmetry conditions applied to faces in x and z directions. The bottom edge was pinned to simulate the pipe being attached to the ground. A pressure load was applied to

all internal faces. A schematic representation of the boundary conditions and loading are shown in Figure 2.4.

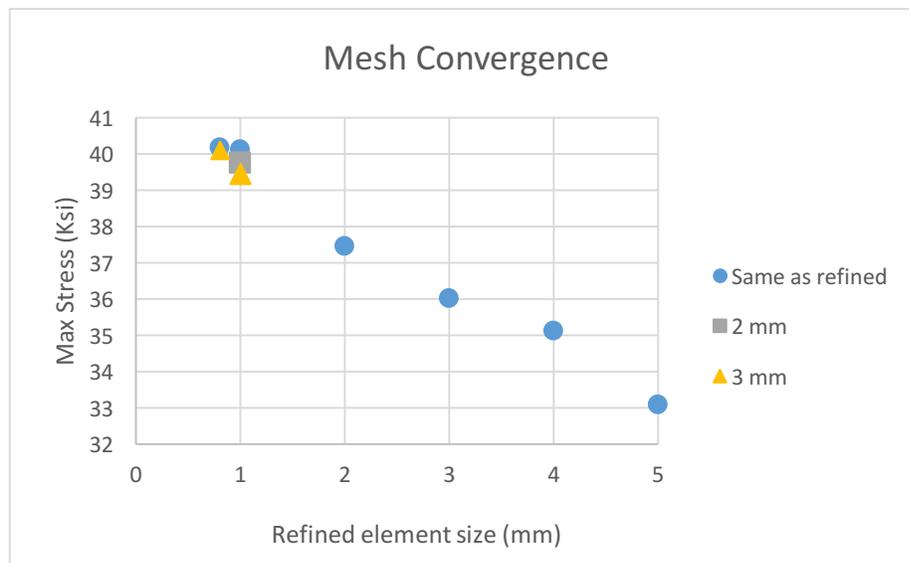
Figure 2.5: Mesh convergence study

A mesh convergence study was performed in order to determine a suitable mesh size. For this study, the same element size was applied to the whole system. The mesh was considered converged once the change in maximum stress was less than 1% regardless the element size. An additional convergence study was performed for a model with a local mesh refinement. For this model, the mesh was refined in the area around the hole and a larger general element size applied to the rest of the pipe. An acceptable result was obtained when the refined element size was 0.8 mm and the general size was 3 mm as seen in Figure 2.5.

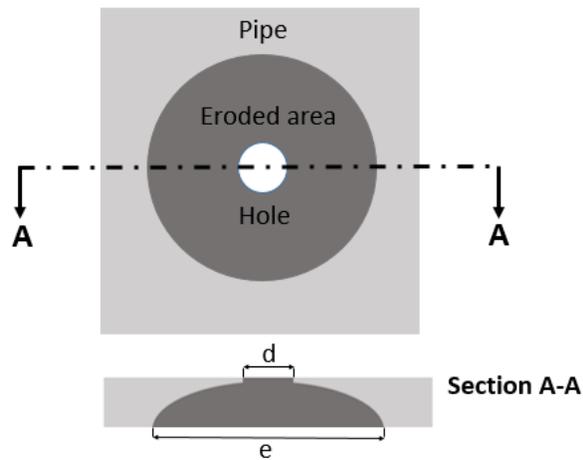
Figure 2.6: Damage size schematic

Diffuse defects with six different extensions and a drilled defect were simulated to investigate the effect of the size of the diffuse area on the performance of the repair. The diameter of the hole was kept constant and the changing parameter was the diameter of the damaged area. A schematic view of an example defect geometry is illustrated in Figure 2.6 where the defect diameter (e) around the hole is five times the hole diameter (d). Opening strains  $\varepsilon_{22}$  were obtained at the interface between the repair and the substrate. This interface was of primary interest because it is where the crack is expected to initiate and grow.

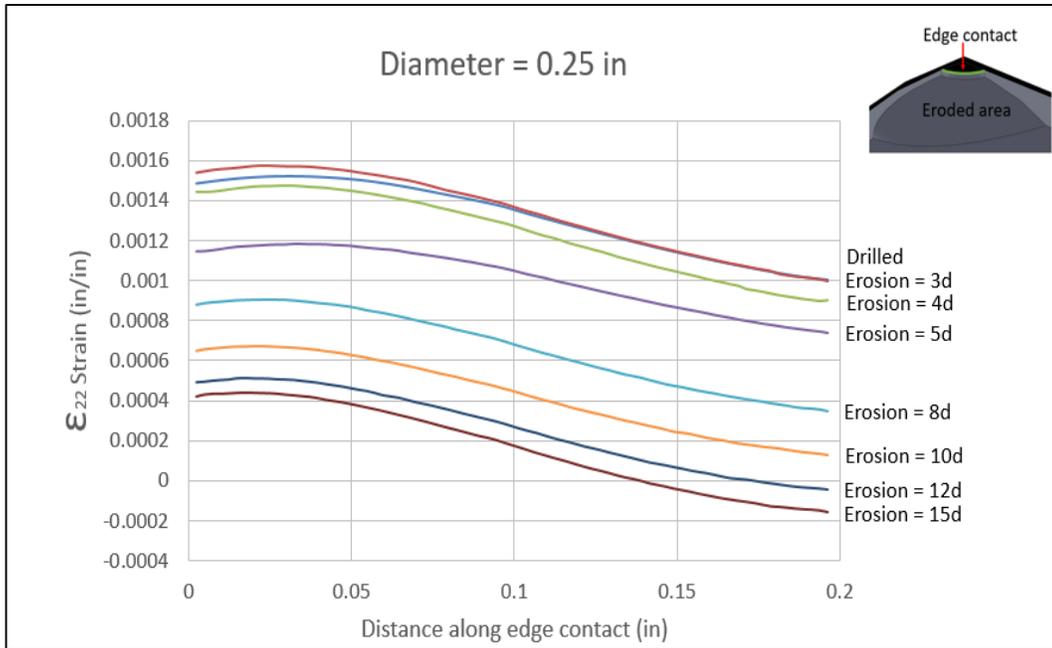
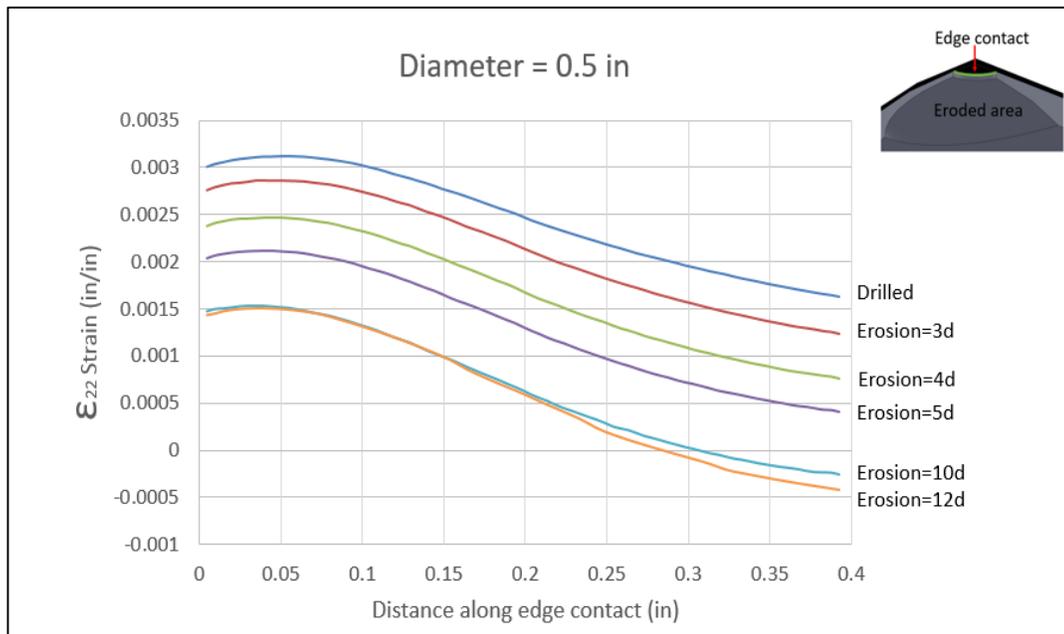
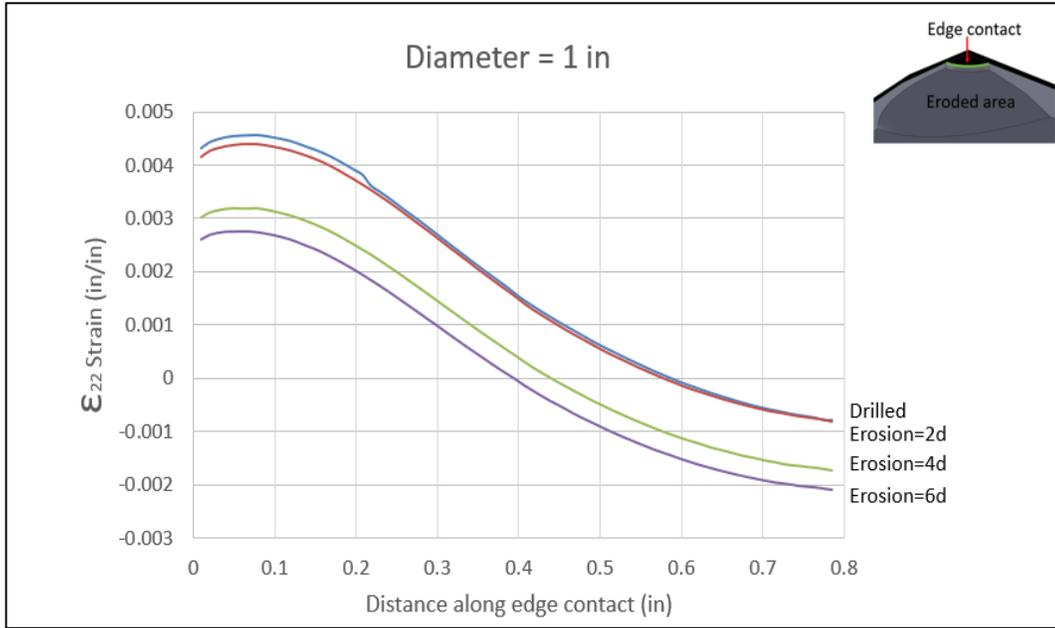
Figure 2.7: Opening strains at the interface for straight pipe with hole diameter = 0.25 in

Figure 2.8: Opening strains at the interface for straight pipe with hole diameter = 0.5 in

Figure 2.9: Opening strains at the interface for straight pipe with hole diameter = 1 in

As seen in Figures 2.7 through 2.9, the trend shows that as the damage area increased, the opening strains decreases. This may be due to the deformation of the thin remaining wall at this location. The applied pressure could be producing additional compression, which would tend to reduce the opening strains. However, there is a non-physical behavior represented by the cusp at the beginning of the contact edge at the symmetry conditions. This behavior is not present in a similar geometry for the elbow specimens presented later and could be caused by the boundary conditions defined in the model. Additional studies are being performed to determine the cause of this behavior. After the diameter of the eroded area approaches 10 times the diameter of hole, the strains become insensitive to the size of the erosion. This may indicate that damage that extends far away from the hole does not have any influence on the repair performance.

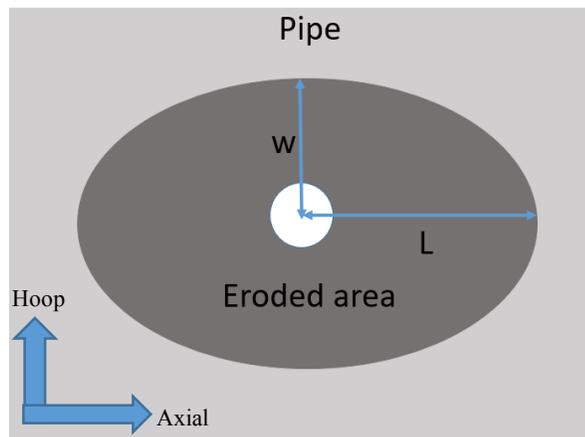
Figure 2.10: Erosion shape scheme

In addition to studying the impact of symmetric variation of erosion around the defect site, the effect of the shape of the eroded area was also studied. Figure 2.10 shows the dimensions used in this study. For this case,  $W$  was kept constant with a value of 5 times the radius of the hole and the  $L$  value of was increased from 1.4 to 9 times the value of  $W$ . This study was motivated due to most erosion patterns found in practical applications and literature had an irregular shape, in most cases similar to an ellipse.

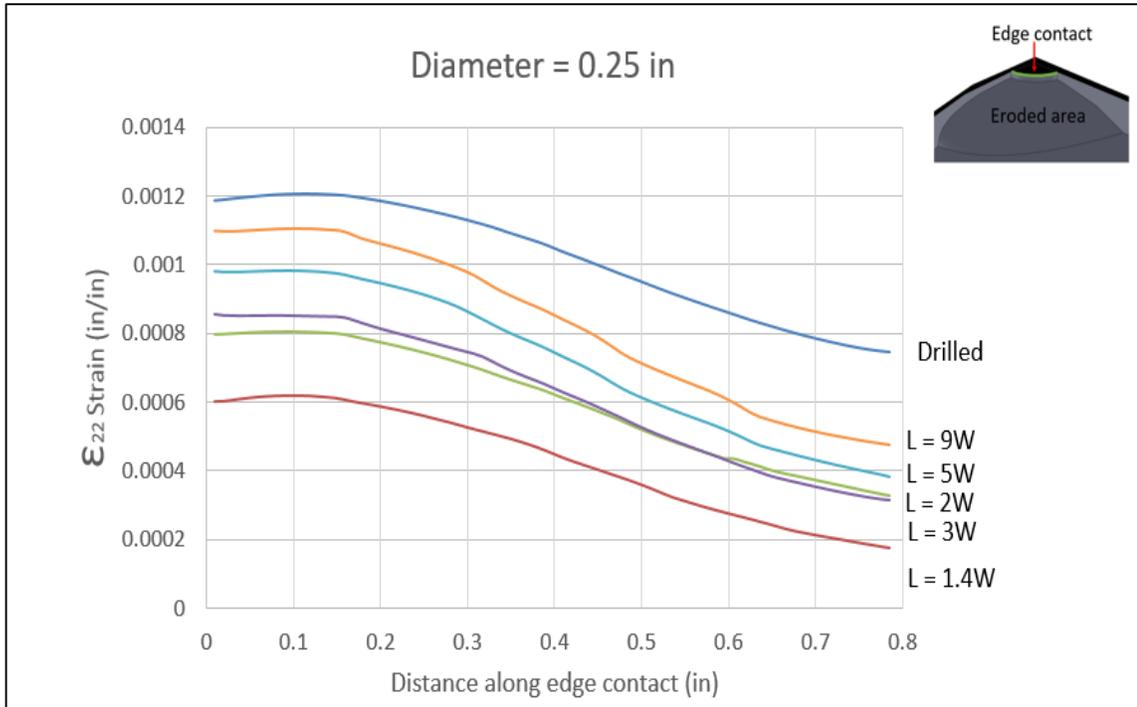
Figure 2.11: Opening strains at the interface for straight pipe with a hole diameter = 0.25" for shape study

As shown in Figure 2.11, the opening strains increase when this ratio increased. One possible explanation for this behavior is that as the defect becomes longer in the axial direction, the substrate tends to deform in the opposite direction of the repair. The deformation is such that the substrate pulls inward from the outward deflection of the repair, increasing the opening strains. An example of this behavior is shown in Figure 2.12(a) where the pipe is deforming inward while the composite is being pushed outward by the internal pressure. This w shape at the defect location was also obtained experimentally in a pressurized the vessel as shown in Figure 2.12(b). Both the FEA and

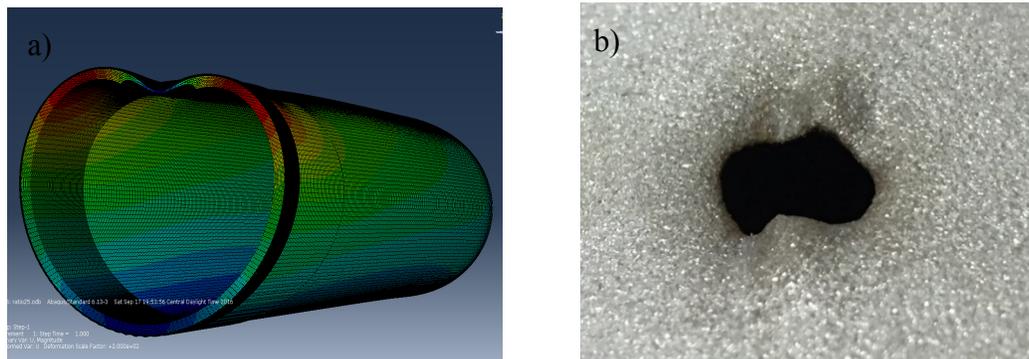
Figure 2.12: Comparison of FEA (a) and experimental results (b) for straight pipe

the experimental test were performed under the same erosion extent and pressure equal to 700 psi.

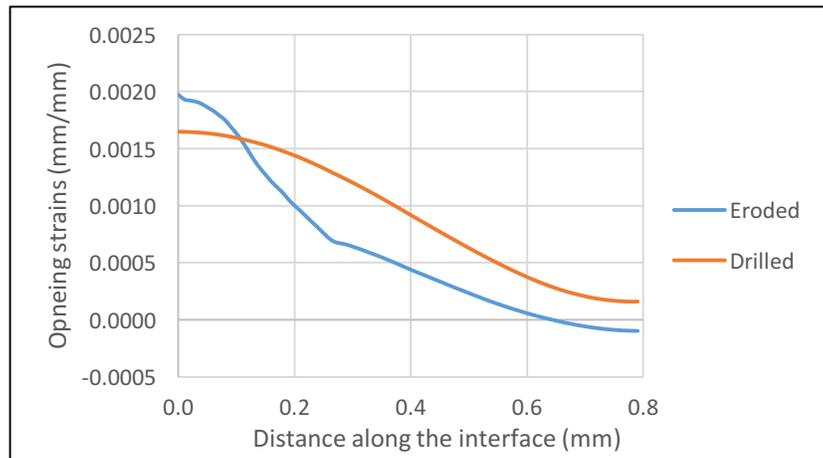
Figure 2.13: Opening strains for elbow assemblies

Opening strains were obtained along the interface between the repair and the substrate. The through-wall defect had a 6.35 mm (0.25 in) diameter at the outer surface of the pipe. In the case of the eroded defect, the damaged area modeled was an ellipse, with the eroded area extending 48 mm in the axial direction and 24 mm in the hoop direction. An ellipse was selected since in most real cases, erosion in elbows takes an elliptical shape [18-19]. A four-layer composite repair was simulated with a total thickness of 1.57 mm. For the analysis presented below, the internal pressure in the elbow was 1000 psi. Similar boundary conditions as used for straight pipes were applied.

Figure 2.13 shows the difference in strains for both defects. For the case studied here, the strains were higher for eroded defects in the critical section of the interface as shown in Figure 2.14(a). These higher strains are likely the result of substrate deflection in the opposite direction than the repair in that section of the interface. However, in the rest of the interface, strains are higher for the drilled defects. These higher strains for drilled defects in the non-critical section of the interface are probably due to thin wall deformation in the same direction of the repair as shown in Figure 2.14(b). As will be discussed below,

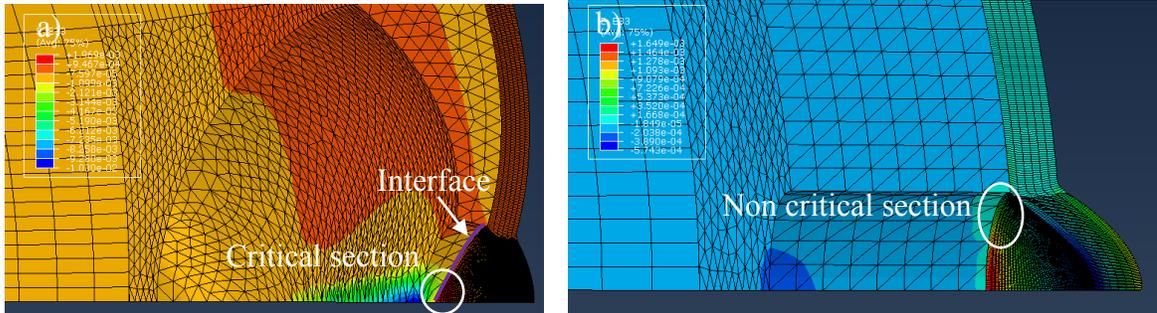
Figure 2.14 Strains at the interface for eroded and drilled defects in elbows

the higher strains in the critical segment of the interface observed in the simulations were correlated with lower failure pressures in the experiments for eroded flaws.

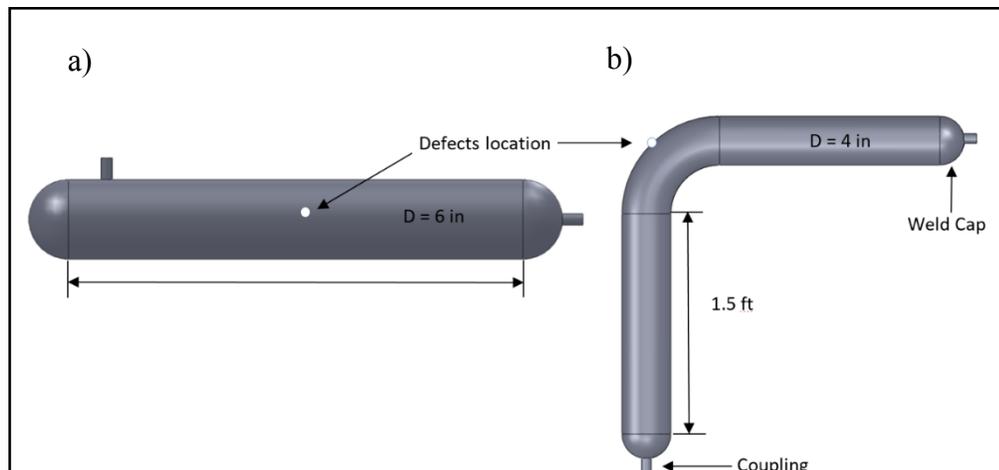
Figure 3.1: Assembly geometry for straight specimens (a) and elbows (b)

In this work, two different geometries were used, a straight specimen and a long radius elbow specimen. For both specimens, the material used was carbon steel ASTM A106b SHC 40 with a specified minimum yield strength (SYMS) equal to 42,000 psi and a wall thickness of 0.28 in. Dimensions and quantities for those specimens are shown in Figure 3.1 and Table 3.1, respectively.

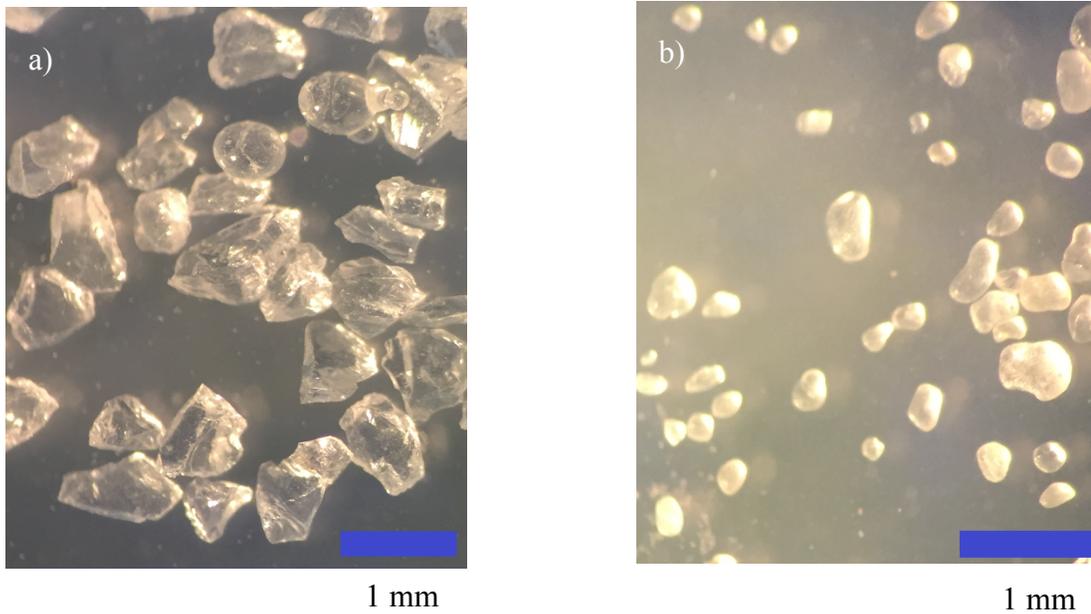
Figure 3.2: Ground glass (a) and sand (b)

particles. The difference in shape between angular and rounded particles causes a resulting greater difference in erosivity [20]. Since the objective was to create the erosion process as fast as possible, ground glass was chosen as the erodent. As Figure 3.2 shows, ground glass (a) has more angular shape than sand used for this study (b).

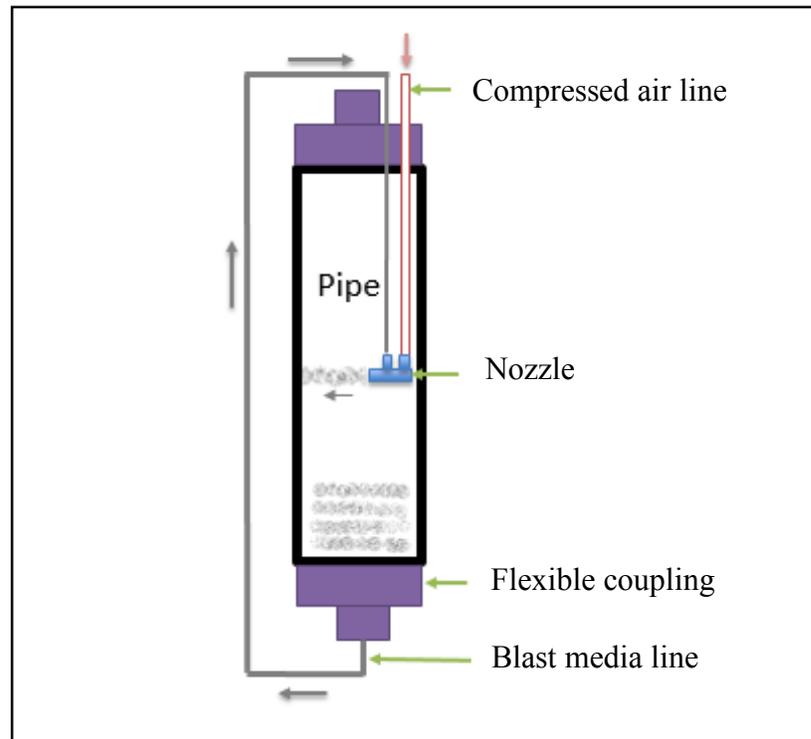
Figure 3.3: Schematic to create erosion on straight specimen

A diffuse flaw was generated using dry erosion. Since the sample was too long to fit in a commercial blast cabinet, a facility was built to produce the erosion in the pipe. A custom-built nozzle was designed to achieve high particle velocity (in the range of 30 m/s) to ensure that the erosion process was completed in a reasonable amount of time. The time between the initiation of erosion to wall-break through was approximately eight hours. Dry compressed air was used as the gas stream. Flexible couplings at the top and the bottom

sealed the pipe, so the blast media could be re-circulated giving a closed loop erosion system. Flaws were produced by eroding in a specific location until a through-wall defect of approximately 0.25 in was formed. The eroded area produced by this method was similar to a circle. The location of this defect was in the middle of the pipe length to reduce the effect of the end caps on the loading. Figure 3.3 shows the schematic for the set-up.

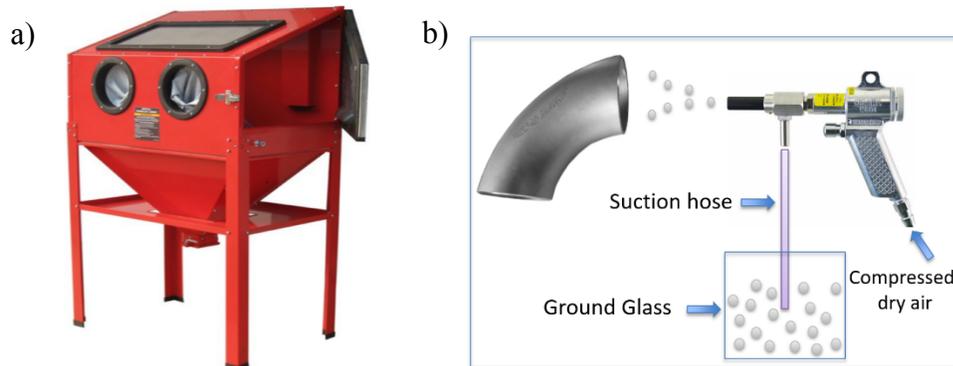
Figure 3.4: Blast cabinet (a) and schematic for nozzle inside the cabinet (b)

Since the elbows were physically smaller, the erosion was performed inside a commercial blast cabinet as shown in Figure 3.4(a). As in the case of the erosion for straight pipes, the blast media was ground glass and dry compressed air was the gas stream. Inside the cabinet there was a nozzle connected to a compressed air line. Both the nozzle and the

elbow were fixed to ensure erosion occurred in the same spot, and the distance between the tip of the nozzle and the impact zone was fixed at 7 inches (b). Since this was a closed cabinet, the blast media fell back into the reservoir after impacting the elbow and could be recirculated. The location of the defect was centered in the elbow as shown in Figure 3.5. This location was chosen based on previous experience with defects from the field.

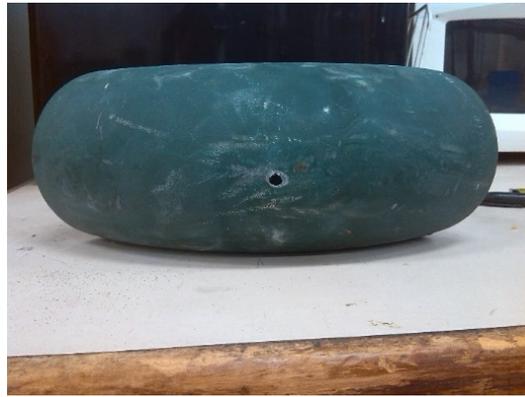
*Figure 3.5: Defect location in elbows*

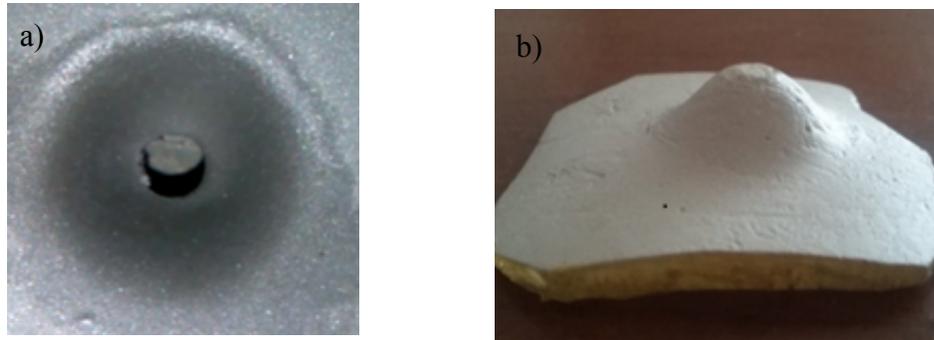
Figure 3.6: Erosion generated inside a straight pipe (a) and defect mold (b)

made of the flaw to allow for characterization via 3D profilometry. To fabricate this mold, the area near the through-hole was sealed using plastic film, and then a liquid epoxy was poured into the flaw and allowed to cure. Figure 3.6 shows the erosion generated inside the straight pipe by ground glass (a) and the mold once it cured (b).

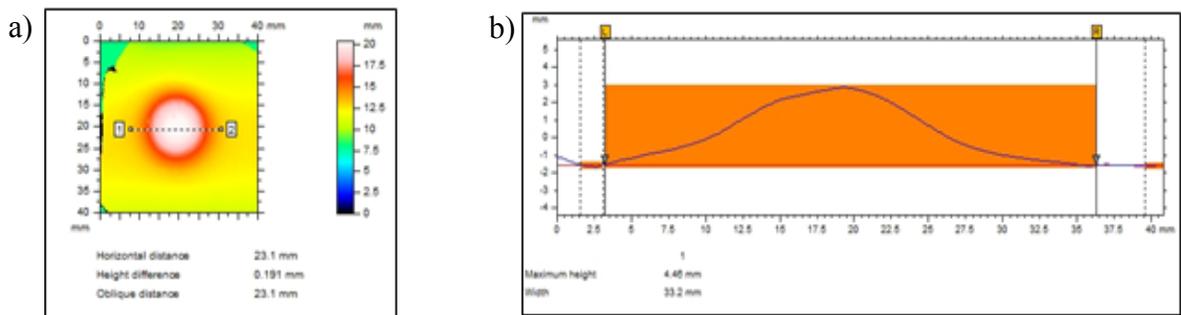
Figure 3.7: Profilometer plots: Top view (a) and side view (b)

After curing, this mold was analyzed using optical profilometry. Figure 3.7 shows both the top (a) and the side view (b) of the eroded area. Based on the measurements, the erosion process generated a circular flaw centered around the through-wall penetration. The profile of the erosion area had a tapered and diffuse shape. This confirmed that appropriately shaped flaws were achievable using the erosion process described above.

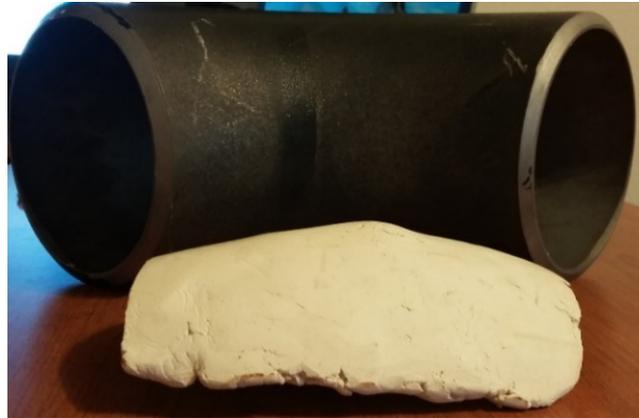
Figure 3.8: Defect mold for elbow specimens

Figure 3.8 shows the mold, which was made with clay. Figure 3.9 shows the line from which the measurement was extracted (a) and the results (b). From the results, a little change in slope which indicates where the erosion initiates can be seen. Based on this measurement, the eroded area is an ellipse with dimensions of 48 mm along the axial direction and 24 mm in the hoop direction.

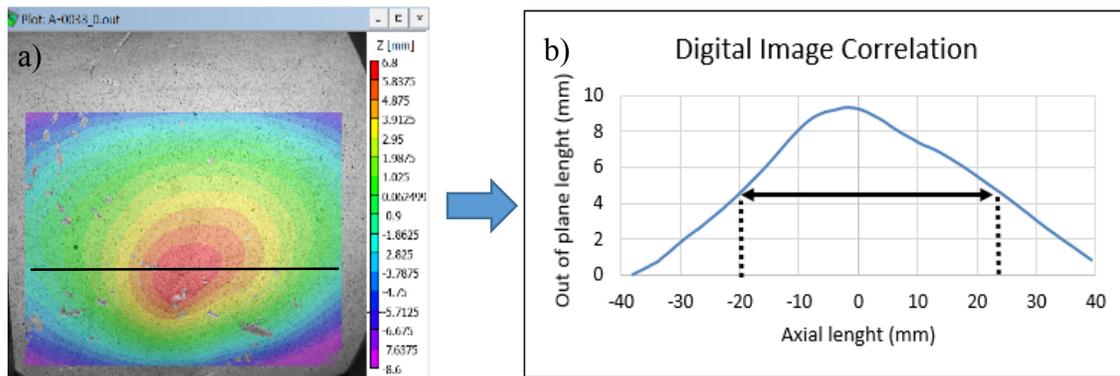
Figure 3.9: Digital image correlation extraction line (a) profile measurement (b)

For elbows, the molding process had to be modified since the defect was located on a curved surface and there was a very smooth transition to the eroded area. This generated a flaw that exceeded the measurement capabilities of the profilometer. Digital image correlation (DIC) was chosen to perform shape measurement on the mold. This method will be described later in this chapter. This mold was bigger than the straight ones in order to be able to detect the small change in slope which indicated where erosion starts.

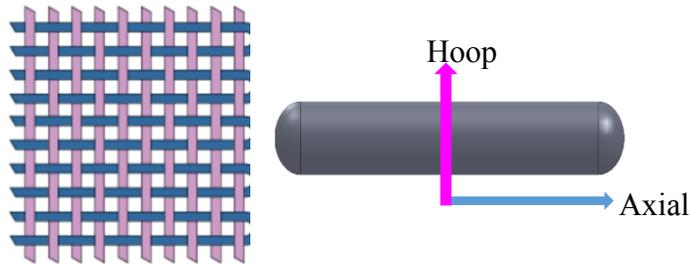
Figure 3.10: Plain wave structure of the carbon fiber

The composite repair system used in this study was based on a carbon fiber reinforcement with a plain weave structure as shown in Figure 3.10. In plain weave, the bundles are aligned so they form a simple cross-cross pattern. Each hoop thread crosses the axial threads by going over one, then under the next, and so on. For straight pipes, a 6k

x 3k fabric was used, which means it has 6000 fibers in the hoop direction and 3000 fibers in the axial direction for every bundle. This fabric was 10 in wide. For the elbows, a 3k x 3k fabric that was 2 in wide was used.

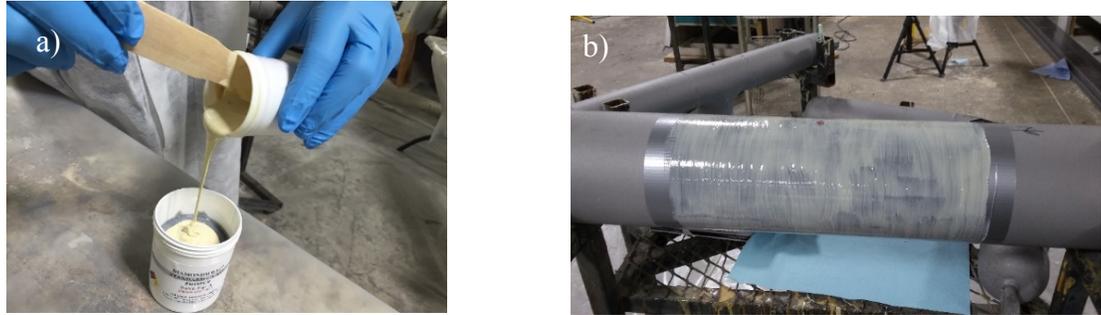
Figure 3.11: Mixing (a) and application of the primer to the substrate (b)

Just prior to installation of the composite repair, the substrate is cleaned with isopropyl alcohol to reduce any surface contaminants. The first step of a repair application is to mix and apply the primer as shown in Figure 3.11. Both the resin and the hardener are stirred independently before mixing with each other (a). The primer is applied with a brush and extends approximately two inches from each side of the repair to ensure complete coverage of the area under that repair (b). The repair used was 10 in long, so the total length of applied primer in the axial direction was 14 in.

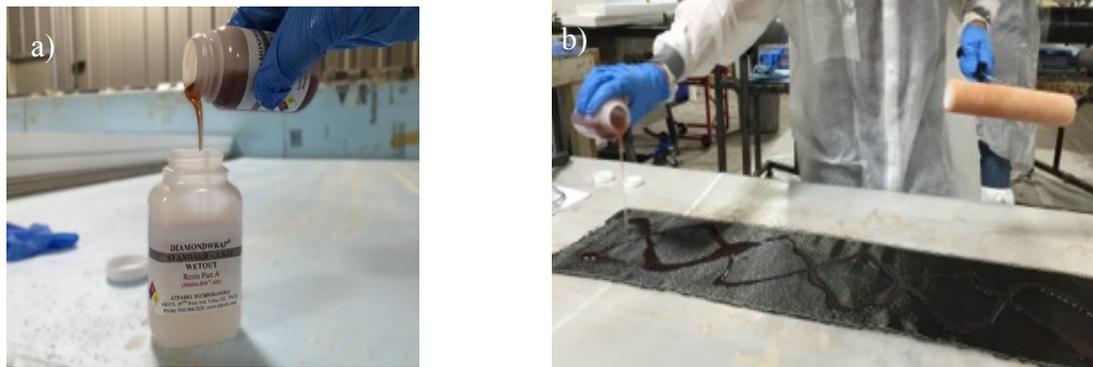
Figure 3.12. Mixing (a) and application of the matrix to the reinforcement (b)

After the primer is applied, the resin and hardener of the wet out epoxy are mixed and applied to the carbon fiber as shown in Figure 3.12(a). In order to saturate the carbon fiber and to avoid any dry spots, a paint roller was used to evenly distribute the epoxy over and through the reinforcement (b).

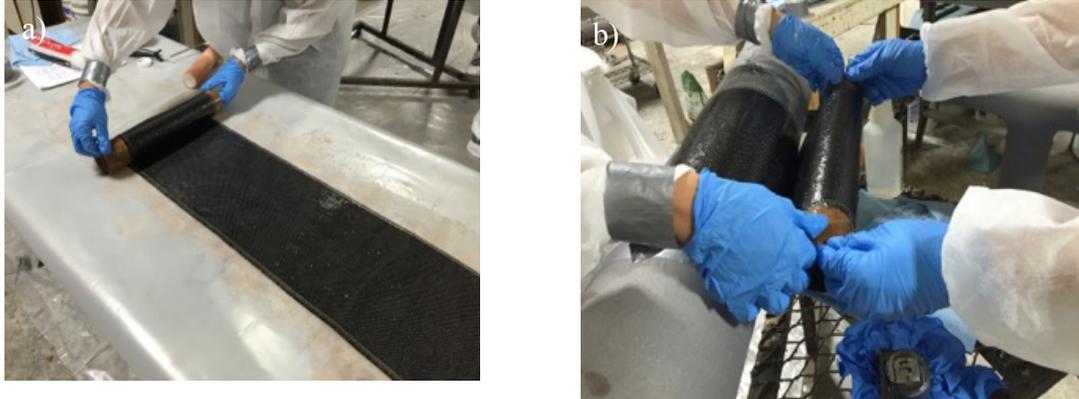
*Figure 3.13: Rolling (a) and application of the reinforcement to the substrate (b)*

The final step is to roll the carbon fiber into a tube and apply it to the pipe as shown in Figure 3.13(a). The procedure for applying the repair is to wrap the saturated reinforcement around the pipe, with the center of the repair aligned with the center of the

defect (b). During the overwrapping process, a small amount of tension is applied to the composite to ensure that no voids are between the layers of repair.

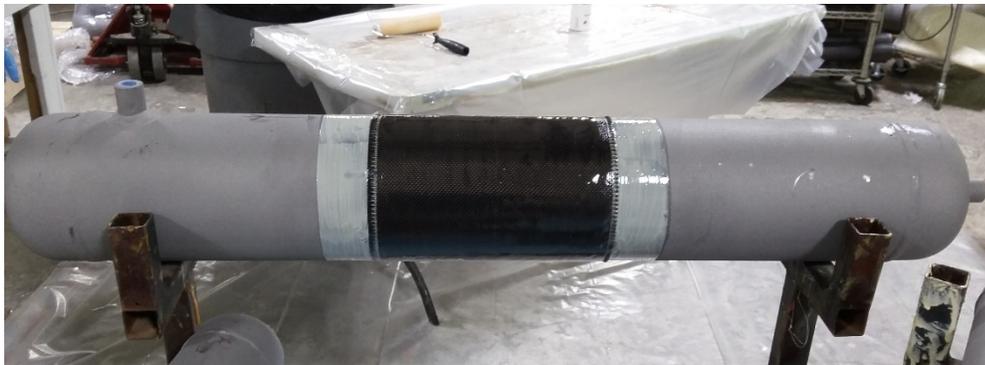
*Figure 3.14: Fully repaired substrate*

After the composite is installed, the repair is allowed to cure for at least 48 hours at room temperature. Figure 3.14 shows a fully-repaired specimen.

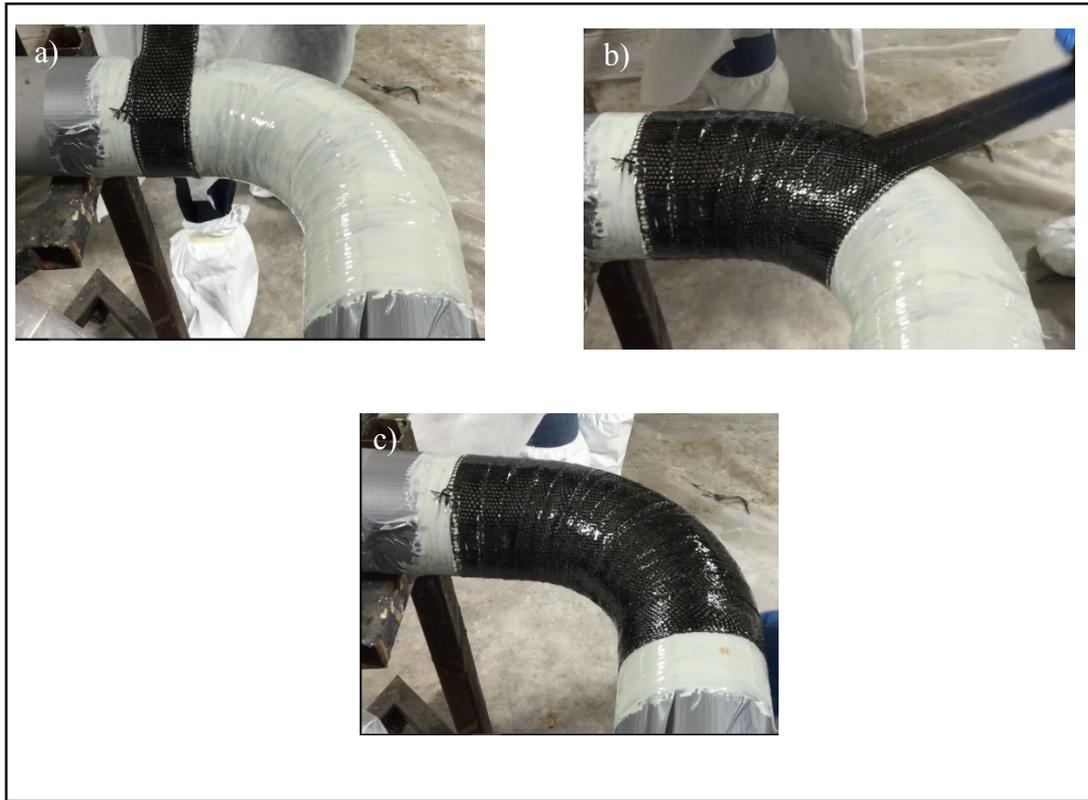
*Figure 3.15: Spiral application method*

The basic installation procedure for elbows is the same as in straight pipes. Because elbows are not a regular shape, the overwrapping procedure is accomplished by a spiral technique. Figure 3.15 depicts the steps in a spiral wrap repair installation. The first step is

to apply a full overlap layer (a) and then start turning by 50% overlap (b) in the centerline until it reaches the other end (c). Each pass provides a two-layer repair. For a four-layer repair, two passes are necessary. Each pass starts from opposite sides.

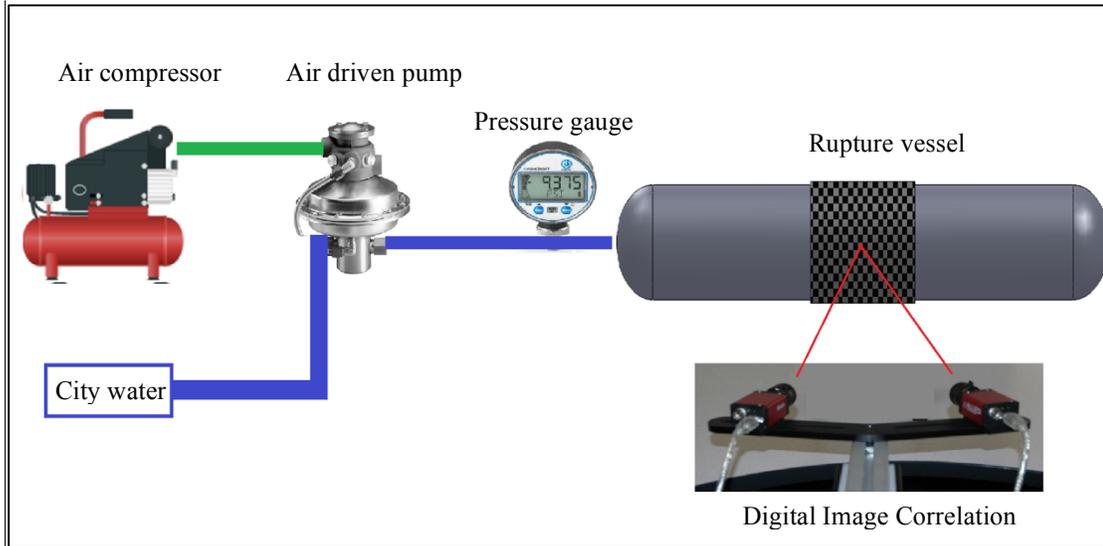
Figure 3.16: Hydrostatic pressure test set-up

Burst testing was performed using a hydrostatic pressure test. Test specimens were filled with water and then pressurized until failure using an air driven hydraulic pump (Sprague S216J100) as shown in Figure 3.16. Pressure was applied at a rate of 100 psi every 15 seconds. Once the failure occurred, the maximum pressure was recorded using a digital pressure gage with a memory function. Simultaneous with hydrostatic pressure testing, Digital image correlation was performed on the area around the hole. DIC was used

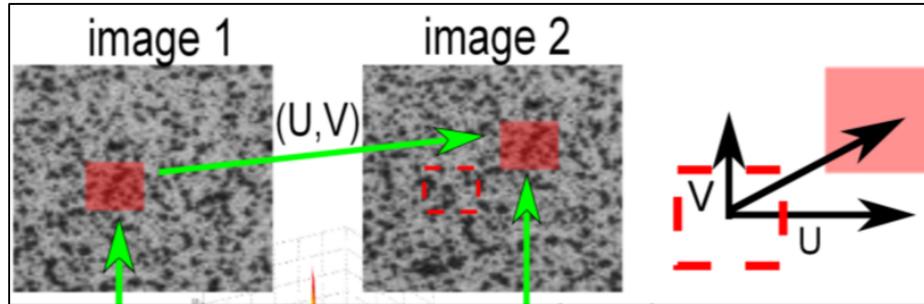
Figure 3.17: Digital image correlation algorithm

Digital image correlation (DIC) is a full-field image analysis method widely applied in many areas of science and engineering. This is typically used to measure deformation, displacements and strains. High speed cameras covering the same area are used to capture the change in position of a black and white speckle pattern applied to an object that is under load as shown in Figure 3.17.

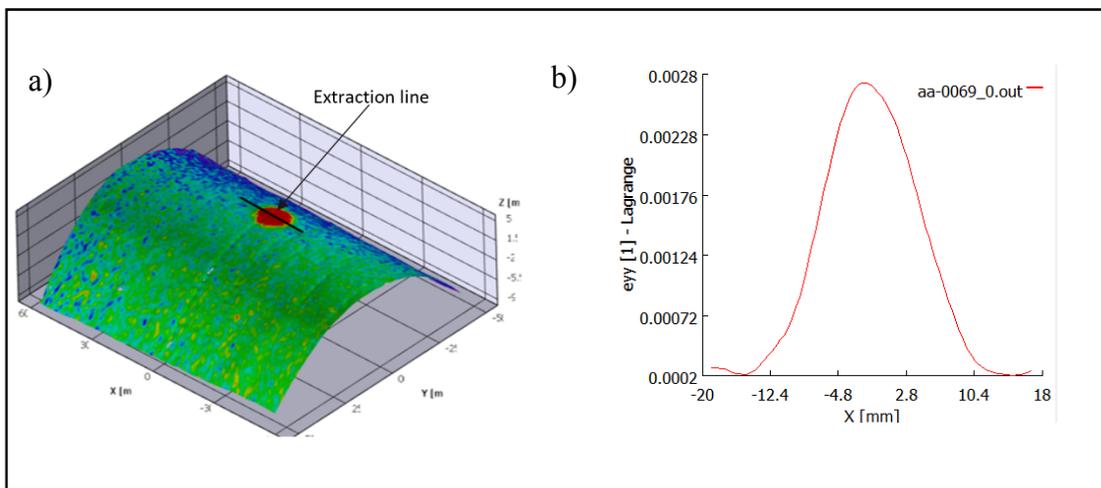
Figure 3.18: Countour (a) and strains obtained by DIC (b)

Afterwards, a correlation algorithm is run to determine the three-dimensional displacement of a specimen surface as shown in Figure 3.18(a). Based on this, displacements and strains are calculated with the post-processing tool (b).

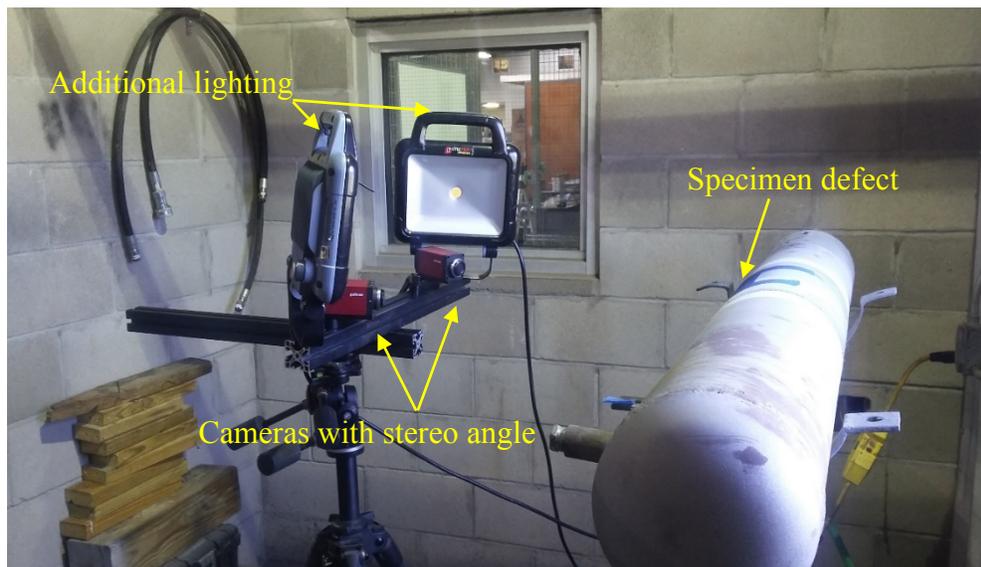
*Figure 3.19: DIC set-up*

The set-up for the DIC used during testing is shown in Figure 3.19. Cameras are equidistant and with the same angle, additional lighting is in place. The speckle pattern is produced on the surface of the repair in the area near the defect.

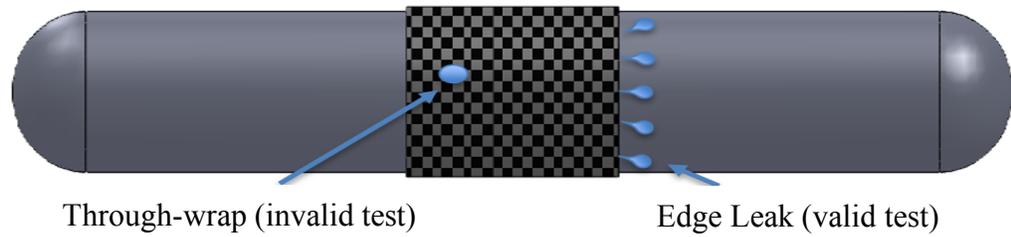
Figure 4.1: Schematic for valid and invalid data points

For a test to be considered valid under ASME PCC-2, the failure must be a leak at the edge of the repair. This is because the expression to calculate failure pressure written in this code considers interface failure when the fluid travels through the interface until it reaches the edge, debonding the repair from the substrate. An invalid test takes place when the failure occurs through the wrap. There are several reasons why this happens. One is the presence of voids in the matrix. Another explanation can be that the matrix is not completely cured. Figure 4.1 shows a representation for these types of failures.

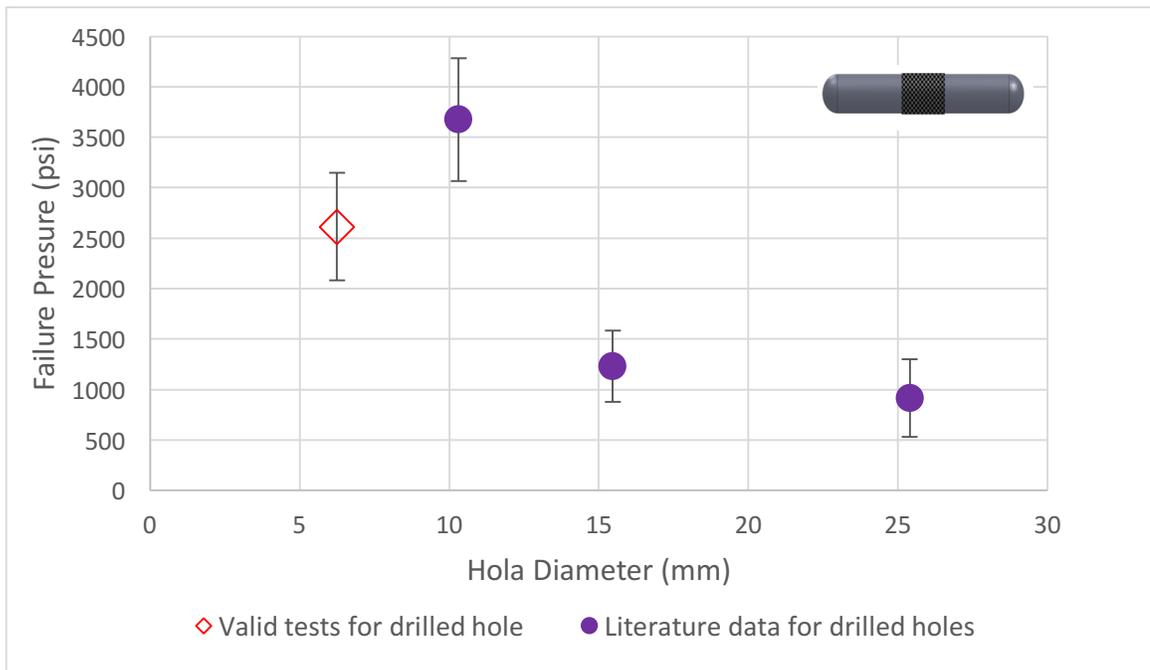
Figure 4.2: Failure pressure for drilled defects with two-layer repair on straight specimens

Figure 4.2 shows a comparison of the test results in the current study compared to previous data obtained on drilled defects. It can be seen that they are below the trend and after running a t-test, they are statistically different with a p value of 0.1083.
