# FINAL REPORT

Project Title: *Wall Break-through in Composite Repaired Defects*

Prepared by: *The University of Tulsa*

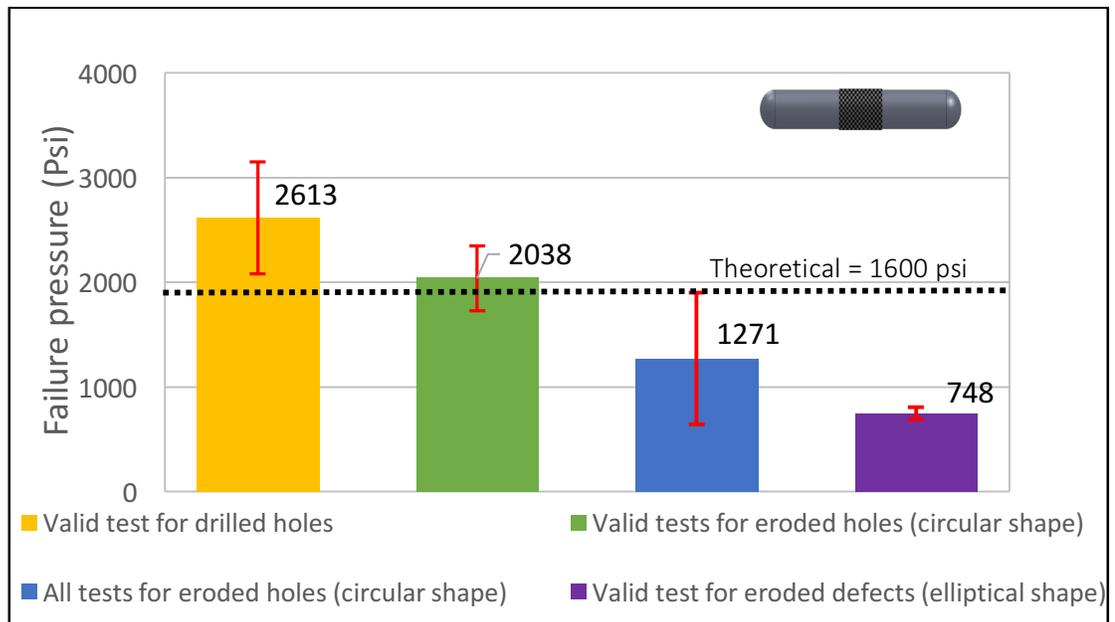
Figure 4.3: Failure pressure for all defects with two-layer repair on straight specimens

Figure 4.3 shows the different failure pressures for all defects. Out of the 9 tests that were performed on specimens with defects having a circular erosion shape, only 3 were valid. This low percentage of valid tests may be due to the fact that the repair was very thin, or as a result of the reduction of the opening strain predicted by FEA. Reducing the opening strains can shift the mode of failure from interfacial failure to bulk composite failure. Comparing the valid tests for eroded defects having a circular shape with the drilled

defects indicated that the failure pressures were statistically different with a p value of 0.279. This result tends to indicate that there is a small variation in fracture energy from eroded to drilled holes. However, both of them are above the theoretical prediction which indicate that the eroded defects do not have a huge impact in the failure pressure for the size of the erosion tested. Comparing all eroded tests regardless of its failure mode, it can be seen that their failure pressures are lower than it would be expected for drilled holes. Finally, comparing the drilled defects with the eroded defects with elliptical shape, it is observed that they are statistically different with a p value of 0.04. Similar to the FEA prediction, the elliptical shape has a significant effect on the failure pressure because the substrate in the region near the through-wall defect is deforming in the opposite direction of the repair, which tends to cause the crack to initiate faster leading to failure.

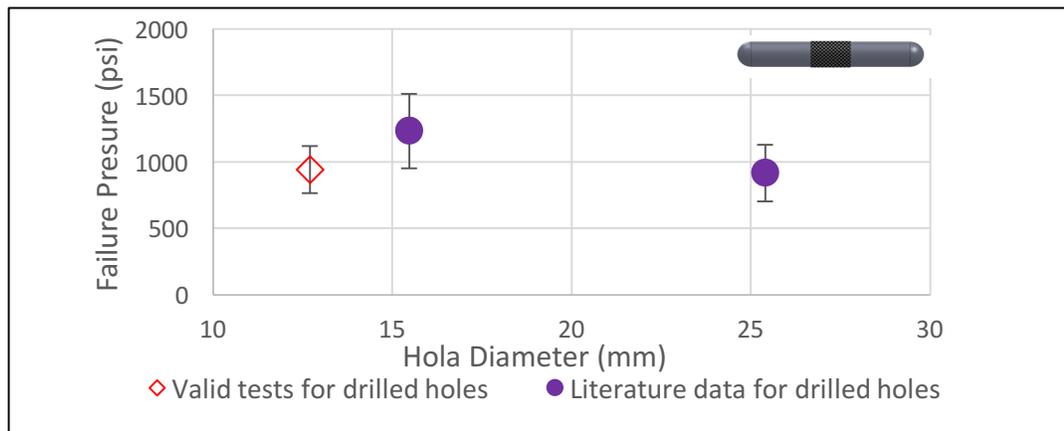
Figure 4.4: Failure pressure for drilled defects with four-layer repair on straight specimens

Figure 4.4 shows the average failure pressure for drilled defects for a four-layer repair. Comparing this failure pressure with experimental data taken from previous work for drilled holes with diameter equal to 15.24 mm, they are statistically different with a p value of 0.1874.

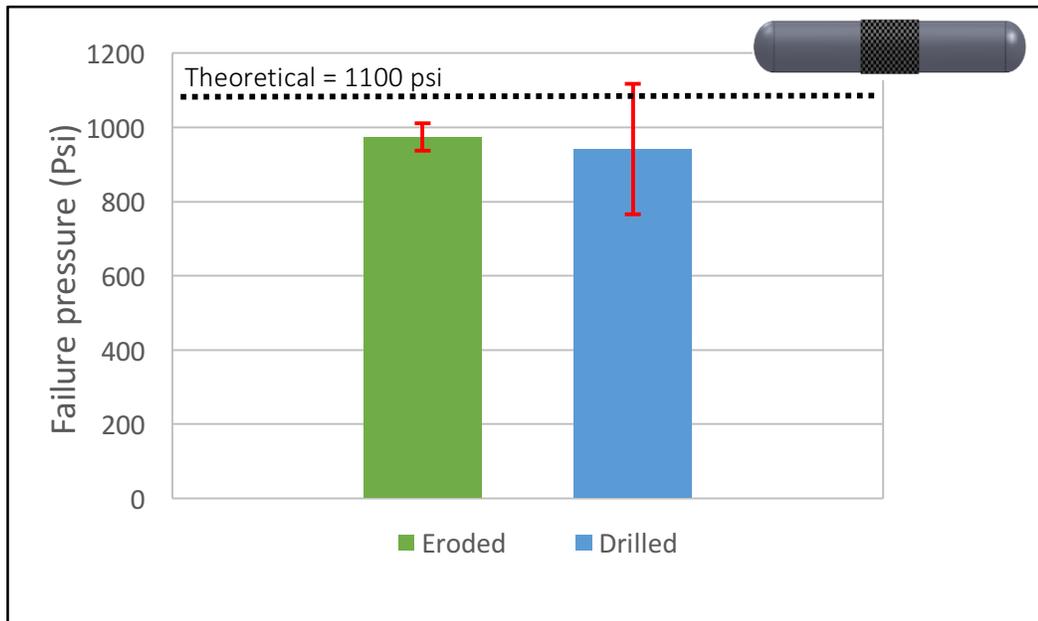
Figure 4.5: Failure pressure for eroded and drilled defects with four-layer repair on straight specimens

In Figure 4.5, it is observed that for this configuration there is not a difference in failure pressure between eroded and drilled defects. Similar to the two-layer repair, this is probably due to the fact that eroded area was not big enough to produce a lower failure pressure in the repair. Also, both defects match very well with the theoretical prediction for this repair thickness.

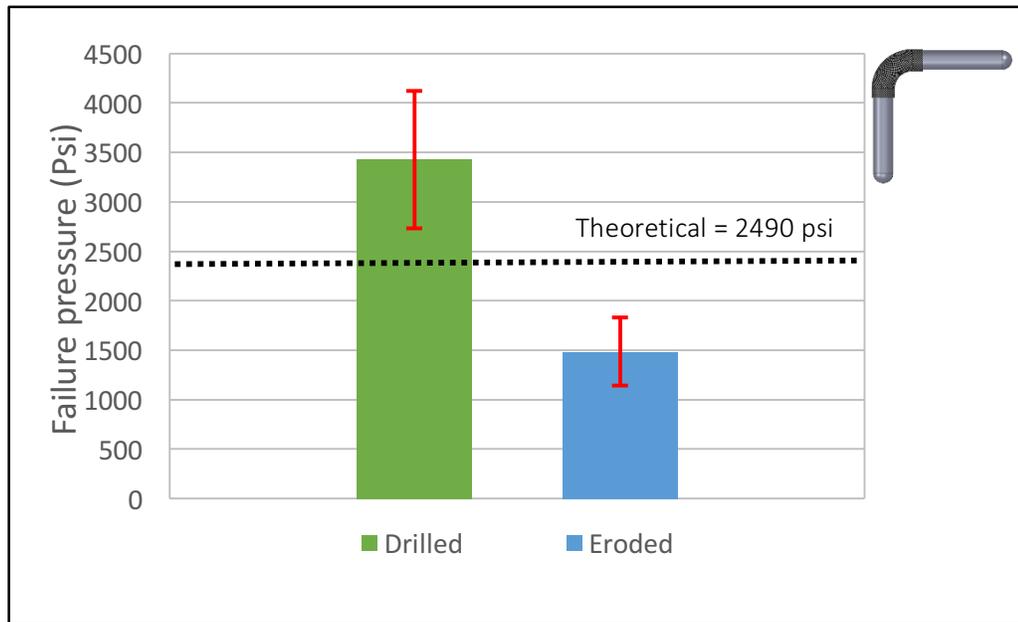
Figure 4.6: Failure pressure for eroded and drilled defects with four-layer repair on elbow specimens

Figure 4.6 shows failure pressure for elbow assemblies, and it can be noted that there is a factor of 2.5 difference in the average of their failure pressure. A standard 2-tailed t-test, using a 95% confidence interval was performed on the data and indicates that drilled and eroded defects are statistically different from one another with a p-value of 0.011. Furthermore, the value for eroded defects is also lower than the theoretical prediction for this repair thickness. This indicates that erosion has a significant impact in the repair performance for elbows in terms of failure pressure. One possible explanation for this behavior is that the elliptical shape of the defect is causing a bending moment that

is pushing the steel in the opposite direction of the repair increasing the opening strains as seen in the FEA simulation.

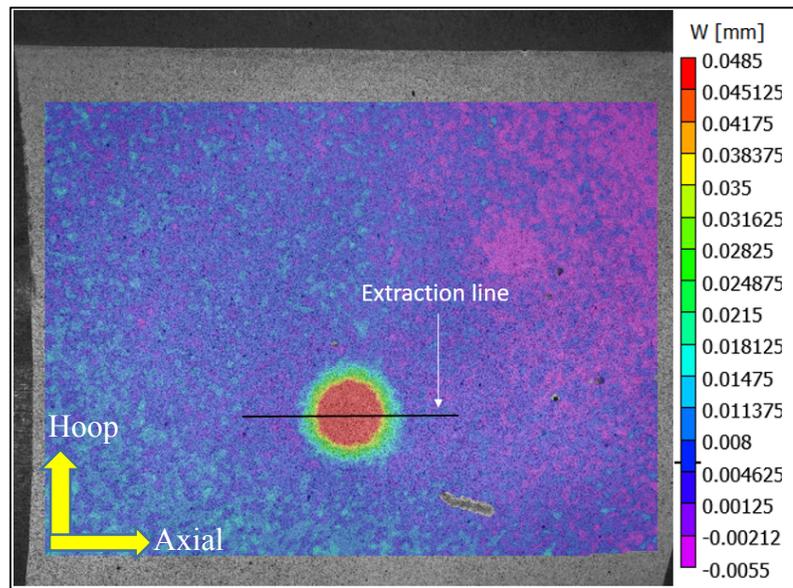
Figure 4.7: DIC extraction data line example

To better understand the performance of repairs applied to the two defect types, DIC was performed on half of the tested specimens. In this section, out of plane displacements and strains in both hoop and axial directions were obtained. The relation between failure pressure and these strains measured at a given pressure is also explored. All values obtained were extracted in the defect area along a line in the axial direction as shown in Figure 4.7.

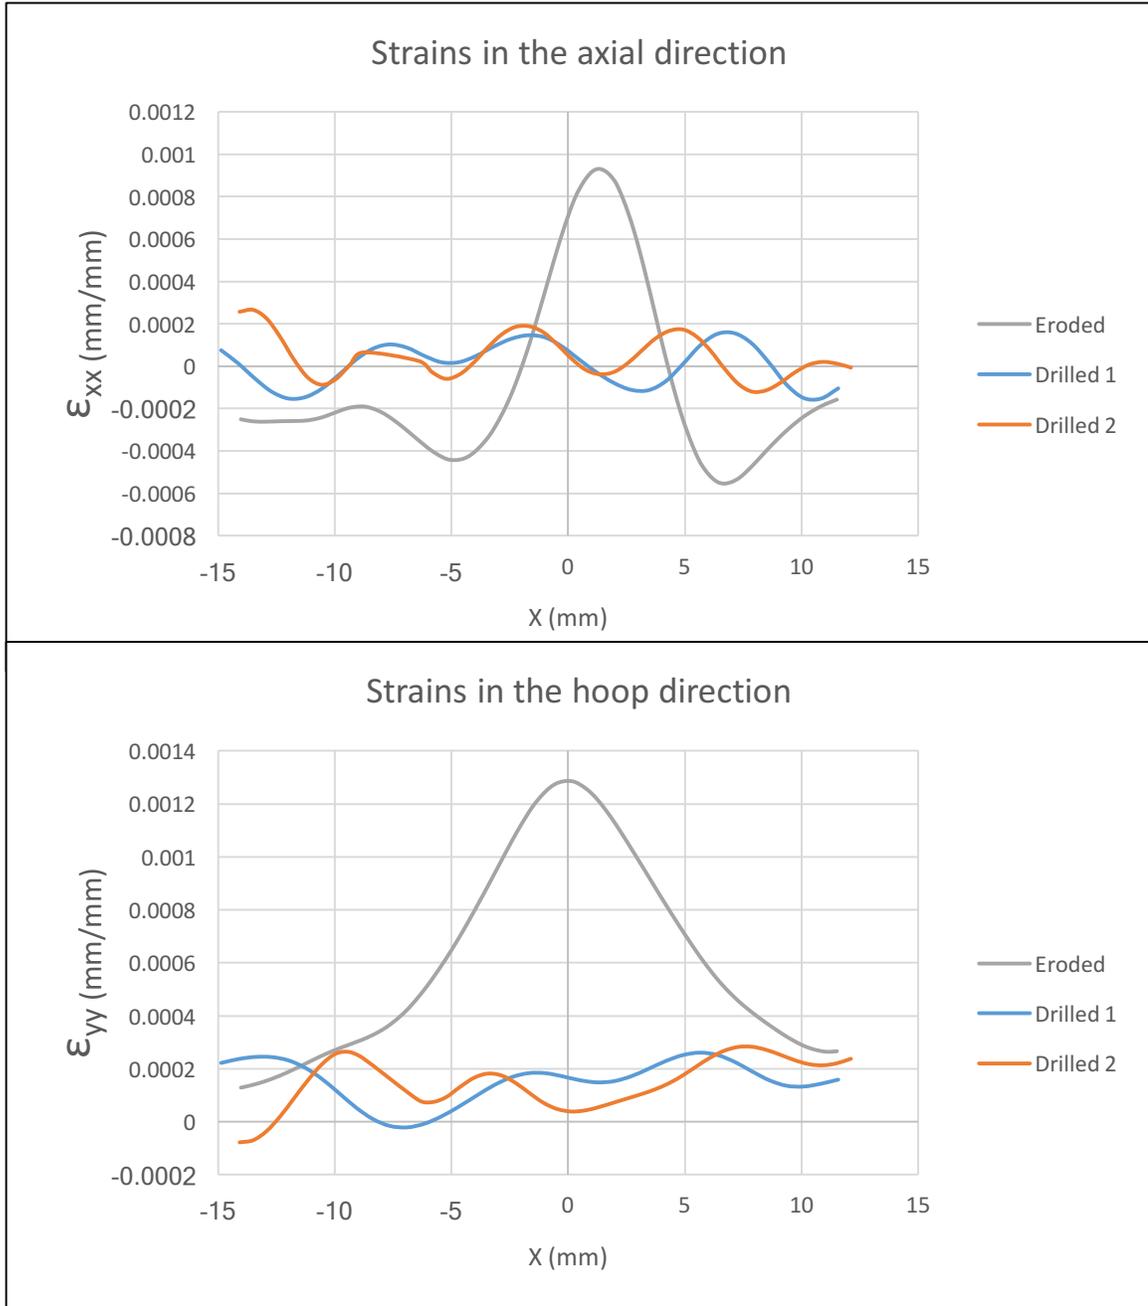
Figure 4.8: Hoop and axial strains for eroded and drilled defects with two-layer repair on straight specimens at 600 psi

Figure 4.8 shows a noticeable difference in strains in both directions between drilled and eroded defects.

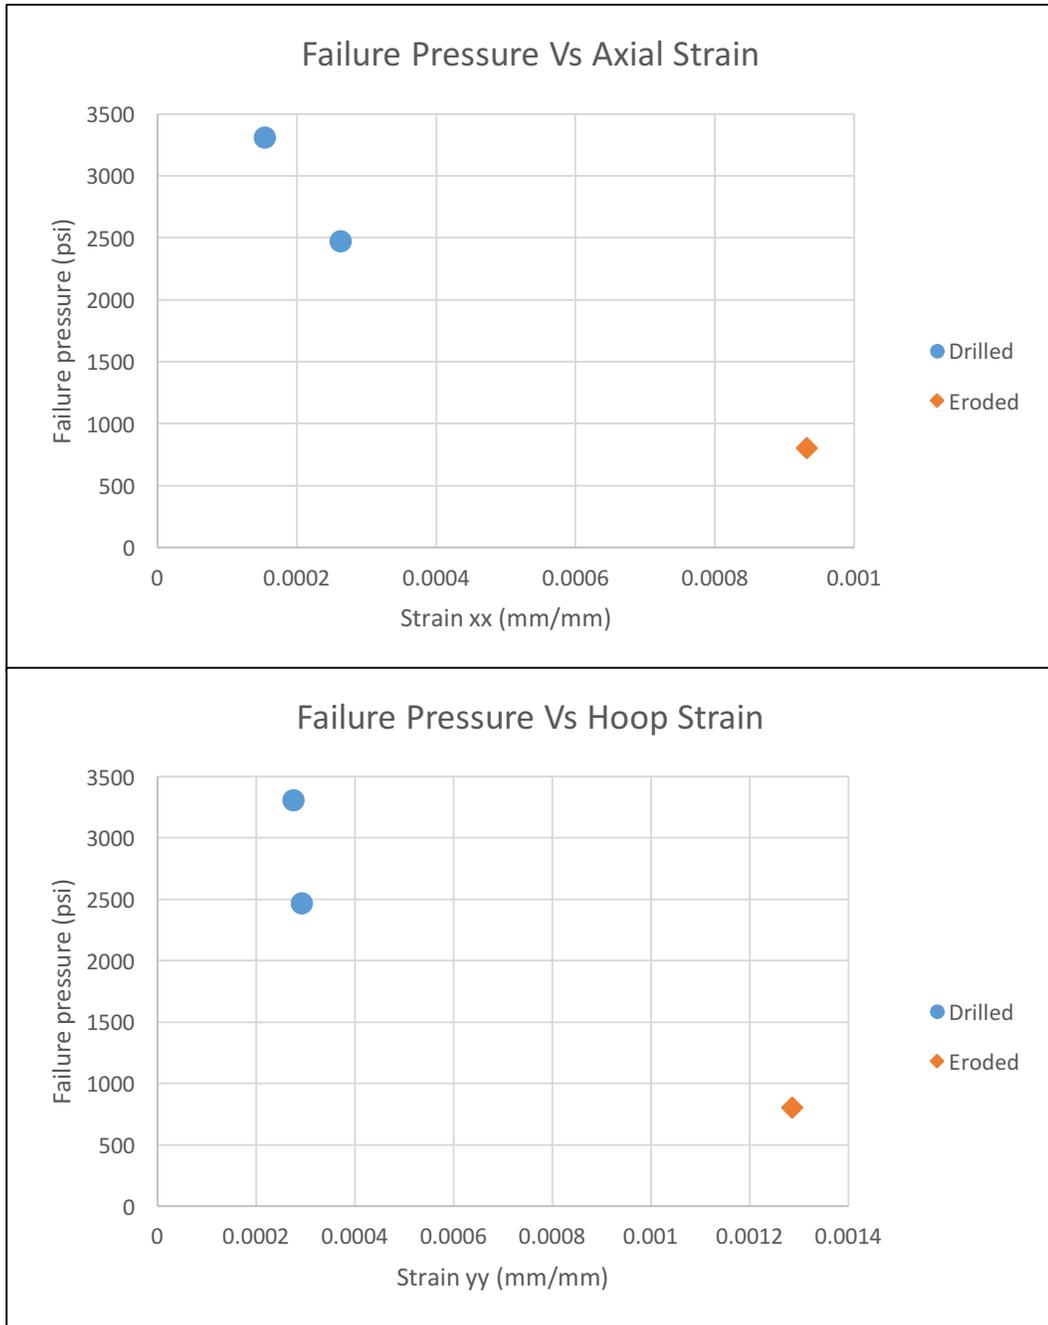
Figure 4.9: Failure pressure Vs strains obtained for eroded and drilled defects with two-layer repair on straight specimens at 600 psi

Figure 4.9 illustrates that these strains represent a big influence in the failure pressure of the specimens. Drilled defects with lower strains in both directions achieved higher failure pressures. This shows a very clear relation between strains and failure pressure. These higher strains may be achieved by the thin damage area deforming, and because this high deformation, they achieved lower failure pressure than for drilled defects.

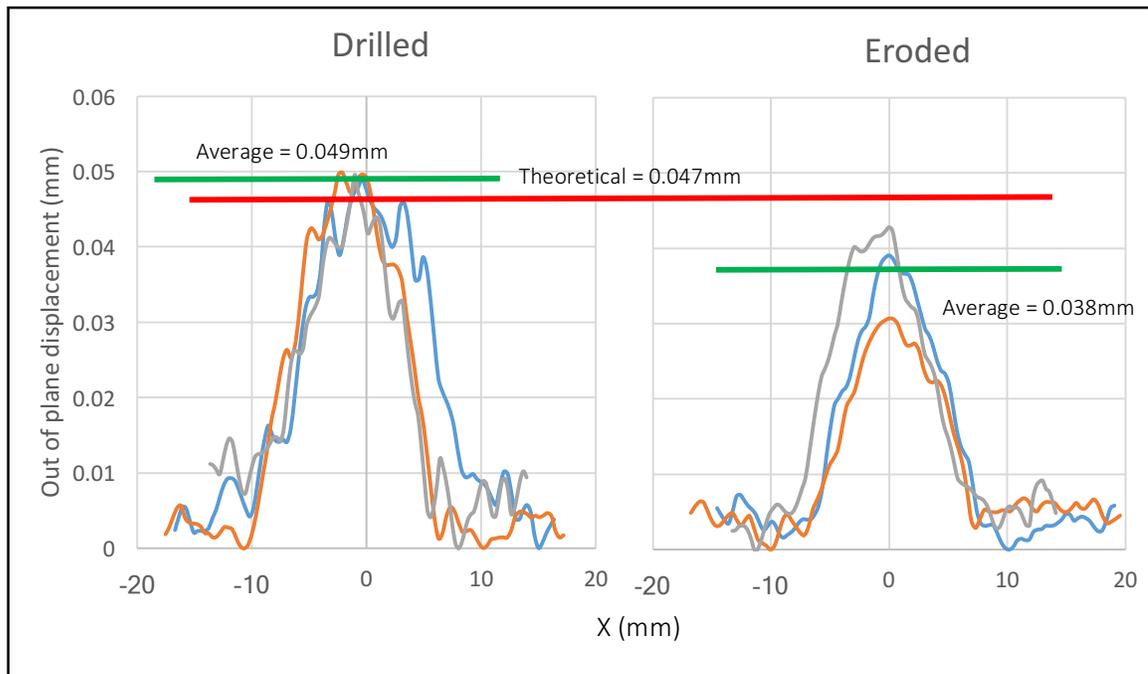
Figure 4.10: Out of plane displacement for eroded and drilled defects with two-layer repair on straight specimens at 800 psi

Figure 4.10 shows that the average of the maximum out of plane displacement for both defects is quite similar. Also, using Equation (2) from plate theory described in Section 1, measurements from both specimens match well with the theoretical prediction for maximum displacement.

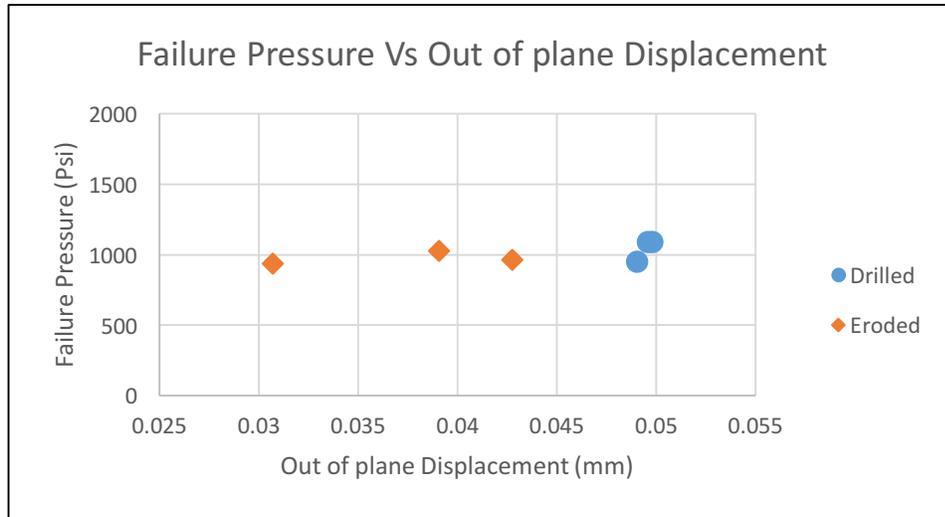
Figure 4.11: Failure pressure Vs out of plane displacement for eroded and drilled defects with four-layer repair on straight specimens at 800 psi

Figure 4.11 shows the maximum out of plane displacement vs. the failure pressure. The out of plane displacement appears to have little correlation to the failure pressure. This is probably because the difference in their averages for out of plane displacement is only 30%.

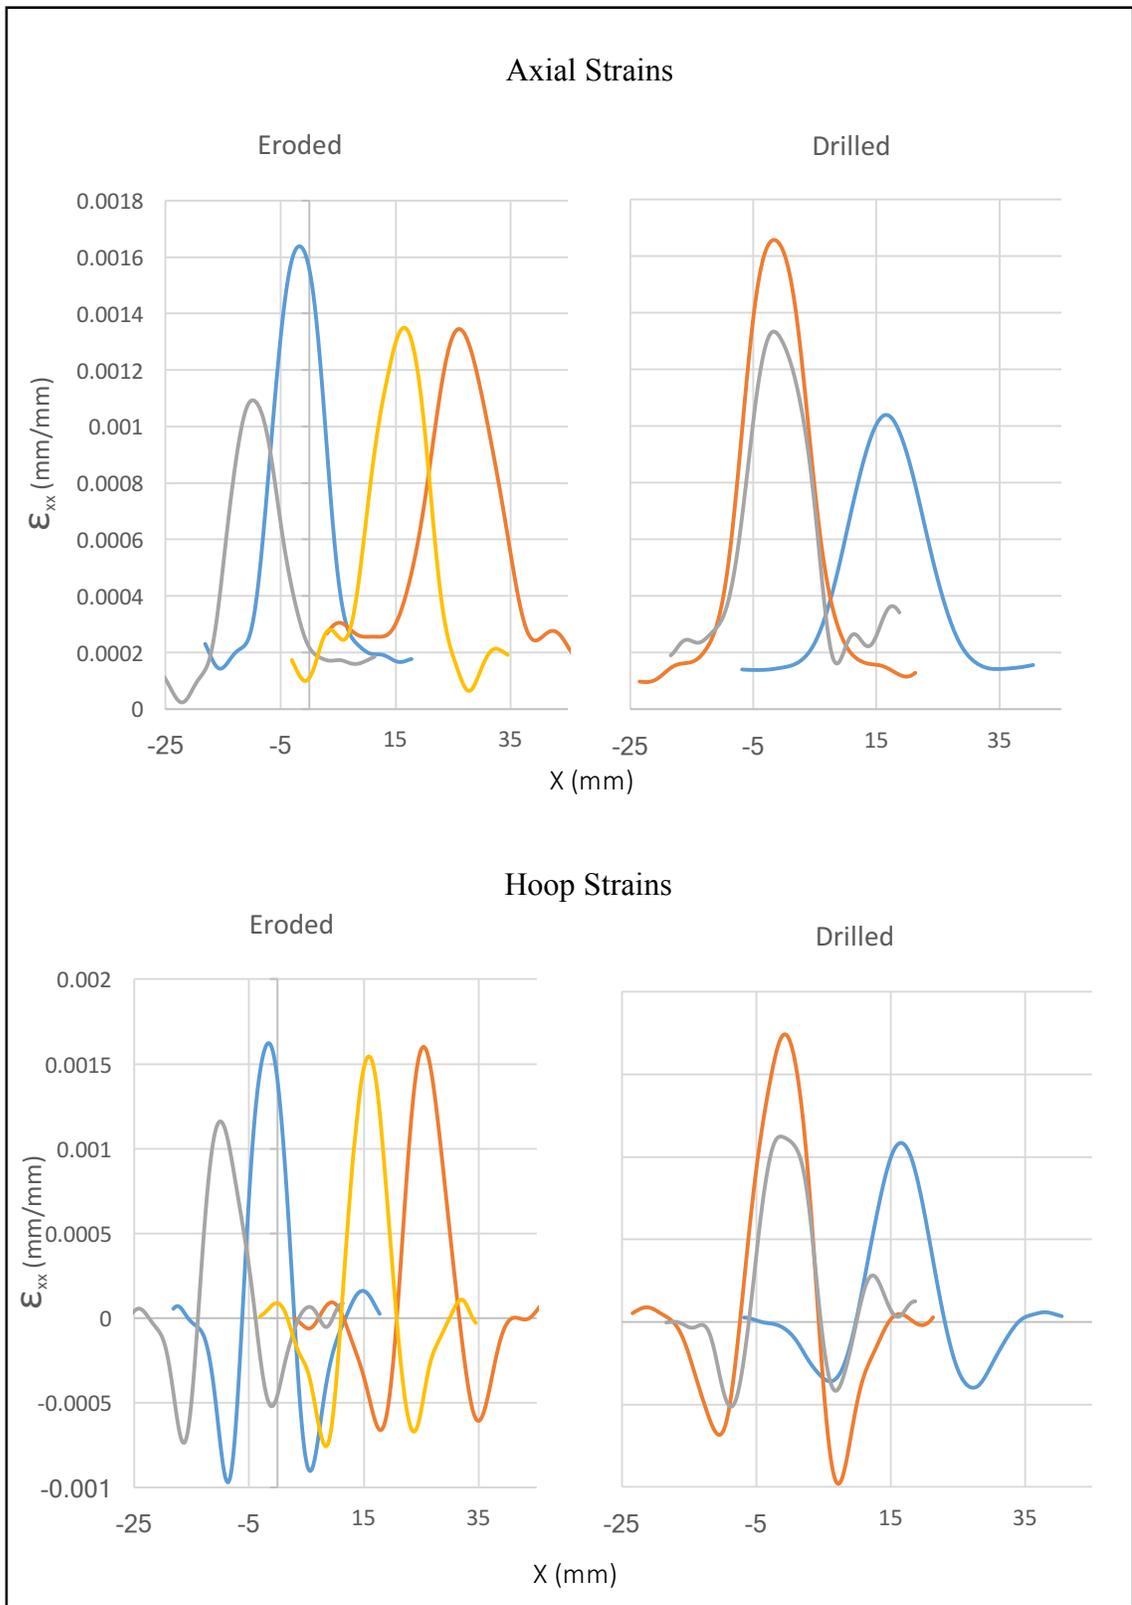
Figure 4.12: Strains in hoop and axial directions for eroded and drilled defects with four-layer repair on straight specimens at 800 psi

Both strains in the axial and in the hoop directions are very similar for both drilled and eroded defects as shown in Figure 4.12. The similarity between these two specimens is expected since the failure pressures are similar.

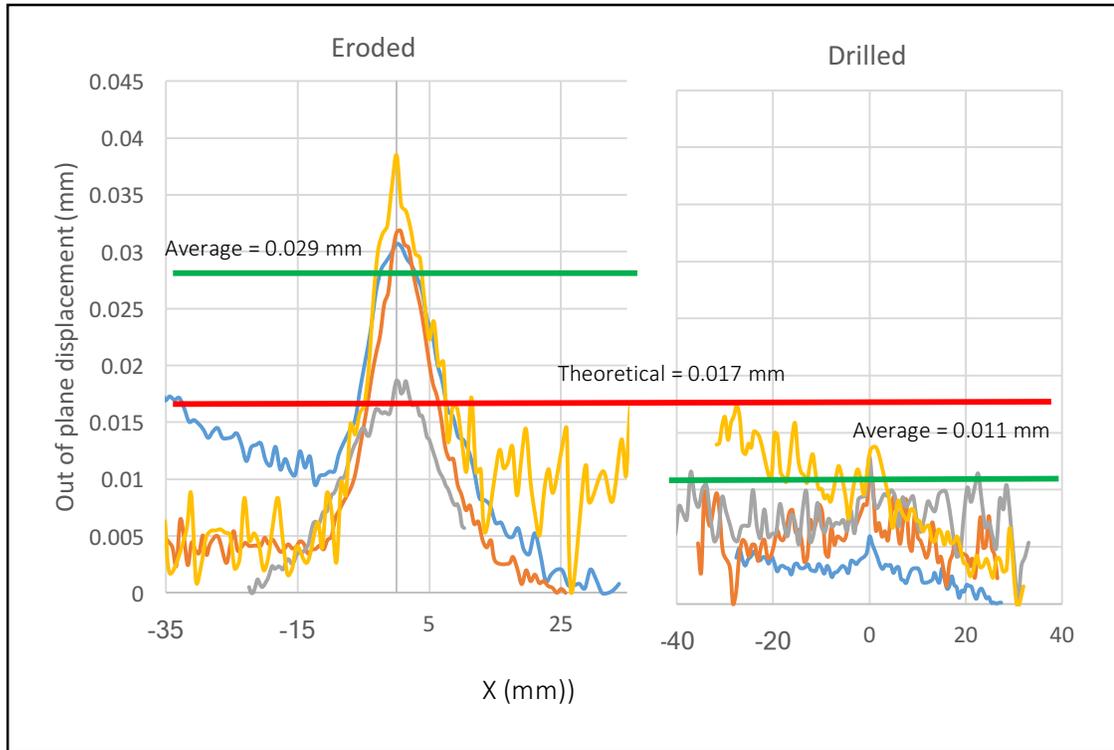
Figure 4.13 Out of plane displacement for eroded and drilled defects for four-layer repair on elbow assemblies at 1000 psi

Figure 4.13 displays the difference in displacement for drilled and eroded defects in elbows. The maximum average displacement for eroded defects is 60% higher than theoretical prediction and almost three times the maximum average for drilled holes. This may be happening due to crack initiation sooner for eroded defects than for drilled ones.

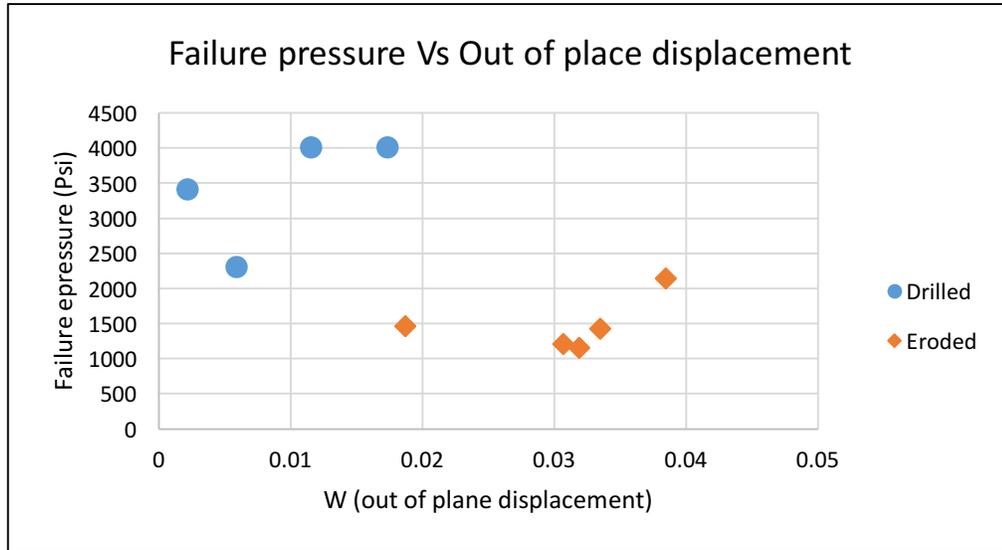
Figure 4.14: Failure pressure Vs out of plane displacement for eroded and drilled defects with four-layer repair on elbow assemblies at 1000 psi

Figure 4.14 shows the relation between failure pressure and out of plane displacement. It can be seen that for those specimens which the out of plane displacement is lower, failure pressure tends to be higher. However, there is one drilled and one eroded point which achieve about the same pressure having very different displacements. This is probably due to exceptional bond strength for the drilled sample having higher displacement or very high fracture toughness at the interface. However, further study is required to understand the performance difference at the extremes of failure pressure.

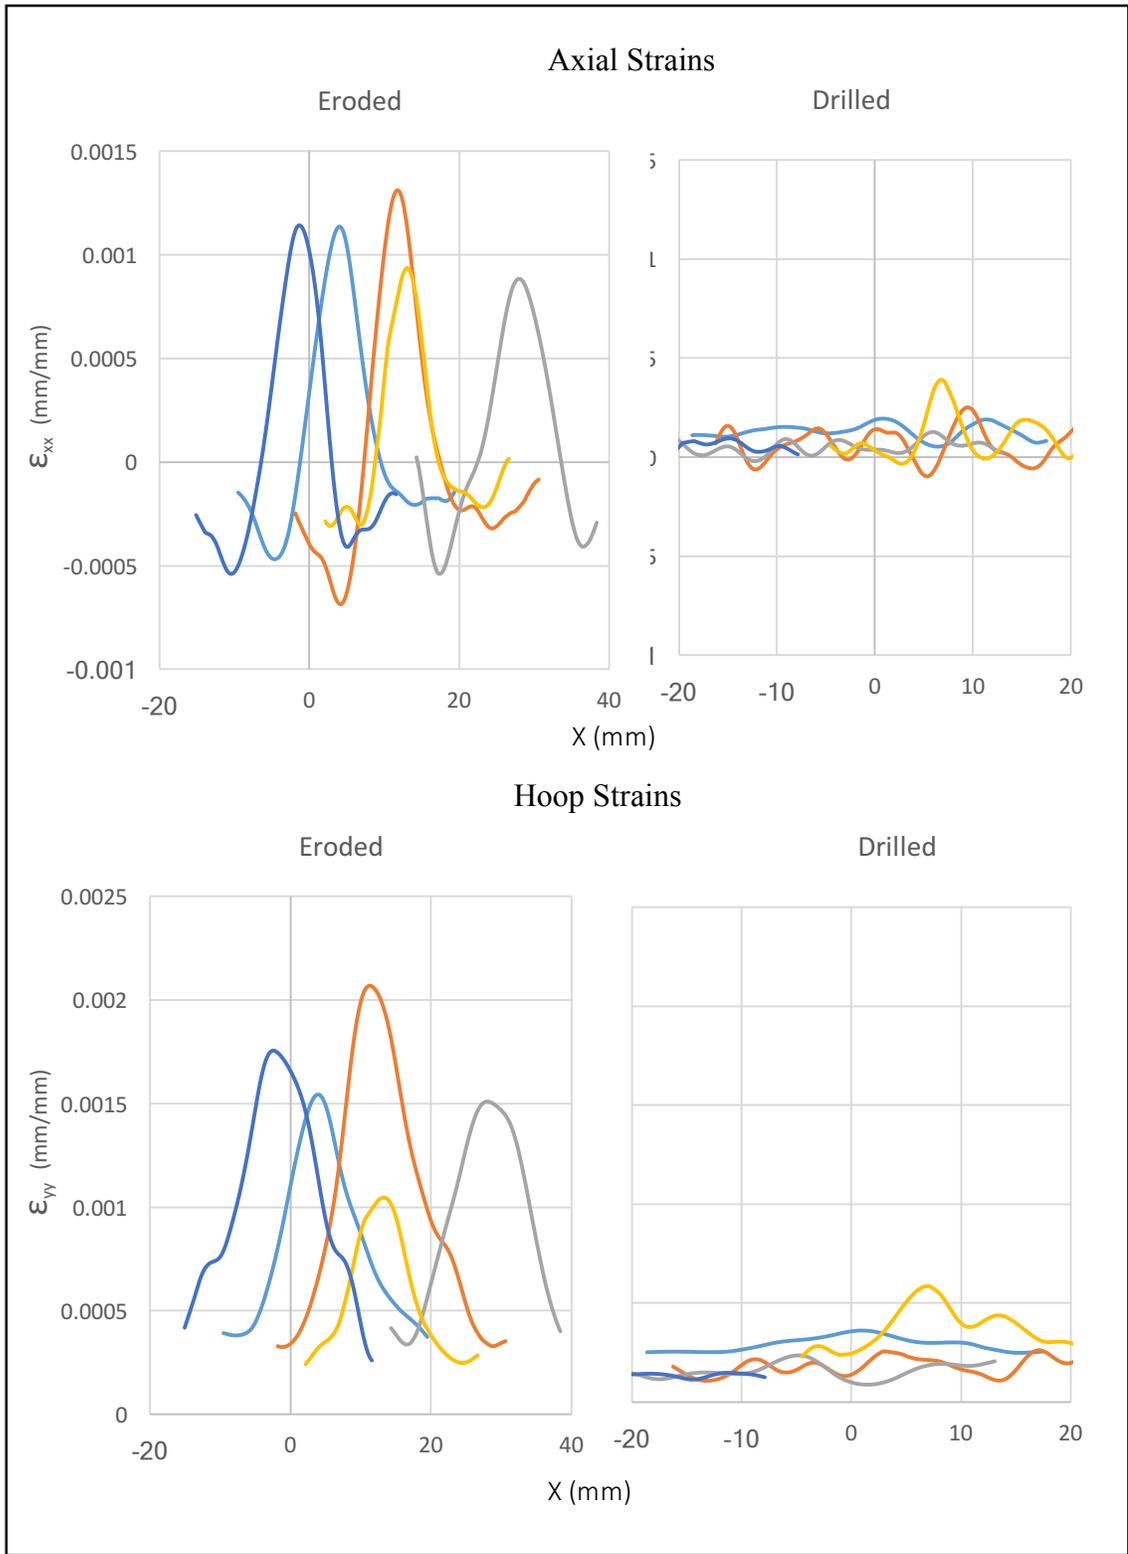
Figure 4.15: Strains in hoop and axial directions for eroded and drilled defects with four-layer repair on elbow specimens at 1000 psi

Figure 4.15 shows both strains in the axial and in the hoop directions are different for drilled and eroded defects. These specimens had the largest difference in failure pressures and this behavior is reflected in the strain behavior. Measured strains in the drilled specimens are extremely low when compared to the eroded specimens. This is expected based on the failure pressures.

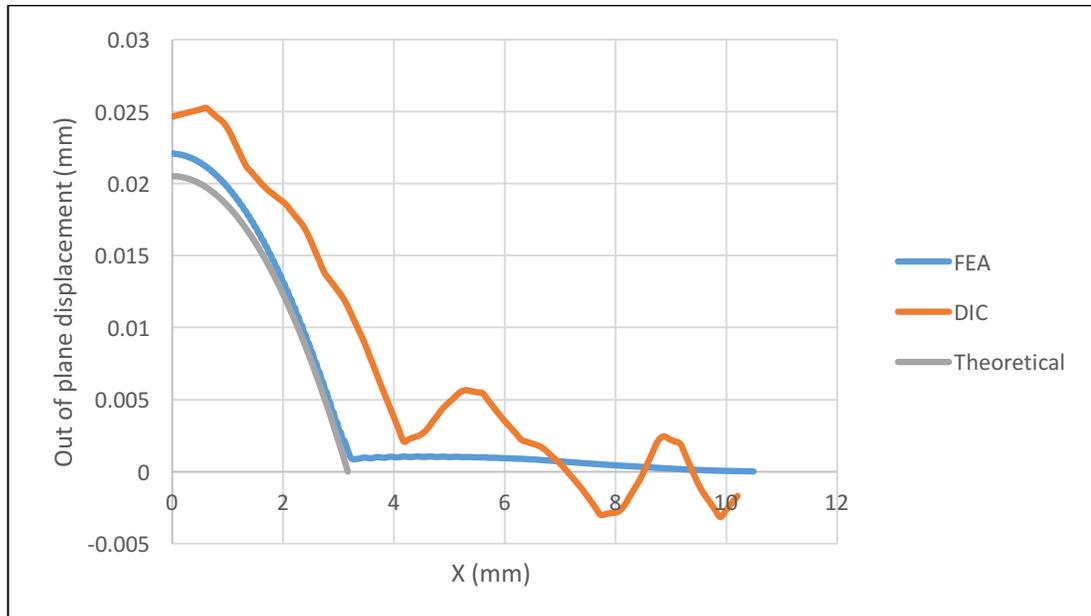
The comparison shown in Figure 4.16 refers to the case for a two-layer repair on a straight specimen. In this case, the defect was modeled as an eroded defect with an elliptical eroded shape and the pressure was 700 psi. As observed below, theoretical and FEA match almost perfectly, and DIC results match very well following the clear trend for FEA and DIC.

Figure 4.16: FEA and DIC Comparison. Out of plane displacement for two-layer repair on straight specimen

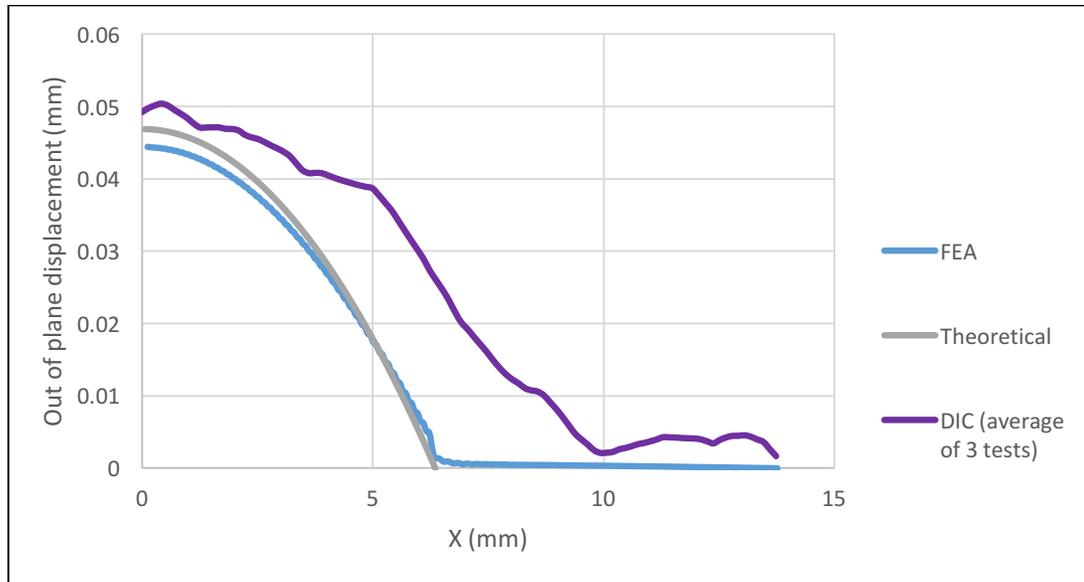
In this comparison, a drilled defect with 0.5 in diameter was simulated using a four-layer repair on a straight specimen. The pressure was 900 psi. This comparison will be made in terms of out of plane displacement and strains in both axial and hoop directions shown in Figures 4.17 to 4.19. The out of plane displacement shows the same trend as for two-layer repair, DIC is probably higher due to imperfections in the bonding between the substrate and the repair because the FEA and theoretical approach consider this interface as perfectly bonded. It is also observed that the DIC curve starts at a different point from the theoretical and FEA curves. This is probably due to the fact that there is a crack growing at the interface between the repair and the substrate, so the repair starts deflecting beyond the edge of the through-wall defect.

Figure 4.17: FEA and DIC Comparison. Out of plane displacement for four-layer repair on straight specimen

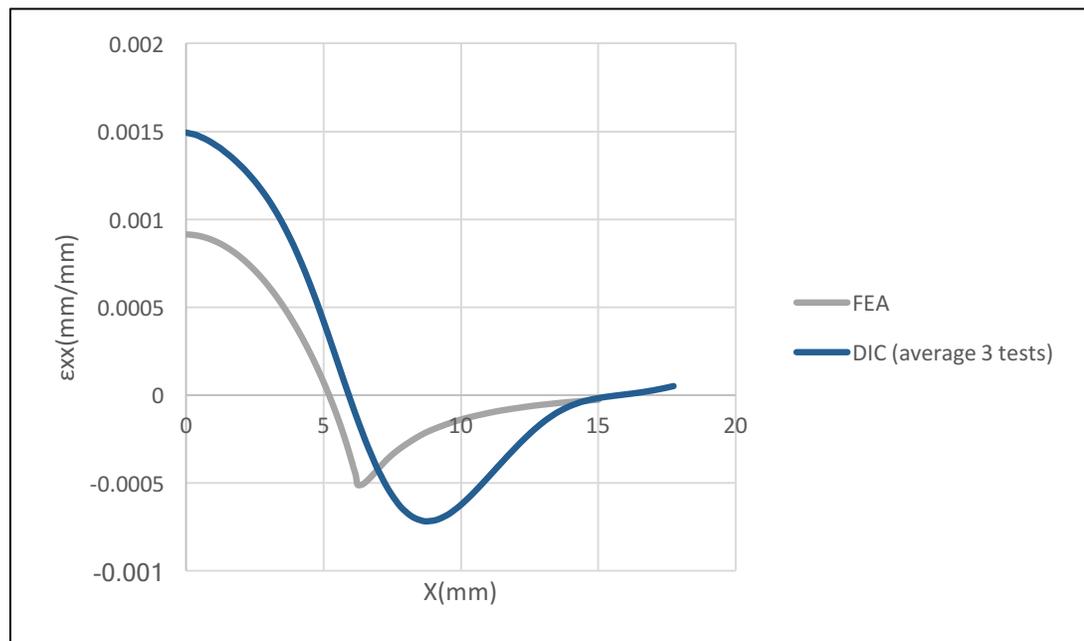
Figures 4.18 and 4.19 show comparison of strains in both hoop and axial directions. It is observed that DIC measurements agree well with FEA predictions. In both directions, the DIC measurements capture very well the trend of these strains.

Figure 4.18: FEA and DIC Comparison. Axial strains for four-layer repair on straight specimen

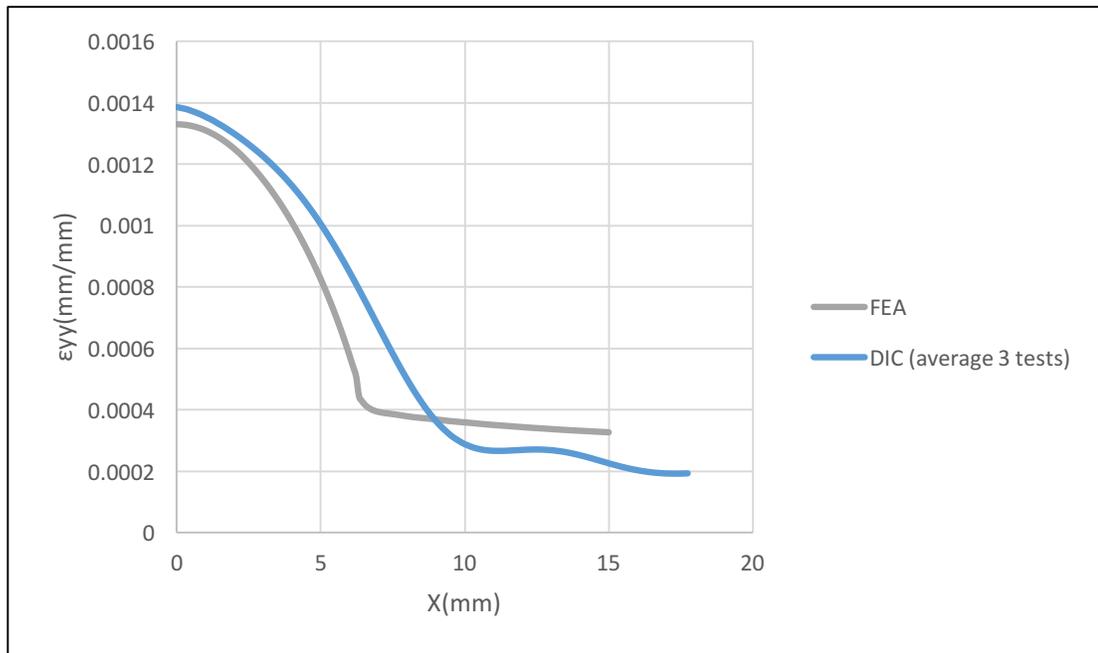
Figure 4.19: FEA and DIC Comparison. Hoop strains for four-layer repair on straight specimen

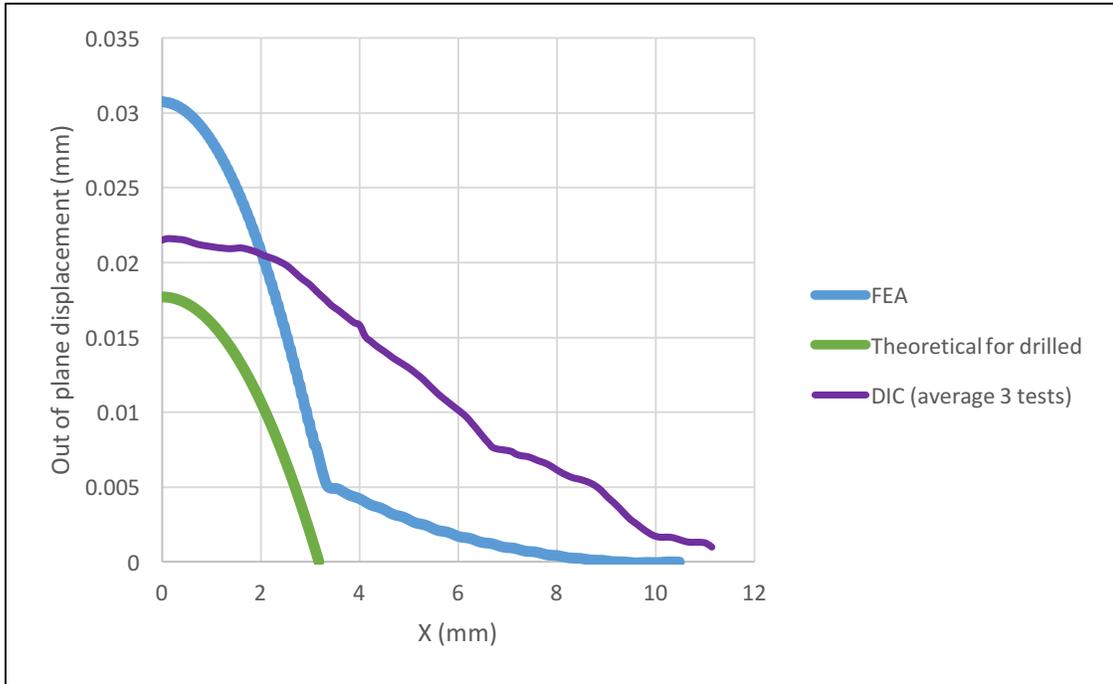
Figure 4.20 shows the comparison of FEA, DIC, and theoretical contours for a four-layer repair on elbow specimen applied on an eroded defect at 1000 psi. As shown in both FEA and DIC, measurements of out of plane displacement were higher than the theoretical prediction for drilled defects. This is probably because the theoretical prediction does not take into account the thin wall of the substrate deforming along with the repair. Comparing FEA with DIC, both follow the same trend, but the magnitudes do not match as well as in the case of straight specimens with four-layer repair. Further studies are ongoing to determine the source of this mismatch.

Figure 4.20: FEA and DIC Comparison. Out of plane displacement for four-layer repair on elbow specimen
