CAAP Quarterly Report

Project Title: <Mitigating Pipeline Corrosion Using A Smart Thermal Spraying Coating System>

Prepared by: <North Dakota State University>

For quarterly period ending: <July 10th, 2017>

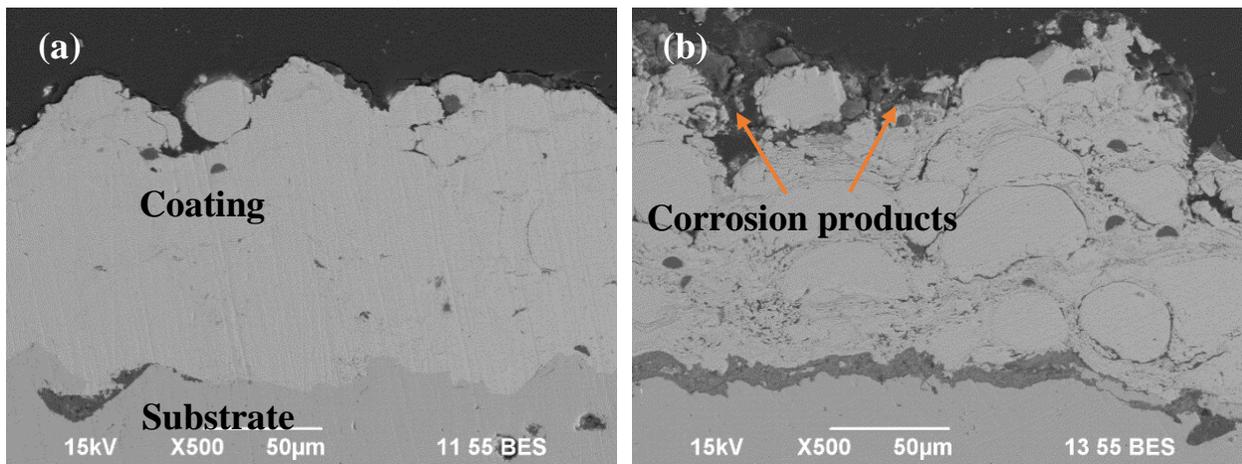
For HVOF deposited Al-Bronze coatings which had been studied previously, the SEM micrographs taken from the cross-section of the coatings before and after corrosion were shown in Figure 1. It could be concluded that corrosion products significantly were formed on the surface of the HVOF deposited Al-bronze coating after corrosion (Figure 1). The dark gray areas presented very close to the surface of the coating were observed after corrosion which did not exist in the SEM micrograph of the HVOF deposited Al-bronze before corrosion. These areas could be associated to the corrosion products formed after exposing to the NaCl solution.

Figure 1. SEM micrographs of the HVOF deposited Al-bronze coating (a) before and (b) after corrosion.

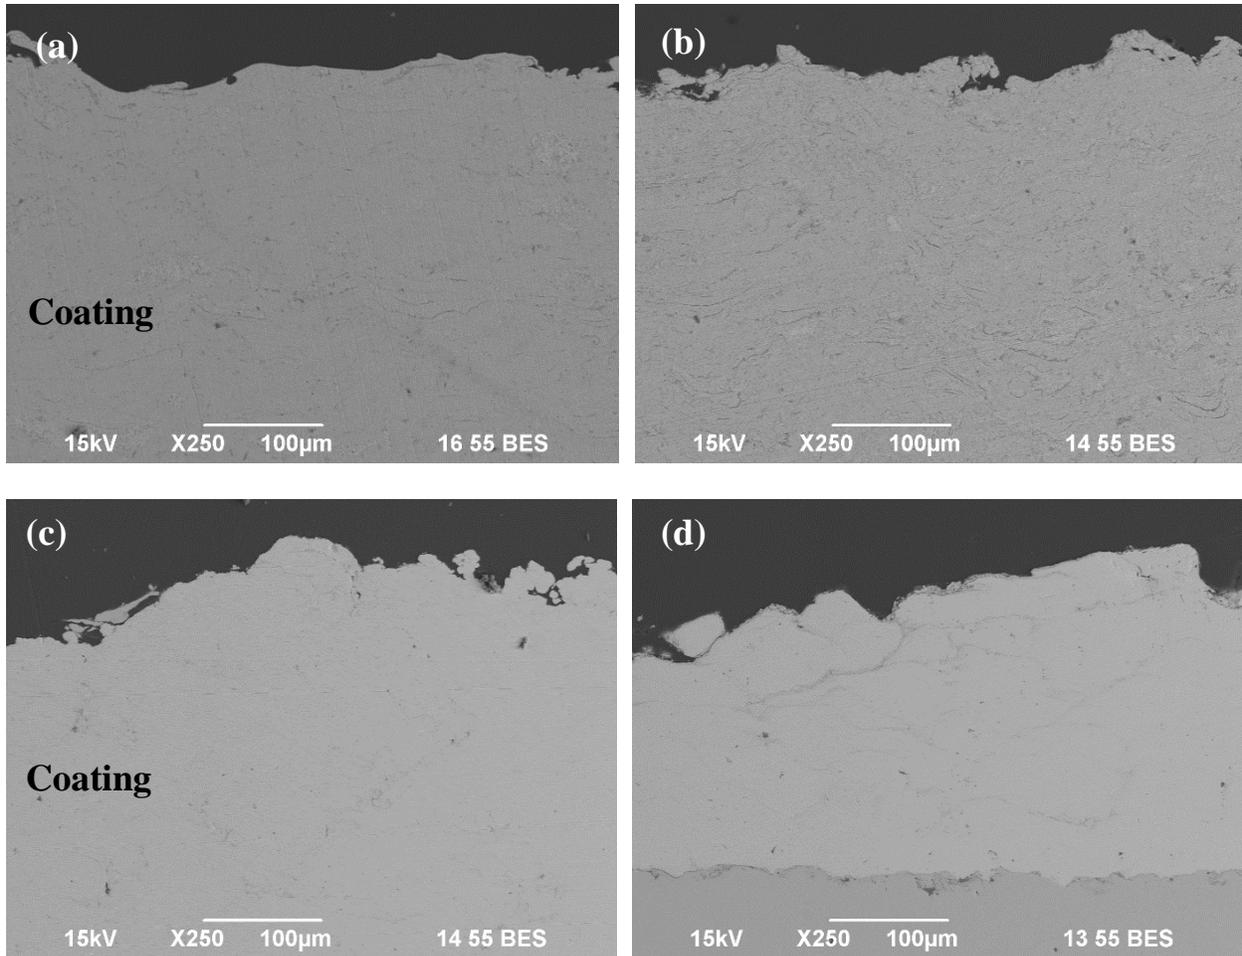
Such corrosion products were not observed on the wire arc deposited Al-Zn as seen in Figures 2 (a, b) and Cu coatings as shown in Figures 2 (c, d). In fact, there was no observable change in the microstructure of the cross section of the coatings, preferably near the surface, before and after corrosion. It indicated very slim change (or if it happened in very small scale, less than few micrometers) in the composition of the Al-Zn and Copper coatings once exposed to the corrosive environment. Figure 2 (a-d) demonstrated this observations in the wire arc sprayed Al-Zn and Cu coatings.

Figure 2. (a) Wire arc deposited Al-Zn coating before and (b) after corrosion, (c) HVOF deposited Copper coating before and (d) after corrosion.

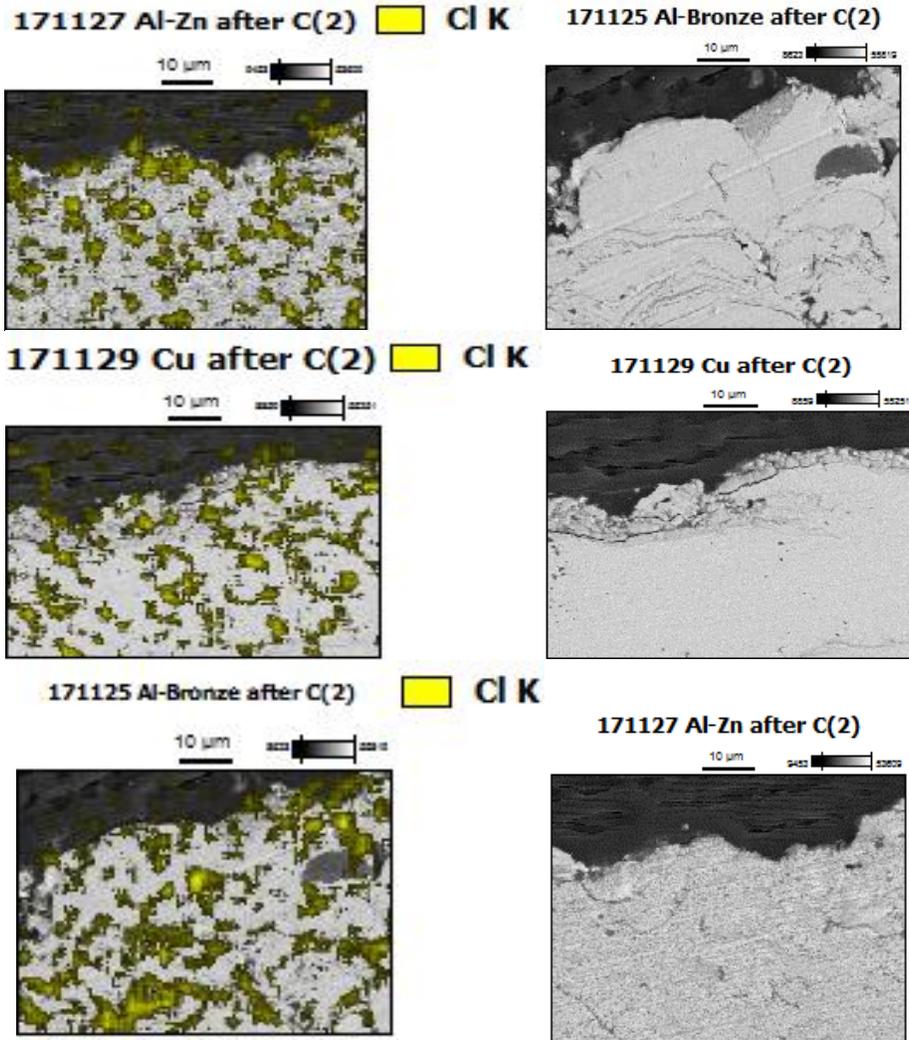
The elemental distribution in the coatings' microstructures was studied by EDS mapping technique and were presented in Figure 3. The major objective of EDS mapping was to detect the depth of the penetration of the deletrious elements, preferably Cl^- , to estimate the effectiveness of the coating to act as a barrier to hinder diffusion of such a detrimenteous elements in to the coatings.

According to the EDS results, chlorine had diffused more in to HVOF deposited Al-Bronze compared to the two other coatings. That could be due to relatively high level of porosity detected in this coating. The other EDS map shown in Figure 4, demonstrated the penetration depth of the Na element inside the coatings. This value for the Al-Zn coating had the lowest value as it appeared as very small area which was overlapping with the Zn map. As could be seen from the images in figure 3, Al-bronze acted less effective compared to the other coatings in terms of blocking the sodium elements inside the coating.

Figure 3. EDS maps of Cl⁻ element penetrated in a variety of thermally sprayed coatings after corrosion experiment in this project.

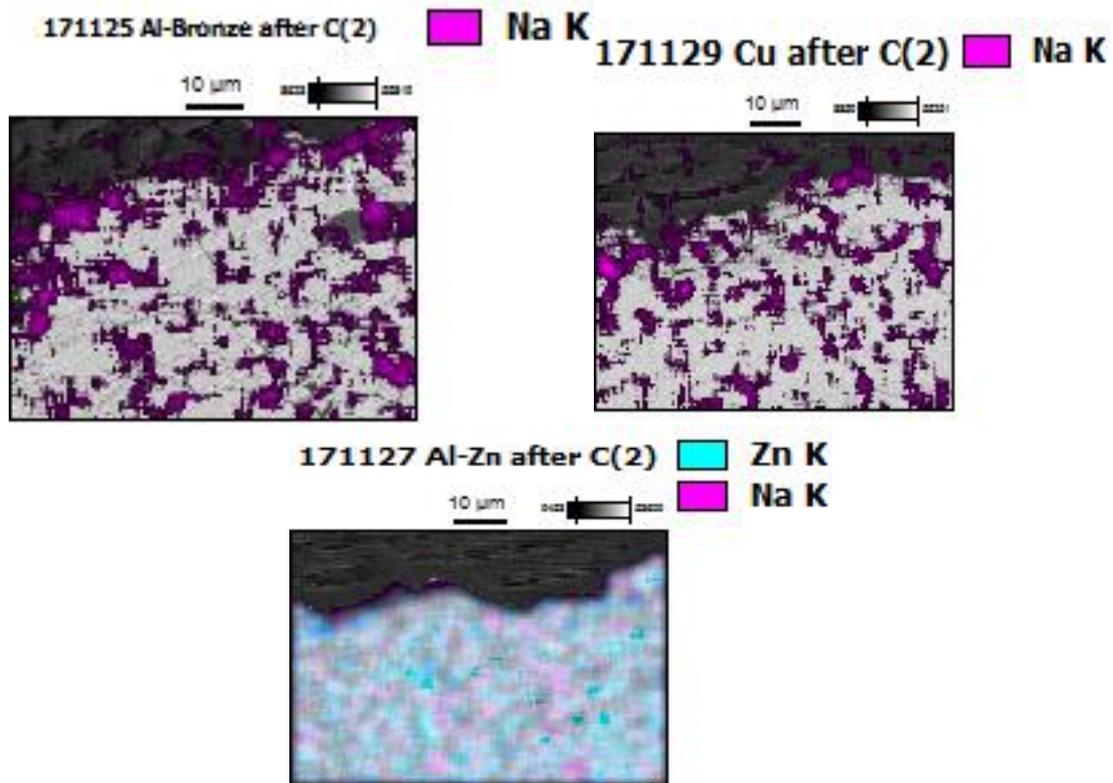
Figure 4. EDS maps of Na⁺ element penetrated in the thermal sprayed coatings.

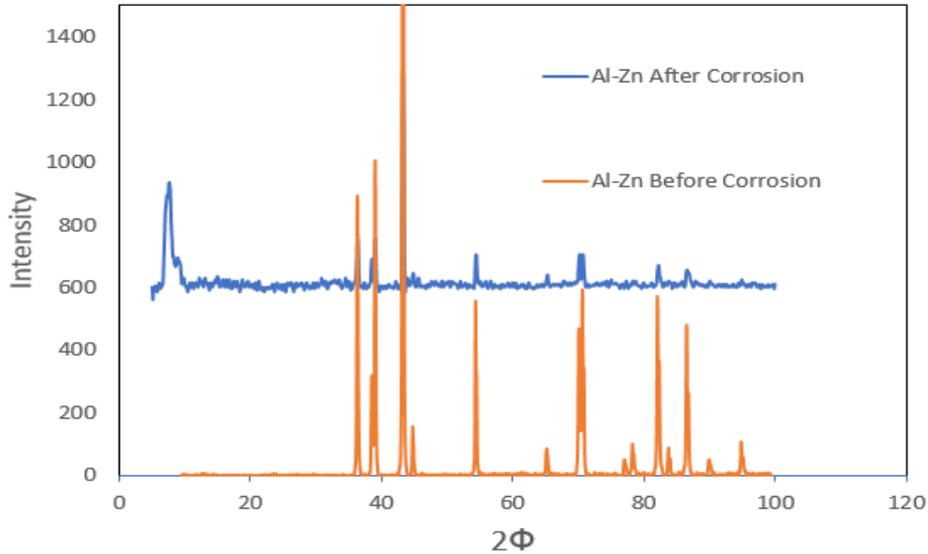
After analyzing the XRD pattern of wire arc sprayed Al-Zn coating as shown in Figure 5, before corrosion, it was observed that the coating was mainly composed of Aluminum and Zinc. After corrosion, some other peaks belonged to aluminum oxide and zinc oxide detected, which were formed as the result of the passivation process of the surface. Presence of these oxides were also identified in the earlier report considering the Tafel curve obtained after corrosion of the Al-Zn coating in 3.5% NaCl solution.

Figure 5. X-Ray pattern of wire arc sprayed Al-bronze coatings before and after corrosion.

The composition of the coatings before and after corrosion were also been evaluated by using a Rigaku Ultima IV diffractometer (Cu K α radiation, voltage 40 kV, current 44 mA, and a fixed incident angle of 1.5 degree in a parallel beam geometry).

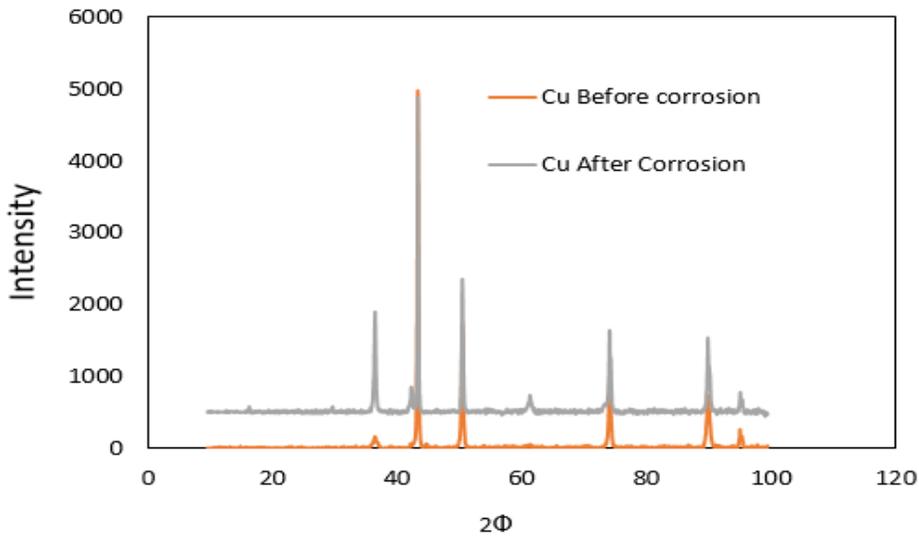
XRD-pattern of the HVOF sprayed copper coatings which was also deposited earlier in this project exhibited some dissimilarity when comparing before and after corrosion conditions in this coating. The XRD pattern shown in Figure 6 demonstrated that copper oxide was the main composition appeared after corrosion whilst it was not detected in the coating structure before the corrosion experiments.

Figure 6. X-Ray pattern of HVOF sprayed Copper coatings before and after corrosion.

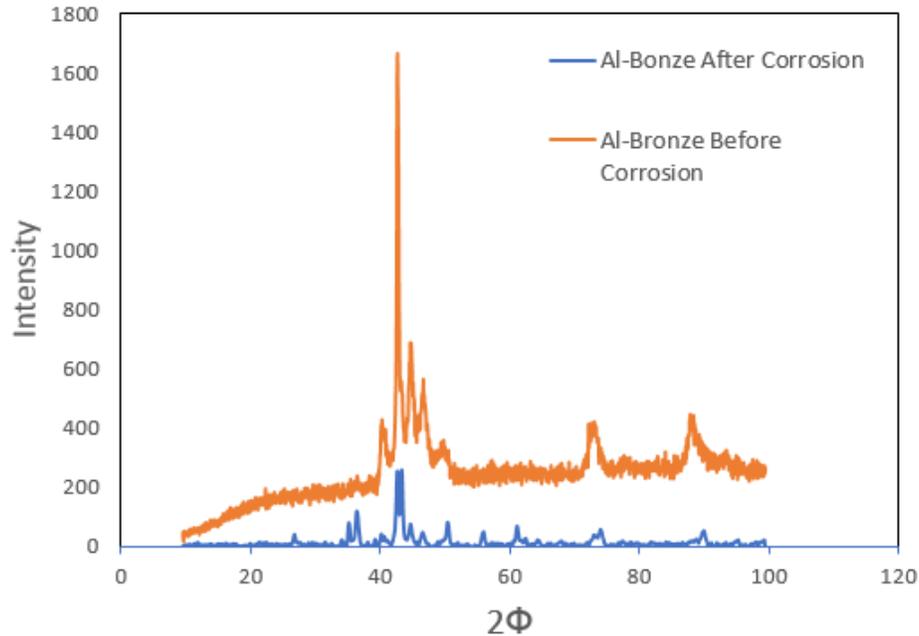
HVOF deposited Al-bronze was mainly contained $AlCu_3$ and $Ni_3ZnC_{0.7}$ before corrosion as it is shown in Figure 7. After exposed to the corrosive environment, there were more materials such as $AlCu_3$, Cu_2O , and $FeO(OH)$ were identified in the Al-bronze coating.

Figure 7. X-Ray pattern of HVOF sprayed Al-bronze coatings before and after corrosion.

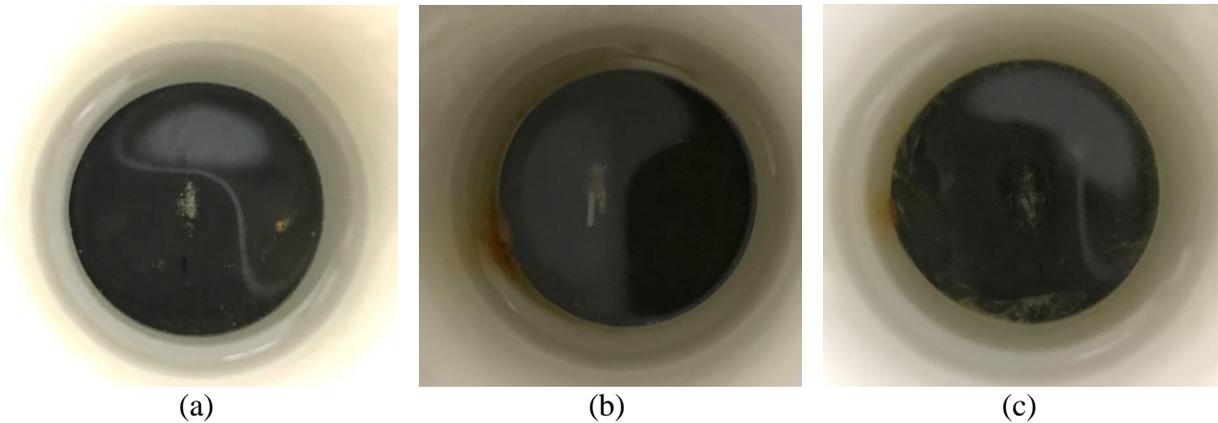
In the fifth quarterly report, it had been mentioned that long-term corrosion tests were carried on three steel plate samples with soft coatings. Epoxy (Duralco 4460 from Cotronics Corp.) had been used as soft coating in this case for the experiments. One optic fiber sensor was embedded on each sample beneath the soft coating to monitor the behavior of coating as time progressed. Figure 8 shows the three samples used in this experiment. The three samples plates (noted as Sample #S1, #S2, and #S3) were made of A36 structural steel and the thickness of soft coatings were 1mm. The corrosion tests run nine months by the time this quarterly report is drafted, resulting in 6,400 hours of monitoring time span. In addition to the three embedded sensors, one temperature compensation fiber optic sensor was placed on the sample to compensate the temperature effects on the corrosion monitoring.

Figure 8. Visual inspection result at Day 1 for: (a) Sample #S1, (b) Sample #S2, and (c) Sample #S3.

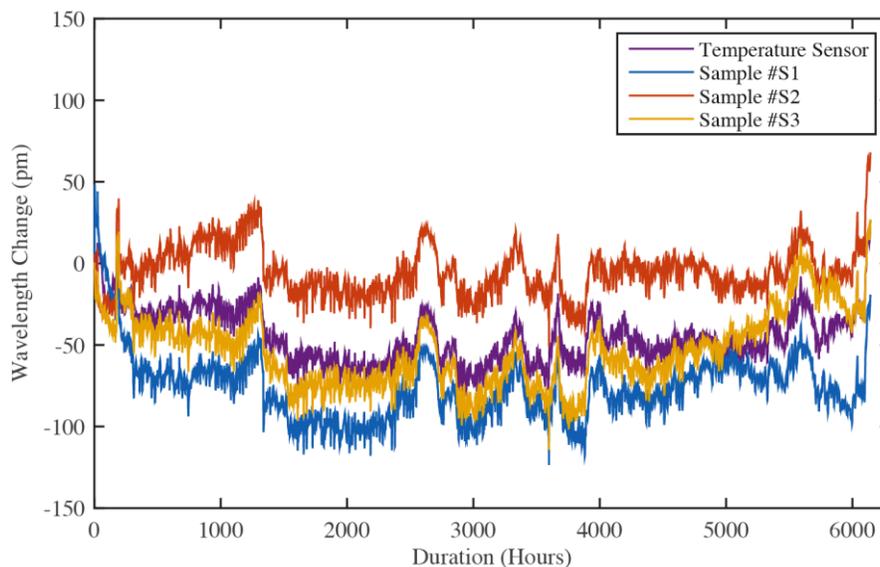
Figure 9 shows the data collected from embedded corrosion monitoring system together with the data collected from the temperature compensation sensor. Figures 10 ~ 12 show the visual inspection results of all the samples on Day 30, Day 150, and Day 270.

Figure 9. Bragg wavelength changes collected from FBG sensor without eliminating temperature effect and de-noising.

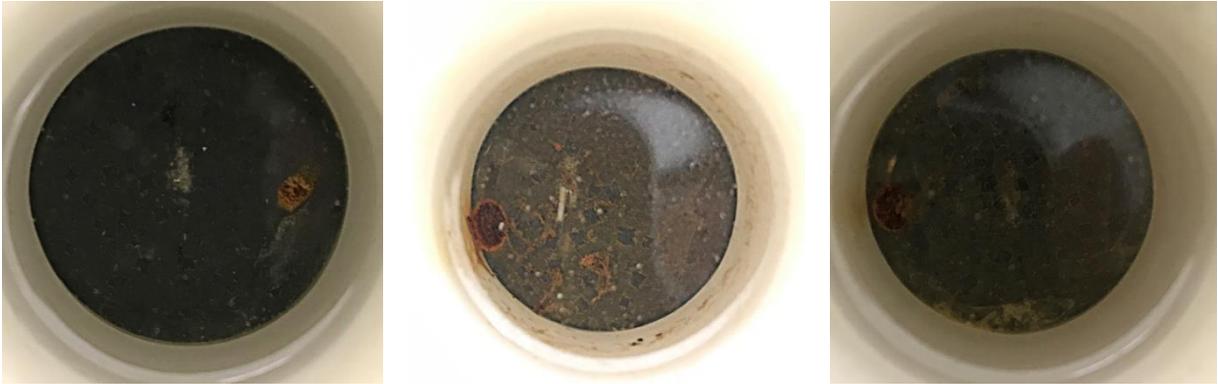
Figure 10. Visual inspection result at Day 30 for: (a) Sample #S1, (b) Sample #S2, and (c) Sample #S3.

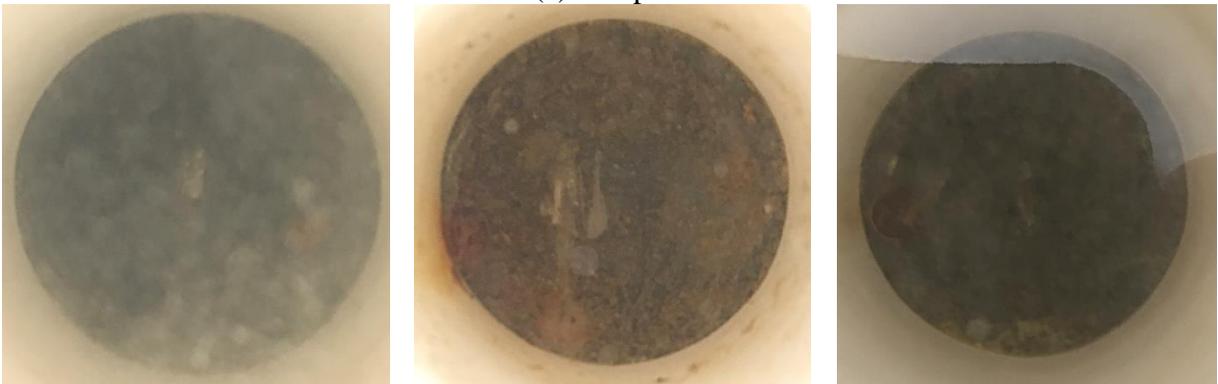
Figure 11. Visual inspection result at Day 150 for: (a) Sample #S1, (b) Sample #S2, and (c) Sample #S3.

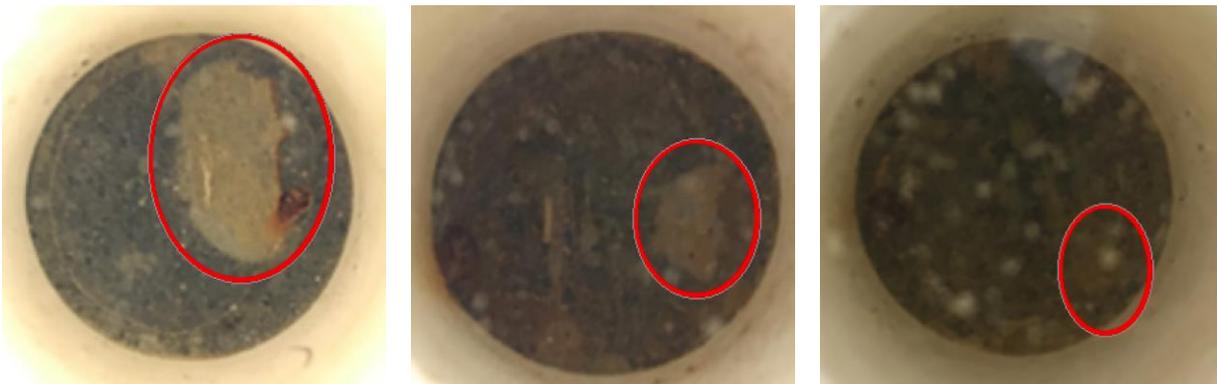
Figure 12. Visual inspection result at Day 270 (Jun 18th, 2017) for: (a) Sample #S1, (b) Sample #S2, and (c) Sample #S3.

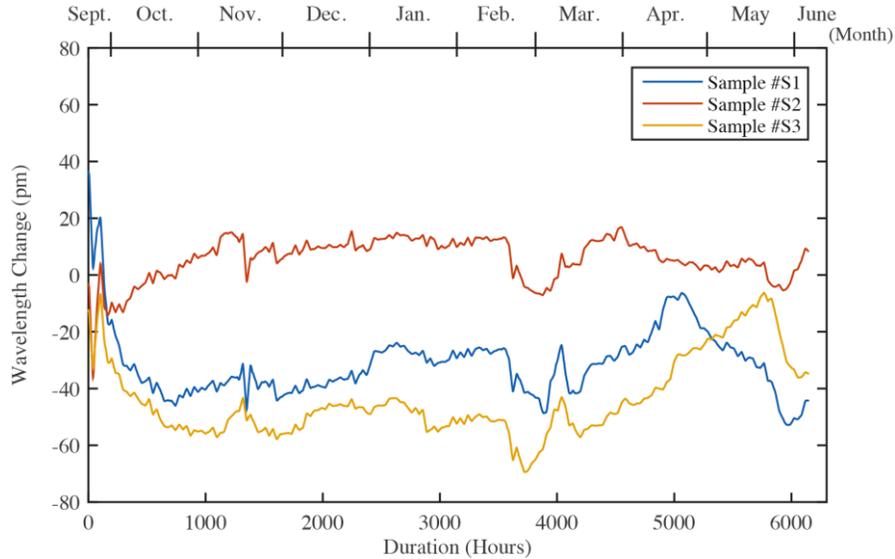
Figure 13 shows the monitored data after temperature compensation for all the three samples. It can be found from this figure that in soft coating, the monitored wavelength approaching stable

state roughly around 700 hours (29 days) for Sample #S1 and 1000 hours (42 days) for Sample #S2 and Sample #S3. Comparing this result to previous results from accelerated corrosion tests conducted on samples coated with hard coatings as seen in Figure 14, which normally required less than 4 days. It is obvious that the soft coating slowed down corrosion development more efficiently.

Figure 13. Bragg wavelength changes collected from FBG sensor with soft coating after eliminating temperature effect and de-noising.

Also, if the corrosion analysis for soft coating is analyzed based on the findings from the hard coatings as shown in Figure 14 (Sample #H1 was pitting corrosion and Sample #H2 was uniform corrosion), the curve pattern in Figure 13 indicated that Sample #S2 had a pitting corrosion on top of the embedded sensor because its wavelength change increased immediately after corrosion started and Sample #S1 and Sample #S3 would have a uniform corrosion propagation because their wavelength change decreased after corrosion started. However, the visual inspection results from Figures 10~12 did not support this assumption since as it can be seen from those figures, all samples showed pitting corrosion development instead of uniform corrosions beneath the soft coatings. This finding means that we cannot use the same assumptions as made for hard coating to

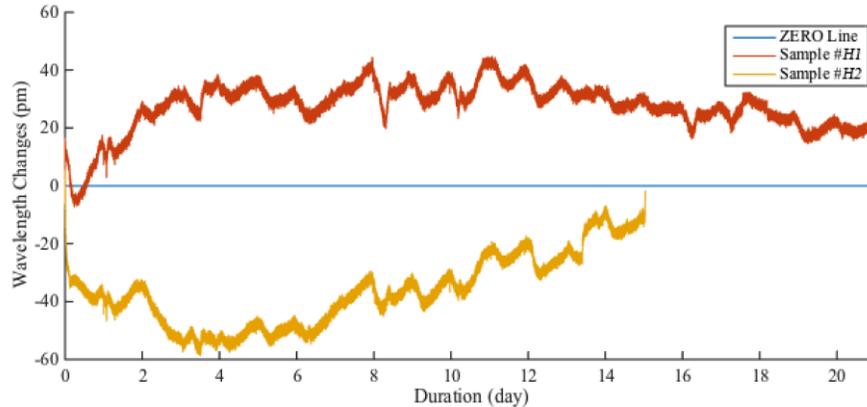
Figure 14. Bragg wavelength changes collected from accelerated corrosion test conducted on samples coated with hard coating.

On the other hand, soft coatings generally have less bonding adhesion at the coating interface comparing to hard coatings. When pitting corrosion occurred under soft coatings, it was more likely that a relatively larger portion of coating near the corroded area were detached from base material, which is known as a delamination. This phenomenon would first decrease the overall stress level around the embedded sensors, leading to a decrease in wavelength. With the corrosion progressing, it would gradually increase the amount of corrosion products which filled up the free space and increase the overall stress around the embedded sensors. As a result, the center wavelength of the embedded fiber optic sensor would have a decrease followed by an increase as observed in the monitored data. It's worth noticing that the soft coatings normally have lower porosity compared to hard coatings, so corrosion would develop much slower with application of soft coating when there were no external damages. Thus the wavelength increase was much slower when soft coating is applied. Under soft coating, the center wavelength of sensor embedded in Sample #S1 increased about 20 pm in 4 months as seen in Figure 13,; compared to 40pm changes of center wavelength of sensor embedded in Sample #H2 in 11 days under hard coating as in Figure 14.

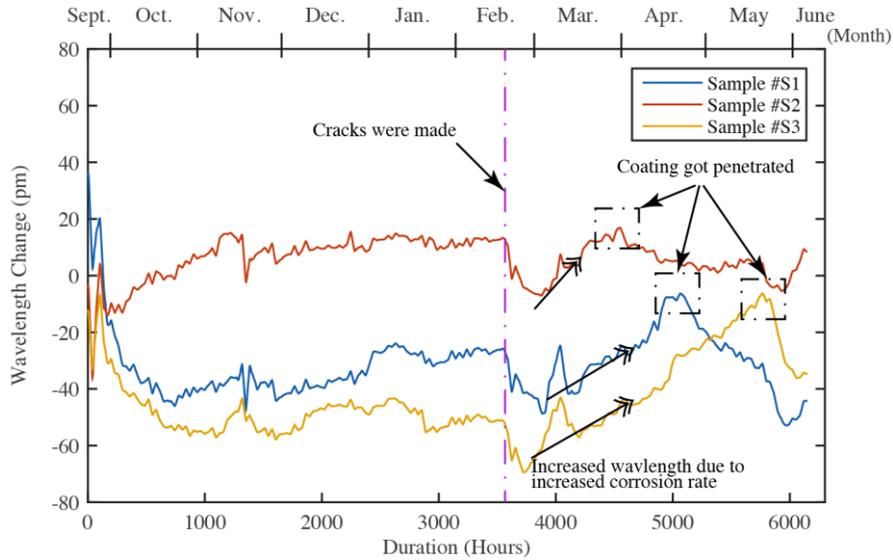
This phenomenon could be further confirmed after cracks on top of sensors were intentionally made on each sample on Day 150 (February 20th, 2017) as shown in Figure 15. A decrease on center wavelengths of the embedded fiber optic sensors could be found on Day 150, followed by an increase after 10 days.. When crack occurred, there would be more coating delamination, leading to a decrease in center wavelengths of sensors. However, because the cracks broke the barrier between base material and outer environment, the corrosion of the base material would increase and corrosion products would start to fill up the free space beneath the soft coating. As a result, the wavelength of the embedded sensors would increase until the coating was penetrated. After coating penetrated by the corrosion products, the wavelength change curve decreased again. In the visual inspection result in Figure 12, it was clear that large portion of soft coatings were delaminated in Sample #S1 (middle part), Sample #S2 (right part), and Sample #S3 (bottom-right part). Clearly, the embedded fiber optic sensors successfully and effectively captured the entire corrosion progress of the steel materials coated soft coatings including the early stage of corrosion, coating delamination progressing, crack initiation, and coating breakage.

Figure 15. Bragg wavelength changes with detailed time tags marked
