CAAP Quarterly Report

Date of Report: <October 10th, 2017>

Project Title: <Mitigating Pipeline Corrosion Using A Smart Thermal Spraying Coating System>

Prepared by: <North Dakota State University>

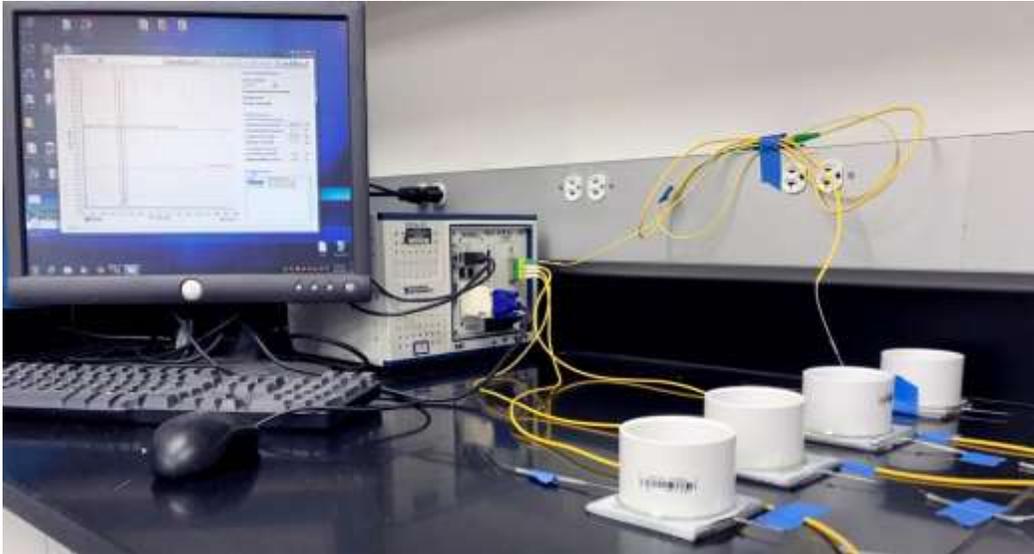
Figure 3. Accelerated corrosion test setup.

In this quarter, three samples were tested in the laboratory using the same experimental setup as used and explained in previous quarterly reports to evaluate the coating quality and capability of corrosion monitoring system. The three samples were wire arc sprayed Al-Zn hard coating at different thicknesses: 1.5 mm and 2mm. All three coatings were deposited on A36 structure steel. The size of the samples were 2 in. × 2 in. As shown in Figure 1, samples were noted as Sample #A1, #A2, and #A3. The coatings on Sample #A1 and #A2 had thickness of 2mm, and the coating on Sample #A3 had a thickness of 1.5mm. Before the accelerated corrosion test was conducted, PVC pipes were attached on top of each coated sample using epoxy by the same method as tests described in previous quarterly reports to keep consistency, as shown in Figure 2. Figure 3 illustrated the overall setup for the accelerated corrosion test. The accelerated corrosion test has run for two weeks till the report, and the NaCl solution used in the test has a NaCl concentration of 3.5wt%.
