CAAP Quarterly Report

Project Title: Distributed Fiber Optic Sensor Network for Real-time Monitoring of Pipeline Interactive Anomalies

Prepared by: Dr. Yi Bao and Dr. Ying Huang

For quarterly period ending: 12/31/2020

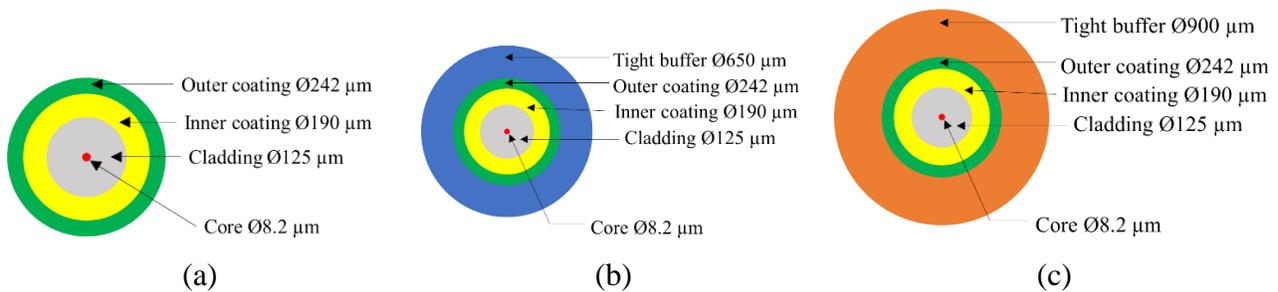
This study investigates three types of telecommunication-grade single-mode optical fibers as distributed fiber optic sensors, including a bare fiber and two coated fibers, as depicted in Fig. 1. In this study, the optical fiber serves as a distributed sensor and the transmission line. The bare fiber is composed of a glass core (diameter: 9 μm), a glass cladding (diameter: 125 μm), an inner coating (diameter: 190 μm), an outer coating (diameter: 242 μm). Light waves propagate along the optical fiber through total internal reflection at the core-cladding interface. The sensing part is the glass core and cladding. The inner coating is a soft acrylic layer which protects the glass fiber from mechanical impact, and the outer coating is a stiff acrylic layer which protects the glass from abrasion and environmental exposure. To further enhance the mechanical strength and facilitates operation of the fiber in practice, the coated fibers are packaged with tight buffers in addition to the bare fiber. In this study, the two types of coated fibers with tight buffers measured 650 μm and 900 μm in diameter are investigated, respectively.

Fig. 1. Cross section of the bare fiber and fiber coated with tight buffer: (a) 242- μm -diameter bare fiber; (b) 650- μm -diameter coated fiber; and (c) 900- μm -diameter coated fiber.

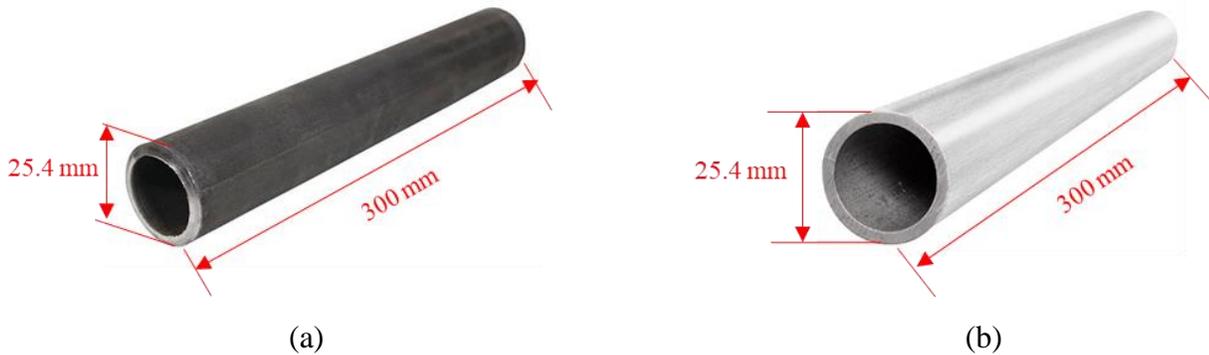
Fig. 2 shows the selected pipe segments. The selected materials of the pipe segments are normal steel and stainless steel, which can be used for the transmission of air, natural gas, oil, steam, and water by following ASTM A733 and ASTM A269. The diameter of pipe segments is 25.4 mm (1 inch) and the thickness is 3 mm (0.12 inch). Each pipe segment is cut into 300 mm in length.

Fig. 2. Selected pipe segments: (a) normal steel pipe; and (b) stainless steel pipe.

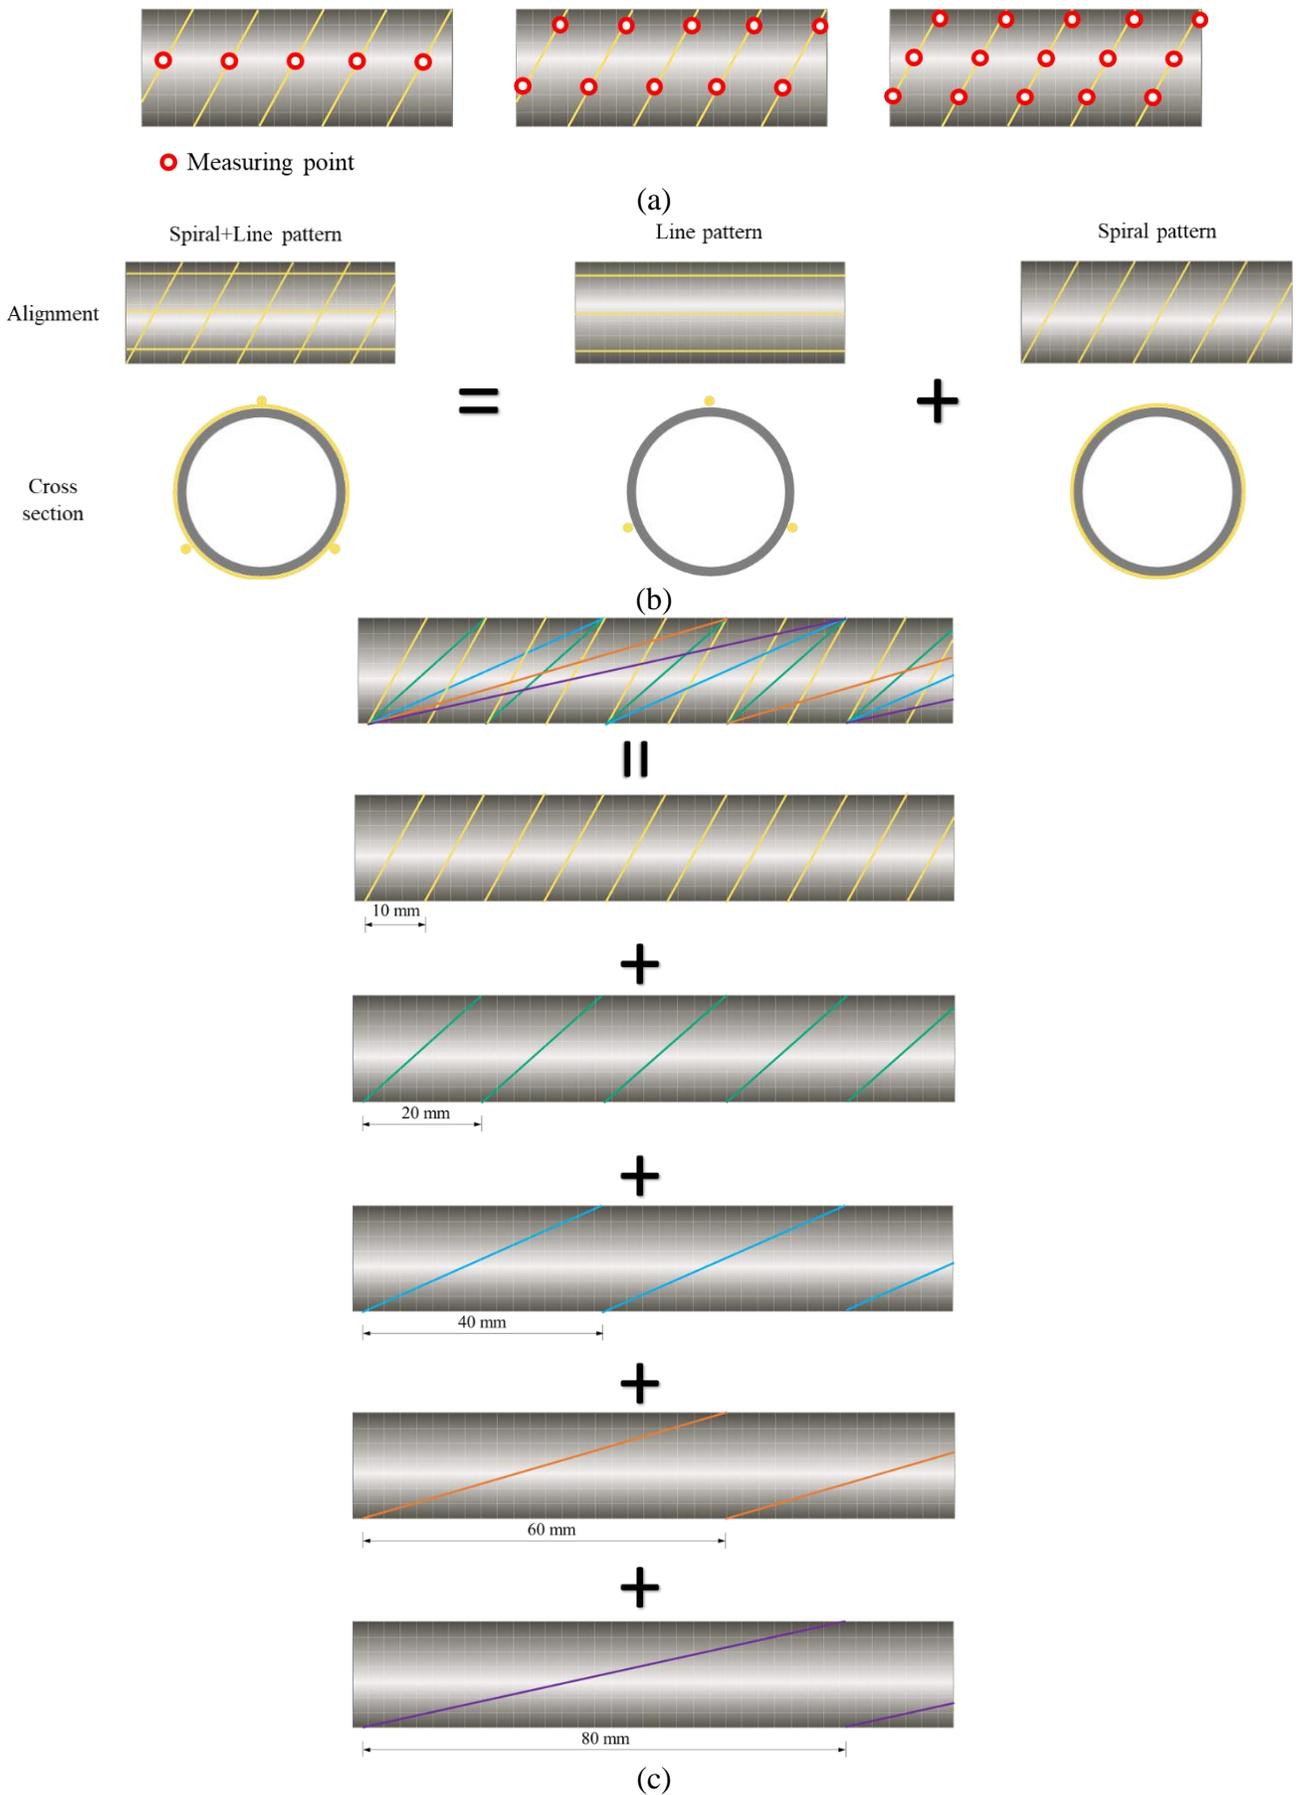
The control case uses a bare fiber (coating thicknesses 900 μm) and the spatial resolution of 0.65 mm. Four steel pipe specimens were prepared and instrumented with distributed fiber optic sensors, namely P0, P1, P2, and P3. Among them, the specimen P0 is stainless steel pipe, which is used as the control; and the specimens P1, P2 and P3 are normal steel pipe, which are used as study group. The specimen P0 was instrumented with coated fiber with 900- μm diameter tight buffer in spiral pattern, and the spacing between the helix fiber is 20 mm. The specimen P1 was instrumented with three types of distributed sensors (Fig. 1) in spiral pattern with 20 mm spacing. The specimen P1 is used to investigate the effects of coating thickness, and both the specimens P0 and P1 can be used for the investigation of spatial resolution on precision of corrosion condition mapping, which is shown in Fig. 3(a). The specimen P2 was instrumented with coated fibers with 900- μm diameter tight buffer in spiral+line pattern in order to investigate the effects of installation patterns, which is shown in Fig. 3(b). the spacing between the helix fiber for the specimen P2 is also 20 mm, and the line pattern divide the circumference of the specimen P2 into three equal parts. The specimen P3 was instrumented with five 900- μm -diameter-tight-buffer coated fibers in different spiral patterns. Five spacings between the helix fiber are investigated, which is shown in Fig. 3(c).

Fig. 3. Instrumentation of: (a) the specimen P1 for investigating spatial resolution; (b) the specimen P2 for investigating installation patterns; and (c) the specimen P3 for investigating installation patterns.

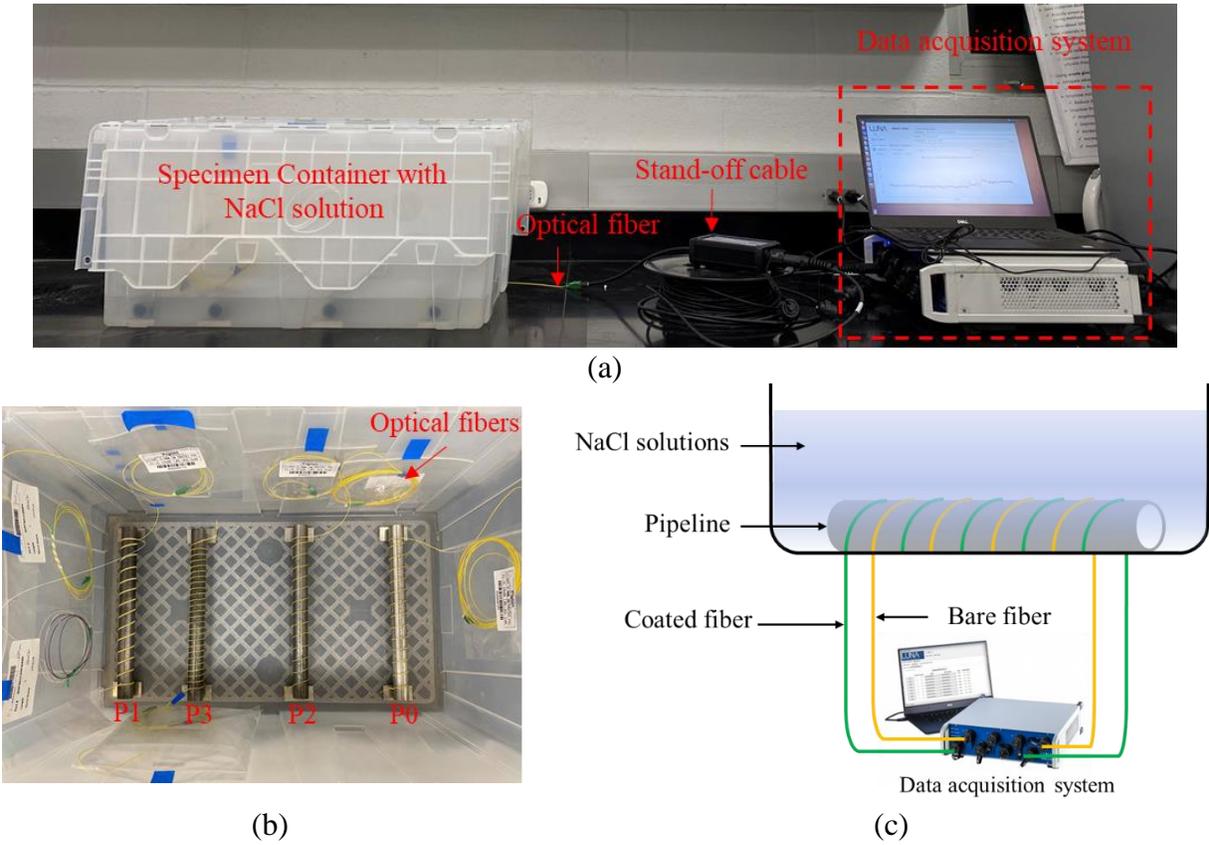
After the adhesive (superglue) get solidified for two hours, pipe segment specimens were immediately immersed in 3.5 wt. % sodium chloride solution. Then, the corrosion test was conducted, as shown in Fig. 4. For each specimen, optical fibers installed on the pipe segment were connected to a OFDR data acquisition system for measurement, as shown in Fig. 4(a). The spatial resolution was set at 0.65 mm, meaning two points with a distance no less than 0.65 mm could be differentiated. Each measurement took about 20 s to 40 s, and each measurement was repeated for three times, and the measurement results were averaged.

Fig. 4. Experimental test of corrosion: (a) test set-up; (b) specimens in the chamber; and (c) illustration of steel pipe instrumented with a distributed fiber optic sensor.

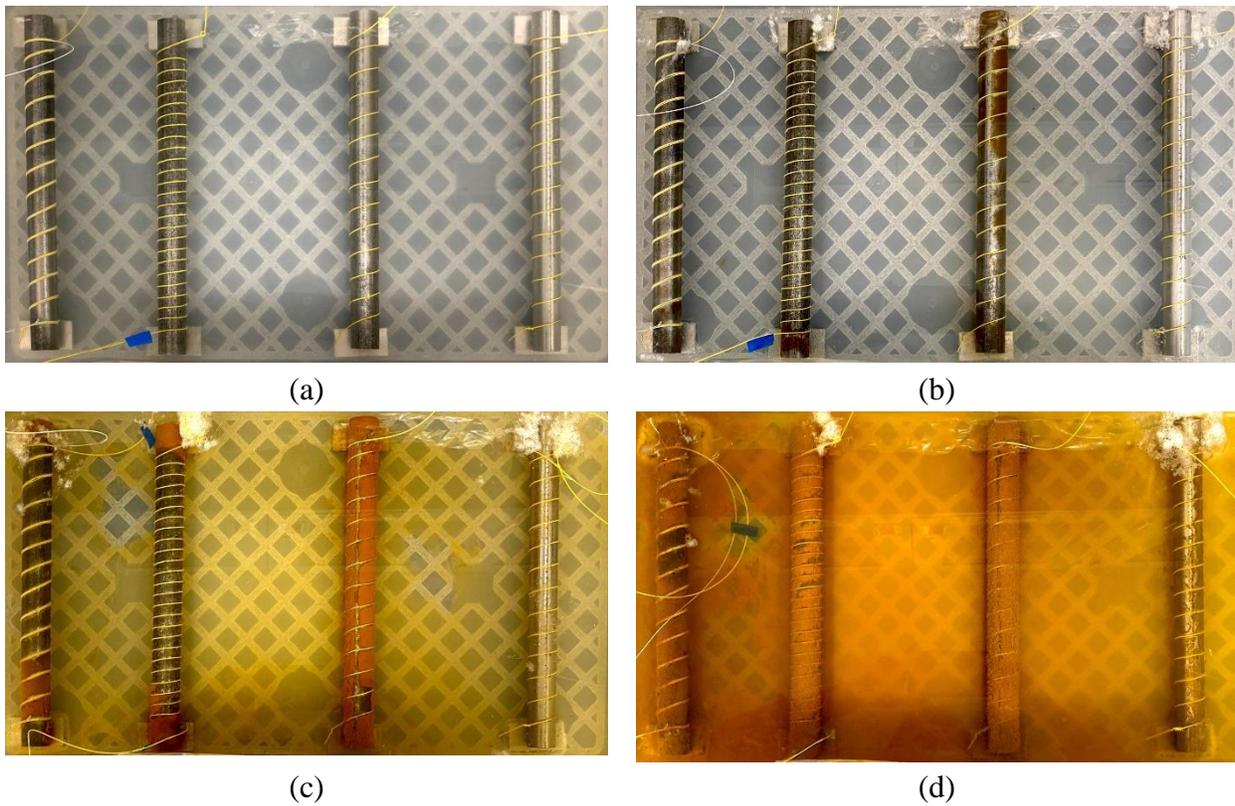
During the corrosion tests, the surface condition of the tested pipe segment specimens was visually inspected at different times, as shown in Fig. 5. As the time continues, rust was observed on the surface of P1, P2, and P3; however, little rust was found on the on the surface of P0, which can be attributed to the use of the stainless steel of P0.

Fig. 5. Visual observation of the pipe segments in different times: (a) 30 h (hour); (b) 60 h; (c) 114 h; and (d) 184 h.

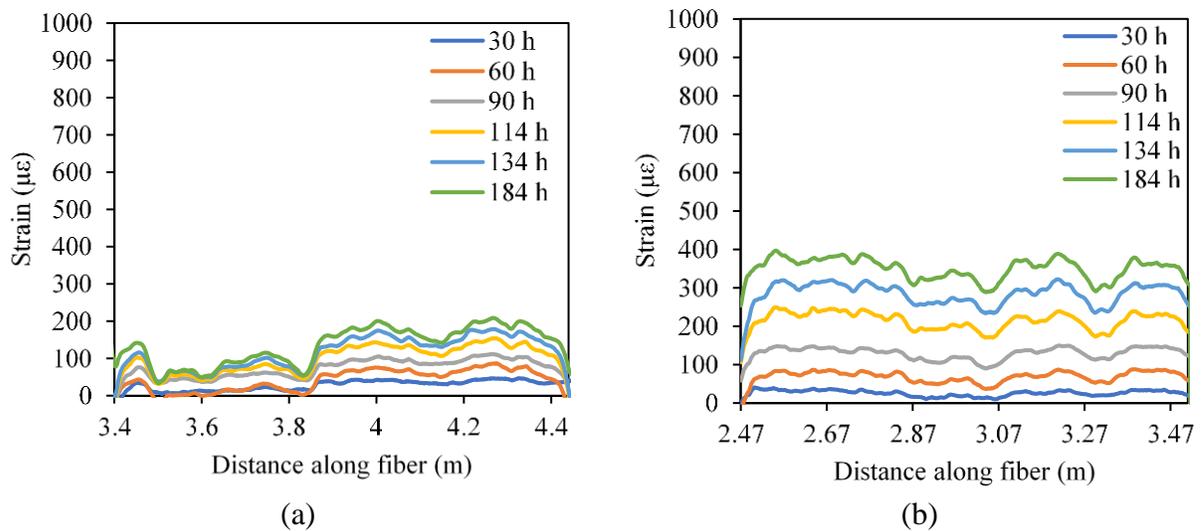
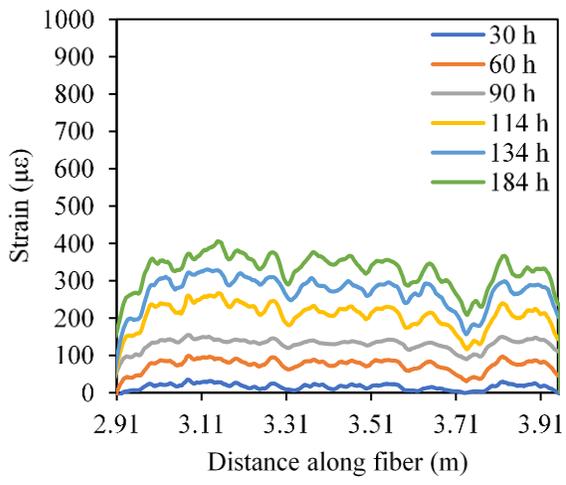
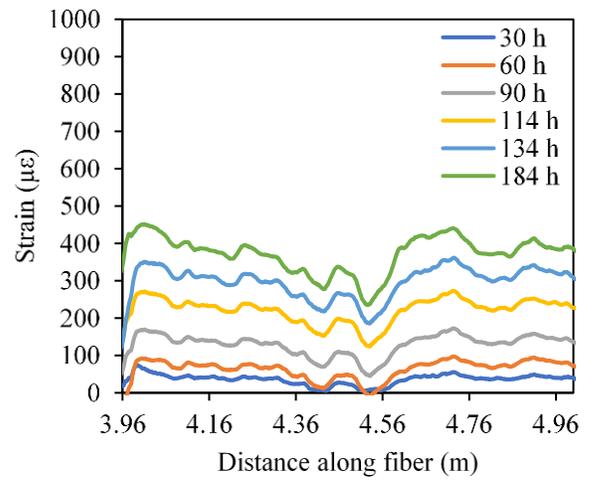
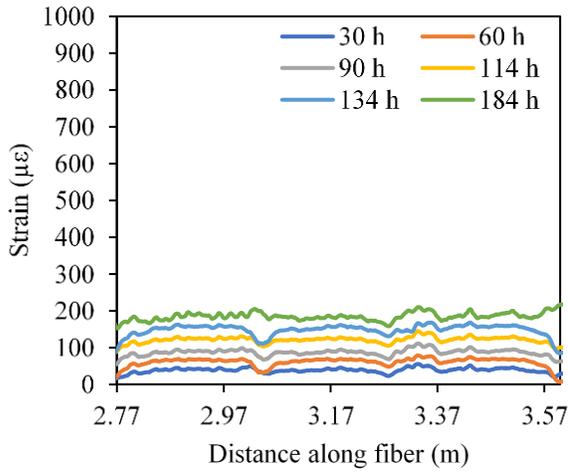
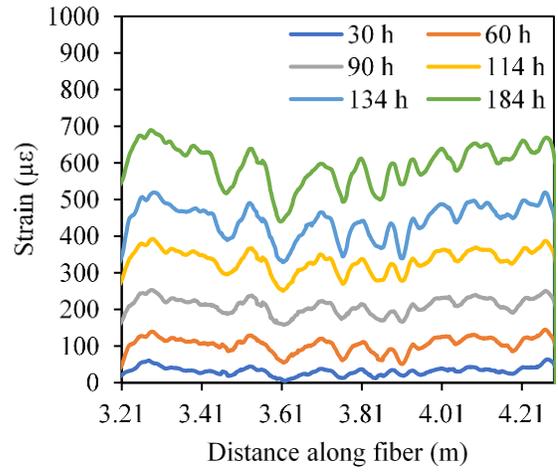
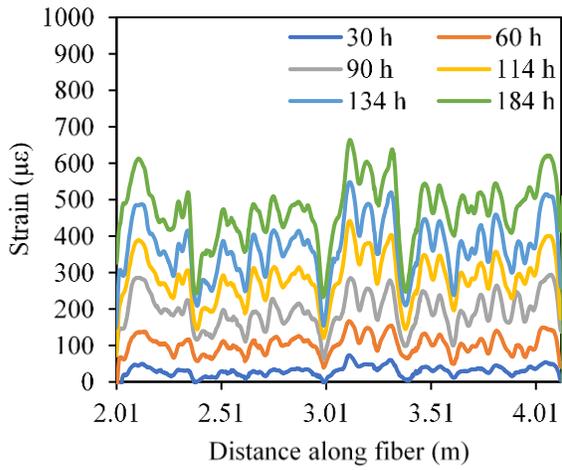
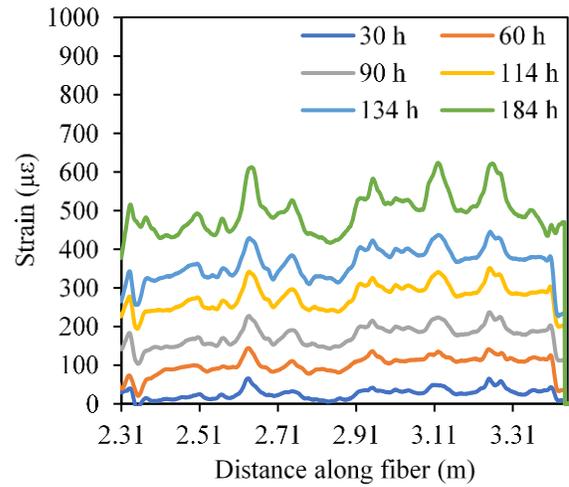
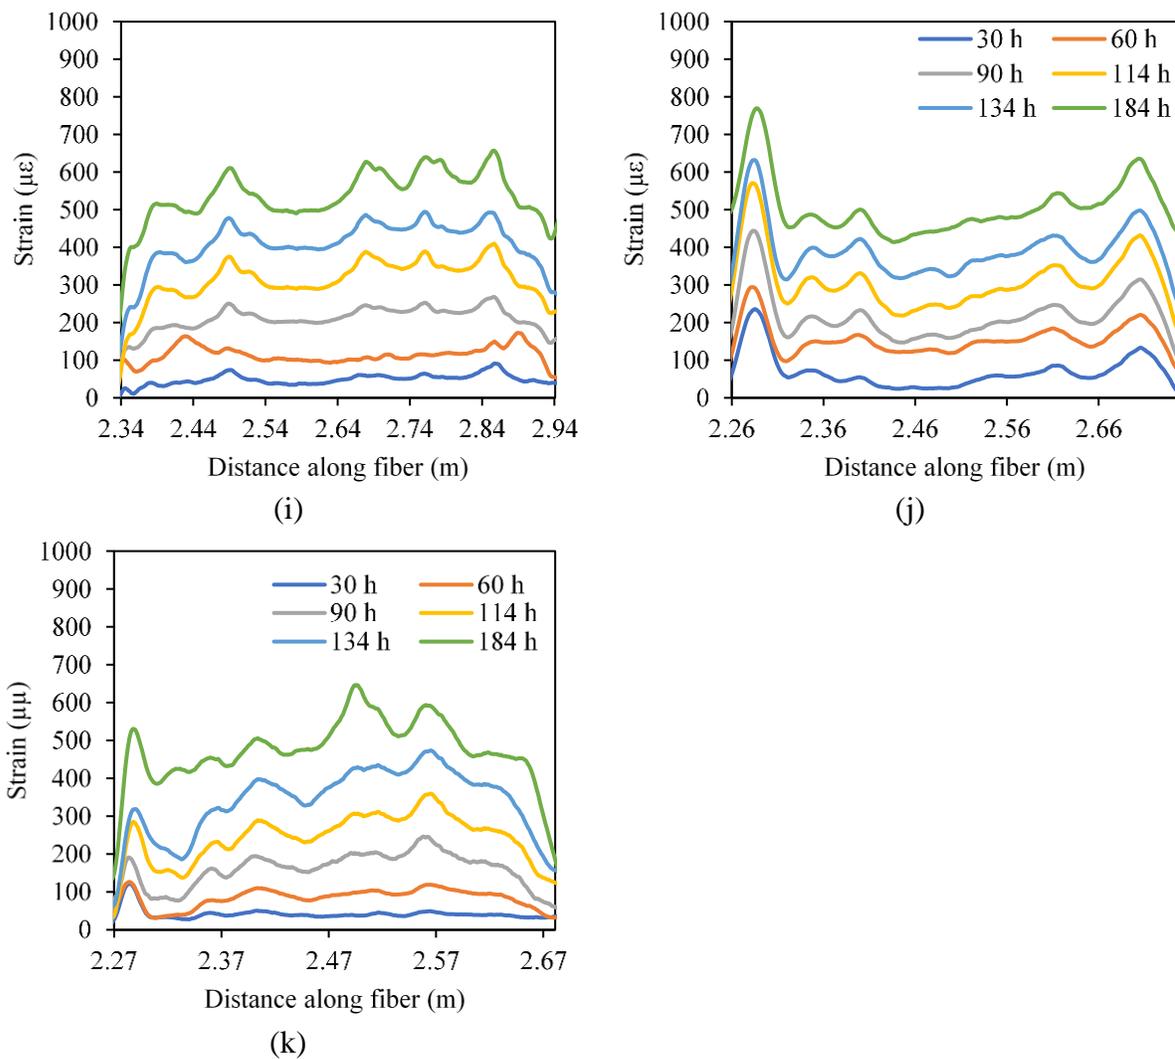
Fig. 6 shows the corrosion-induced expansion strain measured from the distributed sensors installed on the pipe segment specimens. The Y-axis represents the strain measured from the distributed sensor; tensile strain is positive. The X-axis represents the position along the length of the optical fiber. In each figure, the length range of the optical fiber is selected to show the strains in the fiber length that are wrapped on the pipe segment specimens.

Fig. 6. Detailed strain distributions along the distributed sensors in the pipe segment specimens: (a) P0; (b) P1-242 μm ; (c) P1-650 μm ; (d) P1-900 μm ; (e) P2-line pattern; (f) P2-spiral pattern; (g) P3-10 mm; (h) P3-20 mm; (i) P3-40 mm; (j) P3-60 mm; and (k) P3-80 mm.

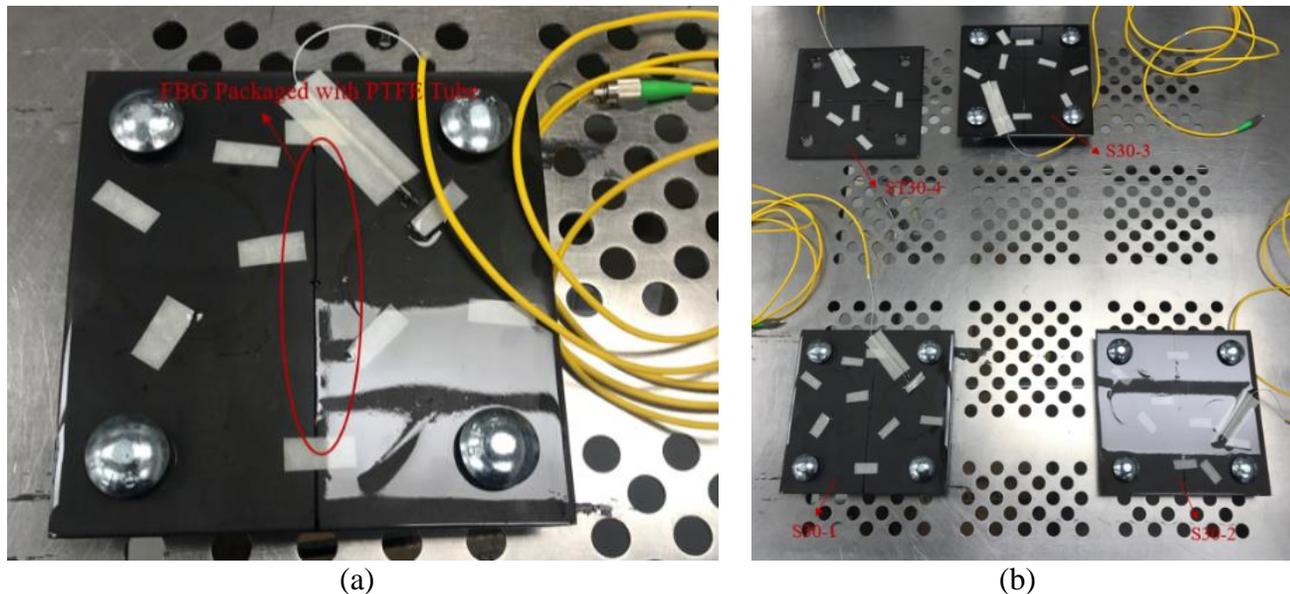
The preparation of experimental samples was similar to that of the samples with bare FBG sensors, but the FBG sensors were packaged with the PTFE tubes (SWTT-30). First, an FBG sensor was inserted into a 4" PTFE tube. Then, the sensing length of the sensor was stretched to be straight and then attached to a ruler with a tape. The center point of the sensing length was marked using a marker, in order to ensure that the center point of the sensing length coincided with the center point of the tube. After fixing the position of the tube, a glue was used to attach the two ends of the tube with the FBG sensor. The completed samples are shown in Fig. 8. They are designated as S30-1, S30-2, S30-3, and ST30-0.

Fig. 8. Samples of FBGs packaged with PTFE tubes.

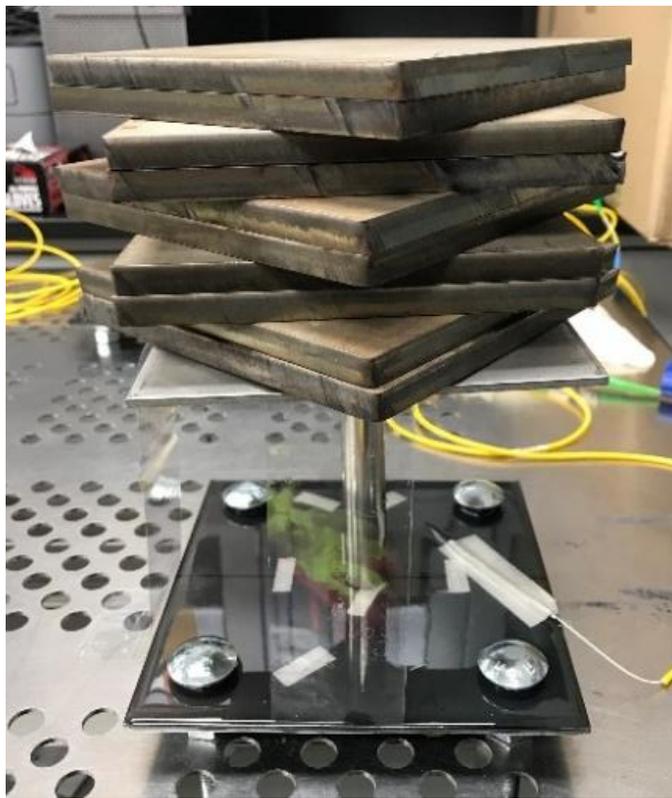
Using the stainless-steel frame with a 6"×6"×0.125" stainless-steel plate and a diameter of 3/4" stainless-steel bar to achieve the loading test. After fixing the frame with tape on the top surface of steel plates where FBG sensors have been embedded, put stainless-steel plates on the stainless-steel frame step by step to achieve the stepwise application of five-level load, as shown in Fig. 9.

Fig. 9. Test set-up of the crack testing.

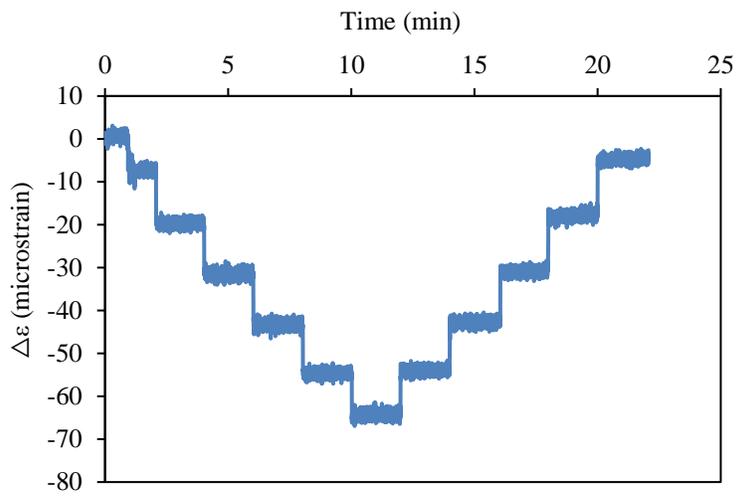
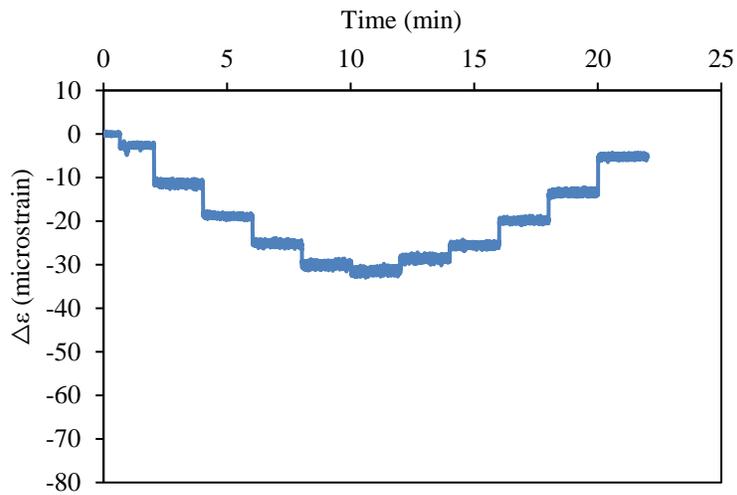
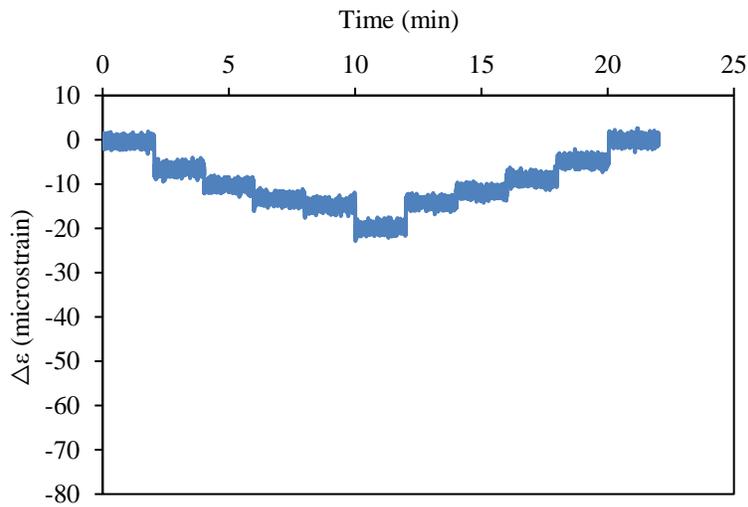
Fig. 10 shows the results of strains measured from the FBG sensors in the three specimens (i.e., S30-1, S30-2, and S30-3). Each level of load was sustained for about 2 minutes. At each load level, the strains in the steel plate were measured using the FBG sensor attached on the steel plate. According to the test design, the increment of the strain for adjacent load levels was $20 \mu\epsilon$ (micro-strains). However, in the actual test, the measured strains from the FBG sensors in the three specimens were much smaller than the theoretical results. Specifically, the total strains measured from the sensors S30-1, S30-2, and S30-3 were $65 \mu\epsilon$, $32 \mu\epsilon$, and $20 \mu\epsilon$, respectively, while the theoretical strain was $120 \mu\epsilon$. The lower strain results were attributed to multiple reasons. On one hand, the package of the tube led to strain transfer effect, which could lead to smaller strains sensed by the FBG sensor. On the other hand, based on the observation of the test processes and the specimens, it was found that the FBG sensors were not straight after they were packaged by the tubes and attached on steel plates, which explained why the measured strains were different in the three specimens.

Fig. 10. Loading test results of steel plates with SWTT-30 packaged FBGs (Microstrain vs. Time): (a) S30-1; (b) S30-2; and (c) S30-3. The results are presented after performing temperature compensation.

Based on the above experience, it was learned that a certain prestress should be applied to ensure that the FBG sensor would be straight throughout the sensor preparation process. The prestress should be small and does not affect the measurement, but it should be large enough to keep the sensor straight, in order to achieve a reasonable measurement performance.

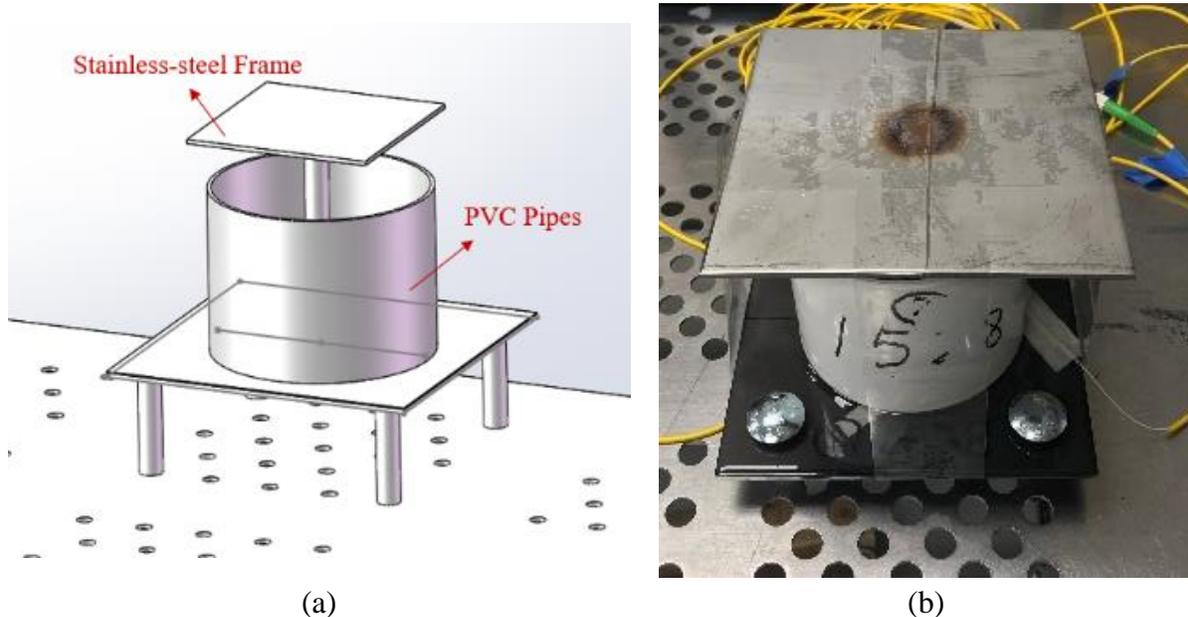
To simulate the real corrosive environment and achieve real-time monitoring of corrosion, PVC pipes with a diameter of 4 inches were attached to the top surface of the steel plates with FBG sensors and filled with 3.5 wt. % sodium chloride (NaCl) solution. The test setup of loading and corrosion is shown in Fig. 11.

Fig. 11. Depiction of the test set-up for loading and corrosion experiment using bare FBG sensors: (a) schematic illustration, and (b) photograph.

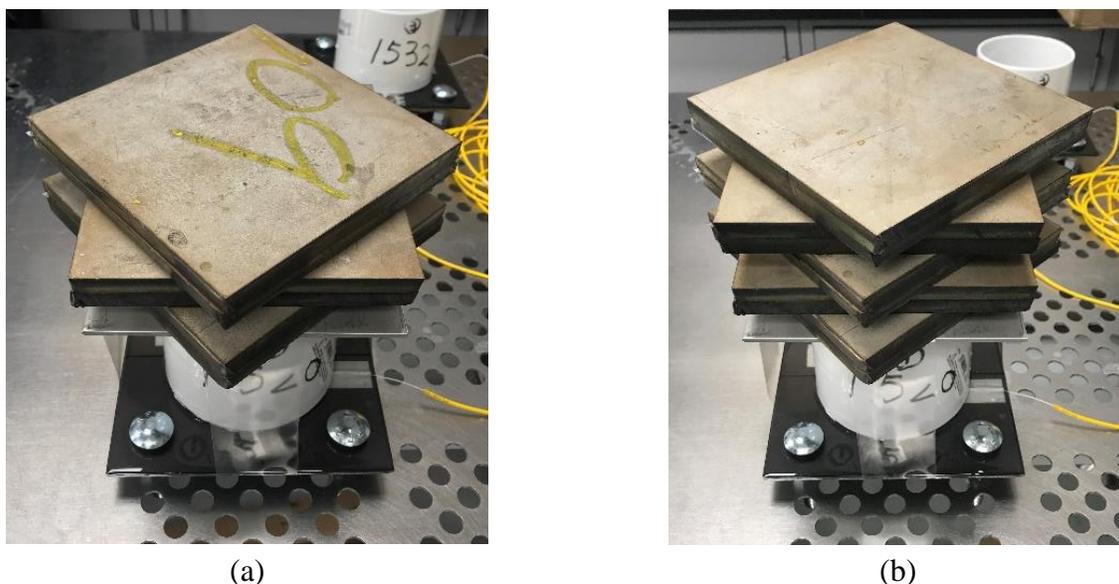
The five-level loading was applied and unloaded step by step by placing the stainless-steel plates on the frame, as shown in Fig. 12.

Fig. 12. Five-level loading: (a) the third level of loading, and (b) the fifth level of loading.

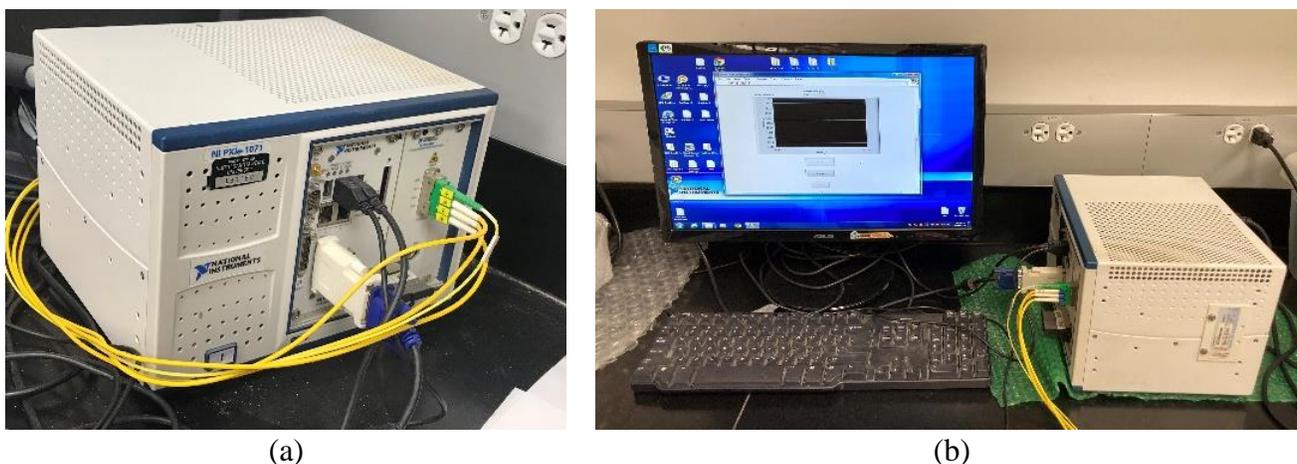
Fig. 13 shows the FBG interrogator. In the experiment, the specimens with bare FBG sensors B0, B1, B2, and B3 were connected to the different channels of the interrogator. Their center wavelengths were 1524 nm, 1520 nm, 1528 nm, and 1532 nm, respectively. The test is still on-going, so only a part of the test data are reported in the following.

Fig. 13. Pictures of the interrogator: (a) the connection of the interrogator, and (b) the test set-up.

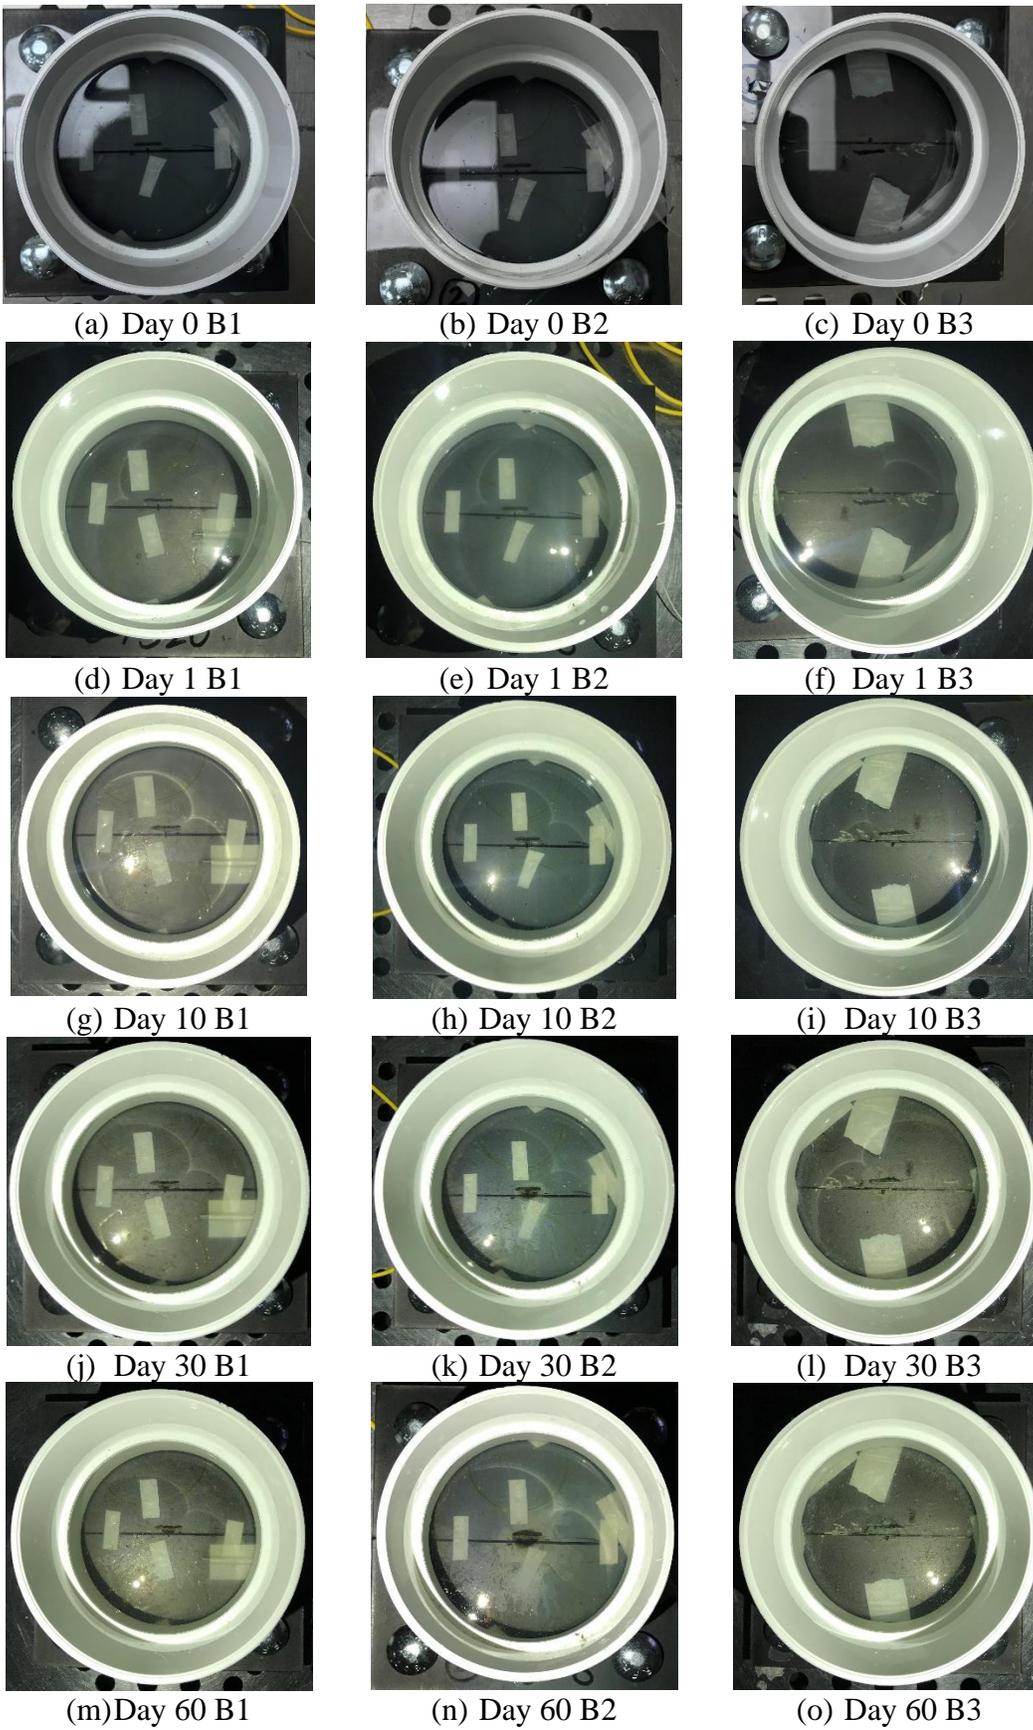
Fig. 14 shows the corrosion degree of three different samples at the beginning (day 0), making cracks (day 1), and the testing at 10 days, 30 day and 60 days. At 10 days, none of the samples showed any visible rust. At 30 days, all the three specimens showed minor corrosion. The specimens B1 and B2 produced brown-red corrosion products. The specimen B3 showed a small white area around the crack, indicating that the solution had entered the gap between the epoxy and the steel plate, but no corrosive product was observed. The reason for the differences in the corrosion degrees is that the cracks were man-made, so the sizes of cracks were different. At the same day, the corrosion severity was random in different specimens. At 60 days, the corrosion areas expanded, and the corrosion phenomenon became more obvious.

Fig. 14. Pictures of the tested specimens at different days (up to 60 days).

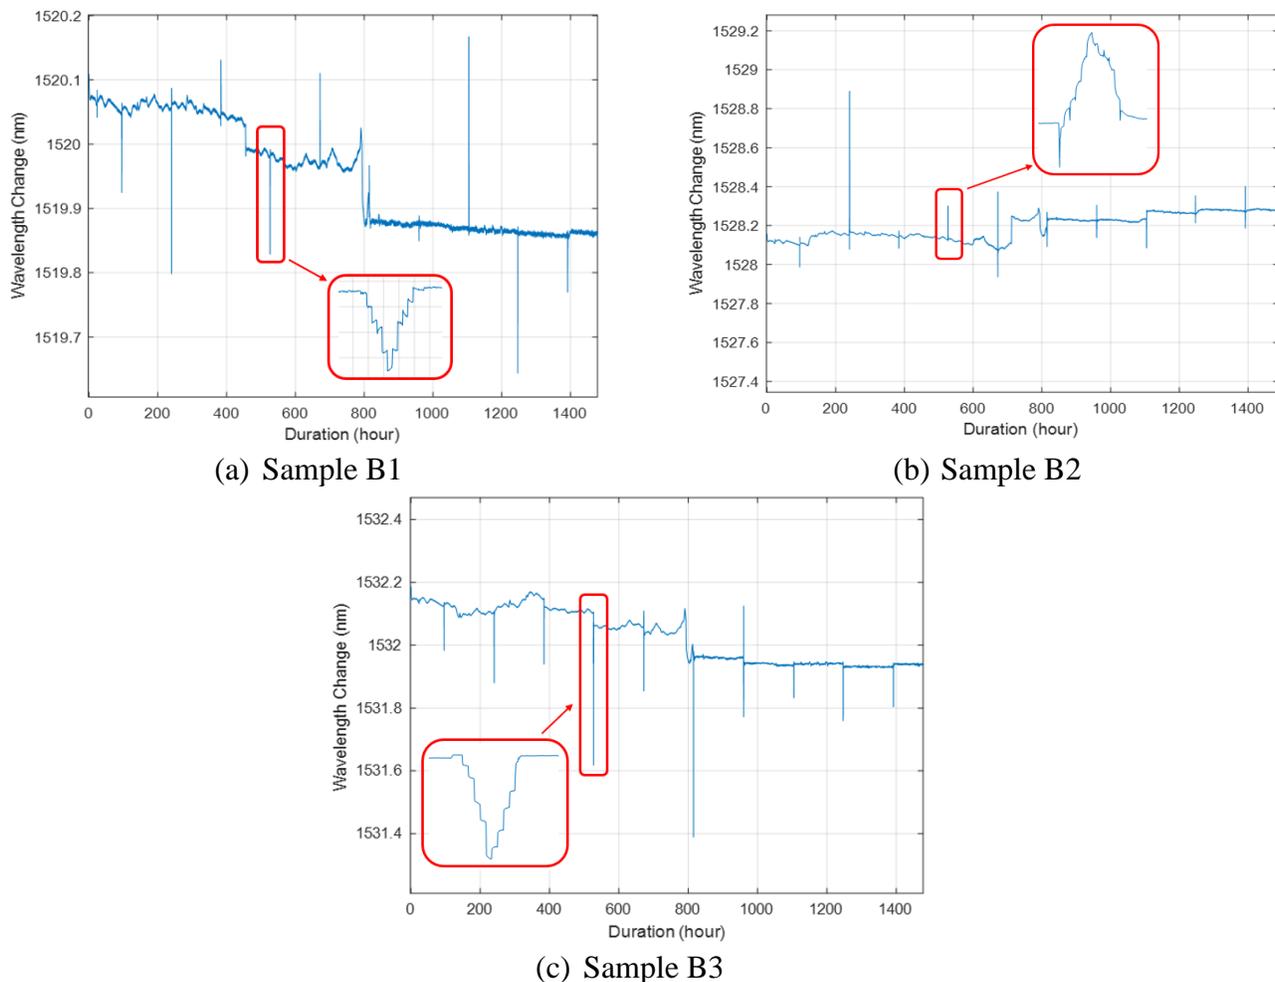
According to the monitoring of wavelength shifts, the wavelengths gradually decreased with time, indicating the occurrence of corrosion. The corrosive products were generated on the surfaces of steel plates, between the steel plates and epoxy, which exerted pressure to the FBG sensor. Therefore, the wavelengths showed gradual decrease. When the loading tests were conducted, the wavelength showed prominent peaks. The number of peaks indicated how many loading tests had been performed. There might be a larger peak or a smaller peak, due to the distribution of corrosive products when they were squeezed, so the FBGs might be compressed or elongated. In each loading and unloading process, the stepwise wavelength shifts could be seen, which are consistent with the results of loading tests. The wavelength shifts of three samples before temperature compensation and detailed diagrams of loading tests are shown in Fig. 15.

Fig. 15. Wavelength shifts of B1, B2 and B3 before temperature compensation.

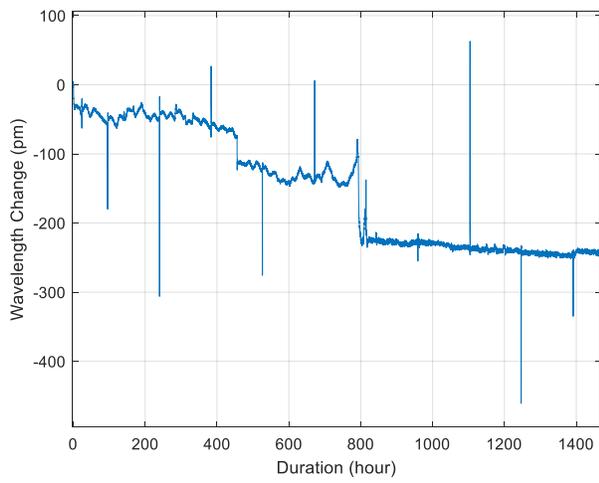
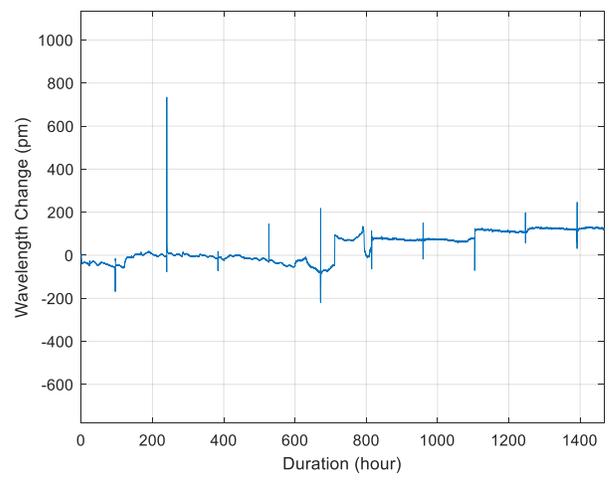
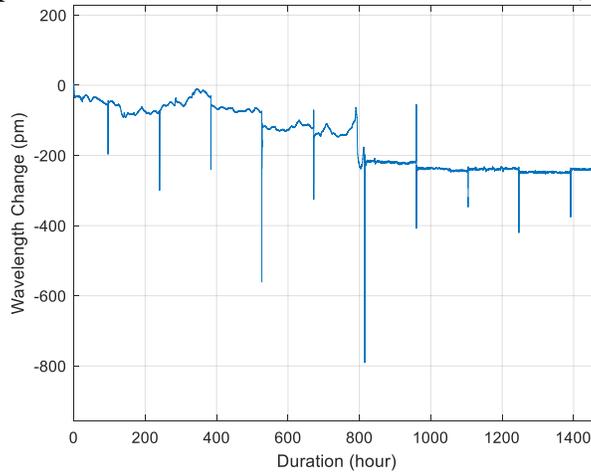
In Fig. 16, the initial measurement of the wavelength of each sensor was not zero. In order to manifest the shift of the wavelength of the FBG sensors during the testing, the measurement data were processed by compensating the initial reading. Therefore, each measured wavelength vs. time curve can be shifted to achieve a zero wavelength change at time zero. The processed results are shown in Fig. 16. Temperature compensation is not performed yet for the data in Fig. 16. The data from the sensor B2 seem abnormal because the data show a different trend from the trends shown by the other FBG sensors. The abnormal data might be related to external forces applied during the loading test. Further analysis is needed to understand the reasons.

Fig. 16. Wavelength shifts from zero of B1, B2 and B3 before temperature compensation.

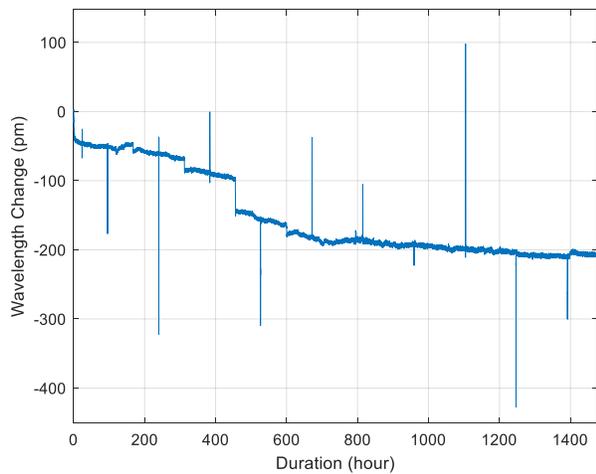
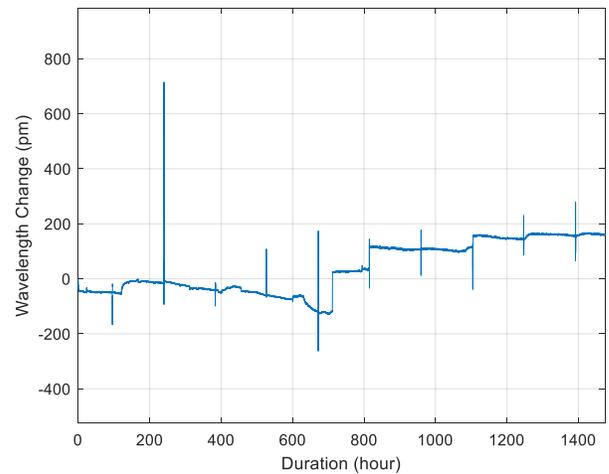
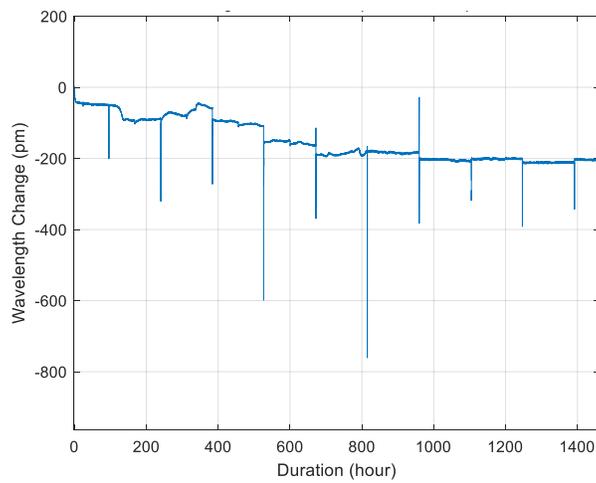
After temperature compensation, the wavelength shifts still exhibited the same changing laws as before temperature compensation, except that the unnecessary small peaks, that is, the temperature-induced wavelength shifts, were removed, as shown in Fig. 17.

Fig. 17. Wavelength shifts from zero of B1, B2 and B3 after temperature compensation.

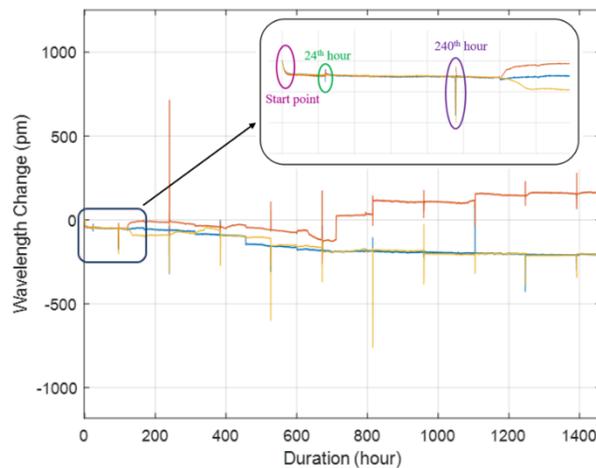
Comparing multiple wavelength shifts, it could be found that at the beginning, there was an overall downward trend because adding the 3.5wt% sodium chloride (NaCl) solution to simulate the corrosive environment was equivalent to applying a uniform load. Meanwhile, the slight fluctuations at the 24th hour were caused by making cracks. And at the 240th (10th day), SB2 had the opposite changing trend from the other two samples, as shown in Fig. 18. The reason is that during the third loading test, the stainless-steel loading frame reversed, and the severe external force applied on the steel plate. This led to premature separation of the coating (epoxy) from the steel plate so that the wavelength shifts gradually increased.

Fig. 18. Compare multiple wavelength shifts after temperature compensation.
