Low Cost, Full-Field Surface Profiling Tool for Mechanical Damage Evaluation

Final Report

Contract No.: DTRT57-09-C-10044

Intelligent Optical Systems, Inc.
2520 West 237th Street
Torrance, California 90505

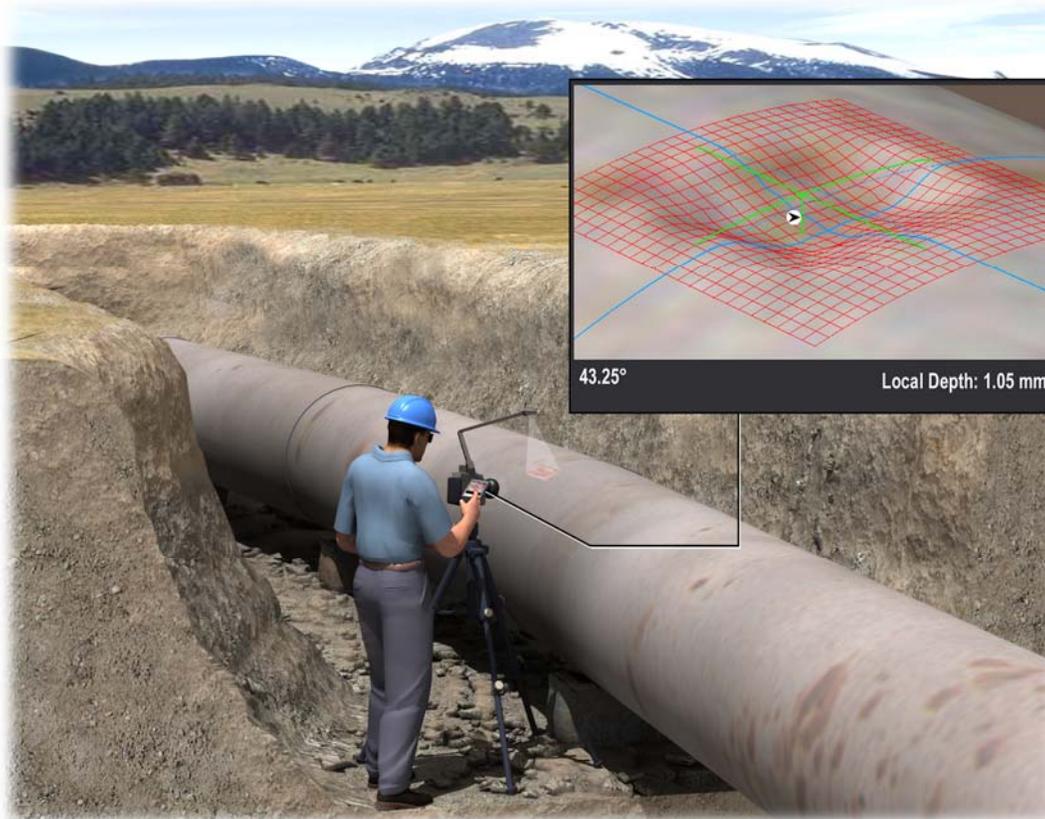
Figure 1-1 A pipeline inspector will be able to capture an image of the illuminated damaged region with a conventional camera. Signal processing will yield the full 2-D depth profile with mm accuracy.

In this project, Intelligent Optical Systems (IOS) developed an inexpensive, full-field, surface-profiling tool for mechanical damage evaluation based on the processing of a single digital image. Little operator training is required for acquiring the profile data. As shown in Figure 1-1, the tool consists of a consumer camera on a tripod with an external laser or LED line pattern illuminator. The illuminator projects a 1-D or 2-D grid of lines downward onto the damaged region. The camera images this region at an angle, so that the displacement of the line pattern over the damaged region provides a measure of the depth. A software package converts the line pattern from the camera image to a profile of the absolute depth, as measured from the undamaged pipe surface. The depth accuracy is on the order of 0.1 mm. In addition, the shape of the full pipe cross section can be extracted. The local profile of the damaged region, plus the shape of the full pipe cross section, together, provides all information required for mechanical

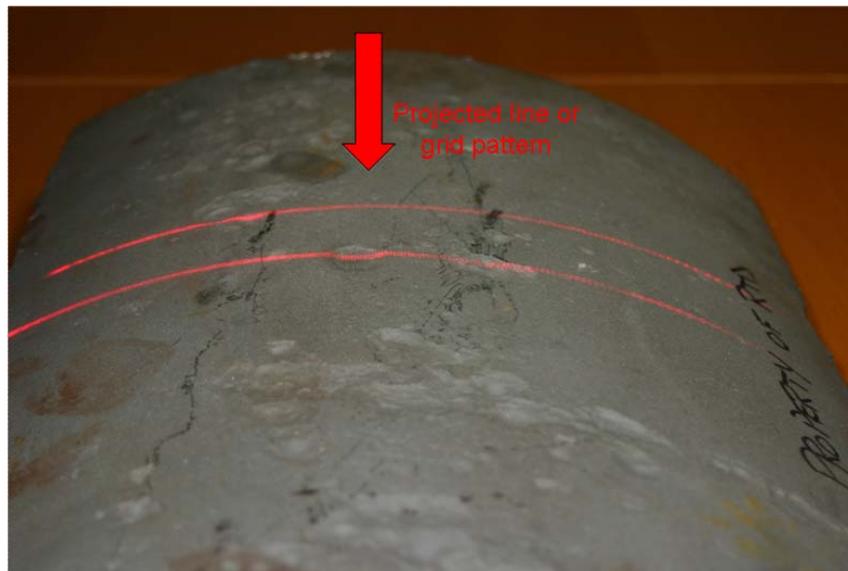
Figure 2-1 Two lines projected onto a corroded pipe section and viewed at a different angle. The distortion of the lines as they pass over corroded regions is clear.

The principle of triangulation for surface profiling is well known. The surface is illuminated at one angle and viewed at a different angle. An example of two lines of illumination on a pipe section with deep corrosion pits is shown in Figure 2-1. The proper trigonometric relationships allow extraction of the surface profile from the distorted shape of the line.

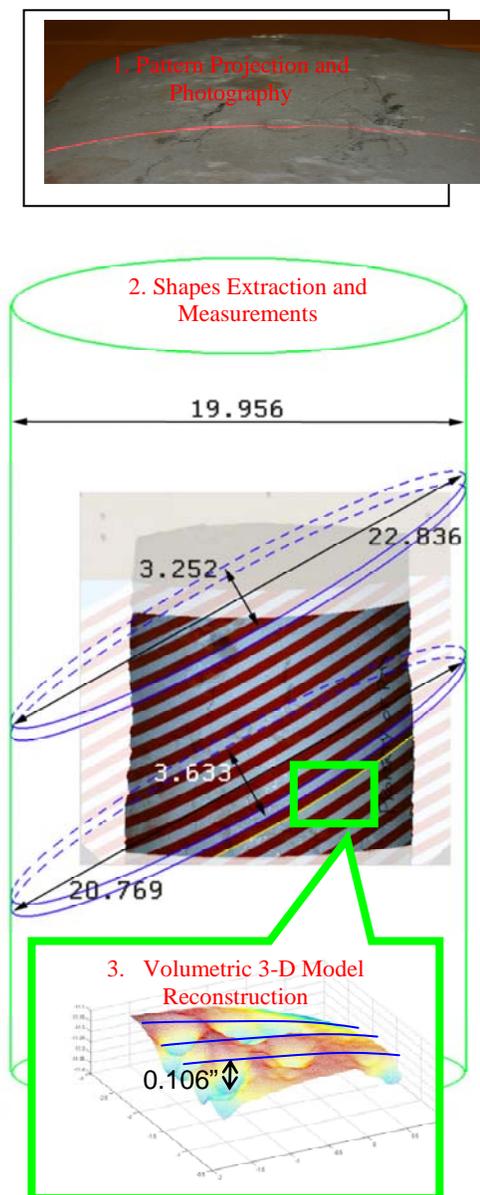
Figure 2-2 (1) Line projected across corrosion pit at its center. On the undistorted surface the line has the shape of an ellipse; (2) example of the extraction of the pipe shape and dimensions from a projected line pattern; (3) extracted 3-D model of the surface provides quantitative damage assessment.

Consider the case introduced above of a dent or corrosion pit illuminated with a single line of light projected perpendicular to the pipe axis and viewed along the axis. An example of this configuration is shown in Figure 2-2(a), in which an LED source projects a line onto a corrosion pit on the outside diameter (OD) of a pipe sample. As before, when viewed at an angle, the line takes on the profile of the curved surface. Our technique uses the measured deflection of the projected line, and an extension of the undeflected line, to measure the depth of the surface feature, and to determine the shape of the distorted pipe. ***Our image-processing algorithms are able to scale the image taken from any perspective, and project an undistorted OD wall across the line image at the dent, so that a true depth profile can be obtained.***

Figure 2-2(b) shows the Phase I results of the extraction of the shape and diameter of the pipe sample shown in Figure 2-2(a). The extracted 3-D model is shown in Figure 2-2(c). A simple line pattern was projected onto the corroded region of the sample, and projected ellipses were fit to the surface. The numbers near the ellipses are the semiaxis dimensions and the number at the top is the calculated pipe diameter.

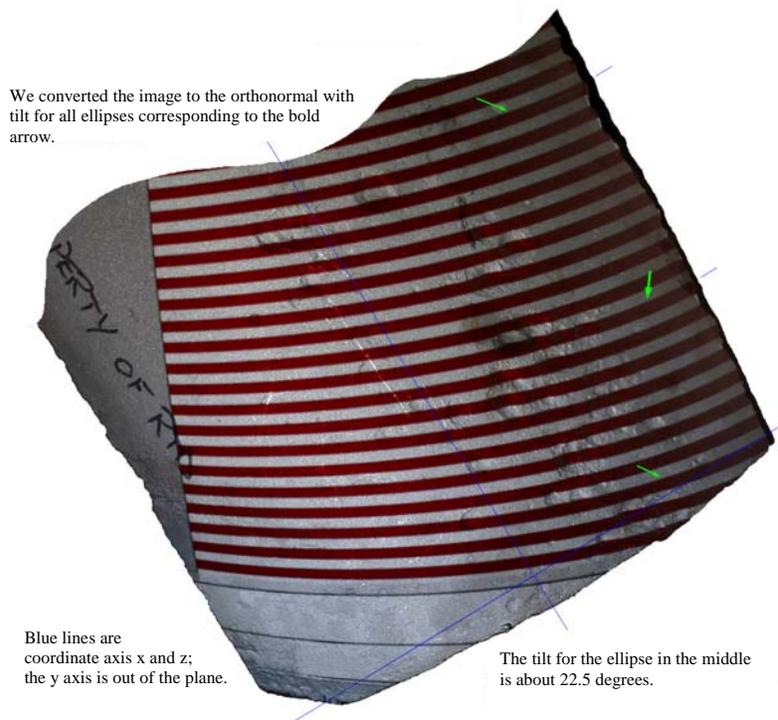
Figure 2-3 Structural light pattern projected on the surface. The curvature of the lines allows the depth of the depressions on the surface of the pipe to be determined.

We developed an algorithm and software for structural light projection that provides optimal performance. The details of the pattern selection are presented in the Task 3 section of this report. The light pattern that we used (see Figure 2-3) covers the entire surface of the pipe.

The curvature of the lines depends not only on the pipe curvature, but also on and pipe, projector, and camera positions. With a fixed camera and light source, one can calculate the depth of the damage by relating the light deviation to the ideal ellipse, and the general shape of the surface (i.e., the diameter of the pipe -- see Figure 2-4). To develop an algorithm and software, we had to develop a mathematical approach on how to interpret/measure the amount of deviation at the surface and compare that value to the ideal ellipse. This approach is described below.

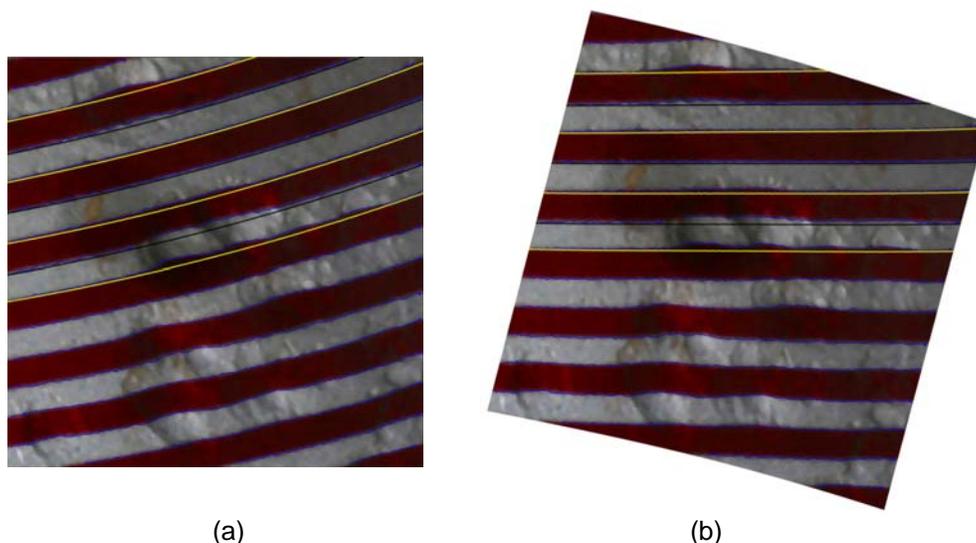
Figure 2-4 Fitting ellipses to the line allows the general shape of the pipe and depth information to be extracted: (a) We determined ellipses that fit to the surface (yellow lines); then we could unwrap the surface (b) in such a way that the yellow lines become straight. The depression depth (blue line) can then be clearly seen as a deviation from the surface (yellow line).

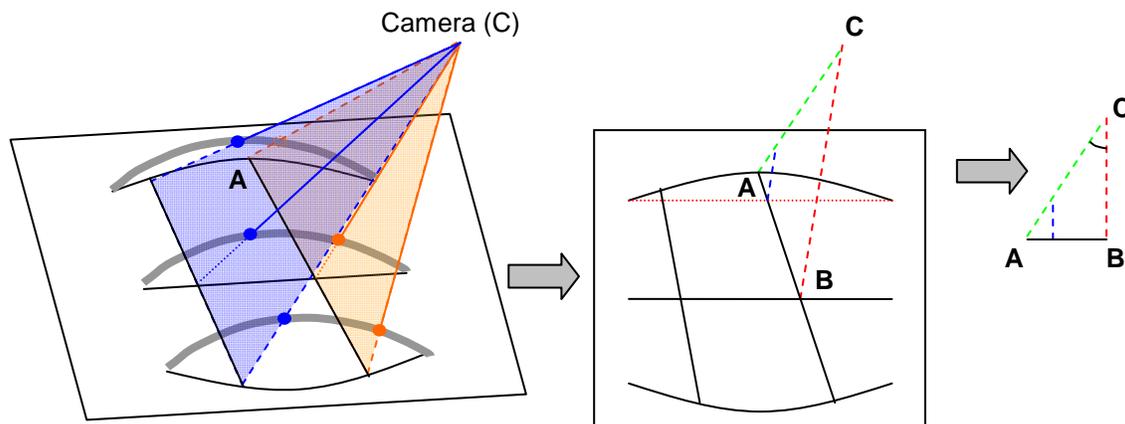
Figure 2-5 Simplified description of the depth measurement procedure. The lines of light on the pipe surface produced by the projector (gray circular lines on the first image) are visible to the camera and appear as ideal ellipses. If the camera lies in the same geometrical plane as the circular line, the ellipse will be visible as a straight line (in the middle); lines to the right or left of the camera geometrical plane will appear as ellipses that bend up (right) or down (left). The curvature of the pipe can be determined using a simple geometrical relationship (ABD triangle). Deviations from the ideal ellipse allow the depth of the depressions to be determined. The distance of the camera from the ideal ellipse line, and the depression surface produce a triangle similar to ABC that can be used to precisely calculate the depression depth.

The approach to calculating and measuring the distance (depth) from the surface to the “ideal” ellipse is shown below. The general setup is presented in Figure 2-5. The measurements are based on simply calculating the proportions of the triangle ABC, but to determine the length of the components, we need to provide an additional analysis.

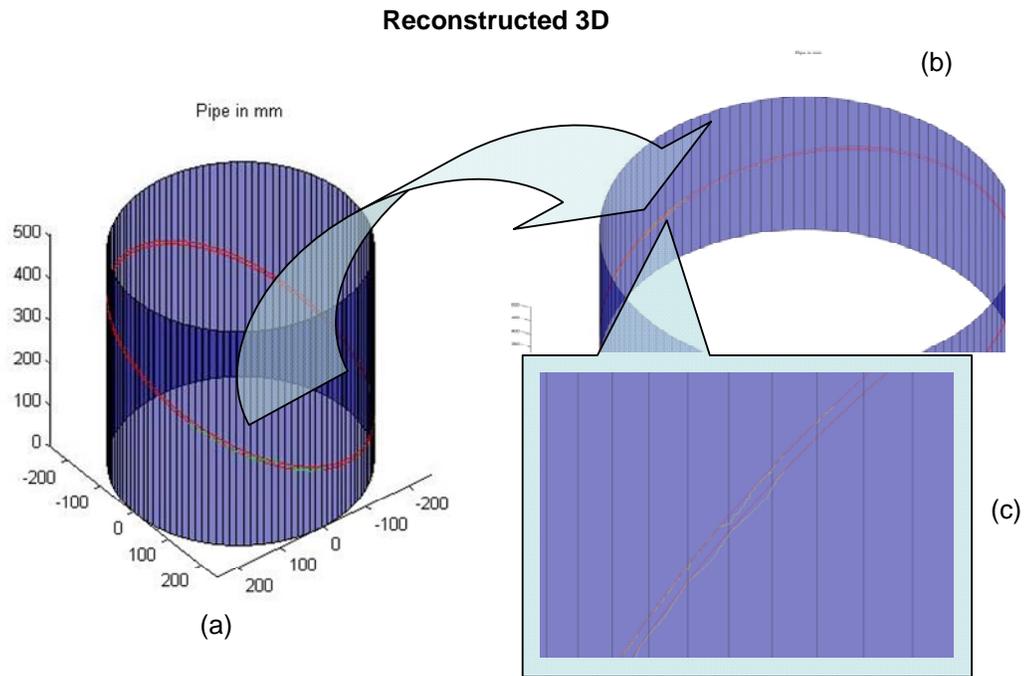
Figure 2-6 Calculated position of the ellipses (red line) at the idealized pipe (blue cylinder): (a) common view, (b) enlarged part on cylinder, and (c) further enlarged part of the surface.

Based on information extracted from the image, we are able to determine both the ellipse parameters and surface deviation from it (see Figure 2-6). The calculated ellipses and surface deviation lines are presented as a 3-D model in Matlab (see Figure 2-7). Profiles with the parts

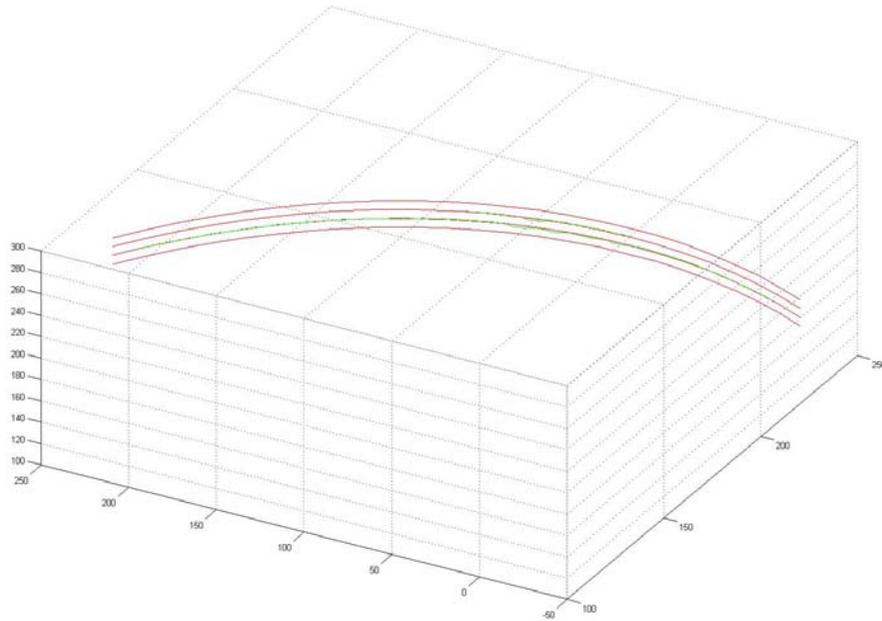
Figure 2-7 The calculated ellipses and surface deviation lines are presented as a 3-D model in Matlab.

The green line is the actual pipe profile; the red line is the ideal shape of the pipe.

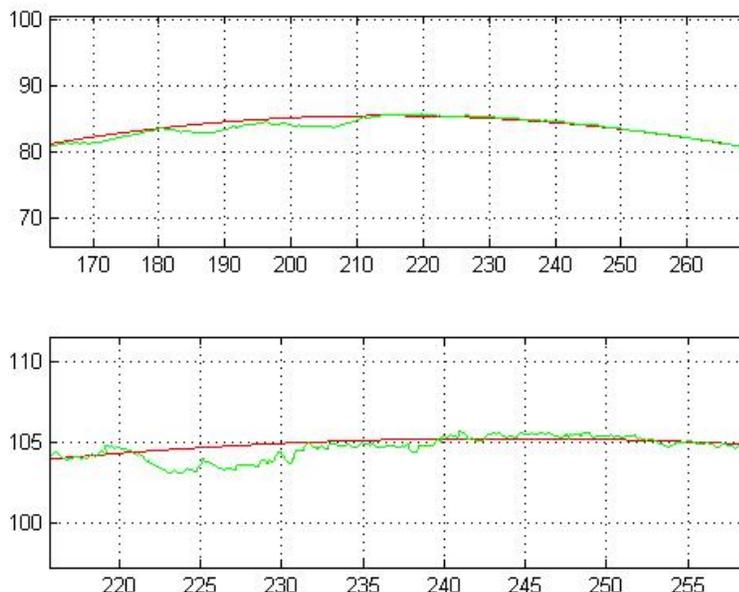
Figure 2-8 Profiles with part of the ellipses that represent the idealized surface of the pipe and the real surface of the pipe section.

of the ellipses that represent the idealized surface of the pipe, and the real surfaces of the pipe section, are shown in Figure 2-8.

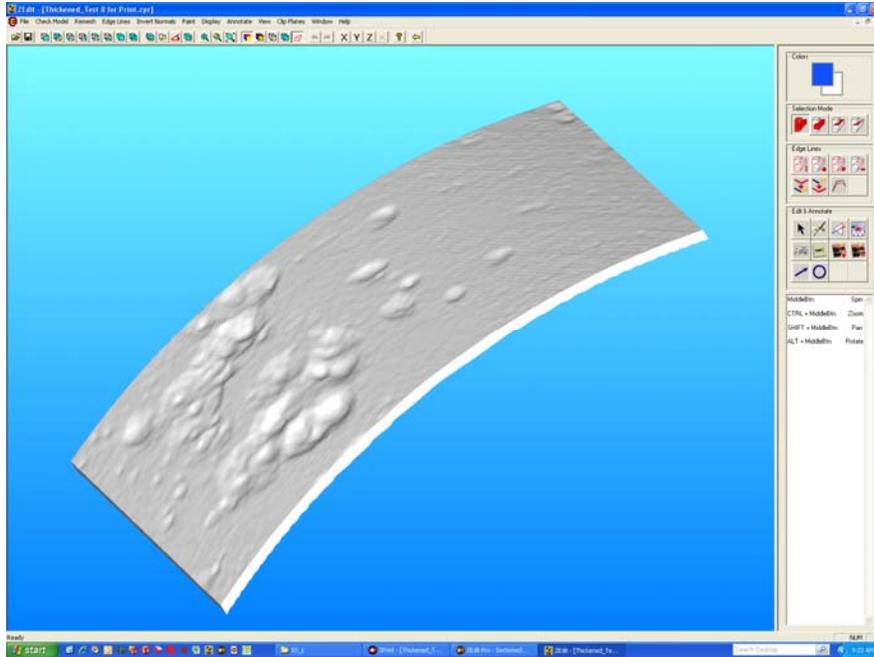
Figure 2-9 Solid model of corroded pipe section.

While we were developing our own hardware for the acquisition of profile data, we had a representative from a commercial 3D profiling instrument company come to IOS and demonstrate one of their laser-based systems. We provided a pipe sample with deep corrosion pits for scanning. They completed the scan, and made a 3-D model of the pipe section (see Figure 2-9). We "printed" this model and made a replica of the pipe section, using a 3-D printer.

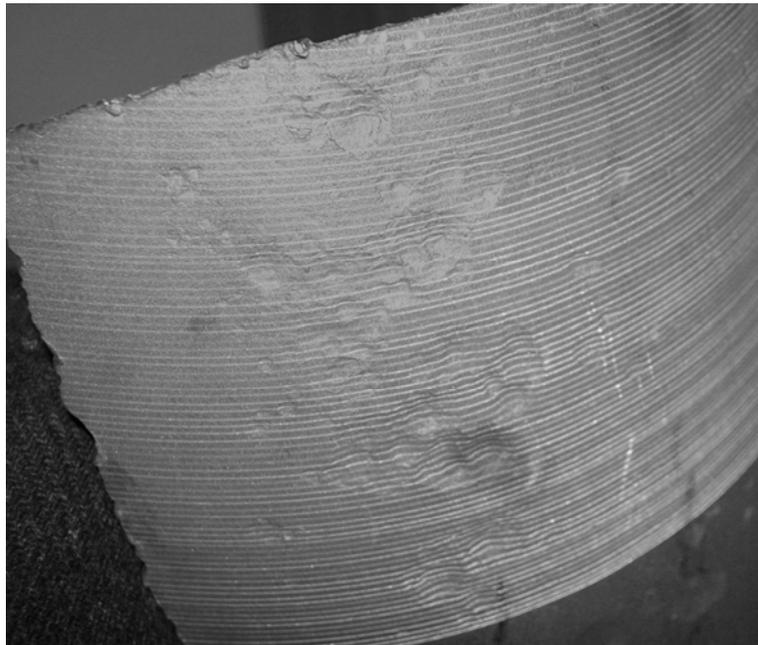
Figure 2-10 Illumination by thin, parallel lines.

We developed software and evaluated software performance based on several patterns of light. The first light pattern evaluation was based on multiple, thin, parallel lines (see Figure 2-10).

We tried to use available image processing algorithms, including IOS proprietary algorithms, to extract each individual line automatically. However, the extracted lines sometimes were cut at the surface due to color and intensity variations, or even were connected to the wrong rows. Better illumination contrast would enable better automated acquisition of the lines.

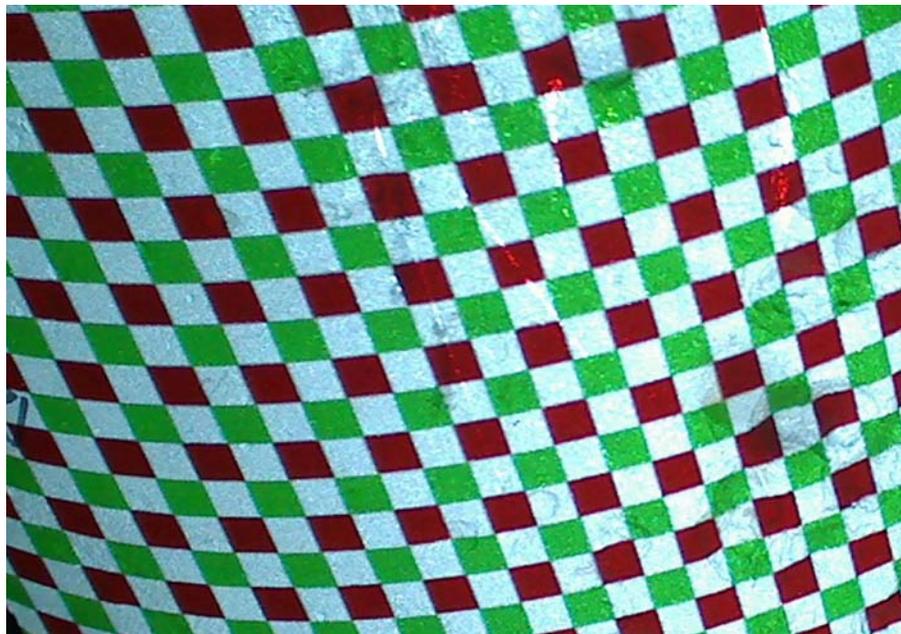
Figure 2-11 Illumination by a checkerboard pattern.

We also tried a checkerboard pattern, as shown in Figure 2-11. This time the projector was bright enough to produce significant differences in color. The resulting extracted shapes are shown with significant magnification. We are now able to precisely map the pattern lines, and produce the desirable measurement precision (Figure 2-12). However, the checkerboard pattern generated instabilities, at the corners, that would affect performance.

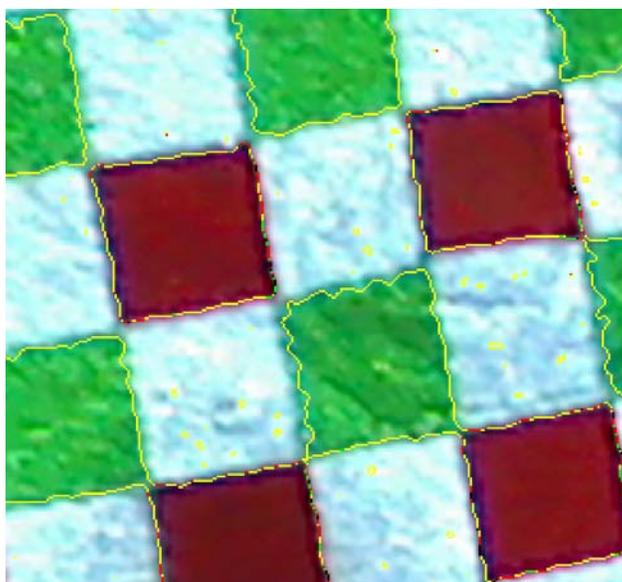
Figure 2-12 Result of the checkerboard pattern processing. The yellow lines are the extracted shape.

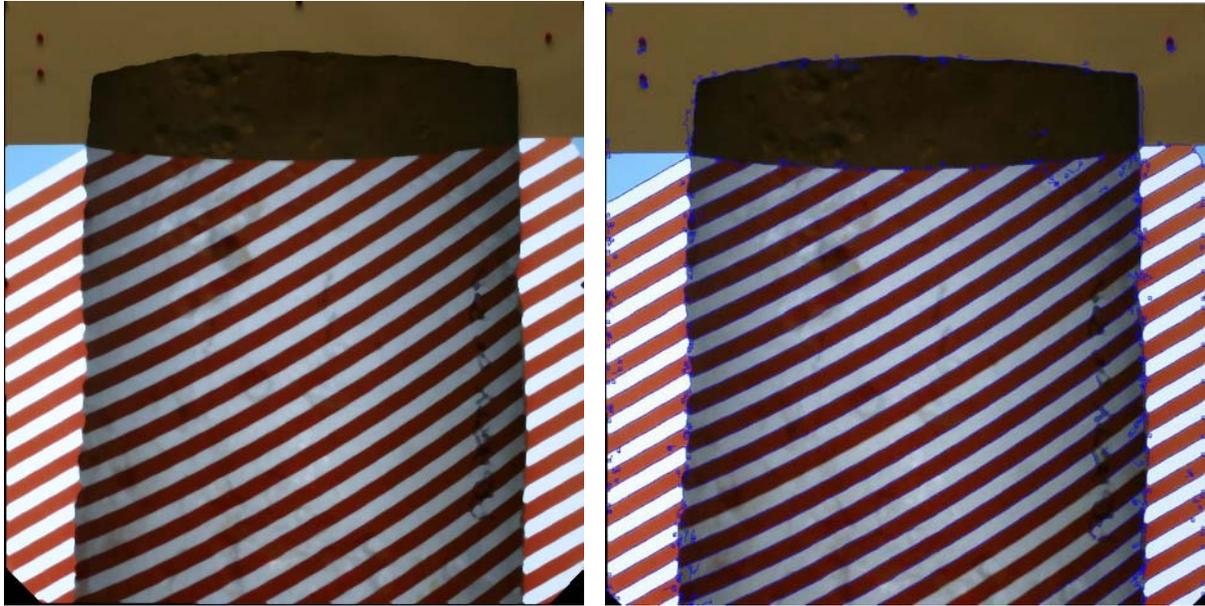
Figure 2-13 Illumination by pattern of thick lines (left), with the extracted lines shown in blue (right).

Finally, we produced a thick line pattern (see Figure 2-13, left) that yielded much more manageable lines, as shown in Figure 2-13 (right). The thick line pattern allows us to produce a reliable pattern of extracted lines (see Figure 2-14) from both sides of the line. The integrity of the extracted lines is much easier to verify.

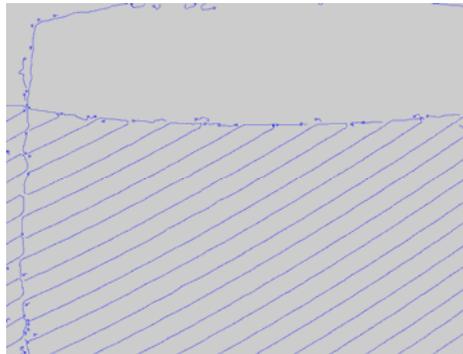
Figure 2-14 The extracted lines only.

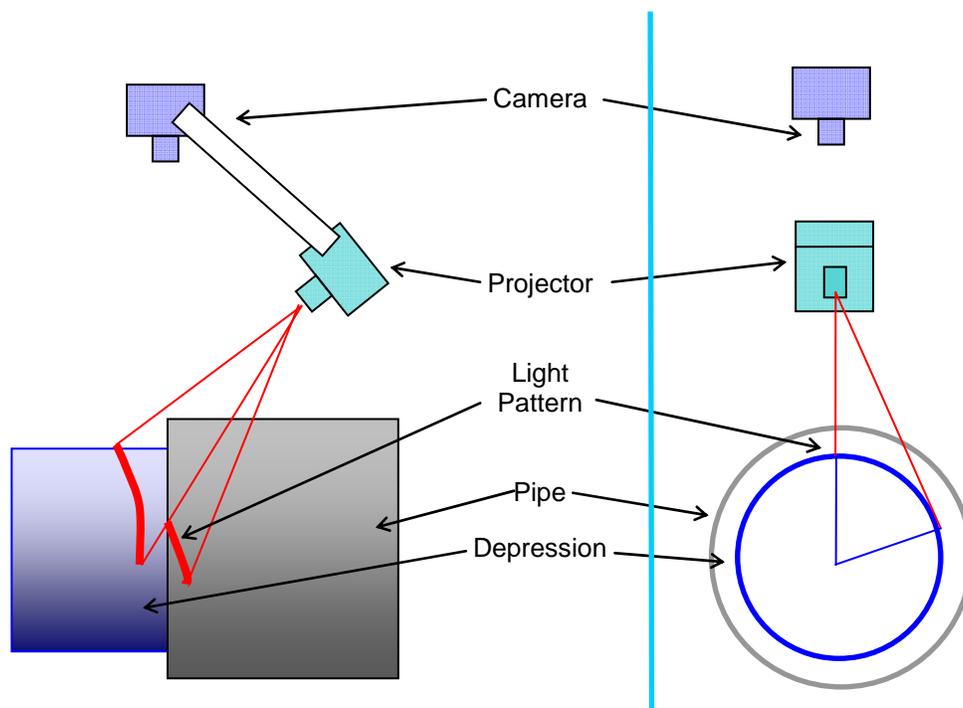
Figure 2-15 Schematic drawing of the Phase II prototype system.

We developed the main principles of the Phase II prototype design. The system will be capable of collecting multiple lines of scan using just one digital photograph, and could provide a complete dense 3-D scan with several photographs. The system will consist of a camera and a micro-projector (or light pattern source) rigidly fixed to each other. The projector, which will be placed at an angle to the pipe, will produce a line pattern on the pipe surface.

The projected pattern can be used to calculate not only the depth and shape of the depressions, but also the ideal shape of the pipe surface, as shown in Figure 2-15.

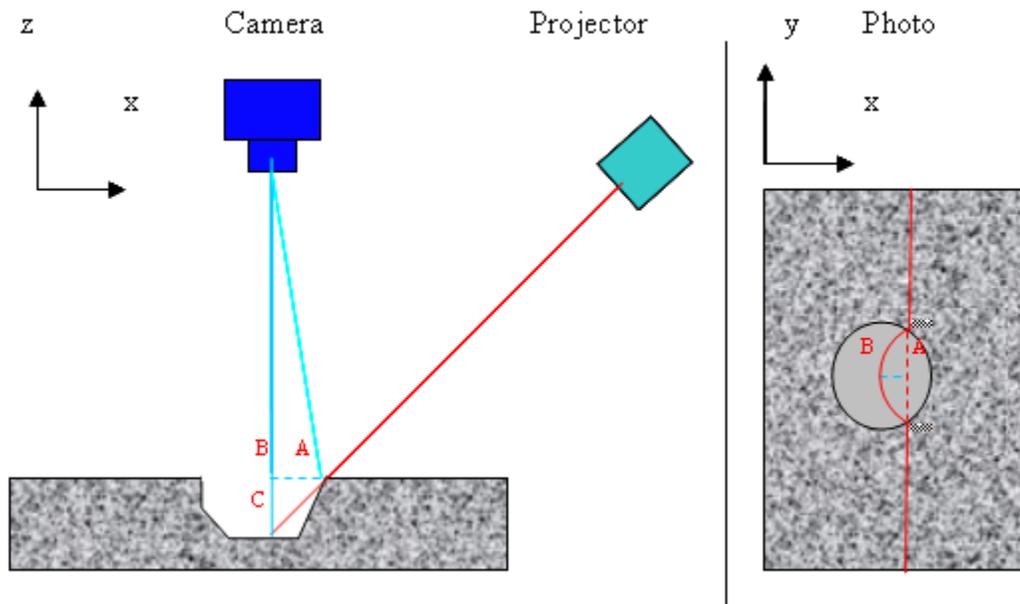
Figure 2-16 Depth extraction.

In the case of a dent or depression at the pipe surface (see Figure 2-16), the line will shift from position A to C at the dent. Shift $|AB|$ can be extracted using a photo camera and a projector. Let's assume that the camera is directed along z , the normal to the surface. The projector and the camera lie in the same xOz plane. If the projector's beam angle is known, then the depth $|CB|$ can be calculated using the simple formula $|CB|=|AB|*\tan CAB$.

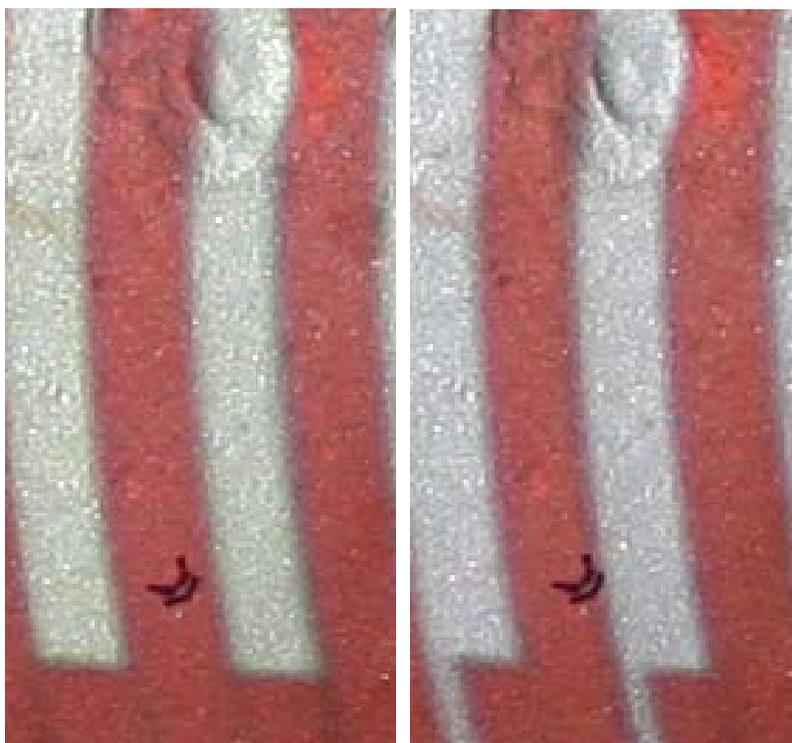
Figure 2-17 The pattern in two photographs automatically shifted using the Matlab software.

To produce a dense depth map, we generated several images when the pattern was shifted normal to the line a known distance (see Figure 2-17). We generated multiple images to generate a dense depth map similar to the laser-based distance measurement map.

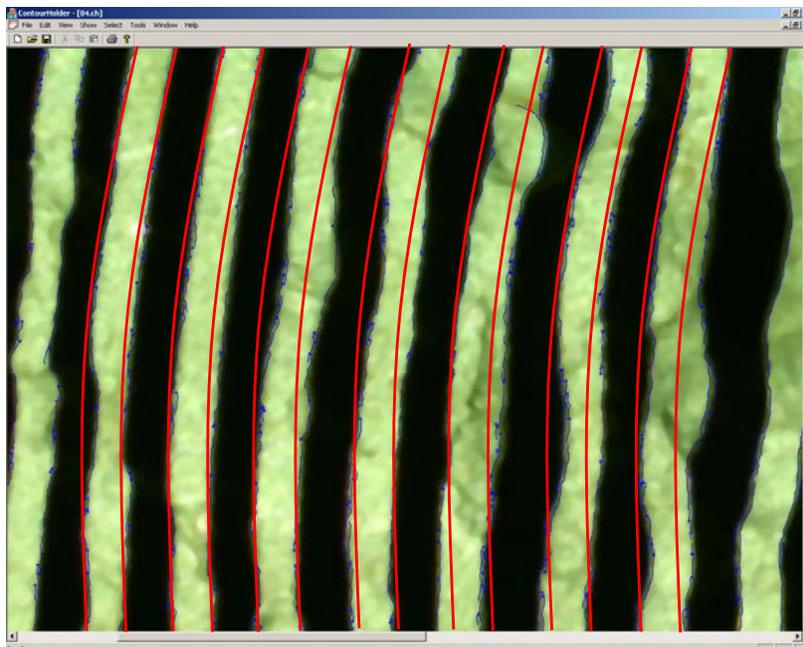
Figure 2-18 Extracted elliptical contours and lines for dense depth map calculation.

The processing of these images allowed us to produce a dense 3D representation of the depression (see Figure 2-18) that is competitive with laser based measurement systems.
