CAAP Quarterly Report

Project Title: *Scaling and Self-Sensing in Composite Repairs of Corrosion Defects*

Prepared by: *The University of Tulsa*

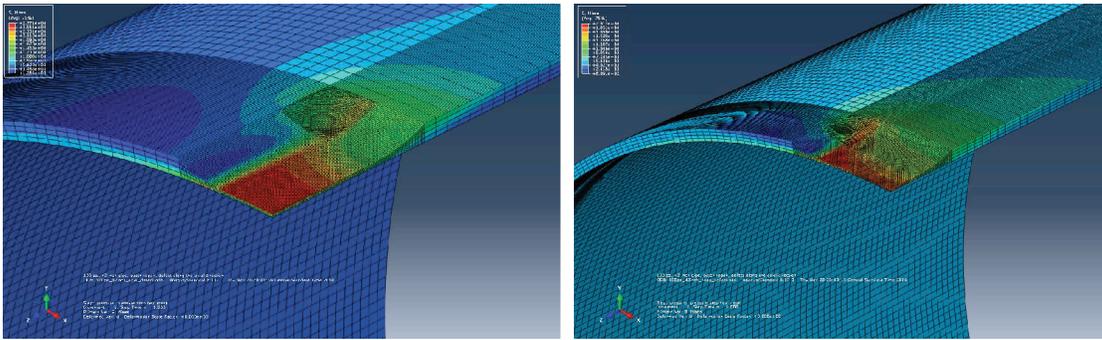
Figure 1: Comparison of axial (left image) and hoop (right image) orientation for the proposed flaw.

Because of limitations of our in-house machining capability, we are investigating the effect of orientation on the flaw for the large-scale sample. We have run initial FEA simulations on the flaw in both orientations. Internal pressure was set at 100 psi as we had determined that this would be below the critical pressure value required to yield the flaw. As you can see in Table 1, there is approximately 30% difference between the two orientations, with the axial orientation being the more severe.

We are working to see if we can modify the flaw dimensions to more approach the axial orientation, which is the orientation on the small-scale repair samples.

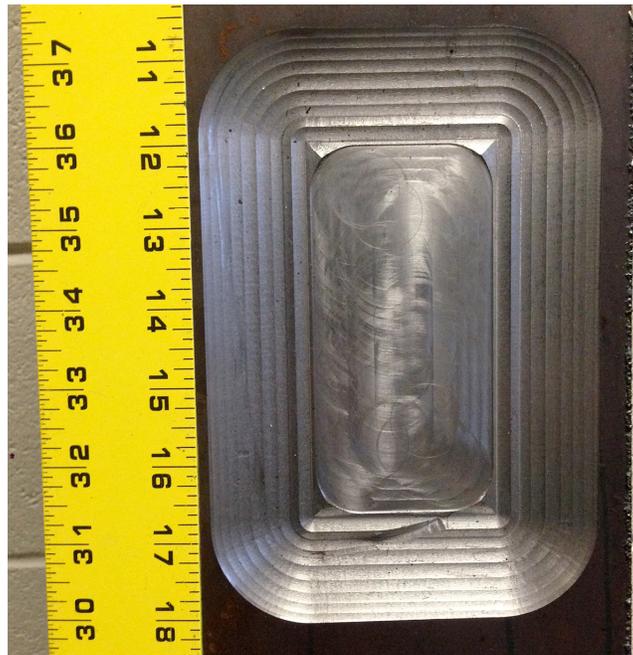
Figure 2: Prototype flaw for rolling tests. Note incomplete machining in corners, this is due to an intentional reduction in machining finish passes.

In addition to the simulation, we are currently working through the prototyping phase for fabrication of the large vessel. Because direct fabrication of the flaw onto a section of 42-inch pipe will likely be difficult to accomplish with machining that is locally available, we are working on a rolling procedure to produce the flaws on the 42 inch vessel. We are planning on milling the flaws into a flat plate, the same wall thickness as the base pipe and then rolling the resulting defect into a 42 inch diameter cylinder. These defect hoops will then be welded into place to form the test vessel. We have fabricated a prototype defect, shown in Figure 2, and will be test rolling this thin plate to determine the effect of rolling on the defect. Assuming that no significant challenges are encountered, we will move forward on this procedure for sample fabrication. It is important to note that the prototype flaw in Figure 2, did not have finish passes to remove the significant ridges that are present. The final machined flaws will have these finish passes to eliminate ridges.
