CAAP Quarterly Report

Date of Report: *July 10, 2015*

Project Title: *Wall Break-through in Composite Repaired Defects*

Prepared by: *The University of Tulsa*

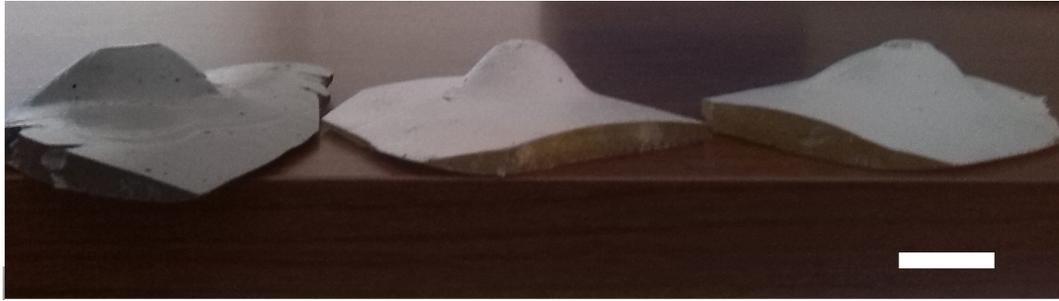
Figure 1: Epoxy molds of eroded flaws from three separate specimens. Scale bar represents approximately 1 inch.

Figure 2 and Figure 3 above show surface profilometry and line scan profiles of one of the eroded specimen molds that were shown in Figure 1. For an approximately 0.25 inch break through we have a 1.3 inch flaw extent. We are working to achieve a larger ratio, but this may not be possible with the straight pipe specimens. We will move to elbows later this year and will see if that gives us a larger flaw extent. Regardless we can achieve a ratio of approximately 5 with respect to the breakthrough and the maximum flaw extent. Based on the testing results described below we will likely investigate an approach where we erode to nearly break through and then drill the remaining ligament so that our eroded and drilled specimens are directly comparable.
