# Final Report

Project Title: Patch and Full-Encirclement Repairs for Through-Wall Defects

Prepared By: The University of Tulsa

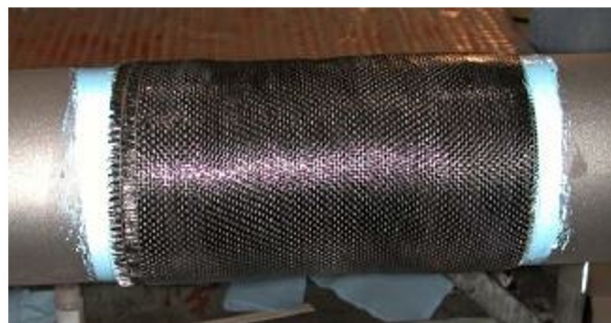
The saturated fabric can then be applied directly to the damaged section of the pipe. This is done by wrapping the fabric completely around the pipe while maintaining tension on the fabric to minimize the number of voids created by air bubbles during installation. Figure 2.4 shows the wrapping process and the final repair [19].

Figure 2.4: Wrapping of wetted out fabric (left) and final repair (right)

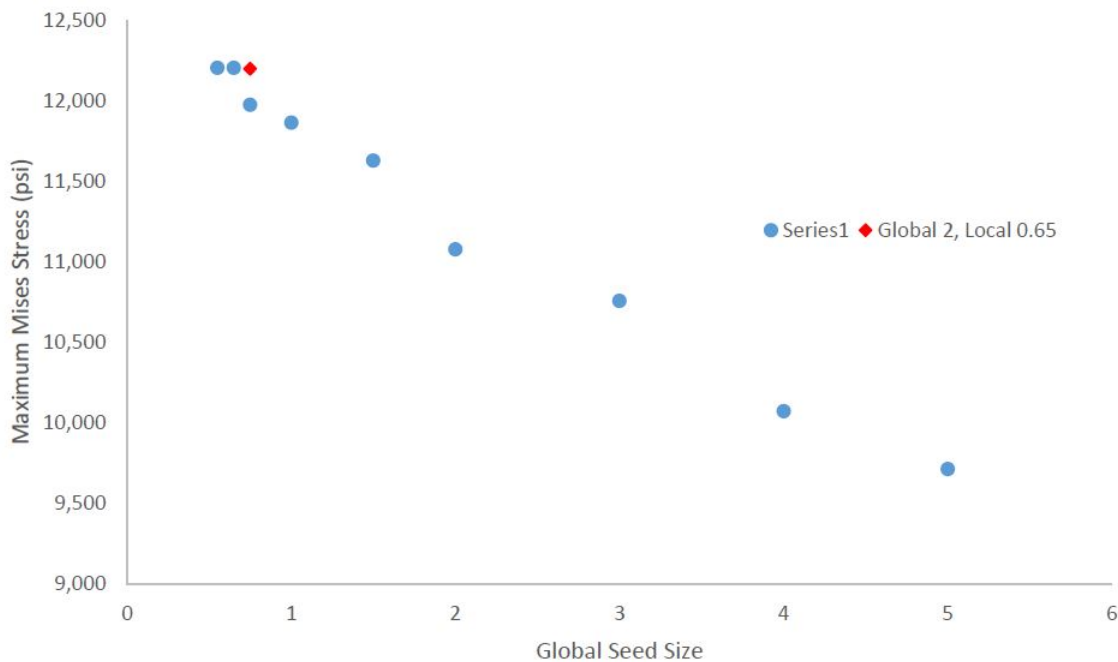
A mesh convergence study was conducted to determine the minimum global and local seed sizing in order to decrease overall computational time without sacrificing accuracy. In order to determine an appropriate local seed size, global seed sizes for the entire model were reduced at fixed increments and the resulting Von Mises stress were extracted. This method continued until the percent difference between maximum stresses in consecutive models was acceptably small. Next, areas of interest remained at the converged seed size while global seed size in the remainder of the geometry increased. Figure 3.2 below shows the results of the mesh convergence study for a hexagonal mesh.

Figure 3.2: Comparison of strictly global seeds and combined seeding

As shown in 3.2, the maximum von Mises stress remained constant below a global seed

size of 0.65. Results of the study also show good agreement between models with an overall global seed size of 0.65 and combined global and local seed sizes of 2.0 and 0.65, respectively. Figure 3.3 below shows the refined mesh above the defect and the progressively coarser mesh in the steel substrate as the distance from the area of interest increases.

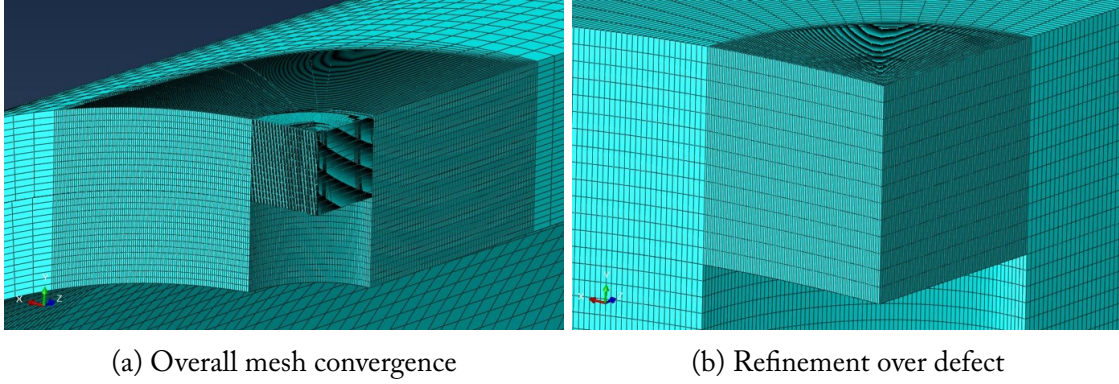
Figure 3.3: Summary of mesh convergence study

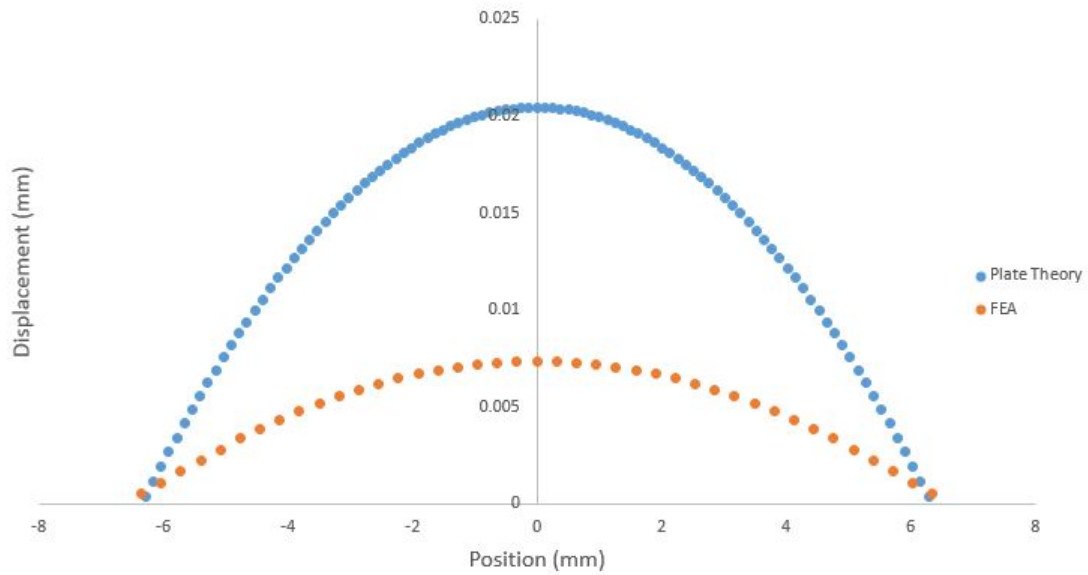
Next, this plate theory profile was directly compared to a profile extracted from an FEA simulation of a pipe with a full-encirclement repair. It should be noted that the FEA simulation does not include a rigid substrate and takes curvature into account when calculating displacements. Thus, in order to compare these two profiles more closely, steel substrate deflections were subtracted from composite displacements in an attempt to mitigate the effects of a nonrigid substrate. The result is shown in Figure 3.6.

Figure 3.6: Comparison of FEA and plate theory displacement profile

The plate theory model predicts much larger displacements than the FEA model with a 59% difference at their peaks. This difference could be attributed to the fact that the plate

theory model is limited to 2-dimensions and does not take into account the anisotropic nature of the composite. Additional discrepancies between models could be a result of the simplifying assumptions in the plate theory model.

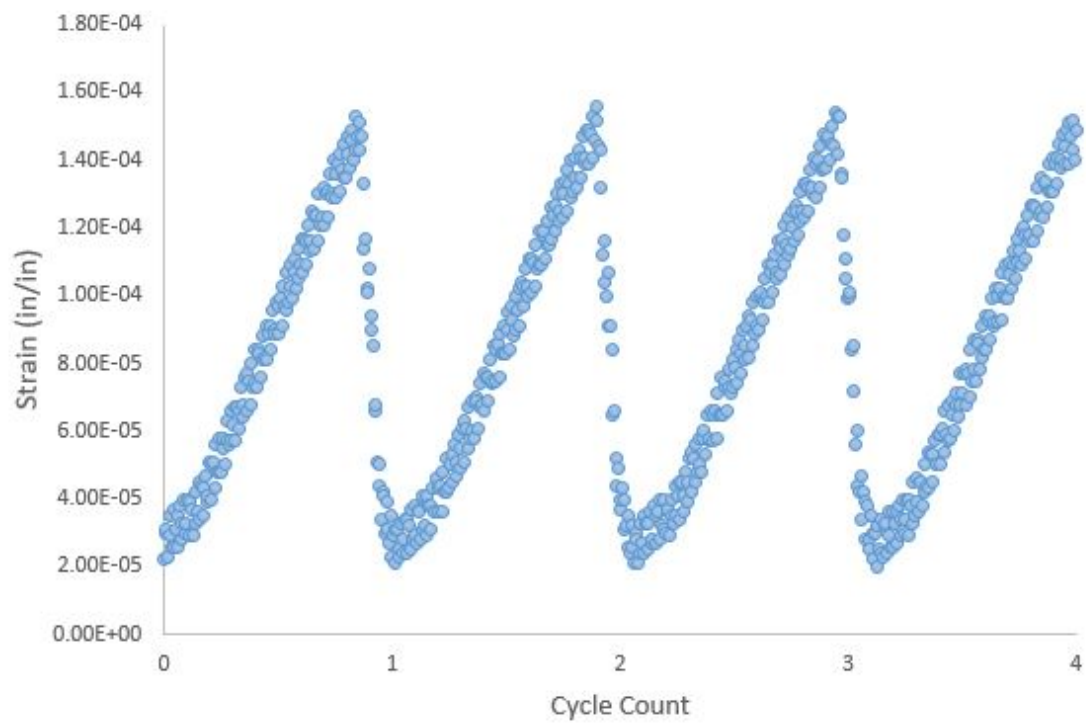
A LabVIEW program was used to measure internal pressure, strain, and fatigue cycles for the 6 of the 18 specimens. As mentioned in Section 4.6.1, this program was triggered via a digital output signal from the control system. Upon receiving this signal, LabVIEW would read a single value for each strain gage, the current pressure, and add a cycle to the total cycle count. Additionally, this program was designed such that every 200 cycles it would record 4 full loops of pressure and strain. This allowed for close monitoring of the system to ensure that it was pressure cycling properly and also that all strain gages were still active and reading good data. Figure 4.5 below shows a representative set of loop data.

Figure 4.5: Strain loop data

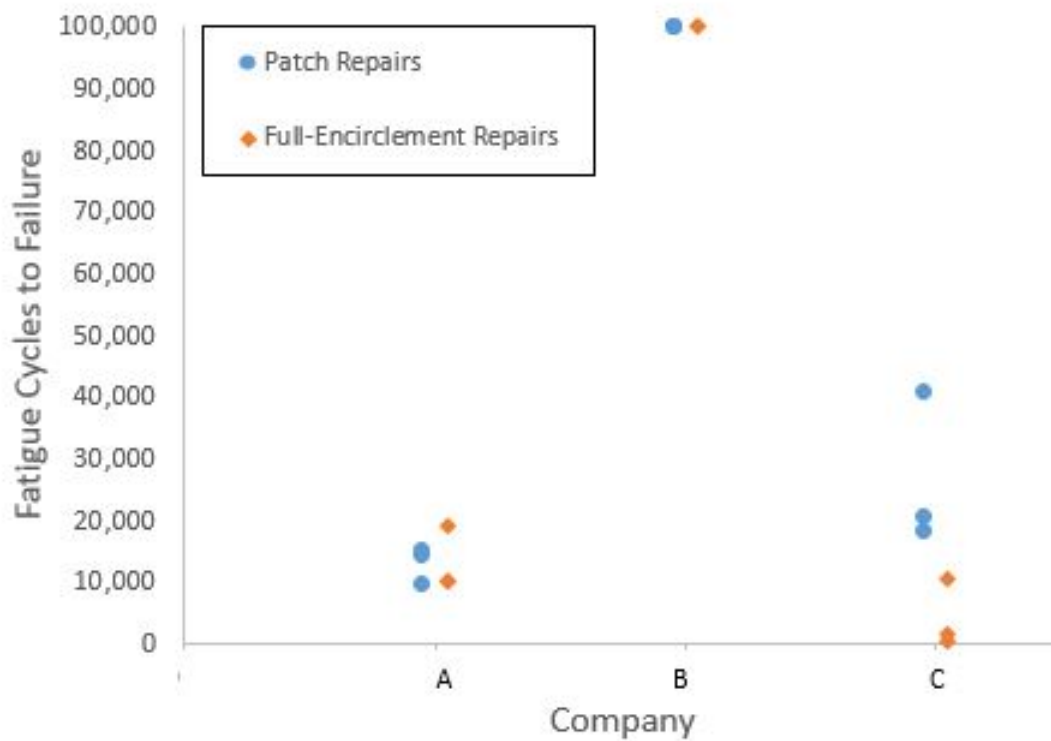
Figure 5.1 below depicts the cycles to failure for each type of repair per company along with the average cycles to failure.

Figure 5.1: Cycles to failure per company

Repairs installed by Company A were very consistent in their fatigue performance. The minimum cycles to failure occurred with a patch repair at 9,794 cycles. The maximum cycles to failure occurred with a full-encirclement repair at 18,976 cycles. The average cycles to failure for Company A was 13,041 cycles with a standard deviation of 3,757 cycles. Company A had the lowest average cycles to failure of the three companies that installed repairs. A standard 2-tailed t-test with a 95% confidence interval was calculated using fatigue data from Company A. The results show that patch-type repairs are statistically similar to full-encirclement repairs with a corresponding p-value of 0.968.

All repairs installed by Company B reached the designated runout of 100,000 cycles, giving them the highest average fatigue cycles to failure of the three companies. It is unsurprising that Company B outperformed Companies A & C due to the fact that their installed repairs were significantly larger as outlined in Tables 4.3 & 4.4. Since all speci-

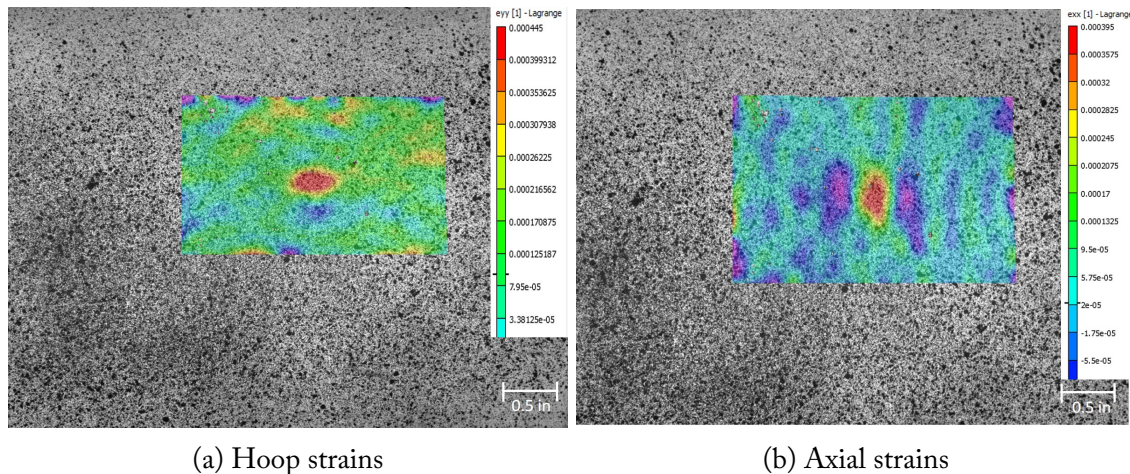
Figure 5.5: DIC analysis of a patch repair installed by Company C at 500 psi

DIC analysis was performed primarily to obtain full-field hoop and axial strain values on the surface of the composite repair. Figure 5.5 below shows a representative DIC strain analysis in the hoop and axial directions for Company C as an example. All DIC analyses

In order to perform DIC analyses, an appropriate area of interest must be defined in which strains will be calculated. To achieve this, the entire speckled region was analyzed and then a smaller area around the defect is reanalyzed. In this case, the area of interest was approximately 2.5 in x 1.75 in.

Figure 5.5a above clearly shows the defect as the circular red area of high strain in the center of the area of interest. For this example, the maximum hoop and axial strains in the composite were 0.0445% and 0.0395%, respectively. Hoop strains rapidly decrease in all directions as the distance from the center of the defect increases beyond the defect edge. This is to be expected as there is no steel substrate to support the composite repair directly over the defect.

Figure 5.5b shows interesting behavior that the surface of the composite repair exhibited when pressurized. The axial strains become compressive just outside of the diameter of the defect, but only in the axial direction. These compressive axial strains were predicted
