Development of Adaptive IWEX a Full Matrix Capture Imaging Technique for In-Ditch Crack-Like Evaluation Project No: DTPH56-13-T-000008

Harvey Haines, 2018 June 05

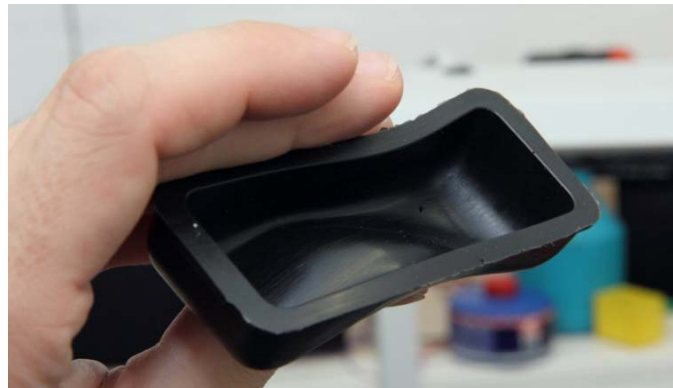
Finished
with a
water wedge

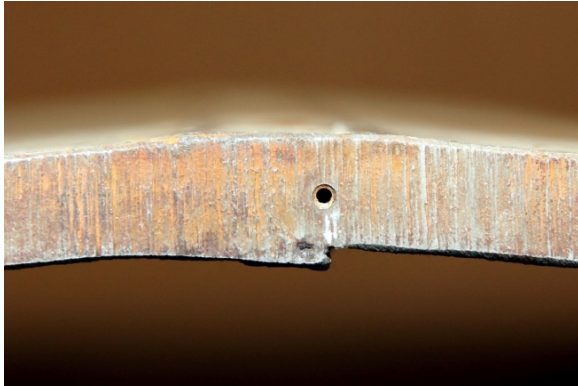
22-in pipe with side drilled hole

photograph

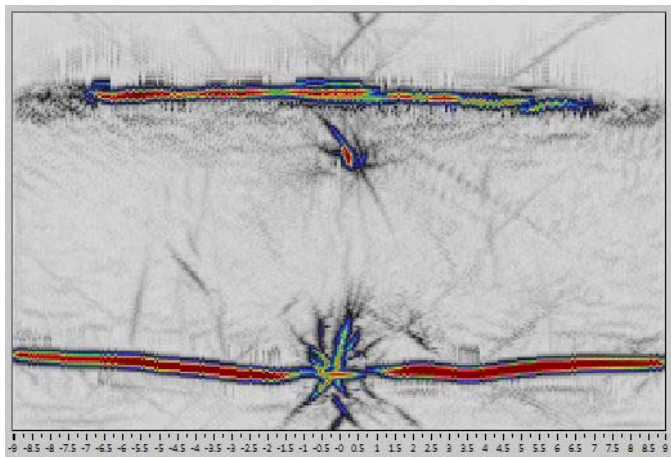
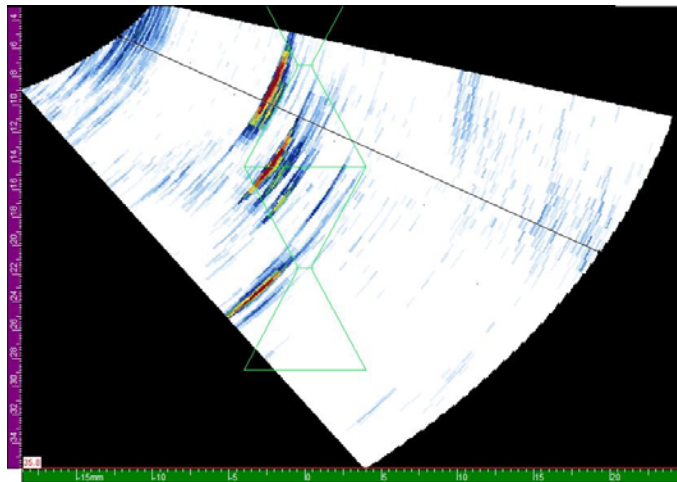
IWEX	Phased array

<p>Upper flaw: upturned fiber imperfection Height: 0.4 mm Depth from OD surface: 1.6 mm, WT: 7.7 mm Detected in IWEX-2 (skip)</p>	<p>Height: 1.0 mm Depth from OD surface: 0 mm Sizing: between 0.5 and 1 skip</p>
<p>Lower flaw: cold weld, surface-breaking Height: 1.0 mm Depth from OD surface: 7.3 mm, WT: 7.7 mm Detected in IWEX-0 (direct), IWEX-1 (tandem)</p>	<p>Height: 1.0 mm Depth from OD surface: 4.5 mm Sizing: between 0.5 and 1 skip</p>

- Both flaws can be detected using IWEX or PA. However, characterization is more difficult with PA. The inclined orientation of the upper flaw from IWEX indicates an upturned fiber imperfection.
- The cold weld is surface-breaking. This is clearer from IWEX. The amplitude of the bond line at the ID is weaker, caused by the flaw casting an acoustic shadow.
- The upturned fiber imperfection is estimated larger with PA. Caused by the UTI not being perpendicular to the OD. The distance between the tip diffractions is greater than the actual vertical extent of the flaw.

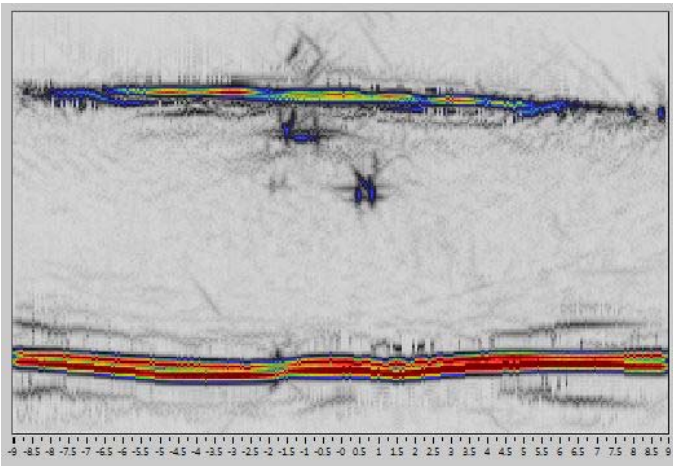
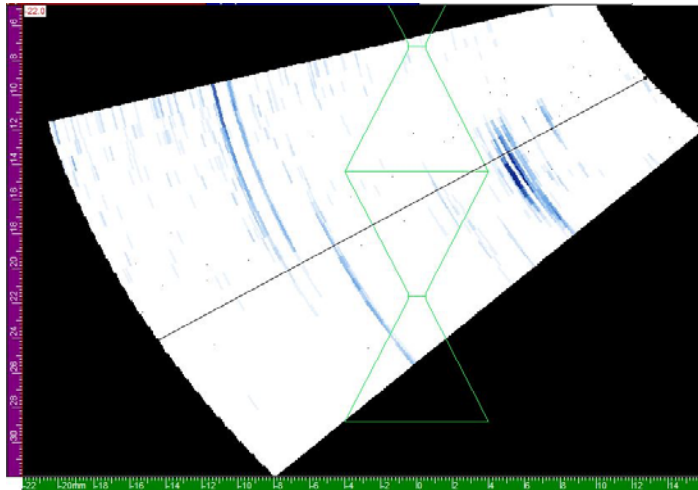
IWEX	Phased array

Location E

<p>Upper flaw: upturned fiber imperfection Height: 0.3 mm Depth from OD surface: 1.0 mm, WT: 7.6 mm Detected in IWEX-2 (skip)</p>	<p>Height: 0.7 mm Depth from OD surface: 0.1 mm Sizing: between 0.5 and 1 skip</p>
<p>Lower flaw: upturned fiber imperfection Height: 0.3 mm Depth from OD surface: 2.5 mm, WT: 7.6 mm Detected in IWEX-2 (skip)</p>	<p>Height: undetermined (<0.5 mm) Depth from OD surface: 0.6 mm Sizing: between 0.5 and 1 skip</p>

- Flaws from PA are relatively weak. This is caused by a decrease in acoustic coupling at scan position.
- Discrimination is not possible using PA. IWEX shows flaw shapes and the position allowing identification as upturned fiber imperfections.
- These 2 flaws are small. IWEX allows identification of upper and lower flaw tips, where the PA sectorial scan can't provide this detail, even though both PA & IWEX use the same 10 MHz freq.
