CAAP Quarterly Report

Project Name: Easy Deployed Distributed Acoustic Sensing System for Remotely Assessing Potential and Existing Risks to Pipeline Integrity

Contract Number: 693JK3215002CAAP

Prime University: Colorado School of Mines

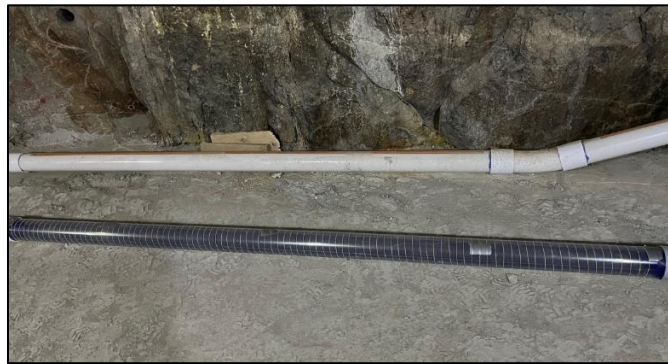
Figure 2. Photograph of section of clear PVC pipe with wrapped cable (yellow) and 3 cm of spacing in between.

- The external cable, a singled mode jacket cable, has been wrapped around the outside of the clear PVC pipes in a helical shape. For every 10 ft of pipe, 100 ft of cable was used, yielding a spacing of 3 cm in between each wrap (Figure 2). Tension and duct tape were used to hold the cable in place.

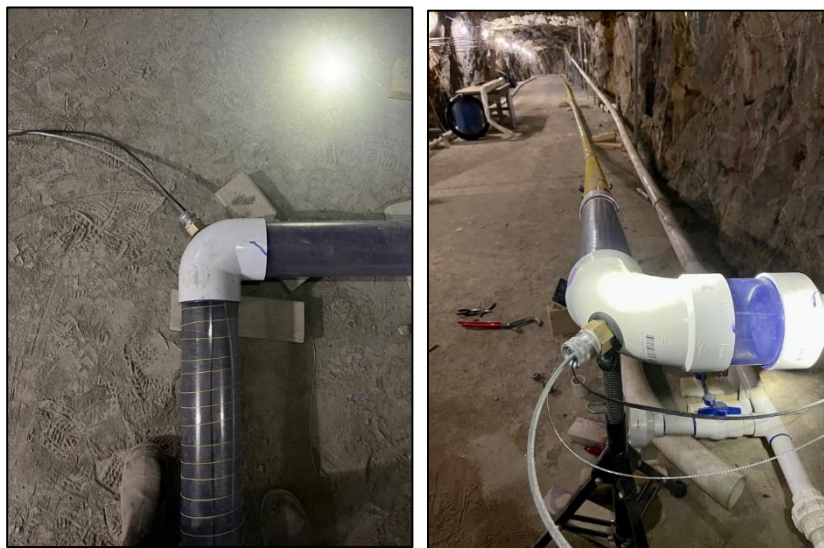
Figure 3. Photographs, left, Sealing using for internal cables at the end of the PVC section. Right, sealing for internal cable at the entrance of PVC test section.

- Three internal cables (thin, thick, and flat) were deployed inside the PVC pipes as proposed. They are freely sitting in the clear PVC pipeline. The internal cables exit the pipe through specially tailored sealings at the opposing ends of the clear PVC section. The sealing uses rubber and poxy to withstand pressures of 40 psi as shown in Figure 3. Also shown in Figure 3 are the two ends of the internally deployed cables.

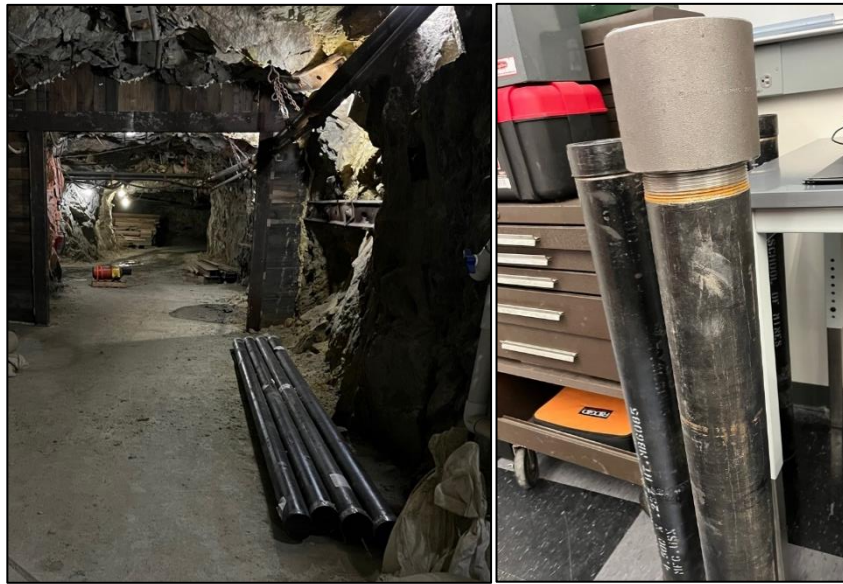
Figure 4. Left, Photograph of carbon steel pipes in Edgar Mine (API 5L X65 schedule 40 4-in, 5 m long each); Right, Photograph of 1-m section of steel pipe with a coupling at the top to connect in the middle of the pipeline

2. Activities completed during the reported period for Tasks#3-6: Detection of Corroded Spots, Deformation, Infrastructure Damage, and Leakage
 - The API 5L, schedule 40 NPS 4-in, grade X65 carbon steel seamless pipes have been received at Colorado School of Mines Edgar Experimental Mine as shown in Figure 4 (left). The test pipeline will consist of four 5-m sections and one replaceable 1-m test section. Now, we have four 5-m sections and five 1-m sections.
 - The four 5-m sections and five 1-m sections have been threaded to make the test pipeline inside Edgar Mine. The 1-m sections will be replaced with the corresponding deformations being tested (corrosion, leak, or dent)
 - Couplings with the threading have been received to connect different sections on site (Figure 4, right).

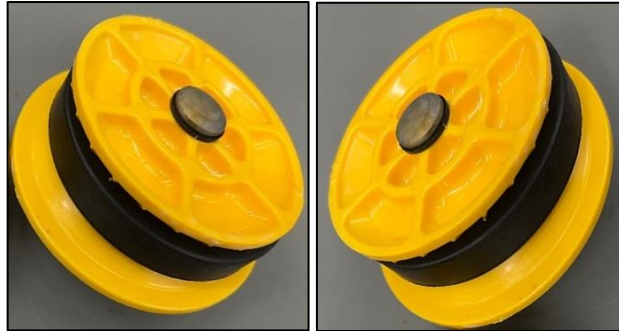
Figure 5. Picture of expansion plugs (natural rubber and plastic plate)

- To create the internal pipeline corrosion, 4-in Pipe plugs (Figure 5) were purchased to allow the deployment of the acid only internally inside the pipe. The plugs seal off the pipe from the inside, as the rubber expands. The plate is plastic, and the natural sealing rubber is proven to be resistant and does not react with the hydrochloric acid used.

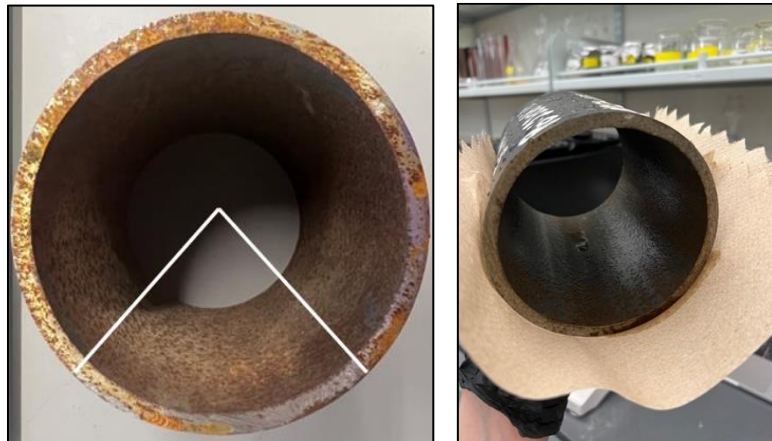
Figure 6. Photographs of 6 o'clock position (left) and cleaned ring (right)

- As a first attempt, the internal corrosion was created at the 6 o'clock position, as shown in Figure 6. The ring was first rinsed in acetone and distilled water and dried. Then, it was plugged from one side, and the 100 ml volume of 12 M Hydrochloric acid was introduced. Afterward, the ring was plugged from the other side using the plug mentioned above. A hole was drilled at the top to prevent pressure buildup following the chemical reaction of the hydrochloric acid and the steel pipe (Figure 7).
