## CAAP Quarterly Report

*Project Name:* Easy Deployed Distributed Acoustic Sensing System for Remotely Assessing Potential and Existing Risks to Pipeline Integrity

*Contract Number:* 693JK3215002CAAP

*Prime University:* Colorado School of Mines

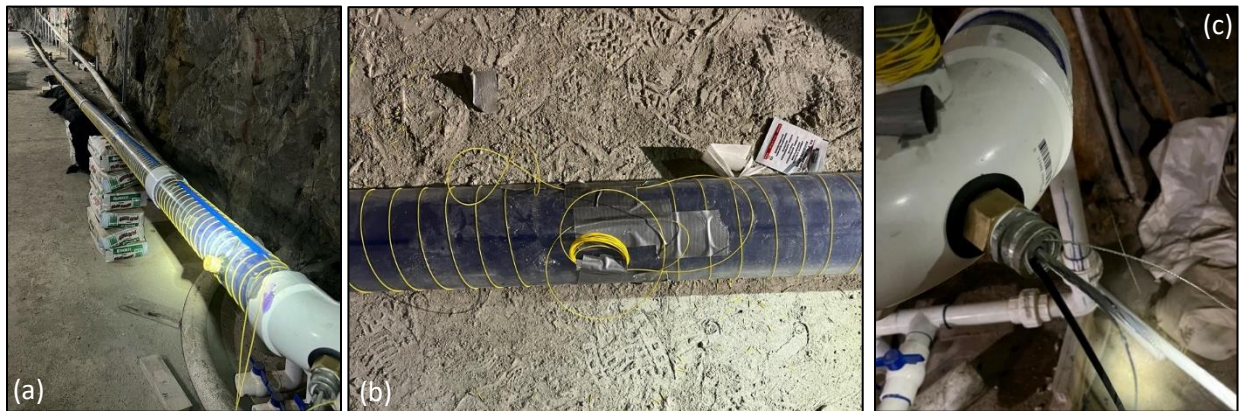
Fig. 1. (a) Photograph of the clear PVC section for Tasks#1 & 2 with helically wrapped cable (yellow) and straight cable covered by blue tape. Sand bags and moving blankets are used to prevent vibration and protect cable. (b) Photograph of a splice at a damaged point in the helically wrapped fiber. (c) Photograph of the sealing for internal cable deployment located at the entrance of the Orica drift in Edgar Mine. All cables are permanently deployed using epoxy compound. Flat and thin cables are damaged at this location.

- Sandbags have been used to prompt the flow loop in the inclined sections to minimize the noise in the dataset as a result of the pipe vibration. Additionally, moving blankets were put in place to help protect jacket fiber cable from rough surfaces (Fig. 1a).

- All cables were spliced together and tested with the Optical Time Domain Reflectometer (OTDR) to evaluate the integrity of the splicing and signal path along the entire length of the cables. Multiple (+9) damaged points in the helically wrapped cable were identified and fixed at various splice points, as shown in Fig. 1b. In order to avoid the deterioration of laser light through the imperfections, the order of cable connection was rearranged in order to place the helically external cable last and prevent contamination of data in the other cables. The splicing of cables has taken more time than expected due to inexperience with splicing, dust, and the complicated environment of the facility and mine.

- DAS data has been collected without any fluid flowing through the pipe so as to further test the integrity of the cable setup. A tapping test with a video recording has been taken to evaluate the setup and identify the location of channels along the cable. The internal thin and flat cables have been identified to be broken at the location of the sealing point, as shown in Fig. 1c. The sealing has been designed to keep the pressure and fluid inside the pipe, however, it has also caused permanent damage to the two more delicate cables.

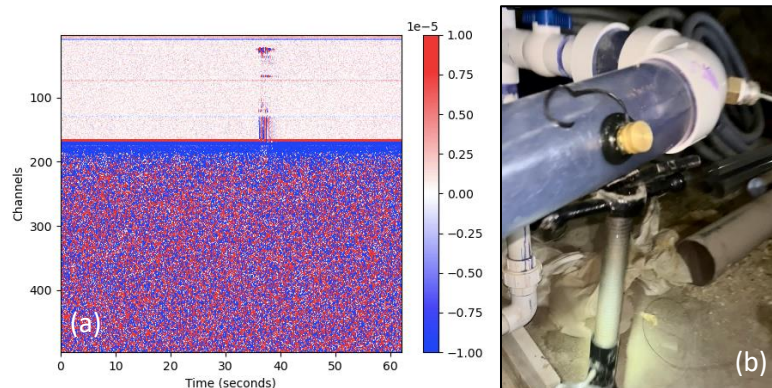
Fig. 2. (a) Waterfall plot of the DAS data collected during a tap test along the helically wrapped cable. After Channel 164 data is only showing noise as the fiber is damaged and no longer sensing the strain from the taps. (b) Photograph of second hole initially created for water inlet; now to be repurposed for extracting thin and flat damaged cables to be respliced.

- The results from the DAS data collected using the Terra 15 interrogator clearly show the damage in the fiber optic cable corresponding closely to channel 164. A damaging reflection is observed at this location in space marked by the red color line throughout time as shown in Fig.2a. In Fig. 2a, at around 36.7 seconds, the tap is observed in the data at various channels. This is expected due to its geometry, however, after channel 164 the tap is no longer observed as the fiber is damaged.

- We plan to resplice the thin and flat cables by extracting said cables through a second hole, shown in Fig. 2b, and improving the seal so as to maintain the integrity of the cables while keeping the fluids and pressure inside the pipe.

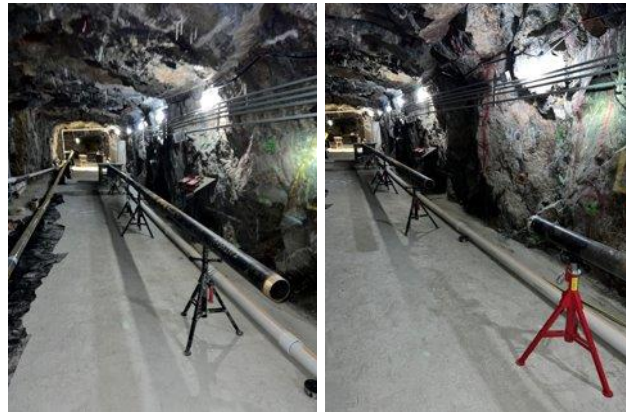
Fig. 5. Photograph of the steel pipeline section connected and supported

2. Activities completed during the reported period for Tasks#3-6: Detection of Corroded Spots, Deformation, Infrastructure Damage, and Leakage.
  - The steel pipeline sections previously received have now been connected and supported for Tasks#3-6. A gap between the two sections is left for the 1 m test section to be installed later based on the Task addressed (Fig. 5).

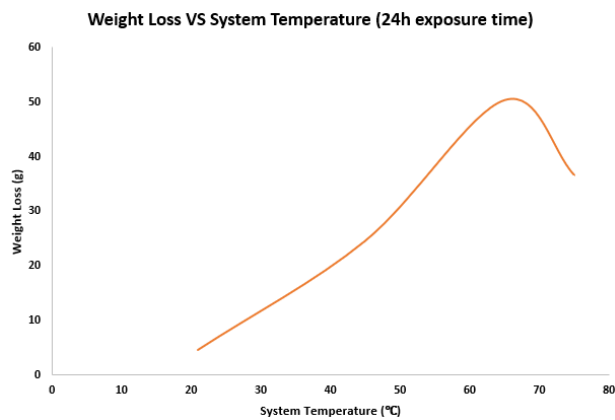
Fig. 8. Plot of weight loss vs. testing temperature for a 24 hour long test

- Results and future plan:
  - The temperature increase applied to the lab tests significantly increased the weight loss and corrosion rates, as shown in Table 1. At 65°C, the weight loss was ten times higher than the reported results at room temperature (Fig. 8).
