# Internal Quarterly Report

**Date of Report:** 5<sup>th</sup> Quarterly Report – January 4<sup>th</sup>, 2023

**Project Title:** Assessment of Nondestructive Examination (NDE) and Condition Monitoring Technologies for Defect Detection in Non-Metallic Pipe

**Prepared by:** EWI

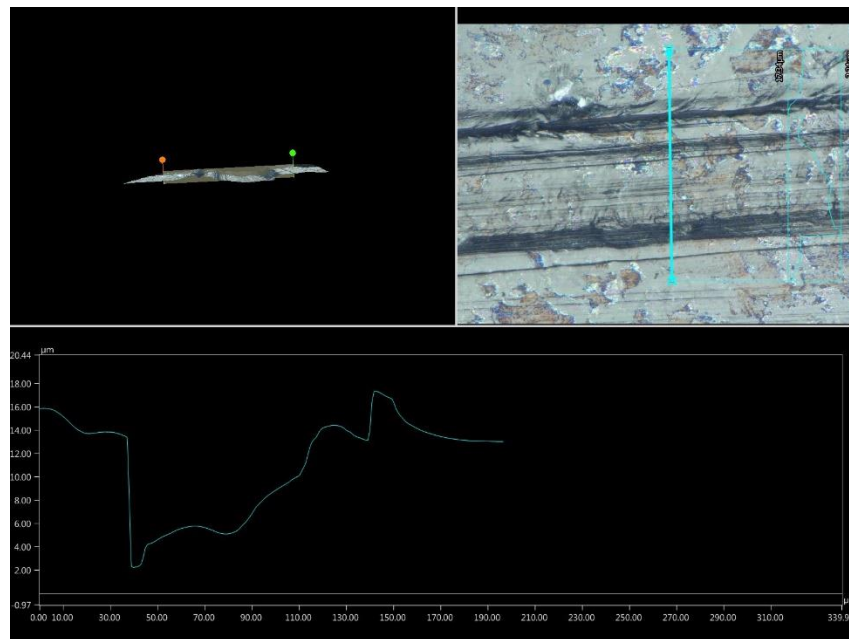
Representative image of scratch profile analysis to be done at the end of testing.

At the conclusion of the tests, final NDE will be performed in the same locations and by the same techniques as the original scans. Detailed analysis will be done to determine if change has occurred in the wall thickness or any other changes that may occur during the testing. After NDE is complete, the pipe sample will be dissected and microscopy will be performed to discern differences between the surfaces in the water/sand environment vs the top area of the pipe that is not exposed to water/sand erosion.

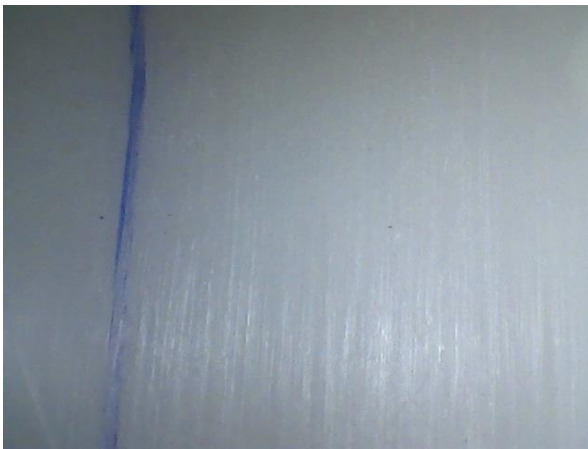
Initial image near mixing blade

There are currently 5 pipe samples under test. Pipe sample 4-3 has now been under test for a period of 21 days. There is good indication in the mixing blade area that there is polishing and some erosion happening on the pipe wall. This is by visual and touch inspection only at this point, but there is a smoothing and apparent reduction in the severity of the scratches. To the touch, the abraded area of the pipe near the mixing blade is smoother than higher on the pipe wall away from the mixing blade.
