CAAP Quarterly Report

Project Name: Easy Deployed Distributed Acoustic Sensing System for Remotely Assessing Potential and Existing Risks to Pipeline Integrity

Contract Number: 693JK3215002CAAP

Prime University: Colorado School of Mines

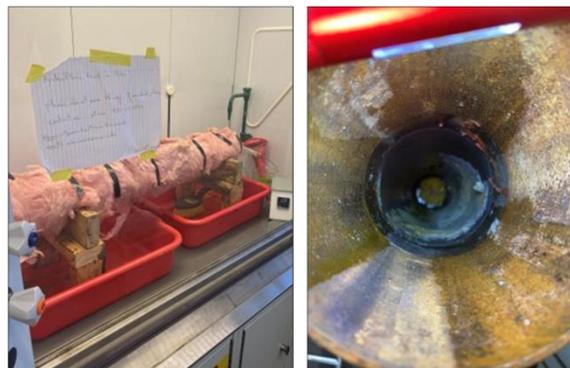
Figure 4. A picture of the experimental setup for corrosion preparation (left) and the interior of the corroded test section (right).

preparing another 1-m test section with a target of ~5.8mm corrosion depth. Pictures of the experimental setup and the interior of the corroded test section is given in Figure 4.
