CAAP Quarterly Report

Project Name: Easy Deployed Distributed Acoustic Sensing System for Remotely Assessing Potential and Existing Risks to Pipeline Integrity

Contract Number: 693JK3215002CAAP

Prime University: Colorado School of Mines

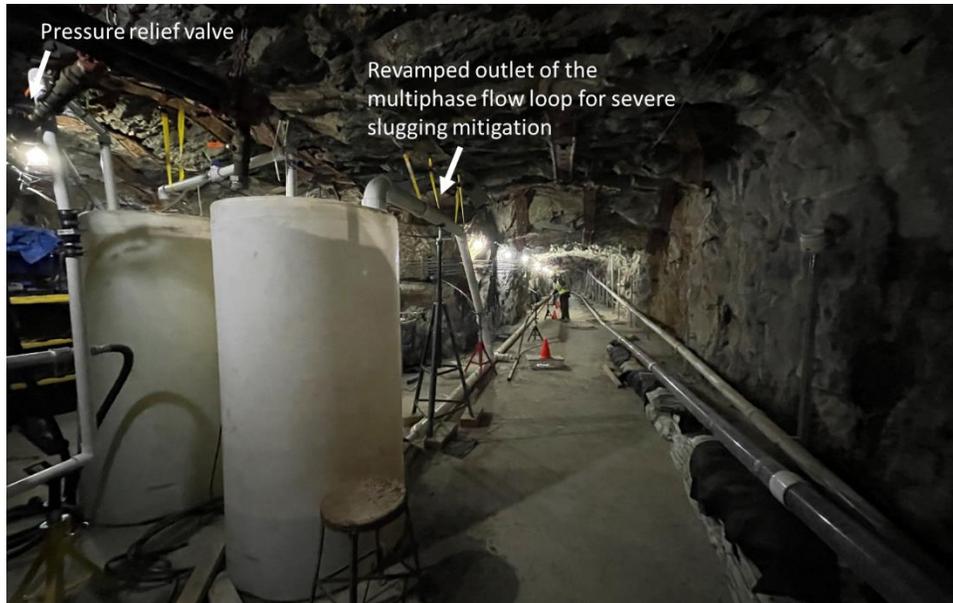
Figure 1. Picture of the multi-phase flow loop

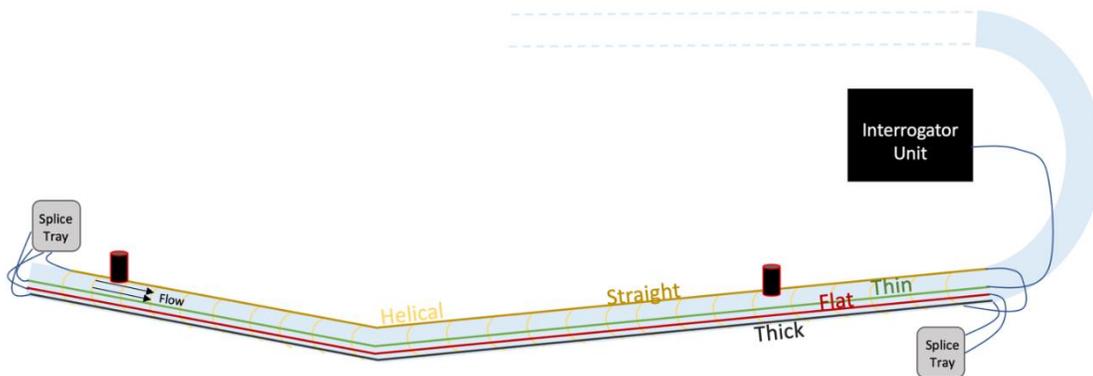
Figure 2. Schematic of Task #2 Layout, depicting the interrogator unit spliced to a sequence of cables - thin, flat, thick, straight, and helical. Two sensors are positioned both uphill and downhill along the experimental section of the flow loop.

- Two pressure sensors were carefully positioned, one at the inlet's start downhill and another toward the outlet of the flow loop, uphill. These sensors were integrated into the LabView Data Acquisition system to facilitate precise data collection.

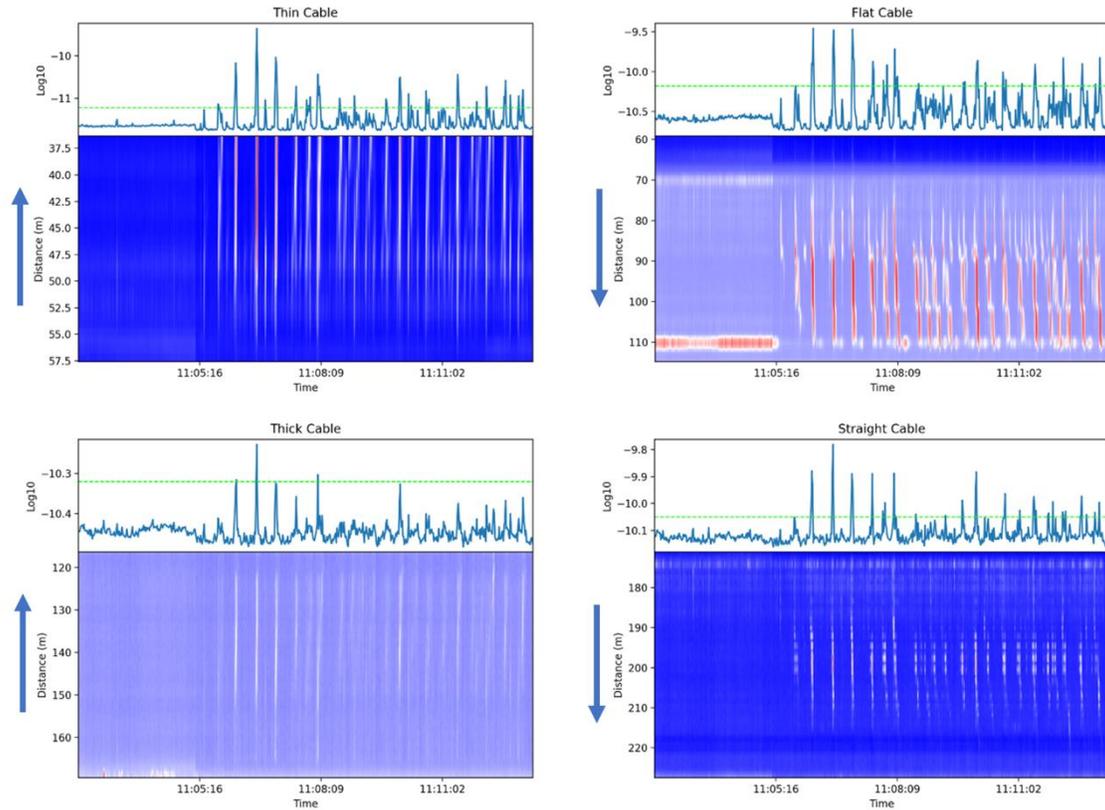
Figure 3. Waterfall plots of processed DAS data, standard deviation DAS data for every second per channel, for the thin, flat, thick, and straight cable designs. Top plots on top of waterfall plots show the average standard deviation of the channels that correspond to the different cable designs. The high standard deviation log-scaled values correspond with slugs observed in the multiphase flow. The air flow velocity changes from 8 to 6 m/s at around 11:05:16. Before this time, the flow is stratified flow without any slugs. After this point, slug flow appears.

- Field observations revealed distinct flow behaviors. Stratified flow was observed within velocities ranging from 18 m/s to 8 m/s, while intermittent slugging occurred at velocities ranging from 6 m/s to 2 m/s. Different cables effectively captured this slugging behavior, as evident in Figure 3.
- Processed DAS data allowed for the precise identification of slugs, which was correlated with data from pressure and flow meter sensors. Figure 4 demonstrates a good correlation, with high values corresponding to slug presence.
- The sensitivity of various cable types was evaluated by comparing a single channel near each pressure sensor for each cable type. Figure 5 reveals that flat cables exhibited the highest sensitivity, followed by thin, straight, helical, and thick cables.

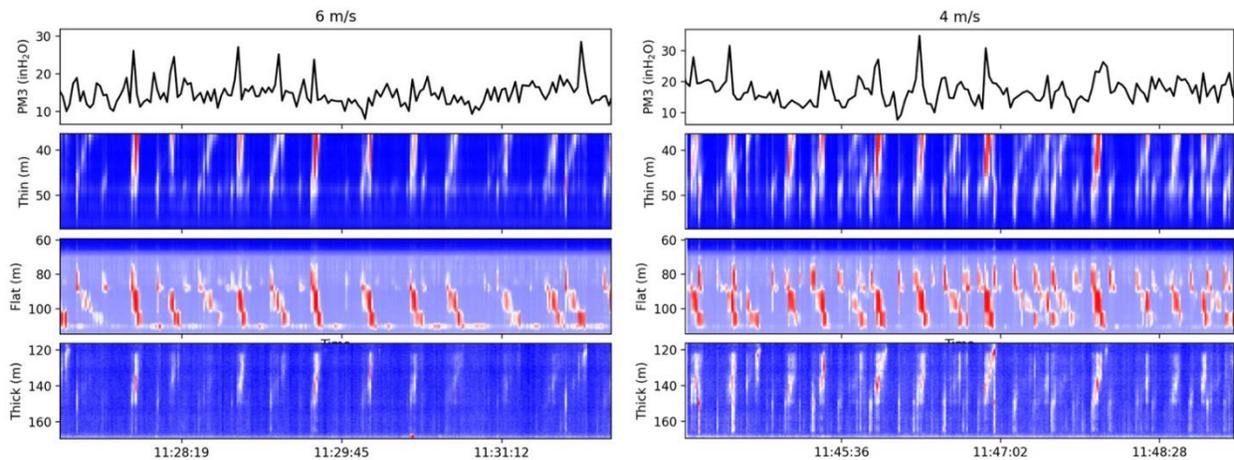
Figure 4. These waterfall plots include the cable sections for the thin, flat, and thick cable designs for different air flow rates (6, 4, and 2 m/s). The top plots are the corresponding pressure measurement in the middle of the uphill section. Overall, the slug signal from DAS corresponds well with that from the pressure measurement.

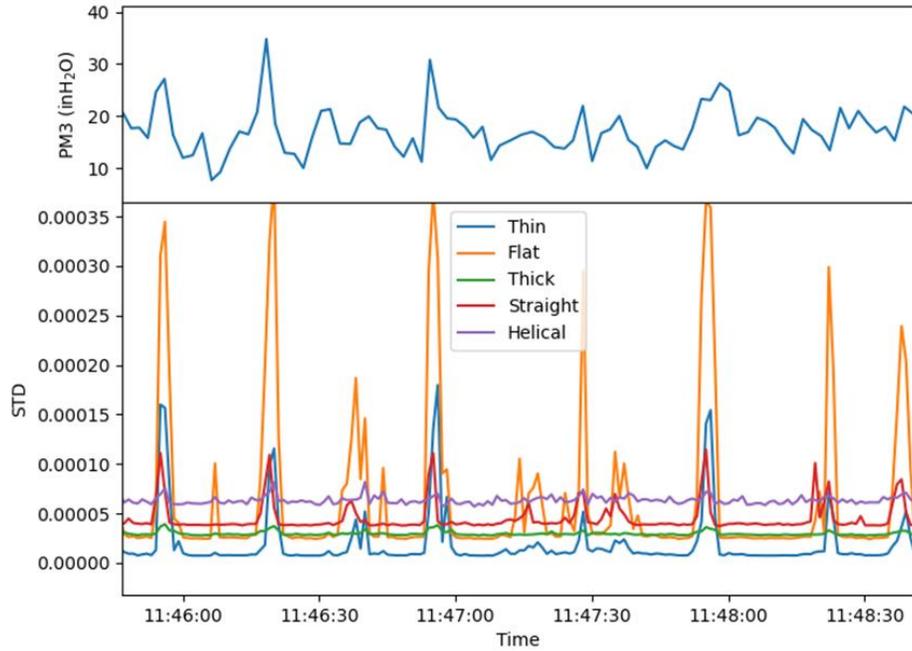
Figure 5. The bottom plot shows the single trace at location near uphill pressure sensor location for each cable design - thin, flat, thick, straight, and helical cables of processed DAS data. The top plot is the corresponding pressure measurement. Here, we can observe that the flat cable has the largest sensitivity to slug detection, followed by the thin, straight, helical, and thick cables.

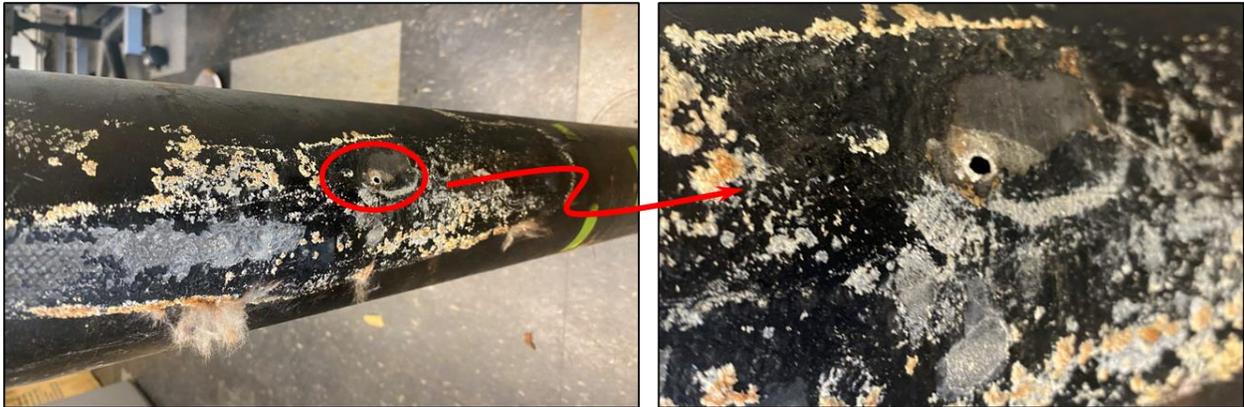
Figure 6. Photograph of the pipe bottom with breakthrough spot

In this task, our primary focus, in line with the results reported in the previous quarterly report, was directed towards increasing the depth of corrosion within the 1-m section. Our efforts were initially centered on the creation of a new corroded 1-m section with a target depth of approximately 5.8 mm while keeping in mind that the pipe wall thickness stands at 6.019 mm. As illustrated in Figure 6, the corrosion induced by the hydrochloric acid penetrated the pipe wall at the bottom of the pipe (6 O'clock position), resulting in a minor leakage spot measuring approximately 2 mm in diameter. These outcomes are consistent with our earlier reported hypotheses and results for several reasons:

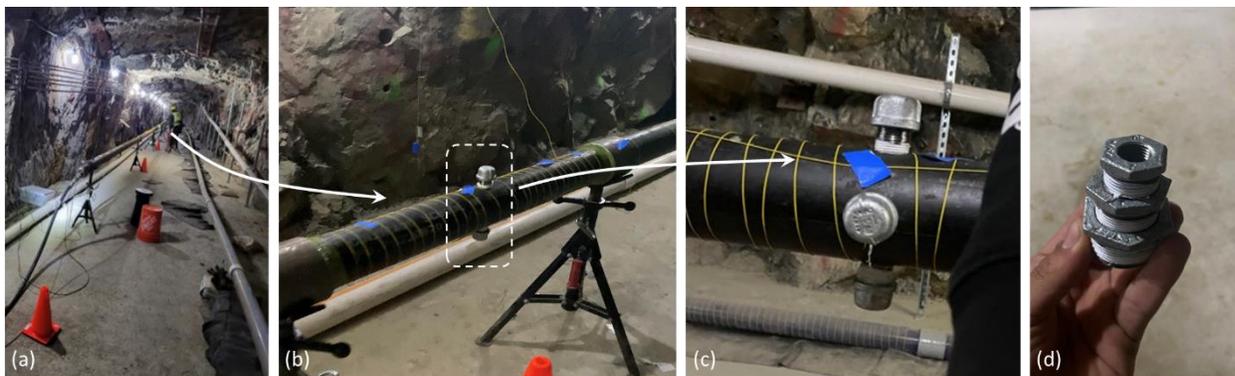
Figure 8. (a) A picture of the facility; (b) 1-m test section for leakage detection; (c) holes with caps on the 1-m test section; (d) reducers for hole size control

During the past period, we repeated the leakage tests using a 1-m test section with 1-in. holes at three different positions to simulate the leakage at different orientations. With reducers, we were able to test four leakage sizes, namely $\frac{1}{4}$ ", $\frac{1}{2}$ ", $\frac{3}{4}$ ", and 1". A picture of the facility is shown in Figure 8. Five gas flow rates, 2, 6, 10, 14, 18 m/s, were tested. We also did the experiments at the same flow rates but without any leakage, which is referred to as the control tests thereafter.

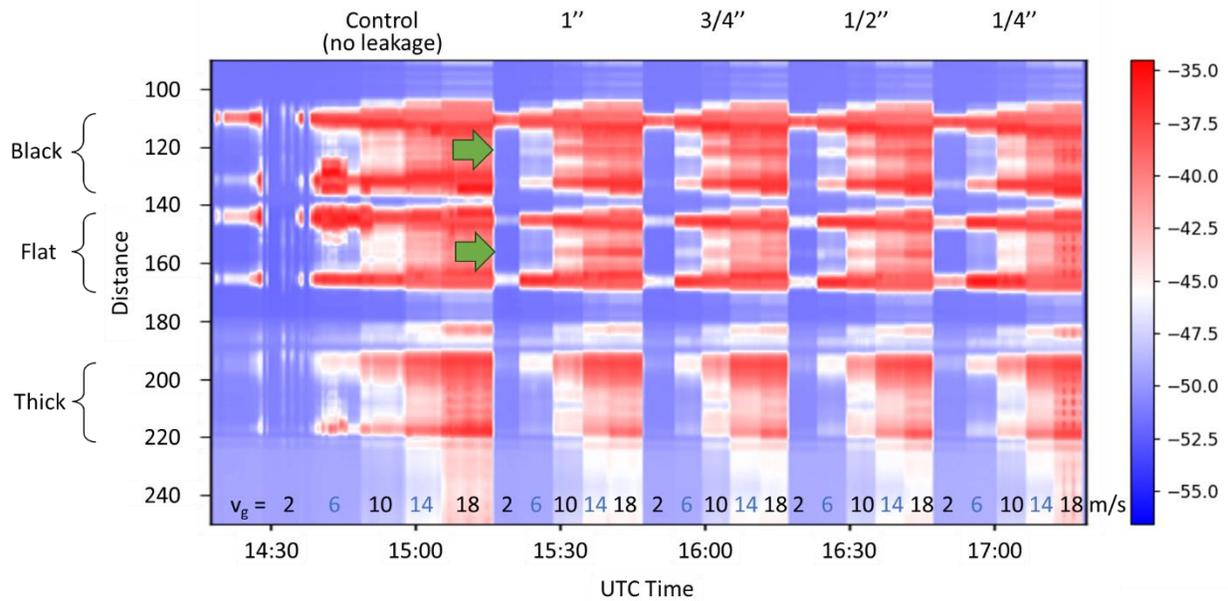
Figure 9: Magnitude of standard deviation values along the fiber during the experiment on August 17th, 2023. For each hole size, the flow rate changes from 2, 6, 10, 14 and 18 m/s. The gas velocities are indicated at the bottom of the image.

During this task, the DAS data were recorded at a frequency of approximately 5600 Hz along a 480-meter fiber, generating a substantial volume of data in a short period. For instance, the three-hour recording session yielded over 150 GB of DAS data. Due to its size, this data set requires pre-processing before any meaningful analysis can be conducted. The first processing we conducted was based on the standard deviation (STD). We segment the data set into one-second intervals and compute the STD for each channel within each second. These STD values are then concatenated into a continuous data set with a 1 Hz sampling rate. This method allows for a data reduction factor of 5600, equivalent to the original sampling rate. Figure 9 provides an illustrative example of the STD data attributes during an experiment involving bottom leakage holes. In this figure, a higher value (depicted in red) signifies a larger standard deviation at a specific time and location along the sensing fiber, which in turn is indicative of higher vibration intensity experienced by the cable section.

The figure displays the vibration intensity for three distinct types of cables during the experiment conducted on the same day. The study commenced with a control experiment featuring no leakage, followed by the sequential introduction of 1", $\frac{3}{4}$ ", $\frac{1}{2}$ ", and $\frac{1}{4}$ " leakage holes at the bottom of the test pipe. For each hole size, flow rates of 2, 6, 10, 14, and 18 m/s were examined. Figure 9 clearly reveals variations in fiber vibration intensity at different flow rates, with higher flow rates inducing stronger vibrations across all cable types.

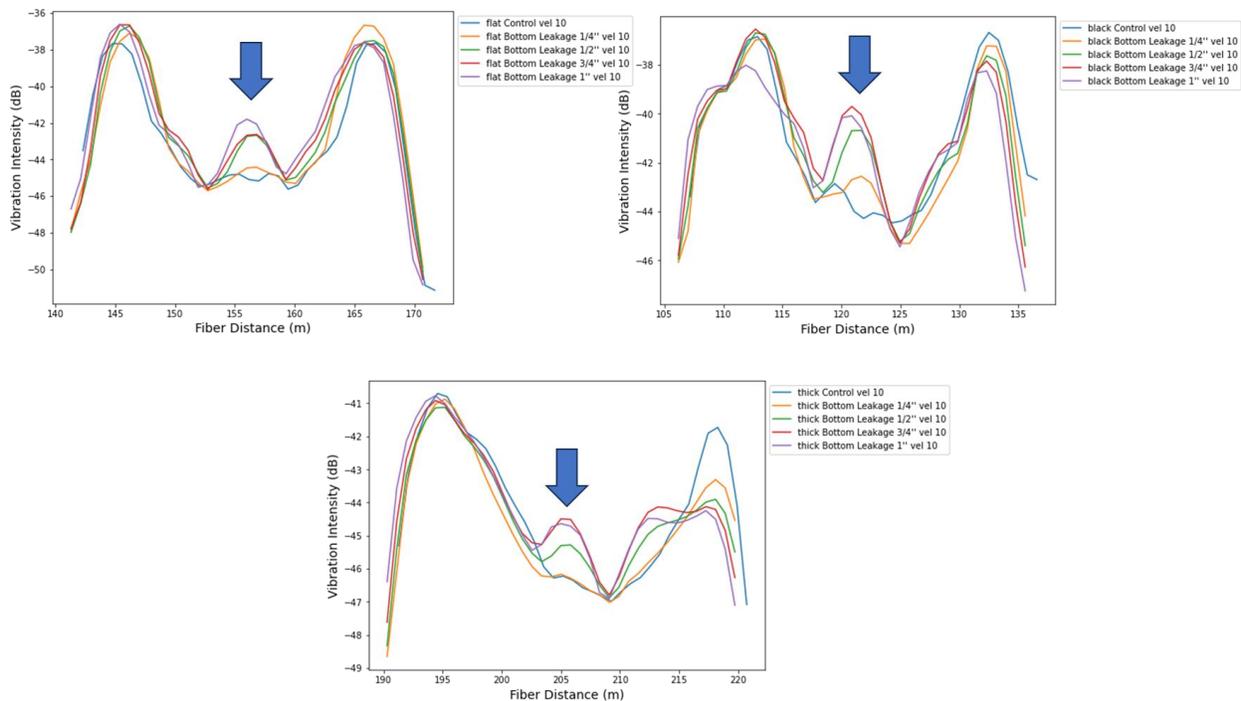
Figure 10: vibration intensity profiles in flat (upper left), black (upper right), and thick (bottom) fiber sections during the leakage experiment. The different curves represent vibration intensities associated with varying leakage hole sizes at a flow rate of 10 m/s. Anomalies in vibration, induced by leakage holes and marked by blue arrows, are observable in all three cable types when the hole size exceeds 1/2 inch.

Figure 10 showcases the sensitivity of different cables to varying leakage sizes. At a flow rate of 10 m/s, all three cable types can detect a vibration anomaly when the leakage hole is larger than $\frac{1}{2}$ ".

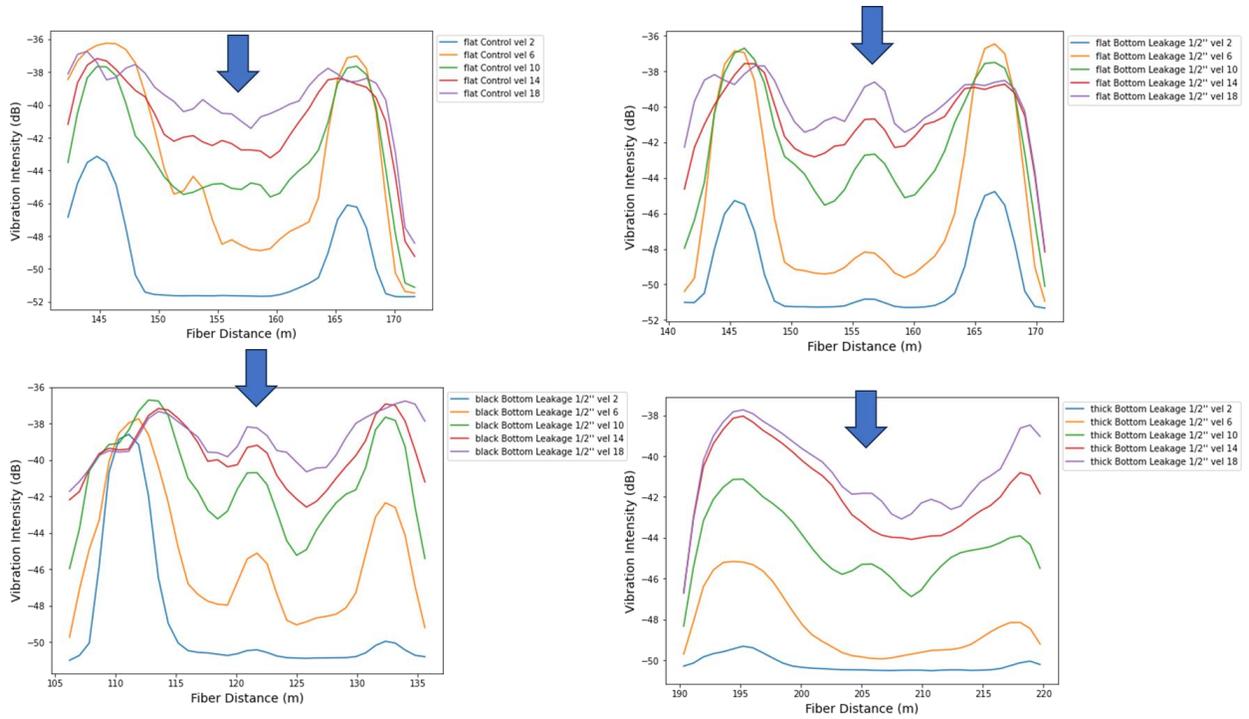
Figure 11: This figure compares the leakage detection sensitivity across different cable types at varying flow velocities. Top left shows a flat cable without leakage as a control experiment. Top right features a flat cable with a leakage hole size of 1/2 inch. The bottom left and bottom right sections present the black cable and thick cable with the same leakage size, respectively.

Leakage detection sensitivity is also influenced by the gas flow rate within the pipe. Figure 11 illustrates the vibration distribution along each internal fiber cable at different flow rates. For instance, in the control experiment, vibration intensity escalates with increasing flow rates for the flat cable, and no vibration anomaly is observable at the pipe's center. Conversely, in the experiment with a $\frac{1}{2}$ " leakage hole, a vibration anomaly is observable at all flow rates for both flat and black cables, whereas for the thick cable, the anomaly is only evident at 10 m/s.

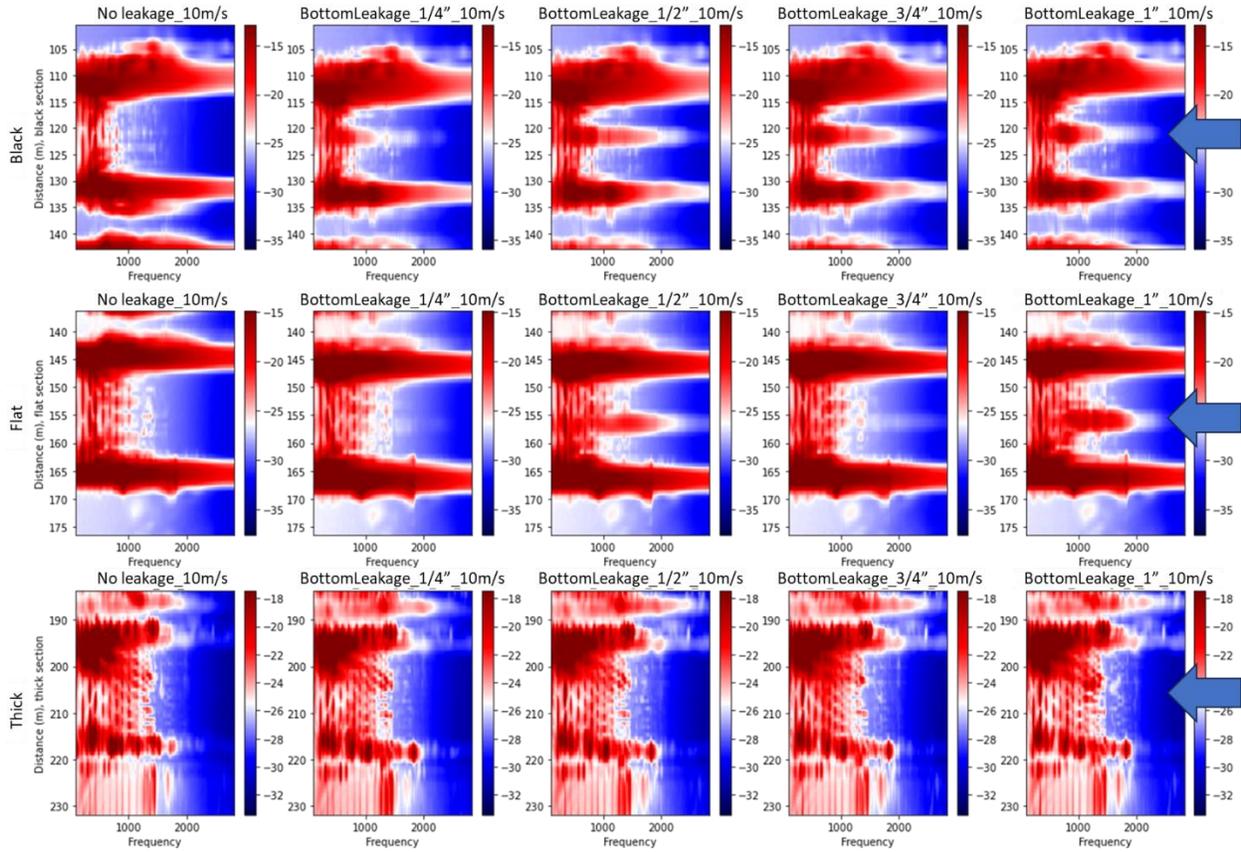
Figure 12: 2D spectra of fiber sections with varying leakage hole sizes at the bottom of the pipe, measured at a flow rate of 10 m/s. The top row displays the black cable section, the middle row showcases the flat cable section, and the bottom row features the thick cable section. Columns from left to right represent the control experiment (no leakage), followed by leakage sizes of 1/4", 1/2", 3/4", and 1", respectively. The color scale is measured in dB. Blue arrows show the leakage point location.

Figure 12 illustrates the 2-D spectra obtained from experiments involving various leakage sizes at the bottom of a pipe with a flow rate of 10 m/s. High amplitude spectra are conspicuously evident near the leakage points (indicated by blue arrows in Figure 12) for most cases involving black and flat cables. However, the leakage point is less identifiable in the spectra of thicker cables.

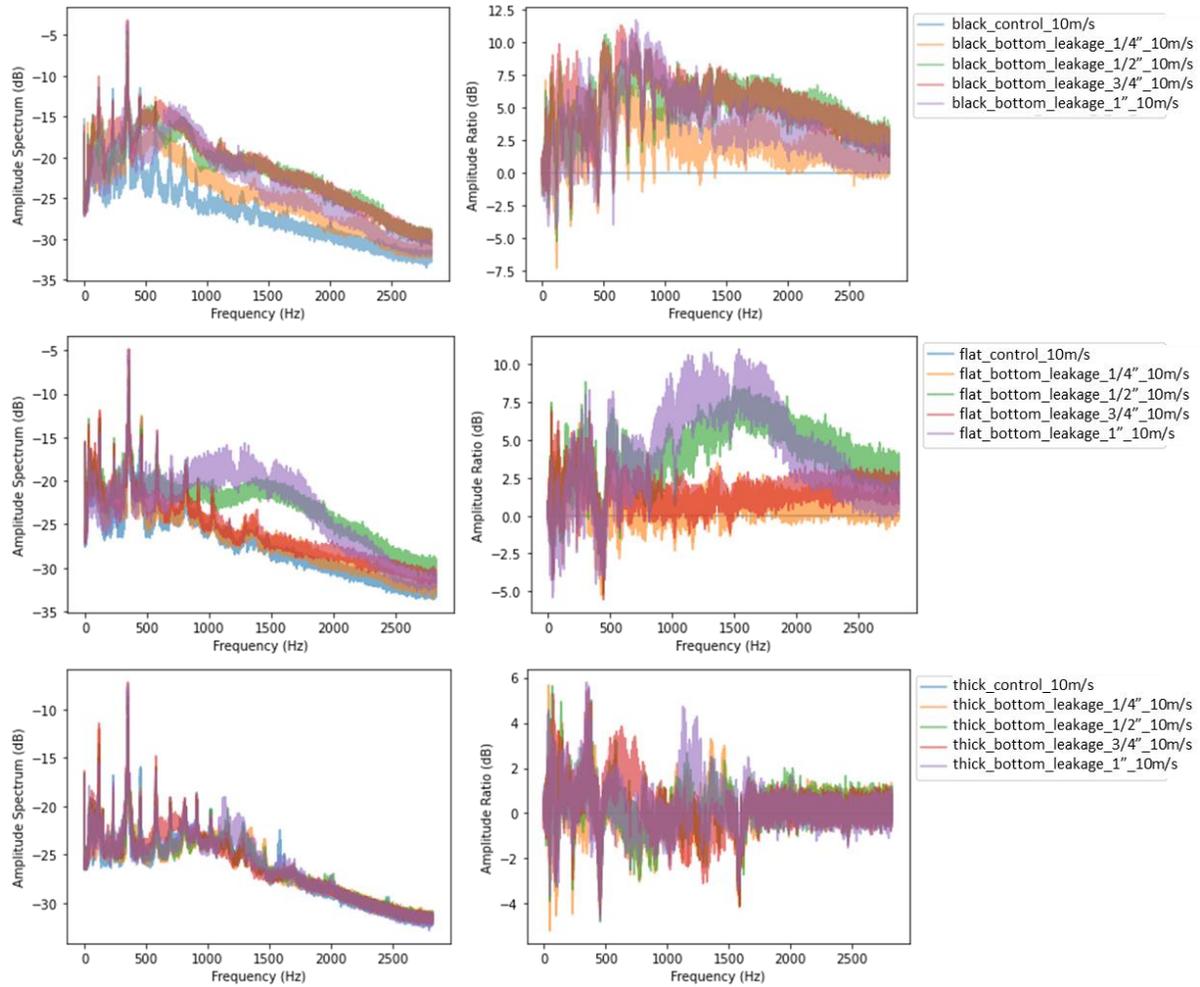
Figure 13: Amplitude spectrum at leakage point locations for various cables and leakage sizes. The flow rate is 10 m/s. The first row displays results for black cables, the second row for flat cables, and the third row for thick cables. The left column shows the amplitude spectrum, while the right column presents the ratio of amplitude spectrum between leakage experiments and the control experiment. All values are expressed in decibels (dB).

To visualize the amplitude spectrum induced by the leakage more clearly, we extracted the amplitude values corresponding to the leakage location from the 2D spectra and plotted them against frequency. Figure 13 presents the amplitude spectrum for experiments with different leakage sizes, all at a flow rate of 10 m/s. The right column of Figure 13 shows the amplitude ratio between the leakage and control (no leakage) experiments. Our findings indicate that the vibrational anomalies caused by leakage span a broad spectrum. For black cables, we observed up to a 10 dB increase in amplitude across most of the measured frequency range at the leakage point compared to the no-leakage scenario.

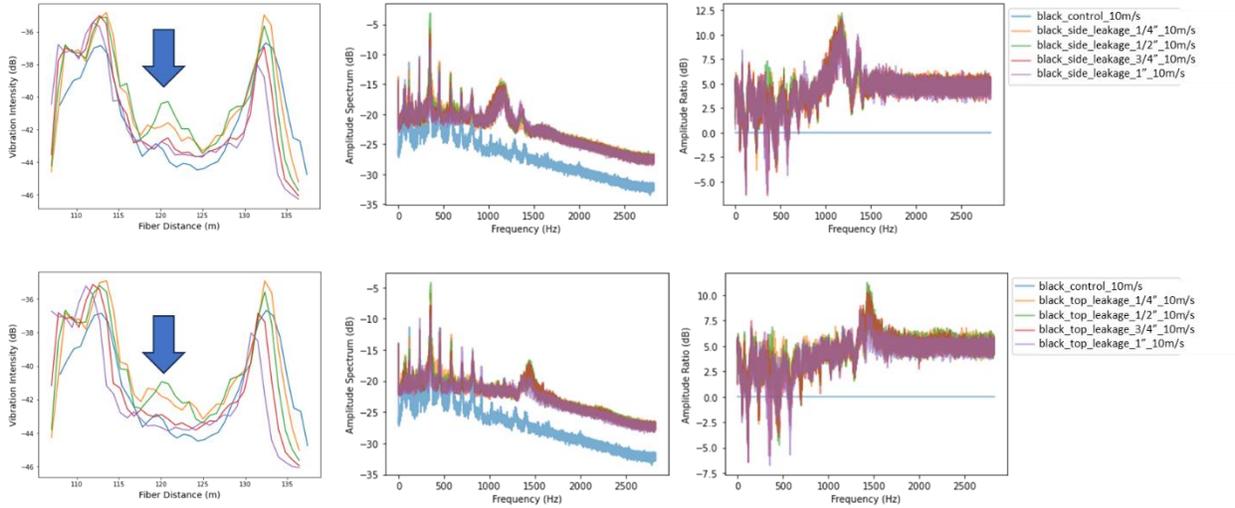
Figure 14: Results from experiments with the black cable where leakage points were introduced at the side and top of the pipe. Top row: side leakage experiments. Bottom row: top leakage experiments. Left column: vibration intensity profiles with varying leakage sizes. Middle column: amplitude spectra at the leakage points. Right column: amplitude ratio between the leakage experiments and the control experiment. The leakage experiments were conducted on different dates than the control experiment, and the fiber was respliced between experiments.

The same analysis was carried out for experiments in which leakage points were introduced at the top and side of the steel pipe. Because these experiments were conducted on different dates from the control experiment, the DAS instrument was disconnected and then re-spliced to the sensing fiber. This action led to a change in the measurement noise floor. Figure 14 presents a comparison of vibration intensity and spectrum analysis for the black cable in both the side and top leakage experiments, conducted at a flow rate of 10 m/s.

We observed that, based on the vibration intensity, spatial identification of the vibration anomaly becomes more challenging for the top and side leakage experiments. Stronger anomalies seem to be associated with smaller leakage sizes, but this trend was not observed at other flow rates or with other cables. The amplitude spectrum results revealed variations in noise levels, which are likely due to the re-splicing of the fiber. Increased amplitude was noted around 1200 Hz for side leakage and 1500 Hz for top leakage. At this stage, it is unclear whether these amplitude increases were induced by the leakage itself.
