# PHMSA Quarterly Report – Public Page

**Date of Report:** *3<sup>rd</sup> Quarterly Report-June 20th, 2024*

**Project Title:** *Dual Purpose PIG for Cleaning and Internal Integrity Assessment for Hazardous Liquid Pipelines*

**Prepared by:** *North Dakota State University and Stevens Institute of Technology*

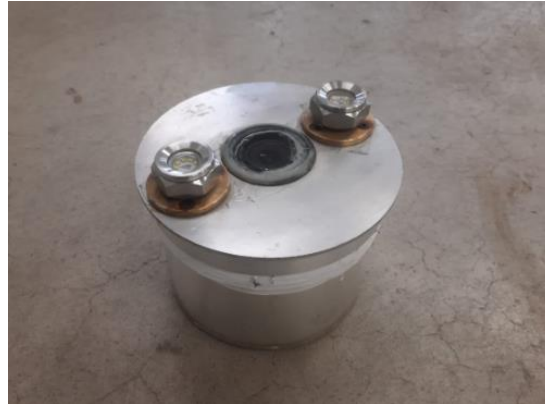
The fabrication of CAV.v.1, using aluminum was completed. The device (Figure 1) comprises of two parts including the cover and the cylindrical body. The cover weighs 0.669 pounds, while the cylindrical body weighs 1.04 pounds.

Figure 1 The first iterative attachment fabrication with light, camera and tempered glass attached

The accessories procured, some of which were already described in Report #2 were thereafter assembled with the device in order to create a watertight component which was then attached to the PIG.

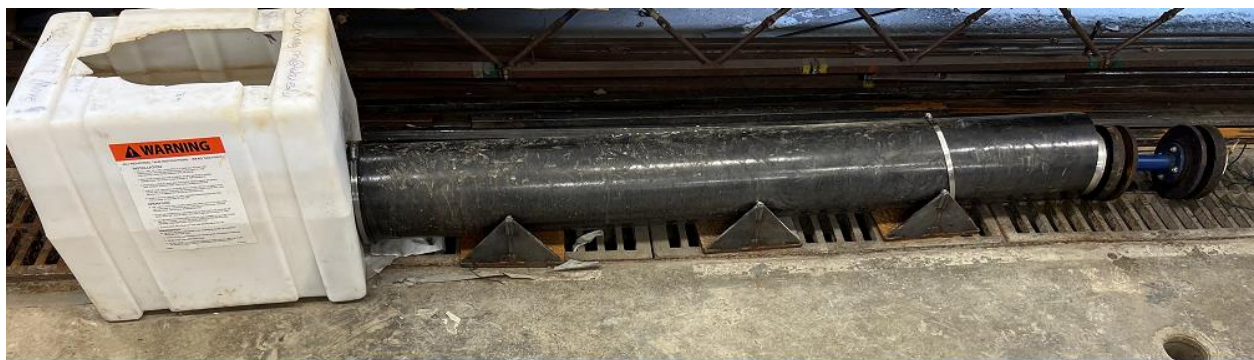
The preliminary testing of the assembly (Figure 2) was carried out so as to start gathering preliminary images and also come up with ways of improving and optimizing the device. The facility for the test was set up in our laboratory. The set-up includes an 8 in carbon steel pipe, connected to a tank with the use of epoxy to prevent leakage.

Figure 2 Preliminary lab test set-up

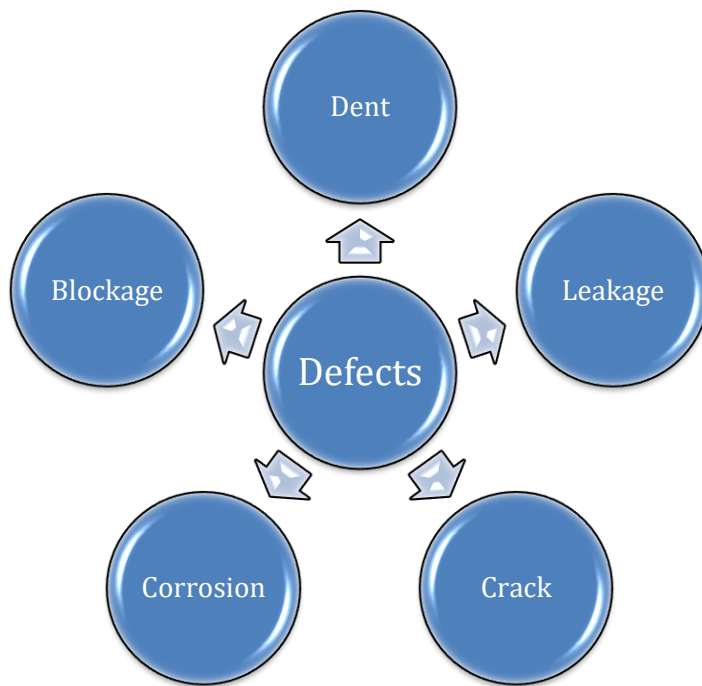
Figure 3 the various types of defects to be simulated

The test was carried out to check the capacity of the camera to gather images of various defects in different pipe conditions and light orientations and also the enable us to see how water tight the device

is. The details of the defects, pipe condition and light orientation tested and to be tested are shown in the Figures 3-5, respectively.

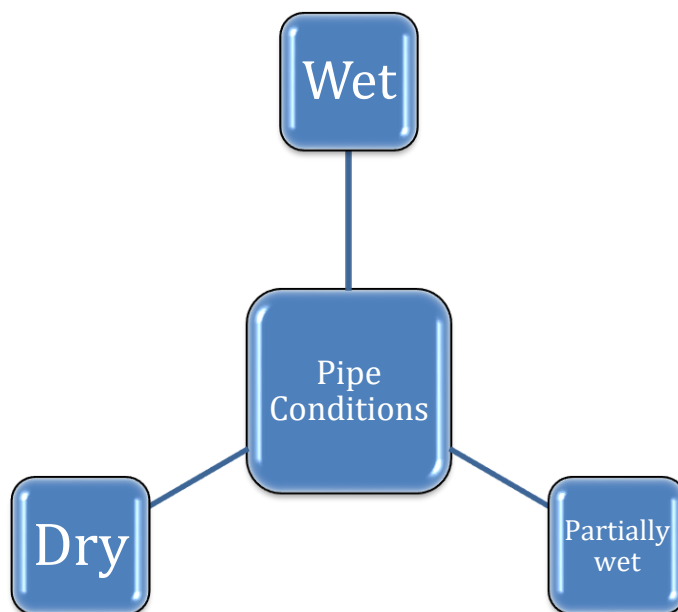
Figure 4 various pipe conditions to be simulated

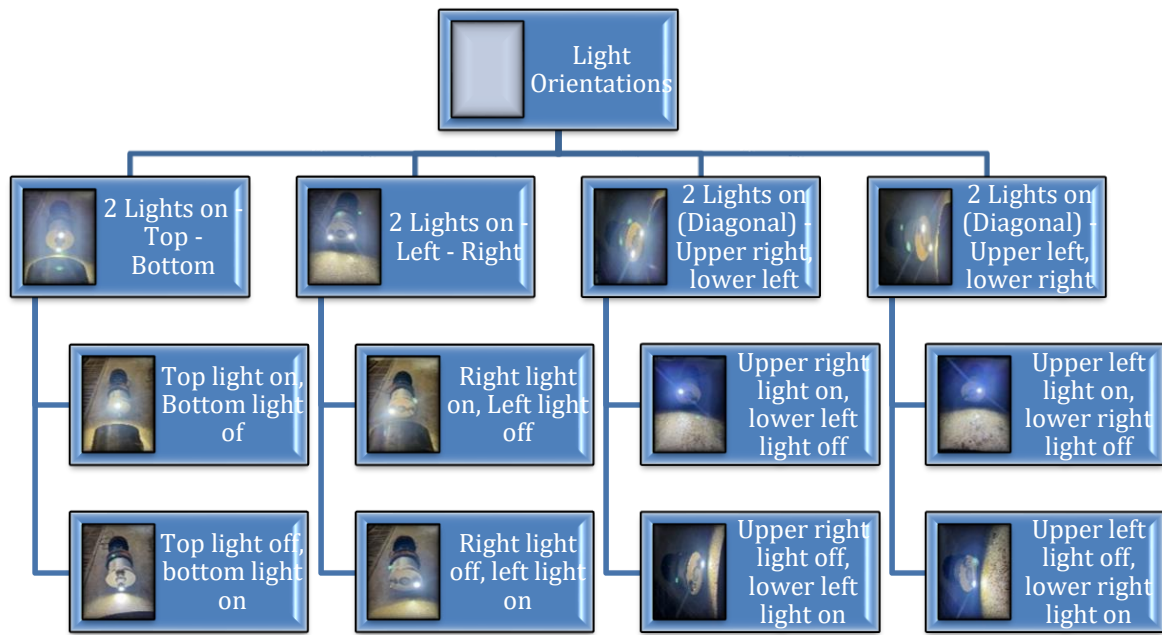
Figure 5 various lights orientations that were considered

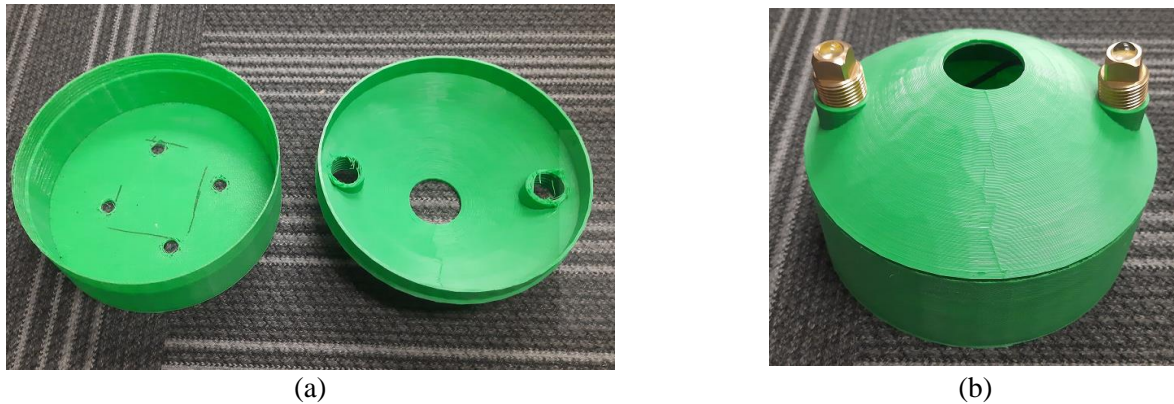
We continued to improve the design of the attachment to CAV.v.2 to reduce the flow resistance from the pipeline to have a dome shape for the attachment as shown in Figure 6.

Figure 6 Trial design 3D model print for version 2 (a) separated (b) overall sketch

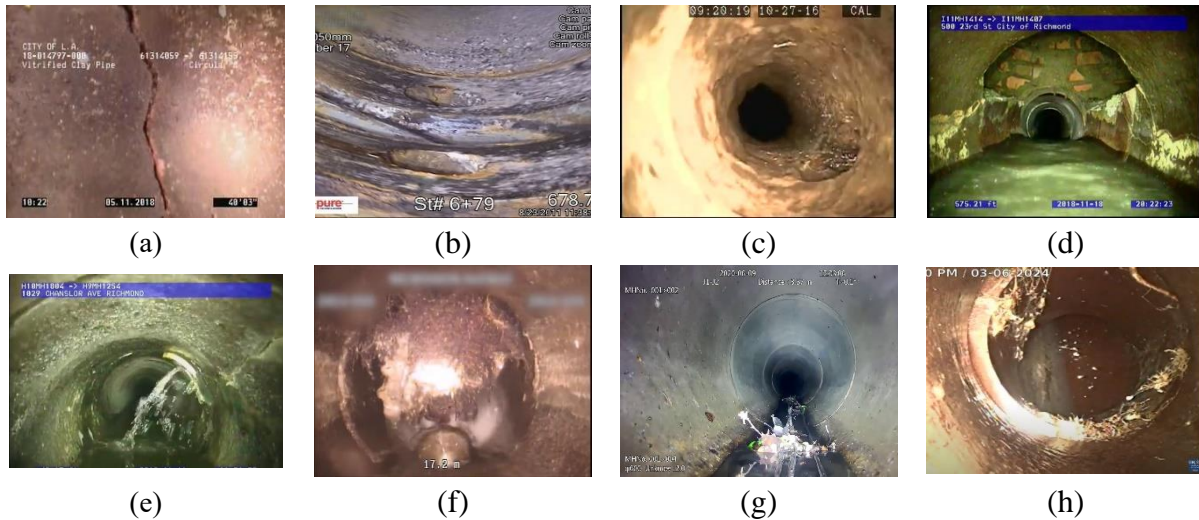
variables, including the presence of low light, the motion of the camera, and the fact that the camera was submerged in liquids. Figure 7. shows some of the instances of the collected images.

Figure 7 Representative pipeline anomalies: (a) crack [1] ,(b) dent [2], (c) corrosion [3], (d) broken pipe [4], (e) leakage [5], (f) blockage [6], (g) settled deposit [7], (h) root intrusion [8].

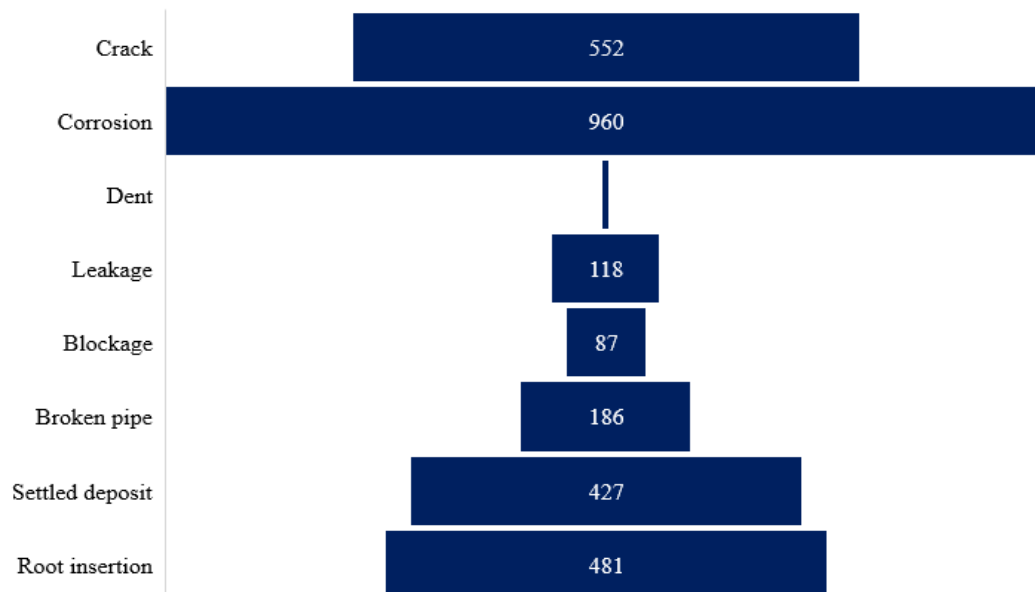
The total number of images that were acquired were greater than 5000 in total, after the images that were deemed to be of no use were removed. Leaks, settled deposits, cracks, corrosion, dents (less than 10 instances), broken pipe, root insertion, and blockage are the seven categories of defects that were observed in the pipes that were gathered. Additionally, there were over two thousand images of the pipelines in their normal conditions that were also included in the collection. Following the completion of the data cleaning process, the following is a list of the final number of photos for each defect in Figure 8.

Figure 8 Number of collected images
